PROJECT TUGBOAT: EXPLOSIVE EXCAVATION OF A
HARBOR IN CORAL

February 1972

TECHNICAL REPORT E-72-23

U. S. Army Engineer Waterways Experiment Station
Explosive Excavation Research Laboratory
Livermore California

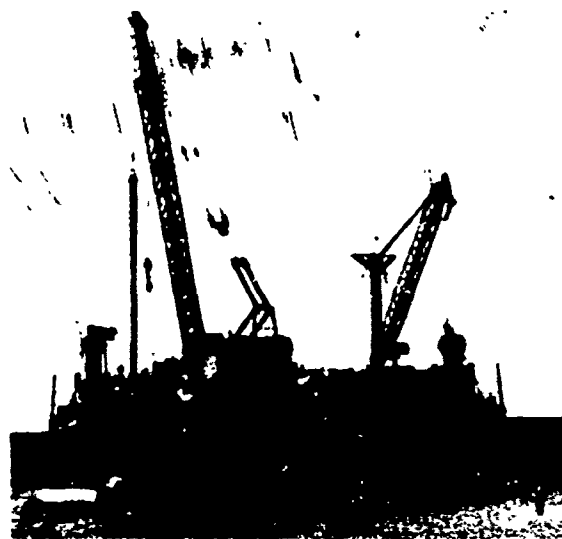
Fig. 20. Drilling platform used during Phase II emplacement construction.

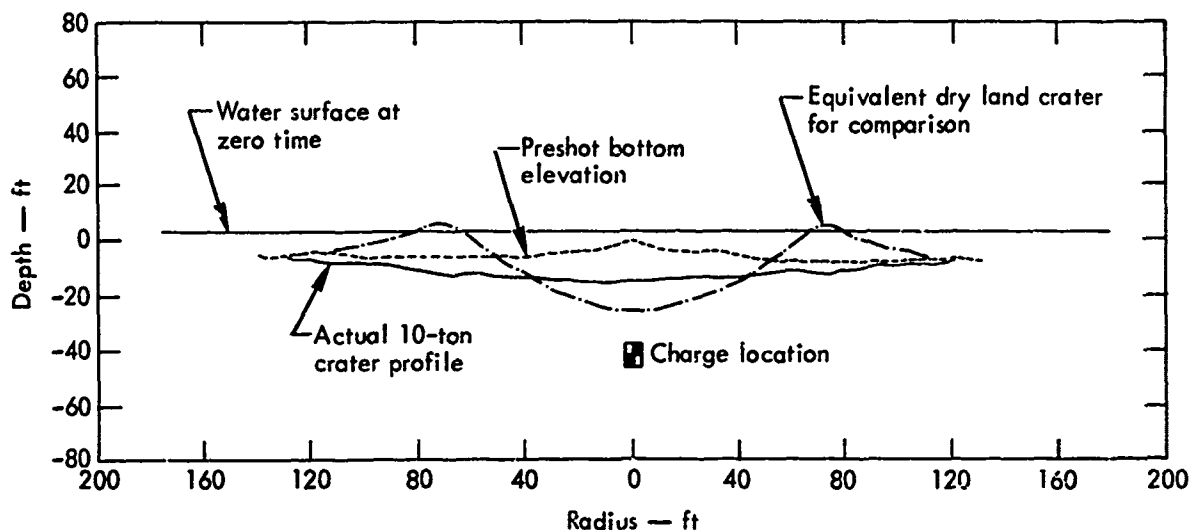
Fig. 40. Comparison of 1e (Echo) crater profile with dry land crater profile having dimensions assumed in the preliminary design.
