AIR CUSHION VEHICLE EVALUATION. SAN  
FRANCISCO, CALIFORNIA, ST. IGNACE,  
MICHIGAN, MILFORD HAVEN, VIRGINIA,  
TRANSPO 72. 1 SEPTEMBER 1971-30 JUNE 1972.

## AIR CUSHION VEHICLE EVALUATION

EU 3960-02

1 September 1971 - 30 June 1972

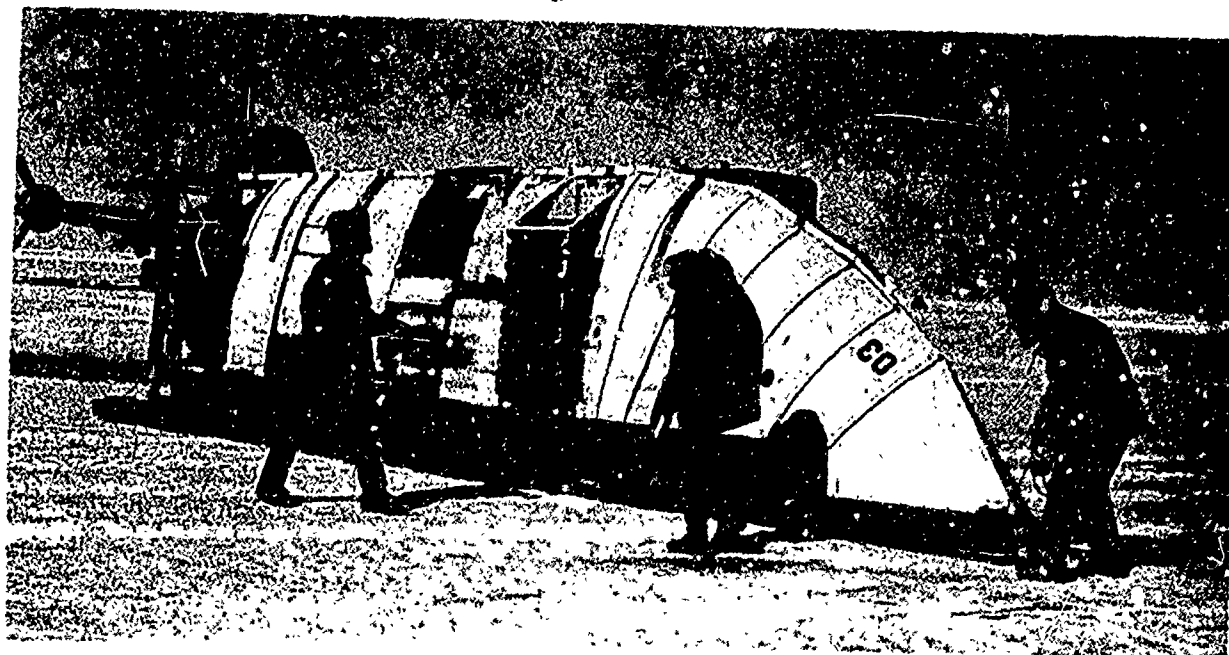
Figure A-2

Craft disassembled into three basic components

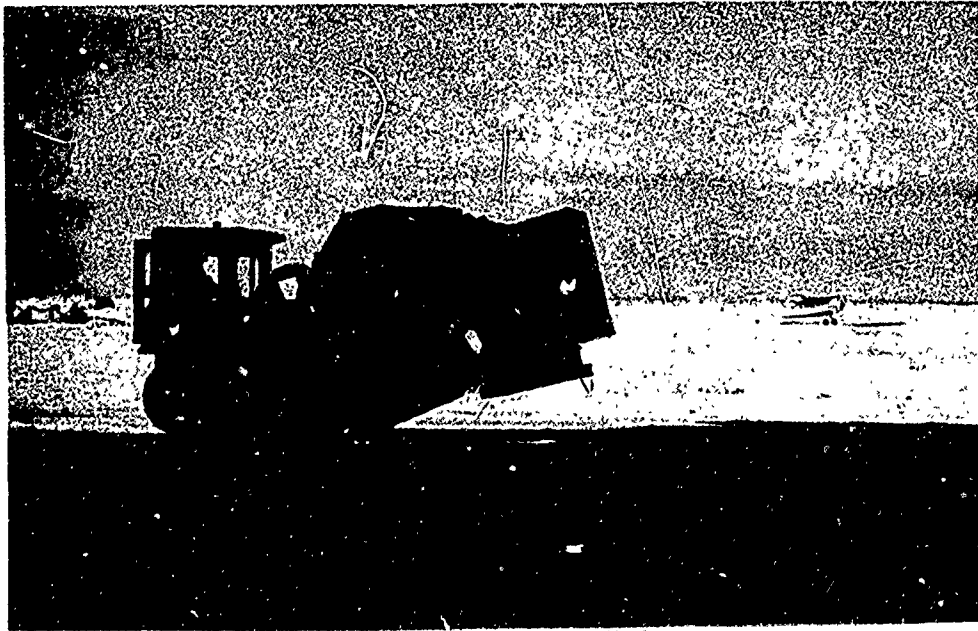
Figure A-3

Side body secured to shipping skid

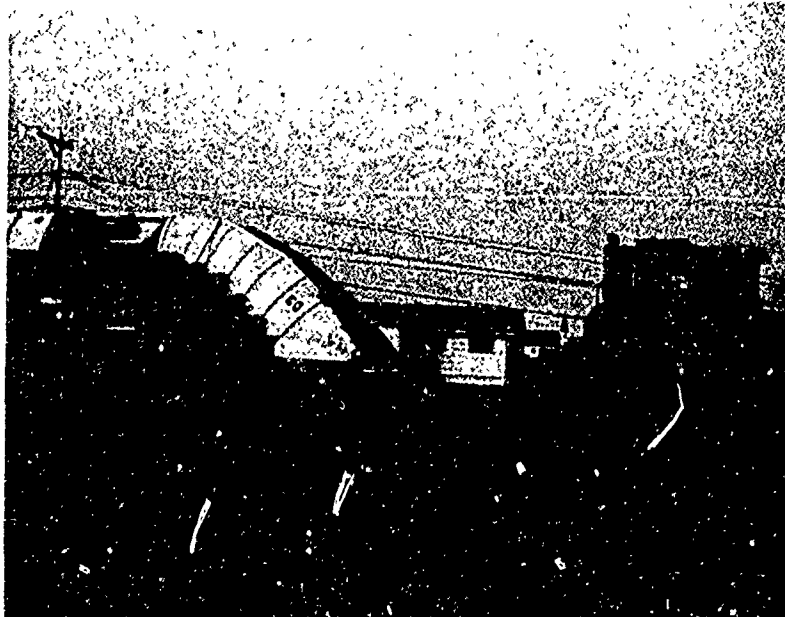
Figure A-4

Side body loaded on sled with fork lift.

The craft components were transported to the airport on cargo sleds.

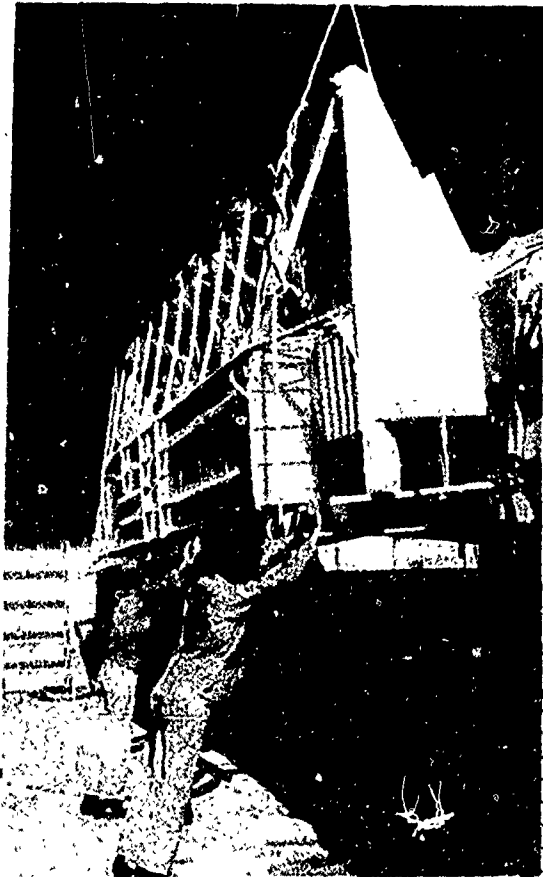
Figure A-9

Positioning side bodies  
on flatbed trailer

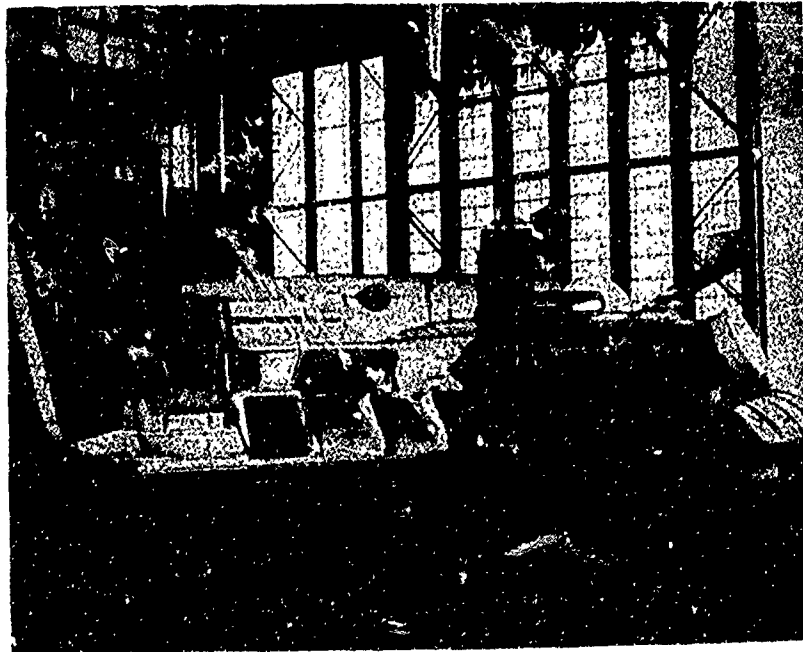
Figures A-12 & A-13  
The facility & equipment provide by NAS Norfolk, made  
reassembly of the craft a relatively simple task.

facility at NAS Norfolk was utilized for the assembly area, figure A-12. Fork lifts and cranes used in the assembly, figure A-13, were provided by the Navy.

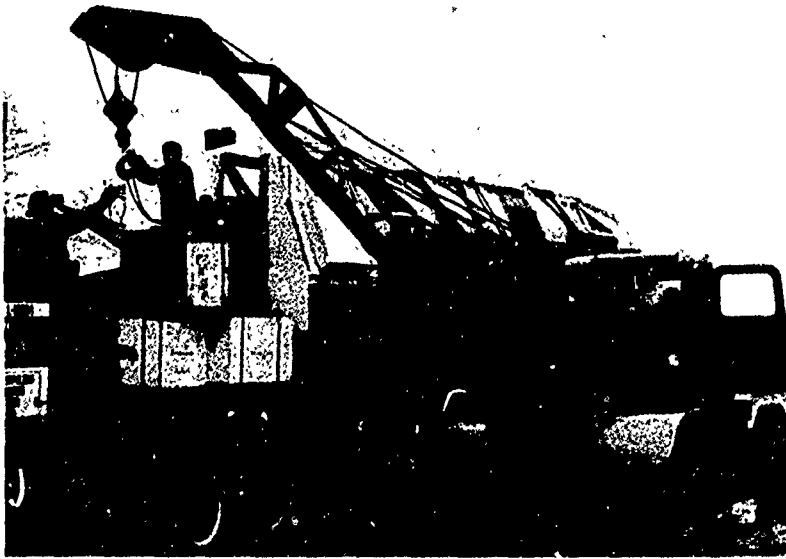
Figure A-16  
Side bodies were  
transported one  
hundred yds, via  
crane, to the  
road transport.

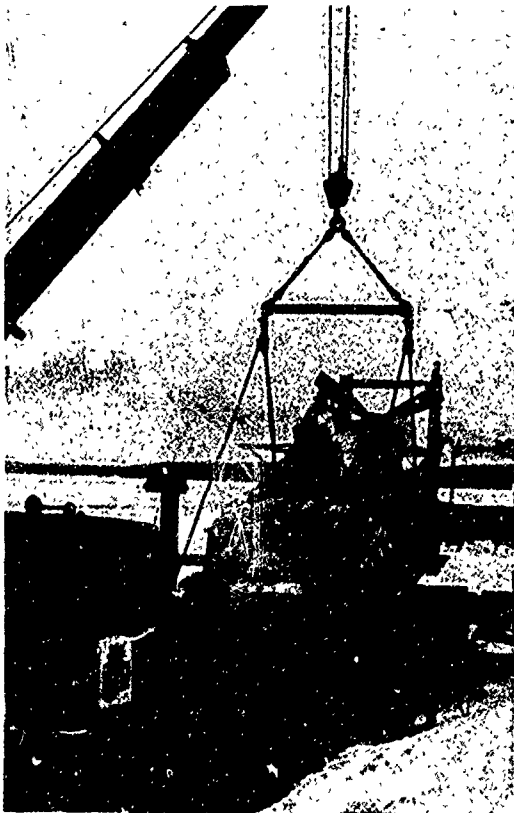
Figure A-17  
Excess space  
on side body  
load utilized  
for transport  
of support  
equipment.

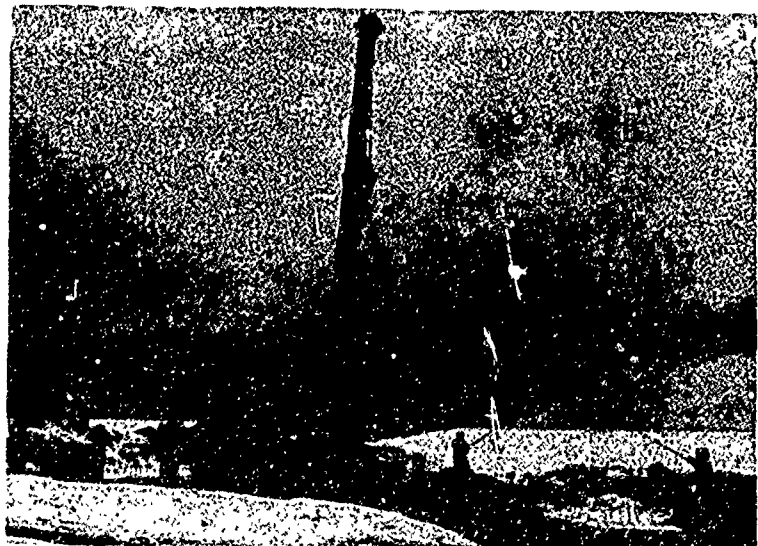
Figures A-18 & A-19  
Center body transported, via  
crane, to awaiting low boy  
transport.

The loading of the center body was slightly more involved than in past situations. The low boy truck, when extended, could be parked no closer than one hundred and fifty yards from the craft. This required that the center body be transported by the crane this distance, part of which was up a 25% gradient from the ramp area. Guide lines were secured to each of the craft's four corners to control the craft movement, A-18. The center body was loaded on the low boy,

figure A-19, and secured. The APU and main skirt were loaded on unused areas of the truck to complete the load.

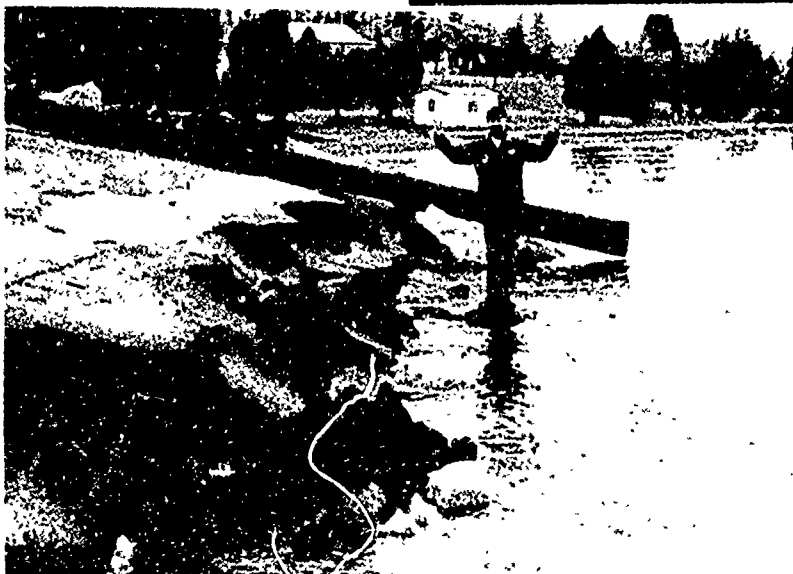
Figure B-4  
Wave action caused  
rapid deterioration  
of ramp.

The initial operations concentrated on familiarizing the crew with the area, the light structures to be serviced, and the approach to the ramp. As early as 14 November, it was noted that the ramp was deteriorating rapidly resulting in an 18 inch lip at the edge.

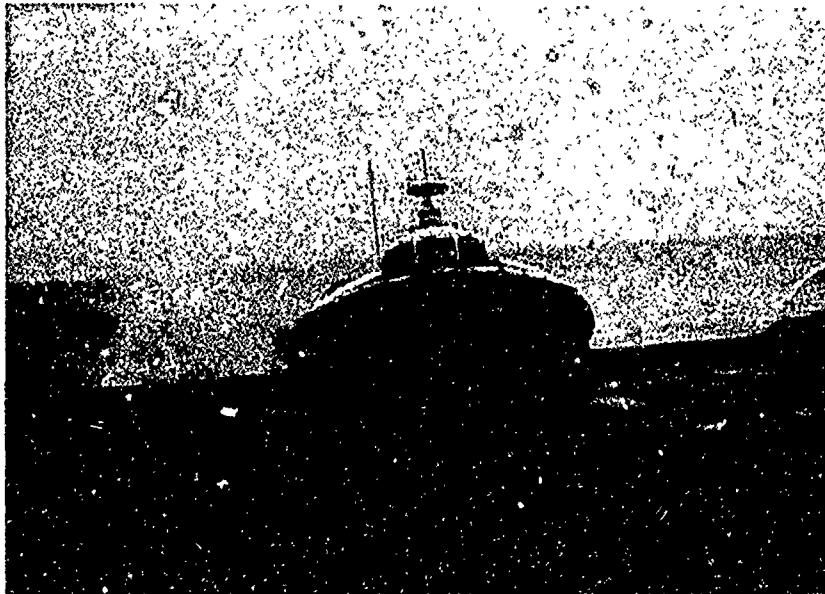
Figure B-6  
ARPA conducts tests  
on ACV 03 at CGAS  
Traverse City.

The craft had sustained considerable damage during the Alaskan operation and shipment south. Repair and refurbishment work was accomplished on a seven day a week schedule until 9 October. The week of 9 through 15 October was used by ARPA to conduct post Arctic evaluation tests on the craft, figure B-6.

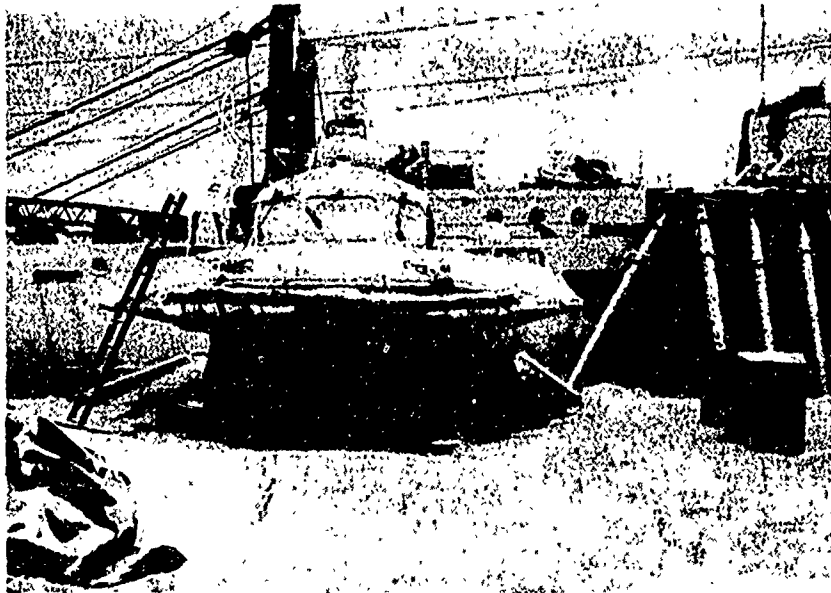
Figure B-9  
Extent of tear in  
peripheral skirt of  
ACV 02.

On Sunday, 6 February, the craft proceeded over the ice south to Cheboygan. ACV 02 successfully negotiated various ice conditions and was proceeding over relatively smooth ice at 35-40 knots when the main skirt tore across the bow and down the starboard side. The rip, which was about 35 feet in length, dumped the air cushion and the craft settled rapidly, though gently, on the ice. The rip was so extensive that temporary repairs could not be made on the ice. The length of the tear is shown with skirt laid out on the hanger floor, figure B-9. Samples of the material were forwarded to Bell Aerospace and the Canadian Department of Transport for analysis.

a. Peripheral skirt tearing most probably is a function of the craft and the ice conditions indigenous to the Great Lakes. Specifically when speaking of "indigenous ice conditions," the ACV had numerous difficulties in negotiating hummocked and wind rowed ice formations. Later in the period, after the various operators became more familiar with this type of formation, they learned to avoid them if possible rather than attempting a transit on a "high hover."

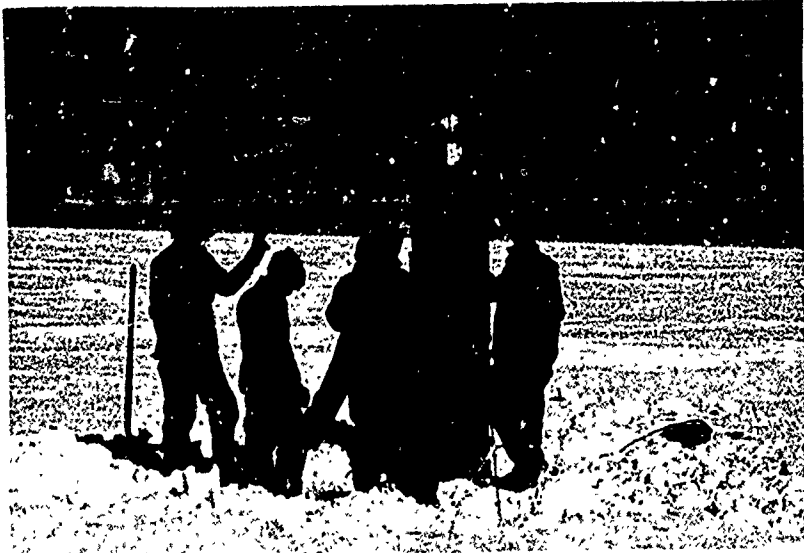
Figure B-10 ACV 02 on barrals next to  
CGC Mackinaw in Cheyboygan, Michigan  
waiting replacement skirt.

The craft was retrieved from the ice by the Cutter Sundew and transported to Cheboygan. The craft was placed on barrels, figure B-10, to affect repairs and remove the skirt. A replacement skirt was shipped from Fort Point but did not arrive until 23 February. The craft was removed from the barrels and made ready for operation; returning to St. Ignace on 25 February.

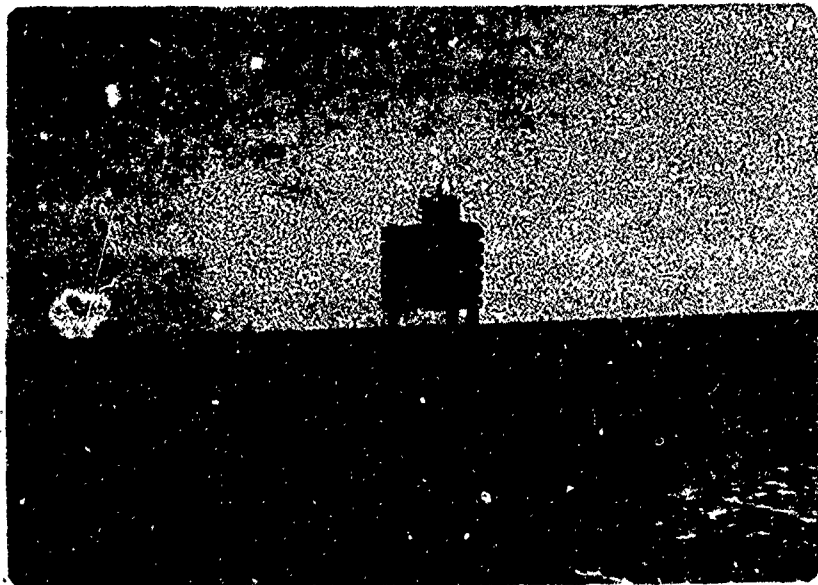
Figures C-4 & C-5

Rapid inspection and repair of ICW aids in shallow water is easily accomplished with an ACV

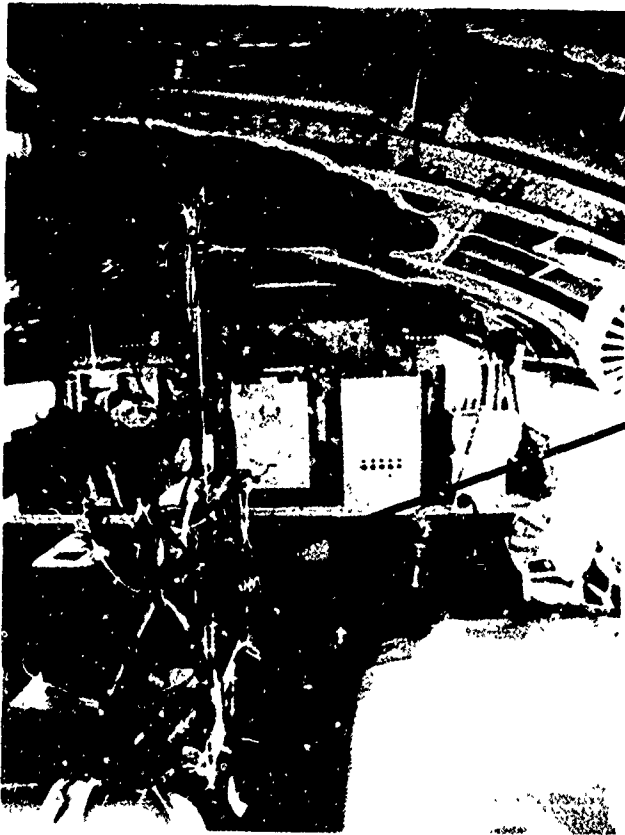
Figure E-1-3

LLTV Electronic Control Package Installed Inside ACV Cabin

The equipment was modified to allow fast and reliable installation on board the ACV. The ACV remained in a Bravo 0 readiness status during the day to respond to District requirements and was placed in a maintenance status at night for installation of the test equipment by NELC engineers. The equipment consisted of a scanner unit and an electronics control package. The crafts observation bubble was removed and replaced with an aluminum plate to which the scanner unit was attached, figures E-1-1 and E-1-2. The rack containing the electronics control package was secured to the existing deck fittings inside the cabin, figure E-1-3. An additional T.V. monitor was installed to the right of the operators control panel, figure E-1-4.

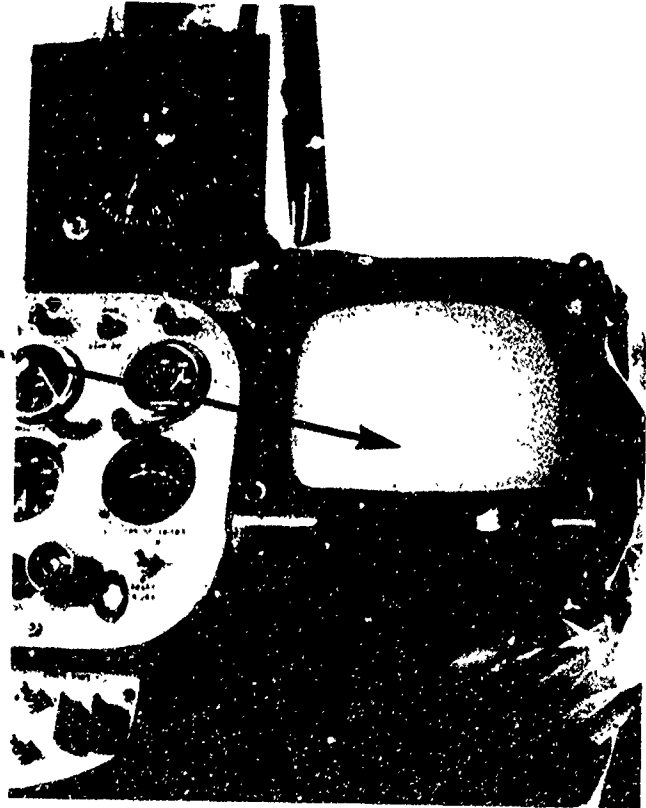
Figure E-1-4

T.V. Monitor Mounted on the Side of Operators Control Panel

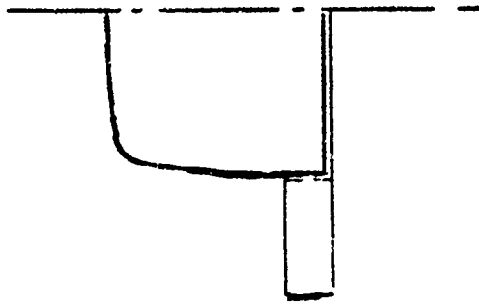
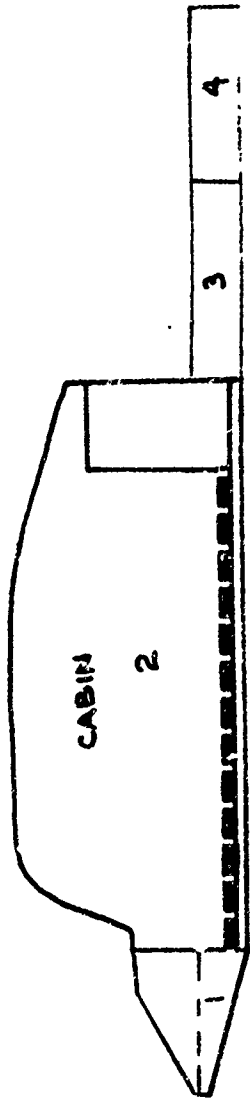
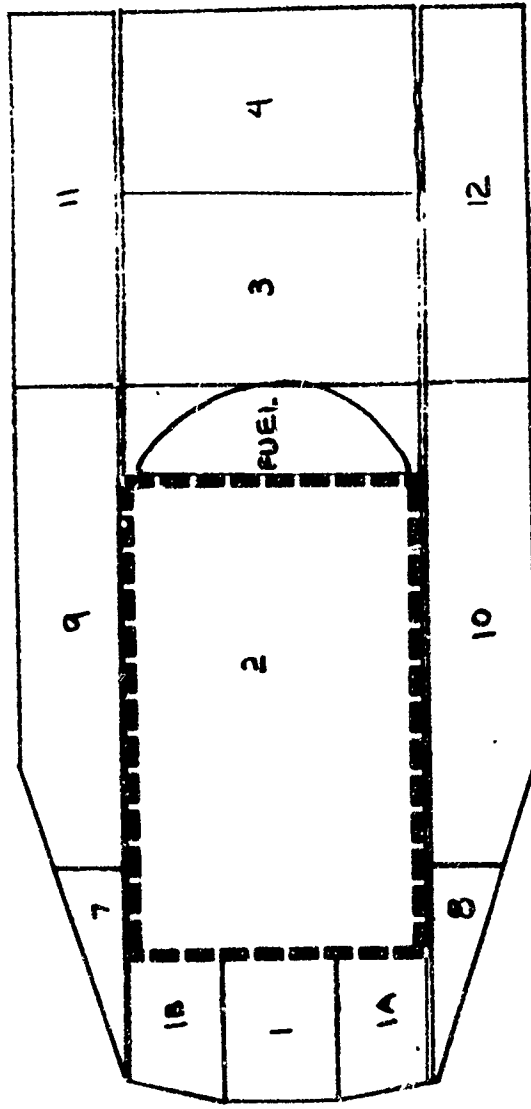
Figure G-1-2  
SK-5. Buoyancy Tanks

The electric bilge pump for the main cabin had been started after the ACV hit the wave but was not removing water due to a frozen discharge line. Buoyancy tank 11 (starboard aft), figure G-1-2, flooded first and the 8' patch leaked allowing flooding of tanks 3 and 4. The craft began to achieve a marginal stability condition and was now stern heavy. Many of the holes in the main cabin were now exposed to the water and flooding became progressive.

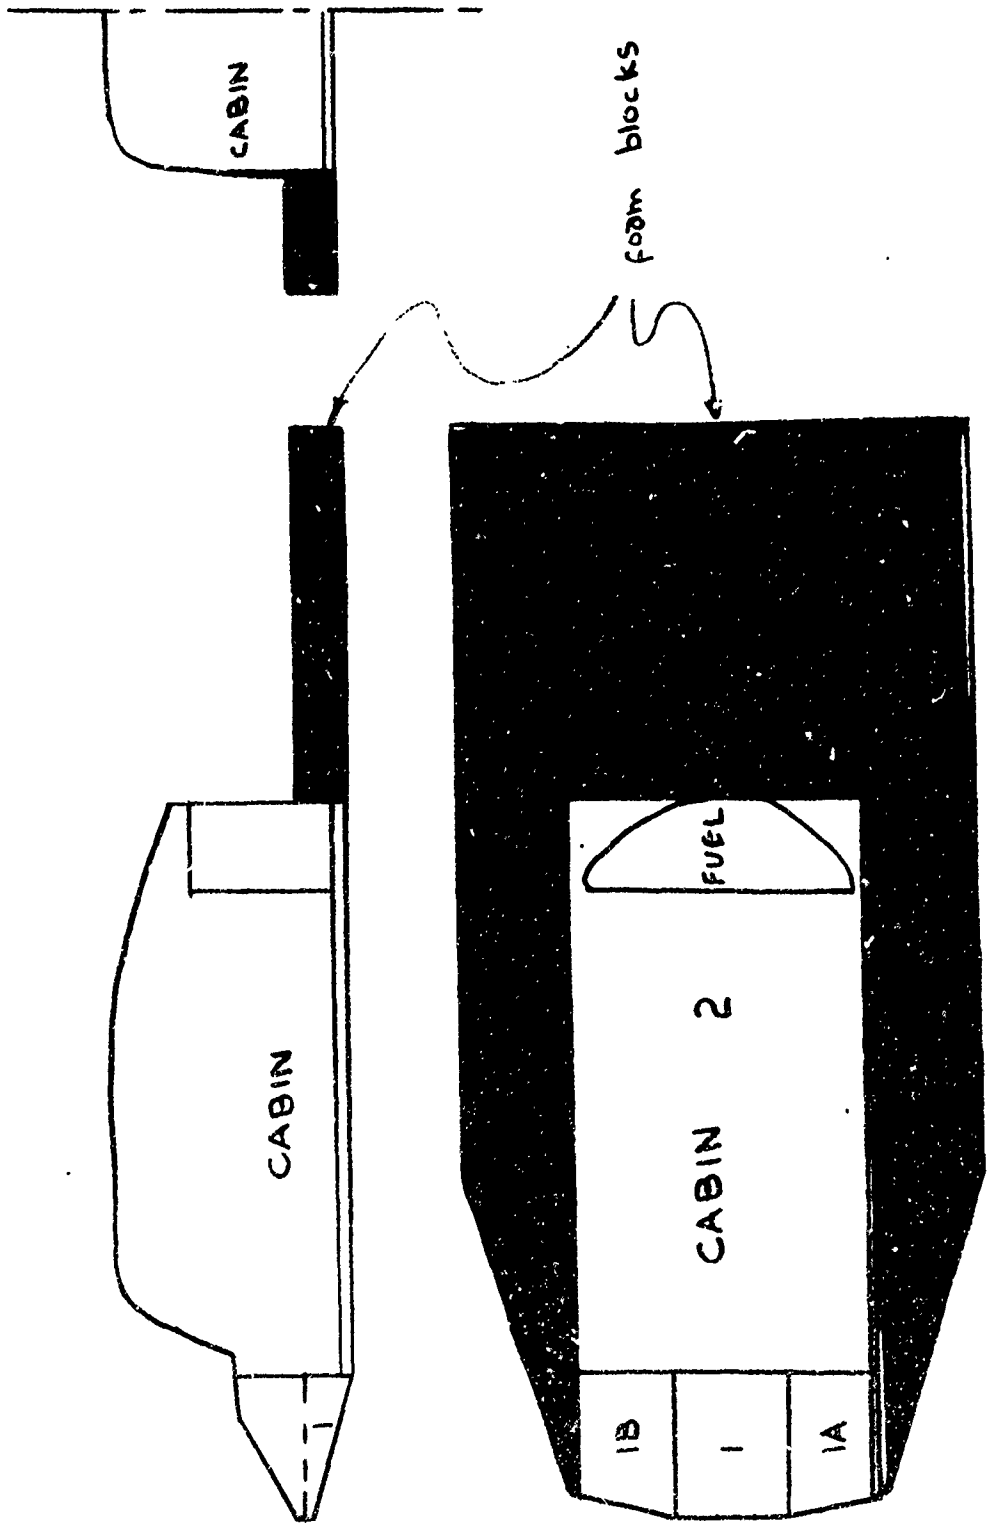
Figure G-2-1  
 Buoyancy Tanks and Foam Installation

With the foam installed in the compartments indicated in figure G-2-1, approximately 9500 lbs. of positive buoyancy was provided. In addition, all tanks were carefully inspected and sealed to insure, as well as possible, the watertight integrity of the buoyancy tanks. The most significant contribution

provided by the installation of the foam was the elimination of an unstable stability potential which would cause the craft to sink on end, as in the case of the ACV 03, or flip over and sink.

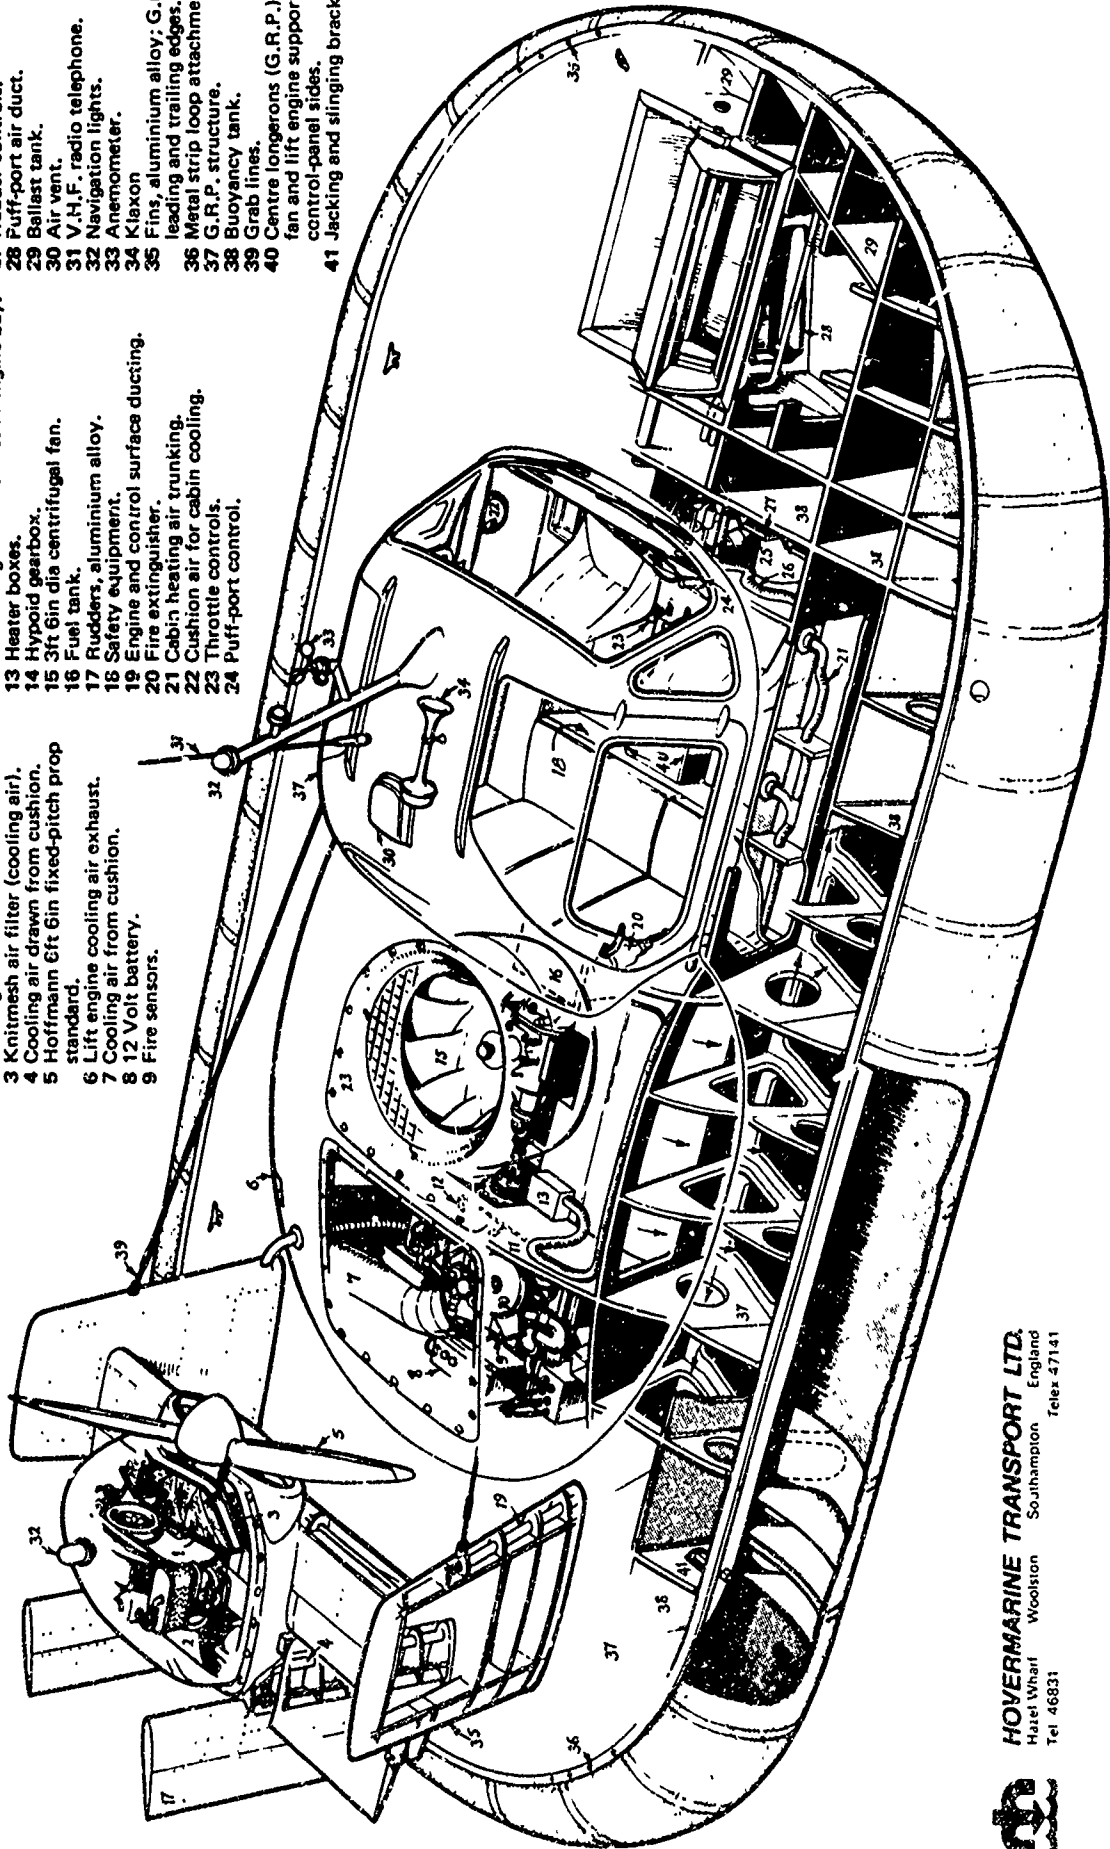
Figure H-1-1

- 25 Ballast pumps.
- 26 Cushion air trunking to demisters.
- 27 Rudder controls.
- 28 Puff-port air duct.
- 29 Ballast tank.
- 30 Air vent.
- 31 V.H.F. radio telephone.
- 32 Navigation lights.
- 33 Anemometer.
- 34 Klaxon
- 35 Fins, aluminium alloy; G.R.P. leading and trailing edges.
- 36 Metal strip loop attachment.
- 37 G.R.P. structure.
- 38 Buoyancy tank.
- 39 Grab lines.
- 40 Centre longerons (G.R.P.) forming fan and lift engine support and control-panel sides.
- 41 Jacking and slinging bracket.

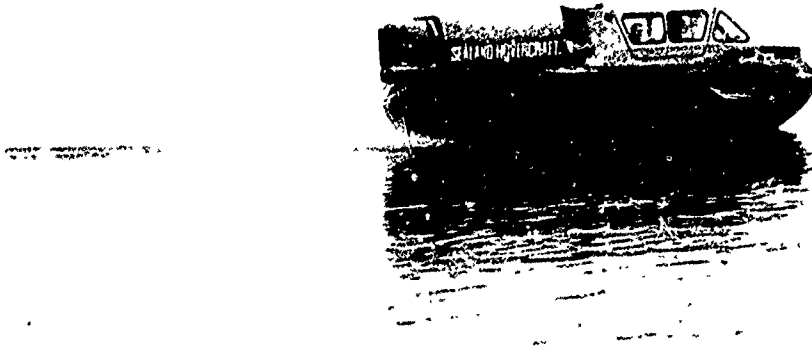
Figure H-2-1 SH-2 Hovercraft in Operation

The engine drives the 39in. diameter centrifugal lift fan. The propulsion is provided by two 32in. diameter four bladed axial-flow fans. The use of these fans and surrounding ducts will greatly reduce the noise generally associated with propeller driven air cushion vehicles. The cushion area of 200 sq.ft. provides a cushion pressure of 20 lbs./sq.ft. at a normal gross weight of 4,400 lbs.

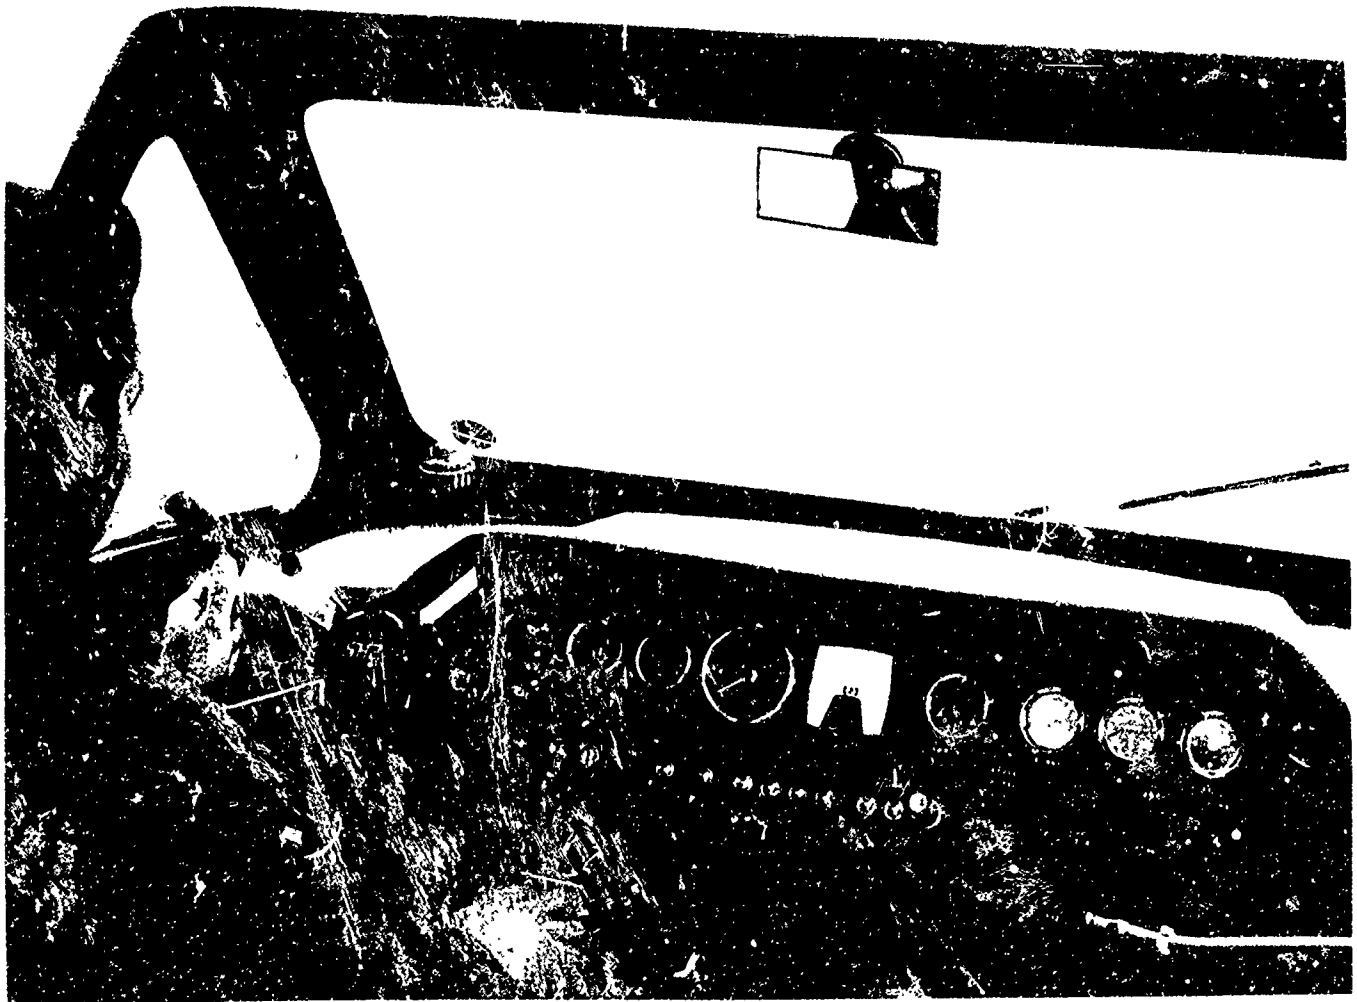
Figure H-2-2 Operator's Position in SH-2 Hovercraft

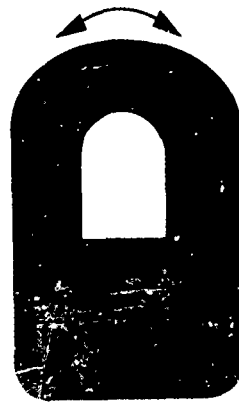
Figure H-2-3

BOW THRUSTERS

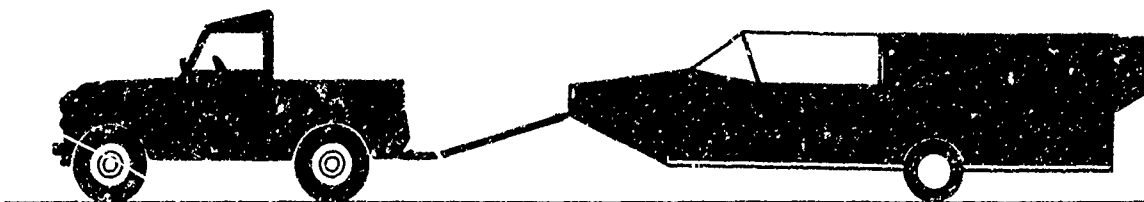
3 ATTACH TOWING HITCH - DRIVE OFF

SH-2 Demonstrates Rapid Transportability

The SH-2 is highly transportable by the use of trailer wheels and an ordinary garage hydraulic jack. The bow of the craft is jacked up, figure H-2-4, the axle and wheels are slid underneath the midships section and bolted on. A trailer bar is bolted to the bow, the jack released and the craft is ready for towing.

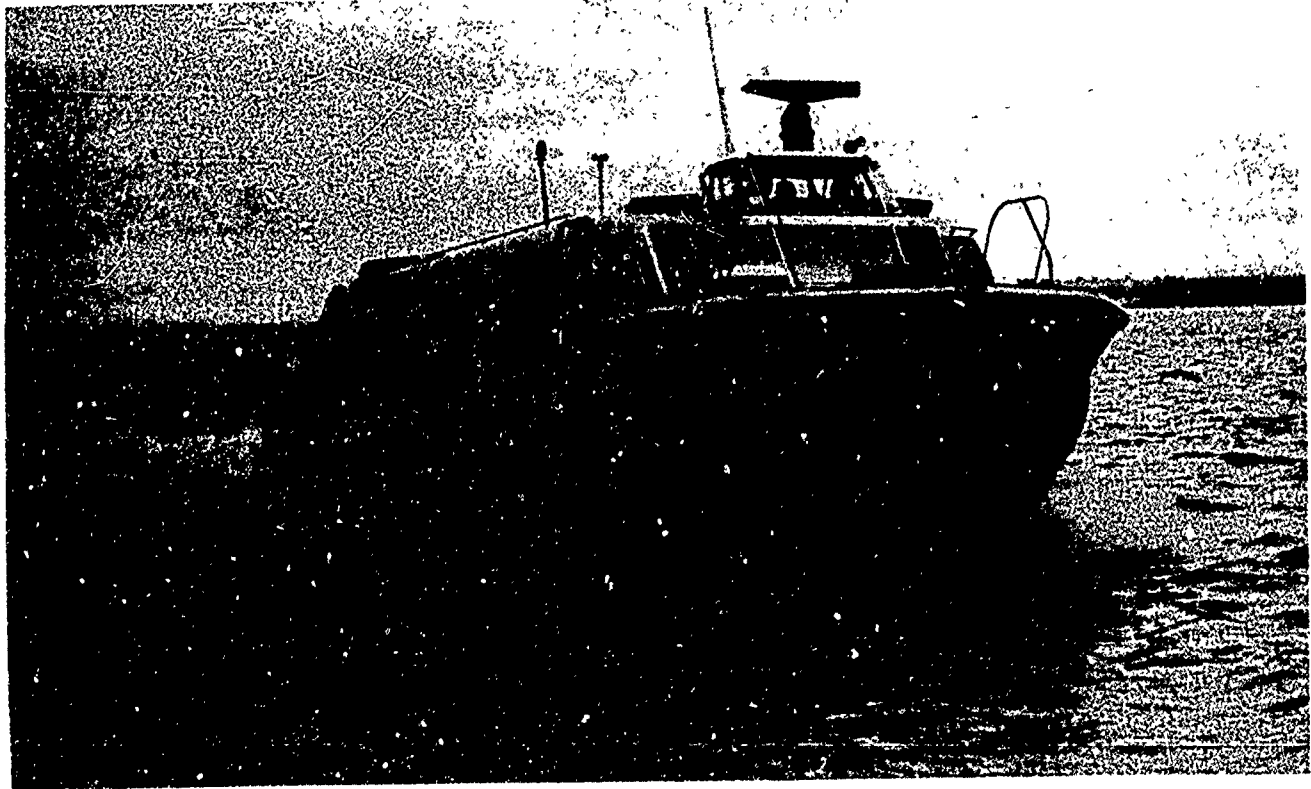
Figure H-3-3 HM-2 MK III ACV Passenger Ferry

Maximum Speed – Calm water, no wind	35 knots (65 k.p.h.)
Acceleration – 0.30 knots	45 secs
Deceleration – From max. speed (normal)	270' (76m)
Deceleration – From max. speed (emergency)	150' (45m)
Mar. Range with standard fuel tanks	500 miles

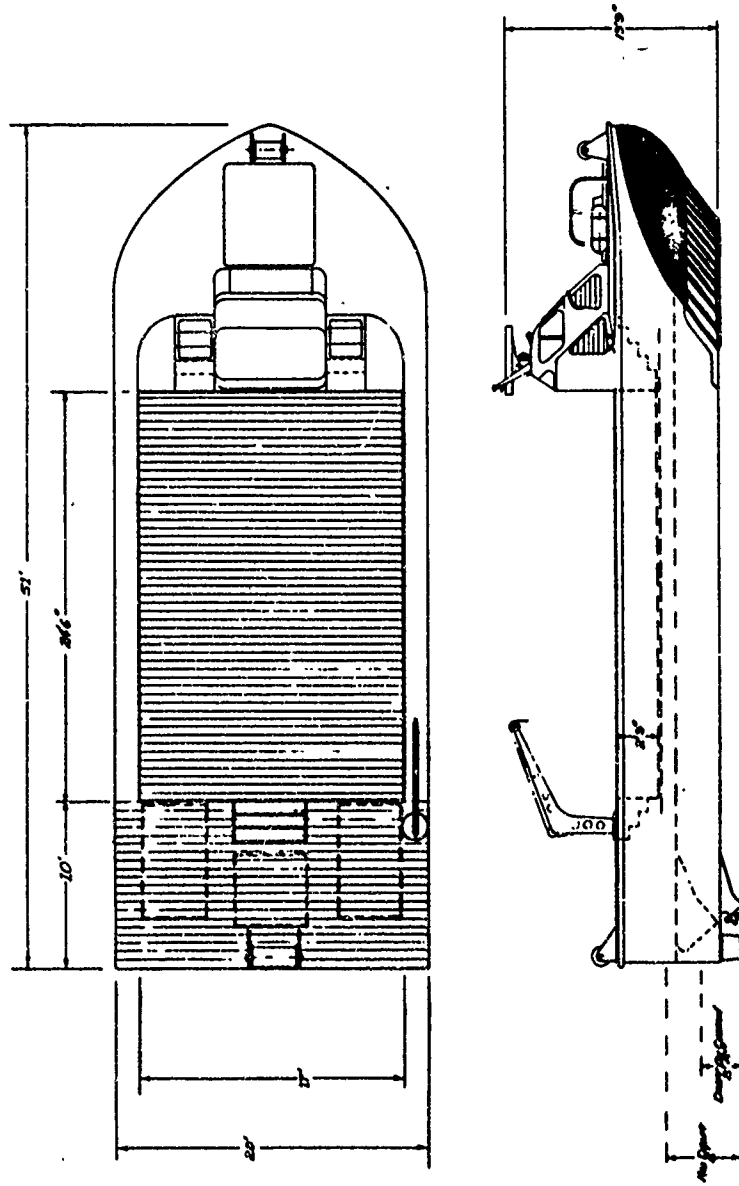
Figure H-3-6

HM. 2 (C) BASIC CRAFT

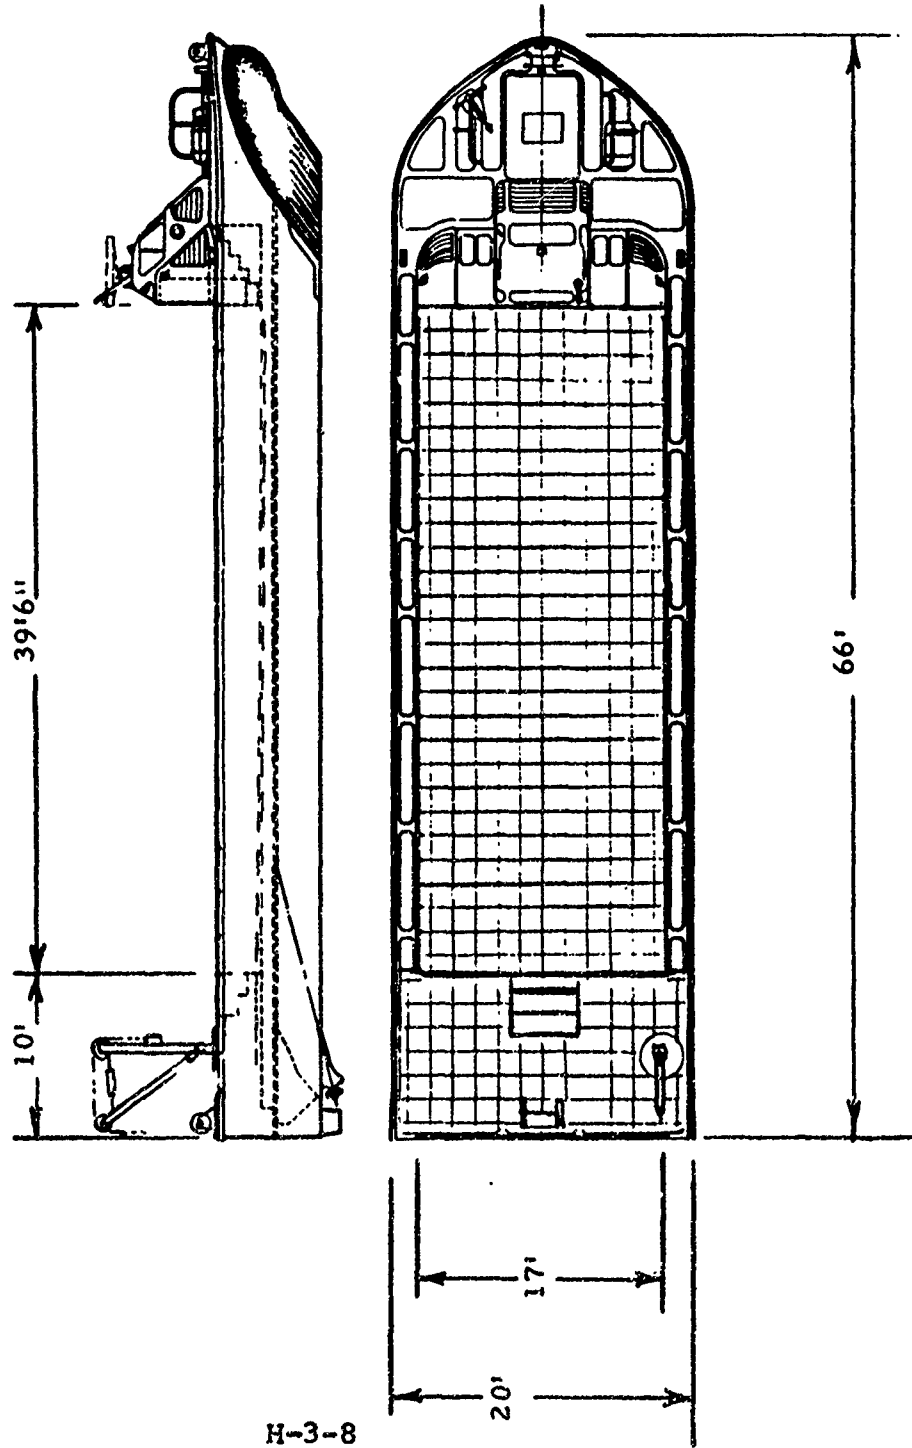
H-3-8

HM. 2-S(C) BASIC CRAFT

Note: Standard HM. 2 (C) modules mate directly with well deck of HM. 2-S(C)

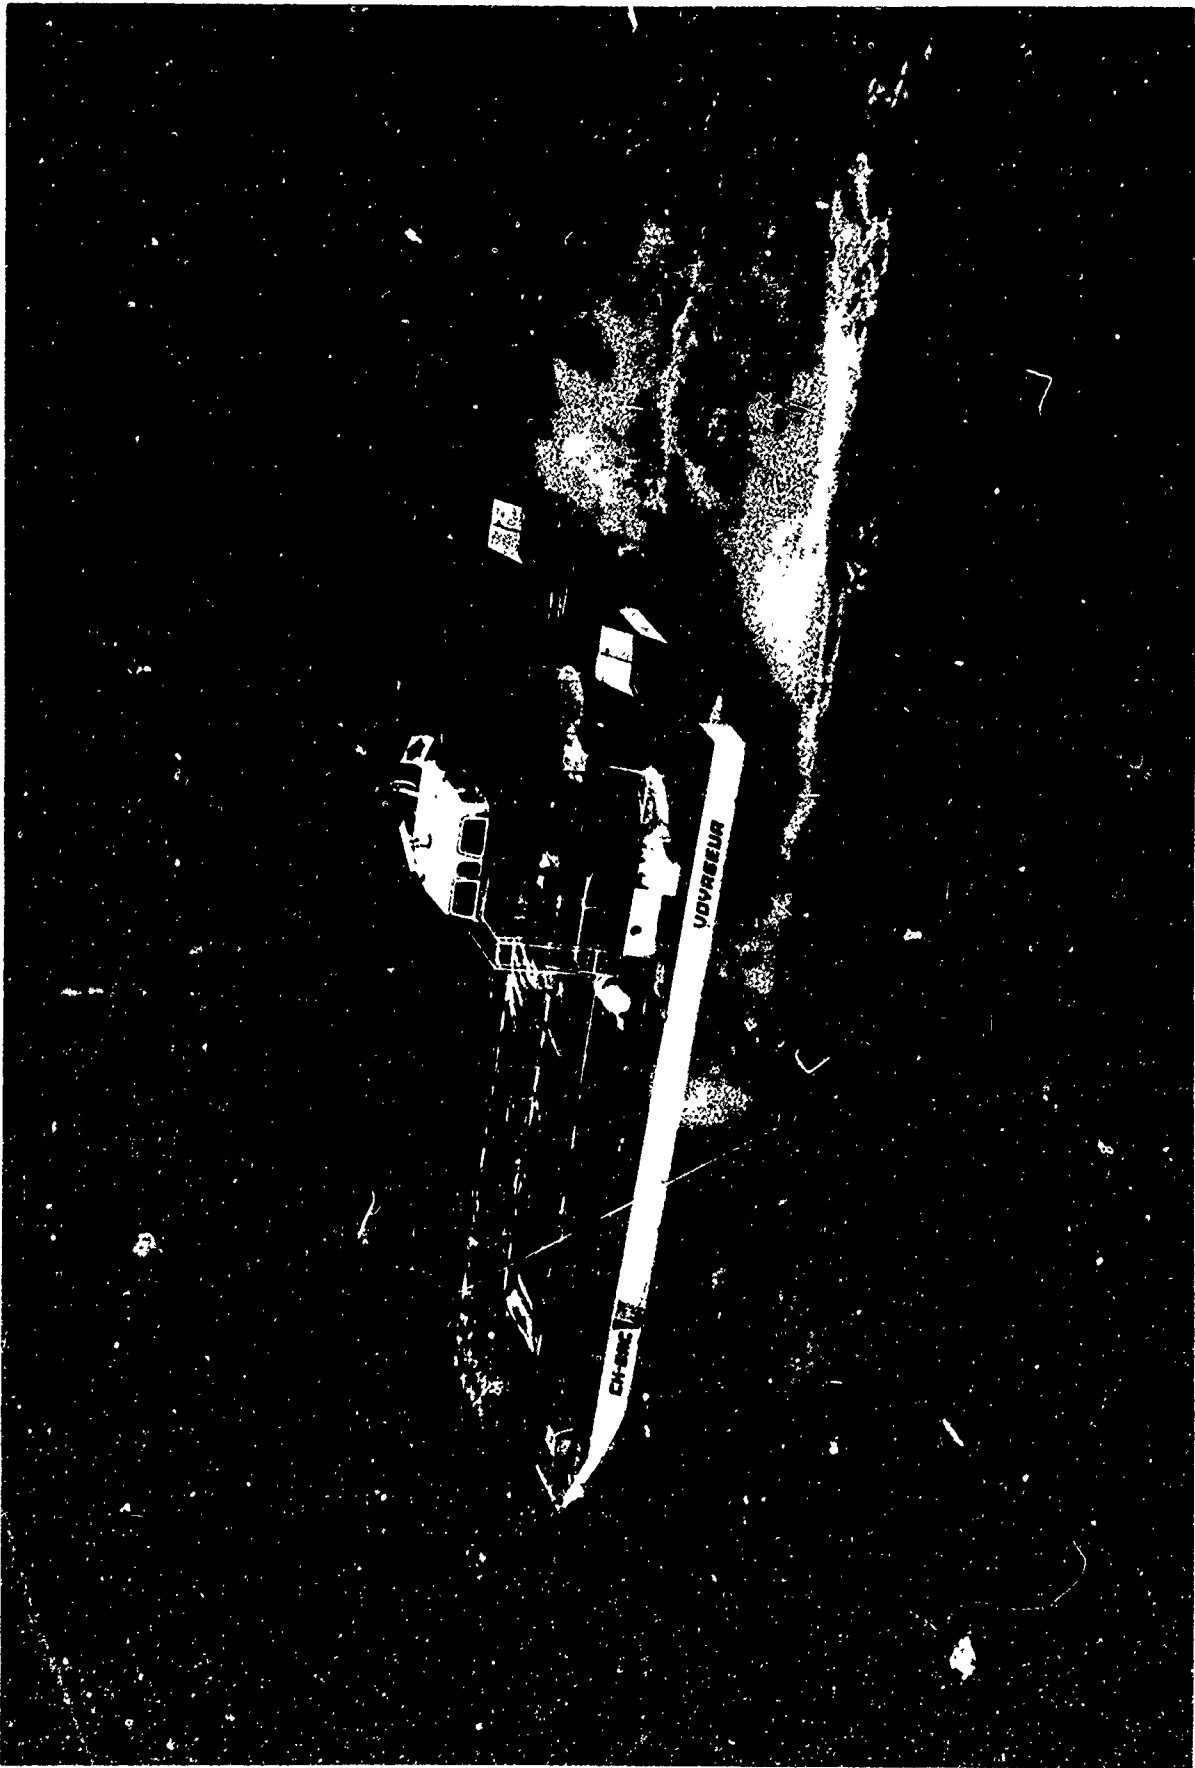
Figure H-6-1  
Voyageur No 01 during trial runs in Canada

Voyageur is a flatbed craft, constructed in modular form, using welded 6000 series aluminum extrusions. These extrusions are in the form of hollow core planking and joint sections. Bolted splice plates are used to structurally join the modules.

Projected applications for this craft required that emphasis be placed on building a simple, rugged structure which will withstand the operational and servicing loads expected. The structure was also designed to reduce cost to a minimum. The design of the modular structure incorporates hollow core thin walled aluminum extrusions which are now available in 0.055" thick inner and outer walls and are presently used as bulkheads in military and commercial ships. Use of this material with extruded corners for joining of the paneling and bulkheads makes a structural box of great stiffness. The Model 7380 is designed around flat surfaces, and the use of this material eliminates the need for formed parts and reduces tooling since all parts require only sawing to size for assembly. The structural modules are welded; the welding process consists mainly of the use of the gas shielded tungsten arc process (TIG gun).
