AIR CUSHION VEHICLE EVALUATION. SAN  
FRANCISCO, CALIFORNIA, ST. IGNACE,  
MICHIGAN, MILFORD HAVEN, VIRGINIA,  
TRANSPO 72. 1 SEPTEMBER 1971-30 JUNE 1972.

## AIR CUSHION VEHICLE EVALUATION

EU 3960-02

1 September 1971 - 30 June 1972

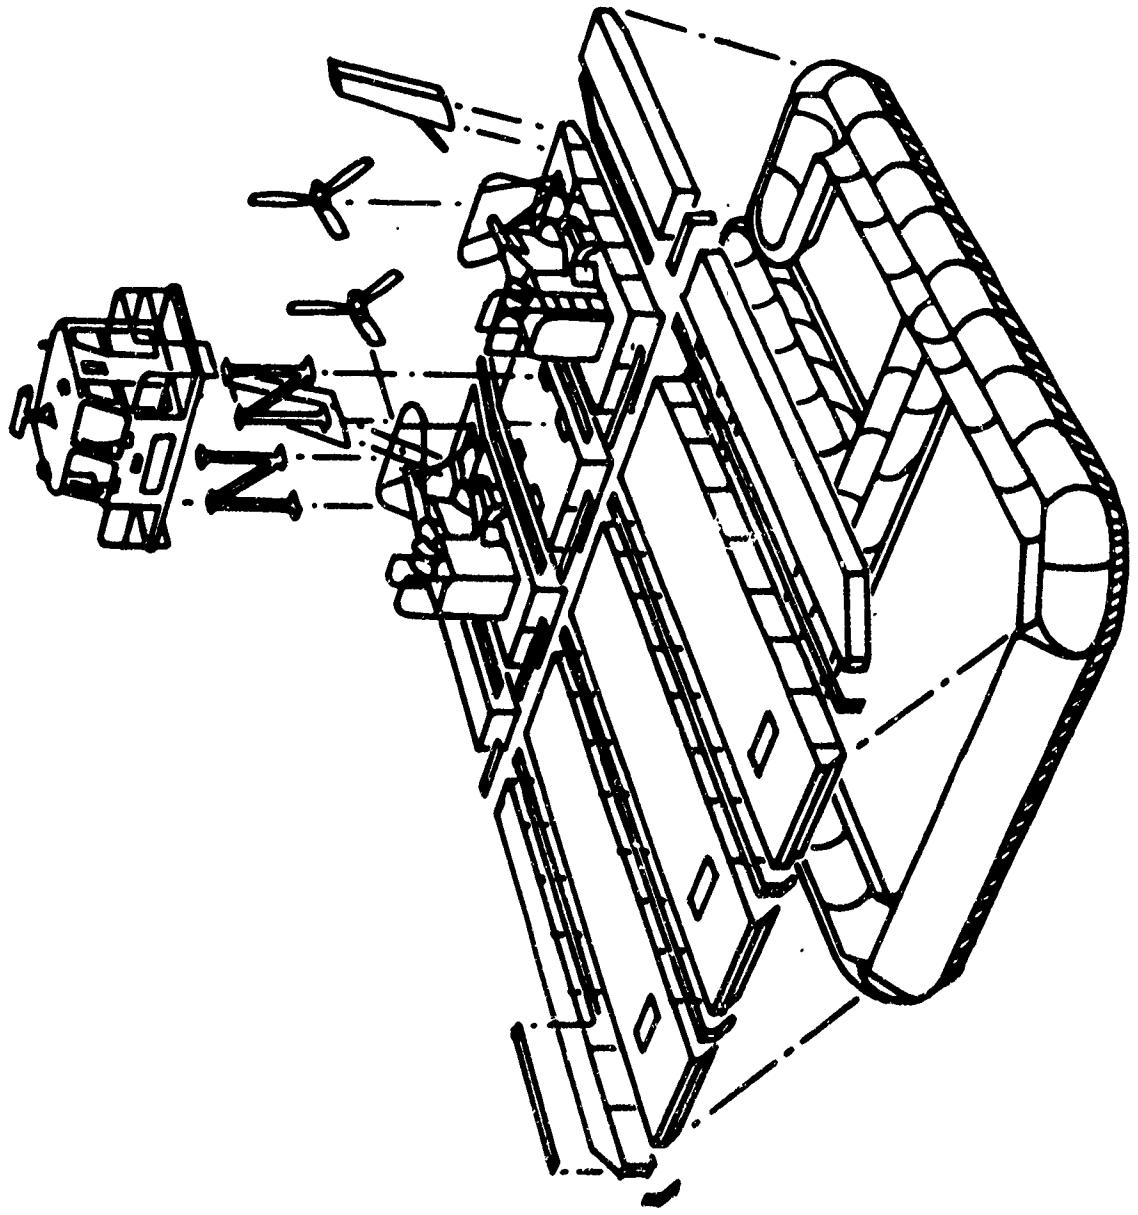
VOYAGEUR - EXPLODED VIEW

Projected applications for this craft required that emphasis be placed on building a simple, rugged structure which will withstand the operational and servicing loads expected. The structure was also designed to reduce cost to a minimum. The design of the modular structure incorporates hollow core thin walled aluminum extrusions which are now available in 0.055" thick inner and outer walls and are presently used as bulkheads in military and commercial ships. Use of this material with extruded corners for joining of the paneling and bulkheads makes a structural box of great stiffness. The Model 7380 is designed around flat surfaces, and the use of this material eliminates the need for formed parts and reduces tooling since all parts require only sawing to size for assembly. The structural modules are welded; the welding process consists mainly of the use of the gas shielded tungsten arc process (TIG gun).

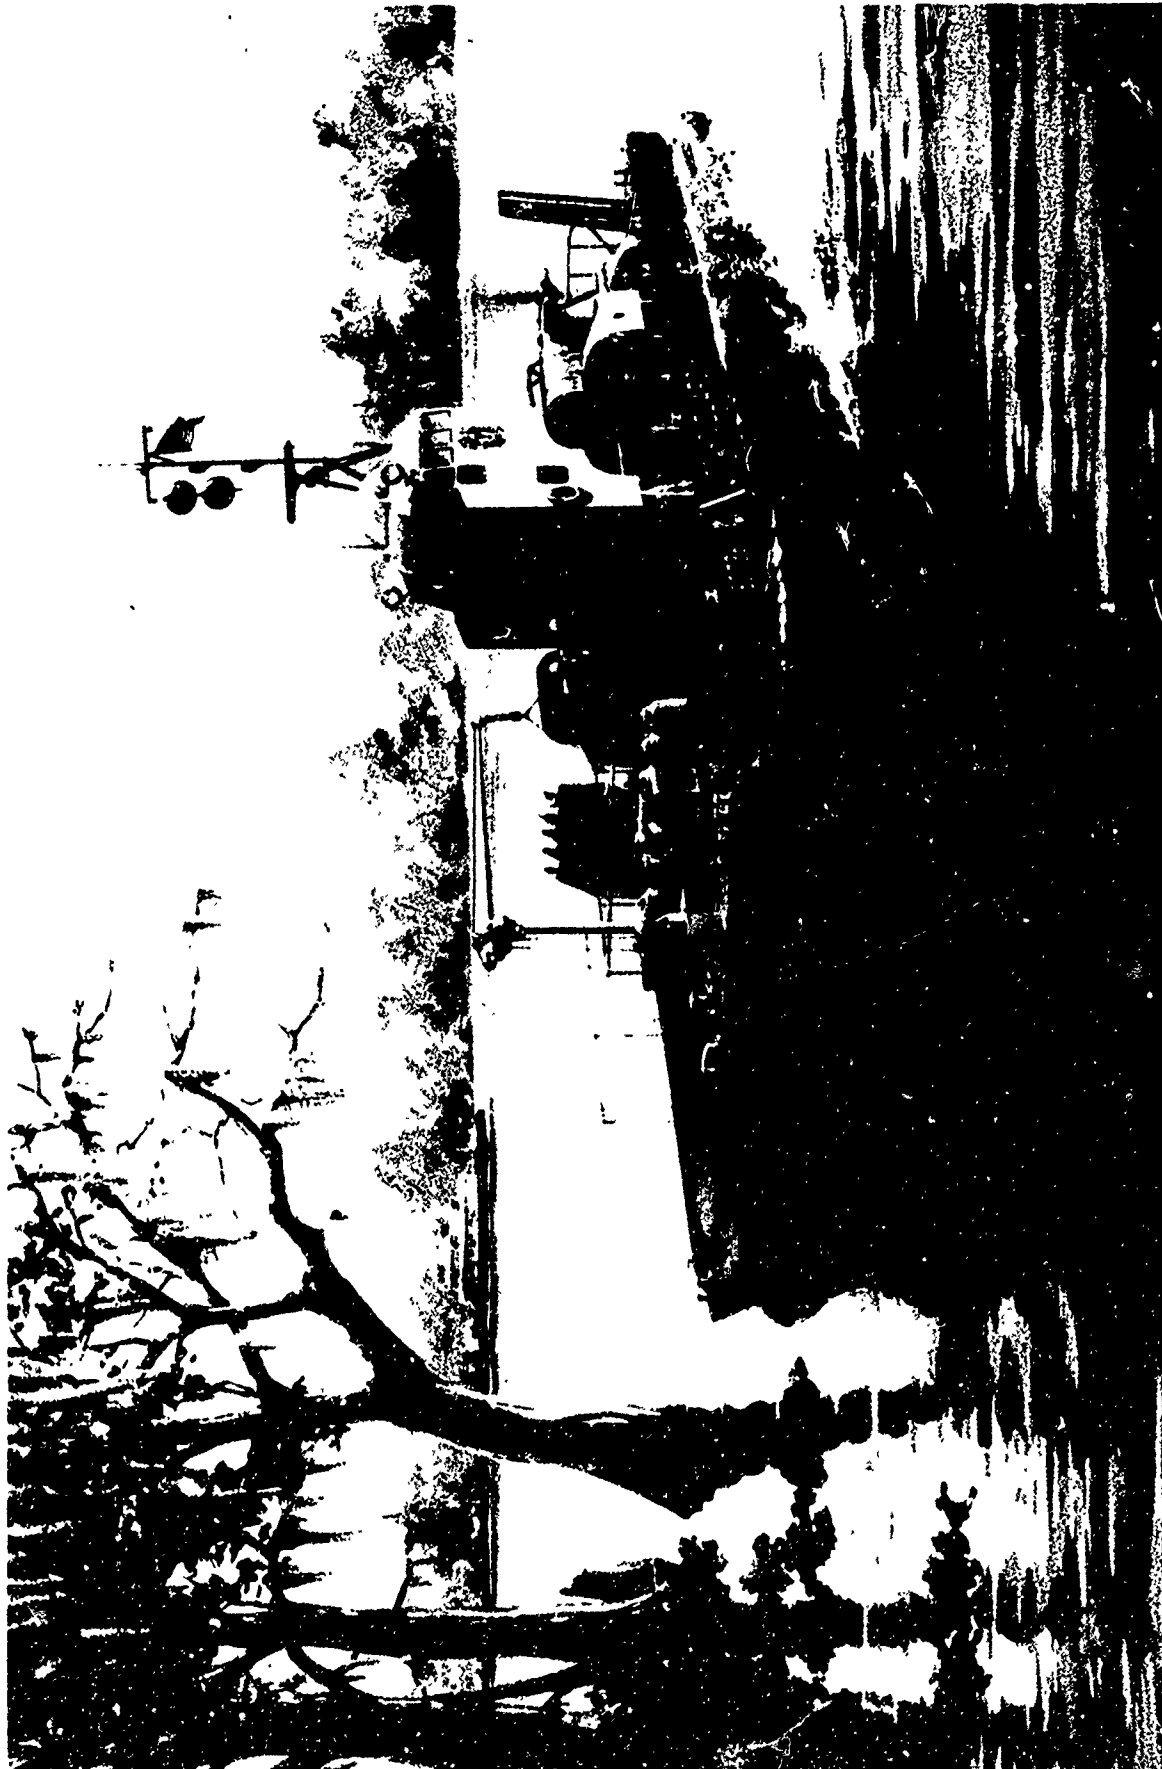
Figure H-6-4  
Voyageur in Aton Mission on inland rivers.

An artists concept of Model 7380 Voyageur configured to accomplish the Coast Guard's AtoN mission is shown in figure H-6-4.

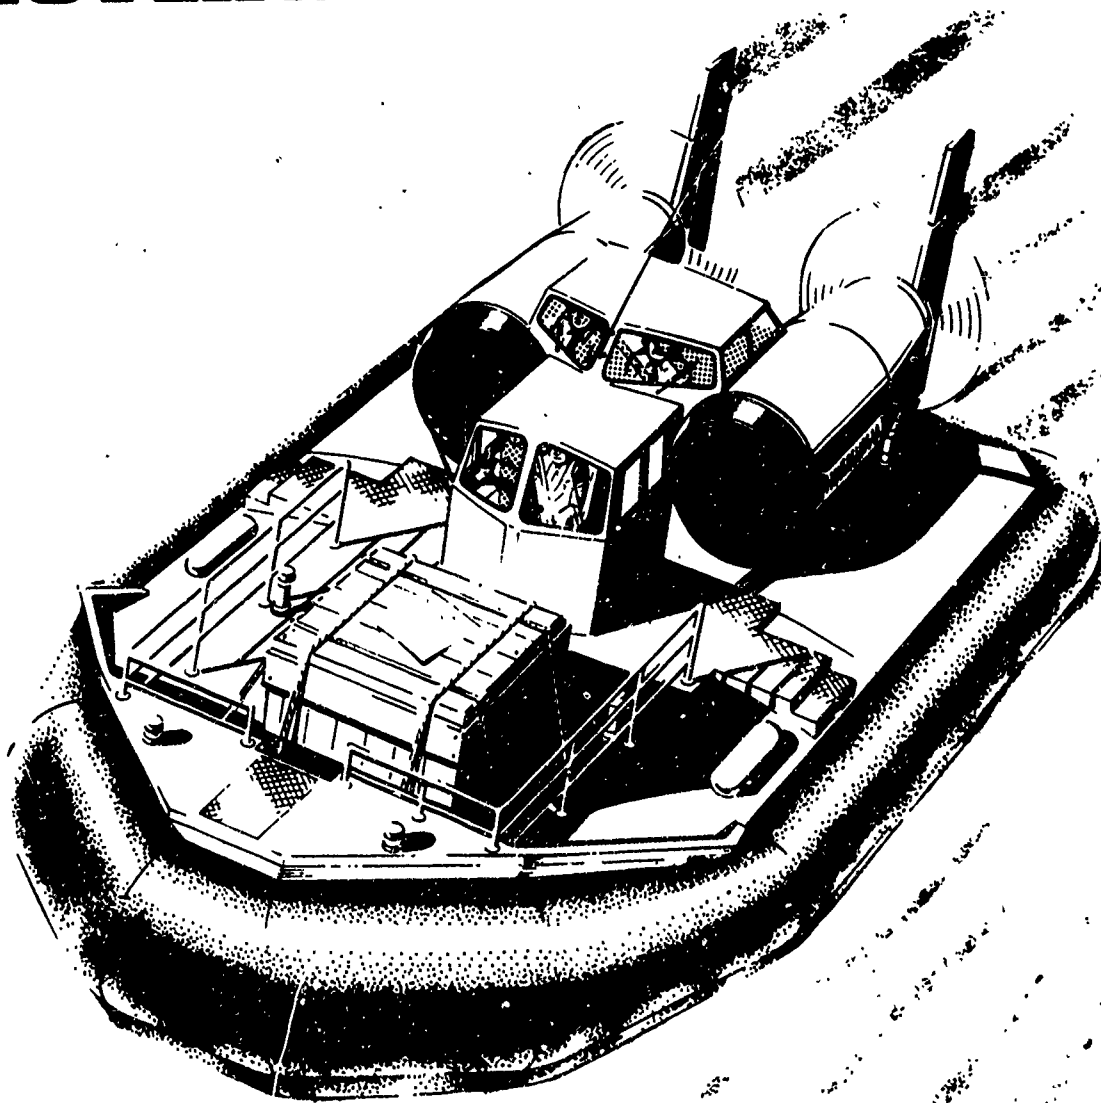
Figure H-8-1

**HOVERGEM MODEL G-4A AMPHIBIOUS TWO TON FREIGHT VEHICLE**

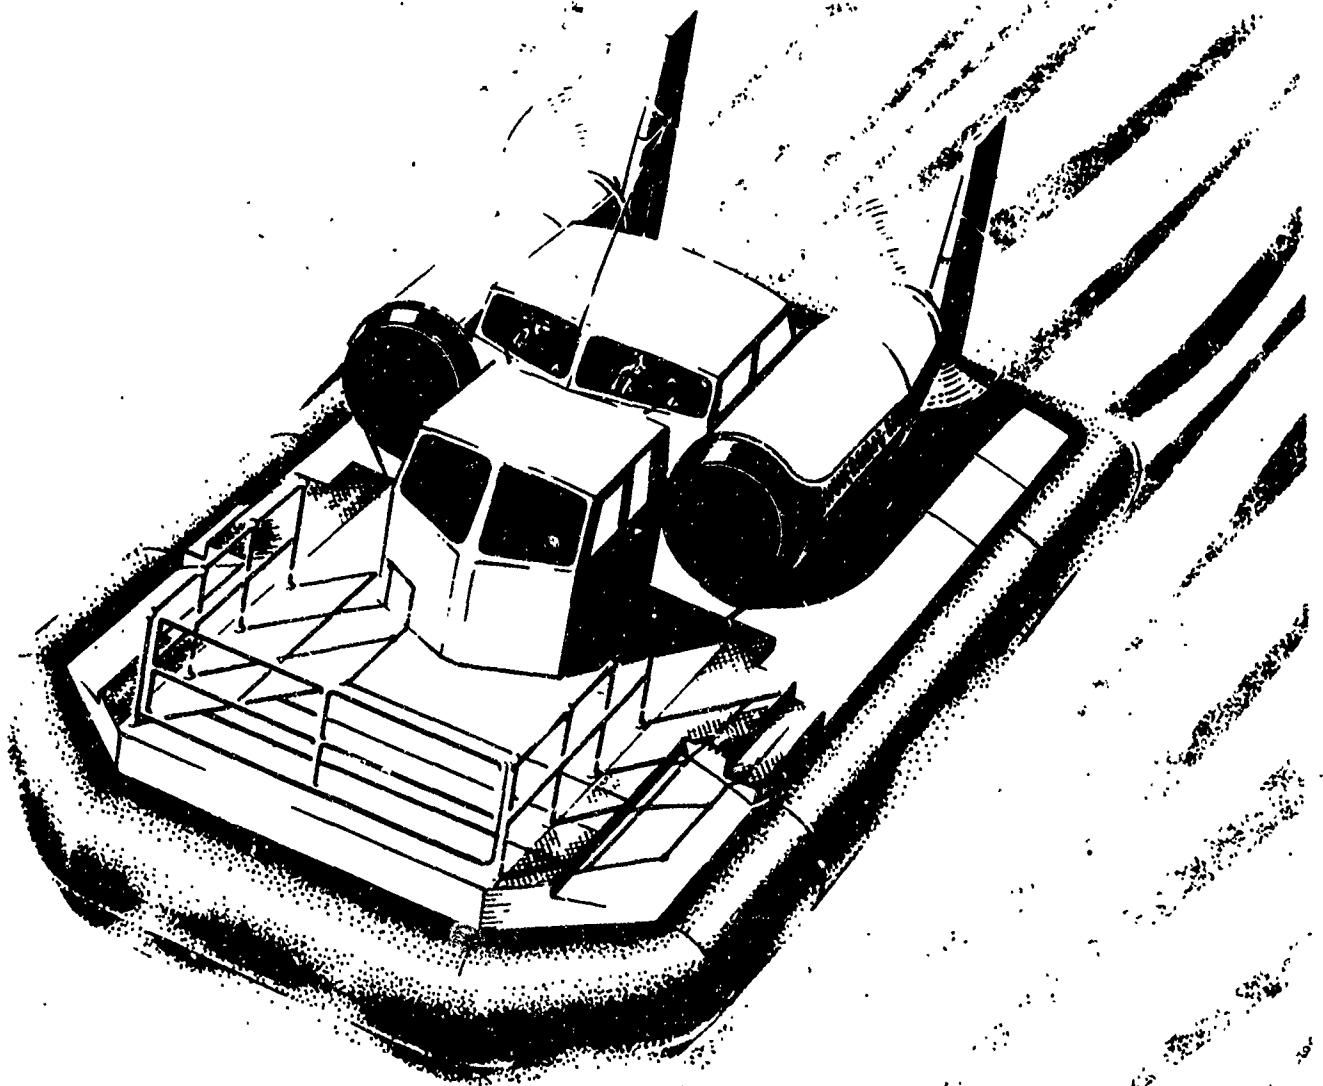
H-8-3

HOVERGEM MODEL G-6A/250 FOUR SEAT, ONE TON UTILITY

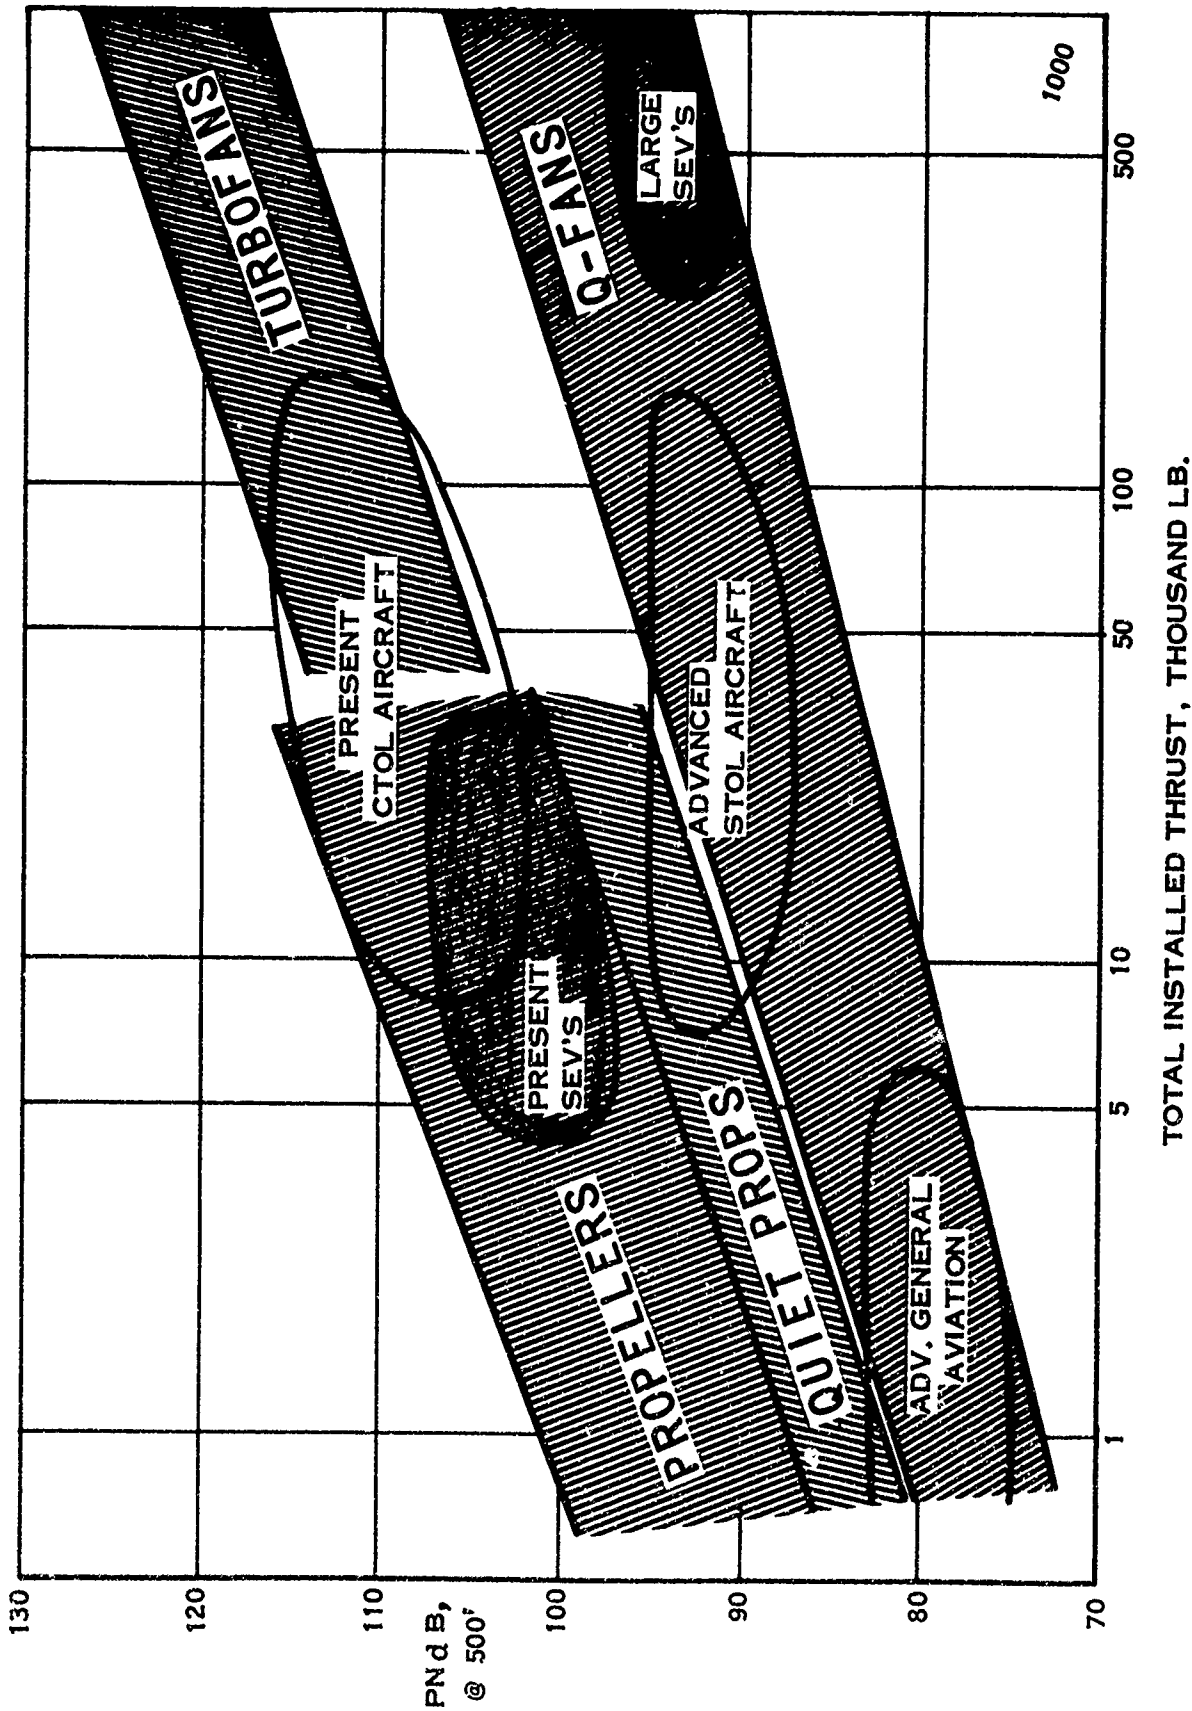
Figure H-9-2

# AIR PROPULSION NOISE

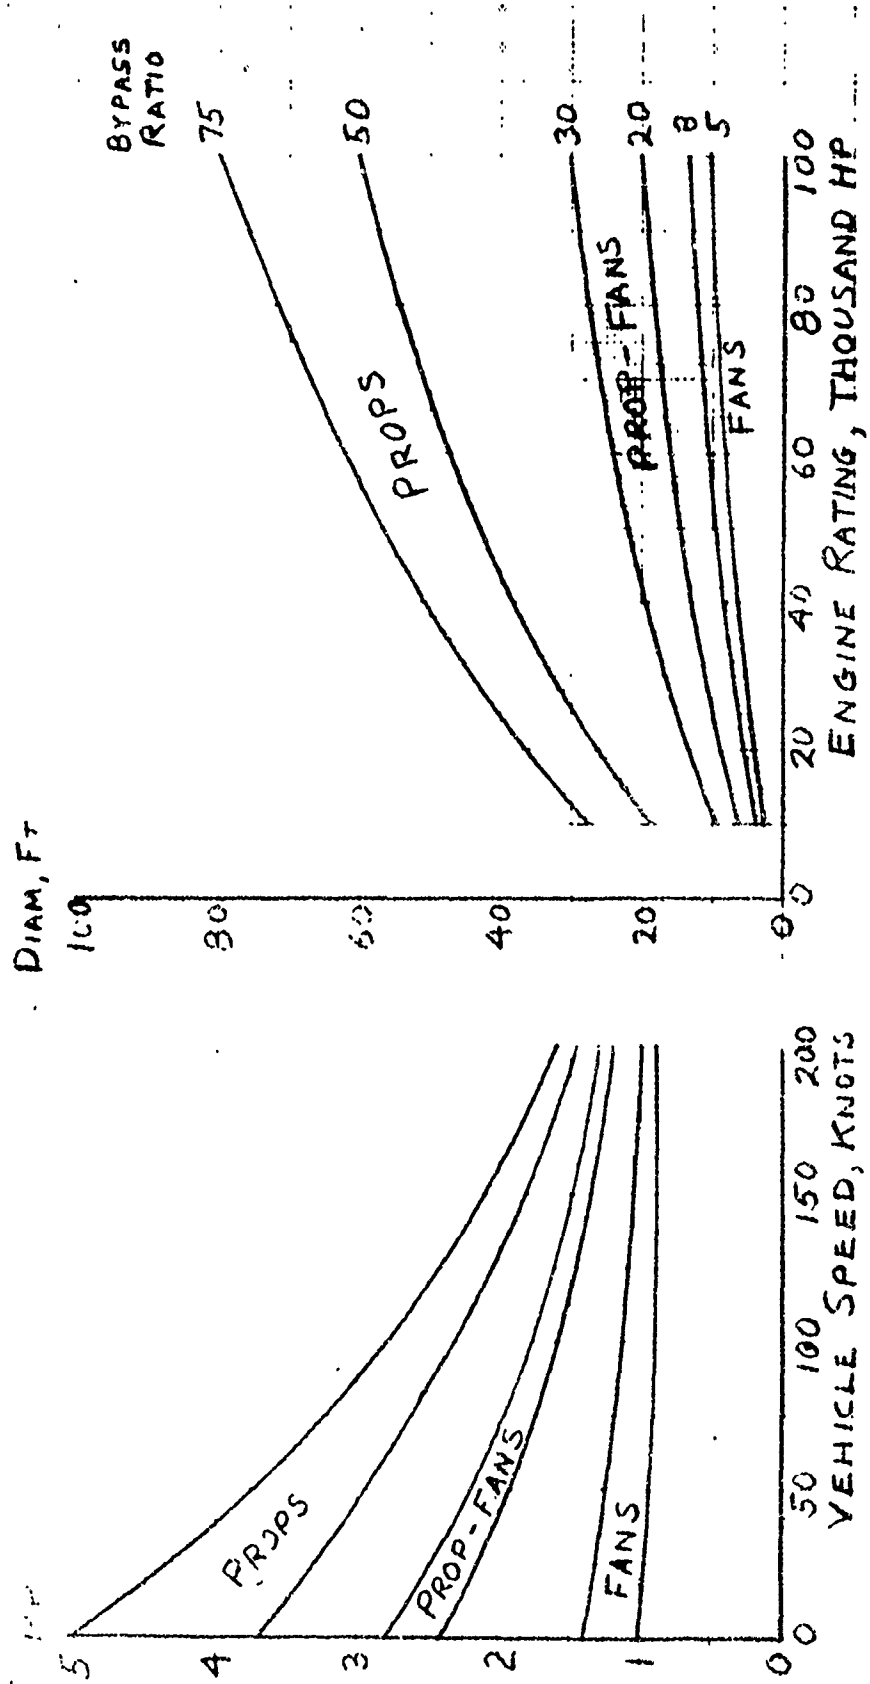
146  
Figure H-9-3

# CHARACTERISTICS OF SHROUDED AIR PROPULSORS
