A Temperature Study of Pneumatic Tires During Highway Operation

TECHNICAL REPORT NO. 11716

by DAVID K. WILBURN

U.S. ARMY TANK AUTOMOTIVE COMMAND Warren, Michigan

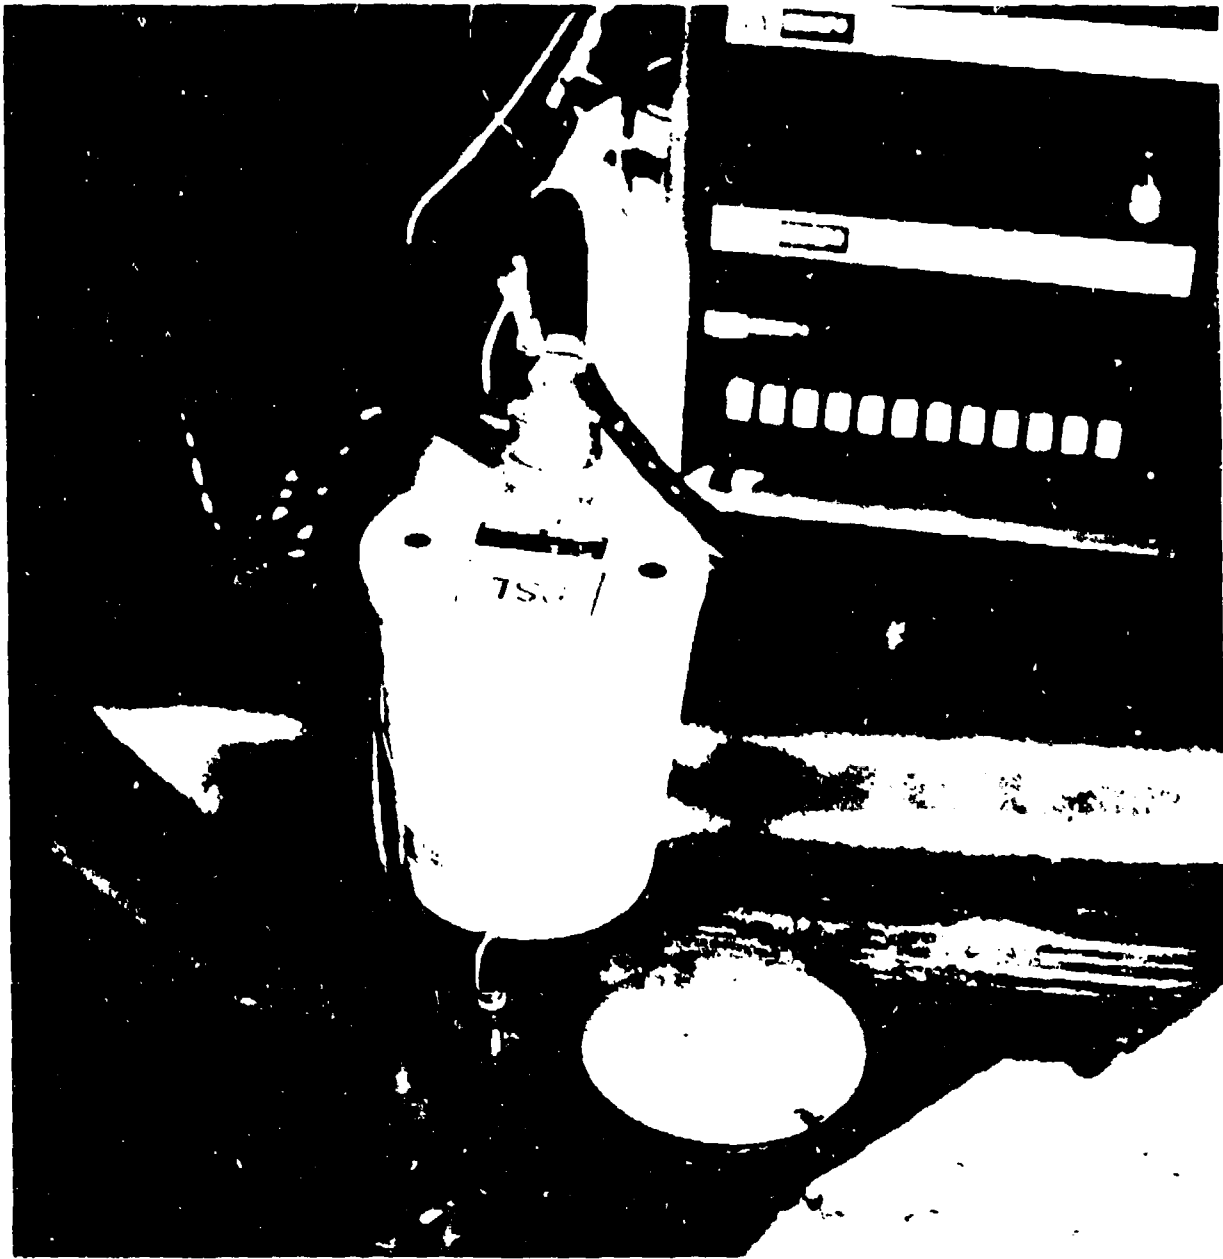
FIGURE 5

INFRARED THERMOMETER POSITIONED TO VIEW
ROAD SURFACE

The pyranometer cell is shown mounted in the roof of the car in Figure 3. To monitor road surface temperature, an infrared thermometer was mounted vertically to view the road surface thru a hole cut in the rear floor panel.

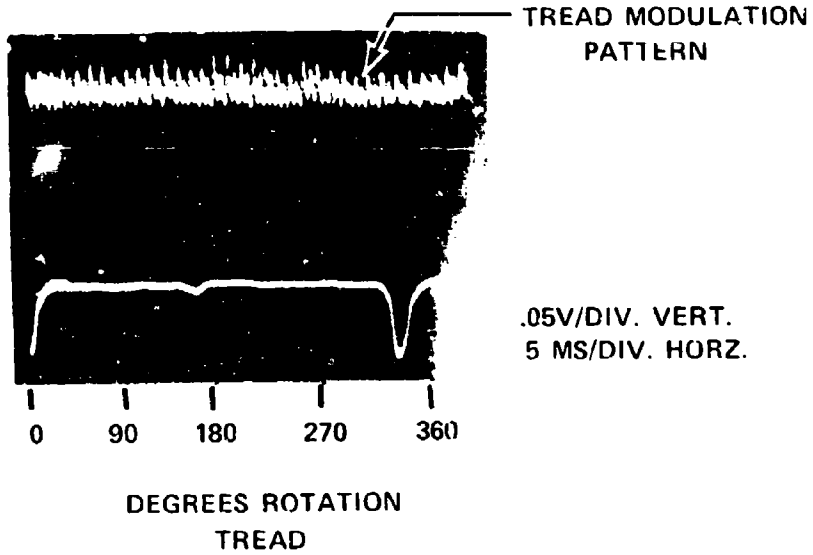
FIGURE 19

CIRCUMFERENTIAL TEMPERATURE
PROFILE, TEST TIRE NO. 6

50 MPH
1000 LOAD
32 PSI
CEMENT
ROAD=105°F
AIR=80°F

DEFECT AREA

- * Ply separation in shoulder opposite serial placed on either side of tread splice produced by 1/2 x 1/2 inch piece of diaphragm stock.
- ** Ply separation in shoulder opposite serial placed on either side of tread splice produced by 1/2 x 1/2 inch piece of aluminum metal foil.

Voltage of Signal Produced by Defect	Millisecond Width of Defect Pulse
Test Tire # 6	+0.2	3
Test Tire # 5	-0.4	2

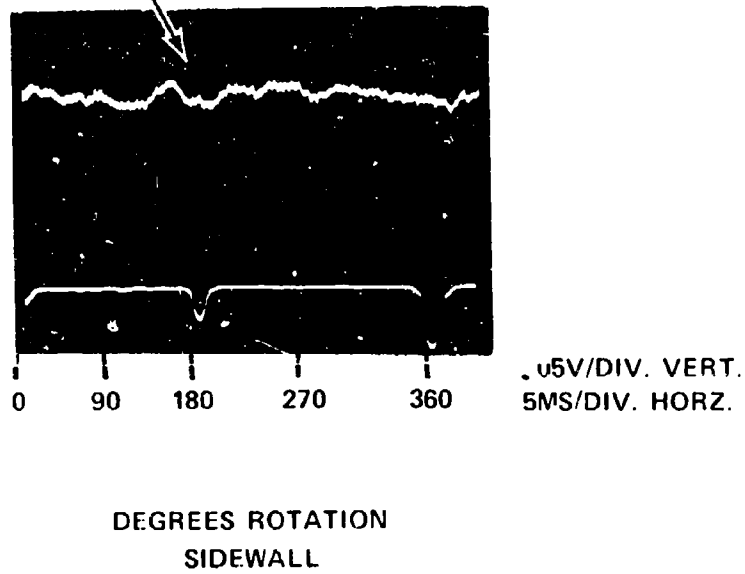
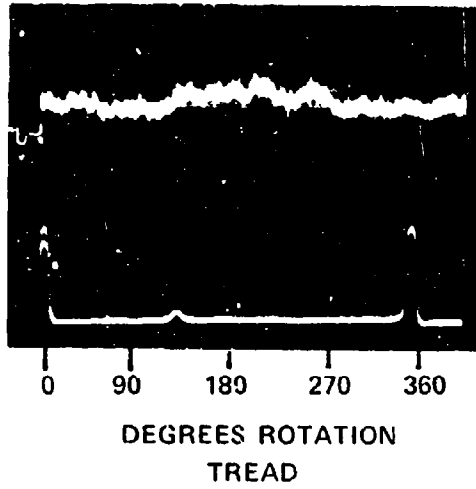
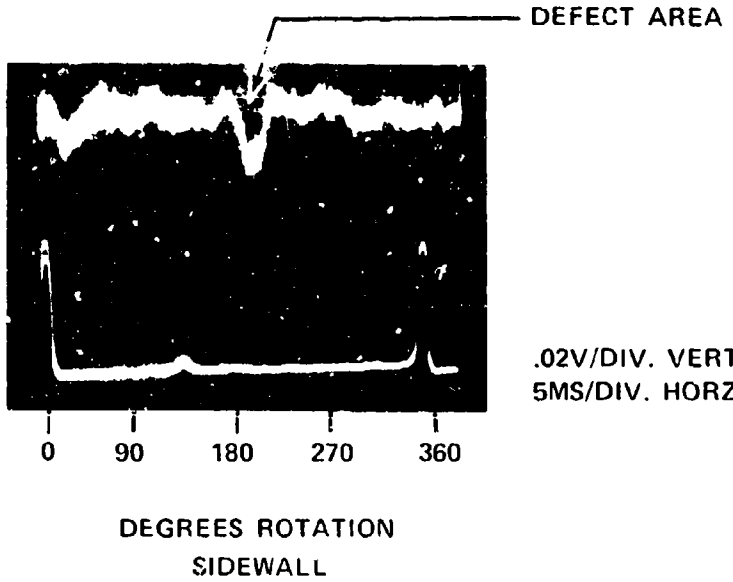
FIGURE 20

CIRCUMFENTIAL TEMPERATURE
PROFILE, TEST TIRE NO. 5

TEST
CONDITIONS
50 MPH
1000# LOAD
32 PSI
CEMENT
ROAD=108F
AIR=74F

.05V/DIV. VERT.
5MS/DIV. HORZ.

.02V/DIV. VERT.
5MS/DIV. HORZ.

The thermal modulation effect produced by the tread pattern in military tires and reported on in reference 1 was not observed in the highway tires. Test tire # 6 having a "high traction tread" produced a slight modulation of the circumferential temperature profile as seen in Figure 20, but did not disturb the normal tread profile.

The circumferential profiles of Figure 20 thru 22 were not calibrated in terms of "temperature of defect". This type of calibration is possible but was not warranted for purposes of this test. As indicated in Table V, the defect area was described in terms of a voltage differential between the signal generated by the defect and adjacent "sound" surface.

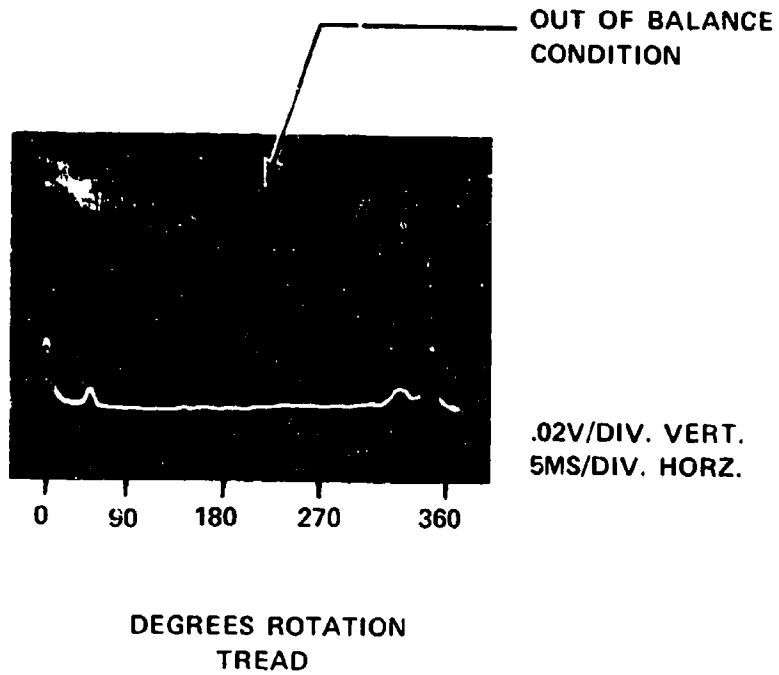
FIGURE 21

CIRCUMFERENTIAL TEMPERATURE
PROFILE OF OUT OF BALANCE
CONDITION, TEST TIRE NO. 1

6. Out-of-balance tires produce a "heat pulse" in the area of the high balance node. The differential temperature of the heat pulse was proportional to the amount of out-of-balance and increased with increasing unbalance. Out-of-balance could not be detected by the "average temperature" measuring method.

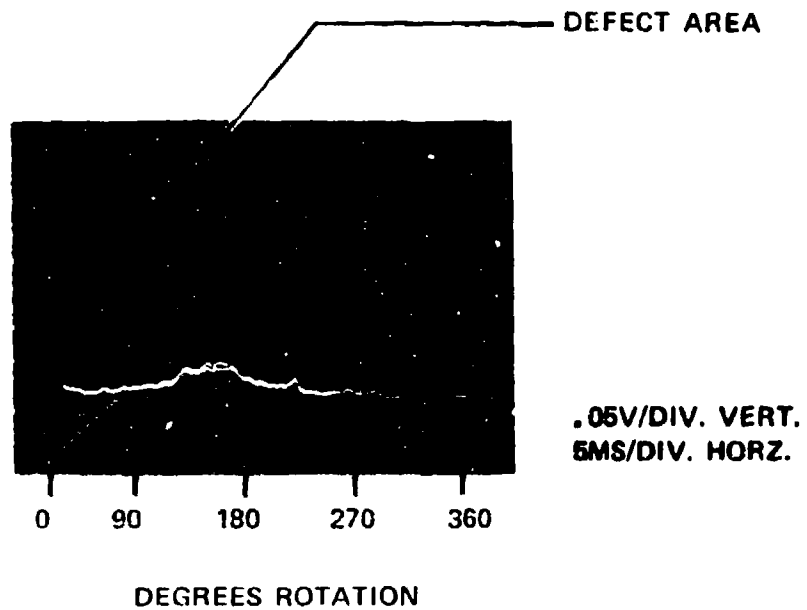
FIGURE 22

CIRCUMFERENTIAL TEMPERATURE PROFILE
OF TREAD AREA, TEST TIRE NO. 2

70 MPH
1000 LOAD
30 PSI
CEMENT
ROAD=119°F
AIR=88°F

11. Two additional used tires of unknown condition were examined by the high speed profiling system for the presence of defects. A small area of temperature discontinuity was detected in one tire and was subsequently verified as a cord rupture and tread unbond by tire sectioning.
