EVALUATION OF A CABLE-NET ROOF MODEL FOR
HASTY FUEL STORAGE RESERVOIRS

Report 2041

November 1972

3. REPORT TITLE EVALUATION OF A CABLE-NET ROOF MODEL FOR HASTY FUEL STORAGE RESERVOIRS			
4. DESCRIPTIVE NOTES (Type of report and inclusive dates) An Interim Report on a Continuing Hasty Fuel Storage Reservoir Problem (Feb - May 1971)

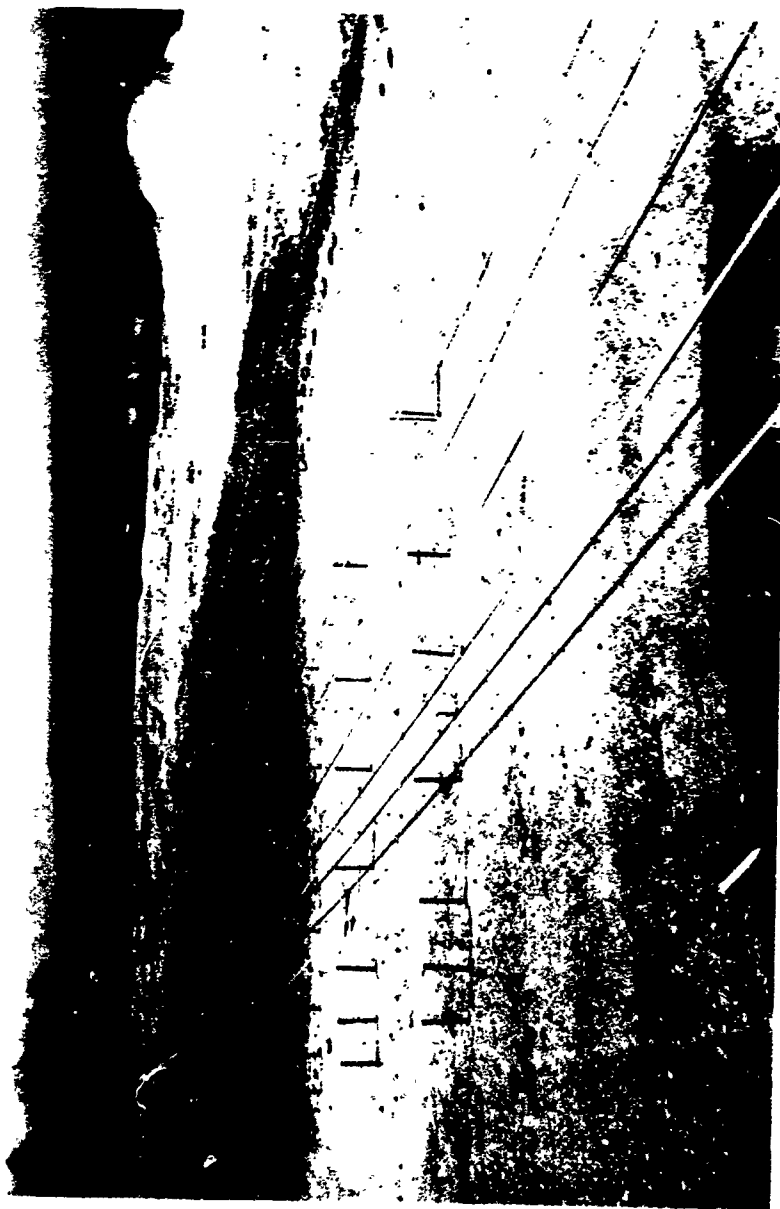
T7011

Fig. 4. Installation of main cables between berms.

3. **Description of Material.** A section of a cable-net roof, one-fifth the actual length of the fuel storage reservoir, was prepared for testing. In order to simulate a reservoir installation, two parallel berms, 8 feet high and 110 feet apart, both having a 5-percent slope toward one end, were constructed (Fig. 2). A deadman anchor consisting of a 24-foot section of 8-inch diameter pipe was buried underneath each berm. Attached to each deadman anchor were seven short lengths of cable spaced 4 feet apart to provide tie-down for the main cables (Fig. 3). Seven main cables 5/8 inch in diameter and 115 feet long were strung between the berms (Fig. 4). A heavy-duty turnbuckle was attached to one end of each cable in order to tighten the cables. On the berm underneath each main cable, an aluminum breastplate was placed to prevent the cables from cutting into the top edge of the berm (Fig. 5).

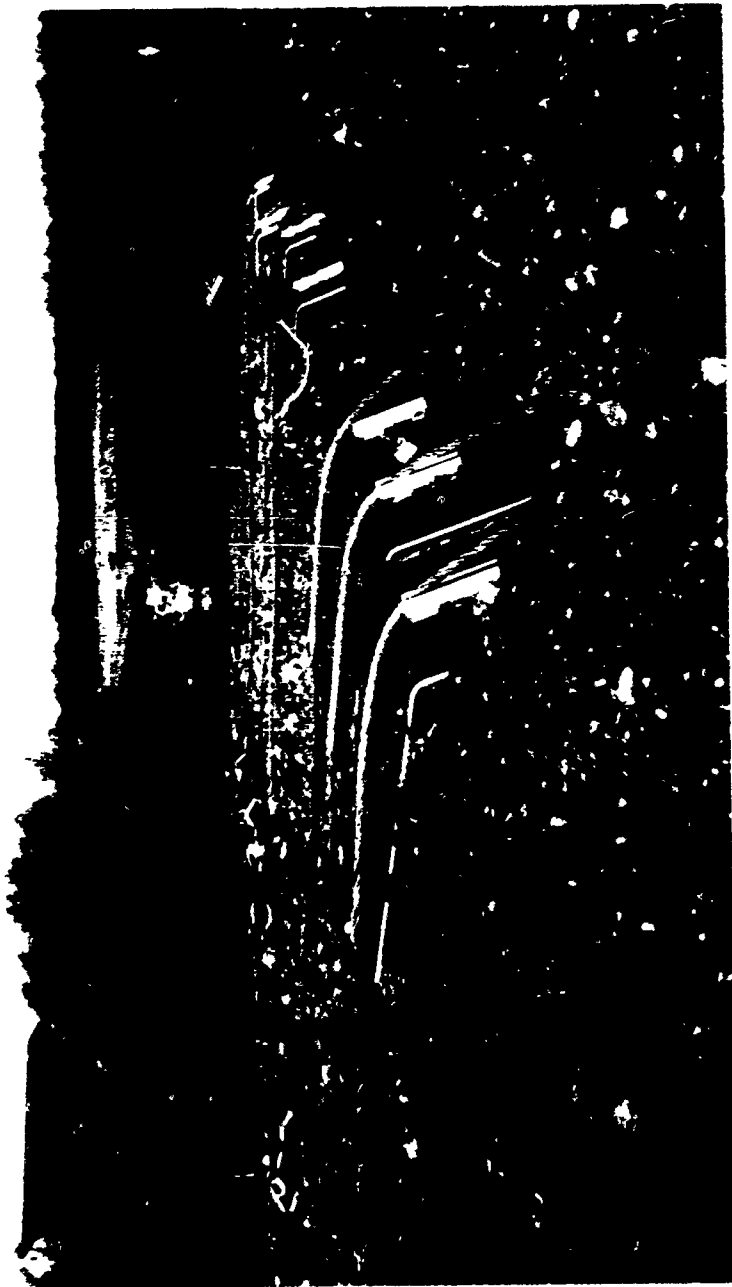
T2061

Fig. 5. Installation of breastplates under cables.

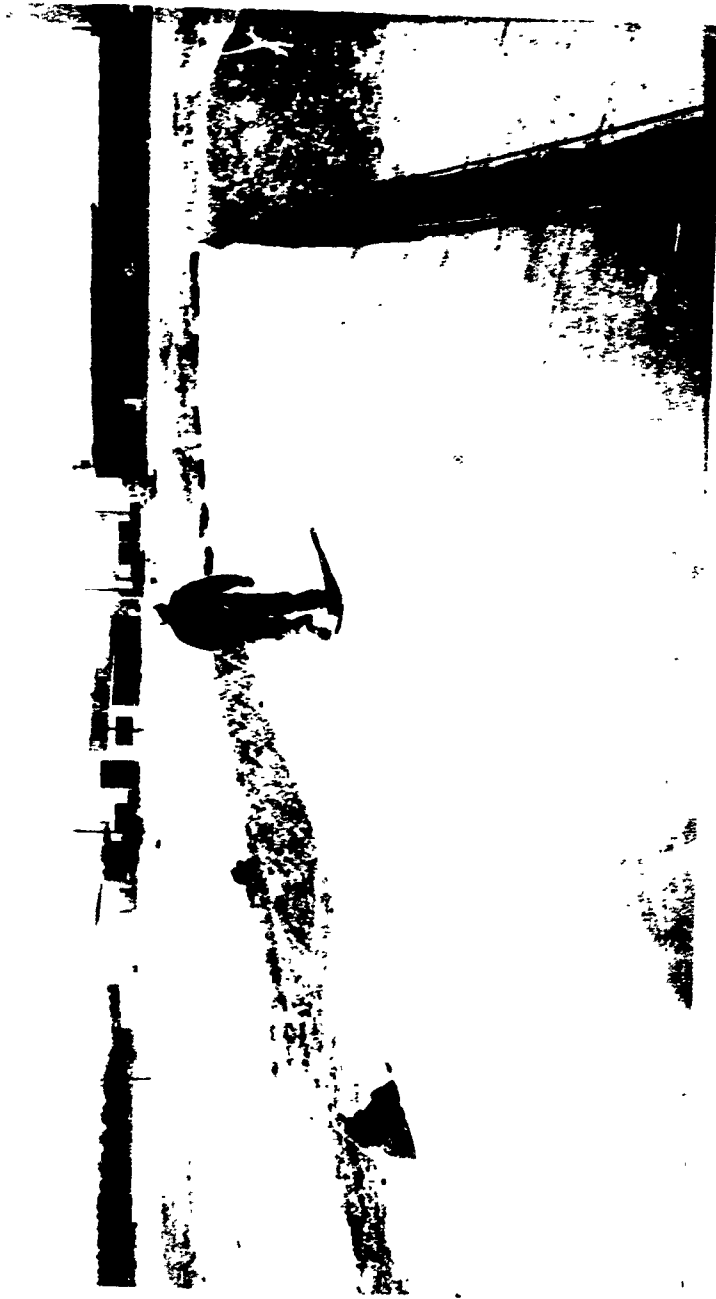
T7064

Fig. 6. Coated fabric covering over cable structure.

After the cables were installed spanning the reservoir between the berms, a section of coated fabric 20 feet long by 110 feet wide was installed over the main cables and anchored down (Fig. 6). Small-diameter cables (1/8 inch in diameter) were then installed at four-foot intervals perpendicular and over the main transverse cables to offer additional support for the coated fabric. In addition, 1/8-inch-diameter cables were installed at 8-foot intervals over the top surface of the coated fabric to prevent an upward lift of the roof from wind forces (Fig. 7).

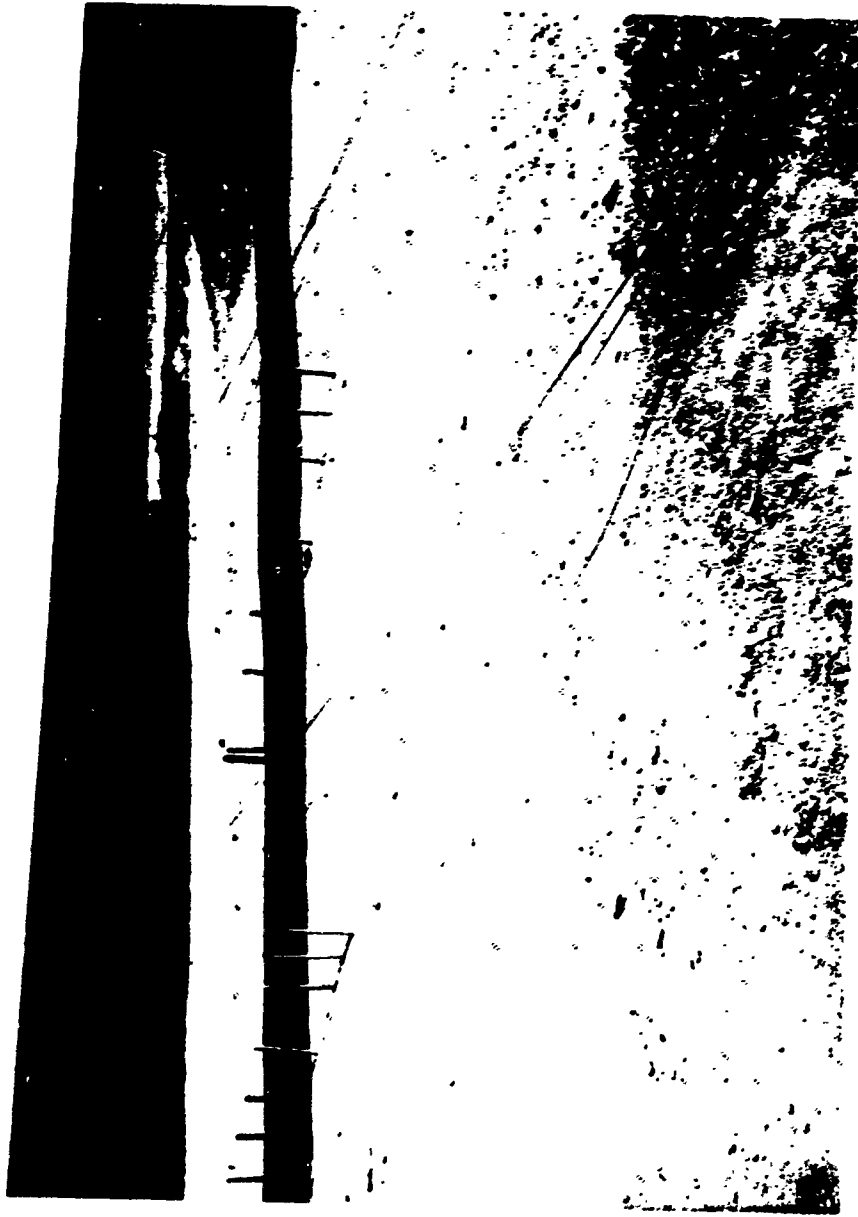
T2129

Fig. 7. Roof section showing small-diameter cables and anchors

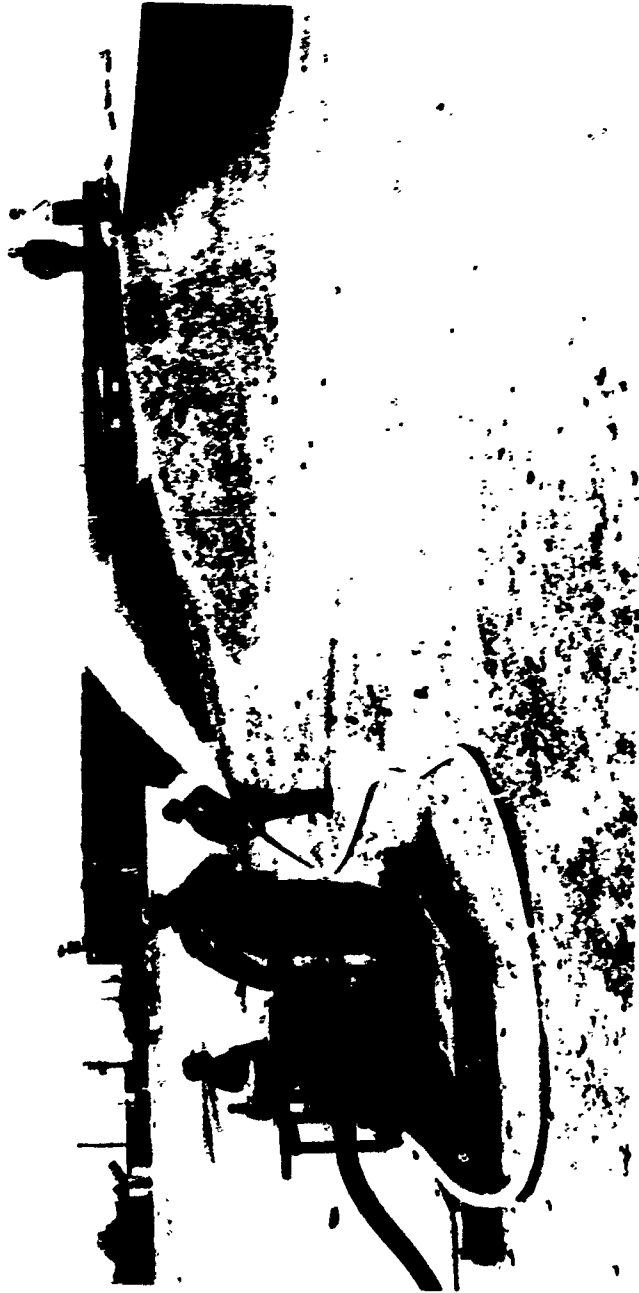
T7132

Fig. 8. Rainfall simulation.

a. **Evaluation of Roof under Simulated Rainfall Conditions.** Rainfall was simulated by spraying water over the entire surface of the roof section using a 2-inch firefighting nozzle and hose attached to a pump and a tank trailer (Fig. 8). The rainfall simulated was a rate of approximately 2 inches per hour for a period of 30 minutes.
