AMMRC CTR 73-6

EROSION-RESISTANT COATING FOR TITANIUM

Pratt & Whitney Aircraft

Final Report - Contract DAAG46-71-C-0173

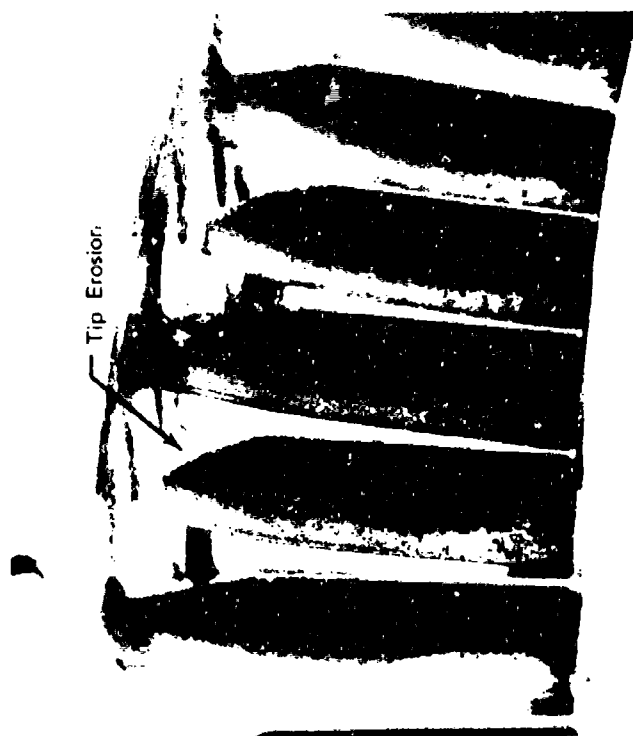
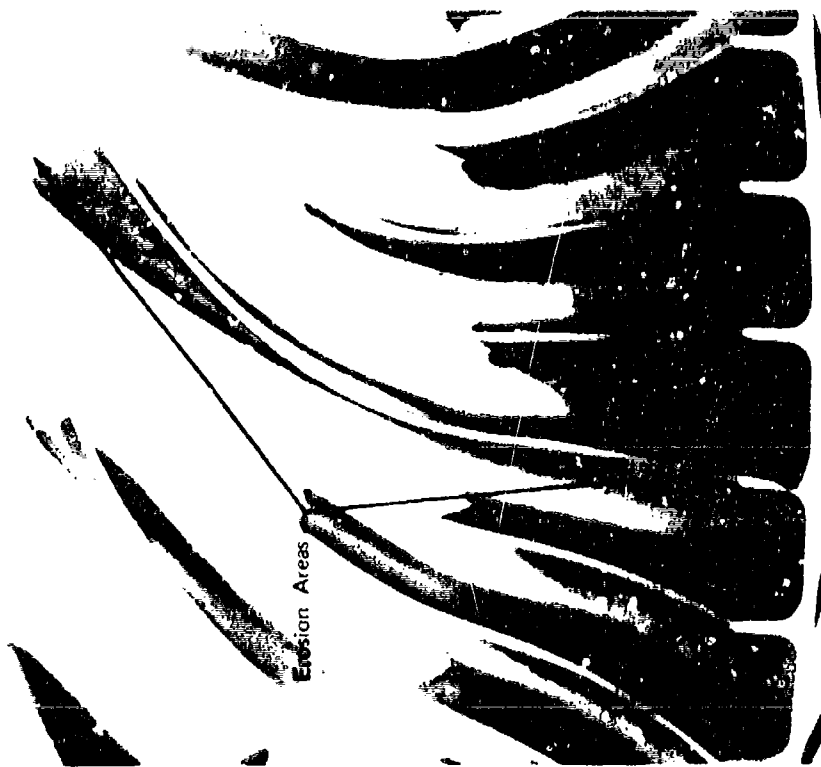
Figure 3. Typical Compressor Erosion Damage

Axial Compressors

Centrifugal Impellers

Gas turbine engines require high airflow per horsepower, and thus are vulnerable to degradation caused by erosive particle contaminants in the air. When subjected to such contamination, degradation is evidenced by loss of power, loss of surge margin, and increased specific fuel consumption because of either erosion or fouling of precision airfoil sections in the compressor and turbine. Most of the early gas-turbine-engine erosion experience was obtained with fixed-wing aircraft operating from paved runways, and particle ingestion was not a significant problem. Tactical helicopter and fixed-wing aircraft operations from unimproved landing sites, however, forced a reappraisal of the vulnerability of gas turbines to solid-particle ingestion. Figure 1 shows helicopters operating under these adverse conditions, and Figure 2 shows a fixed-wing aircraft operating in the same type of environment. Premature engine removals, because of resultant erosion damage, drastically reduced the time between overhaul, in some instances by a factor of 10 or more. Generally, when the engines were overhauled, all compressor components had to be replaced. Examples of typical axial and centrifugal compressor damage are shown in Figure 3.

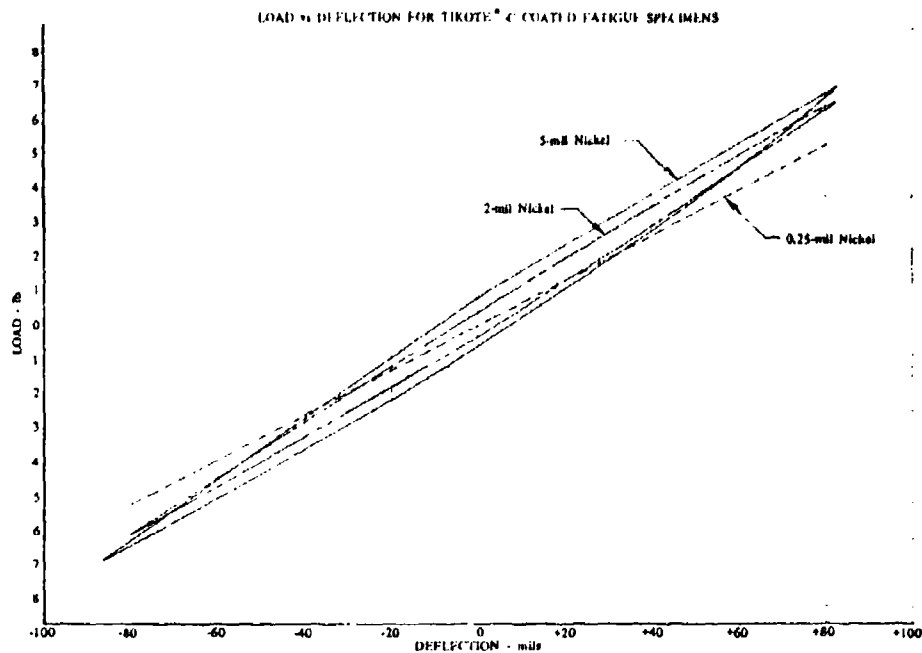
Figure 14. Load vs Deflection for TIKOTE<sup>®</sup>-C Coated Fatigue Specimens. DF 94721

The cause of changes in frequency and power that were observed during the fatigue testing of the TIKOTE-C-coated fatigue specimens with thicker nickel plating was determined to be yielding of the annealed nickel plate. Load vs deflection curves for the three types of coated fatigue specimens are given in Figure 14. The fatigue specimen with 5-mil nickel plating sustained an 8-mil permanent deflection when loaded to a calculated stress level of 30,000 psi. The 2-mil nickel plated specimen sustained a 4-mil permanent deflection under the same stress loading, while the fatigue specimen with the standard 0.25-mil nickel plating was completely elastic. The degree of permanent set was reversible and caused a hysteresis loop when flexed in both directions. This cold working of the thicker nickel plating could explain the observed decreasing power required to fatigue those specimens as shown in Figure 15. Also, the frequency of the samples remained relatively constant until a surface crack probably occurred. This was relatively early in the case of the 5-mil nickel plated specimens, and the subsequent gradual failure may be the result of a crack inhibiting effect in the ductile nickel layer.

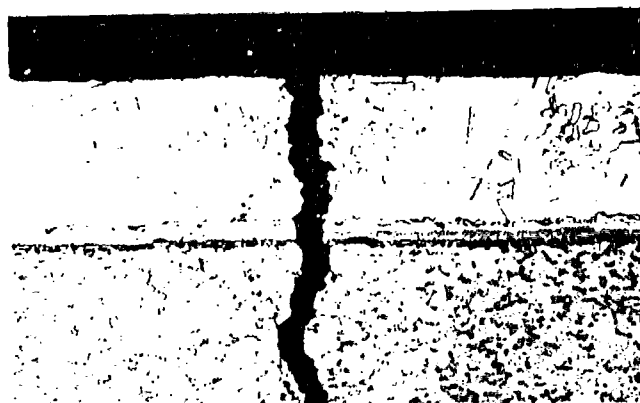
Figure 18. Cracks in TIKOTE<sup>®</sup>-C-Coated Fatigue Specimens With 2- and 5-mil Nickel Plate

Failed fatigue test specimens were examined to evaluate the concept of retardation of crack propagation by the ductile layer of nickel plate. In cross sections taken normal to the fatigue cracks, all observed cracks had propagated through the TIKOTE-C coating, nickel, intermetallics, and into the titanium. Photomicrographs of cross sections of TIKOTE-C-coated fatigue specimens with 2-mil and 5-mil nickel plate are shown in Figure 18. Cracks are readily visible through the nickel plating, intermetallics and into the titanium substrate. On the 2-mil nickel specimen, it can be seen that 1.2-mil layer of pure nickel remains and that on the 5-mil nickel specimen 3.5-mils of pure nickel remains.

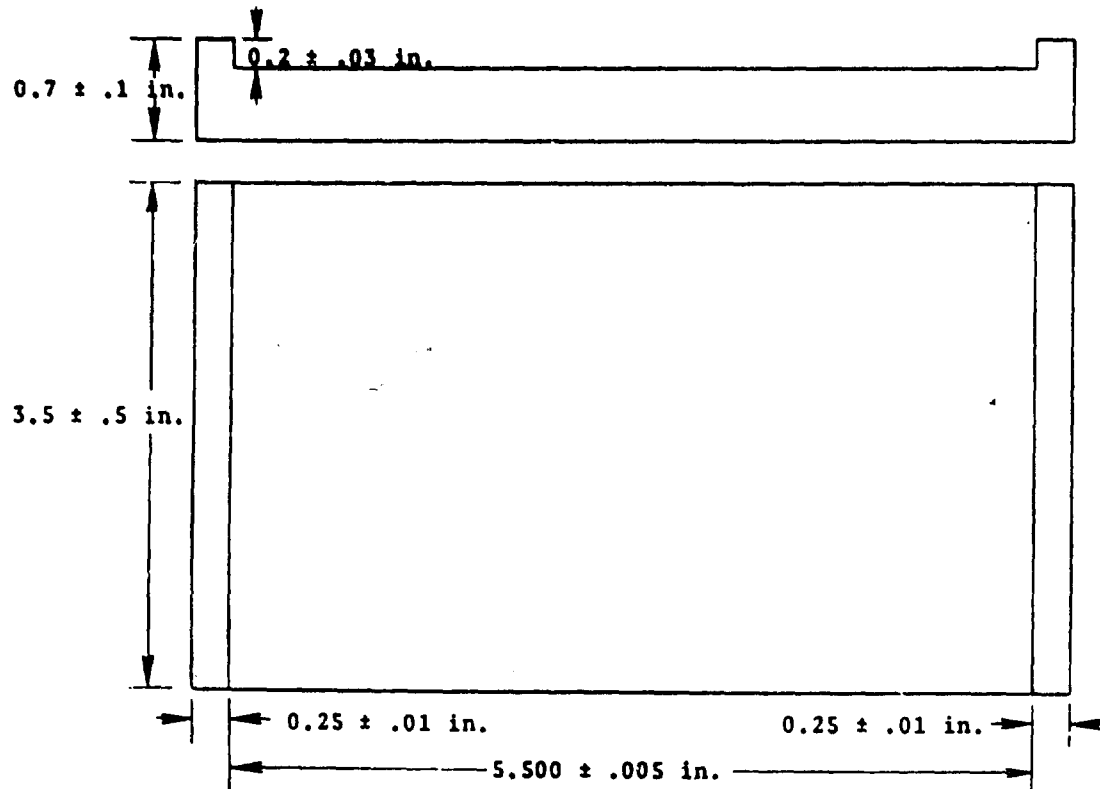
**FIGURE 1 SPECIMEN HOLDER**

**Material: Nickel Base Alloy or Nickel Plated, Type 300 Series  
Stainless Steel. Finished Dimensions After Plating.**

- 2.1 Stress Corrosion Test Specimens: AMS 4916 sheet,  $5.741 \pm 0.005$  in. long,  $0.032 \pm 0.001$  in. thick,  $0.5 \pm 0.1$  in. wide.
- 2.2 Specimen Holder: Refer to Figure 1.
- 2.3 Oven: Circulating air, capable of heating to and maintaining  $900^{\circ}\text{F} \pm 10$  for 100 hours.
- 2.4 Microscope: Capable of 10X magnification.
- 2.5 Microsyringe: Capable of measuring  $50 \pm 5$  microliters.
- 2.6 Sodium Chloride Solution: 3% aqueous solution of sodium chloride prepared with distilled or demineralized water.
