ENVIRONMENTAL ENDURANCE TESTING OF AN  
ELASTOMERIC PITCH CHANGE BEARING

Army Air Mobility Research and Development  
Laboratory

February 1973

**USAAMRDL TECHNICAL REPORT 72-73**

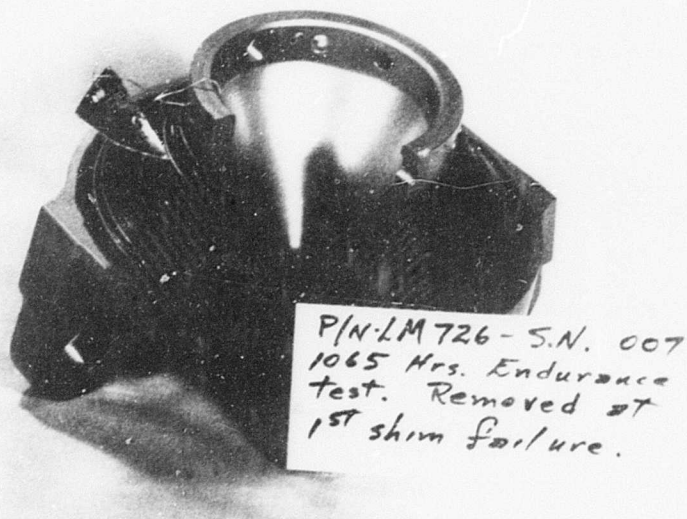
Figure 62. Sectioned View of Test Sample 6 (S/N 007) After Failure at 1065 Hours.
