**STRUCTURAL PROPERTIES OF DUAL HARDNESS
STEEL ARMOR**

ALBERT A. ANCTIL, RICHARD CHAIT,
CHARLES H. CURLL, and ERIC B. KULA
METALS RESEARCH DIVISION

ARMY MATERIALS AND MECHANICS RESEARCH CENTER
Watertown, Massachusetts 02172

AMMRC TR 73-6

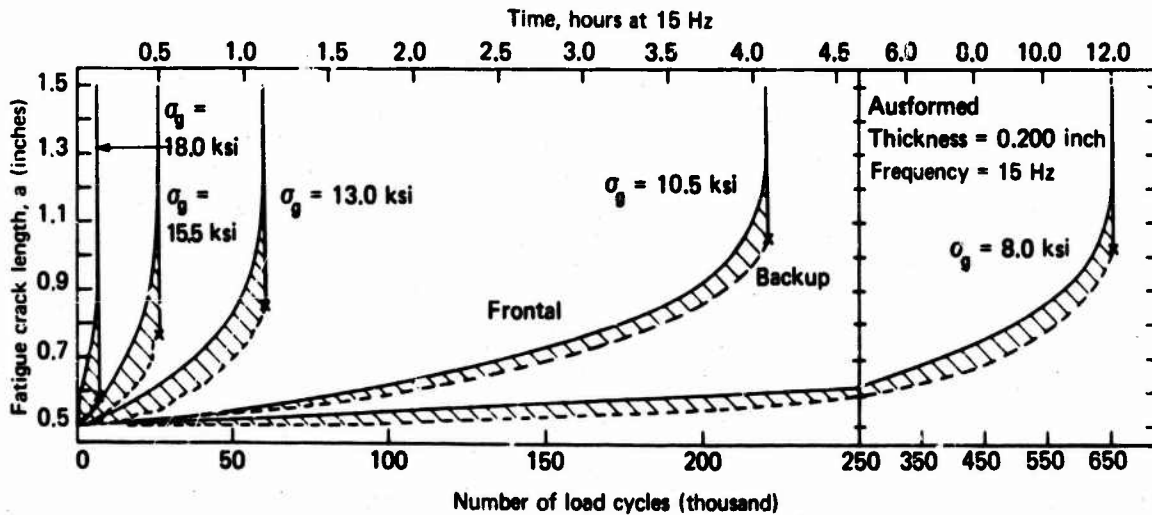
Figure 2. Fatigue crack length as a function of the number of load cycles and stress for ausformed, dual hardness steel

Typical fatigue crack growth rate data at several different maximum stresses are presented in Figure 2, for the ausformed steel. The cracks grow at an increasing rate as the number of cycles increases. In general, the cracks grow at a faster rate in the hard, frontal material, and lag behind in the softer backup material. On these 3-inch-wide specimens, the crack in the hard face typically will grow completely across the width of the specimen by fatigue, followed by fast fracture of the remaining backup material. As the gross stress level is increased, the number of cycles to failure decreases in customary fashion. Of particular interest in these DHS specimens is the observation that the lag in crack growth in the backup material increases as the maximum gross stress increases, e.g., at the onset of fast fracture in the backup, the fatigue crack length is smaller the higher the stress.⁴

For monolithic materials, crack growth data such as are shown in Figure 2 can be analyzed to produce data relating the crack growth rate and the stress intensity factor range ΔK . The growth rate per cycle da/dn is determined by the slope of curves, and ΔK is calculated from the instantaneous crack length "a" and the stress range $\Delta\sigma$, by the use of a formula of the form $\Delta K = k\sqrt{a} \Delta\sigma$, where k is a constant. For many materials, the results are found to obey an equation of the type frequently employed, $da/dn = C(\Delta K)^n$, where C is a constant, and the growth rate exponent n is in the range 2 to 4. This equation is useful in calculating crack growth rates and residual fatigue lives under various loading conditions.

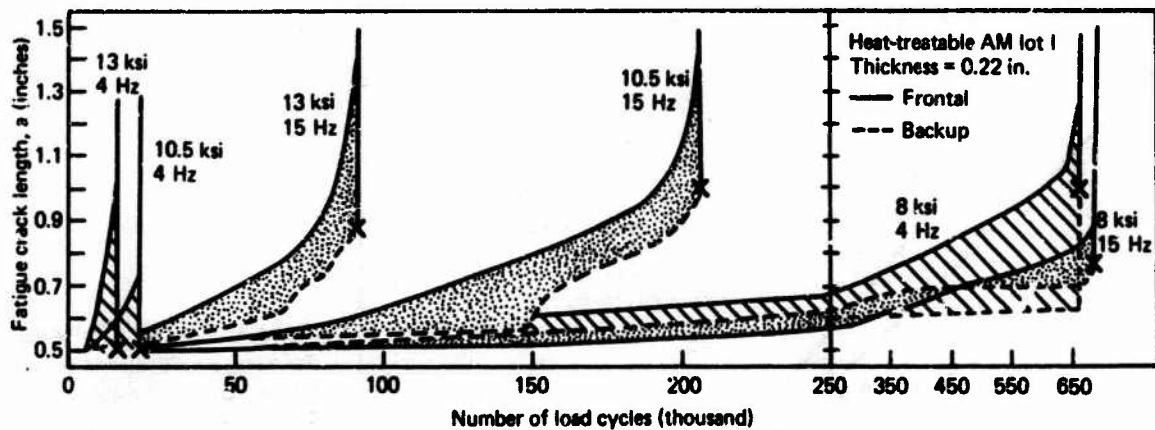
Figure 4. Fatigue crack length as a function of the number of load cycles and frequency for air-melted (lot I), heat-treatable, dual hardness steel

The frequency of loading can have an important effect on crack propagation. Crack growth curves for air melt Lot I at three different stress levels and frequencies 4 and 15 Hz are shown in Figure 4. These frequencies are typical of those that would be encountered by DHS in a helicopter, where the frequency of loading is determined by the product of the number of rotor blades and the revolutions per minute of the rotor. From Figure 4 it can be seen that at the lowest stress used, 8 ksi, there is little difference between the two frequencies, but at gross stress levels of 10.5 and 13 ksi the crack growth rates and the fatigue lives are markedly affected, with the lower frequency giving rise to the poorer properties.

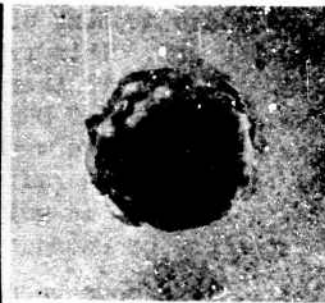
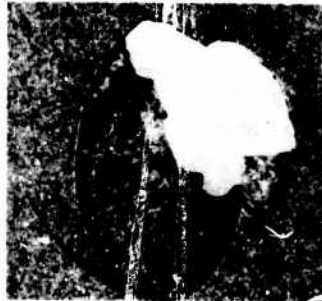
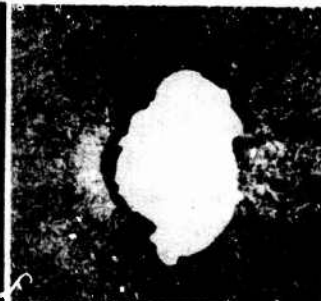
a. Ausformed
Thickness, in. 0.2
Projectile .30 AP
Penetration CP

b. Ausformed
Thickness, in. 0.32
Projectile .30 AP
Penetration PP

c. Heat-Treatable/Air Melt
Thickness, in. 0.26
Projectile .30 AP
Penetration CP

d. Heat-Treatable/VIM
Thickness, in. 0.24
Projectile .30 AP
Penetration CP

e. Heat-Treatable/VIM
Thickness, in. 0.24
Projectile .30 Ball
Penetration CP

Figure 7. Typical ballistic damage patterns for ausformed and heat-treatable dual hardness steel

Some typical examples of ballistic damage encountered in DHS are shown in Figure 7. The first pair of photos (a) show plugging and radial cracking on the front face. The rear face probably petaled, but most of the deformed area spalled off, leaving some radial cracks. The second pair of photos (b) shows a partial penetration, with a probable front spall of the frontal material and petaling on the backup material, in the third pair of photos (c) is shown an example of plugging or conical spall, with some radial cracking in the front face. The fourth (d) and fifth (e) pair of photos show ballistic damage in the VIM steel by caliber 0.30 AP and ball ammunition. In both cases there is plugging, with cracks tending to form logarithmic spirals along planes of maximum shear stress in the plate. The rear surface shows evidence of plastic deformation and spalling of the backup material.

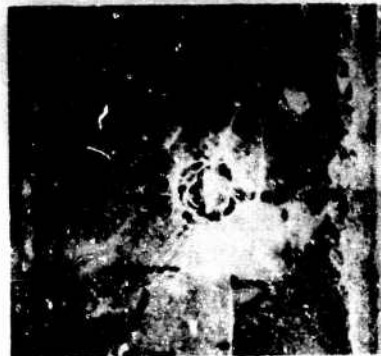
Figure 8. Ballistic damage resulting from impact of caliber 0.30 ball projectile at various applied stress levels. Material is air-melted (lot II), heat-treatable, dual hardness steel.

Applying a load during ballistic impact can increase the extent of radial cracking type of damage as can be seen in Figure 8. Here, test plates of air melt Lot II impacted with caliber 0.30 ball at a velocity sufficient to cause complete penetration show a marked increase in the extent of damage as the applied load is increased. The applied stress can be increased until the resultant damage is sufficient to cause fracture upon ballistic impact. This stress level, termed σ_f , was established at 26 ksi for the caliber 0.30 ball and 34 ksi for the AP. The effect of stress level on ballistic damage is shown in Figures 9 and 10 for the ball and AP projectiles. In terms of the number, maximum length, and accumulated length of ballistically induced cracks it is seen that the ball projectile is more damaging than the AP, which tended to produce plugging, thus accounting for the lower critical stress value. Note that in one instance (specimen 12, Figure 10), damage comparable to the ball projectile was obtained for the AP projectile. It is also interesting to note that the cracks described in Figures 9 and 10 did not penetrate through the thickness. No evidence of crack formation was found on the backup portion of any of the specimens in this series.

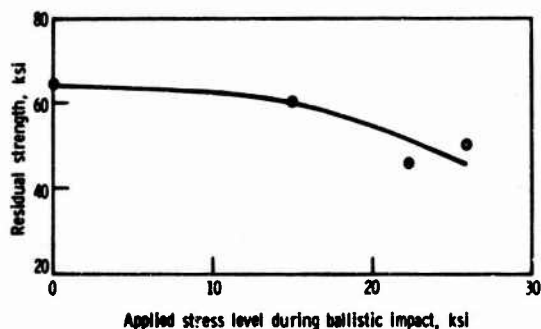
Figure 12. Effect of applied stress level during ballistic impact by caliber 0.30 ball projectile on residual strength. Material is air-melted (lot II), heat-treatable, dual hardness steel.

Base-line tensile properties of the various types of dual hardness steel armor were shown in Table II. A complete penetration of the air melt LC 'I armor lowers the residual strength to about one fourth of the undamaged strength level. There is further degradation in the residual strength of test plates ballistically impacted under load as shown in Figure 12. The drop to the 50 ksi residual strength level occurred for plates ballistically impacted near σ_f , the critical fracture stress. This is due to the increase in extent of cracking at these applied stress levels (Figure 9).
