**EROSION STUDY OF 7.62MM CR-MO-V STEEL GUN TUBES**

**PART I. Erosion Analysis and Characterization**  
**PART II. Fatigue Behavior in Reactive Environments**

**TECHNICAL REPORT**

WEAPONS LABORATORY, ROCK ISLAND ARSENAL

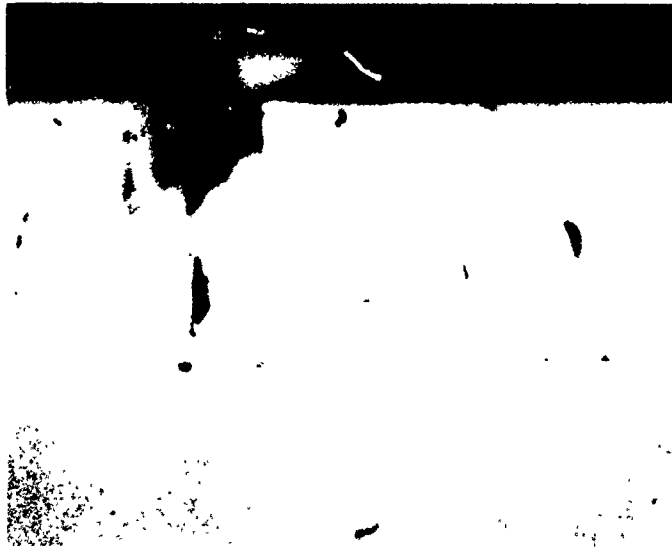
FIGURE 3. Pits developing in steel at base of cracks in Cr plating. Barrel C-10.

(a) Photomicrograph, transverse section. Unetched, 500X.

(b) Scanning electron micrograph. Nital etch. 10,000X.

The first evidence of any alteration appeared at the Cr-steel interface after only ten rounds, as is shown in Figure 3. These pits were always observed to be associated with cracks in the plating, but all of the cracks did not result in pits. This pitting condition had not significantly changed after 50 rounds; however, an almost complete absence of pitting was observed on the barrel fired for 100 rounds. An X-ray spectrometer analysis of a pit in barrel C-50 (Figure 4) showed Pb, Ca, and possibly P to be present. The presence of P was also indicated in the pits in barrel C-10. Bore surface samples from barrel C-100 did show extension of cracks into the steel which is depicted in Figure 5. After 100 rounds, the chemistry of the bore surface, Figure 6, included aluminum, lead,\* sulfur,\* calcium, copper and zinc. No foreign elements were detected in the fine cracks of the C-100 barrel.

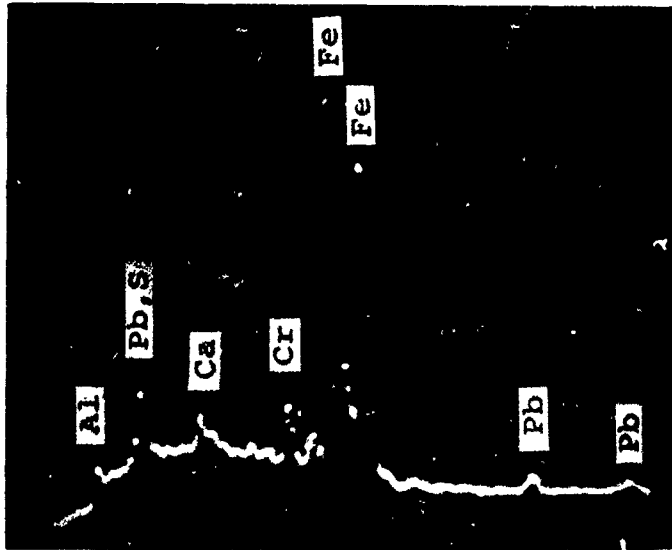
FIGURE 10. Chemical analysis in crack leading from pit at location indicated by white dot in top photograph. Barrel C-200.

(a) Scanning electron micrograph of bore surface sample. Nital etch, 3000X.

(b) X-ray spectrometer results.

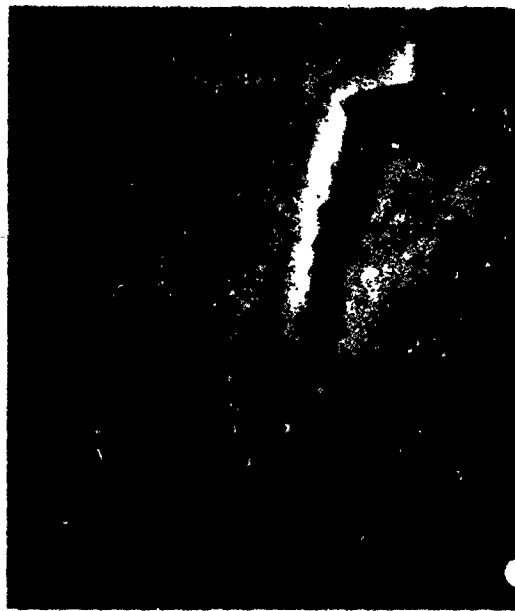
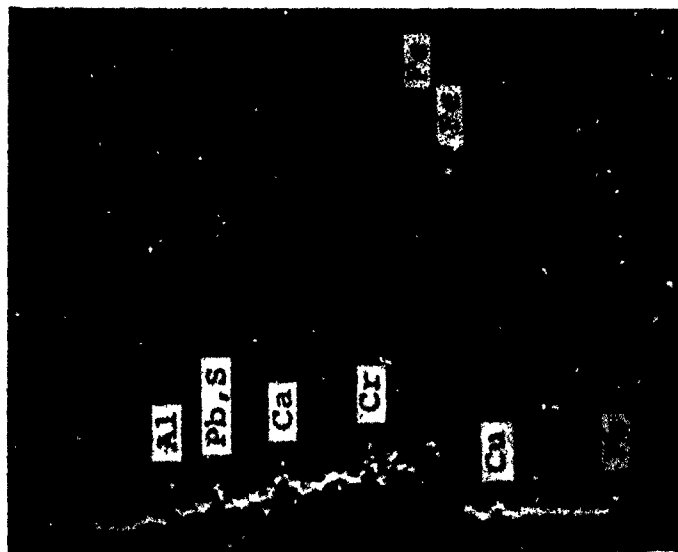
FIGURE 14. Chemical analysis of crack (white dot) in barrel C-2100. Analysis in reaction zone (black dot -- not shown) yielded no foreign elements.

(a) Branch crack and reaction zone as it appeared in transverse sample. Scanning electron micrograph, unetched 3000X.

(b) X-ray spectrometer analysis.

Cracking and associated reaction zone formation continued through 1500 rounds and appeared as shown in Figure 14 after 2100 rounds. Analysis of this fine crack surrounded by reaction zone resulted in finding the foreign elements at the very tip of the crack, but analysis in the reaction zone provided a chemistry identical to that of the base steel. Granular removal of the Cr plating resulted in cavities in the bore surface that can be seen in Figure 15.

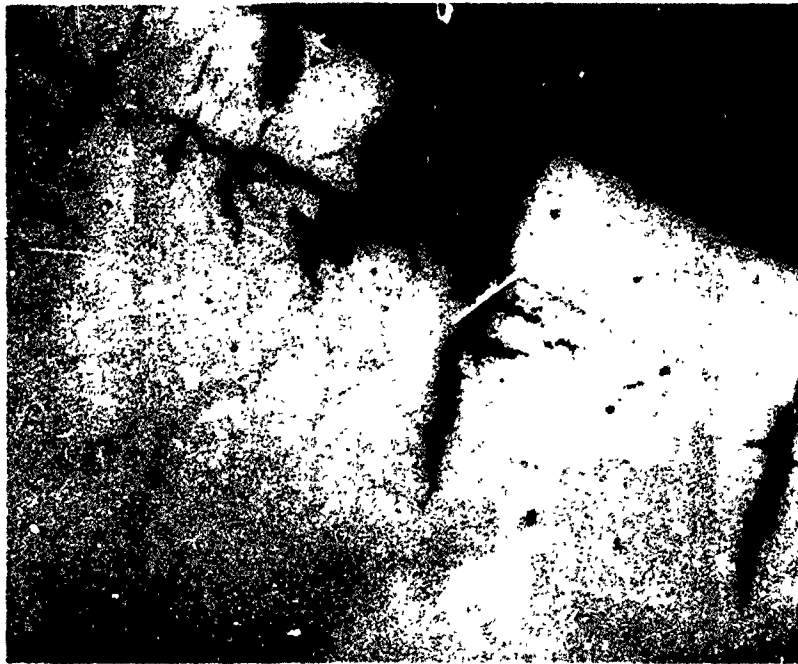
FIGURE 17. Photomicrographs capturing the condition of cracking representative of barrel C-3000.

(a) Poor condition evident on transverse section. Unetched, 250X.

(b) Crack in early stages of formation. Transverse section, nital etch, 1000X.

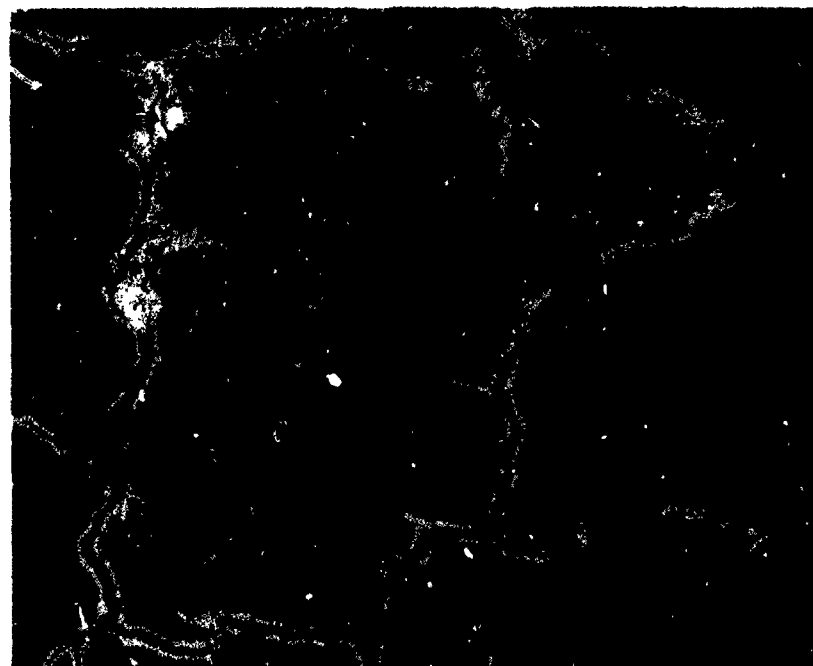
FIGURE 28. Photomicrographs of crack network in barrel U-3000.

(a) Bore surface sample, nital etch, 100X.

(b) Same as above, 250X.

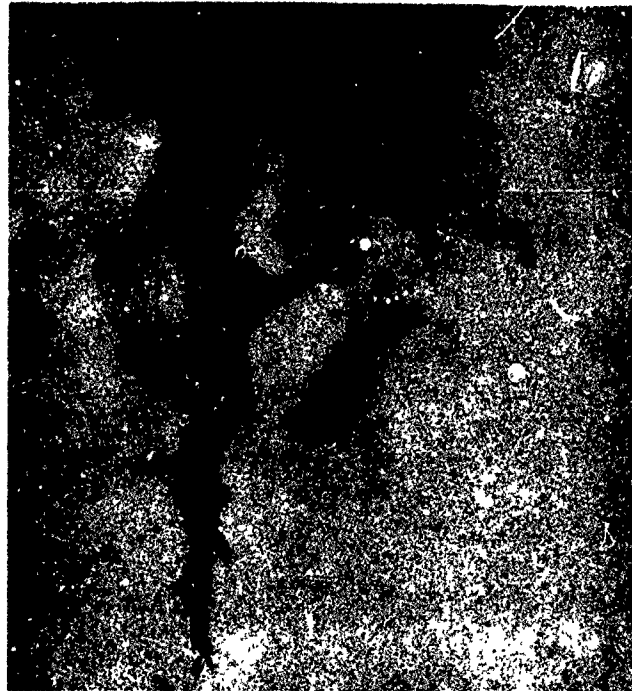
FIGURE 29. Photomicrographs depicting the reaction zone in barrel U-3000.

(a) Bore surface sample, note reaction zone over entire surface, Unetched, 500X.

(b) Transverse sample, reaction zone lining crack. Unetched, 1000X.

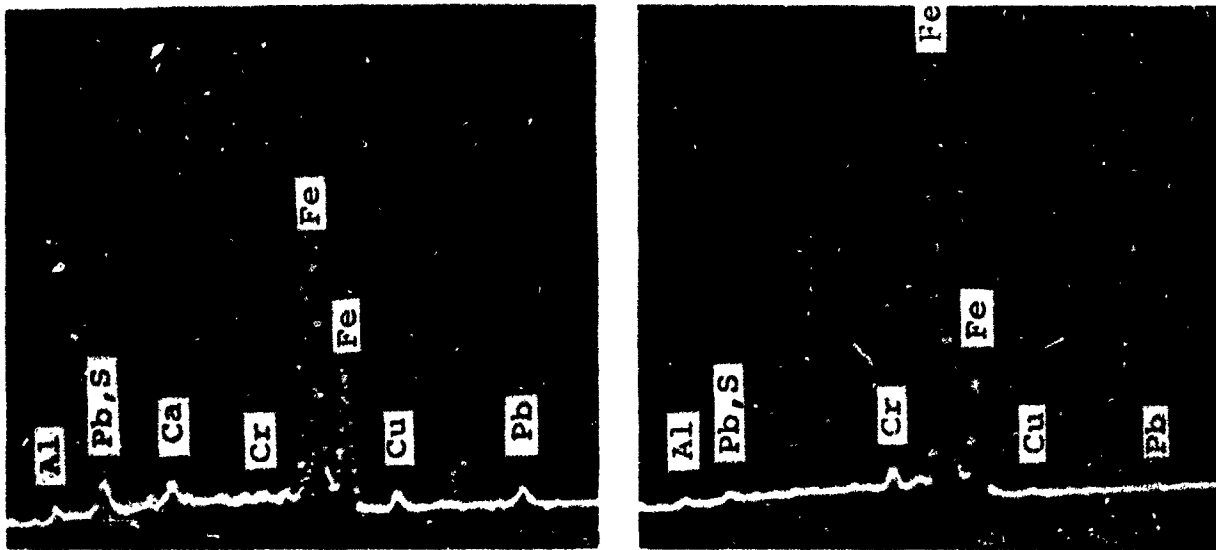
FIGURE 31. Chemical analysis of crack and reaction zone in barrel U-3000.

(a) Scanning electron micrograph, 3000X, indicating positions of chemical analyses.

(b)  $\lambda$ -ray spectrometer results - crack (left) and reaction zone (right).

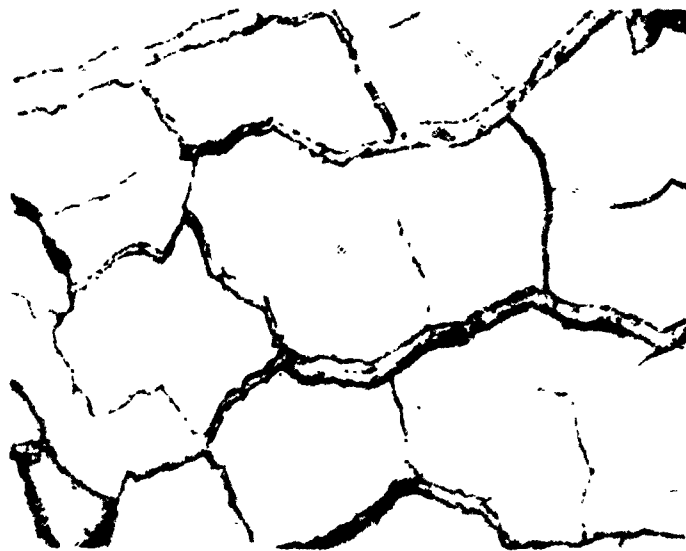
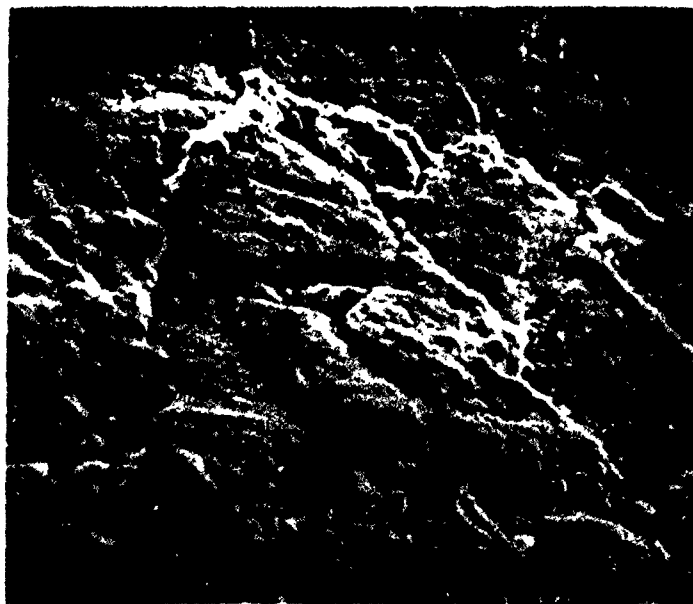
FIGURE 34. Copper deposits in incoherent Cr plating.

(a) Photomicrograph showing Cu throughout cracks in Cr plating. 100X.

(b) Copper assisting in Cr grain removal by wedge effect. Scanning electron micrograph, 300X.

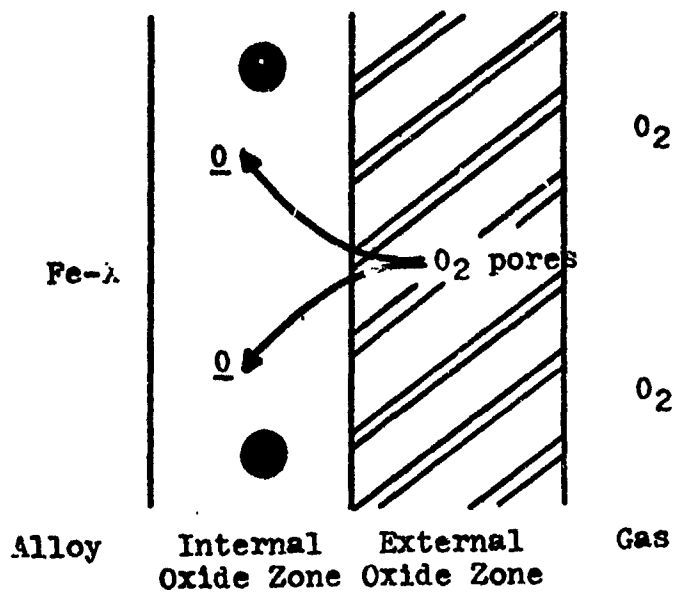
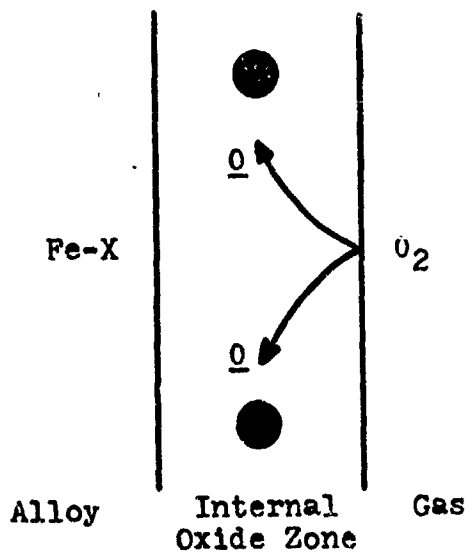
FIGURE 73. Representation of internal oxidation.  
(After Rahmel<sup>36</sup>)

/// Iron oxides
