TECHNICAL REPORT NO. LWL-CR-01C73

SNOW STABILIZATION FOR HELICOPTER LANDINGS

Final Report
Contract No. DAAD05-73-C-0170

By
Franklin Institute Research Laboratories
Benjamin Franklin Parkway
Philadelphia, Pennsylvania 19103

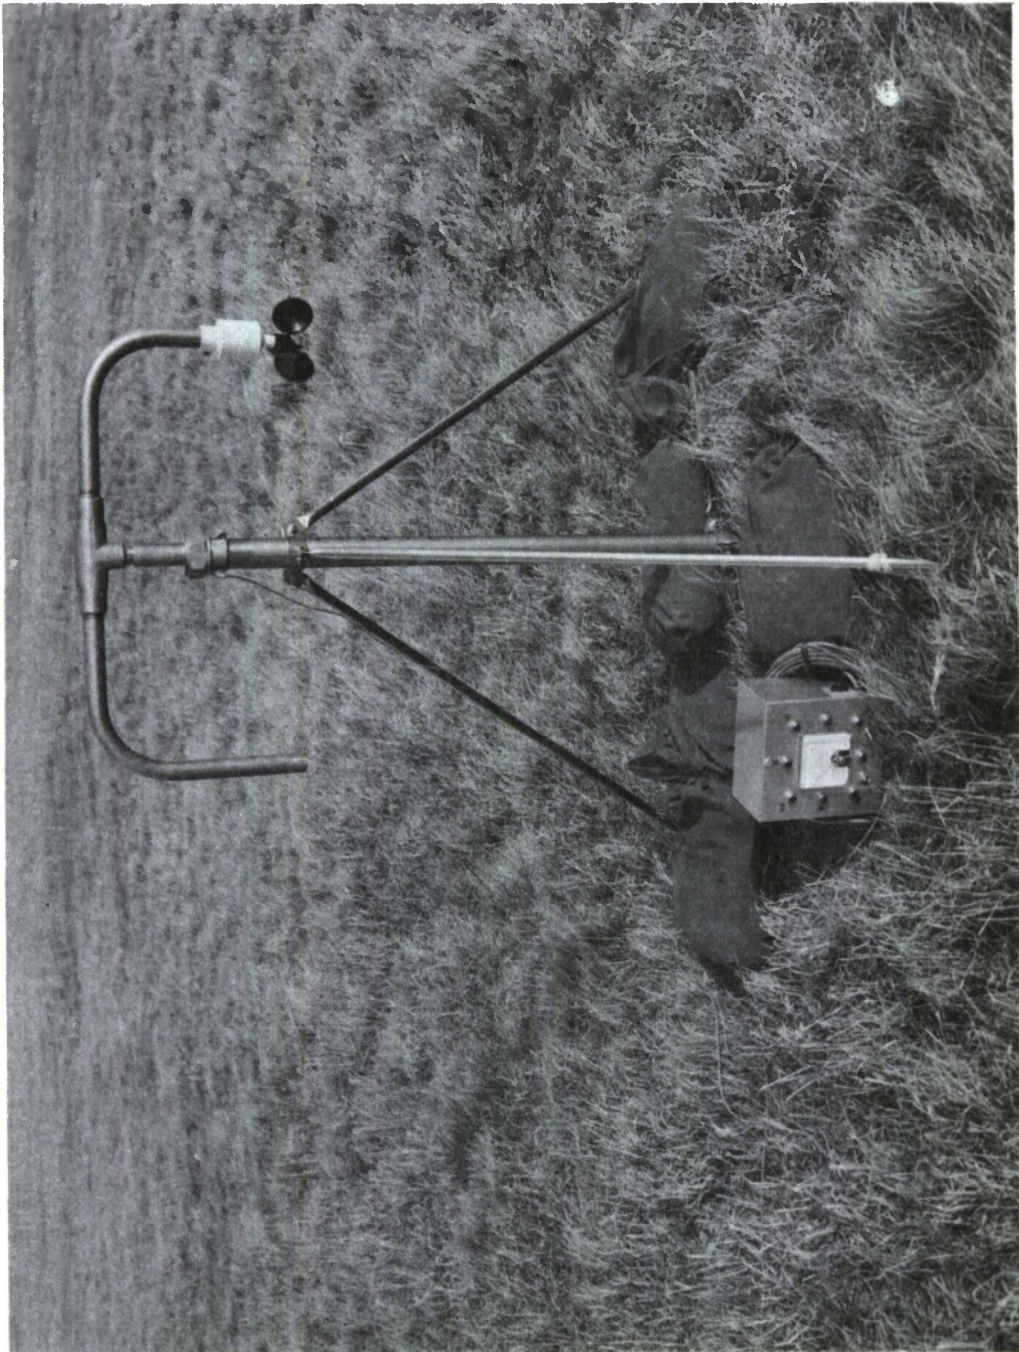
Figure 2-1. Anemometer Used in Downwash Tests

To monitor helicopter downwash velocities, a modified Type C Wind System was purchased from the Belfort Instrument Company. The Type C System includes a standard three-cup anemometer wind speed transmitter, a single tail direction vane and an eight-light direction.

Wind speed is sensed by a wind-powered permanent magnet, alternating current generator working through a rectifier in the meter movement. The meter is calibrated from 0 to 50 miles per hour with a tripling switch that increases the scale range to 150 miles per hour.

Wind direction is indicated by a rotating commutator, fixed brush type vane which utilizes eight contact points for 360° of rotation. The indicator displays a circle of eight lights, one for each cardinal and intercardinal point of the compass. The contacts are so positioned as to allow adjoining contacts to be energized simultaneously; thus sixteen points of the compass or every 22 1/2 degrees are indicated.

Monitoring of downwash velocities was recorded using the modified anemometer described in Section 2, A. The anemometer cups were positioned at a height of 18 to 20 inches above ground in all helicopter tests. Maximum wind velocities have been estimated by the U.S. Army Aeromedical Unit at Fort Rucker to be between 5 and 20 inches above ground for most operational helicopters.

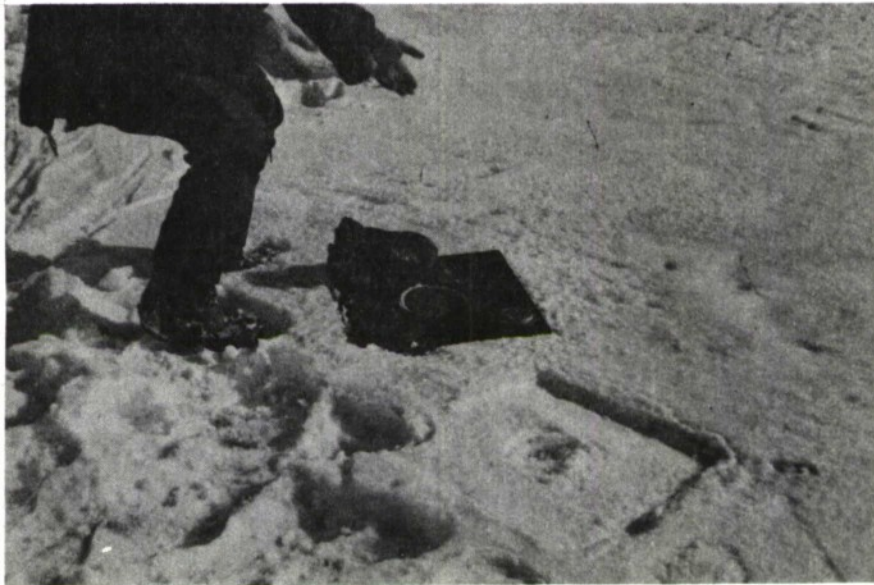
Figure 2-3. Load Bearing Test

To evaluate the load bearing strength of the treated and untreated snows, a simple device was built consisting of a series of weighted discs which are placed on a 7 inch diameter plywood disc positioned on the selected snow area. When the load bearing strength of the snow is exceeded, a fracture of the snow surface occurs. Generally, untreated snow has load bearing strength of approximately ten pounds per square foot.

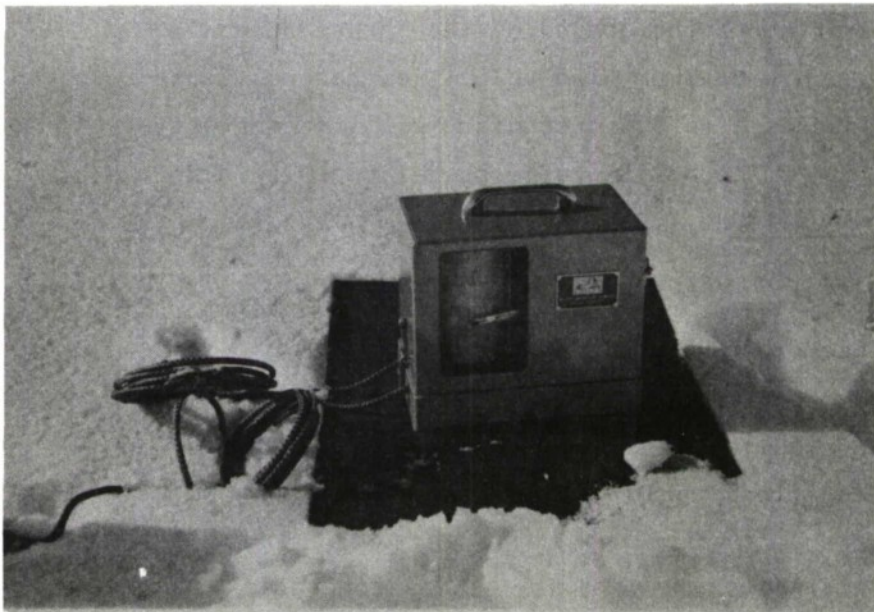
Figure 2-4. Recording Thermograph

This instrument was used to record surface and subsurface snow temperatures simultaneously during snow stabilization procedures.

The sensing elements are liquid-filled bourdon tubes. The recording mechanism is enclosed in a steel and glass case. The clock movement, which revolves the cylinder, is geared for weekly rotation, and temperature fluctuations recorded in degrees centigrade.

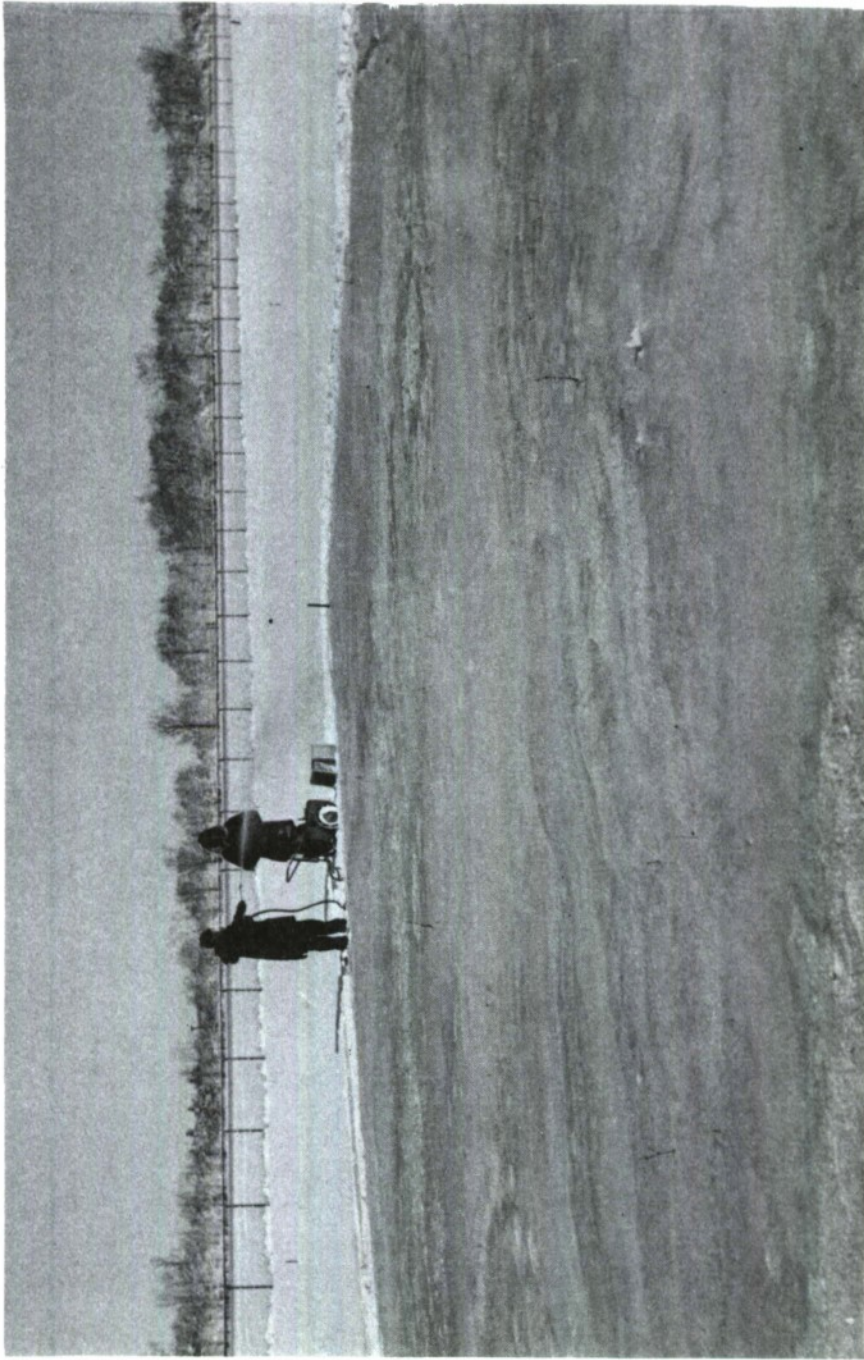
Figure 3-5. Spraying Methanol on Test Pad

Practice spraying was conducted near the main test area on a few small pockets of coarse residual snow and the barren ground. During these practice sessions when the wind speed was above 3 mph, the sprayer personnel experienced great difficulty in applying the prescribed coverage rates of one ounce and one-half ounce per square foot. Attempts at correcting this situation by decreasing the operating pressure from 220 PSI to 140 PSI and changing the nozzle orifice opening from 1/16 inch to 1/8 inch provided only minimal improvement. To overcome this aerosoling behavior effect of the methanol, it was necessary to increase the application rate to concentrations of approx. 4 ounces and 2 ounces per square foot of area when ground wind speeds were above 3 mph.

Although spraying distances of 25 feet were obtained when the spray system was received and checked out (at FURL), this distance was severely reduced at Watertown when the wind was greater than 3 mph. Distances of 16 to 18 feet were the maximum attainable. As a result of this second inadequacy, it became necessary for the spray gun operator to walk upon

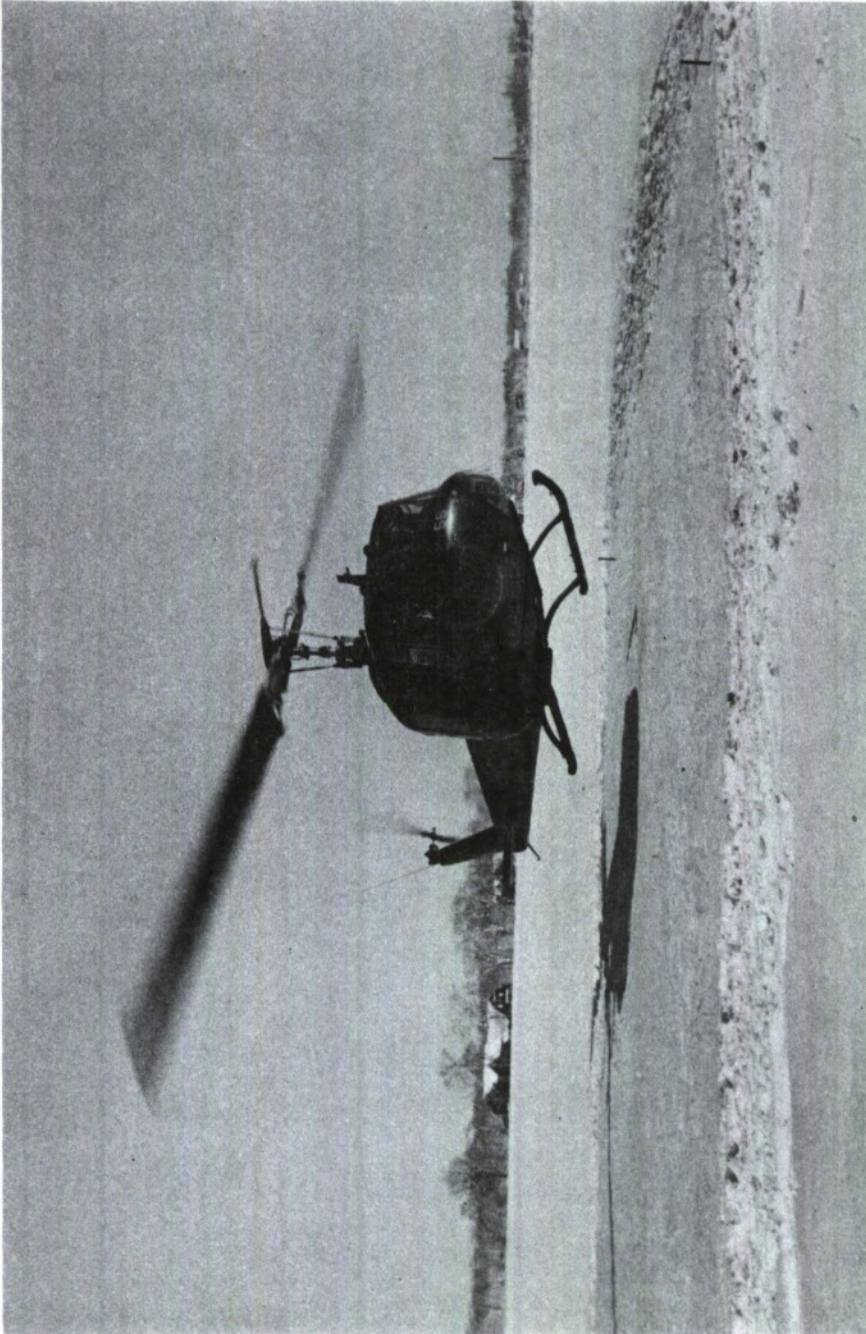
The aircraft personnel reported that the two areas treated with the higher concentrations (\approx 4 oz.) of methanol gave superior suppression to a possible "white-out" condition with ground visibility always present. For comparison purposes, a landing was attempted in an untreated area near the test pads. The pilot experienced great difficulty in making the landing due to the "white-out" which destroyed orientation with the ground.

Figure 3-9. Hovering Over Stabilized Snow (Front View)

Figure 3-10. Hovering Over Stabilized Snow (Side View)
