AMMRC CTR 73-24

AN INVESTIGATION OF METALLURGICAL FACTORS WHICH AFFECT FRACTURE TOUGHNESS OF ULTRA-HIGH STRENGTH STEELS

WILLIAM E. WOOD, EARL R. PARKER, and VICTOR F. ZACKAY

Lawrence Berkeley Laboratory University of California Berkeley, California 94720

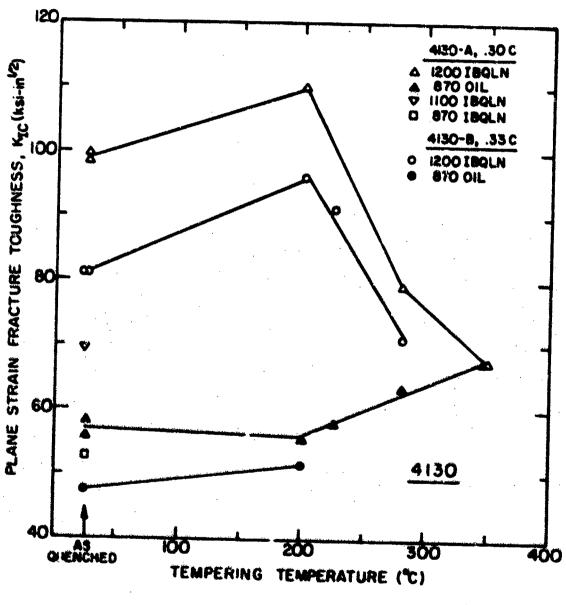
Fig. 16

The fracture toughness results for all conditions tested are given in Table VI, and some of these are plotted in Fig. 16. For this alloy the normal commercial heat treatment is to austenitize at 870°C followed by oil quenching (870, 0il). This results in a fracture toughness of 57 ksi-in. $^{1/2}$ for the as-quenched condition. If the specimen is ice brine quenched and refrigerated in liquid nitrogen (L.N.) after sustenitizing at 870°C, (870, IBQLN) there is no increase in toughness. However, by raising the austenitizing temperature from 870°C to 1200°C, followed by oil quenching, the toughness abruptly increases to 85 ksi-in. 1/2 in the as-quench condition. From Fig. 16, it is seen that the maximum toughness is obtained by austenitizing at 1200°C followed by an ice brine quench and L.N. refrigeration (1200, IBOLN). If the austenitizing temperature is lowered to 1100°C, the toughness again drops from 99 ksi-in. 1/2 to 69 ksi-in. 1/2. The response to tempering for the commercial heat treatment (870, 011) and the best heat treatment (1200, IBQLM) are exactly opposite. The (870, 011) hest treatment shows no response until tempered at a high enough level to cause a drop in strength and hence an increase in toughness. On the other hand, the (1200, INQLM) treatment does exhibit a response to a low 200°C temper but then drops catastrophically at higher temperatures down to the level of the commercial heat treatment. This is a common phenomenon in high strength steels and is referred to as "500"F embrittlement". Finally, the value of the fracture toughness

achieved for any heat treatment condition is very sensitive to the amount of carbon. Figure 16 illustrates how changing the carbon content from 0.30 to 0.33 shifts the fracture toughness of both the commercial heat treatment and the (1200, IBQLN) heat treatment lower. Summarizing then, in order to obtain the best possible fracture toughness, both a 1200°C austenitizing temperature and a very severe quench are required.

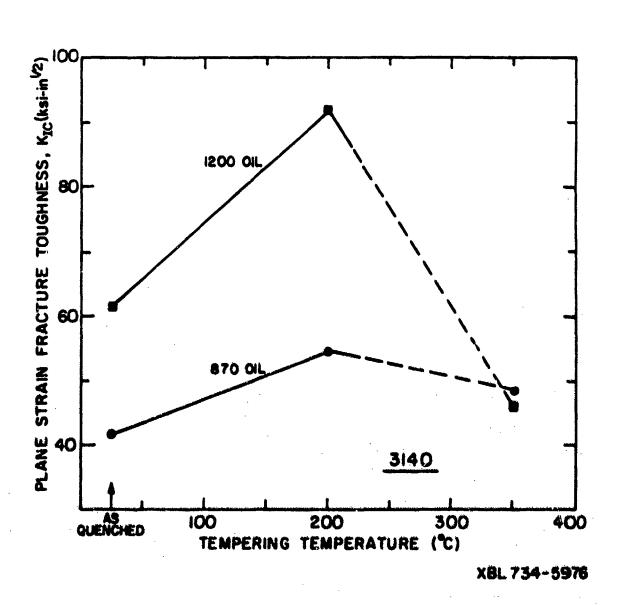
A limited amount of data has been obtained for alloy 3140 and is given in Table XII. The fracture toughness for both the (1200, 011) and (870, 011) heat treatments are graphed as a function of tempering temperature in Fig. 21. While the information is not complete, the results in Table XII and Fig. 21 show that this alloy does respond significantly to the (1200, 011) heat treatment and that as for several other alloys the step quench heat treatment does not result in as high a fracture toughness as the direct (1200, 011) heat treatment. Finally, this alloy does show an abrupt drop in toughness when the direct (1200, 011) heat treatment is tempered above 200°C.

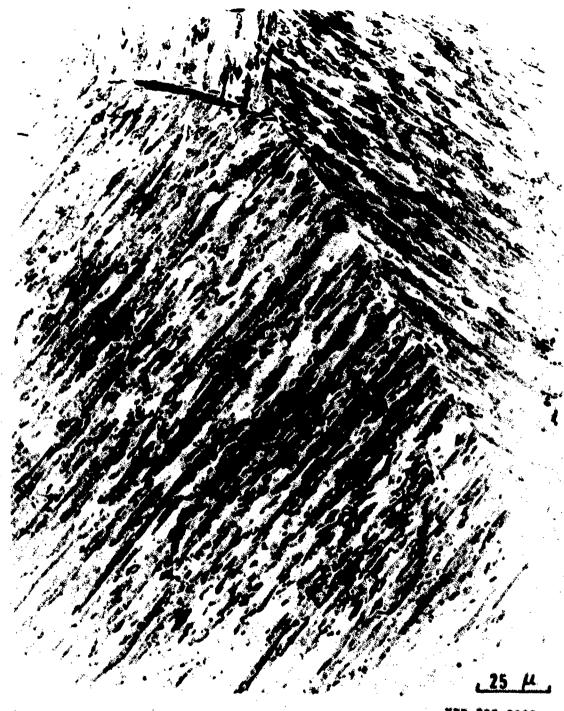
4130 (1200, IBQLN) AQ

The as-quenched microstructure after austenitizing at 1200°C and ice brine quenching followed by liquid nitrogen refrigeration is shown in Figs. 34, 35 and 36. The large grain size of the specimens austenitized at 1200°C is revealed in these figures. The microstructure is comprised of martensite and bainite which has nucleated along prior austenite grain boundaries (Fig. 35). Figure 36 clearly shows how these plates grow out from the grain boundaries. Small particles can be seen in Fig. 35 and are about 1 micron in diameter. These have been identified as

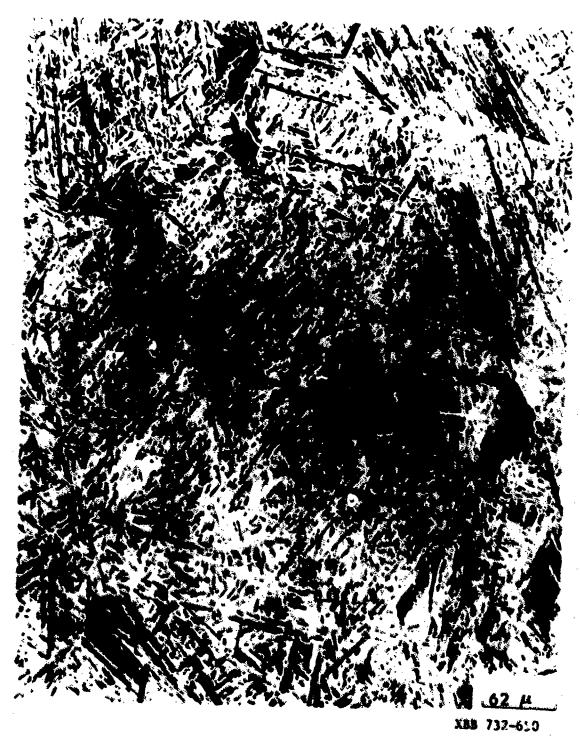
Fig. 43

4130 (12004870, 011) AQ

Using a step quench into oil, (1200+870, 0il) does not produce a change in the microstructure. Upper buintte is visible again originating from grain boundaries (Figs. 43 and 44).

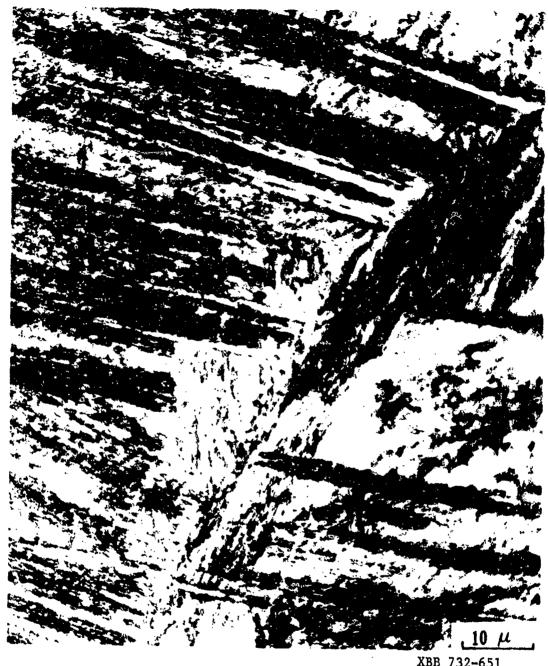
Fig. 44

4130 (1200+870, 011) AQ

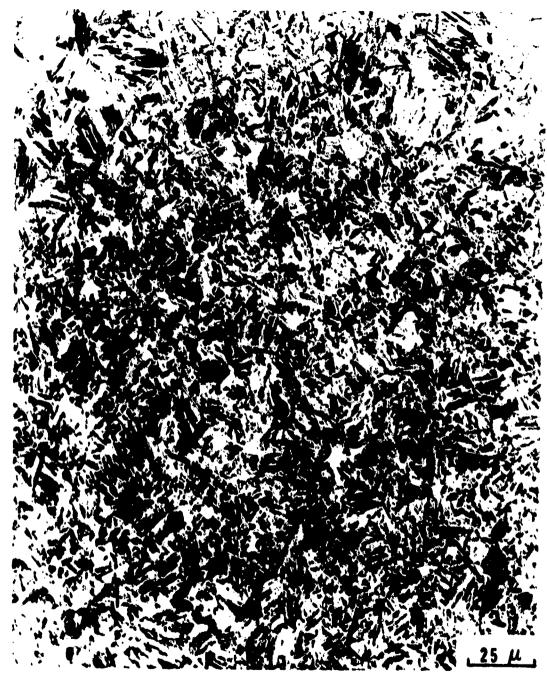
Fig. 49

4130 (870, 011) AQ

The microstructure which results from the commercial 870°C austenitization followed by an oil quench is shown in Figs. 49 and 50. Figure 50 reveals that this heat treatment results in the formation of ferrite and very coarse upper bainite in which the ferrite laths

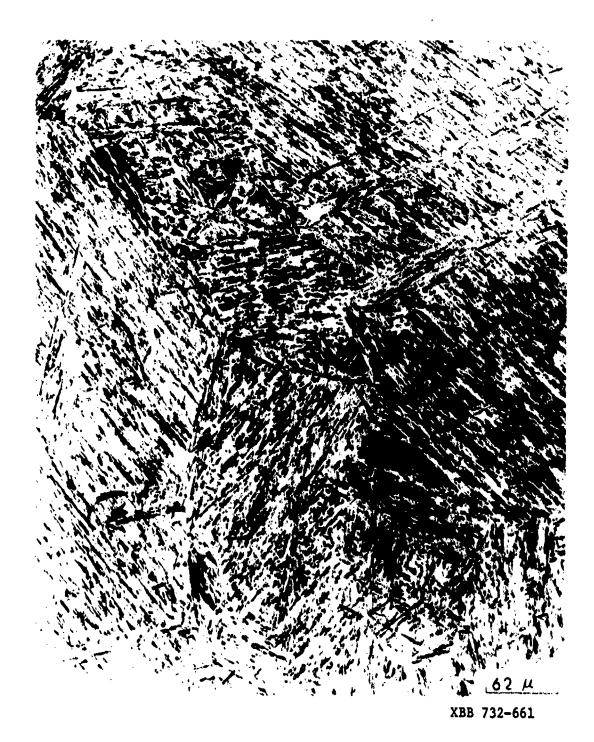
4330 (1200, IBQLN) AQFig. 51

The microstructure of the (1200, IBQLN) heat treated fracture toughness specimen is very similar to that of alloy 4130. The general appearance of the microstructure of this alloy for this heat treatment is shown in Fig. 51. It is difficult to identify without transmission electron microscopy whether this heat treatment results in a fully martensitic or mixed martensitic and bainitic structure. However, a decomposition product can be seen along the sites of prior austenite grain boundaries. For the (1200, 011) heat treatment though, there are small regions of upper bainite found occasionally along prior austenite grain boundaries. An interference contrast micrograph (Fig. 52) in which the dark etching region, marked by arrows, can actually be seen to consist of many very finely spaced parallel plates originating from the grain boundary. The long dark etching plates radiating outward from the grain boundaries in the (1200, 011) heat treatment (Fig. 53) are actually made up of several parallel units characteristic of bainite. Finally, a very fine film of ferrite outlines the grain boundary in Fig. 54 for the (1200, 011) heat treatment. All the features identified in Figs. 52 through 54 for the (1200, 011) heat treatment can also be found in the specimen given a (1200 -870, 011) heat treatment (Fig. 55).

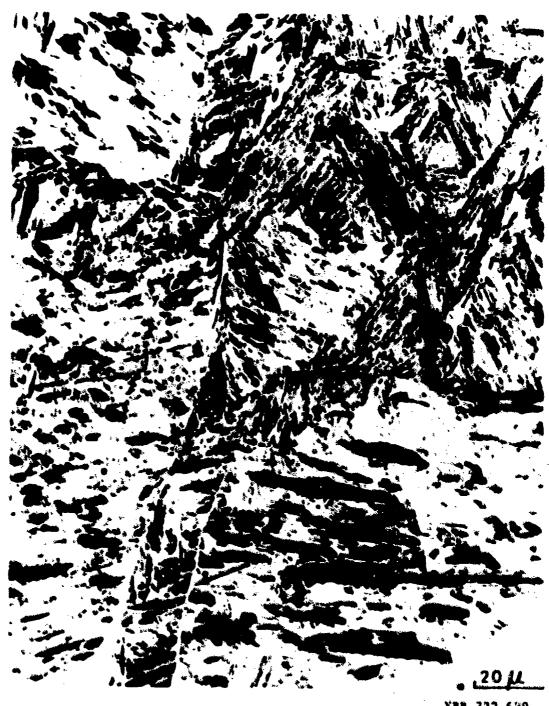
Fig. 55

4330 (1200+870, 011) AQ

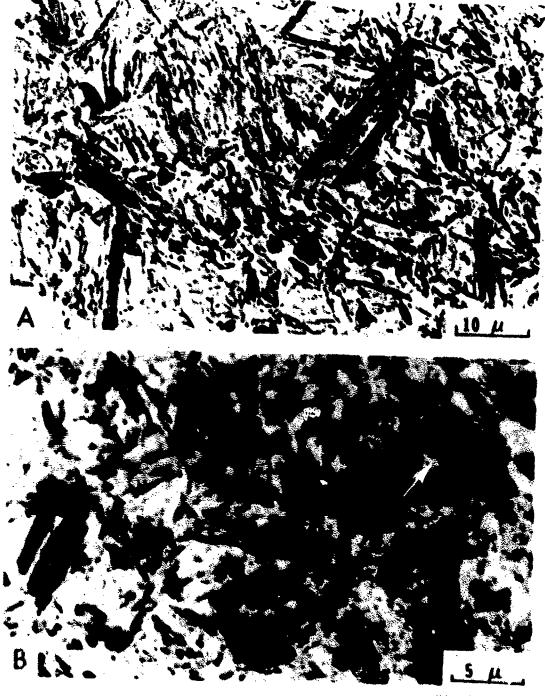
Fig. 57

4140 (870, 011) AQ

The microstructure of this alloy is shown in Figs. 56 through 62. As with the previously examined alloys, the (870, Oil) heat treatment resulted in the formation of extensive amounts of upper bainite (Figs. 57A and 57B). The large grained (1200, Oil) heat treatment eliminated almost all of the coarse upper bainite features found in the fine grained material. Occasionally a finger like or feathery type of decomposition product was observed. Examples of this are marked by arrows in Figs. 58 and 59, and also in Fig. 60, an interference contrast micrograph.

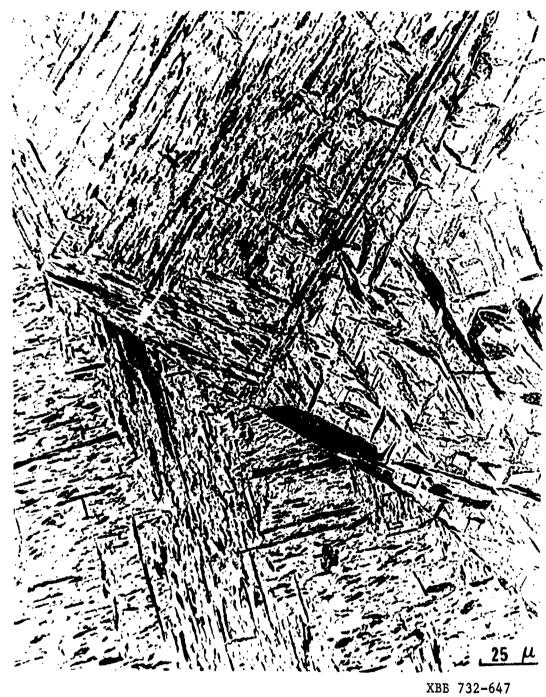
Fig. 58

4140 (1200, Oil) AQ

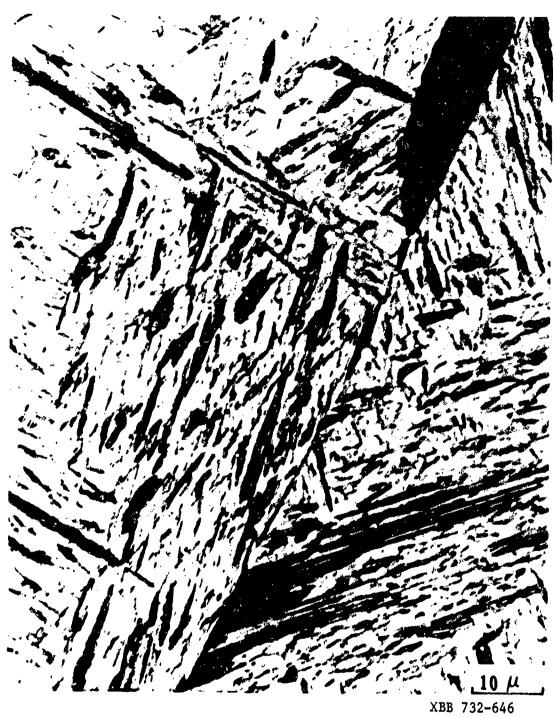
Fig. 59

4140 (1200, 011) AQ
