TRANSMISSION THERMAL MAPPING (CH-47C
FORWARD ROTOR TRANSMISSION)

Boeing Vertol Company

3. REPORT TITLE TRANSMISSION THERMAL MAPPING (CH-47C FORWARD ROTOR TRANSMISSION)		
4. DESCRIPTIVE NOTES (Type of report and inclusive dates) Test and Demonstration Report (Final Report)

5. AUTHOR(S) (First name, middle initial, last name) Rocco C. Tocci A. J. Lemanski Nelson J. Ayoub		
6. REPORT DATE May 1973	7a. TOTAL NO. OF PAGES 167	7b. NO. OF REFS
8a. CONTRACT OR GRANT NO. DAAJ02-72-C-0075	8a. ORIGINATOR'S REPORT NUMBER(S) USAAMRDL Technical Report 73-24

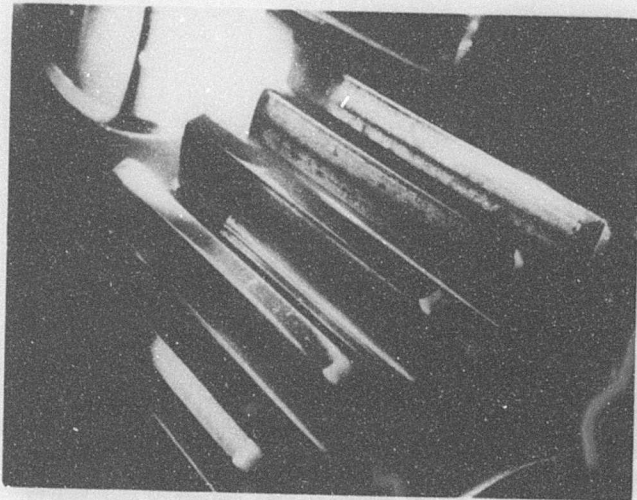
Figure 66. Second-Stage Planet Gear at End of Test 3 at 75 Percent Torque.

A teardown inspection (out of the test stand) was made after the 75 percent torque run segment of test 3. Figures 62 through 66 are photographs of the acceptable condition of the teeth of the spiral bevel pinion, first-stage sun, first-stage planet, second-stage sun, and second-stage planet gears, respectively. Figure 67 shows the condition of the sump, screen, and thermocouple. Figure 68 shows the installation of new thermoplacards behind the oil dam (dam removed) on the I.D. of the spiral bevel pinion at bearings A, B, and C. (The installation of a new thermoplacard on the conical I.D. under the spiral bevel pinion teeth is out of the photograph field of view.)
