EXFOLIATION OF MAGNESIUM-GRAPHITE  
COMPOSITES: A COMBINED METALLOGRAPHIC  
AND ANALYTICAL APPROACH.

Marc H. Richman, et al

Army Materials and Mechanics Research Center  
Watertown, Massachusetts

July 1973

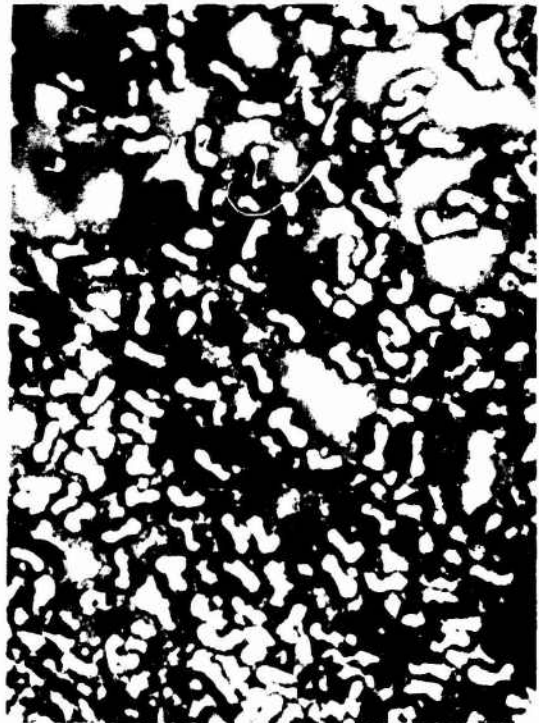
Figure 3. AZ91C Mg-Graphite fiber composite (cross sections)

Since the fibers are in bundles they tend to preserve their bundle-like morphology even after infiltration. However, infiltration and wetting are much more extensive in the good area (Figure 3a) than in the bad area (Figure 3b). This is further corroborated by the higher magnification photomicrographs of Figures 3c and 3d. Indeed, in Figure 3d each fiber is seen surrounded by a dark phase rather than by the light magnesium alloy matrix.

There is, to be sure, some porosity visible in Figures 3a and 3c, but it is very slight as compared to the total lack of wetting in Figures 3b and 3d.

a. Good area. Mag. 100X

b. Bad area. Mag. 100X

c. Good area. Mag. 500X

d. Bad area. Mag. 500X

Microprobe analysis was conducted on the cross-sectioned samples of good and bad areas. Spectral patterns of the elements present in the range magnesium through uranium revealed the presence of only magnesium and aluminum in the matrices of the good and bad areas and also of the dark phase (see Figure 3b) around fibers in the bad areas. A light element study revealed that the dark phase at the interface between fiber and matrix contained sufficient oxygen to be an oxide type of compound.

A quantitative microprobe analysis was made for the concentration of aluminum at various points in the structure. From this it was determined that the good matrix contained 1.0 weight percent (w/o), the bad matrix 1.2 w/o, and the dark phase adjacent to the fibers in the exfoliated regions 17.0 w/o of aluminum. This indicates that the normal matrix content of AZ91C alloy was depleted of aluminum from 8.1 to 9.3 w/o to 1.0 to 1.2 w/o while the dark phase at the fiber/matrix interface was rich in aluminum (17 w/o). This data would indicate that the dark phase was a compound of aluminum with oxygen.

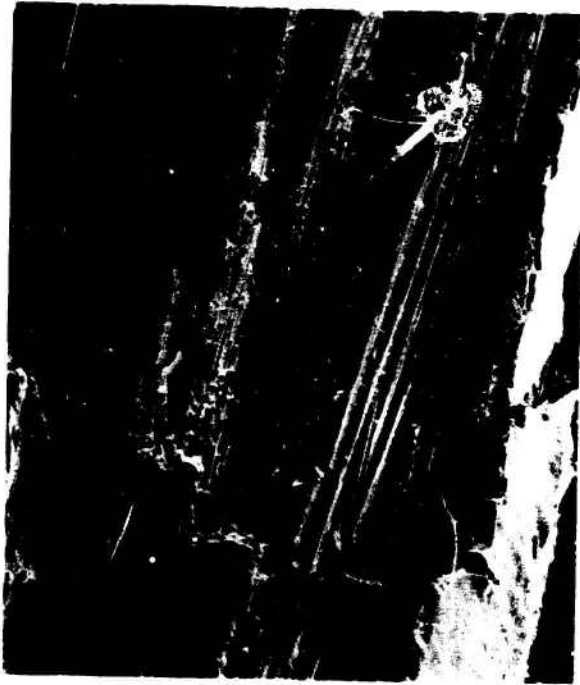
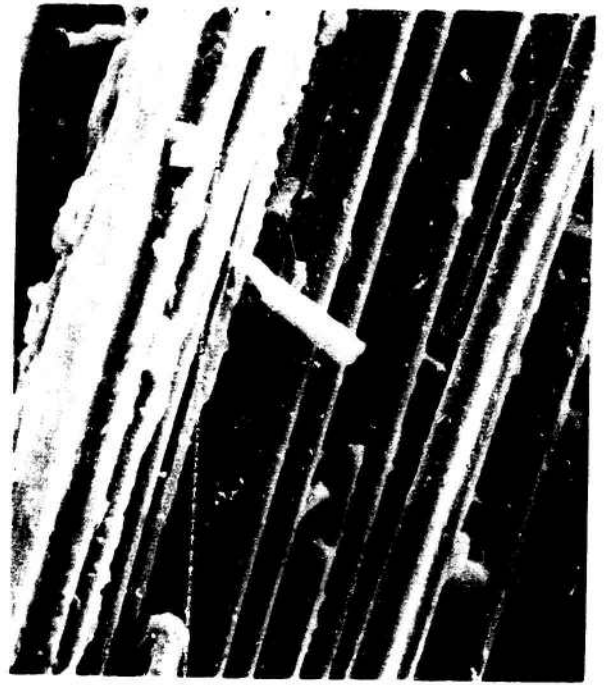
Figure 4. AZ91C Mg-Graphite fiber composite exfoliated surface, area A

The surfaces at two sites are shown at two different magnifications in Figures 4a and b and 5a and b. From these scanning electron micrographs it is evident that there is little if any infiltration of the matrix alloy into the fiber bundles. This results in considerable porosity and lack of wetting of the graphite fibers by the magnesium alloy matrix. Indeed, in Figure 5a a very large void is clearly evident. This sparsity of magnesium alloy matrix adjacent to the fibers and the large voids suggest, as did the optical micrographs, that exfoliation either produces voids and debonding or is caused by them.

19-066-1641/AMC-72 a. Mag. 50X

19-066-1640/AMC-72 b. Mag. 1000X

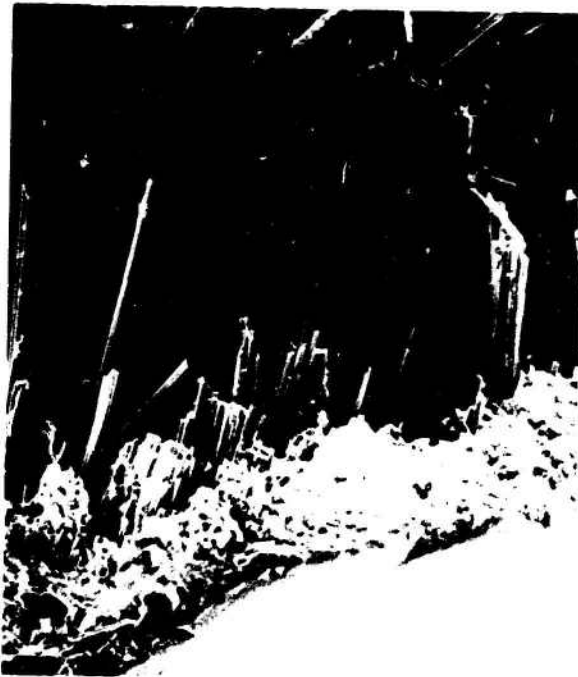
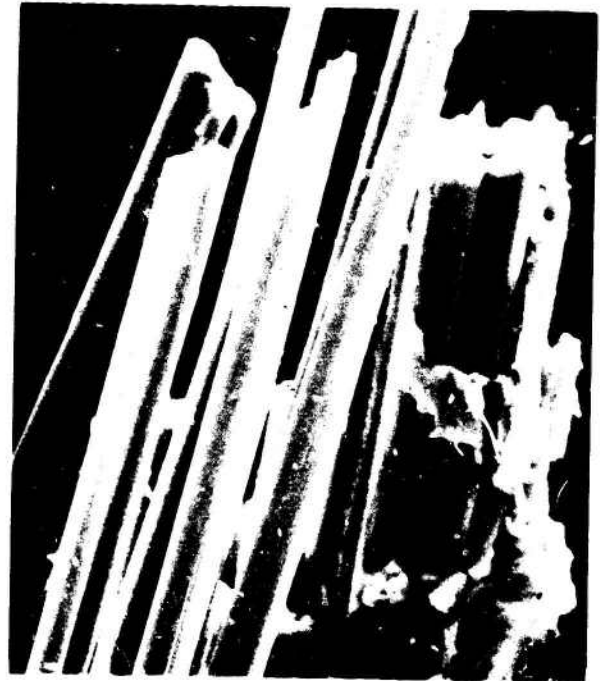
Figure 5. AZ91C Mg-Graphite fiber composite exfoliated surface, area B.

19-066-1632/AMC-72 a. Mag. 100X

19-066-1630/AMC-72 b. Mag. 2000X

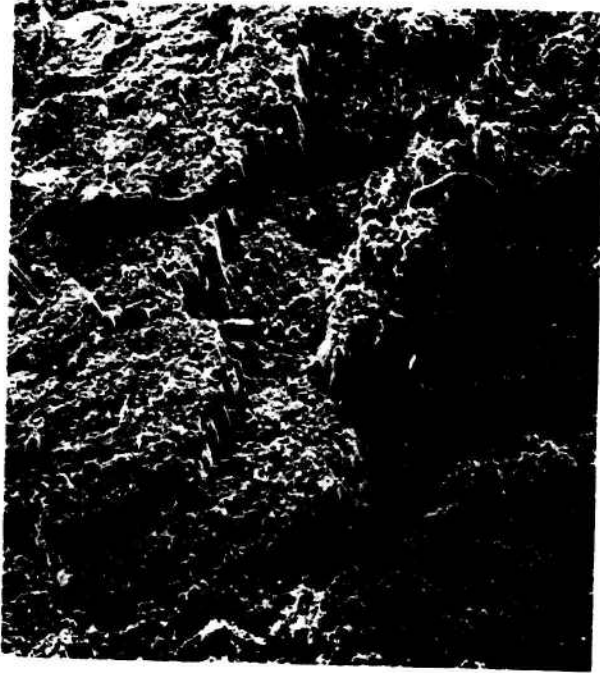
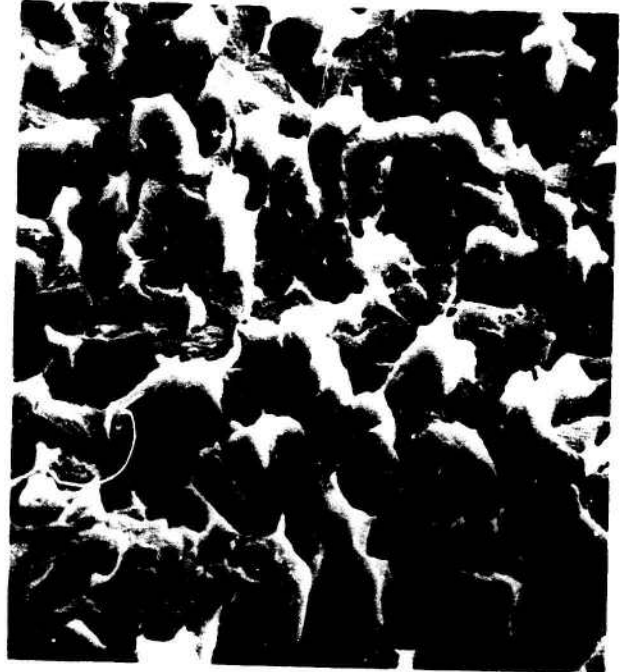
Figure 6. AZ91C Mg-Graphite fiber composite, good area (fractured)

It is easy to see that there is very little evidence of internal porosity or voids in the good region of the composite and that the wetting and bonding is extremely good. In Figure 6b the fibers break off cleanly at the fracture surface while considerable plastic deformation of the matrix has occurred. There is also clear evidence that the intimate bonding of the matrix to these fibers remains even after fracture. It should be noted that despite the convoluted shape of the Celion fibers, excellent infiltration has been obtained.

a. Mag. 100X

b. Mag. 1000X

These scanning electron micrographs clearly indicate a lack of any wetting or bonding between fiber and matrix in the exfoliated regions of the composite while in the good regions there is excellent wetting and bonding.

While the above discussion indicates that magnesium-graphite should not be worthwhile as a composite system, all danger of exfoliation can be removed if good wetting and bonding are achieved. This holds for both magnesium and magnesium alloy matrices. This can be clearly seen by studying the scanning electron micrographs of the good areas in Figure 6 or the optical micrograph of Figure 3a. If such wetting and bonding can be achieved, there is no danger of exfoliation. This has, indeed, been observed in practice in both the pure magnesium and the AZ91C alloy matrices. There is also ample evidence that the elimination of the aluminum from any alloy renders the material more suitable as a matrix metal for this composite system.

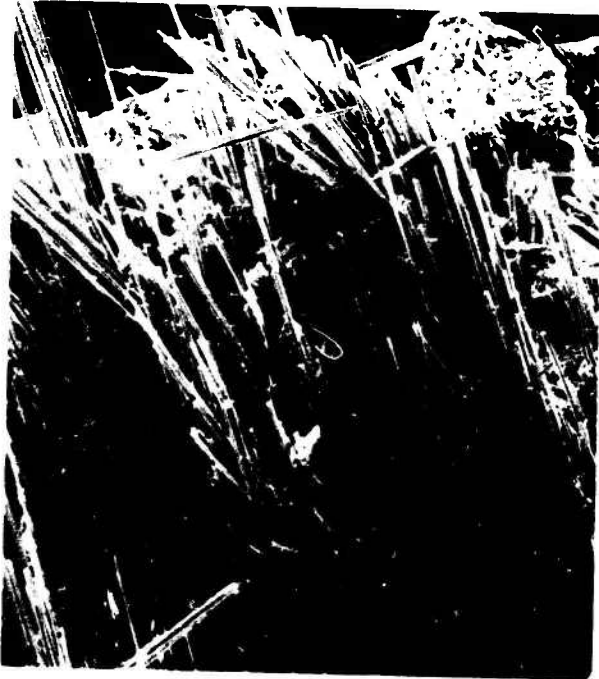
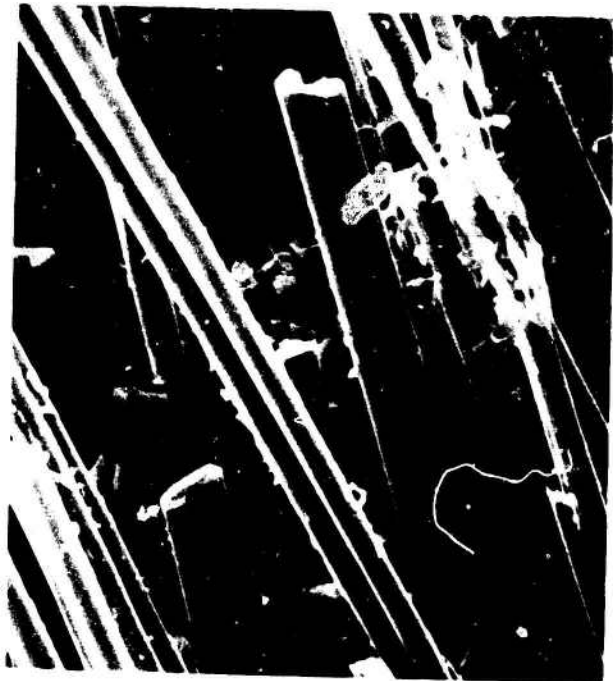
Figure 7. AZ91C Mg-Graphite fiber composite, bad area (fractured)

In contrast to the good area of Figures 6a and b, the bad regions of Figures 7a and b show little or no wetting and bonding. The fibers are virtually devoid of matrix metal and are fractured at various points along their lengths. Scattered small particles of matrix metal may be seen in Figure 7b adhering to some fibers.

a. Mag. 100X

b. Mag. 1000X
