FAILURE PROCESSES IN METAL MATRIX COMPOSITES

GENERAL ELECTRIC COMPANY

PREPARED FOR  
AIR FORCE MATERIALS LABORATORY

REPORT DOCUMENTATION PAGE		READ INSTRUCTIONS BEFORE COMPLETING FORM
1. REPORT NUMBER AFML-TR-73-290	2. GOVT ACCESSION NO.	3. RECIPIENT'S CATALOG NUMBER
4. TITLE (and Subtitle)  FAILURE PROCESSES IN METAL MATRIX COMPOSITES		5. TYPE OF REPORT & PERIOD COVERED Interim Report - Phase I 1 July 1972 to 1 October 1973

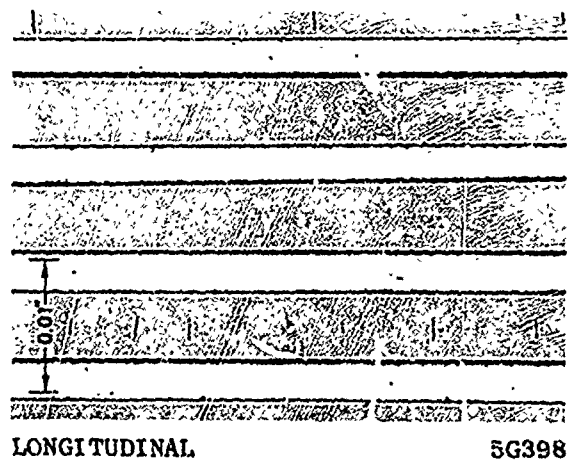
Figure 5 Typical Microstructure of GE-MPTL [0] 8  
Boron/Aluminum Composite Material Fabricated  
Using the MBA/CRB Process

Destructive evaluation of composite materials consisted of boron filament tensile tests, B/Al tape tensile tests, and volume percentage constituent checks. To determine presence of filament degradation due to diffusion bonding, the aluminum matrix is dissolved and the remaining filaments are pulled in tension. Results are presented in Tables VII, VIII, and IX. Tape tensile tests were performed as a quality control measure using a specimen design as shown in Figure 4. The strengths from these quality measurements, Table X are somewhat lower than were expected in light of the excellent filament tensile strengths obtained. The lower strengths are deemed to be attributable to the difficulties in performing reliable tests on monolayered tape. However, the tapes were of acceptable quality level to be used in the fabrication of shear and compressive creep specimens. Volume percent of composite constituents was determined by weight analyses and results are given in Table XI. Metallographic examination of B/Al composite materials used in this program indicated bonding and filament arrays were acceptable as previously shown by NDE evaluation. Typical photomicrographs are presented in Figures 5, 6, and 7.

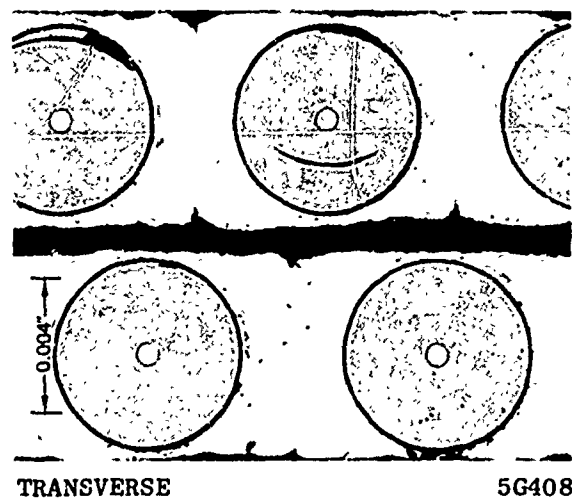
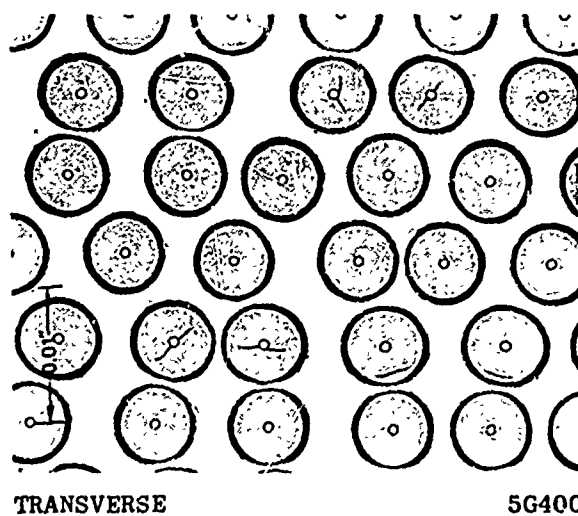
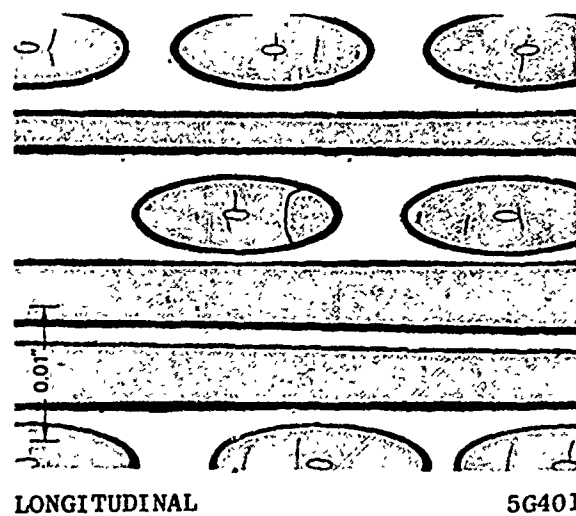
Figure 7 Typical Microstructures of 50 V/O 5.6 MIL B/2024 Al Composite Products Produced by Avco Corporation

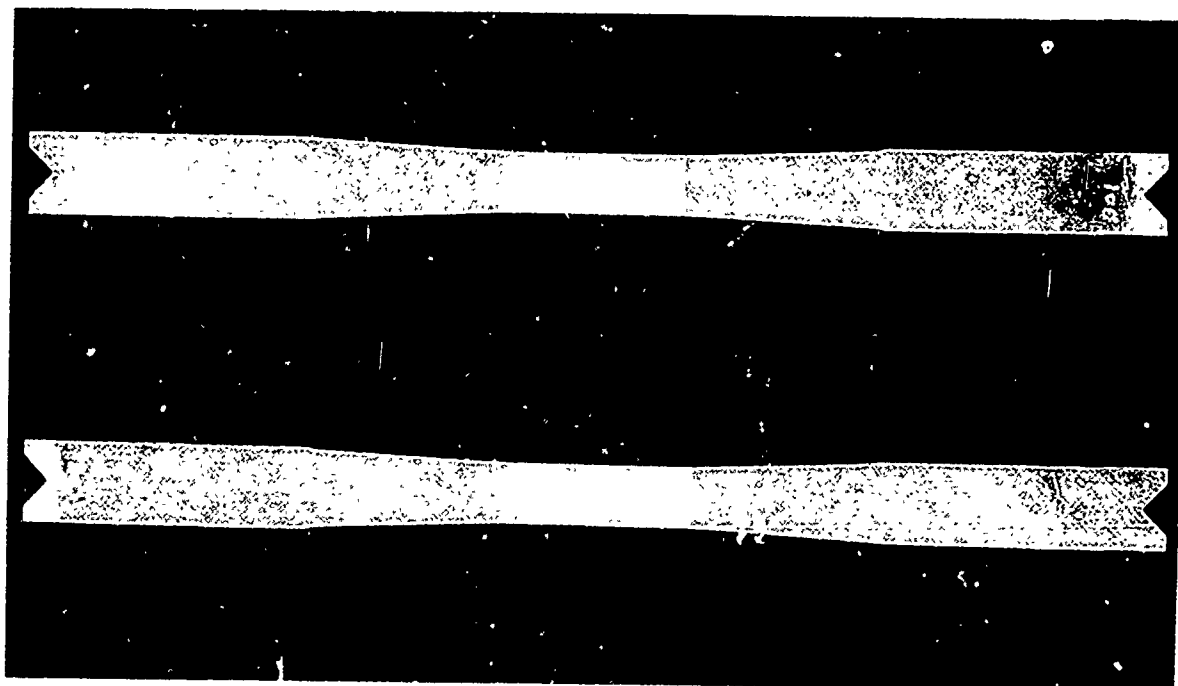
(C7212696)

Figure 8 Machined Longitudinal Tensile Test Specimens Utilizing Protective Outer Surface of Stainless Steel Mesh. Specimens of This Configuration Were Used for Base Line Data Acquisition.

Figure 10 is the specimen configuration similar to Figure 8, but without the outer ply containing the stainless steel mesh. This specimen was used in the majority of the program testing including tensile, tensile fatigue, rupture and torsion creep. The grip regions were reinforced with metal sheets suitably bonded to the test specimen tab surfaces.

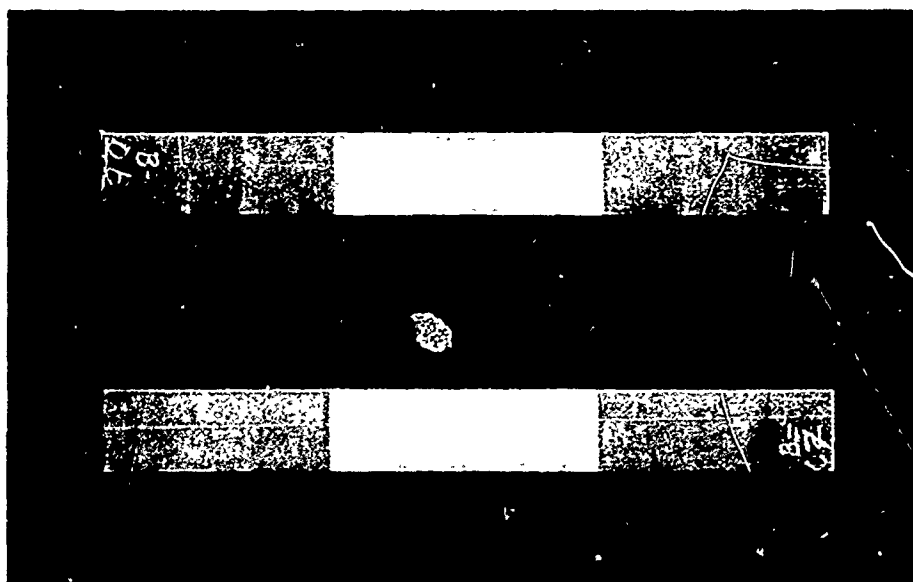
(C7212695)

Figure 9 Machined Transverse Tensile Specimens Utilizing Protective Outer Surface of Stainless Steel Mesh. Specimens of This Configuration Were Used for Base Line Data Acquisition

Figure 9 shows the transverse tensile specimen geometry used in obtaining the baseline data on only the  $[90]_8$  specimens. In our recent study on transverse test configuration, this geometry was found to yield the most reproducible data. Extra care is needed in machining of the edges to minimize filament fracturing. As in the case of the standard tensile specimen shown in Figure 8, this specimen also contains the stainless steel mesh integrally bonded into the outer aluminum alloy layers of the grip regions.

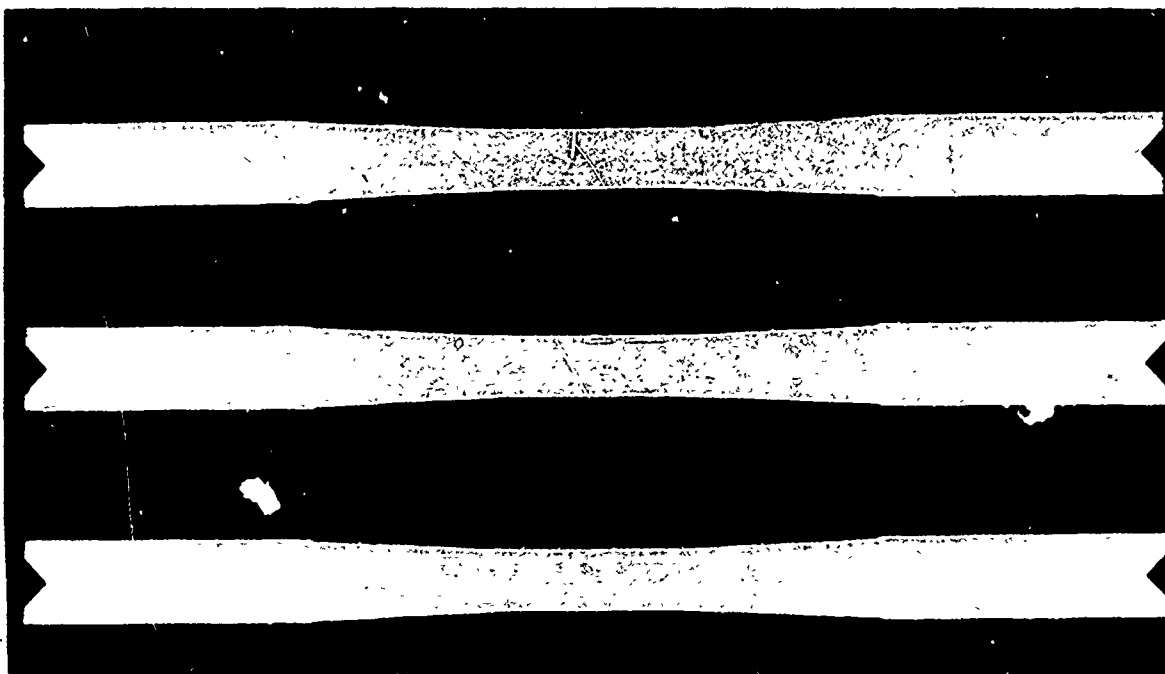
(C7212697)

Figure 10 Typical Machined Specimens Used for Tensile, Tensile Fatigue, and Stress Rupture Testing. No Protective Outer Surface of Stainless Steel Mesh Exists

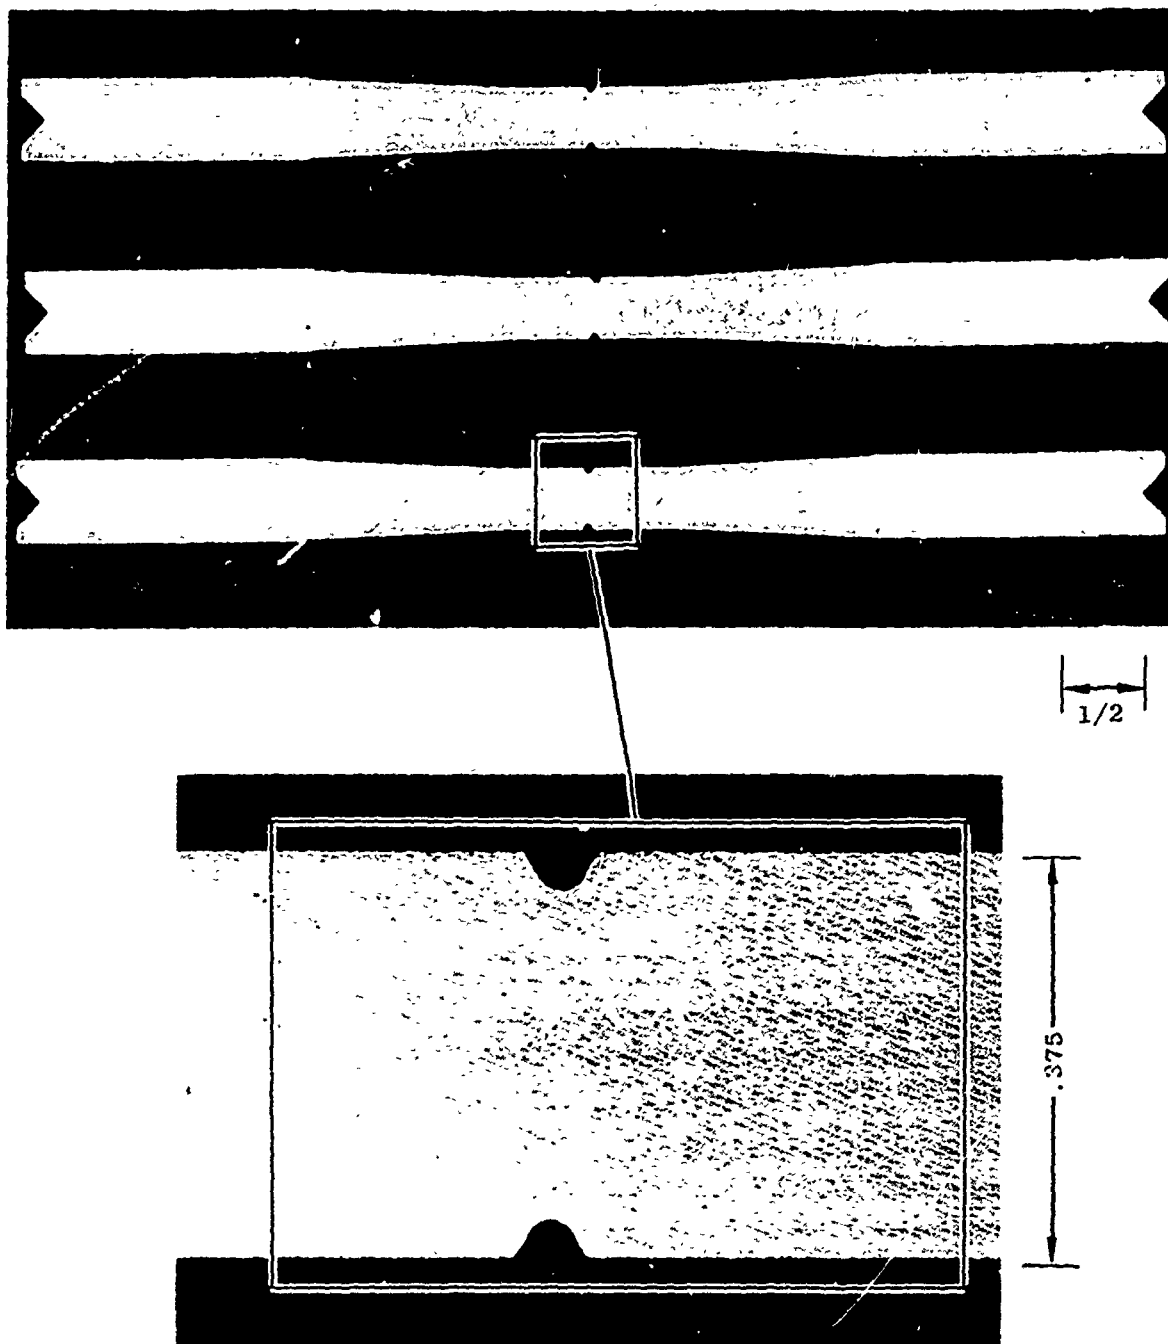
(C7212698)  
(C7212699)

Figure 11 Typical Machined Specimen to be Used for Notched Tensile & Notched Tensile Fatigue Testing. No Protective Outer Surface of Stainless Steel Mesh Exists

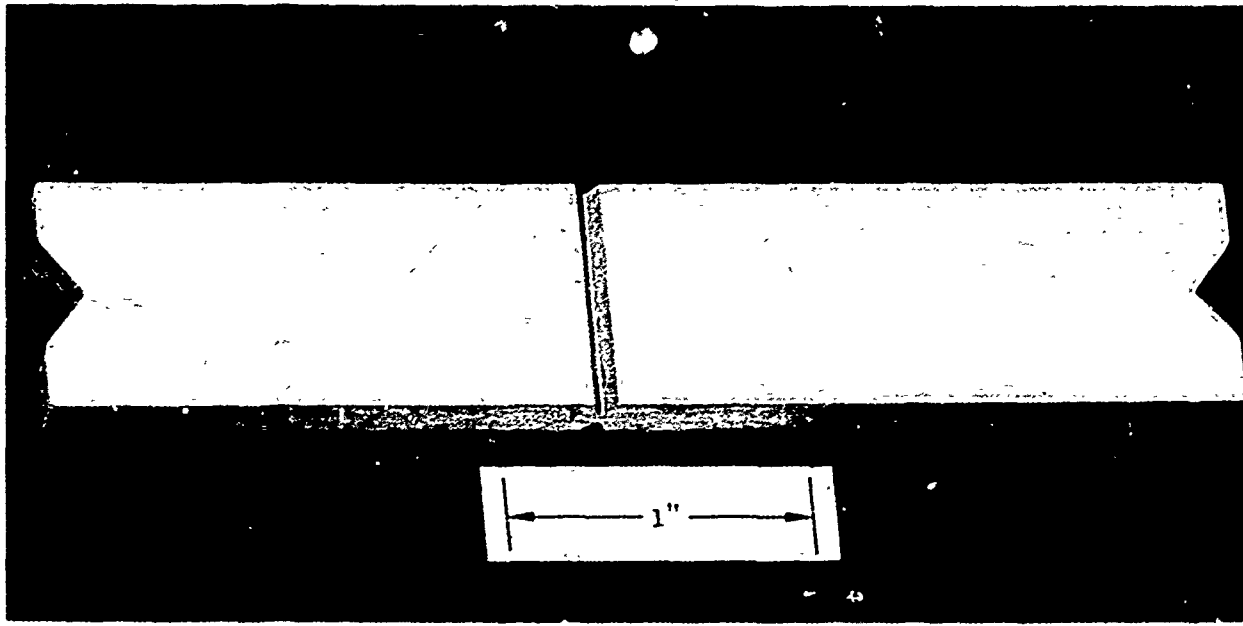
Figure 12 Double Lap Shear Creep Specimen

Fabrication of panels required for the double lap shear creep specimens, Figure 12, required a two step process. First, individual 8 ply panels were formed. For the B/6061 Al and B/2024 Al systems 8-ply panels received from Amercom, Inc. and AVCO Corporation were utilized. For the wire mesh/2024 Al system additional panel consolidation was required by GE. Nine panels were consolidated, each panel consisting of 13 layers of wire mesh/2024 Al monolayer tape. Each tape consisted of a sandwich layup of 0.0015 inch 2024 Al/150 mesh stainless steel/0.0015 inch 2024 Al pre-consolidated by hot rolling to give an individual thickness of about 0.0047 inches. The panels were then subsequently consolidated at 940°F/30 min/5 ksi. The second step required to obtain panels for the double lap shear creep specimens necessitates an additional consolidation of a three panel layup. The layup consist of another sandwich type layup where the upper and lower panels full size and the center panel sectioned into two pieces and separated, laterally, a distance equal to that required in the design of the double lap shear creep specimen. Mating surfaces were roughened and cleaned prior to final consolidation.

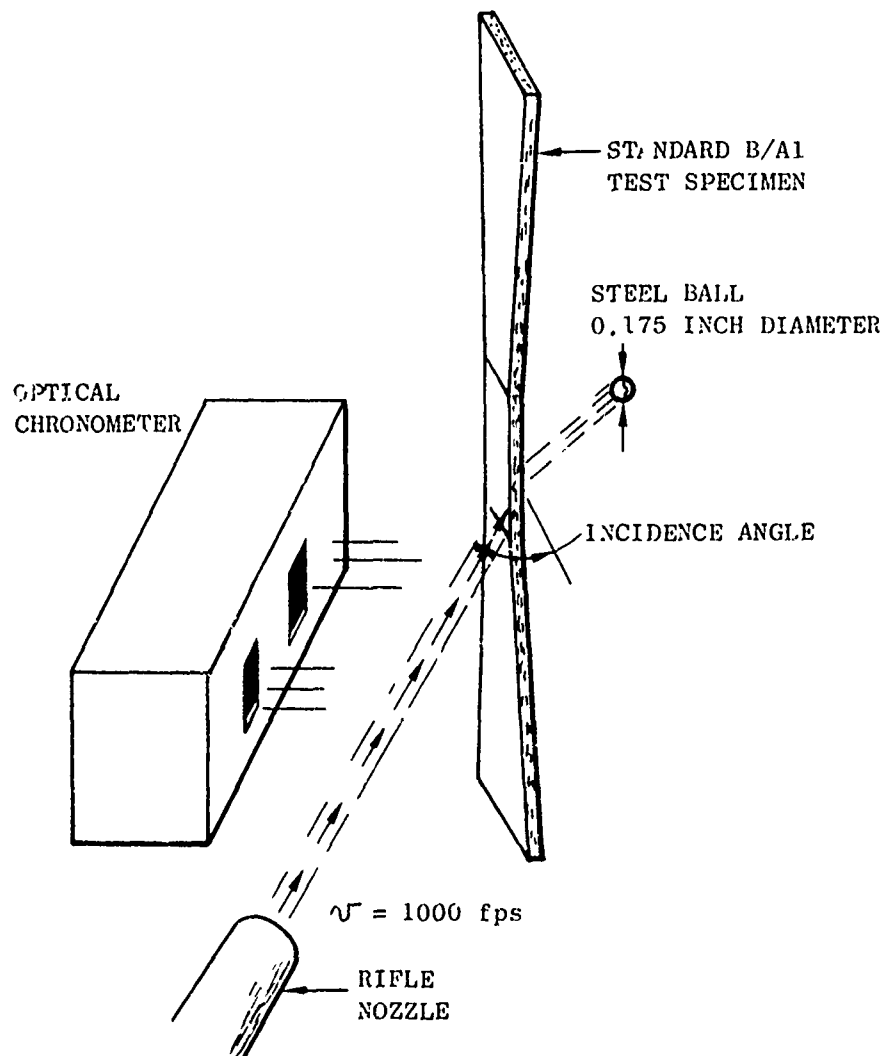
Figure 14 Schematic Illustration of the Impact Test Setup For Impacting the Standard Specimen Edge with a 0.175 inch Diameter Steel Ball

A major requirement for compressor blade material is the ability to withstand high velocity impact damage. As an integral part of this program the effects of this blade type damage on standard specimens were evaluated. Steel ball projectiles were impacted into one of the test specimen edges to conduct the experiments. Based on conditions which govern the angle of impact between the projectile and the blade leading edge<sup>(2)</sup> in conjunction with the specimen geometry, a 60° incidence angle ( $\gamma$ ) was selected. A schematic illustration of the specimen arrangement is shown in Figure 14. The 0.175 inch diameter steel ball impacted the specimen edge at approximately 1000 fps and induced an edge notch with an estimated stress concentration factor ( $K_t$ ) of about 2.0.

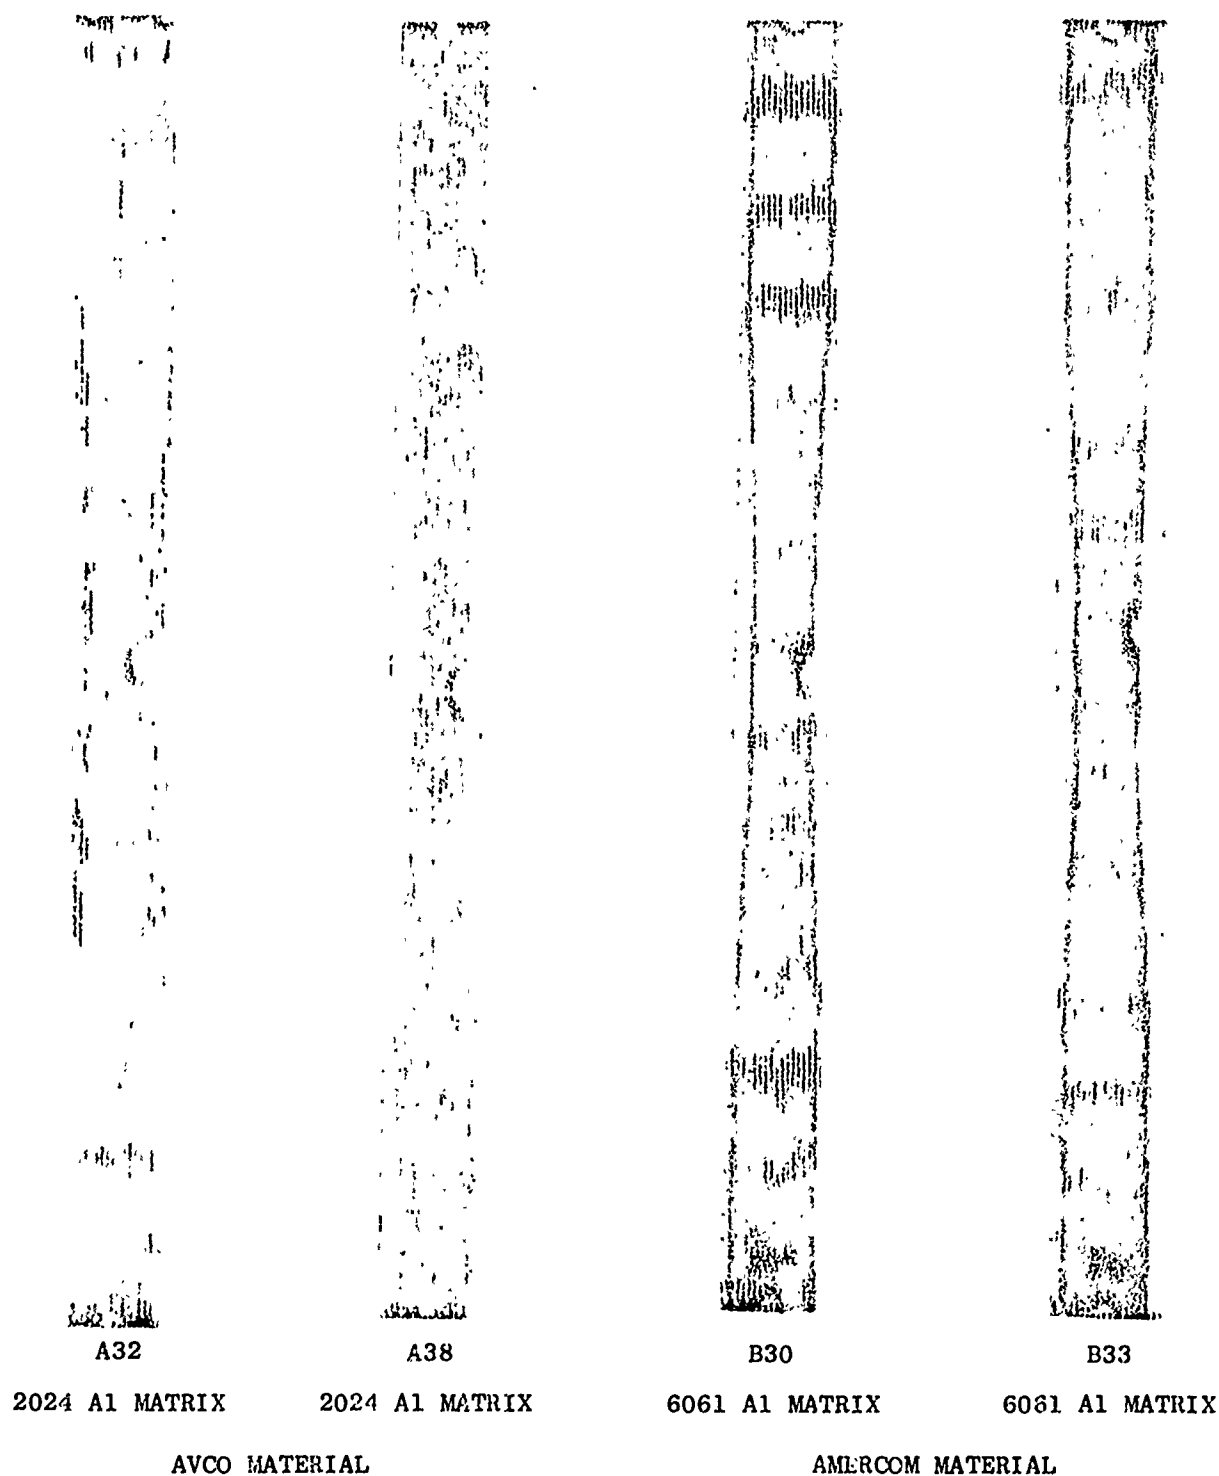
Figure 15 Typical Through Transmission "C" Scans of B/A1 Specimens  
Ballistically Impacted at 1000 fps on Right Center Section  
of Gauge Region

Twenty four 8-ply specimens were ballistically impacted at 1000 fps prior to tensile testing. No fracturing occurred during the ballistic impact. Typical through transmission ultrasonic C-scans (TTUCS) with gray scale are shown in Figure 15. These C-scan traces indicate a slight degree of irregularity near the edge of the impact, but there was no detectable delamination. Additional inspection utilizing red dye penetrant observations revealed no crack indications.

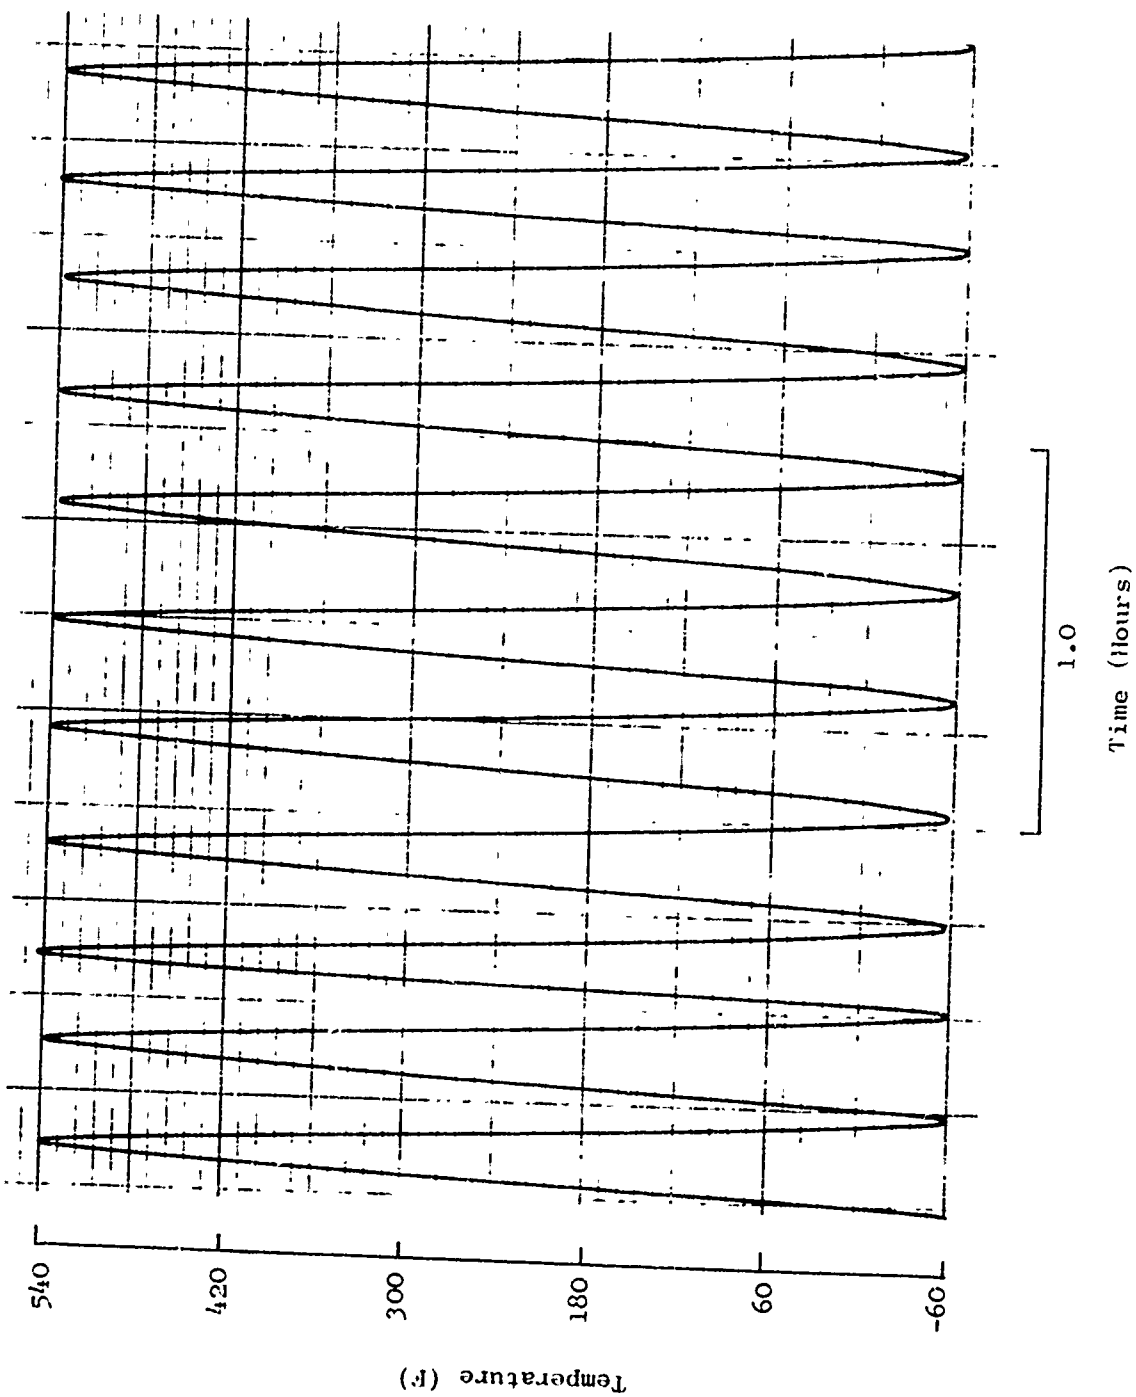
Figure 18 Time Temperature Trace for Cyclic Thermal Exposure (Cycles 85-95)

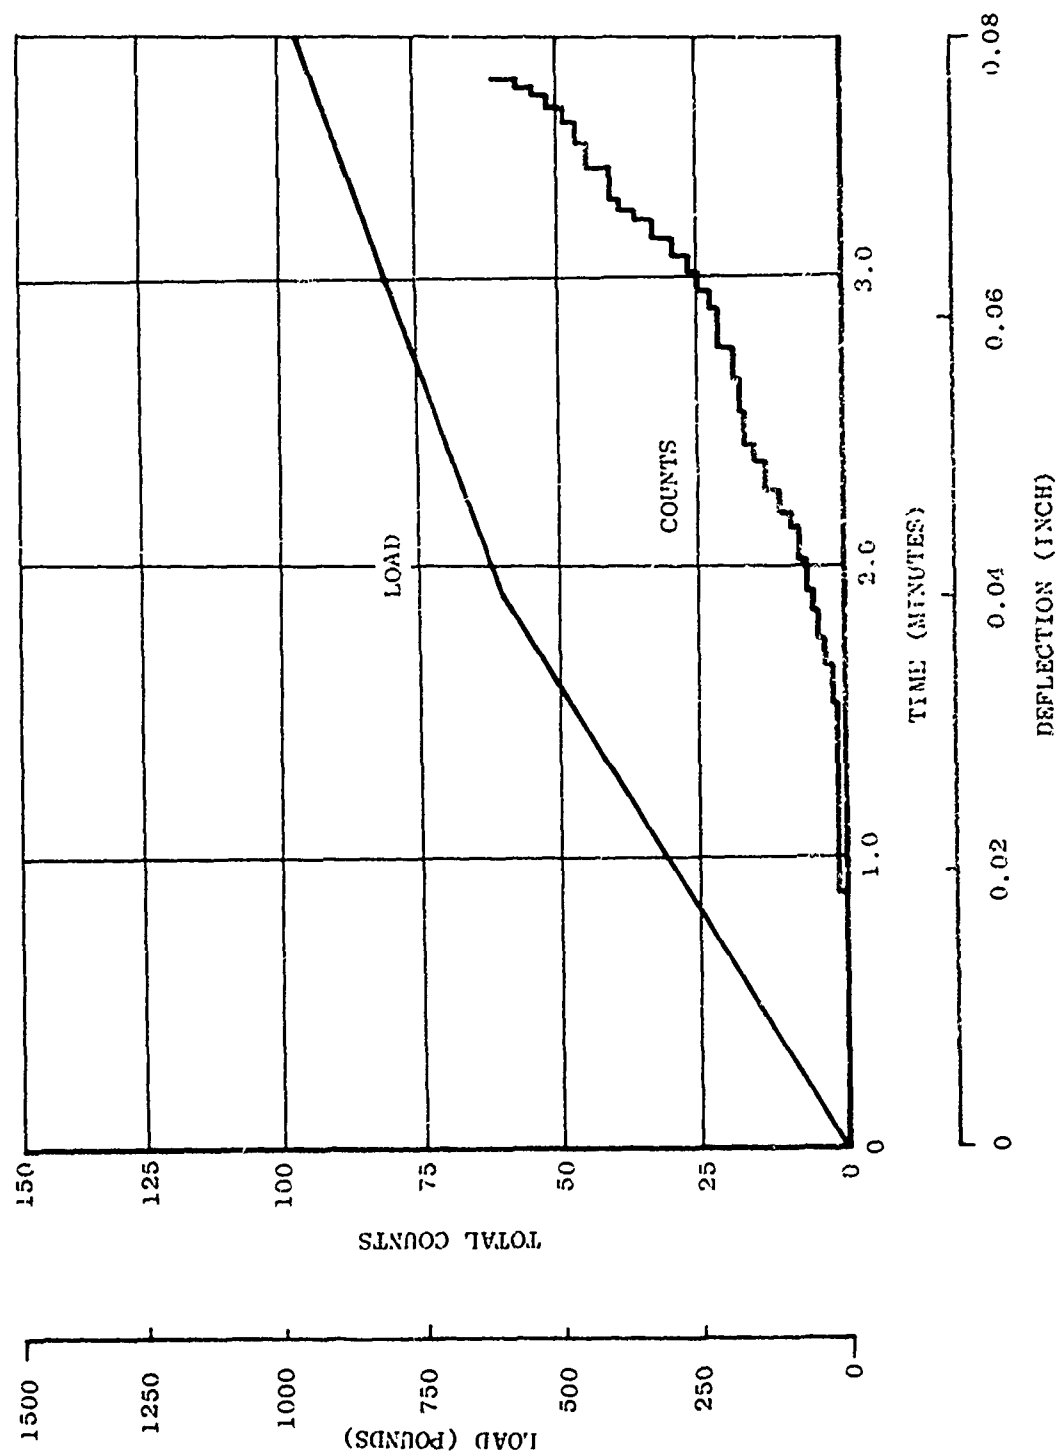
Figure 19 Acoustic Emission and Deflection Record of a Monolayer B/Al Tape Specimen Tested in Tension

A typical record of both the load-deflection values are shown in Figure 19, the 55 or so individual acoustic events recorded up to failure are assumed to be filament fractures.

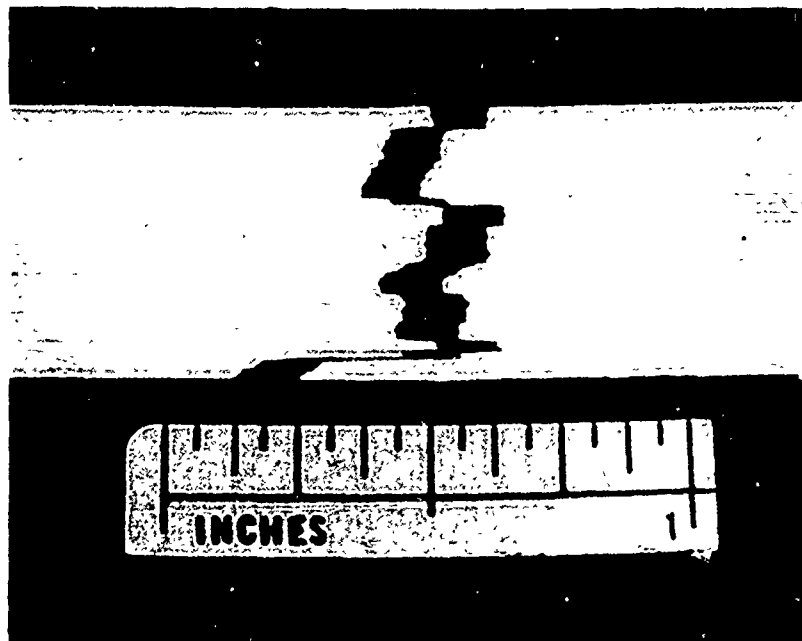
Figure 26 Fracture Appearance of a 20 V/O B/Al Monolayer  
Tape With a 6061 Matrix

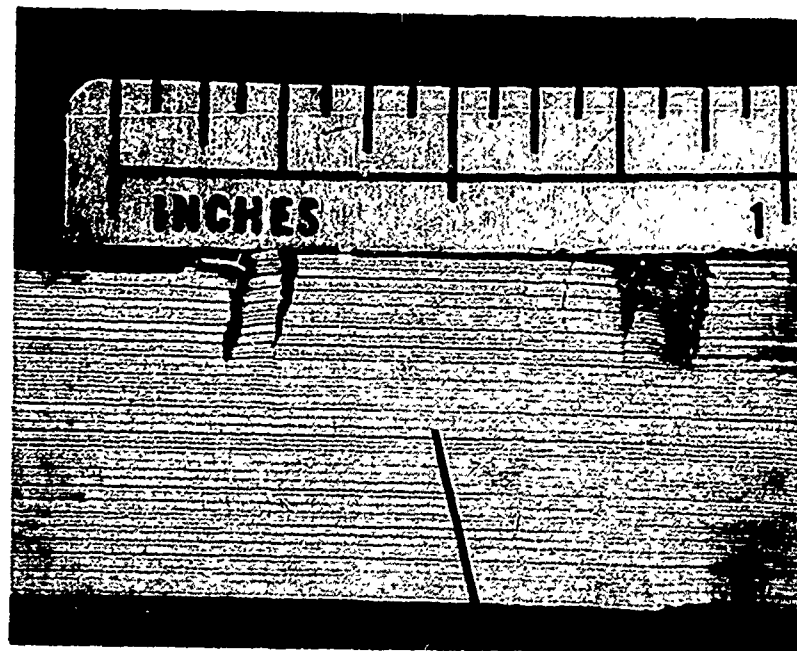
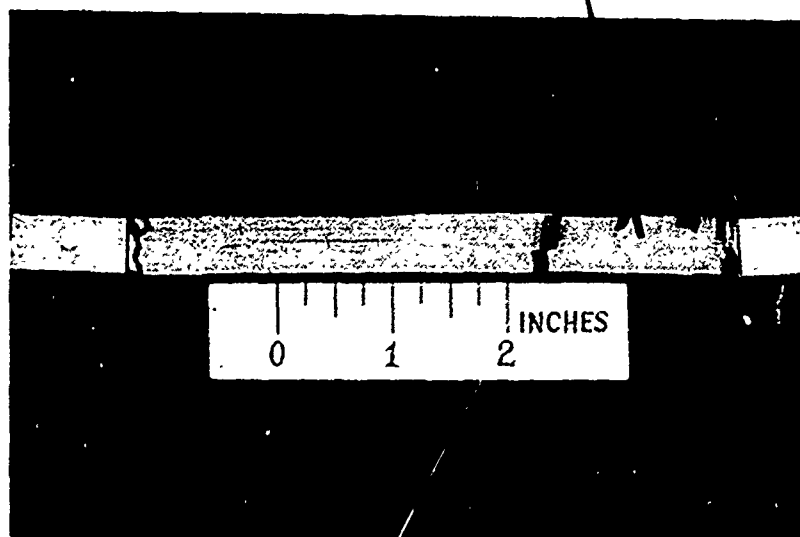
Figure 27 Failure Appearance of a 50% B/Al Monolayer Tape Specimen. Approximately 34 Filament Breaks Were Detected Acoustically Prior to Failure.

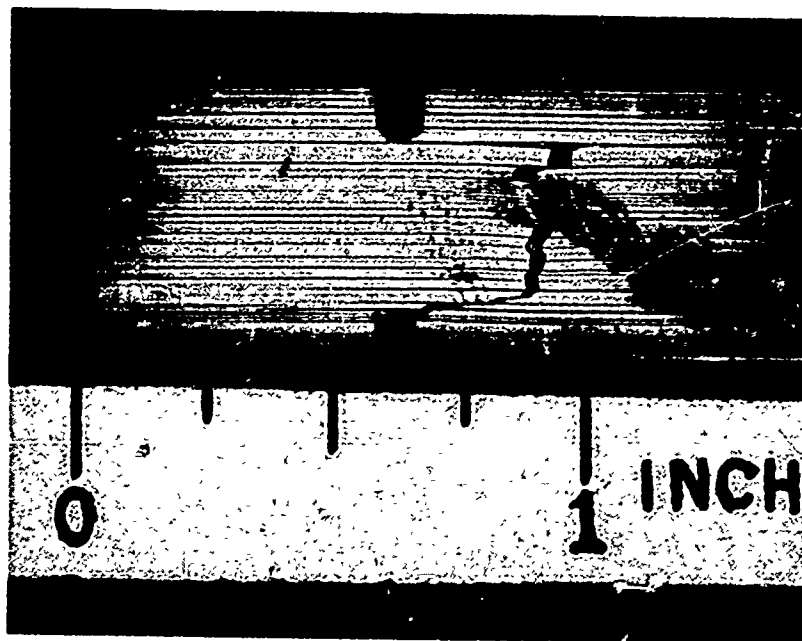
**Figure 28** Failure Observation After Tensile Testing of a Notched Monolayer B/Al Tape Specimen. There Were 5 to 6 Filament Breaks Detected Acoustically Prior to Failure.

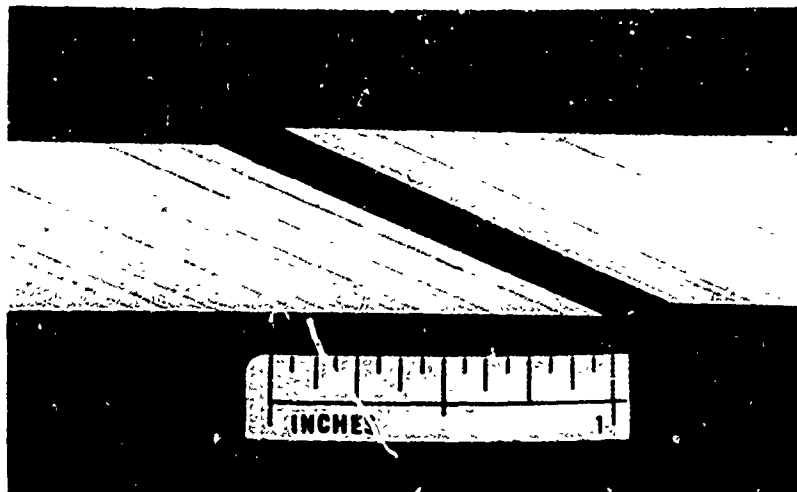
FILAMENT ORIENTATION -  $22^\circ$

FILAMENT ORIENTATION -  $90^\circ$

Figure 29 Failure of Two 50 V/O Composites With the Boron Filaments Oriented With Respect to the Filament Axis

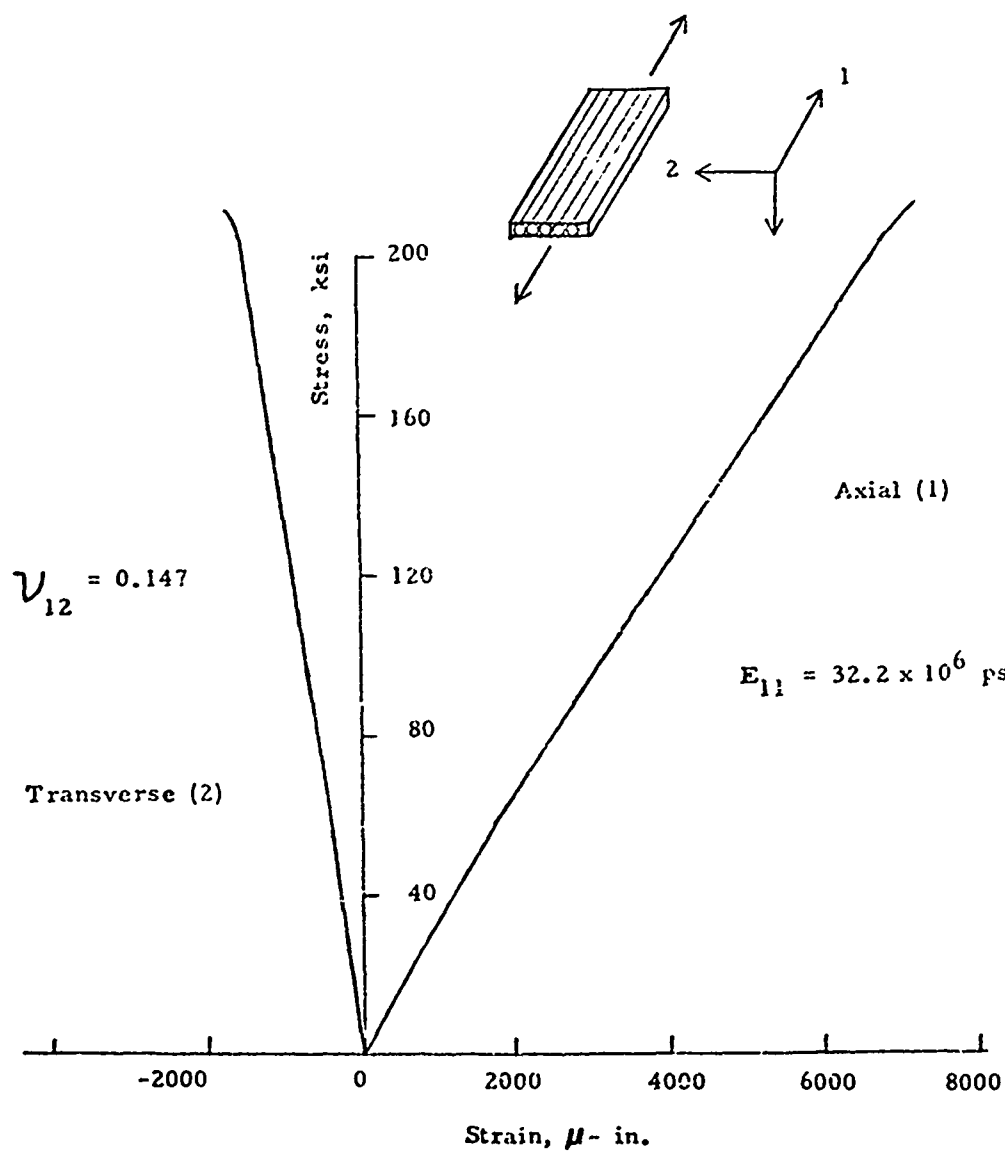
Figure 30 Stress-Strain Curves for 0-degree 50 V/O Monolayer Tape

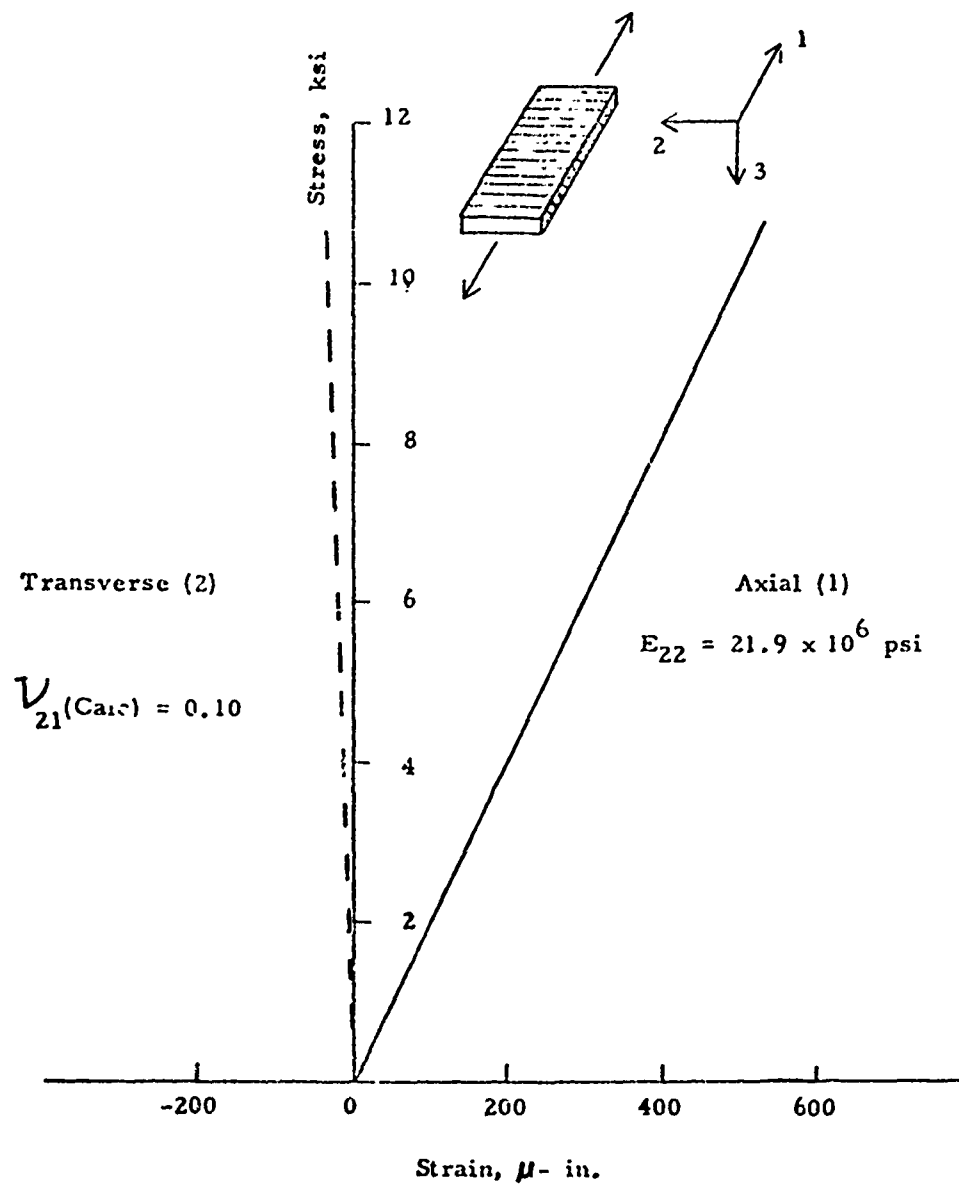
Figure 32 Stress-Strain Curves for 90-degree 50 V/O Monolayer Tape

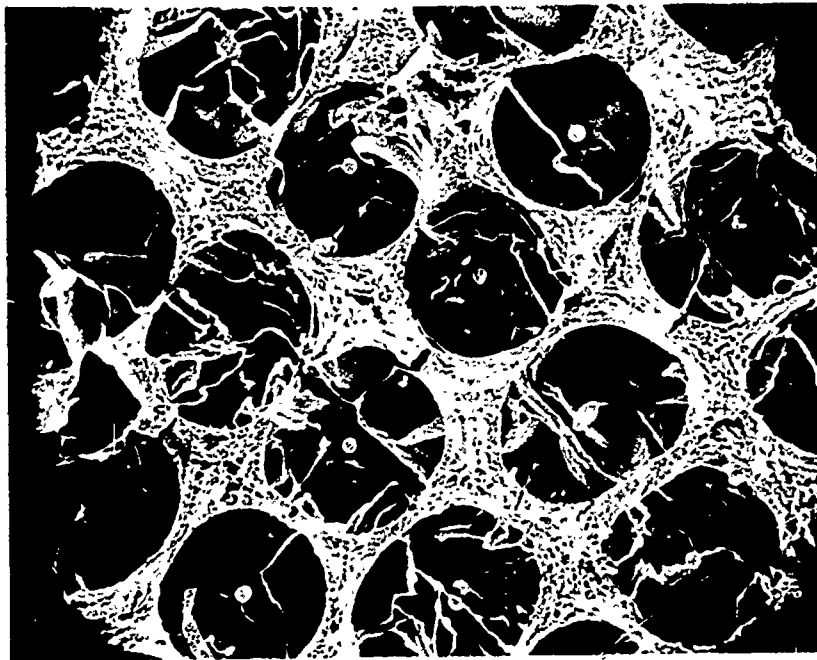
FILAMENTS AND MATRIX AT 143X

MATRIX AT 1430X

Figure 33 Fracture Surface of a B/2024 Tensile Specimen Tests at 75°F

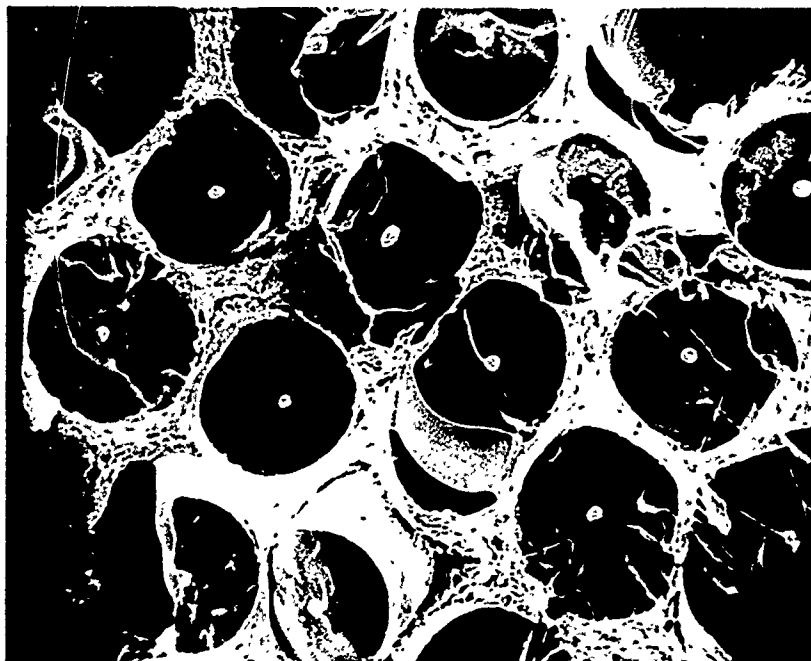
FILAMENTS AND MATRIX AT 145X

MATRIX AT 1450X

Figure 34 Fracture Surface of a B/2024 Tensile Specimen Tested at 600°F

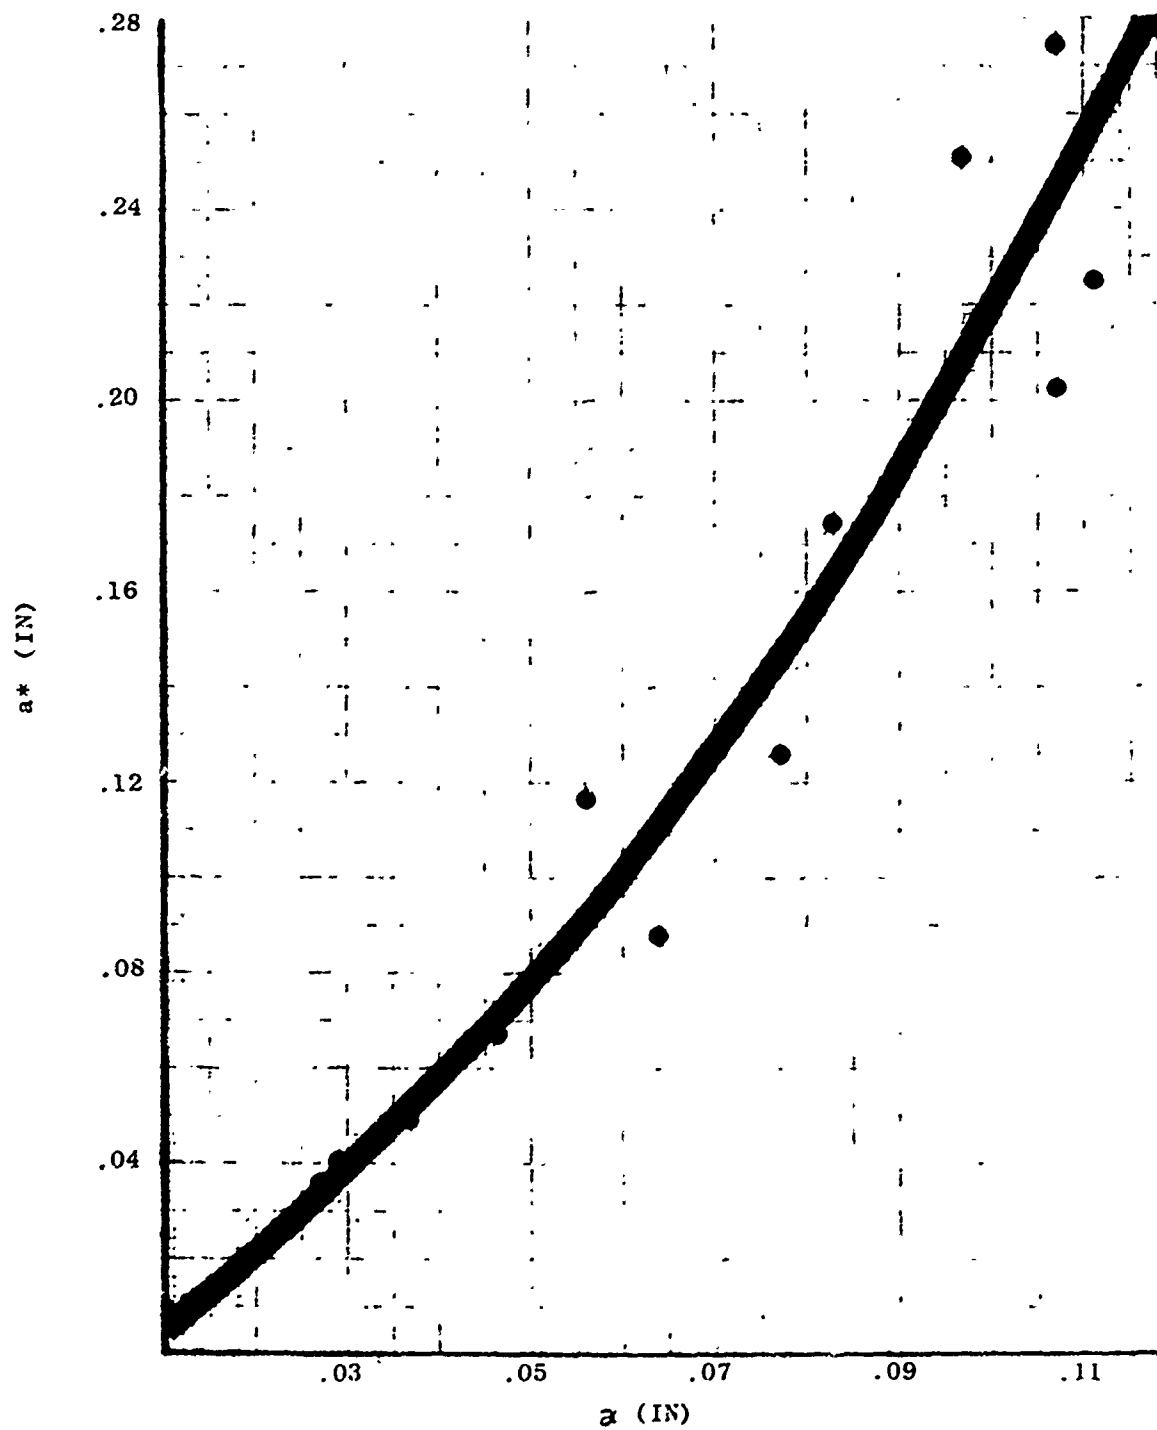
Figure 35 Plot of Apparent Notch Depth ( $a$ ) Vs. Effective Notch Depth ( $a^*$ ) in Ballistically Impacted  $[22/0/-22/0]_8$  B/AI Composite Specimens

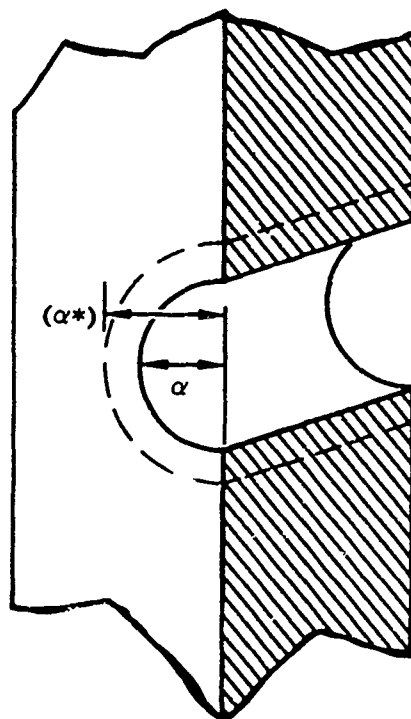
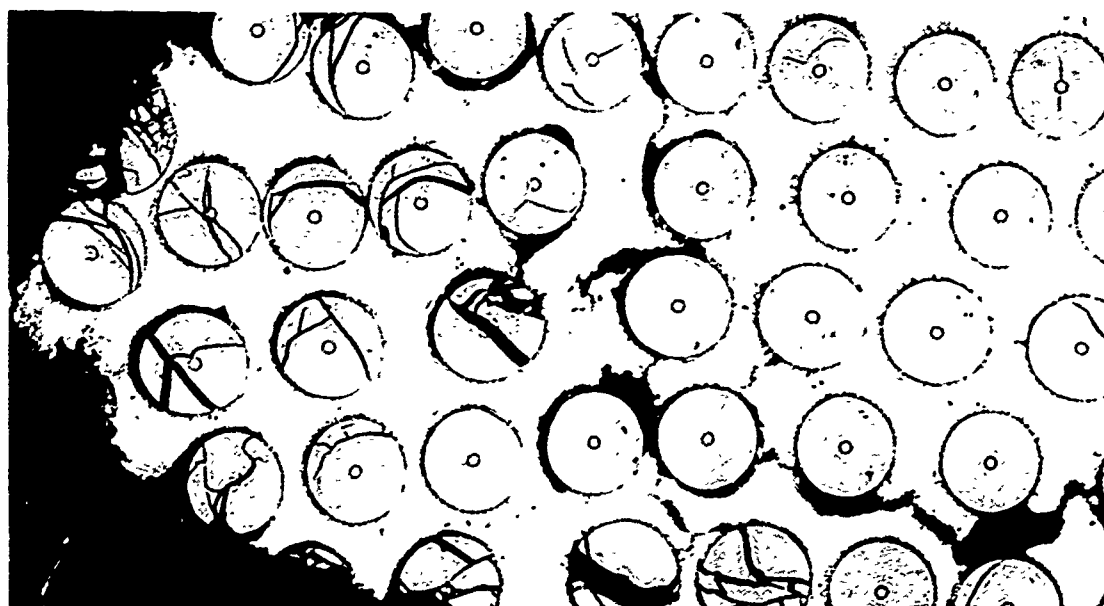
Figure 36 Explanation of Concept of Effective Notch in Ballistically Impacted  $[22/0/-22/0]_8$  B/Al Specimens

The impacted fatigue specimens were evaluated using the concept of effective reduction in cross-section  $a^*$ , evolved in analyzing the impacted tensile specimens. Fatigue limits obtained in the same manner as for the smooth specimens are presented in Table XXII.
