FAILURE PROCESSES IN METAL MATRIX COMPOSITES

GENERAL ELECTRIC COMPANY

PREPARED FOR  
AIR FORCE MATERIALS LABORATORY

REPORT DOCUMENTATION PAGE		READ INSTRUCTIONS BEFORE COMPLETING FORM
1. REPORT NUMBER AFML-TR-73-290	2. GOVT ACCESSION NO.	3. RECIPIENT'S CATALOG NUMBER
4. TITLE (and Subtitle)  FAILURE PROCESSES IN METAL MATRIX COMPOSITES		5. TYPE OF REPORT & PERIOD COVERED Interim Report - Phase I 1 July 1972 to 1 October 1973

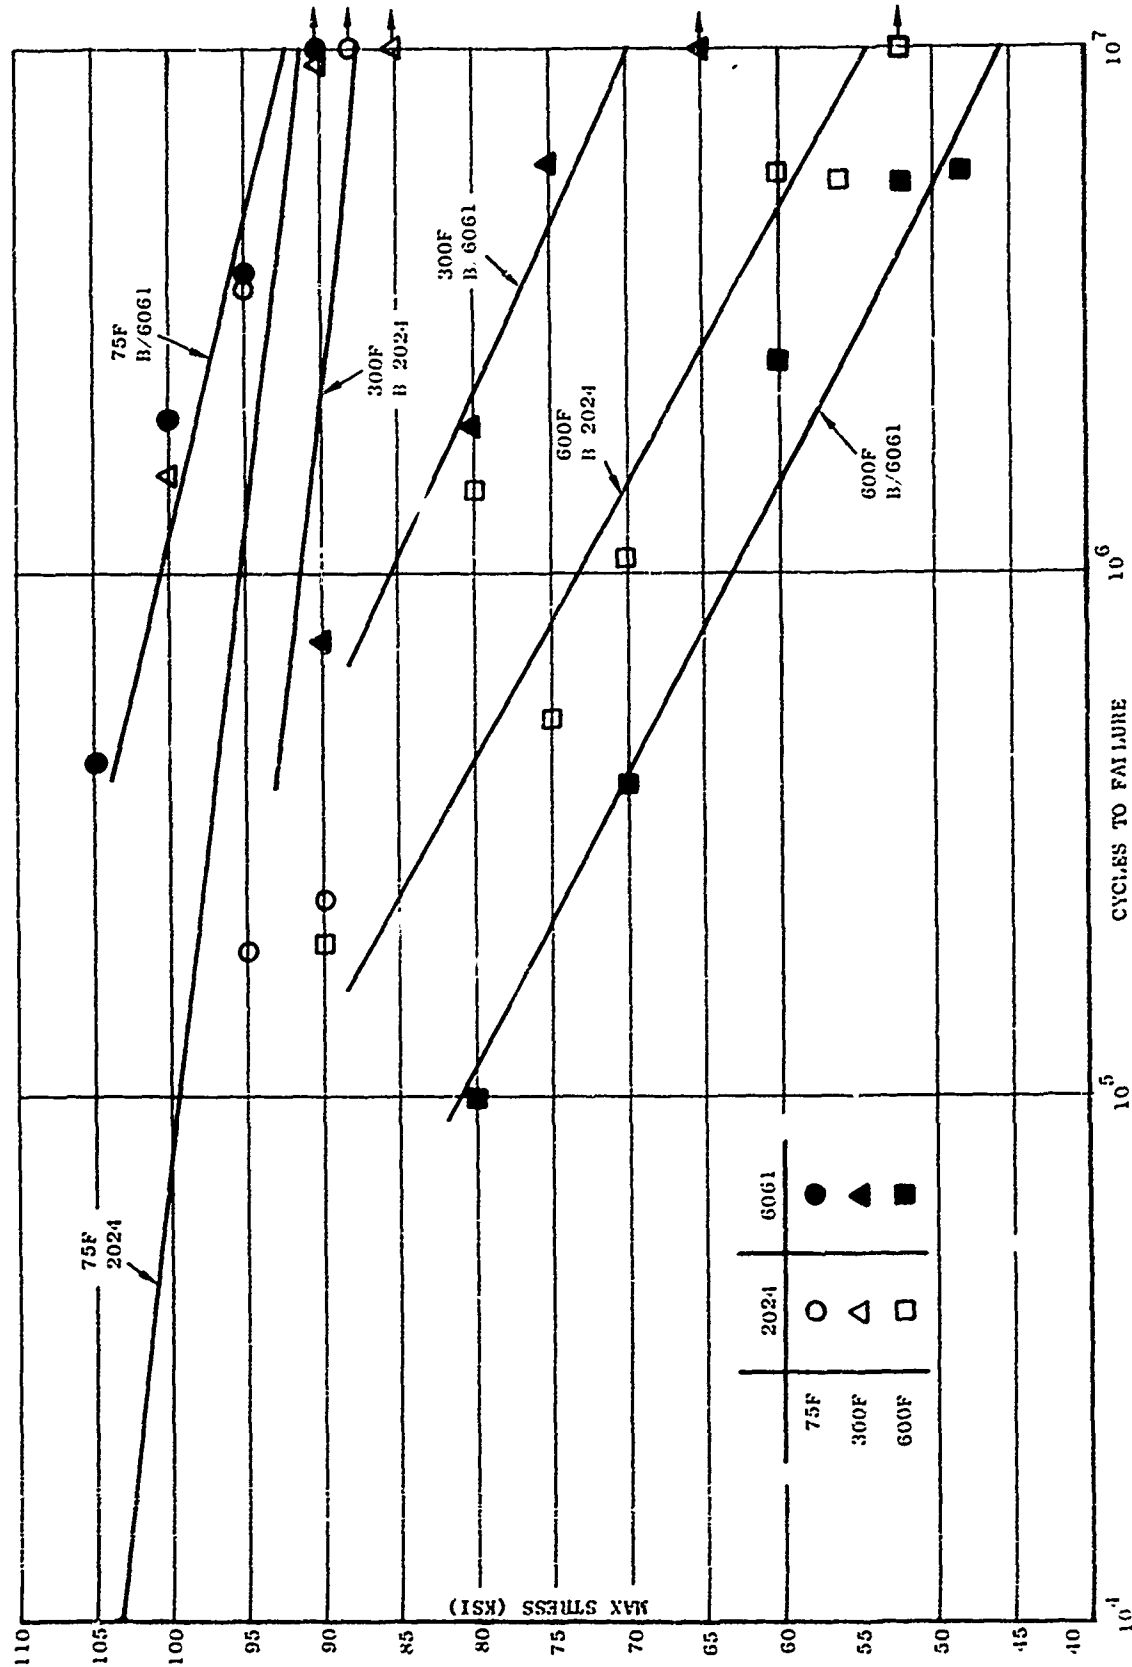
Figure 37 Axial Fatigue Results of Standard B/2024 and B/6061 [22/0/-22/0]8 Composite Specimens Tested at 75, 300, and 600 F (A=0.95)

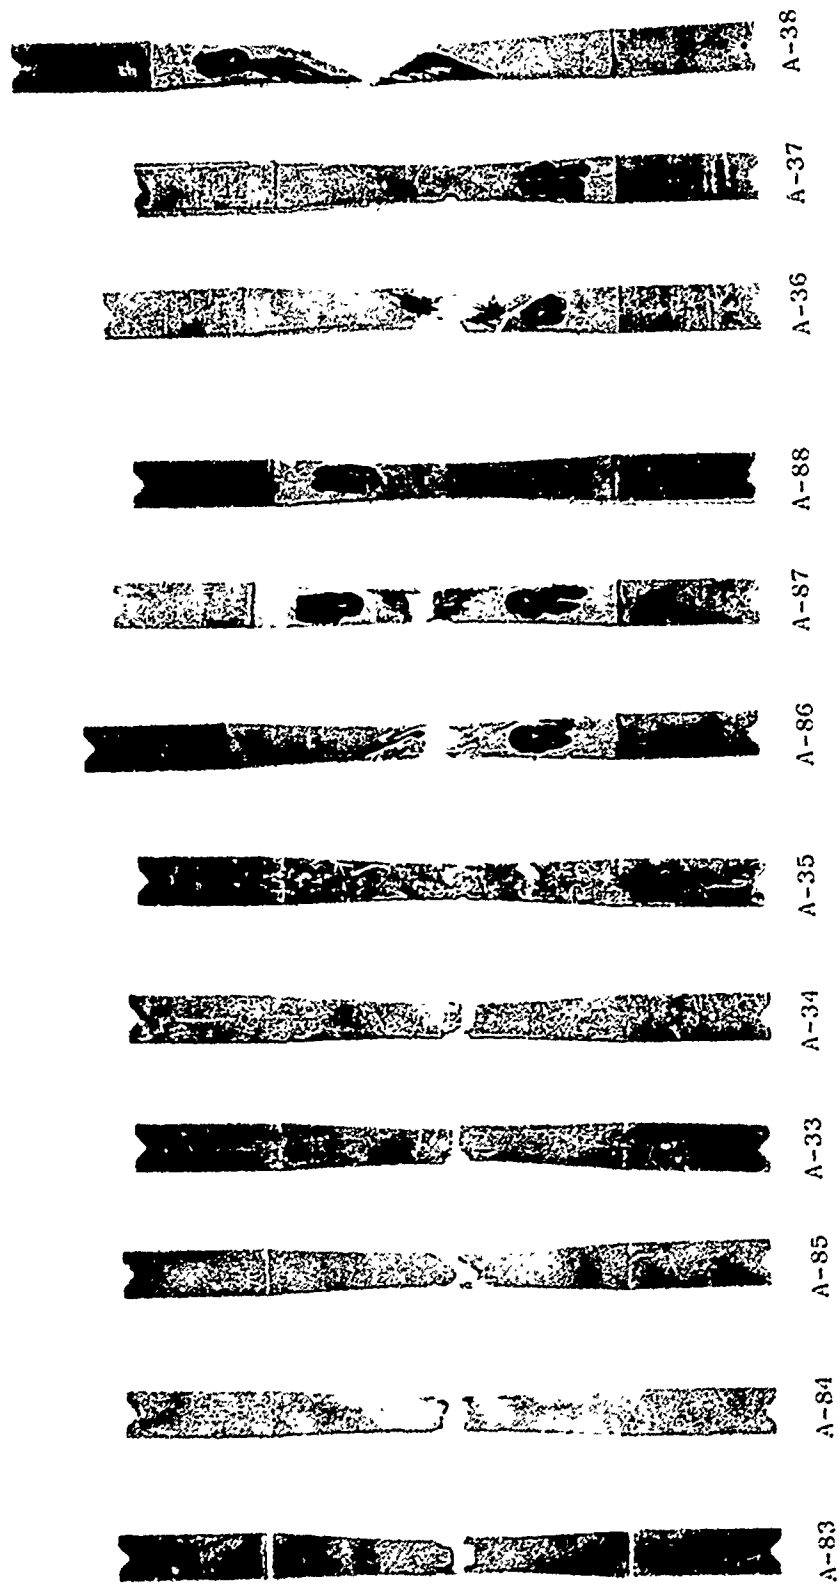
Figure 43 Double Edge Notched and Ballistically Impacted B/2024 Axial Fatigue Specimens After Testing at 75 and 600F

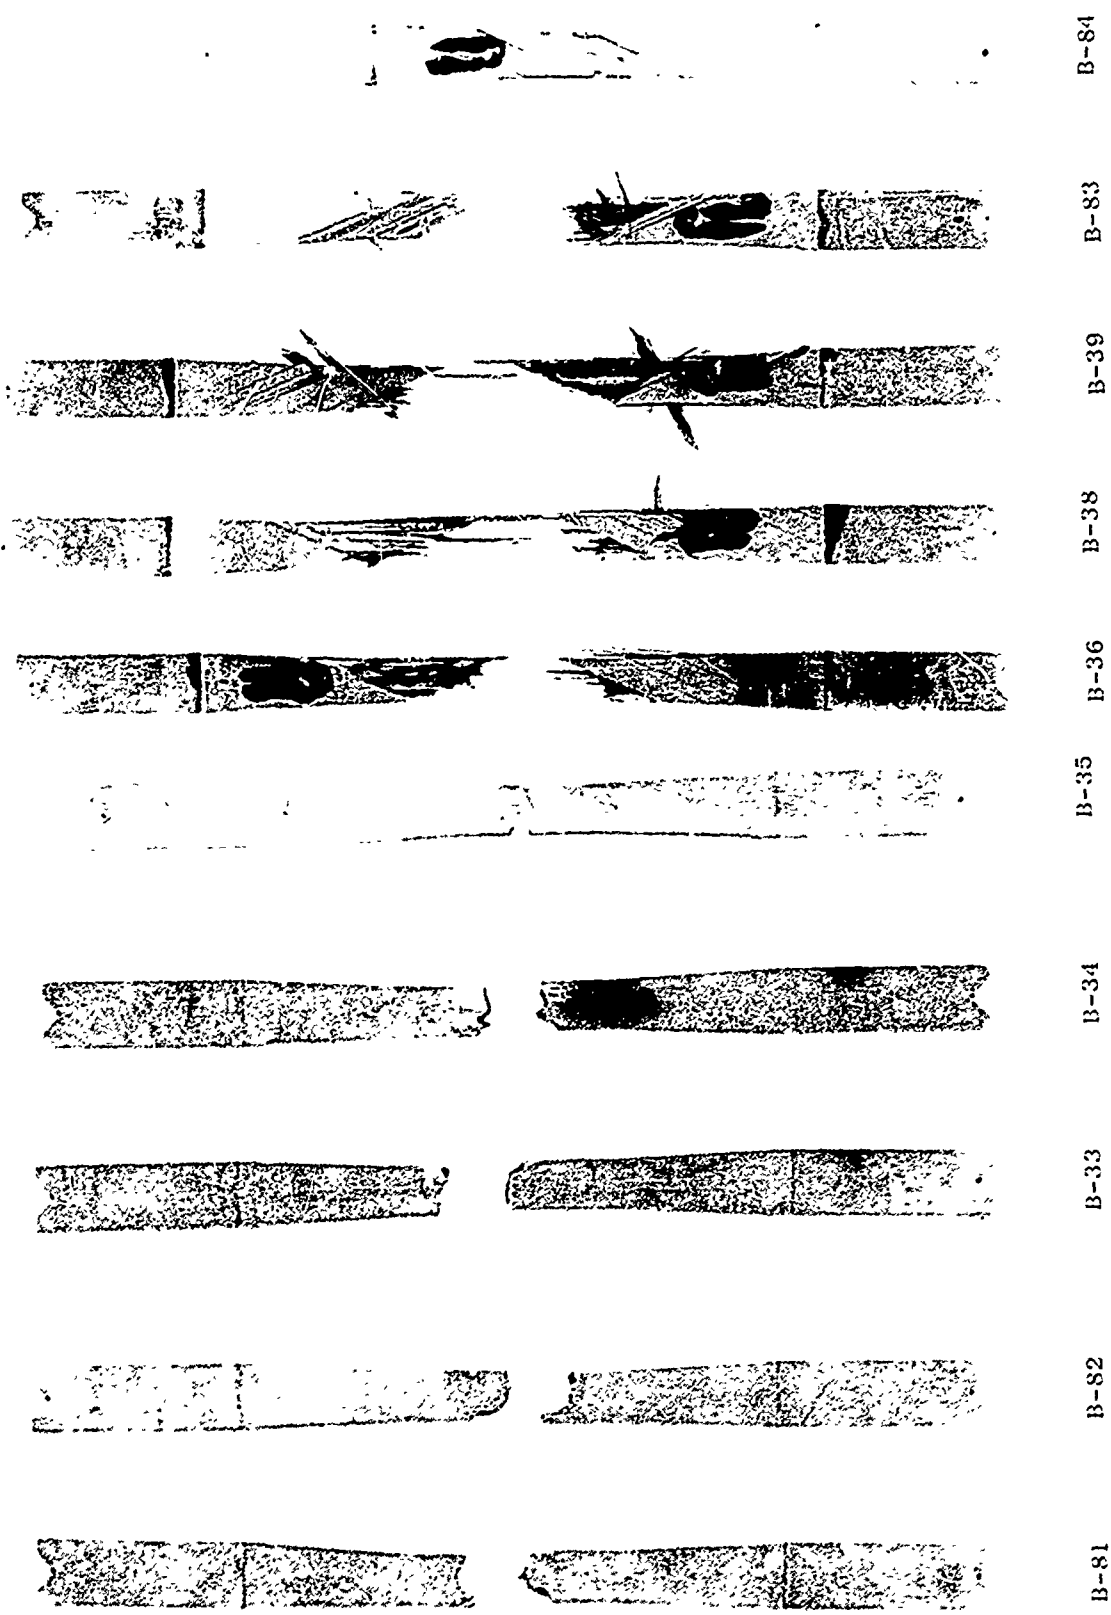
Figure 44 Double Edge Notched and Ballistically Impacted B/6061 Axial Fatigue Specimens After Testing at 75 and 600F

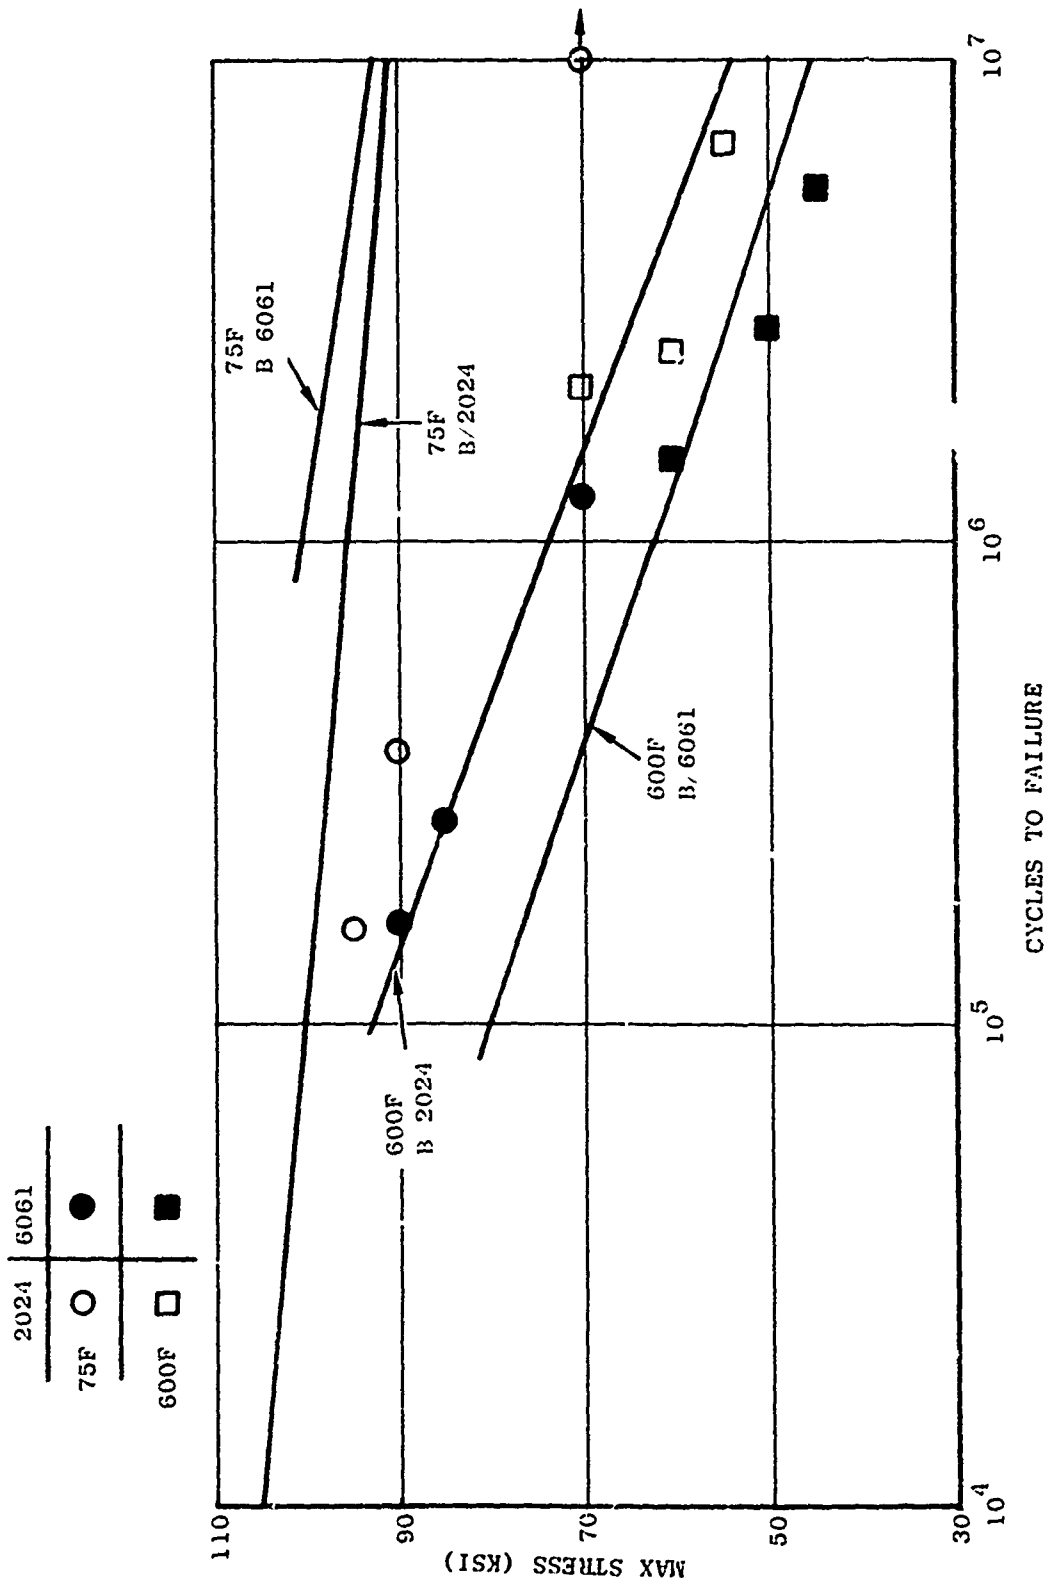
Figure 45 Axial Fatigue of B-Al Composite Specimens Thermally Cycled from - 60F to +540F Two Thousand (2000) Times

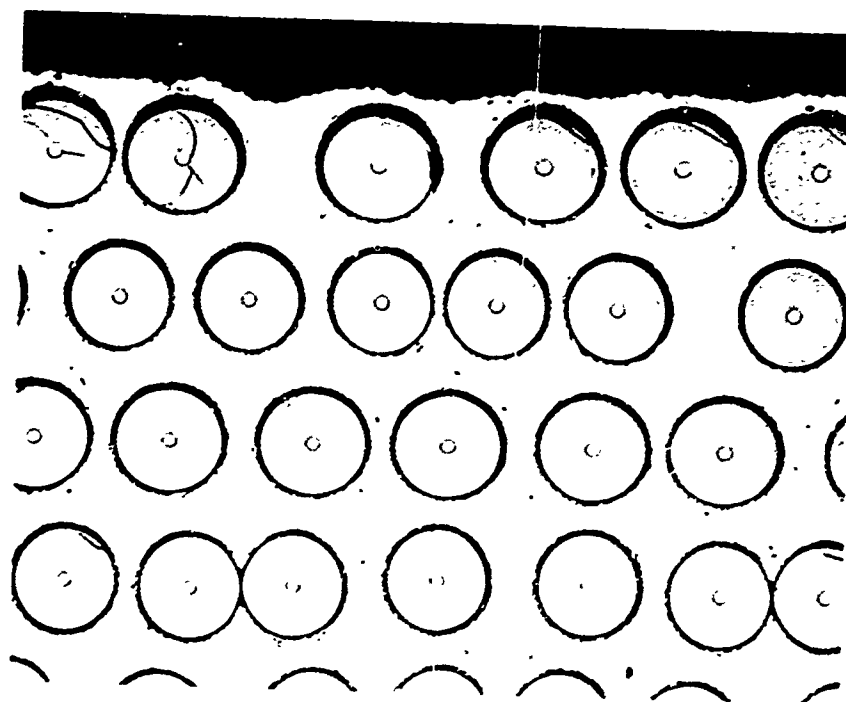
Figure 47 Microstructure of B/Al  $[22/0/-22/0]_8$  Composite Material Having Undergone Two Thousand (2000) Cycles from  $-60^{\circ}\text{F}$  to  $+540^{\circ}\text{F}$  (100X)

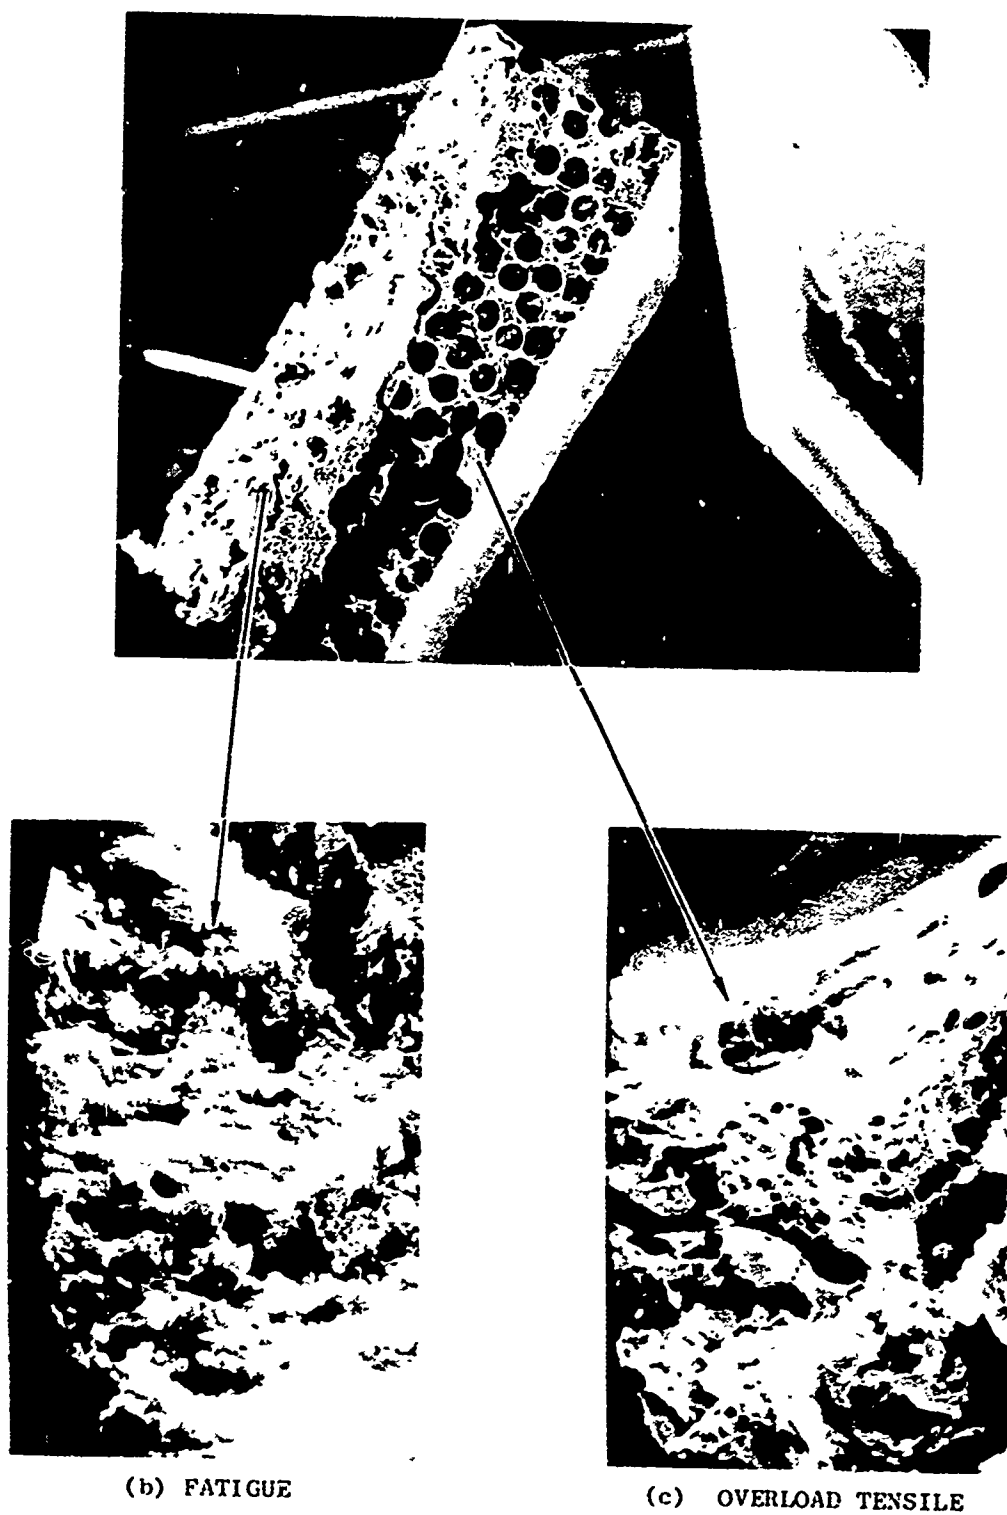
Figure 48 Fractography of an Axial Fatigue Specimen [ (a) 27 X, (b) 1425X, (c) 1350X ]

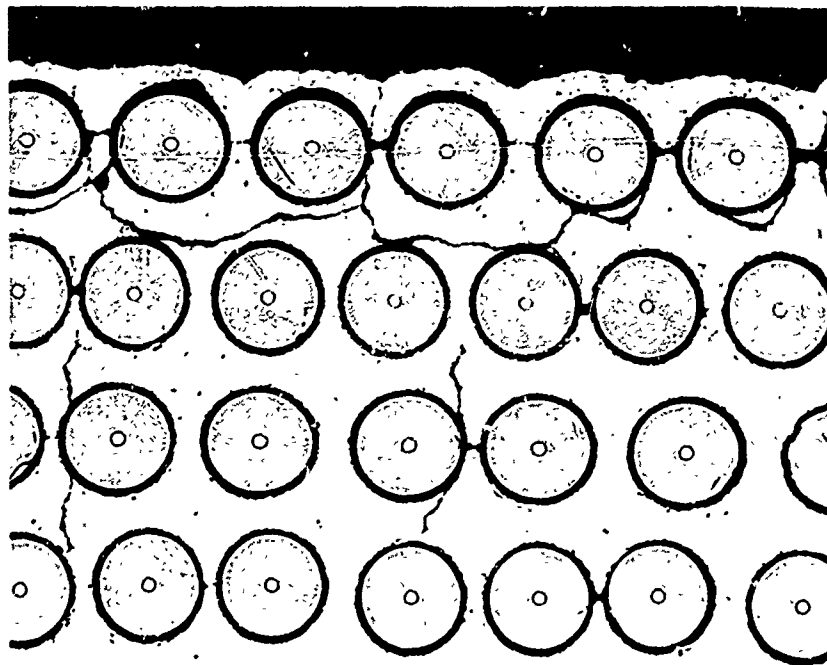
Figure 50 Fatigue Damage in a B/6061 Specimen Subjected to Axial Loading (100X)

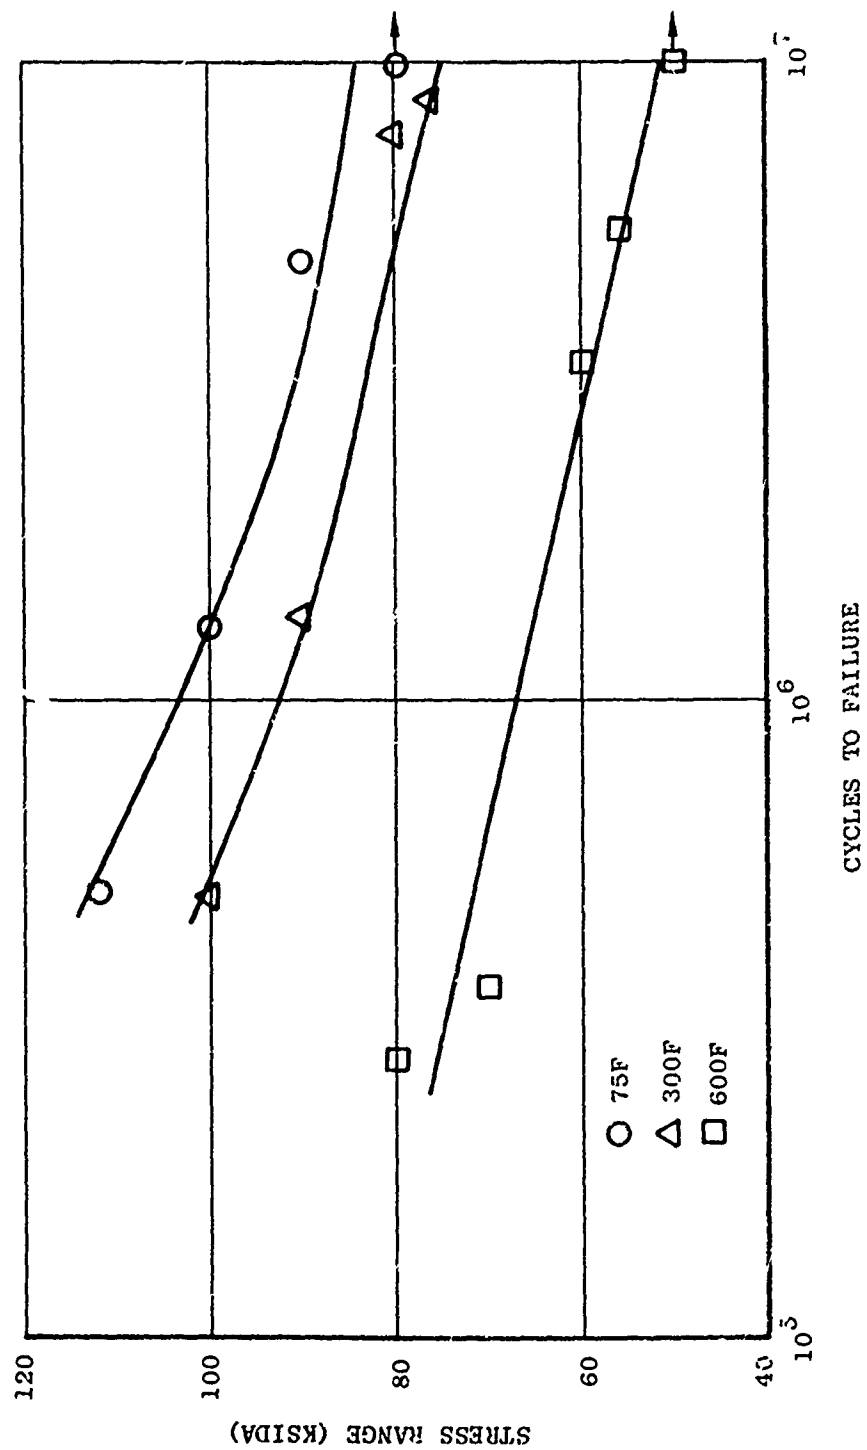
Figure 51 Flexural Fatigue Results of B/2024 Al at 75F, 300F and 600F ( $A=\infty$ )

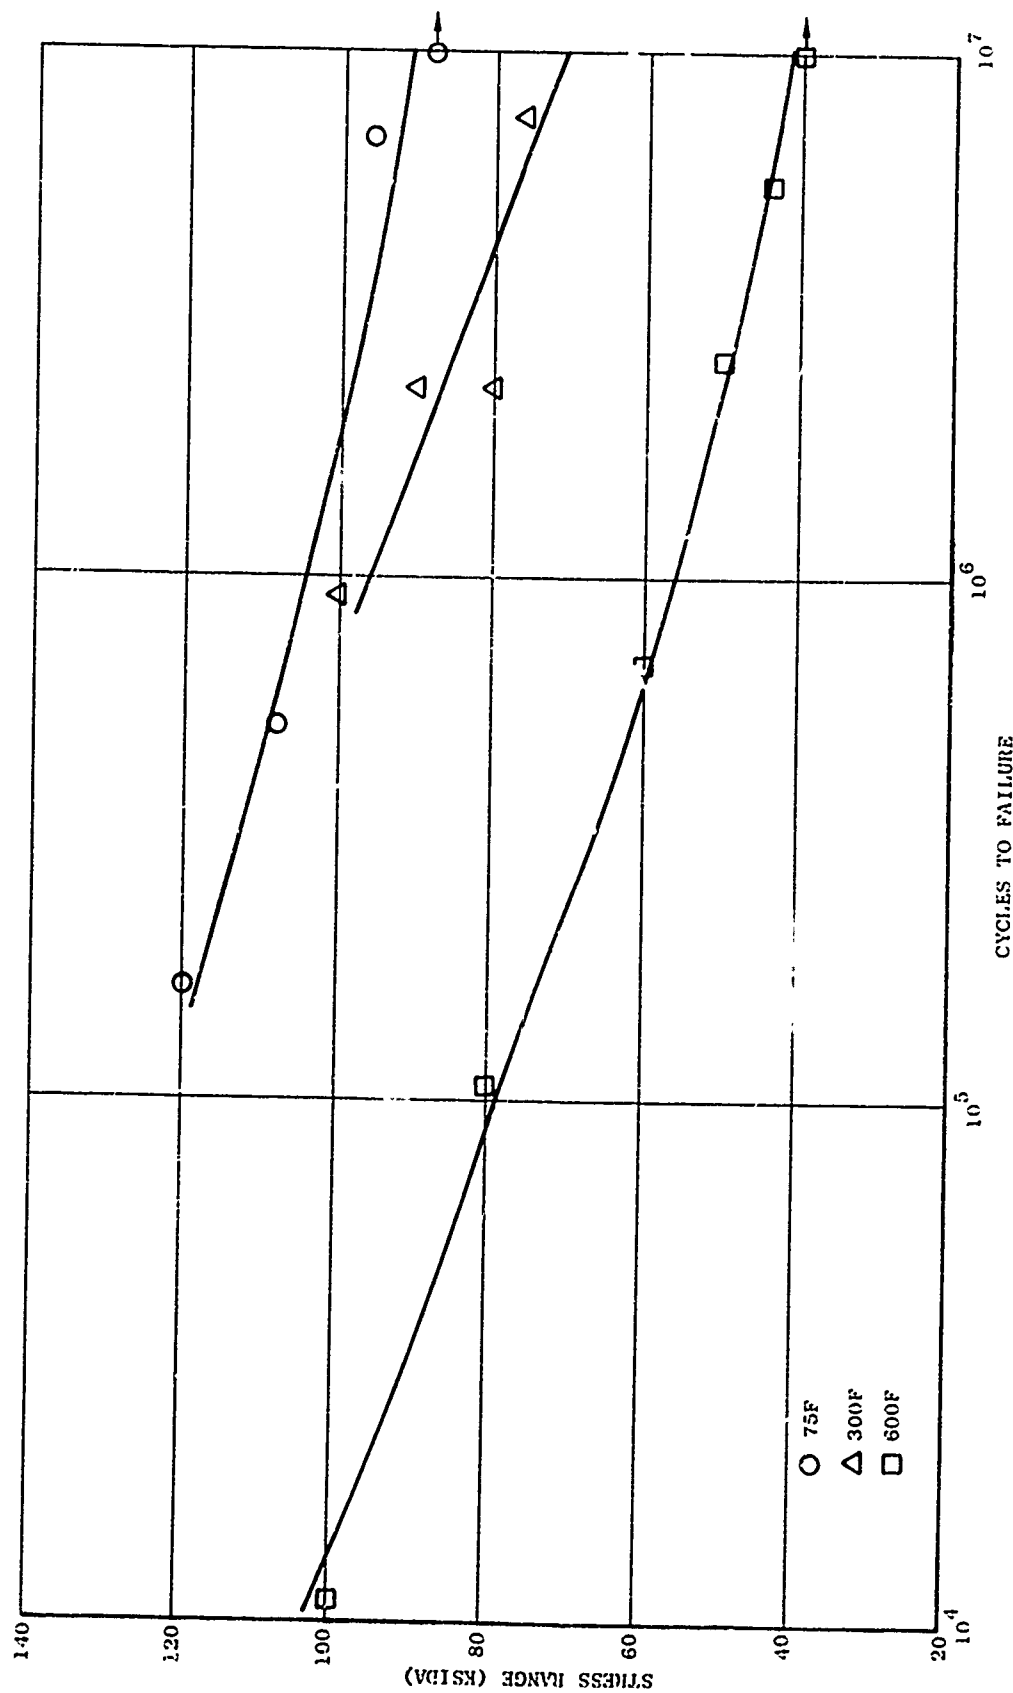
Figure 52 Flexural Fatigue Results of B/6061 Al at 75, 300 and 600F ( $A=\infty$ )

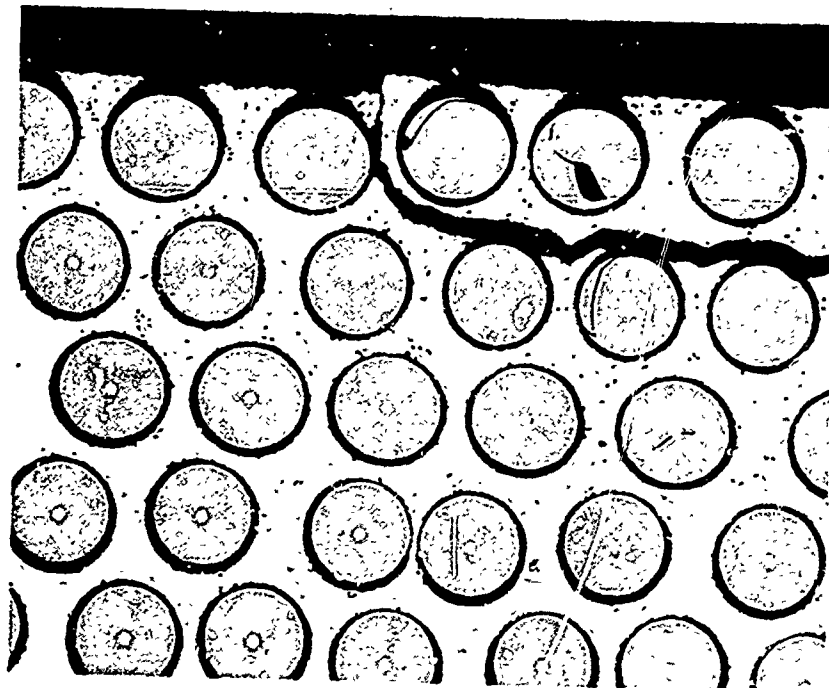
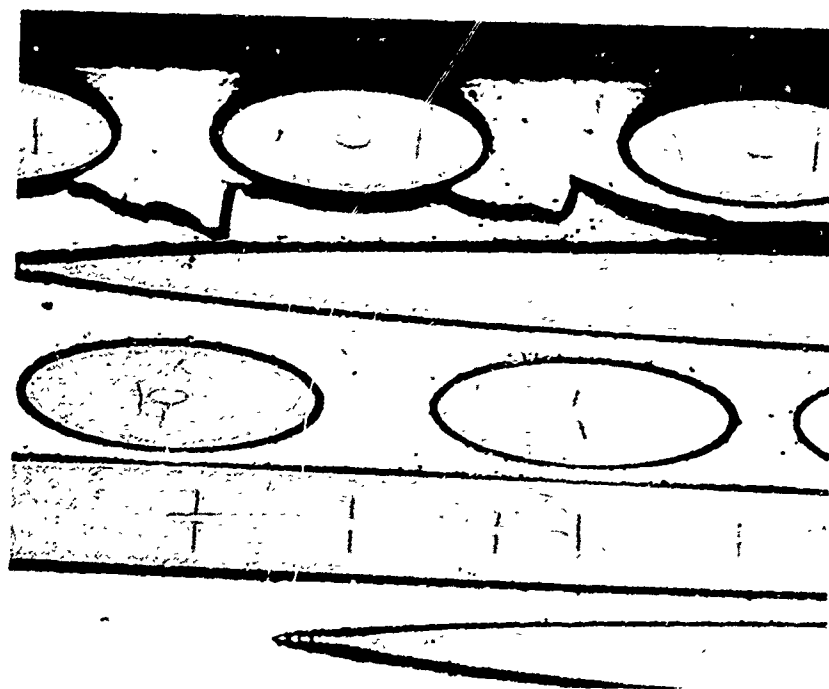
Figure 55 Photomicrographs Showing Damage Caused by Flexural Fatigue (Top Transverse Cross-Section; Bottom, Longitudinal) (100X)

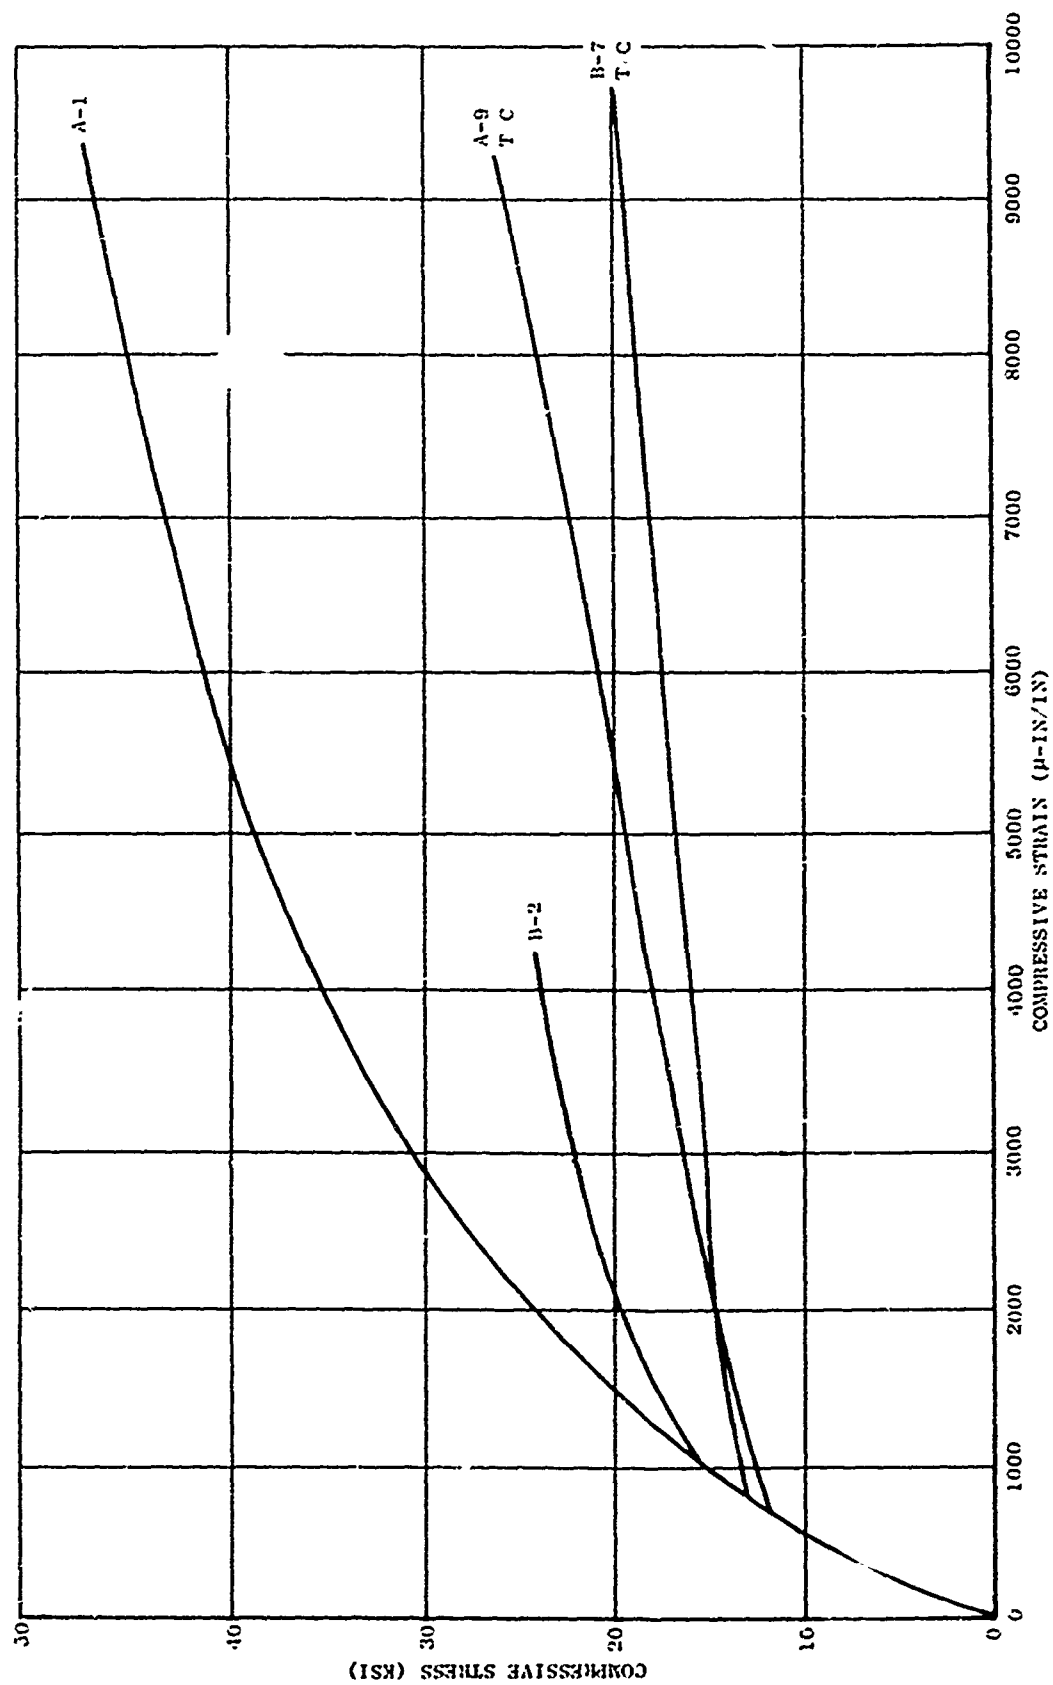
Figure 57 Comparison of B/2024 and B/6061 (22/0/-22/0)<sub>g</sub> Composite Material Behavior to Compressive Loading Before and After Cyclic Thermal Exposure, -60 to +540F Two Thousand Times

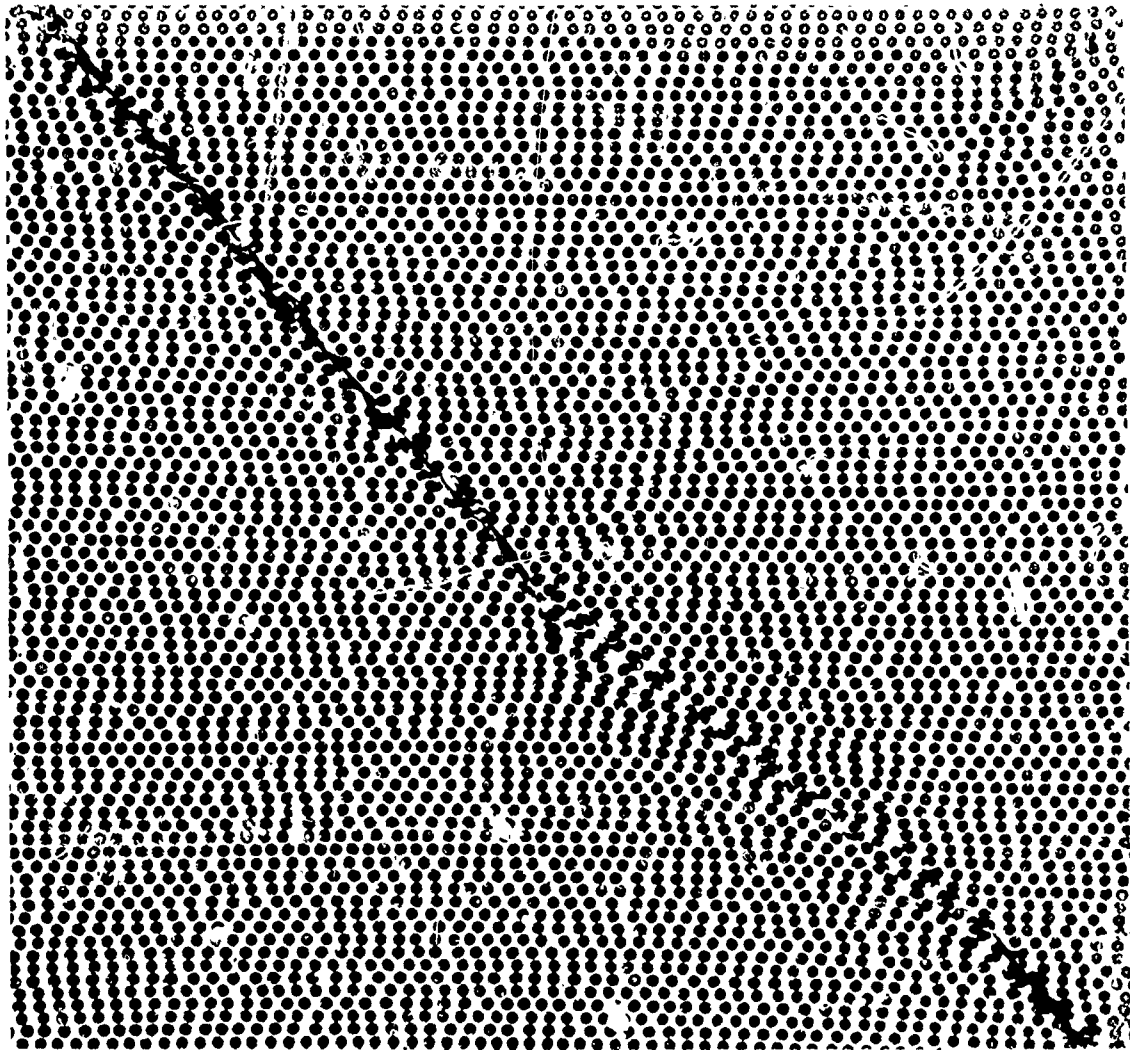
Figure 58 B/2024 Compression Specimen after Testing (~12X)

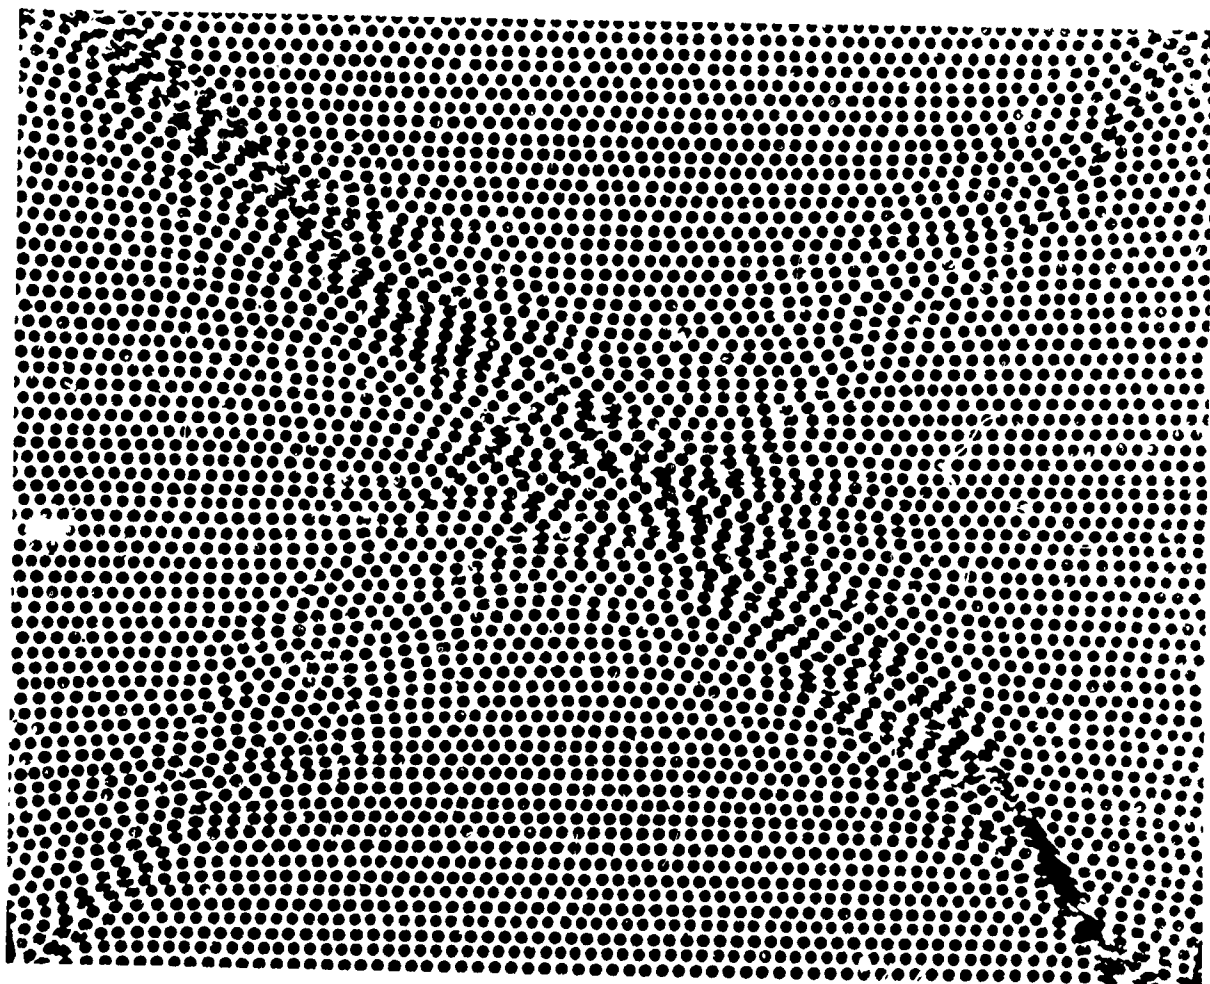
Figure 59 B/6061 Compression Specimen After Testing ( $\times 2X$ )

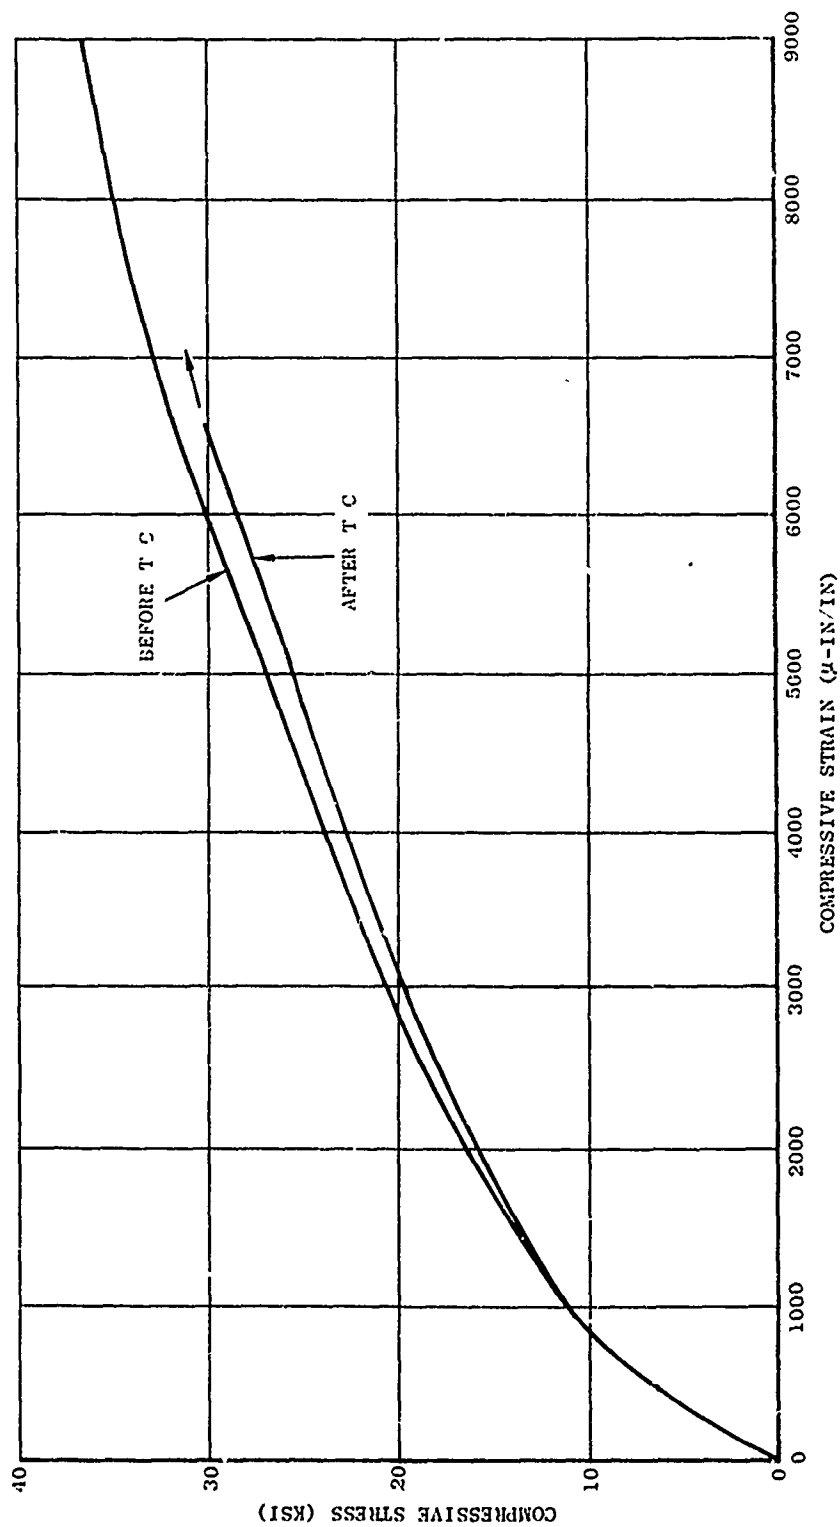
Figure 60 Comparison of 2024 Al/304 SS Mesh Composite Material Behavior to Compressive Loading Before and After Cyclic Thermal Exposure, -60F to + 540F Two Thousand Times

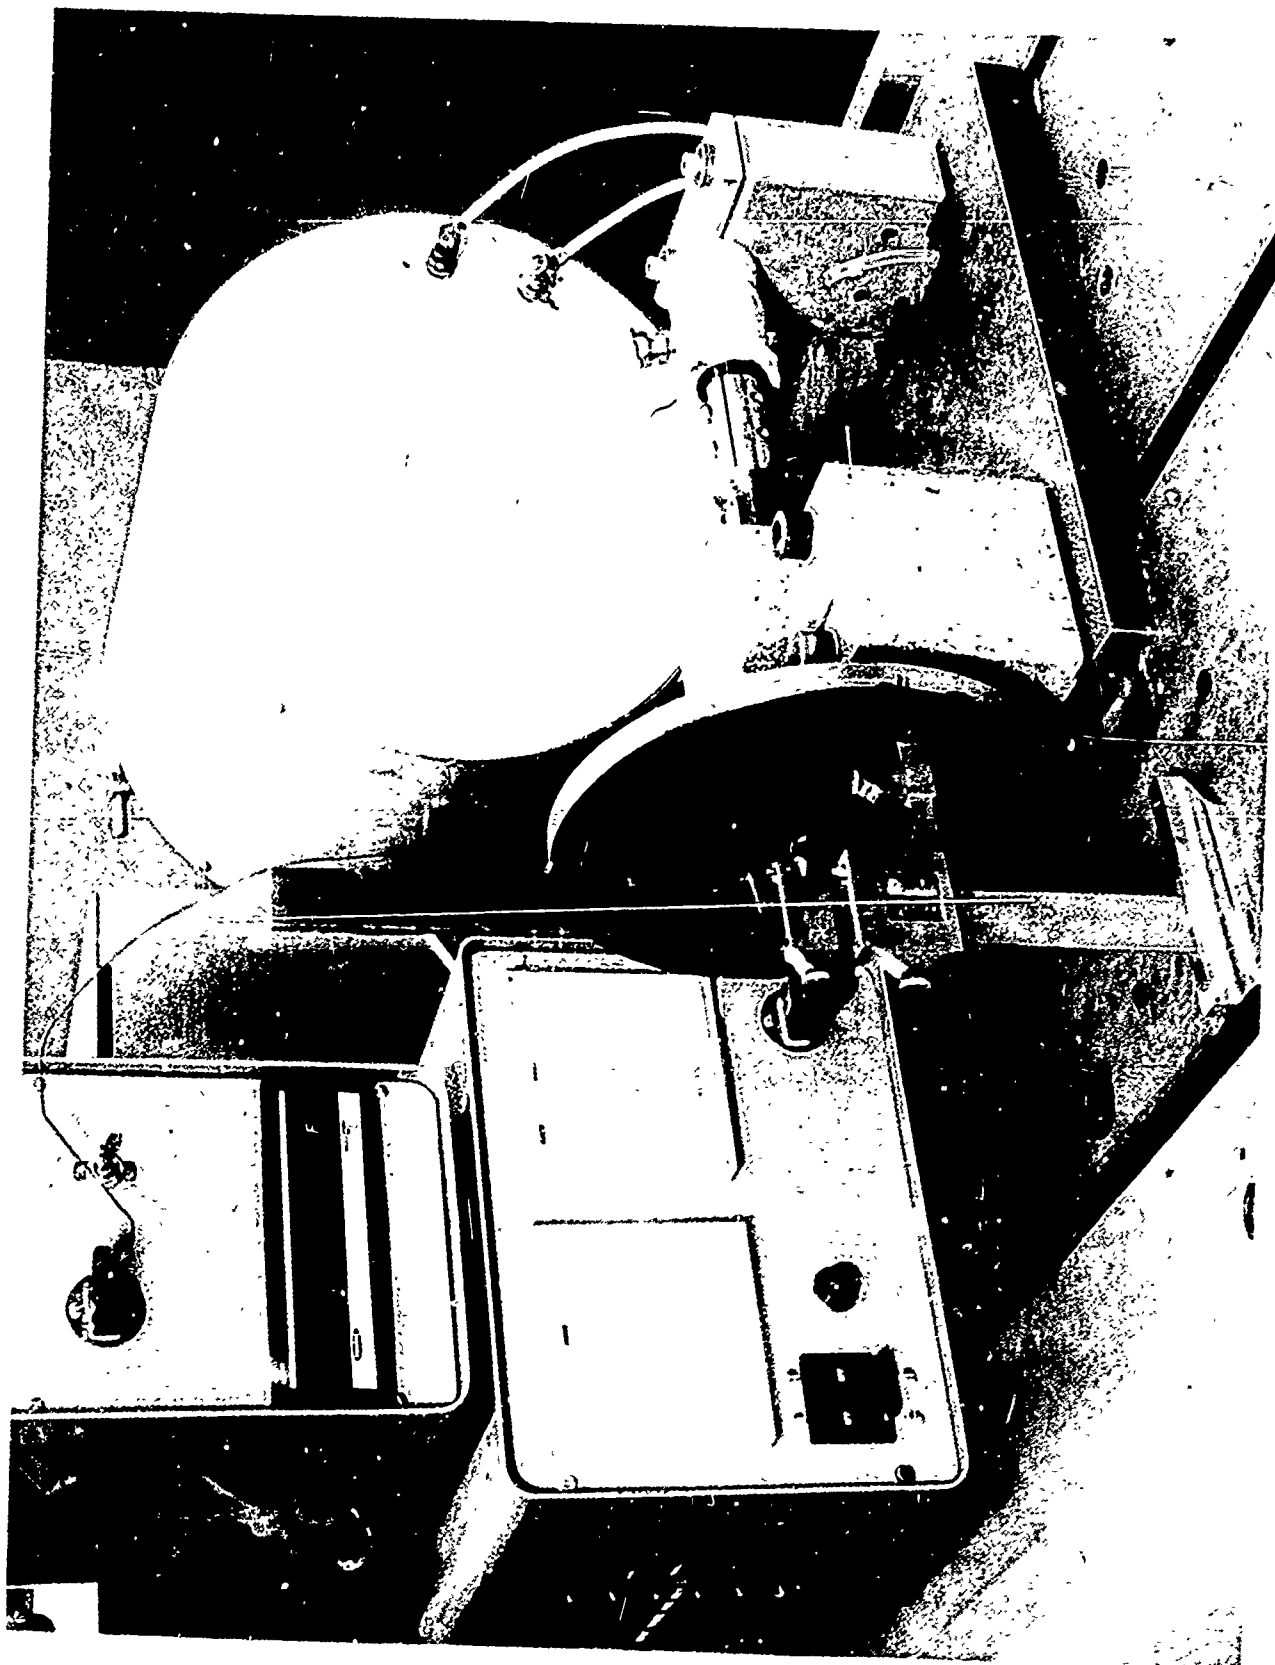
Figure 62 Torsion Creep Test Fixture
