FAILURE PROCESSES IN METAL MATRIX COMPOSITES

GENERAL ELECTRIC COMPANY

PREPARED FOR  
AIR FORCE MATERIALS LABORATORY

REPORT DOCUMENTATION PAGE		READ INSTRUCTIONS BEFORE COMPLETING FORM
1. REPORT NUMBER AFML-TR-73-290	2. GOVT ACCESSION NO.	3. RECIPIENT'S CATALOG NUMBER
4. TITLE (and Subtitle)  FAILURE PROCESSES IN METAL MATRIX COMPOSITES		5. TYPE OF REPORT & PERIOD COVERED Interim Report - Phase I 1 July 1972 to 1 October 1973

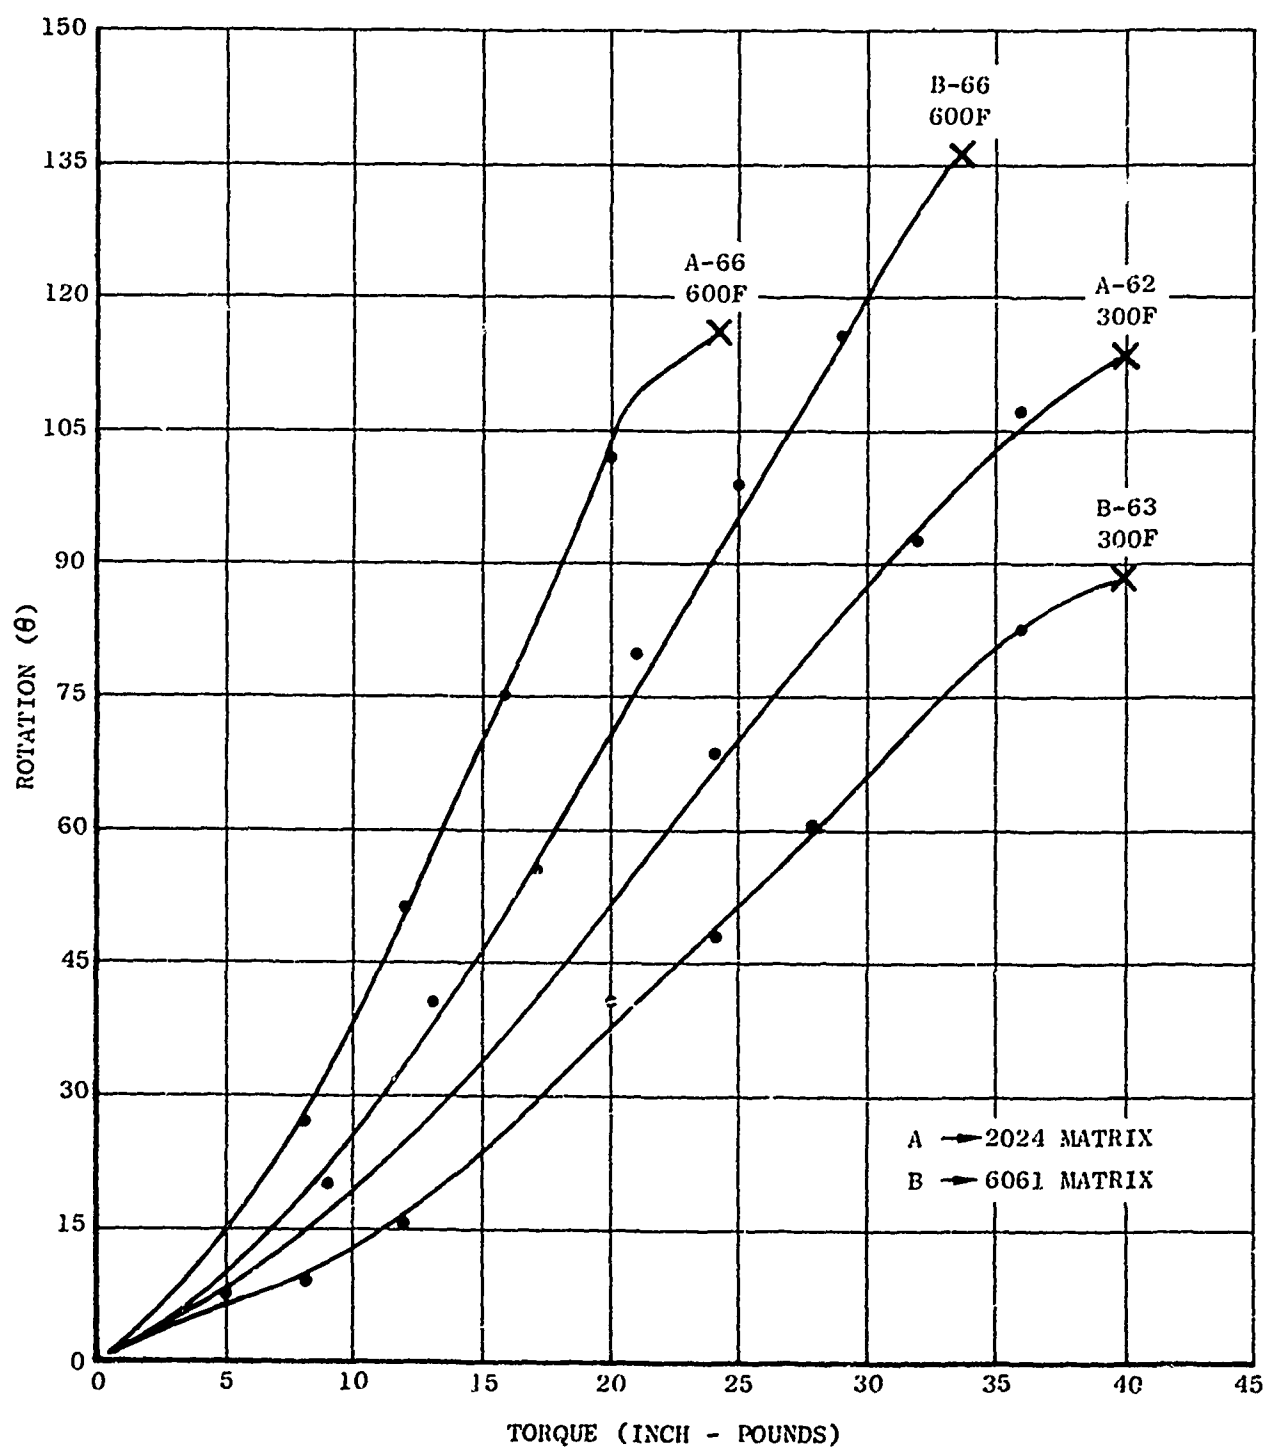
Figure 63 50 v/o [22/0/-22/0]<sub>8</sub> 5.6 Mil B/A1 Specimens  
Loaded in Torsion at 300F and 600F

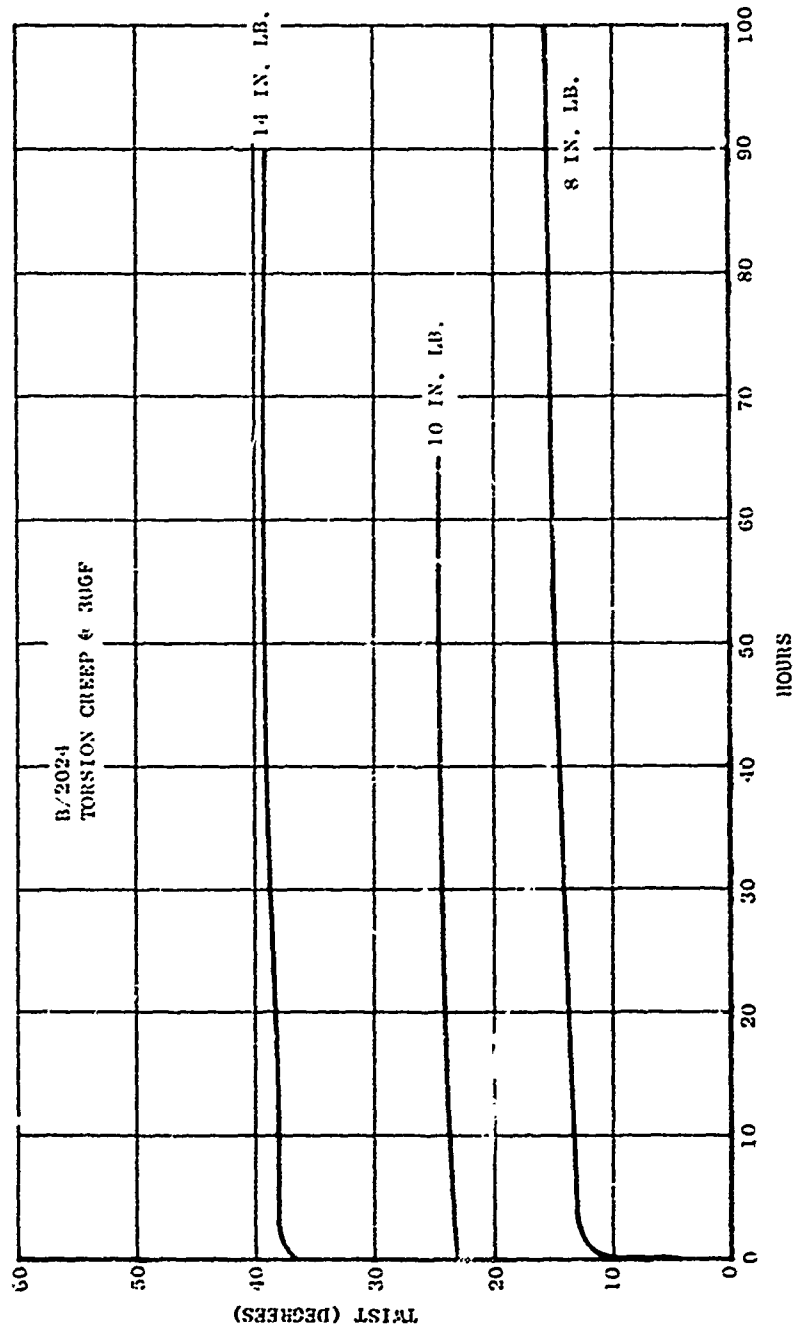
Figure 64 Torsion Creep of B/2024 [22/0/-22/0]<sub>8</sub> Standard Specimens at 300F

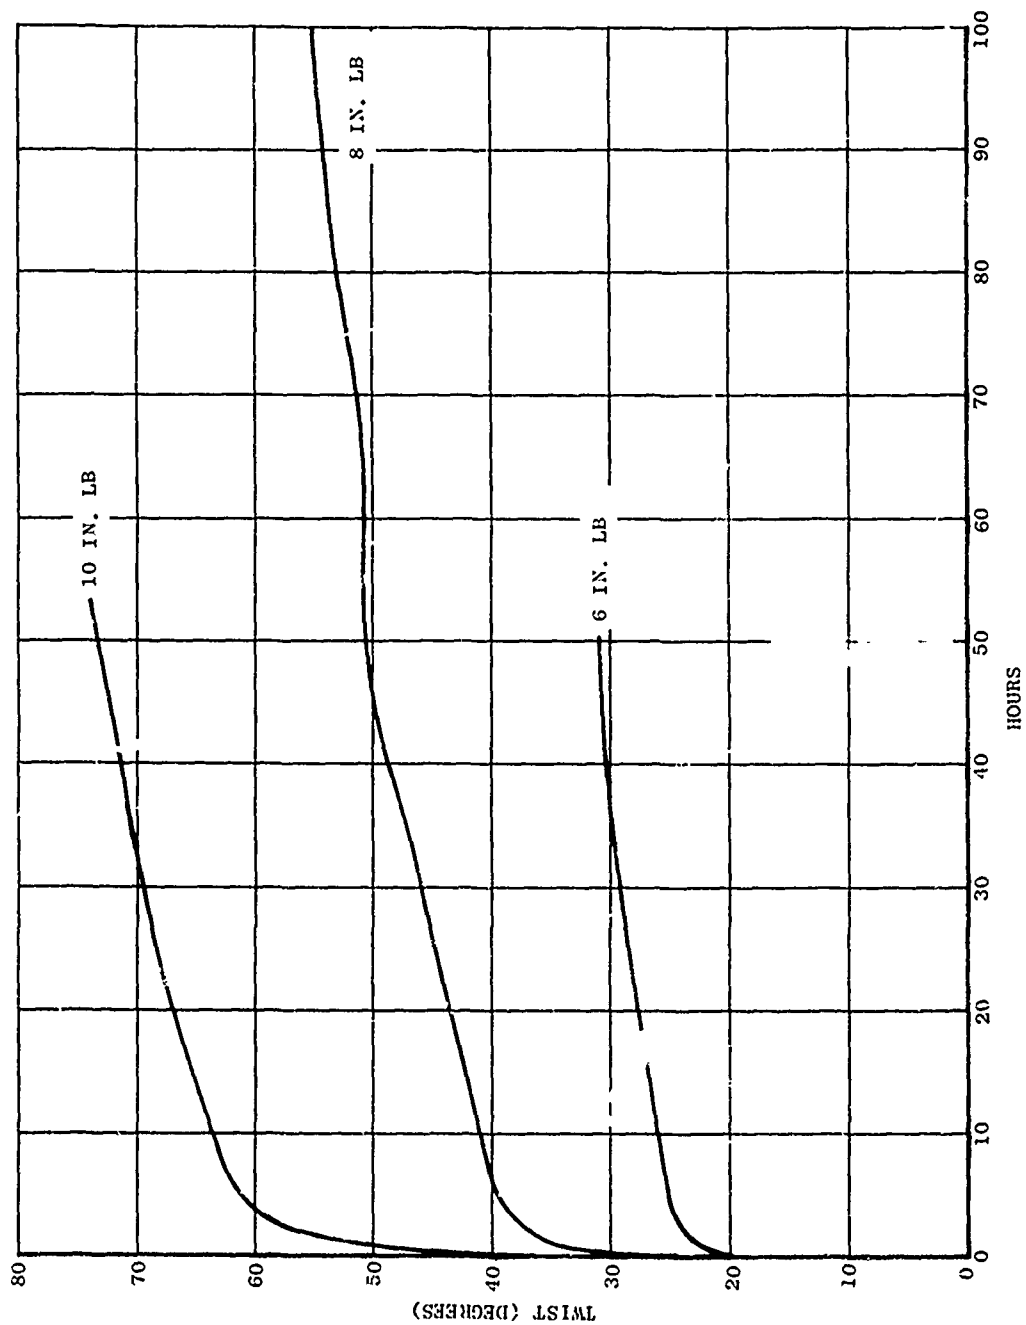
Figure 65 Torsion Creep of B/2024 [22/0/-22/0]<sub>8</sub> Standard Specimens at 600F

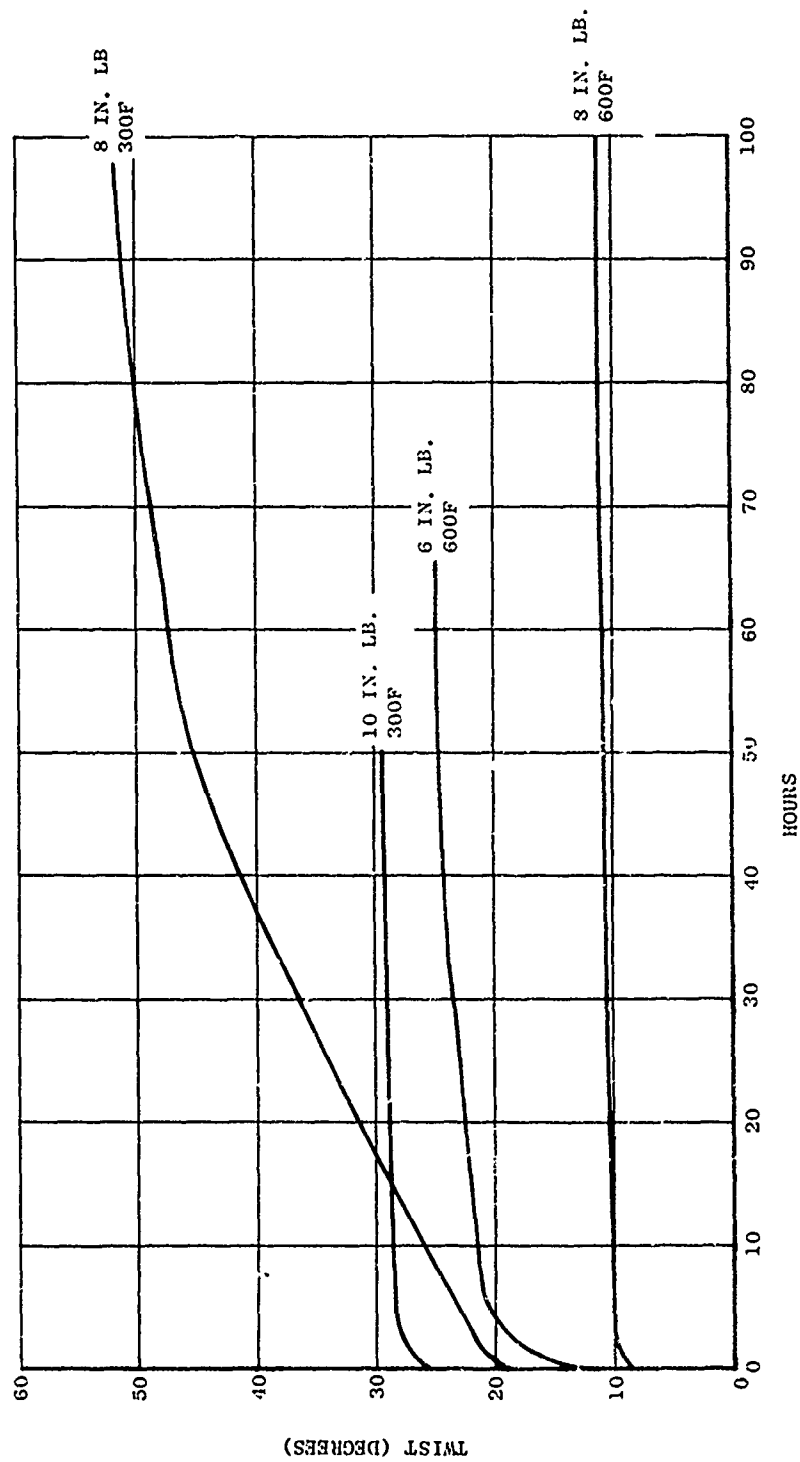
Figure 66 Torsion Creep of B/2224 and B/6061 [22/0/-22/0]<sub>8</sub> Standard Specimens at 300F and 600F

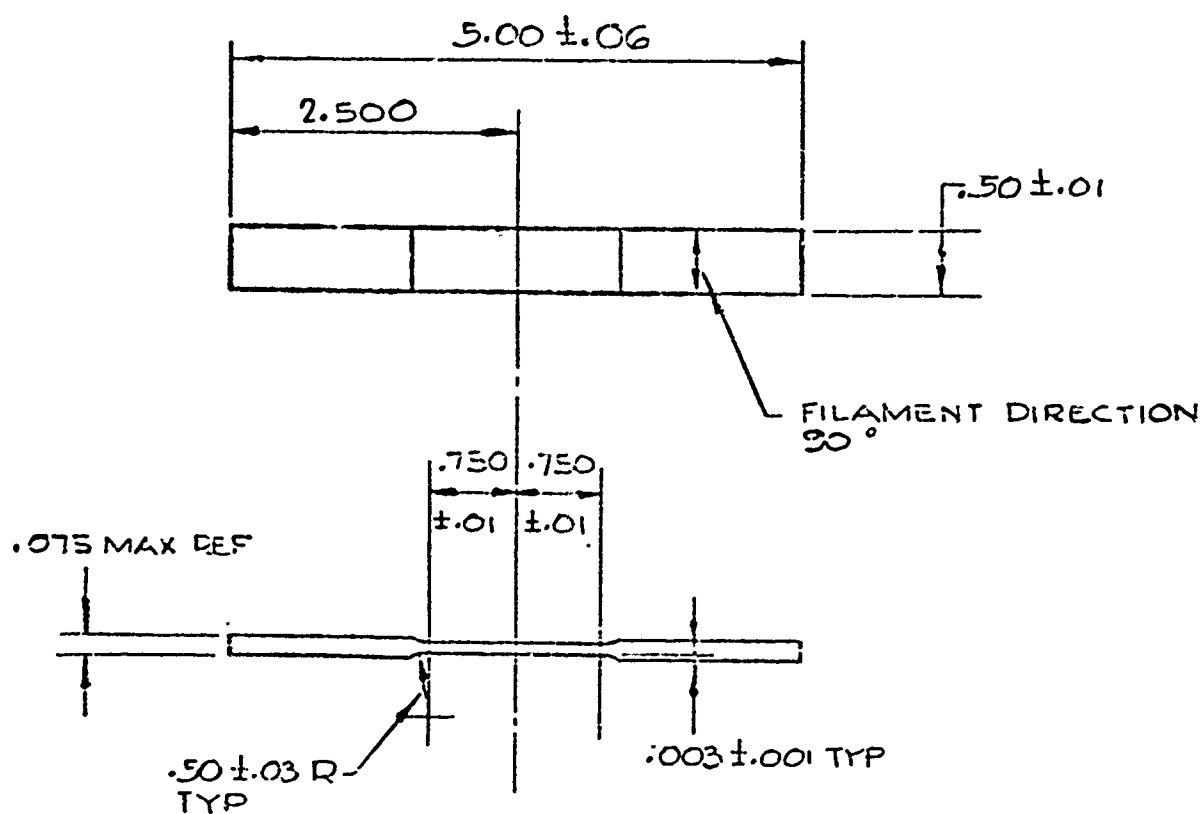
Transverse Tensile Test Specimen Configuration to be used for Baseline Data Acquisition. Design Assumes Presence of Protective Outer Surface of Stainless Steel Mesh.

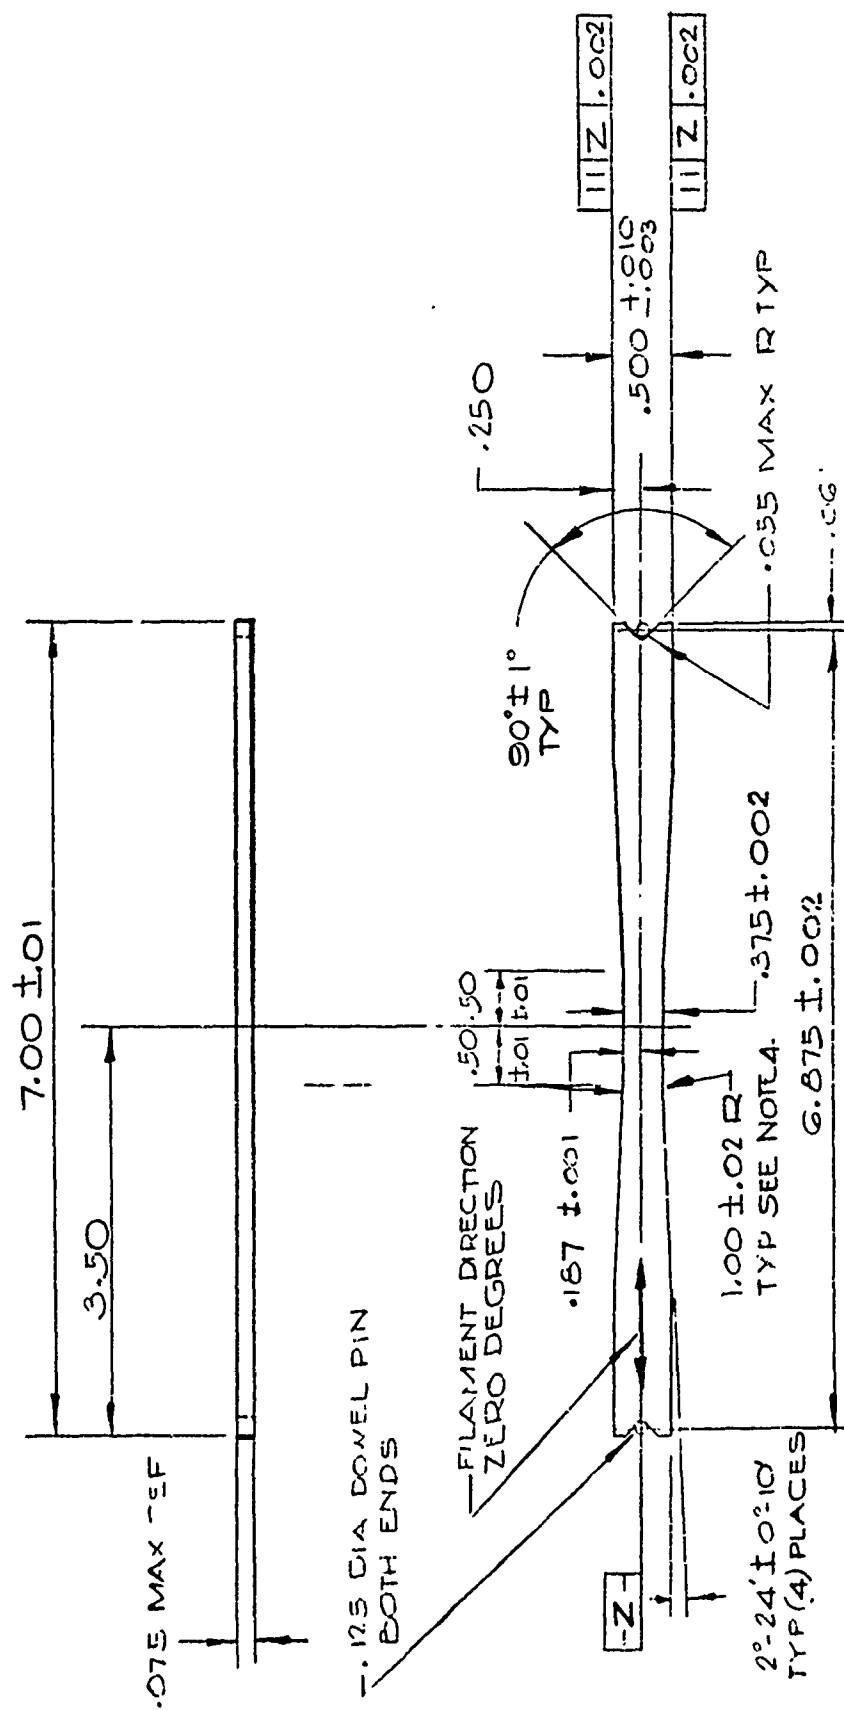
Tensile, Tensile Fatigue, and Stress Rupture Test Specimen Configuration.  
Design Assumes No Protective Outer Surface of Stainless Steel Mesh.

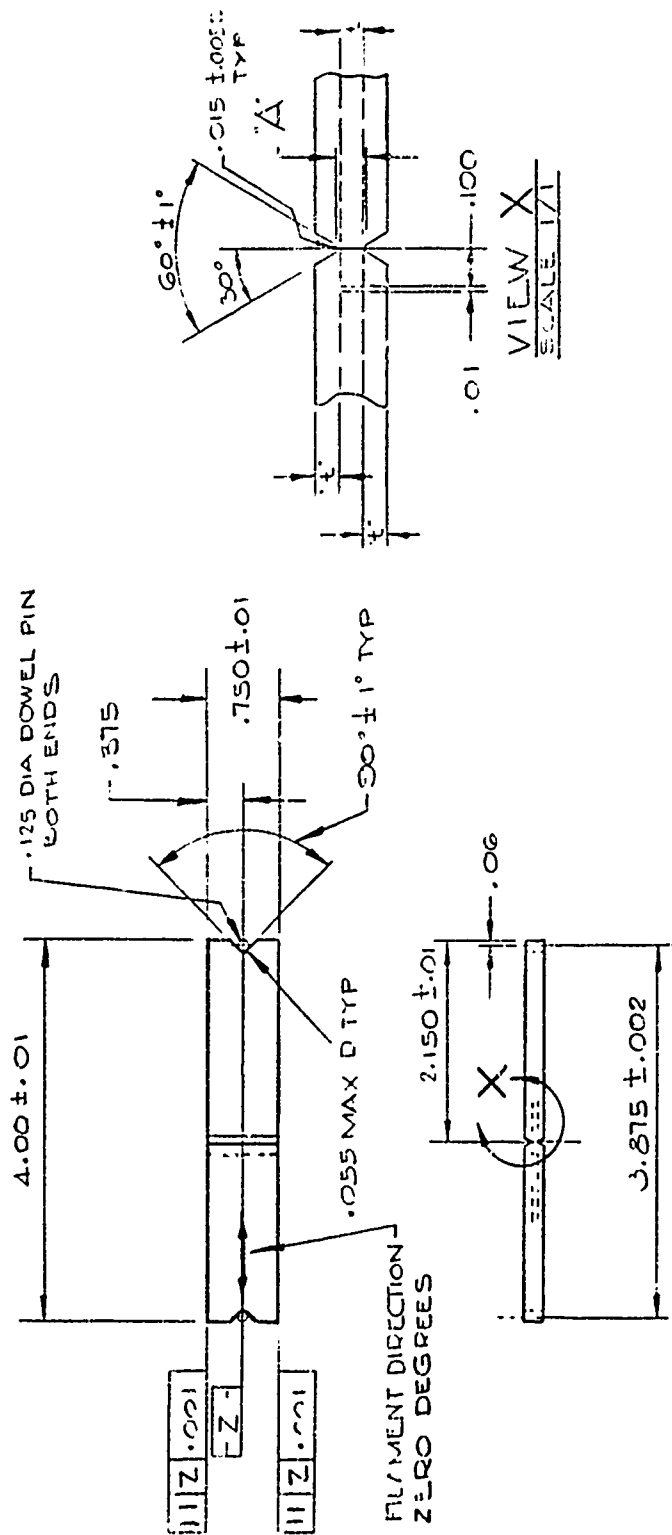
Double Lap Shear Creep Test Specimen Configuration.
