TEST RESULTS REPORT AND TECHNOLOGY
DEVELOPMENT REPORT, HLH/ATC DRIVE SYSTEM
AFT ROTOR SHAFT BEARING TEST

Boeing Vertol Company

Army Aviation Systems Command

January 1974

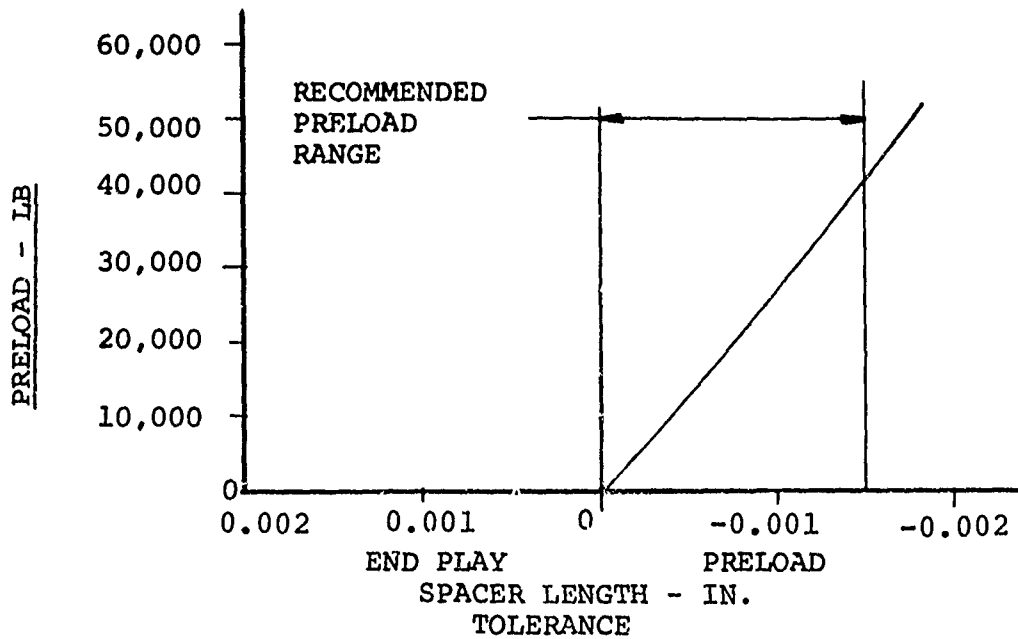
Figure 9. HLH Rotor Shaft Tapered Roller Bearing Preload Study.

PRELOAD POUNDS VS PRELOAD SHIM THICKNESS

5. The bore of each bearing and the shaft outer diameter at each bearing seat were measured and recorded to determine the exact shaft fit. Dimensions were recorded to the fourth decimal place. Using all of these dimensions, the following equation was used to determine the size of the spacer to provide the proper preload. The preload spacer length tolerance (P) based on Figure 9 was +0.000 and -0.0015 inch.

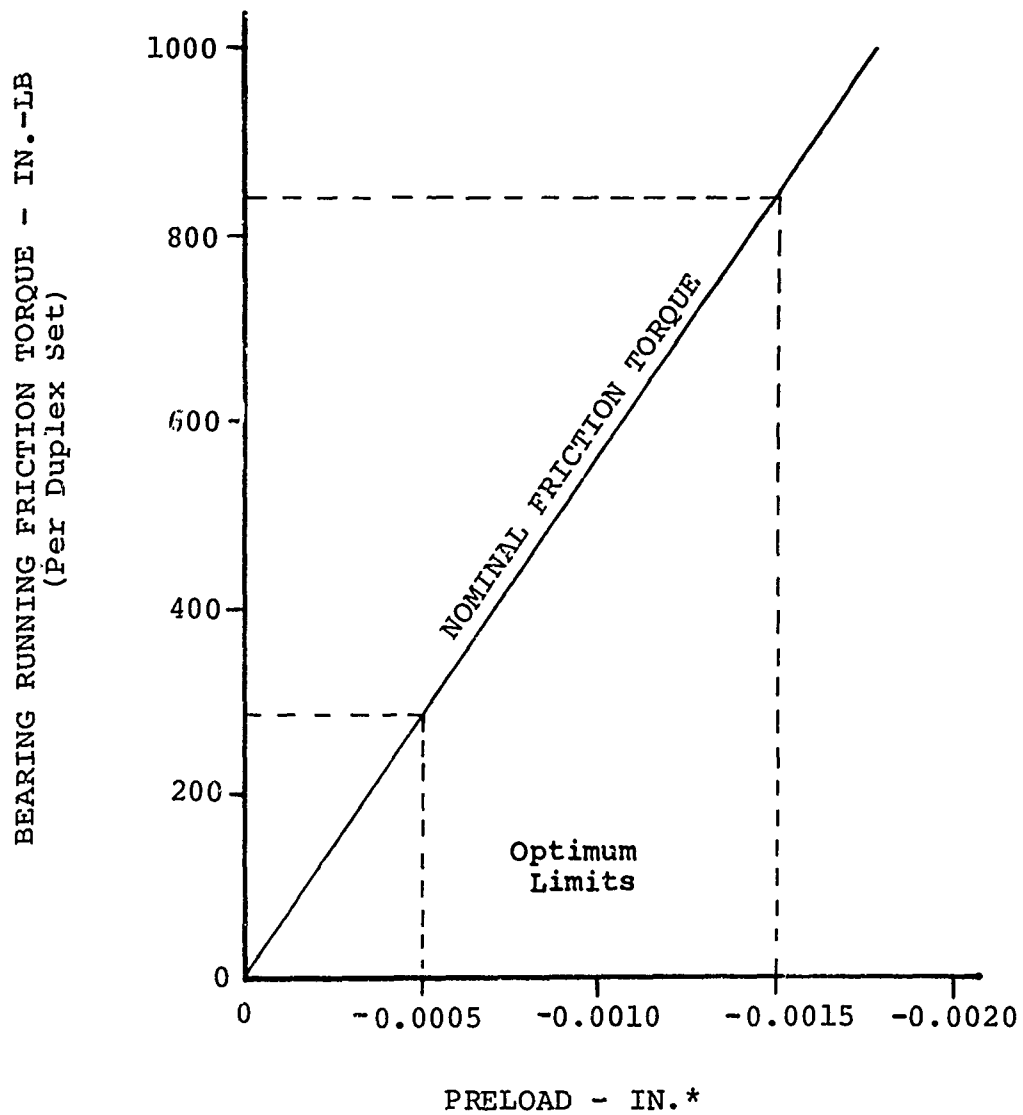
Figure 12. Bearing Friction Torque Versus Preload.

*preload to be determined by the difference between the required spacer length and the actual machined spacer length.

the torque required to rotate the bearing housing assemblies on the test bearings. The resulting housing assembly friction running torque was within the limits shown in Figure 12. As indicated in Table VII, the friction torque condition of the upper housing assembly was the zero "end play" (zero preload) condition for the bearing set.

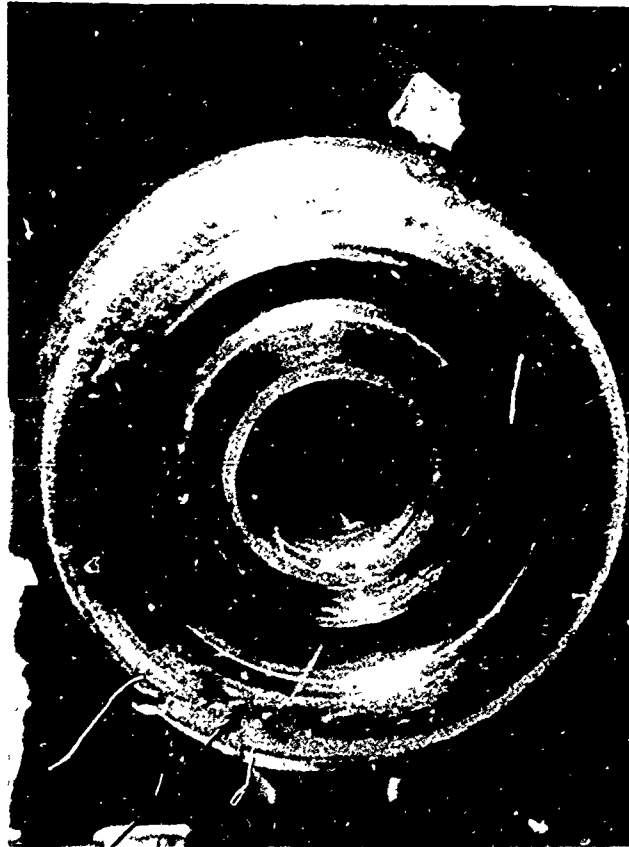
Figure 34. Cracked Roller.

NOTE THAT CRACK EXTENDS ACROSS
SPHERICAL END AND INTO PIN BORE

Thirty-eight rollers showed typical geometric stress concentration spalling on the large end, in some cases extending two-thirds of the way down the roller. Some rollers also showed irregular cracking across the large end extending from the radius blend to the cage pin hole (Figure 34).
