ENDURANCE TESTING OF AN LM-726-4
ELASTOMERIC PITCH CHANGE BEARING

Lord Kinematics

Army Air Mobility Research and Development
Laboratory

June 1974

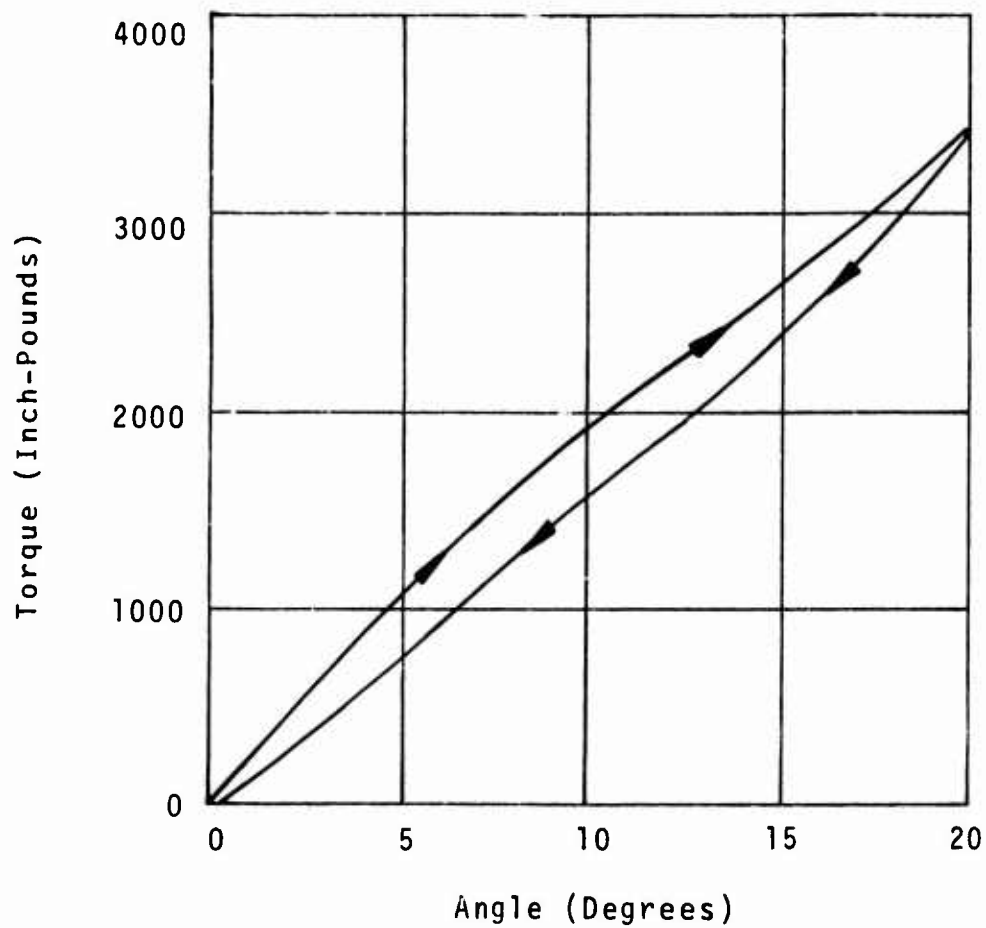
Figure 3. Torsional Spring Rate of LM726-4, S/N 071.

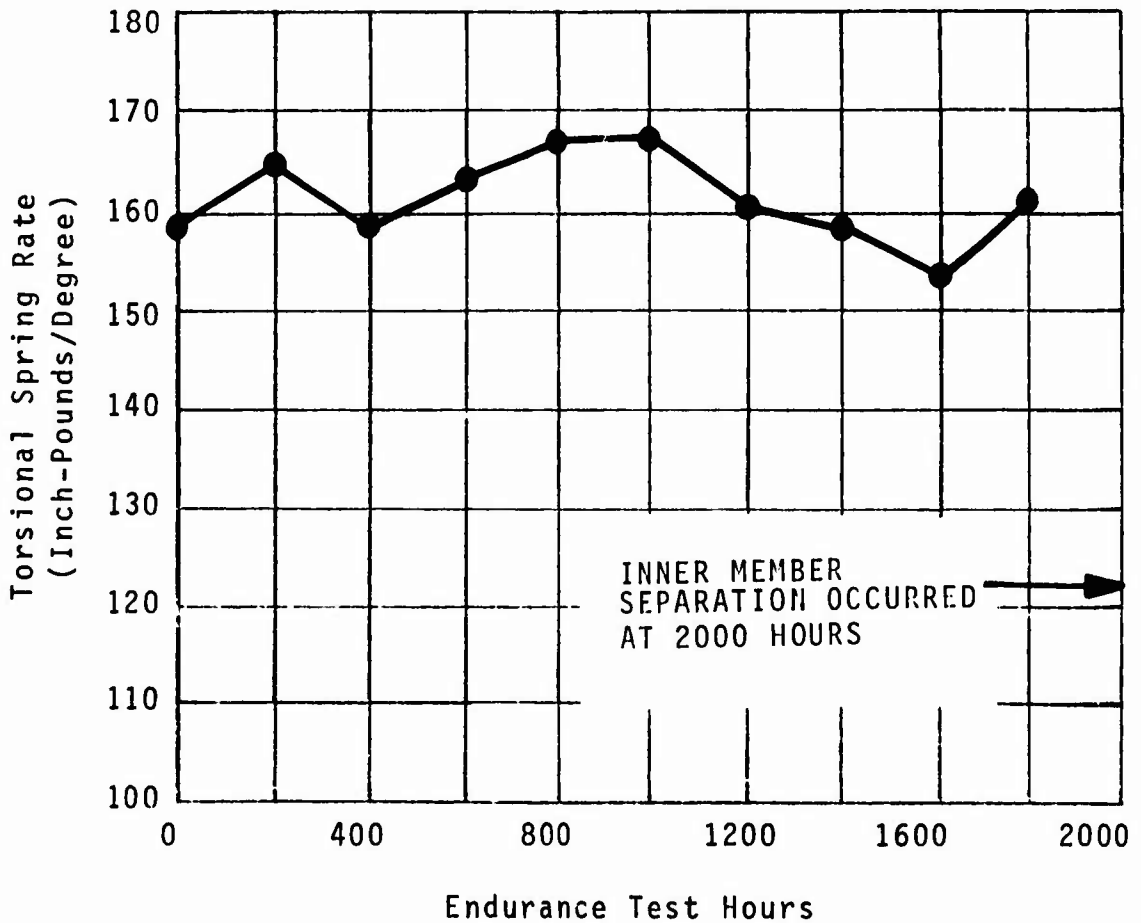
Figure 10. Static Axial Spring Rate of Test Sample 1 (S/N 004).

Figure 11. Static Torsional Spring Rate of Test Sample 1 (S/N 004) Without CF Applied.

Figure 12. Static Axial Spring Rate of Test Sample 2 (S/N 005).

Figure 13. Static Torsional Spring Rate of Test Sample 2 (S/N 005) Without CF Applied.

Figure 14. Static Axial Spring Rate of Test Sample 3 (S/N 006).

Figure 15. Static Torsional Spring Rate of Test Sample 3 (S/N 006) Without CF Applied.

The results of the periodic axial and torsional load versus deflection tests of the six endurance test samples are contained in Figures 10 through 23. The axial spring rate value was obtained by dividing the normal centrifugal force load of 56,000 lb by the axial deflection obtained at that load. The value shown as the torsional spring rate is the peak-to-peak torque divided by the peak-to-peak deflection of 40°.

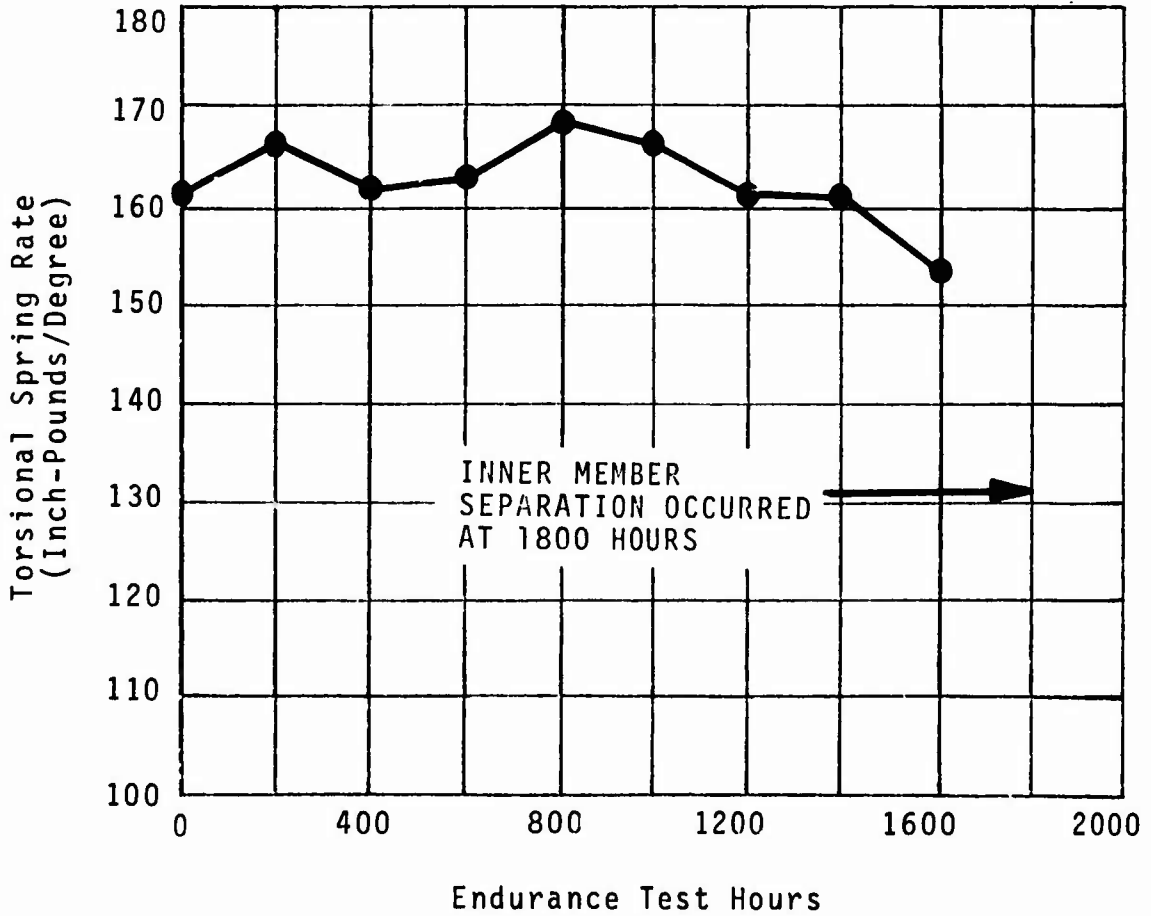
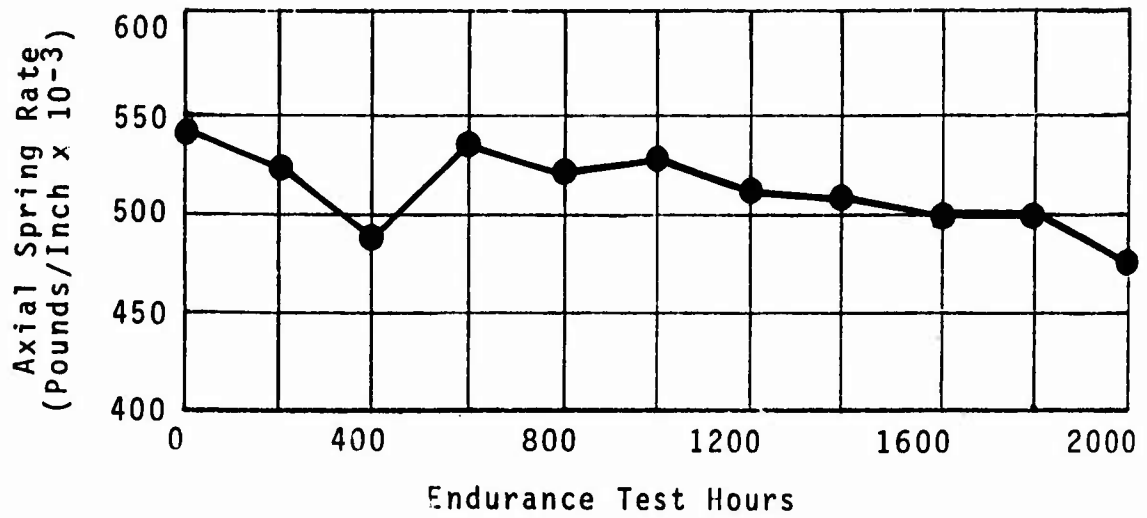
Figure 16. Static Axial Spring Rate of Test Sample 4 (S/N 009).

Figure 17. Static Torsional Spring Rate of Test Sample 4 (S/N 009) Without CF Applied.

Figure 18. Static Axial Spring Rate of Test Sample 5 (S/N 014).

Figure 19. Static Torsional Spring Rate of Test Sample 5 (S/N 014) Without CF Applied.

Figure 20. Static Axial Spring Rate of Test Sample 6 (S/N C16).

Figure 21. Static Torsional Spring Rate of Test Sample 6 (S/N 016).

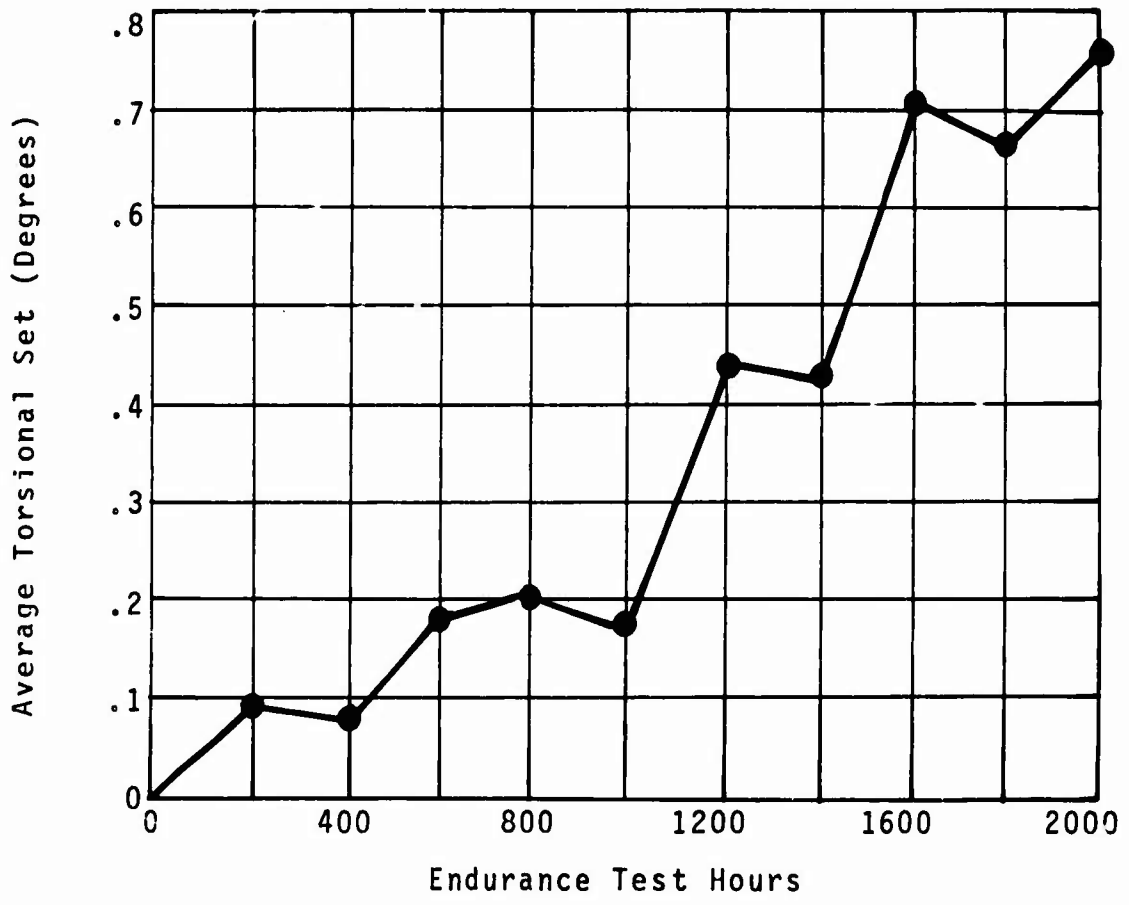
Figure 25. Average Torsional Set of Test Samples 1 through 6.

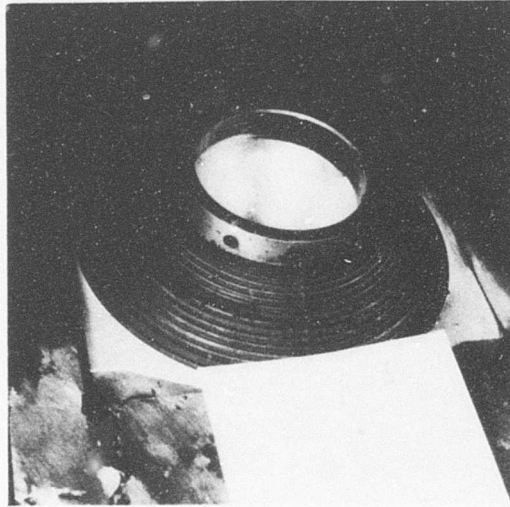
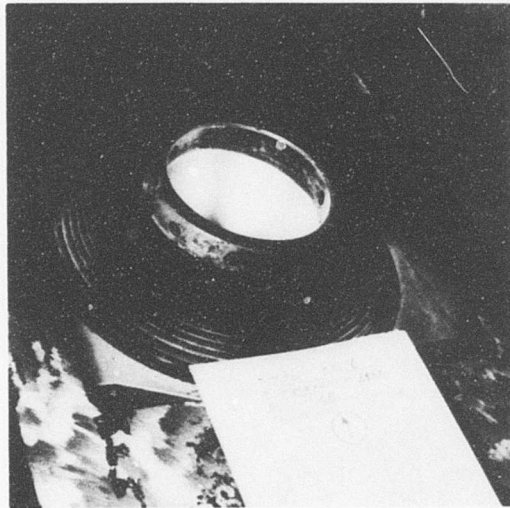
Figure 44. Test Sample 1 (S/N 004) After 1400 Hours of Endurance Testing. (Appearance is typical of Test samples 2, 4, 5, and 6.)

Figure 45. Test Sample 3 (S/N 006) After 1400 Hours of Endurance Testing. (This sample is the most severely damaged at this point of the test. A depth of separation is visible in first layer in left center of photo.)

Figure 46. Test Sample 1 (S/N 004) After 1600 Hours of Endurance Testing. (Appearance is typical of test samples 2, 4, 5, and 6.)

Figure 47. Test Sample 3 (S/N 006) After 1600 Hours of Endurance Testing. (Most severely damaged sample. Note depth of separation visible in left center of photograph.)

Test sample 3 may be considered to have failed even though it did not fulfill a strict interpretation of the failure criterion. The torsional spring rate at 2000 hours was approximately 37% below the initial value, and the depth of elastomer loss in the innermost section exceeded 2.0 inches. Good engineering judgment would not allow this bearing to continue on test beyond 2000 hours.
