MANUFACTURING METHODS TECHNOLOGY  
(MM AND T) FOR BALLISTICALLY TOLERANT  
REPLACEMENT FLIGHT CONTROL COMPONENTS

Whittaker Corporation

Army Air Mobility Research and  
Development Laboratory

July 1974

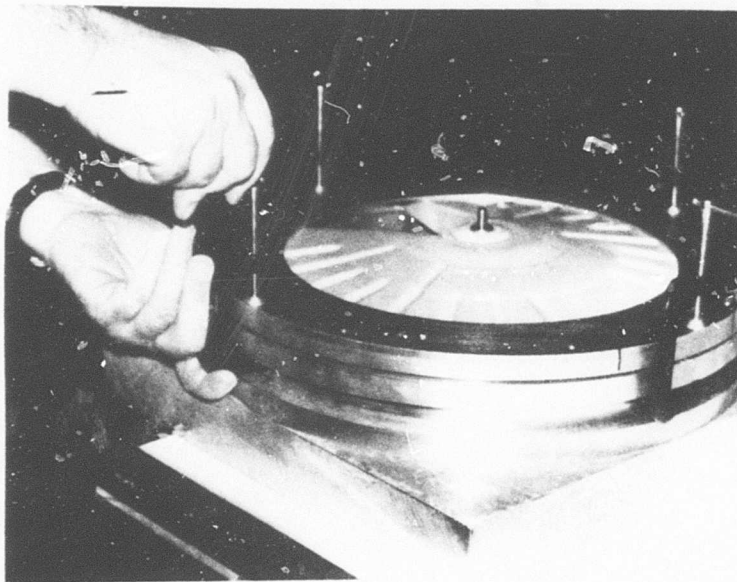
Figure 5. Assembly Fixture for Quadrant.

Fixtures were made for the assembly and bonding of the two components. The fixtures held the individual details in their proper positions and provided the necessary clamping pressure for bonding the parts together. Assembly fixtures for the quadrant and the connecting link are shown in Figures 5 and 6.

The quadrant is assembled and bonded in an assembly fixture. The fixture is constructed so that the correct positions of all parts are maintained until the adhesive has cured. All parts, including the metallic bearing and bushings, are bonded in place with EA 9320 adhesive, which is a two-part, room-temperature curing adhesive. Highlights of the assembly operation of the quadrant are shown in Figures 21 through 24. After bonding, removing excess adhesive and flash and drilling two holes for the cable retaining pins are the only operations remaining. Figure 25 shows an assembled quadrant.

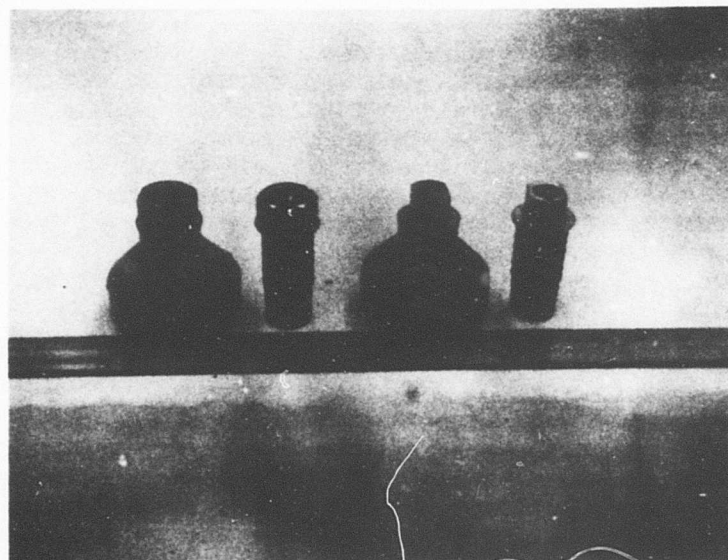
Figure 10. Completed End Fittings for Connecting Link.

The end fittings were fabricated by molding the BMC material, the continuous glass preform, and the metal attachment insert in one molding operation. First, the continuous glass reinforced insert was prepared by die cutting three patterns of glass/epoxy prepreg. These plies were then formed around a Teflon mandrel and inserted inside a Teflon female tool for staging and forming at temperatures of approximately 150°F for 45 minutes (see Figures 7 and 8). The preforms were then removed from the forming tools and placed in the compression molding tool along with the metal attachment insert. Following the insertion of these two details into the preheated tool, the BMC charge is added as bulk material. This is shown in Figure 9. The assembly is then molded and cured. Two fitting details are required for each connecting link, each having a different attachment fitting configuration. The molded fitting detail is shown in Figure 10.

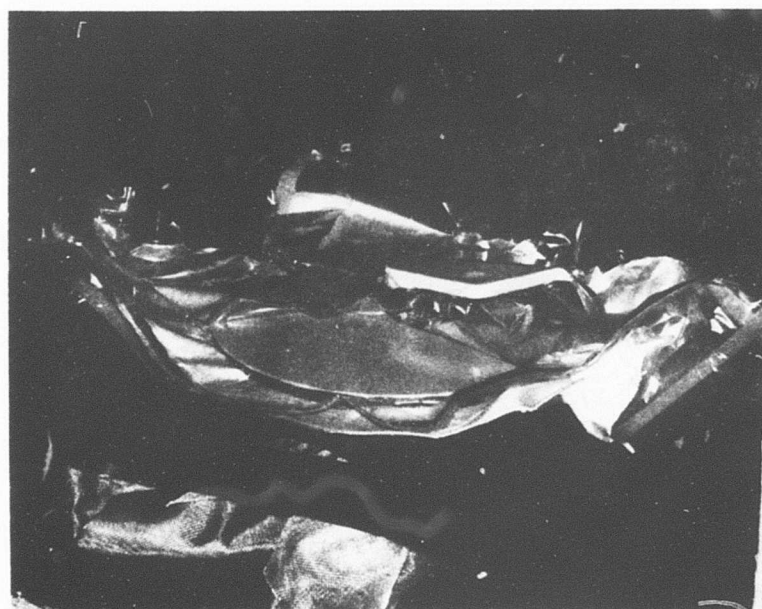
Figure 15. Layup of Fabric for Quadrant.

The upper quadrant disc is compression molded in a matched metal die. The outer face, consisting of three plies of continuous glass fabric epoxy prepreg, and the bulk molding compound which makes up the backup structure are molded in one operation. The glass fabric prepreg is laid up over a Teflon-coated mold, which is made of BMC material, and vacuum bagged. It is then staged at approximately 250°F for 1 hour and 30 minutes. The staging gives the fabric enough rigidity to remain in its proper place in the mold during the subsequent molding operation. The fabric layup and staging are shown in Figures 15 and 16.

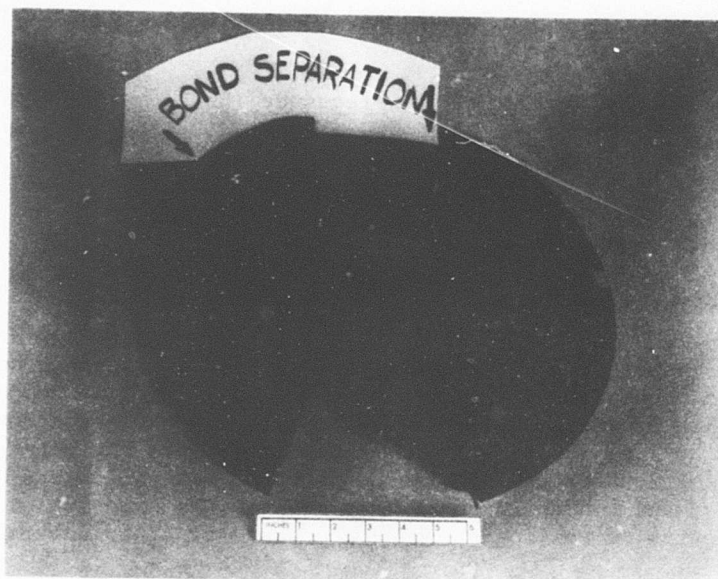
Figure 28. Quadrant After Fire Test.

The lower disc was severely charred and the surface was distorted in the area that ignited. The peripheral bond between the lower and upper discs had separated over a distance of 9 in. in the

area where the cables are attached to the quadrant. The BMC material in the molded upper disc and fittings was only slightly discolored and did not appear to be damaged (Figure 28).

Due to the damage on the lower disc of the quadrant it was decided to apply a thermal protection coating to one of the earlier rejected lower quadrant discs and retest it separately for fire resistance. A 0.030-in.-thick coating (two coats) of 410-1A thermal protection coating was applied to the disc in accordance with NASA Tech Brief 70-10450. The coated lower quadrant disc was placed horizontally approximately 8 in. above the burner. After 1 minute and 45 seconds, it burned slightly, but the flames self-extinguished when the disc was raised approximately 12 in. The disc was immediately lowered again and held over the burner for 15 seconds to complete the 2-minute test. When removed, the disc was burning slightly, and when the flames did not self-extinguish after 5 seconds they were put out.
