PROCEEDINGS OF THE THIRD INTERNATIONAL CONGRESS
ON MARINE CORROSION AND FOULING HELD AT
GAITHERSBURG, MARYLAND, ON OCTOBER 2-6, 1972

Proceedings of the
THIRD INTERNATIONAL CONGRESS ON MARINE CORROSION AND FOULING
October 2-6, 1972
National Bureau of Standards
Gaithersburg, Maryland, U.S.A.

Corrosion and Fouling

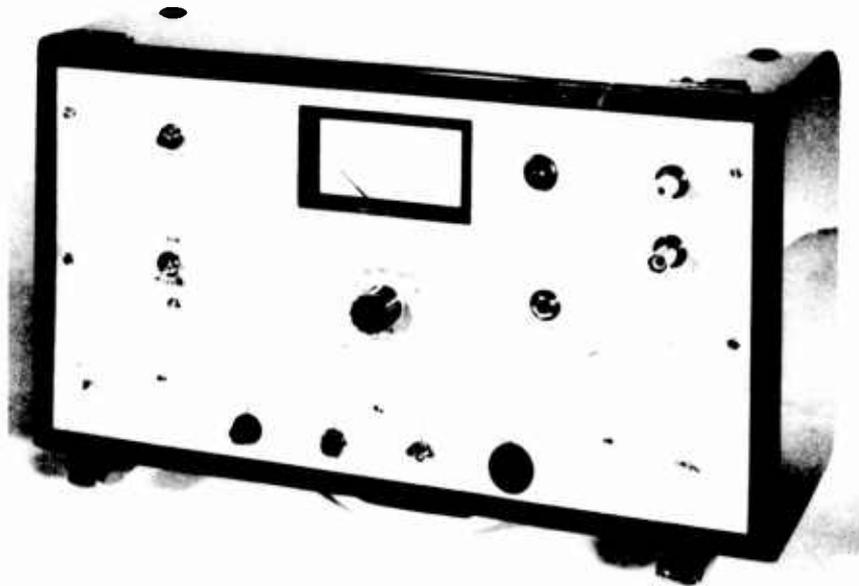
Figure 5. Corrosion meter

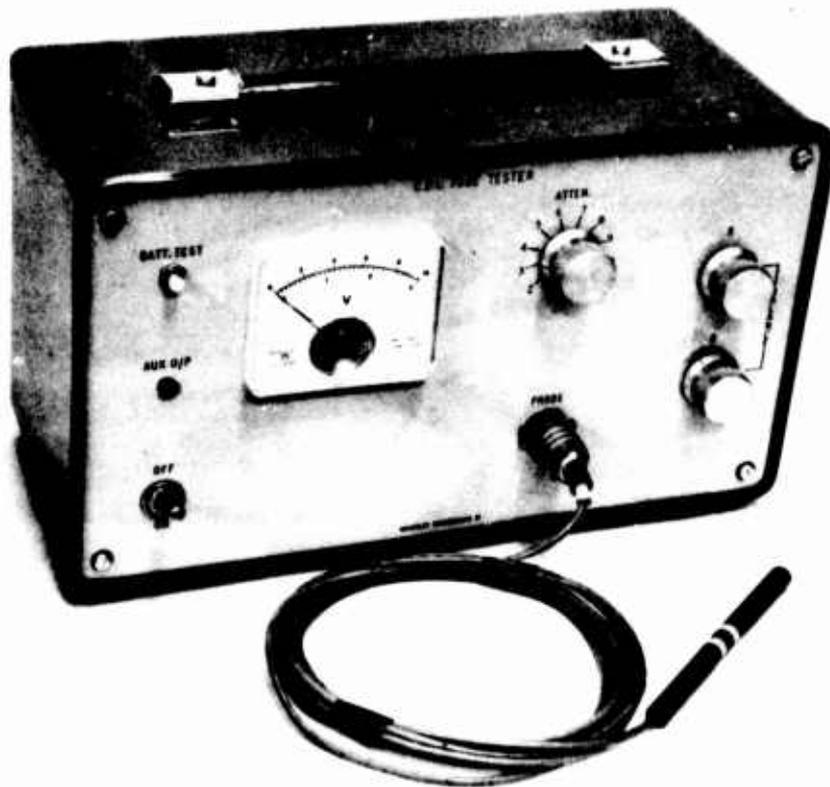
Figure 6. Eddy current heat-exchanger tube testing instrument.
