HELICOPTER SECONDARY STRUCTURES
RELIABILITY AND MAINTAINABILITY
INVESTIGATION

Kenneth B. Krieger

United Aircraft Corporation

July 1974

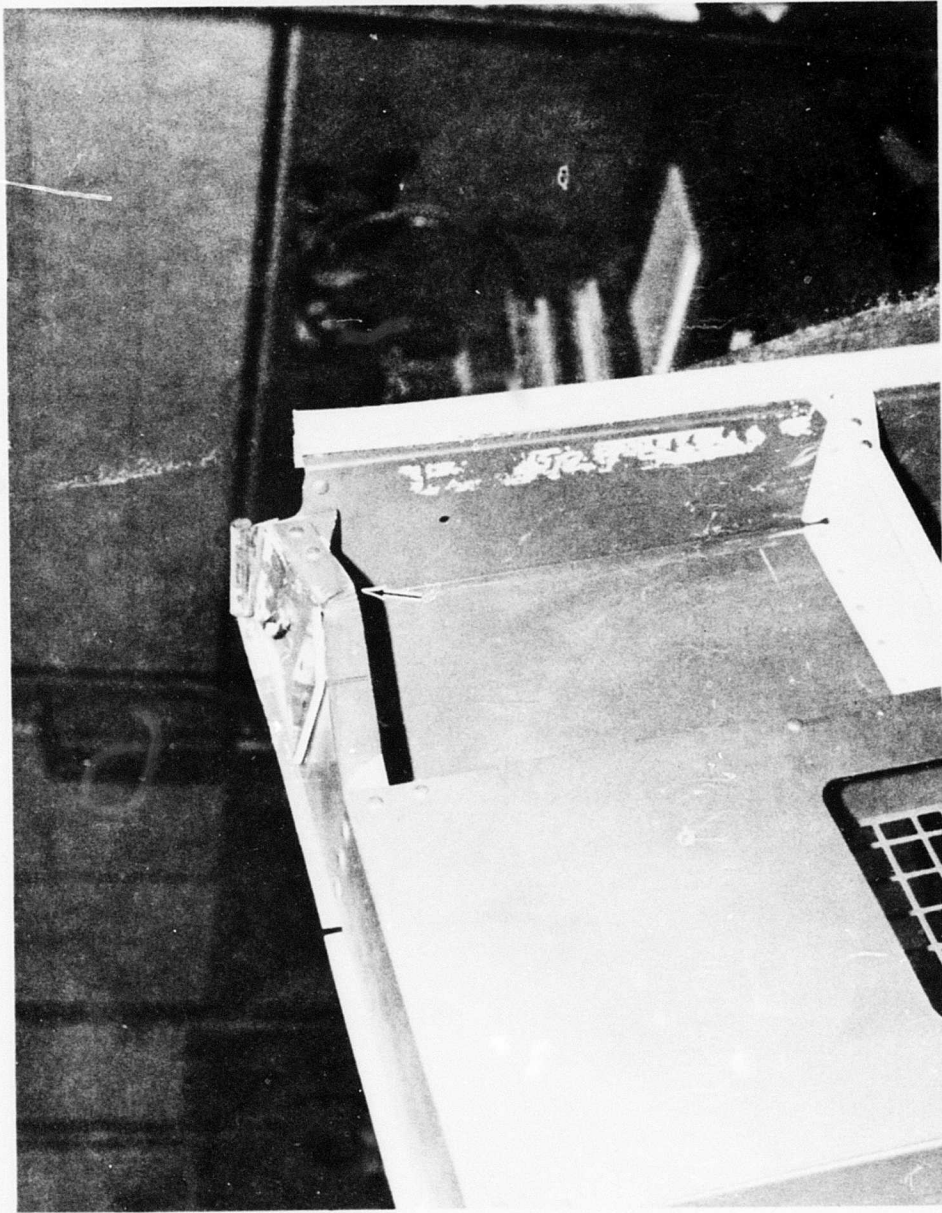
Figure 24. Main Rotor Pylon, Redesign, Alignment Pin Mount Damage.

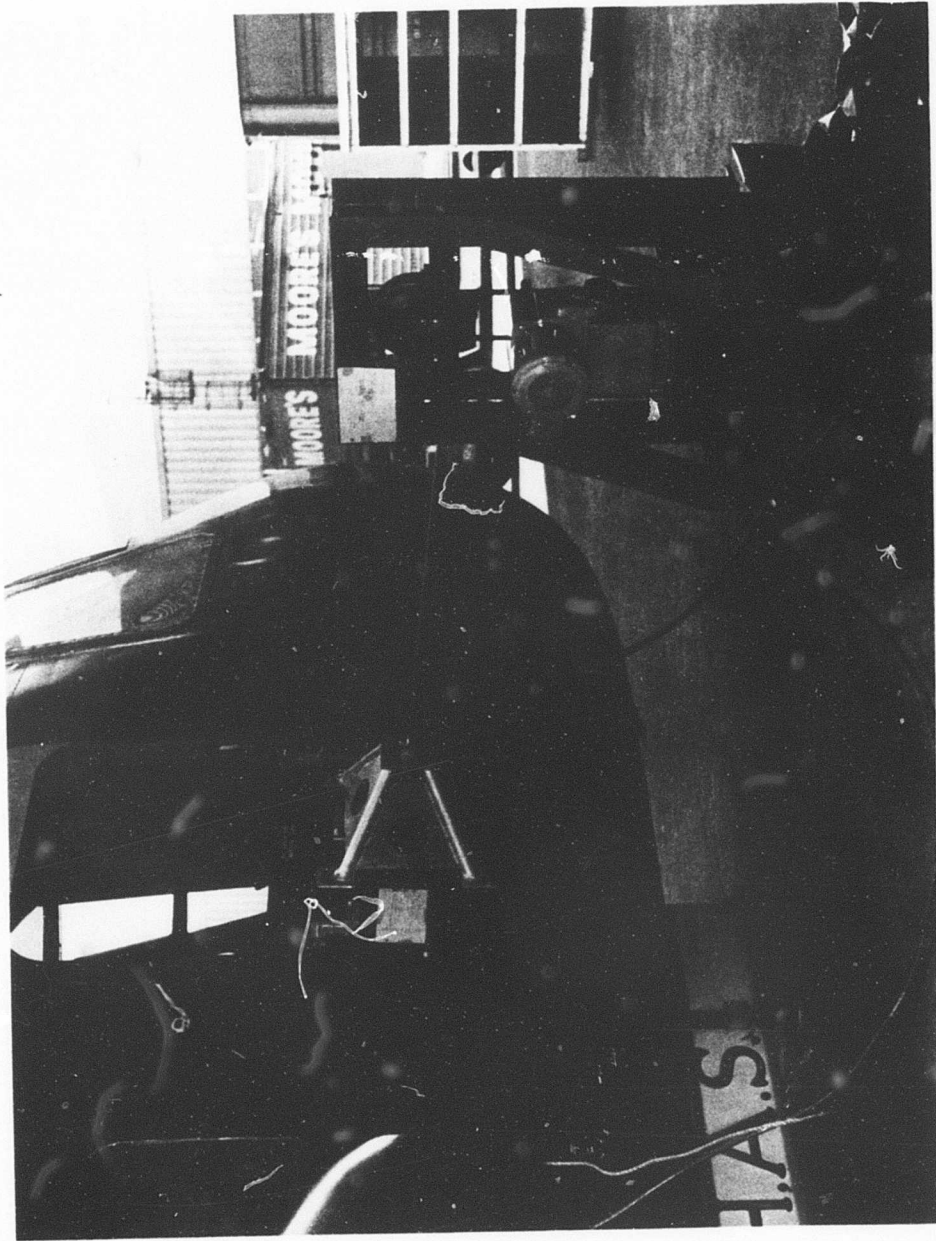
Figure 27. Lower Personnel Door, Vibratory Load Test Setup.

Unlike the other two test items, the vibratory loading on the door (Figure 27) resulted in fatigue cracks similar to field modes. The original design lower personnel door developed the cracks in the skin through the support

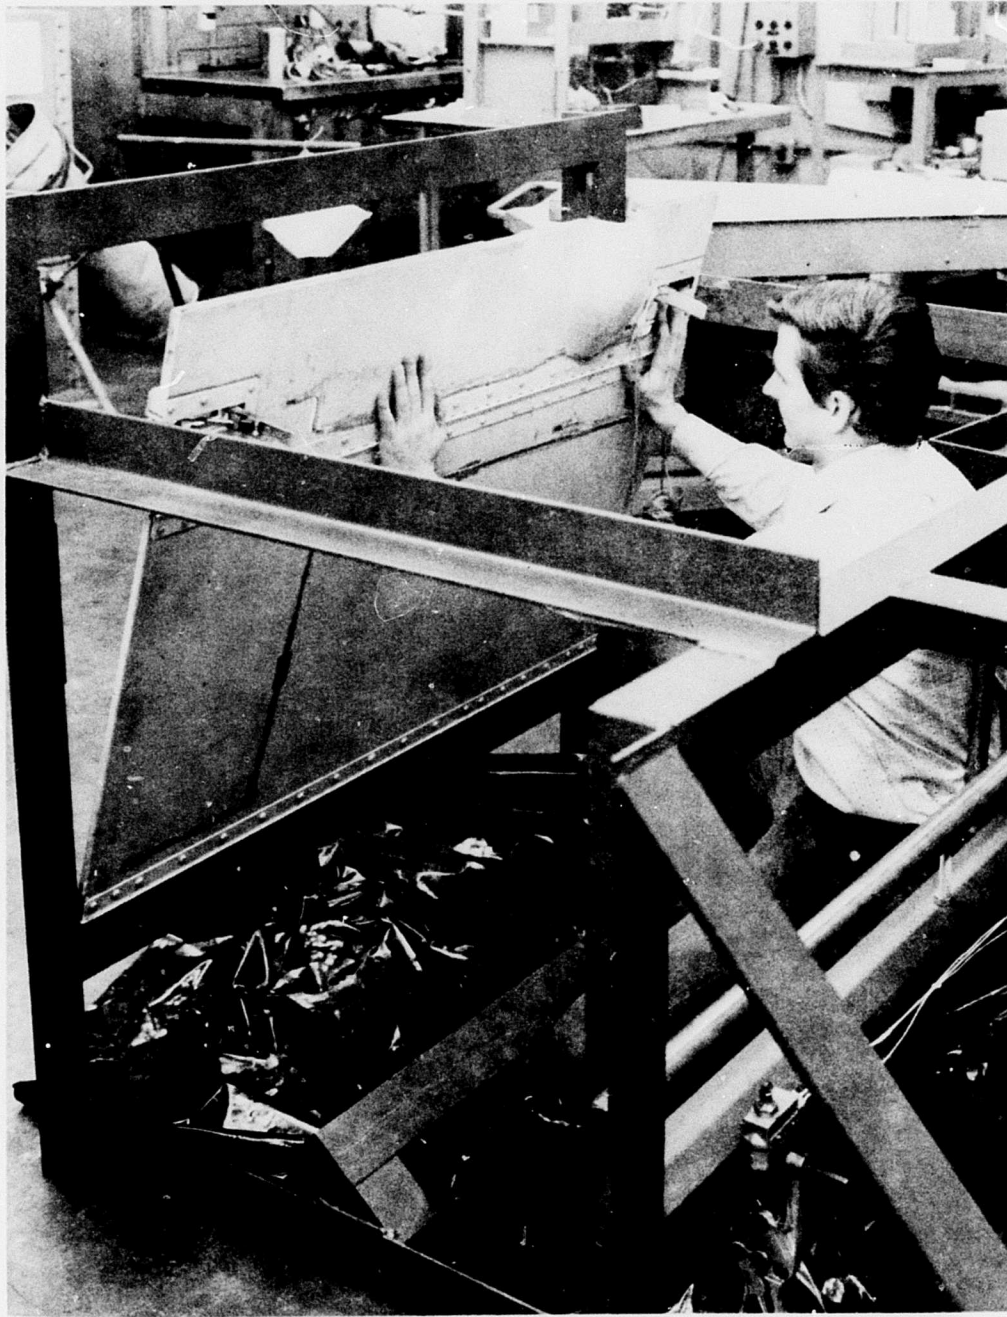
Figure 41. Work Platform Assembly, Manual Cycling.

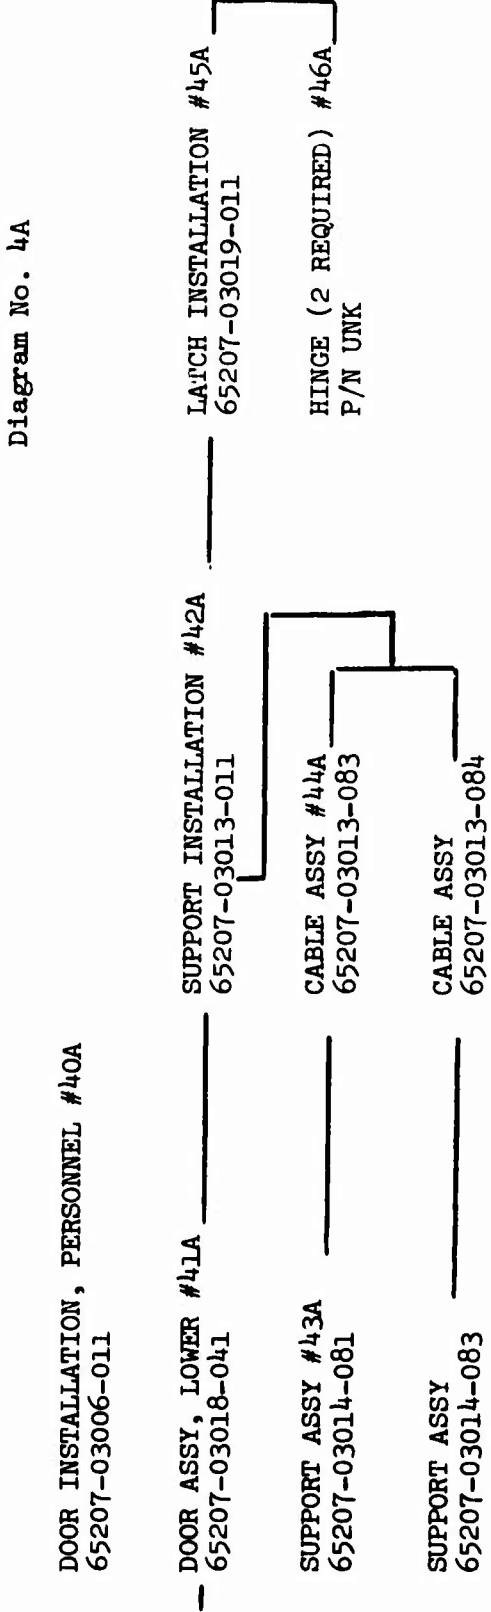
TABLE XXXIII. RELIABILITY LOGIC DIAGRAM - PERSONNEL DOOR

DUAL PIN LATCH
REDUNDANT SUPPORT ASSY

Probable Areas of Failure
