ARMY CONCEPT TEAM IN VIETNAM  
APO 96243

SUBJECT: Final Report of Cartridge, 40mm, WP,  
XM-574, ACTIV Project Number AAD 9/67

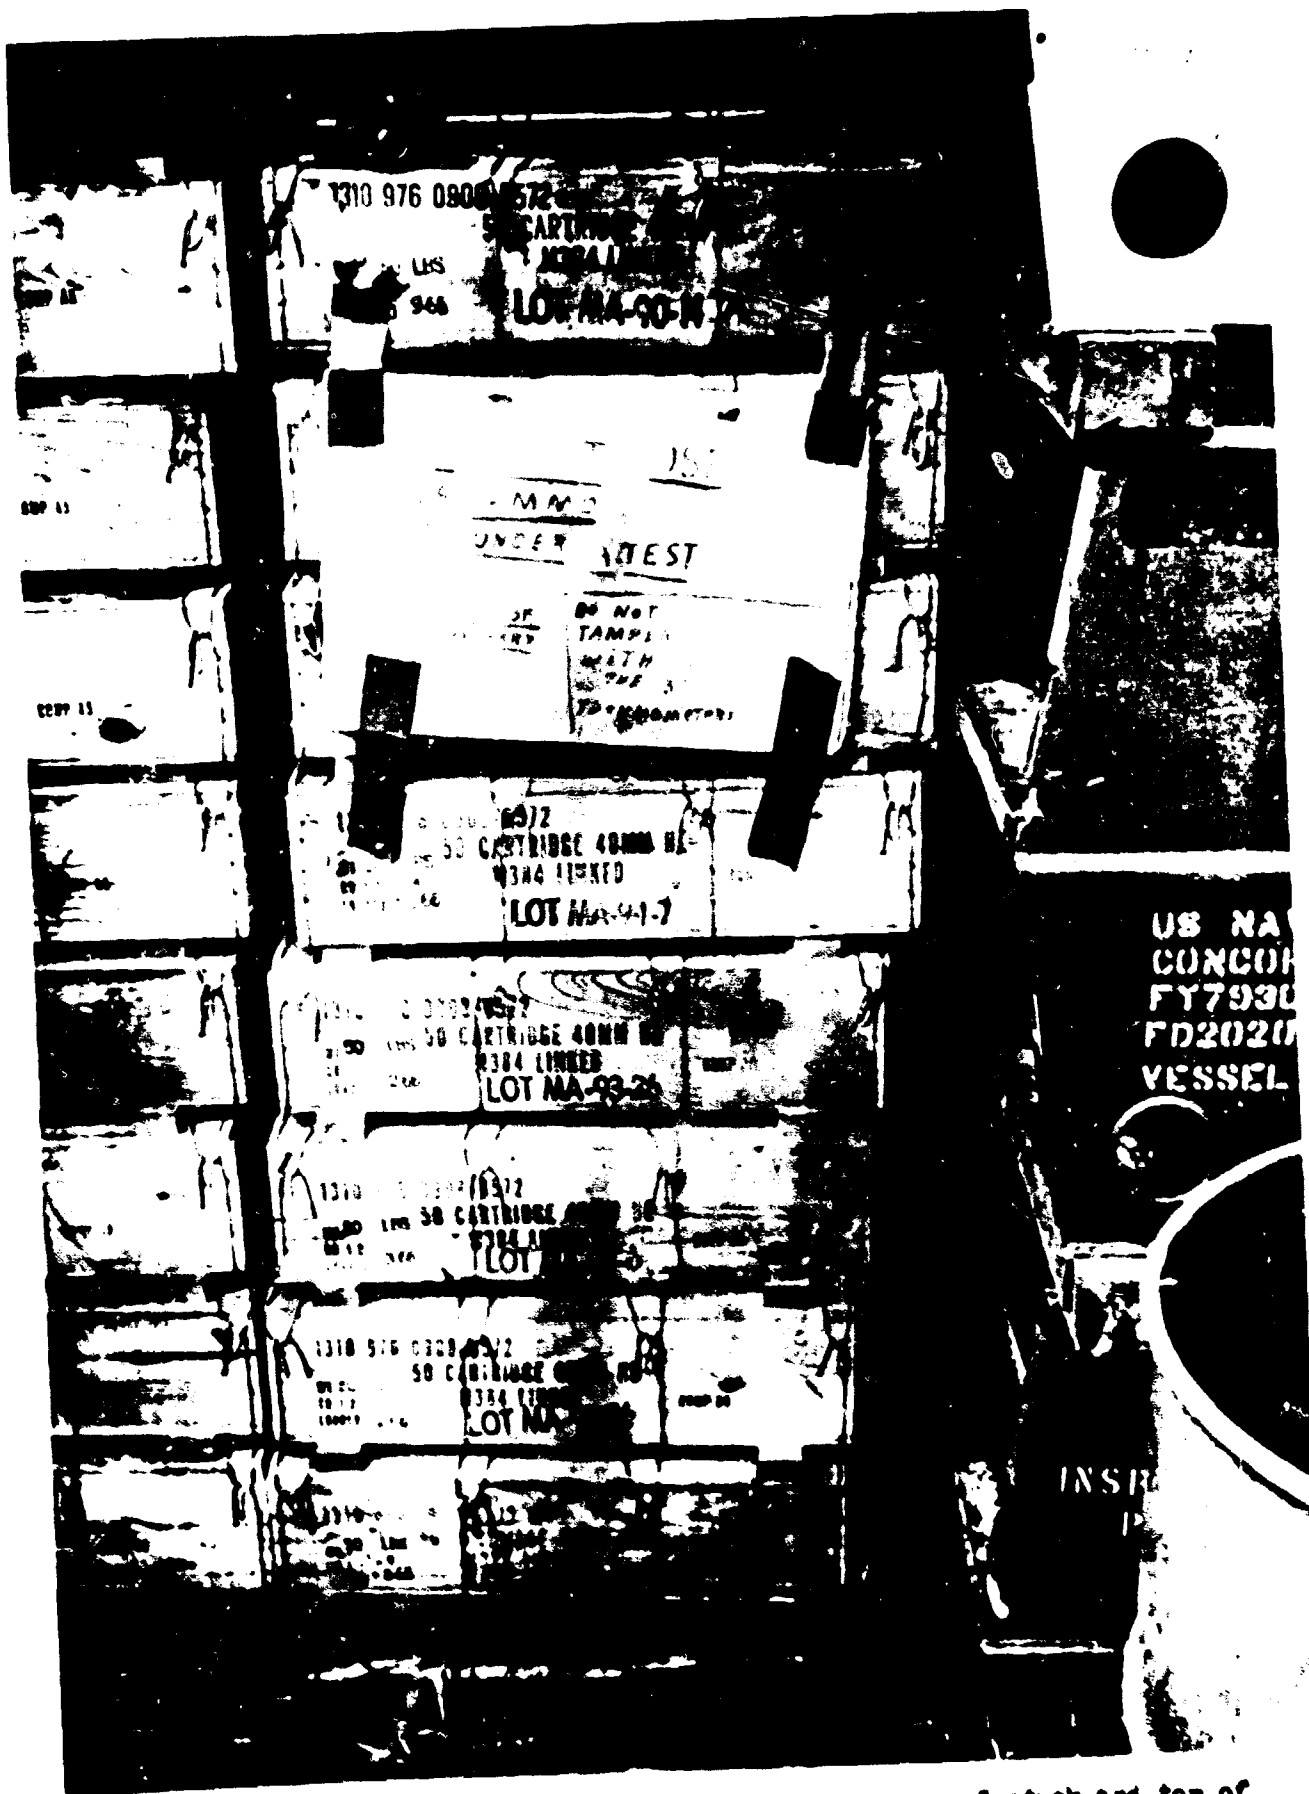
Thermometers located at bottom of stack, center of stack and top of stack in ammunition storage area. Early morning direct sun rays covered lower three boxes. Incl 14

point in the helicopter. A third thermometer was mounted within the M-5 turret at the gun feeder (Inclosures 10 and 11), the last point in the system where 40mm rounds are located prior to entering the gun breech and barrel. A fourth thermometer was mounted in the ammunition box where 40mm ammunition is stored when the gun system is loaded and mission ready (Inclosure 12.) The M-5 system was loaded with ammunition throughout the data collection period. In the ammunition storage areas (Inclosure 13) three thermometers were used. They were placed (as shown in Inclosure 14) on top of the stack, in the center of the stack, and approximately six inches above ground level at the bottom of the stack.

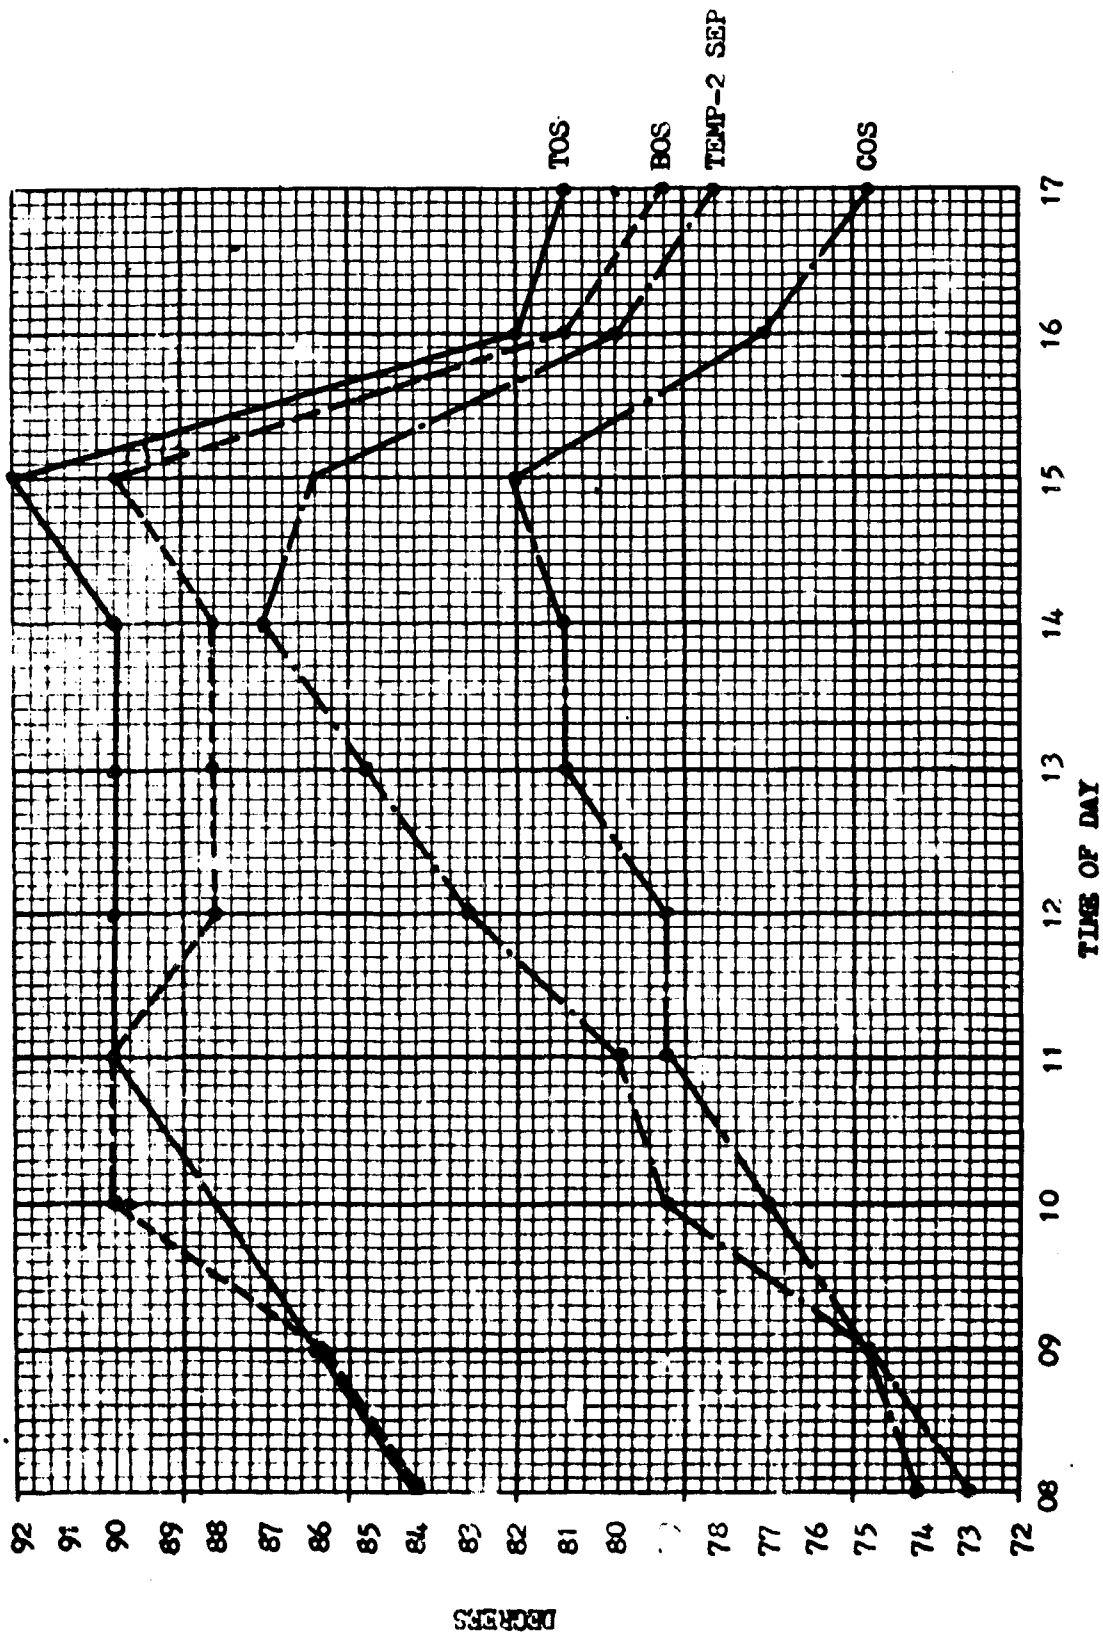
Ammunition Storage Area Temperatures, 29 Aug 66, Bien Hoa

Ammunition Storage Area Temperatures, 30 Aug 66, Bien Hoa      Incl 25

Ammunition Storage Area Temperatures, 28 Aug 66, TSN ASP Incl 26

Ammunition Storage Area Temperatures, 29 Aug 66, TSN ASP

Ammunition Storage Area Temperatures, 30 Aug 66, TSN ASF

Ammunition Storage Area Temperatures, 31 Aug 66, TSN ASP

Ammunition Storage Area Temperature, 1 Sep 66, TSN ASP  
Incl 30

Ammunition Storage Area Temperatures, 2 Sep 66, TSM ASP

Ammunition Storage Area Temperatures, 4 Sep 66, TSN ASP Incl 33

Ammunition Storage Area Temperatures, 5 Sep 66, TSN ASP Incl 34

Ammunition Storage Area Temperatures, 6 Sep 66, TSN ASP

Ammunition Storage Area Temperatures, 7 Sep 66, TSM ASP

Ammunition Storage Area Temperatures, 8 Sep 66, TSN ASP

g. Temperatures in stacks of 40mm ammunition in covered storage areas ranged from 4° F lower to 8° F higher than recorded free air temperatures. Ammunition in open storage (roof only) reached temperatures as much as 33° F higher than the free air temperature in places where direct sun rays entered the storage area. The critical temperature of 109° F was not reached in covered ammunition storage areas during this test period but, by extrapolation, the critical temperature might be reached whenever the free air temperature is 101° F or higher.
