**AIRCRAFT GROUND-FLOTATION INVESTIGATION**  
**PART XVI — DATA REPORT ON TEST SECTION 15**

*U. S. ARMY ENGINEER WATERWAYS EXPERIMENT STATION*

TECHNICAL REPORT AFFDL-66-43, PART XVI

SEPTEMBER 1966

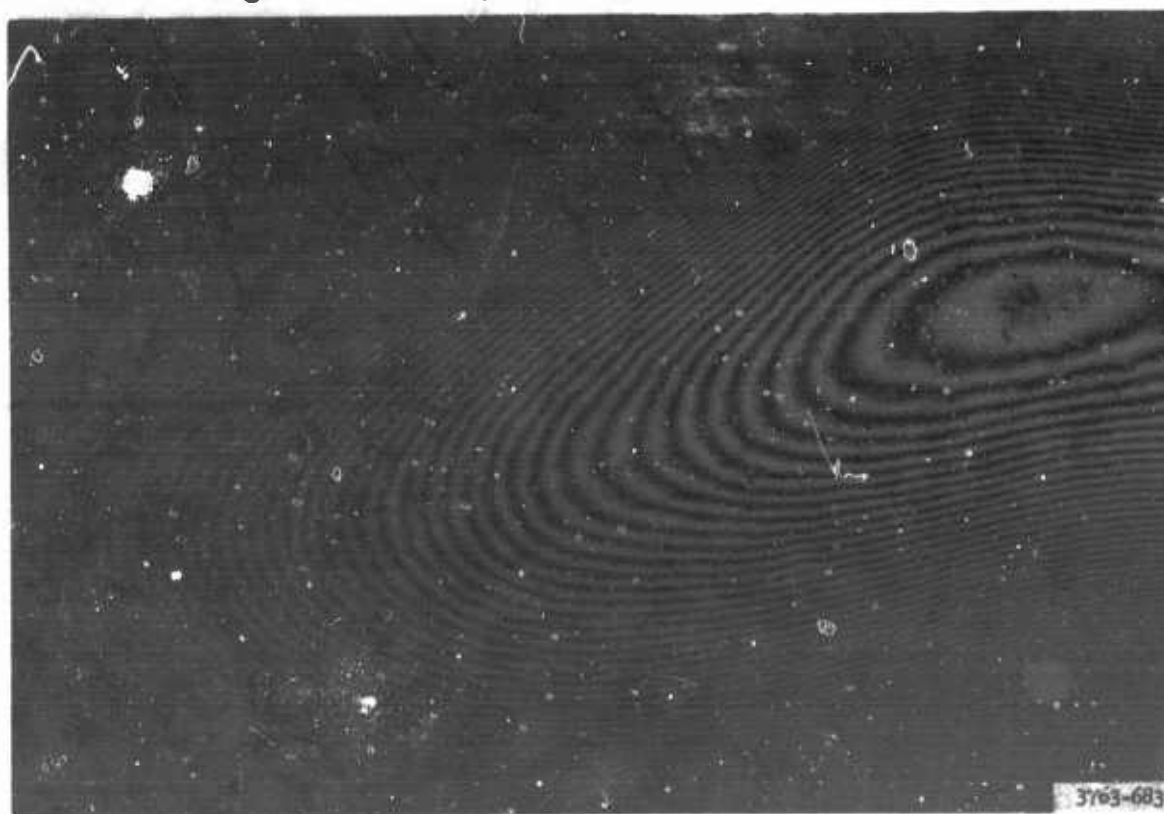
Figure 5. Item 2, lane 33, prior to traffic

Item 2. Item 2 prior to traffic is shown in figure 5. At 25 coverages, the item was considered failed due to roughness (figure 6). The rated CBR for the item was 4.4.

Item 2. Item 2 prior to traffic was similar in appearance to item 2, lane 33 (figure 5). At 49 coverages, the item was considered failed due to roughness (figure 10). The rated CBR for the item was 4.7.

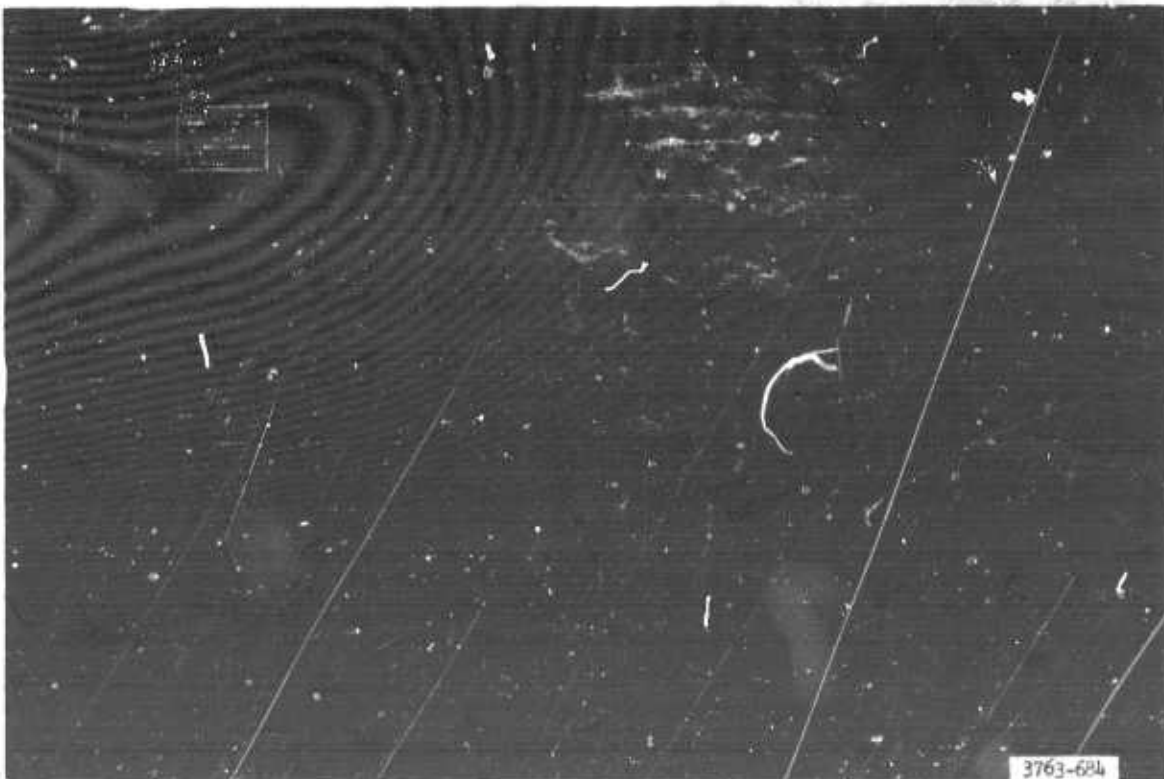
Figure 7. Item 3, lane 33, prior to traffic

Item 3. Item 3 prior to traffic is shown in figure 7. The surface held up well under traffic until 59 coverages when the item was considered failed due to excessive roughness (figure 8). The rated CBR for the item was 8.1. Data recorded on item 3 are considered unreliable due to an unexplained variation in tire inflation pressure.

Item 3. Item 3 prior to traffic was similar in appearance to item 3, lane 33 (figure 7). The item settled somewhat under traffic, but roughness was slow in developing. At 400 coverages the item was considered failed due to excessive roughness (figure 11). The rated CBR for the item was 7.0.
