TECHNICAL REPORT NO. 3-744

TRAFFICABILITY TESTS ON UNCONFINED ORGANIC TERRAIN (MUSKEG)

Report 1

SUMMER 1963 TESTS

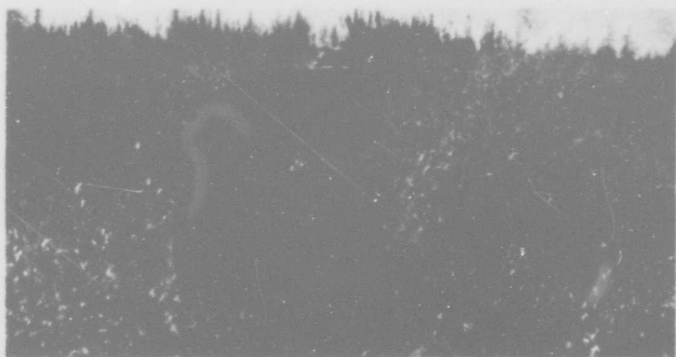
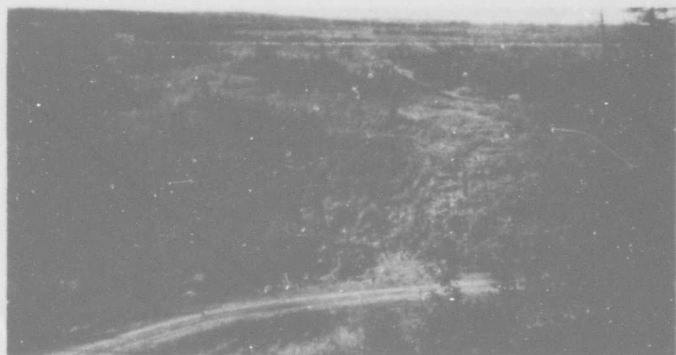
Fig. 4. A&A area
VTS-1

Fig. 5. Birch Hill area
VTS-1 in foreground;
looking toward VTS-9,
-10, and -11

species and cover density. Representative ground photos of portions of each area are shown in figs. 4 through 7.

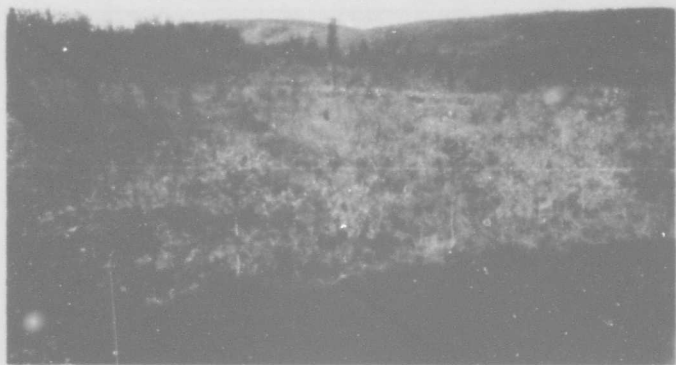
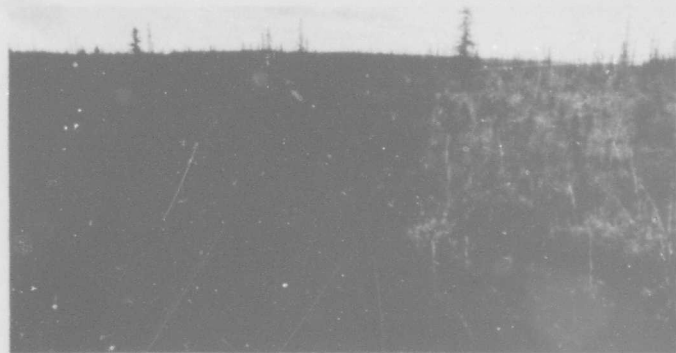
Fig. 6. Birch Hill area
VTS-2

Fig. 7. Birch Hill area
VTS-3

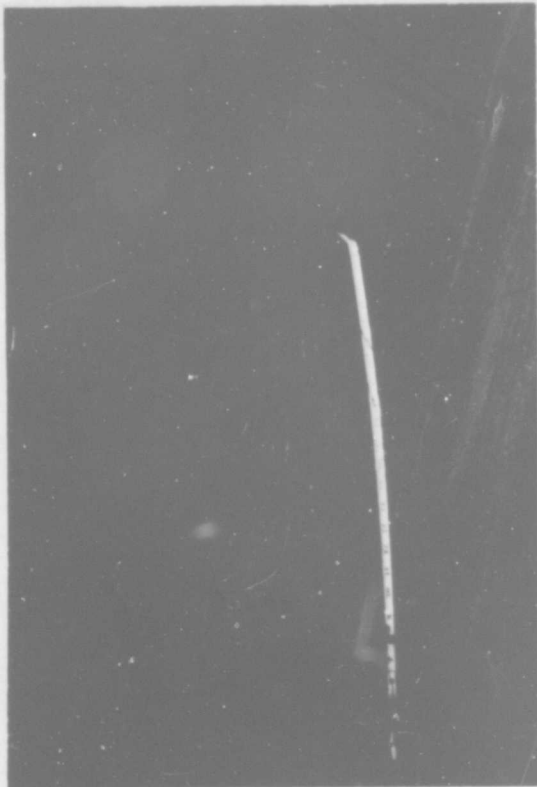
Fig. 8. Tussock

10. Tussocks. The most predominant topographic feature encountered was tussocks. In the areas studied, this feature resulted from the growth habit of cottongrass. The plants (fig. 8) have a tufted top and vertical sides and occur in patches. Sometimes the plants are close enough together for a man to walk on or for a vehicle to ride on, but at other times they are spaced far enough apart to make walking on them difficult to impossible. The tussocks encountered during this program were relatively firm and usually ranged in height from 5 to 15 in.; however, a few plants as high as 30 in. were seen.

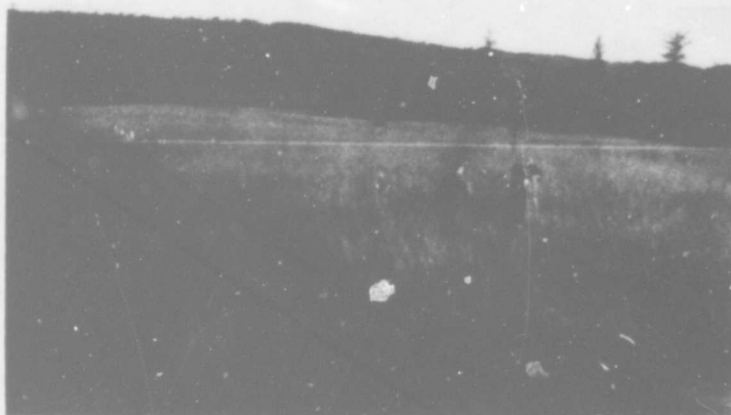
Fig. 9. Depression

12. Depressions. Another topographic feature encountered was depressions (fig. 9). These normally contained water and supported vegetation different from that surrounding them. Depressions examined ranged in

size from about 25 by 50 ft (A&A area, site 2) to about 500 ft in diameter (Birch Hill area, site 7).

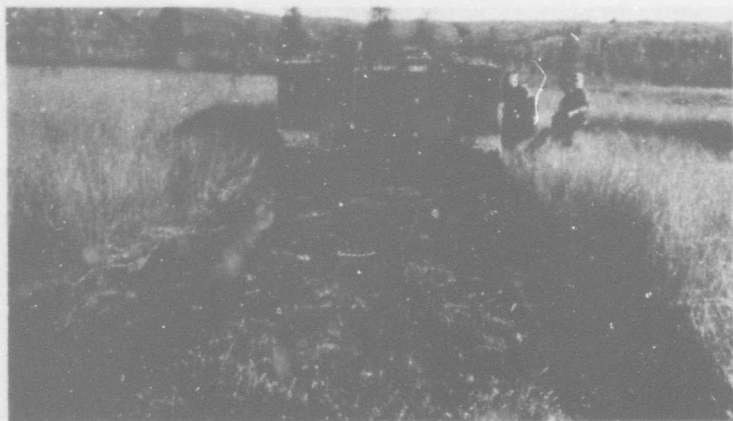
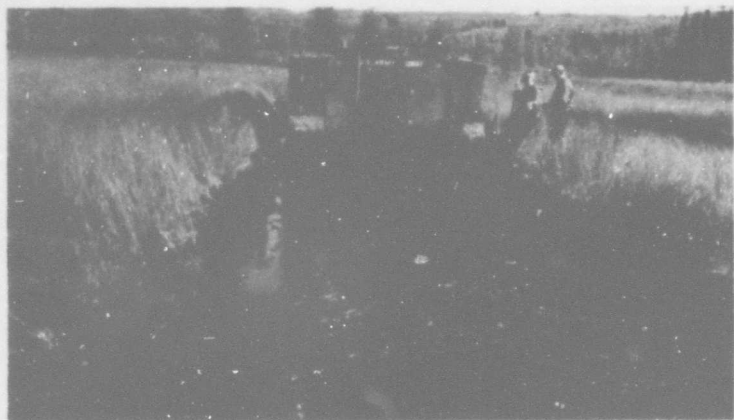
Fig. 15. M59 armored personnel carrier, test 21

a. After 10 passes

b. After 20 passes

c. Immobilized on 39th
pass

31. M59 armored personnel carrier. Data plots of the M59 tests are shown in fig. b of plate 1. Thirteen tests were run; three tests (20, 21, and 25) resulted in immobilizations on the 17th, 39th, and 11th passes, respectively, and one test (5A) resulted in the vehicle experiencing difficulty (high track slip) on the 8th through 10th passes until it moved enough muskeg out of the ruts for the tracks to reach permafrost. Fig. 15 shows the M59 at various intervals during test 21.

32. The go-no go line shown for the M59 in plate 1 ignores the fact that test 3 was a go test, i.e. considers that test 3 was an anomaly. (Such anomalies are not rare in the admittedly incomplete type of analysis made herein.) There is justification for considering test 3 an anomaly since the vehicle completed 20 passes at a cone index less than and depth to permafrost greater than two of the tests (20 and 25) in which the vehicle became immobilized. However, it should be noted that test 3 was conducted in an area flooded with about 9 in. of water. As the vehicle moved in the test lane, the relatively firm muskeg was mixed with the water to develop an almost liquid mass. The rut development was rapid and was further aided by large waves of liquid material that were removed from the test lane each time the vehicle reached the end of a pass. By the fifth

pass, the ruts were already 23 in. deep, and the vehicle was traveling within 13 in. of the permafrost, apparently close enough to benefit therefrom.

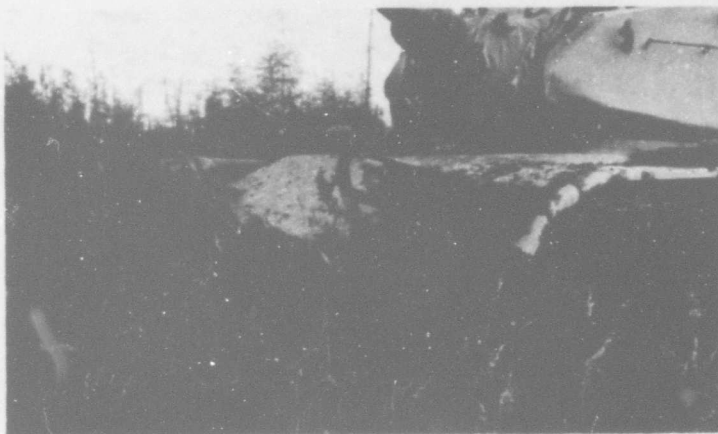
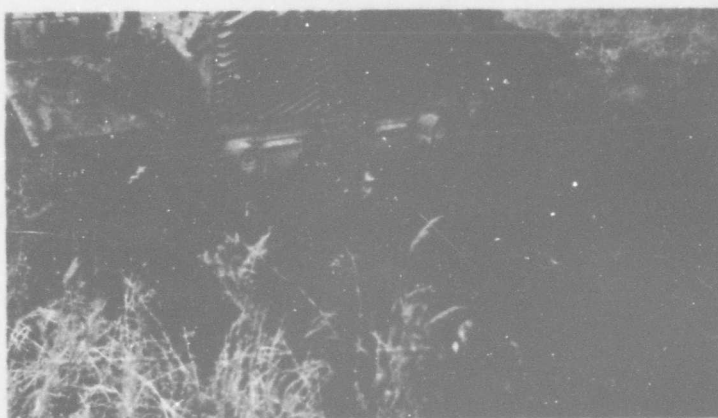
a. Front view showing buildup of vegetation

b. Rear view showing sheared area between tracks

Fig. 17. M60A1 immobilized on first pass by buildup of vegetation in front of vehicle, test 9

39. Scenes illustrating the effect of rutting on two M60A1 tests are shown in figs. 17 and 18. In fig. 17 front and rear views of the M60A1 immobilized on the first pass in test 9 show the effects of deep rutting on early passes. Vegetation is sheared by the underbelly of the vehicle and piled up in front,

thereby causing a halt in forward progress. In this test the vehicle was able to back up and continue traffic in the initial part of the test lane while riding on permafrost. In a similar test (test 8), the vehicle was unable to back over the pile of muskeg accumulated at the end of the test lane (fig. 18a) but was able to go forward and, with a series of back-and-forth movements, turn completely around (fig. 18b) and then go out of the test lane at a slight angle (fig. 18c). The vehicle was riding on permafrost for most of this operation.

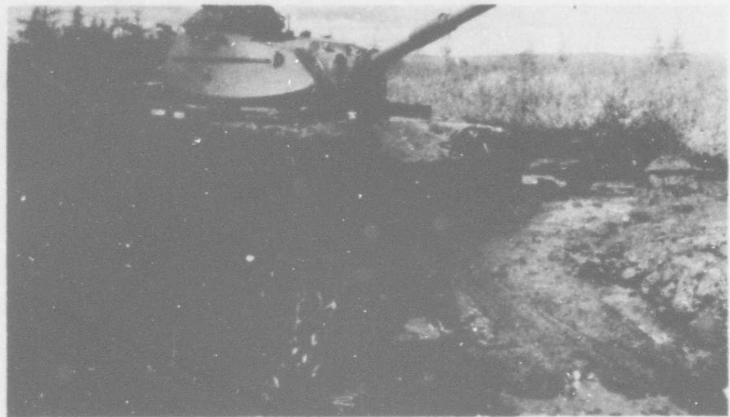
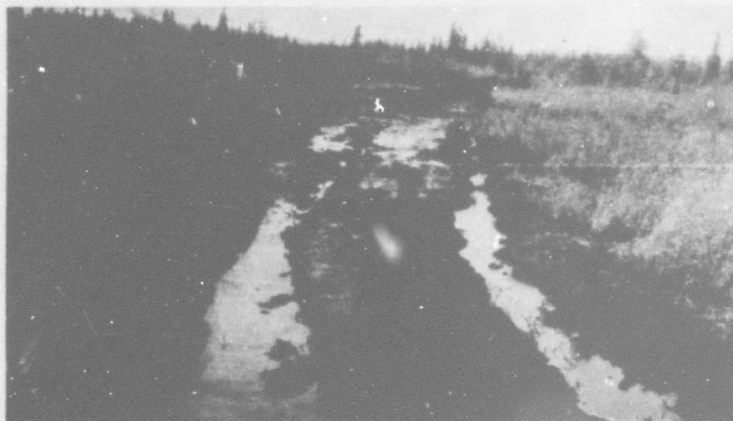
Fig. 18. M60A1, test 8

a. Immobilization in reverse, on pile of muskeg

b. Turning around by series of back-and-forth movements

c. Test lane after M60A1 departed at a slight angle to original lane

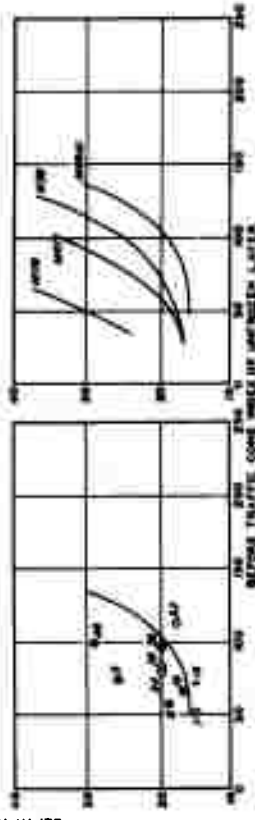
NOTE: NUMBER NEAR NUMBER IS TEST NUMBER.
 20 TO 30-IN. LAYER WAS CRITICAL LAYER FOR 1015 AND 1016. 10-IN. LAYER WAS CRITICAL LAYER FOR OTHER 3 VEHICLES.

EFFECTS OF CONE INDEX OF UNFROZEN LAYER AND DEPTH TO PERMAFROST ON VEHICLE PERFORMANCE

41. Cone index of the unfrozen layer is plotted against depth to permafrost in plate 2 for all vehicle tests. Segments of performance curves were drawn using the hypothesis described in paragraphs 24 and 25. In this plate it may be seen that the curves have similar shape and position with respect to vehicles as those in plate 1, except that the M41 and M59 have distinct curves. Fig. e, plate 2, indicates that the M41 is able to perform on weaker and deeper muskeg than the M59. If the hypothesis holds for extremely weak and deep muskeg, the M59 will perform better under such conditions than the M41 since the M59 is amphibious and the M41 is not.
