STUDY OF STRESS-CORROSION CRACKING  
OF ALUMINUM ALLOYS

Final Report

Rocketdyne  
A Division of North American Aviation, Inc.  
Canoga Park, California

R-7026

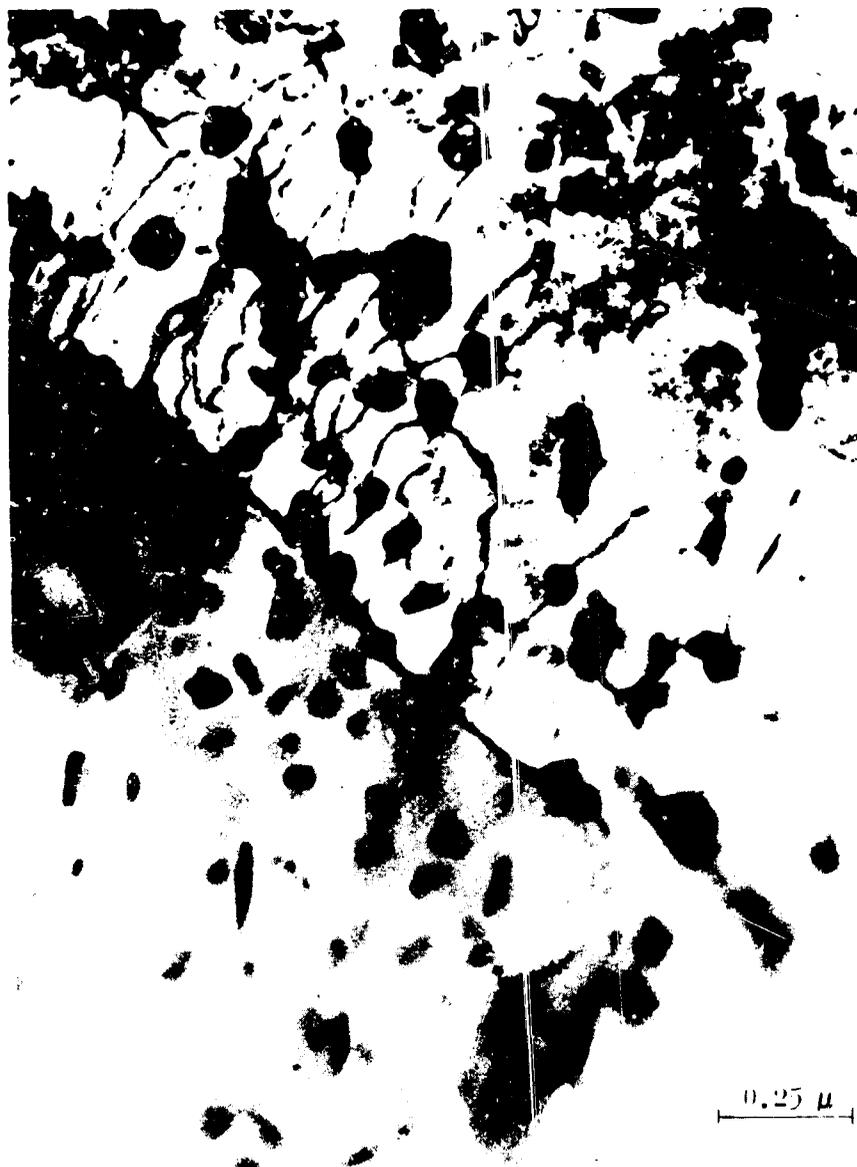
Figure 1. Transmission Electron Micrograph of 7075-T6 Specimen Showing Close Association of Dislocations and Grain Boundary Precipitates.

Thin film microscopy disclosed no differences between the grain boundaries in -T6 and -T73 specimens, other than the close association of dislocations with precipitates in -T6 specimens (Fig. 1) which was not in evidence in -T73 specimens (Ref. 1). The composition of the grain boundary precipitates in the two tempers was shown to be the same, viz.,  $MgZn_2$ , through the use of selected area diffraction and dark field techniques, and the precipitate morphologies and sizes were also similar. A corrosion study of unstressed -T6 and -T73 specimens in an aqueous 3-12 percent NaCl solution indicated that the main corrosion process is identical in the two conditions. This process consists of the dissolution of the grain boundary precipitates,<sup>(2)</sup> which thus act as anodes.

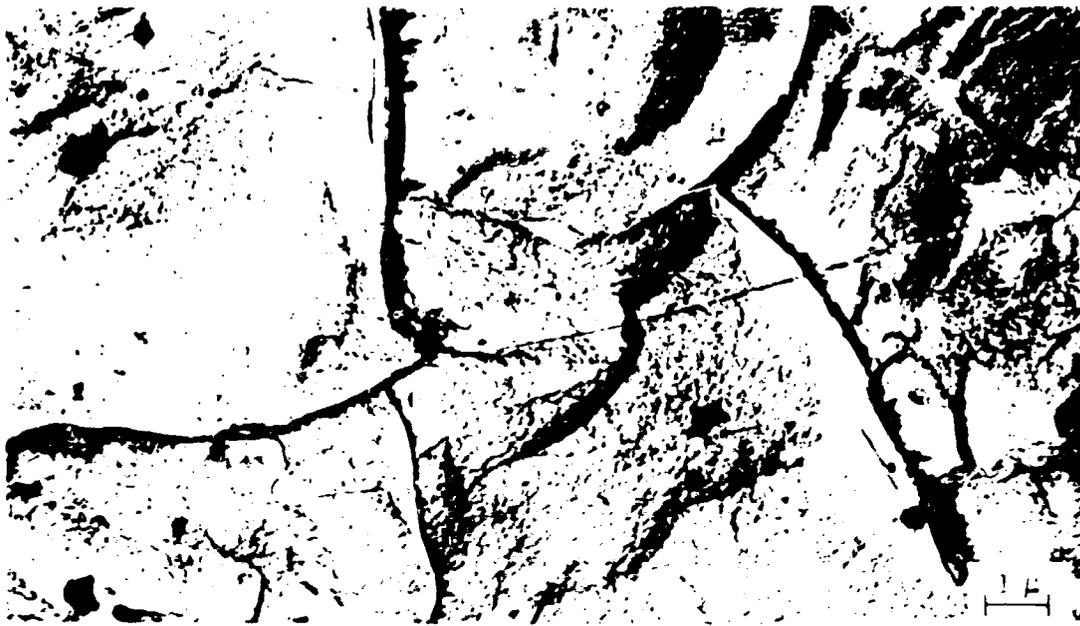
Figure 12a. Intergranular Fracture Typical of Stress-Corrosion Phase of Failure in a Notched 7075-T73 Specimen. (Note corrosion product in rough-textured area.)

The fractographs showed that the fracture surfaces in the dark areas were almost entirely intergranular in nature, while those in the light areas were predominantly transgranular (Fig. 12). Quite severe corrosion had taken place in the dark areas, and the products of the corrosion reaction were considerably more abundant in these areas than in the light areas.

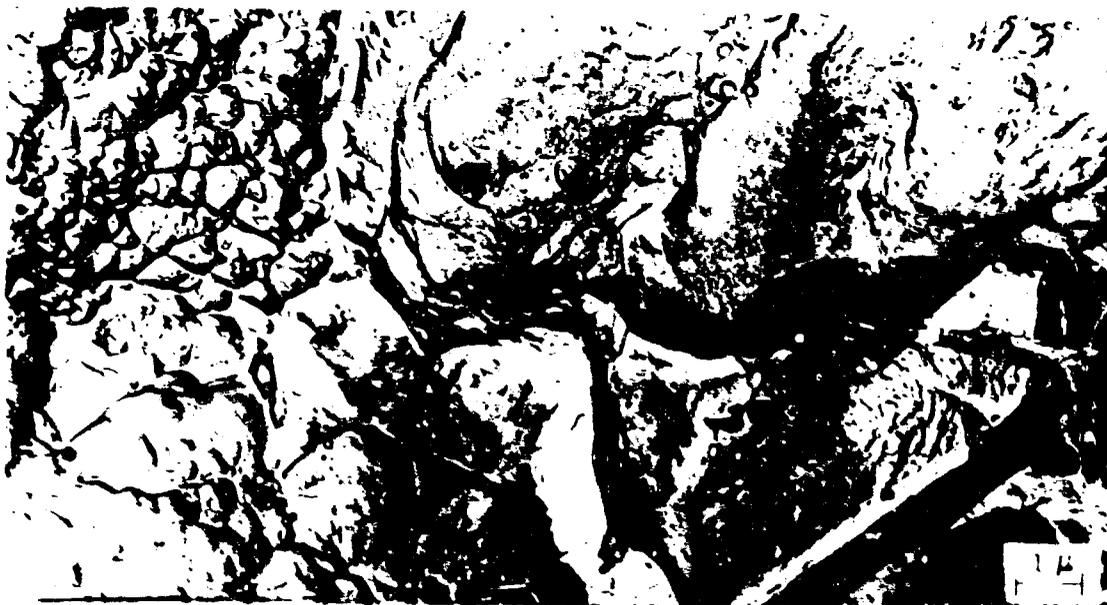
Figure 15b. Fractograph of a Notched 7075-T6 Tensile Specimen Showing Less Extensive Dimpling Than in Unnotched -T6 Specimen

The fractographs obtained from the tested tensile specimens revealed approximately what was expected: a predominantly dimpled, transgranular appearance, with the extent of dimpling being smaller in the notched than in the unnotched specimens (Fig. 15 and 16). Occasionally, the fracture was observed to be intergranular (Fig. 15b, 16b, and 17).

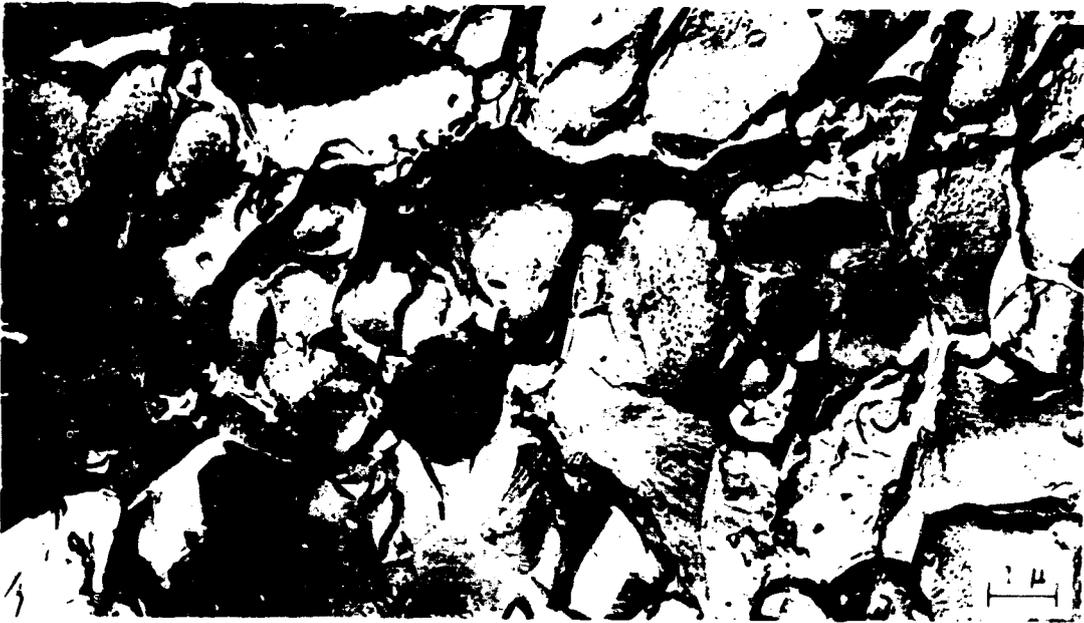
Figure 17. Intergranular Fracture in an Unnotched 7075-T6 Tensile Specimen
