Technical Note N-886

ROTECTION OF FLOATING PONTOONS FROM CORROSION -- PART I. INSTALLATION AND INITIAL PERFORMANCE OF TEST FLOATS by Richard W. Drisko, Ph. D. 17 April 1967

U. S. NAVAL CIVIL ENGINEERING LABORATORY Port Hueneme, California

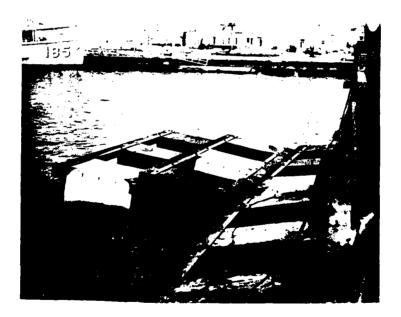
Figure 6. Test pontoon floats in storage available for use by the fleet.

The three test camel floats were placed in the storage area (Figure 6) along with other such floats available for fleet use. These floats are being used extensively by the fleet (Figure 7) receiving the type of service for which they were designed. In such use, they accumulate a film of oil at the water line from floating oil in the harbor and an accumulation of miscellaneous debris dumped over the side of the moored vessels (see Figure 7). Nevertheless, the three coating systems have provided excellent service with no apparent damage after six months of service to the fleet. The tops of the pontoons were cleaned with sea water and a stiff bristle brush before examining the coating.
