CRACK GROWTH PROPERTIES OF WELDS

IN HY-80, HY-100 AND HY-130/150

HIGH STRENGTH STEELS

Technical Memorandum #39
Task 0722

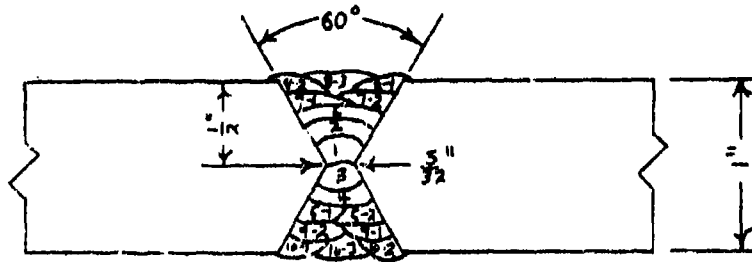
Specimen No.: 85B1
Base Metal: HY-80
Electrode: MIL-11018, 5/32" dia.
Preheat: 200°F
Interpass Temperature: 200-300°F
Current & Polarity: Direct current, reversed polarity
Position: Flat
Heat Input: 45,000 joules/inch

Remarks: Block technique used on first two layers.
Root ground before depositing third layer.

FIGURE 1 - Details of Joint Design and Welding Procedure of 22x20x1 in. HY-80 Butt Welded Plate Type Specimen

b. One 22x20x1 inch HY-80 plate type specimen with a central longitudinal butt weld. Details of the joint design and welding procedure are shown on Figure 1.

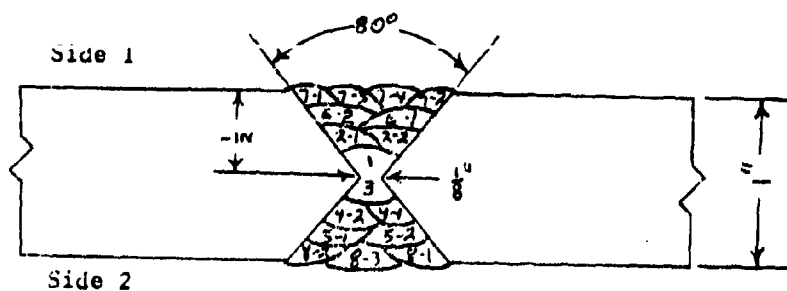
Specimen No.:	83B1
Base Metal:	5% Ni HY-130/150, U.S.S. Heat No. X53588, Plate No. 090339
Weld Metal:	Code A, 1/16" dia.
Process:	Metal Inert Gas - Spray Transfer
Shielding Gas:	99% Argon, 1% Oxygen at 50 CFH
Preheat & Interpass Temp:	250 - 300°F
Current & Polarity:	Direct Current, Reversed Polarity 320 - 350 Amps, 30 Volts
Position:	Flat
Heat Input:	45,000 joules/inch
<u>Remarks:</u>	Grind root before depositing third layer.

FIGURE 2 - Details of Joint Design and Welding Procedure of 22x20x1 in 5 percent Ni HY-130/150 Butt Welded Plate Type Specimen

c. One 22x20x1 inch 5 percent Ni HY-130/150 plate type specimen with a central longitudinal butt weld. Details of the joint design and welding procedure are shown on Figure 2. Visual examination of the 2 butt welded plates prior to testing revealed no surface cracks at the toe of the weld.

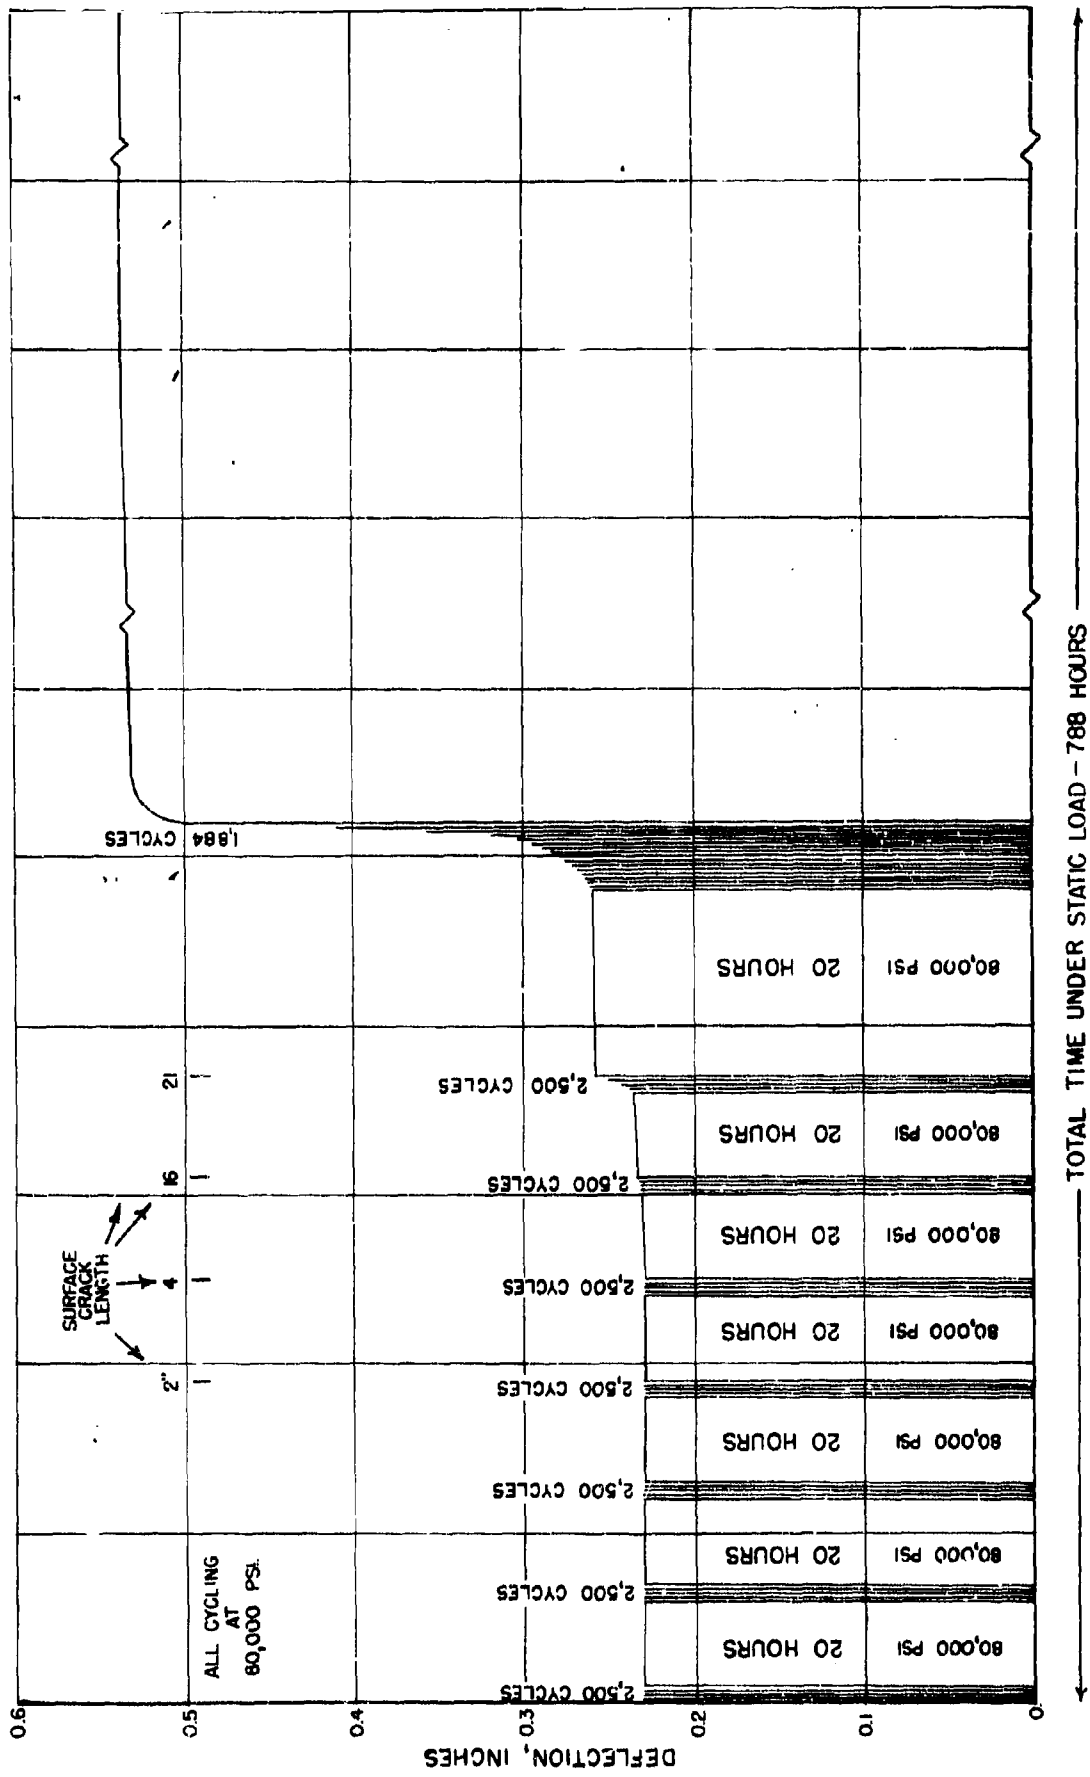
FIGURE 3 - STRESS CORROSION OF HY-80 STEEL - BUTT WELDED

(SALT WATER ENVIRONMENT)

b. The HY-80 butt welded specimen was subjected to cyclical and static loadings in a smaller Plate Fatigue Machine. The plate was simply supported along the 22-inch edges at a span of 20 inches, free along the two short edges and uniformly loaded over the entire surface. The number of cycles, the number of hours under static load, and the stress levels that the plate was subjected to are indicated graphically on Figure 3.

9. Stress corrosion data obtained on the HY-80 butt welded plate type specimen under a sea water environment are listed in Table 1 and shown graphically on Figure 3. The specimen did not show any marked increase in deflection as a result of cracking until after 15,000 cycles of zero to 80,000 psi stress and 120 hours under a static stress of 80,000 psi. At 19,384 cycles the deflection exceeded a 100 percent increase over the initial deflection and during a continuation of the test under static loading the deflection showed a negligible increase up to 580 hours and no increase from 580 to 788 hours at which time the test was stopped.

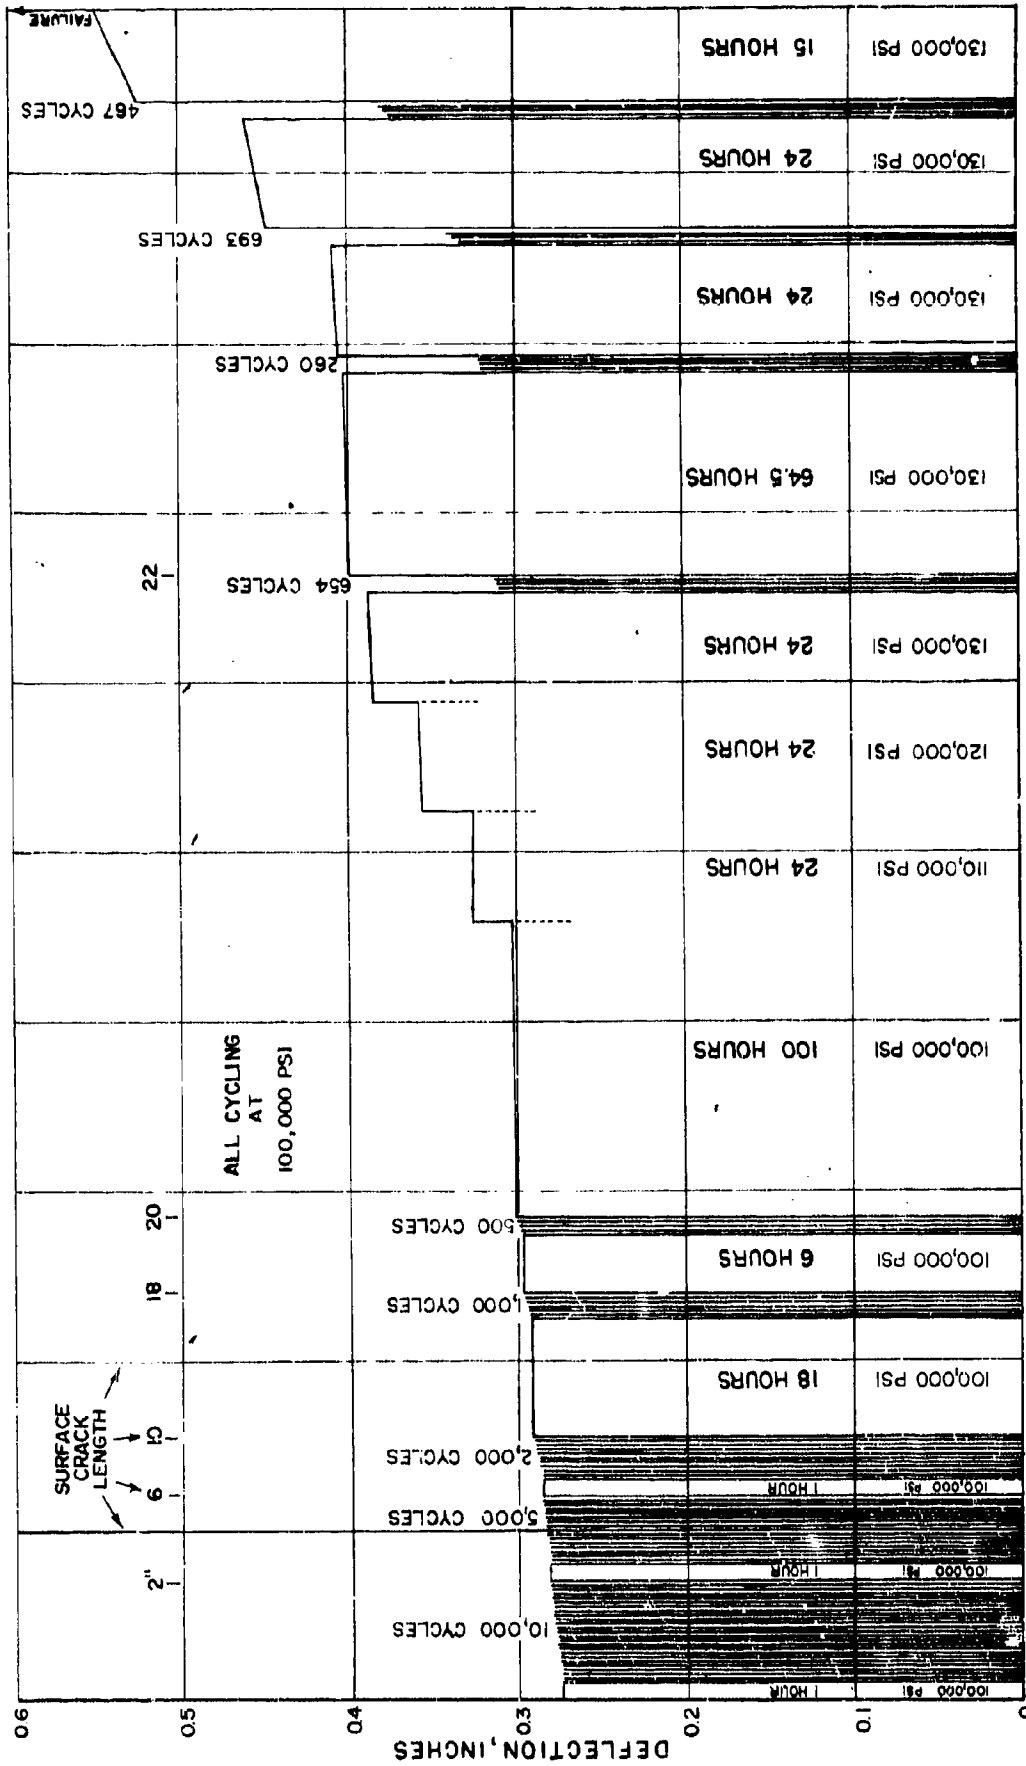
FIGURE 4 - STRESS CORROSION OF 5% Ni HY-130/150 STEEL - BUTT WELDED
 (SALT WATER ENVIRONMENT)

TOTAL TIME UNDER STATIC LOAD - 326.5 HOURS

c. The HY-130/150 butt welded specimen was subjected to a similar procedure as the HY-80 butt welded specimen. The number of cycles, the number of hours under static load, and the stress levels that the plate was subjected to are indicated graphically on Figure 4.

10. Stress corrosion data obtained on the HY-130/150 butt-welded plate type specimen in a sea water environment are also listed in Table 1 and shown graphically on Figure 4. Since only one specimen was available the data shown plotted on Figure 4 are the result of a combination of cyclical and static loadings in order to obtain maximum data from the specimen. It will be noted that all cycling was conducted at 100,000 psi and that the static load was increased so as to raise the stress level from 100,000 psi to 130,000 psi and cause more rapid crack propagation. This occurred only after the increase in deflection over the initial deflection was 100 percent which is usually considered ultimate failure in the cyclical test. It will be observed from Figure 4 that

after the surface crack length reached 22 inches (the total length of the weld), the specimen sustained 1420 cycles of stress at 100,000 psi and 127.5 hours under a nominal static stress of 130,000 psi before ultimate failure occurred. Figure 8 is a photo of the cracked plate after the stress corrosion test.

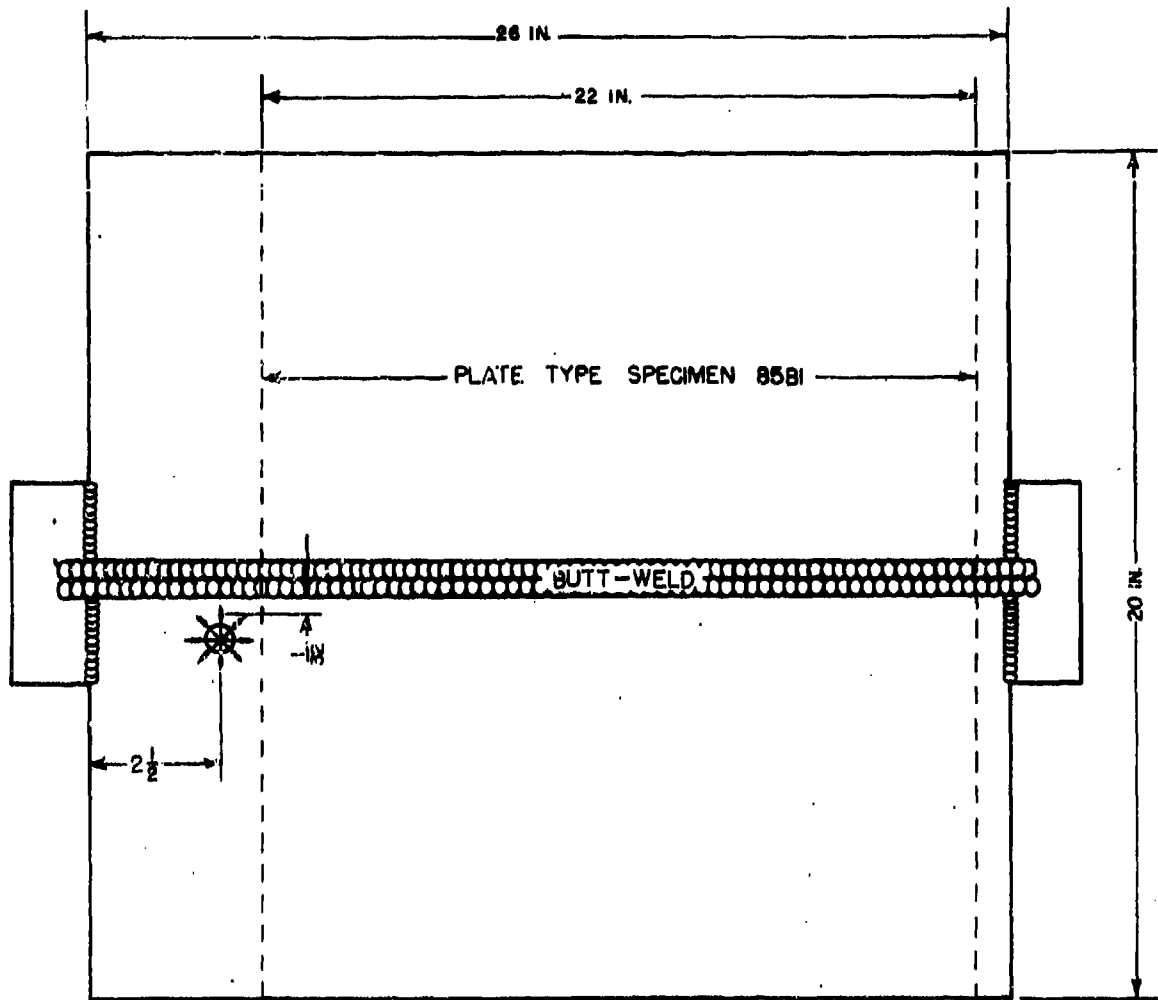
HOLE DIA. 7/16 IN.
 HOLE DEPTH 7/16 IN.
 GAGE CIRCLE DIA 5/8 IN.
 C6-IXIM50A STRAIN GAGES
 0.080 GAGE LENGTH

MEASURED RADIAL
 RELAXATION STRAINS
 IN MICROINCHES

FIGURE 6-HOLE LAYOUT FOR RESIDUAL STRESS MEASUREMENTS IN BUTT-WELDED 1 IN. HY 80 PLATE

11. Relaxation strains shown on Figure 6 for the HY-80 butt weld indicate compressive residual stresses in the plate away from the butt weld which rise to relatively high tensile stresses at the toe of the weld. Based on a linearly varying residual stress distribution, and following the procedures of reference (e), residual stresses at the toe of the weld were calculated to be 140,000 psi tension parallel to the weld and 47,000 psi tension transverse to the weld. Since the yield strength of the steel is approximately 80,000 psi the high value of 140,000 is not considered truly representative but the indications are that the true residual stress is at least equal to the yield strength. It should also be noted from Figure 6 that the hole was drilled 2-1/2 inches from the edge of the plate to which a run-off tab was attached. Thus, while the residual stresses measured do not represent precise determinations, they do indicate that the butt weld subjected to stress corrosion studies did contain high residual stresses at the weld.

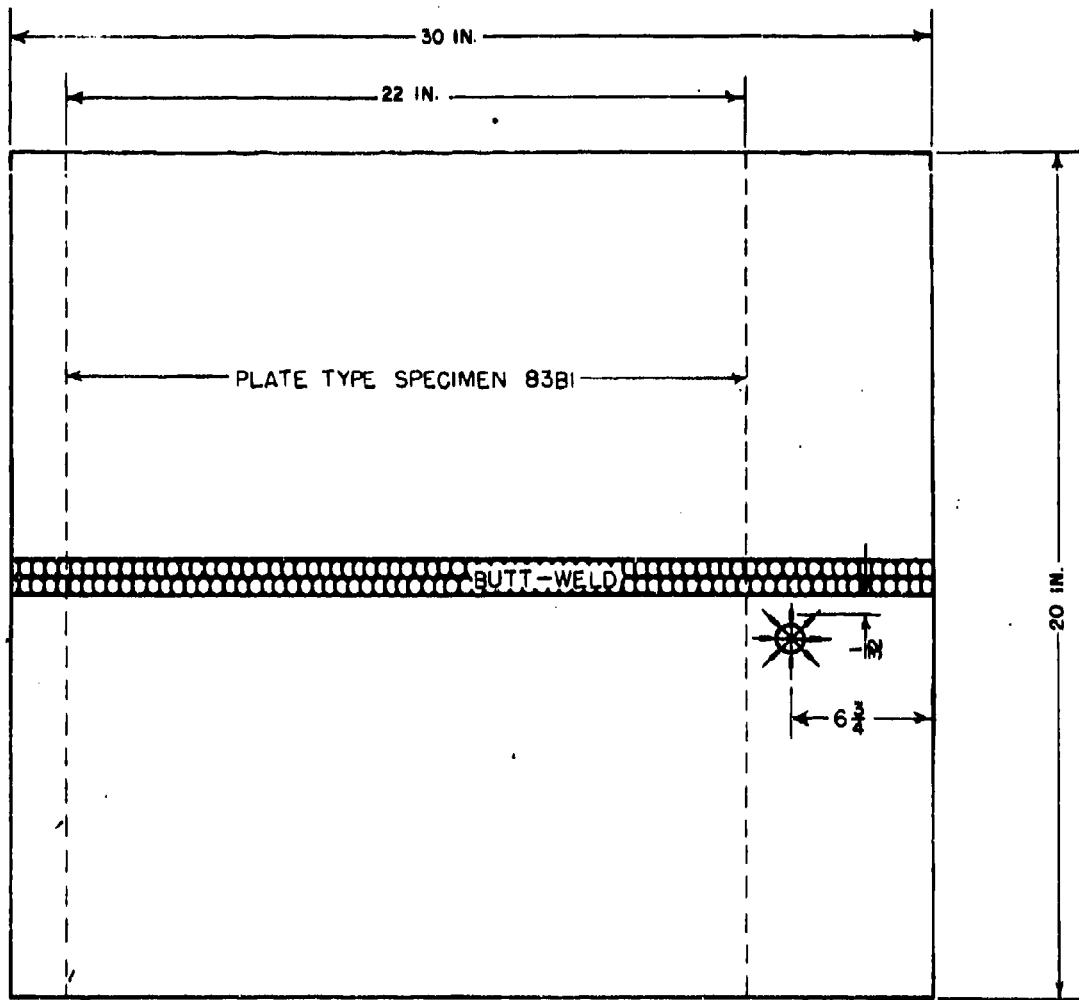
HOLE DIA. 7/16 IN.
 HOLE DEPTH 7/16 IN.
 GAGE CIRCLE DIA. 5/8 IN.
 C6-1X1M50A STRAIN GAGES
 0.050 GAGE LENGTH

MEASURED RADIAL
 RELAXATION STRAINS
 IN MICROINCHES

FIGURE 7 - HOLE LAYOUT FOR RESIDUAL STRESS MEASUREMENTS IN
 BUTT-WELDED 1 IN. HY 130/150 PLATE

12. Figure 7 shows a fairly irregular pattern of residual strain distribution for the HY-130/150 butt welded plate. Following the procedures of reference (e) the residual stresses at the toe of the weld were calculated to be 24,800 psi compression transverse to the weld and 11,800 psi tension parallel to the weld. These apparent irregular results have been noted in other measurements on butt welds and indicate that further study is required on residual stresses in butt welds and the effect of welding sequence and procedures on the magnitude and distribution of these stresses. The residual stress measurements on the HY-130/150 specimen indicate that the butt weld subjected to stress corrosion tests contained relatively low surface residual stresses.
