# Technical Report

Corrosion and Stress Corrosion of  
HY-130(T) Steel and HY-80 Steel  
in Marine Environments

Applied Research Laboratory  
United States Steel

July 15, 1967

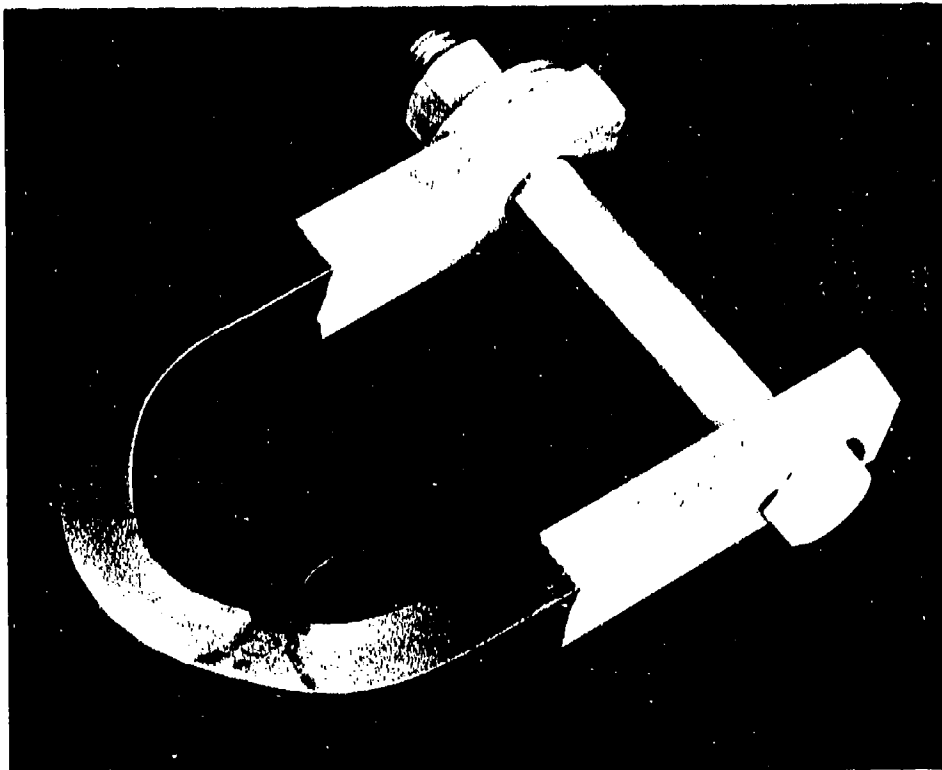
Figure 3. U-bend stress-corrosion specimen  
machined from welded plate.  
Approximately 1/2 actual size.

The specimens were then stressed by bending them over a 2.5-inch-diameter mandrel until the specimen legs were parallel. A bolt was inserted through holes in the specimen ends, and a nut was tightened until all stress was borne by the bolt. This procedure stressed the outer fibers of the U-bend specimens well beyond the 0.2-percent offset yield strength. The nominal strain on the outer fibers was 16.5 percent. Figure 3 shows a stressed welded U-bend specimen. To prevent galvanic action between the

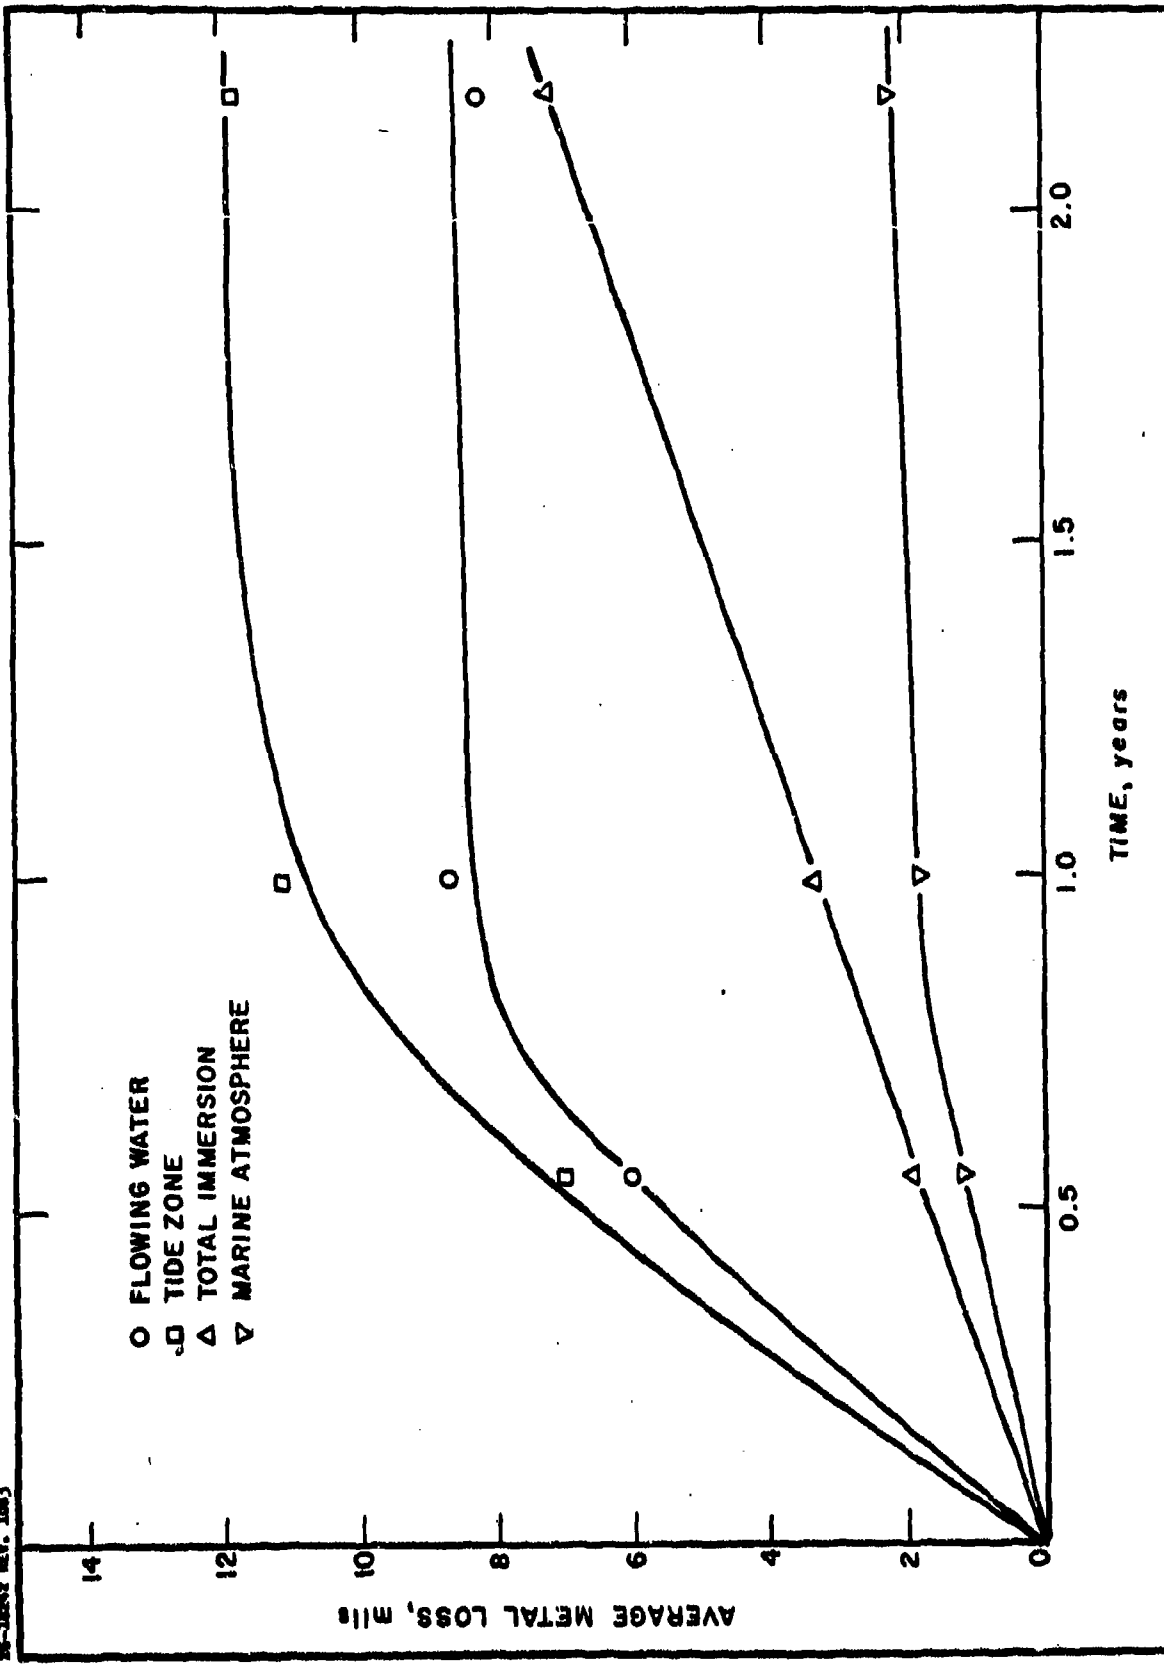
**CORROSION OF HY-80 STEEL IN MARINE ENVIRONMENTS**

The results obtained from plain-plate HY-80 steel specimens are given in Figure 4. The corrosion rate of this steel decreased during the 2-year exposure in the tide zone, in flowing sea water, and in marine atmosphere. The initial corrosion rates of about 13 mils per year (mpy) in the

tide zone, about 11 mpy in flowing sea water, and about 2 mpy in the marine atmosphere decreased appreciably after about one year of exposure. During the second year of exposure the corrosion rates were about 0.7 mpy in the tide zone, 0.2 mpy in flowing sea water, and 0.3 mpy in the atmosphere. In the total-immersion exposure the corrosion rate remained essentially constant at about 3 mils per year. The gradually decreasing corrosion rates, in all exposure conditions except total immersion, indicate that the rust films were becoming protective.

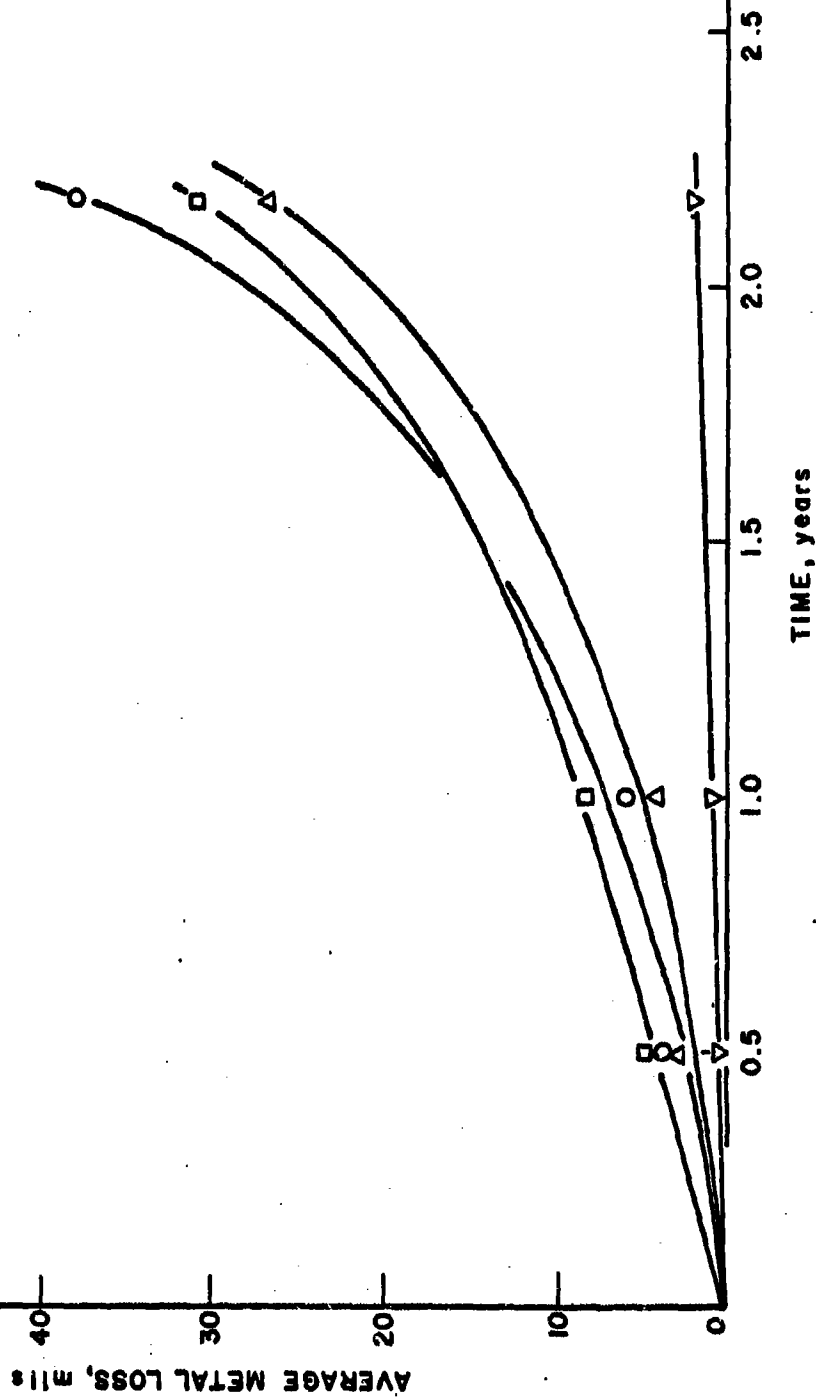
# BASE-METAL CORROSION OF HY-80 STEEL WELDMENTS IN MARINE ENVIRONMENTS

The corrosion behavior of welded HY-80 steel specimens is given in Figures 5, 6, and 7 for the base metal, heat-affected zone, and weld-metal, respectively. In all sea-water environments the weldments were corroded most in the weld metal and in the base metal, and considerably less in the weld heat-affected zone. In the marine atmosphere the corrosion rates were approximately equal (1.0 to 1.5 mpy) in the three areas of the specimens and did not change appreciably during the two-year exposure period. In the sea-water environments the corrosion rates of base metal and weld metal were about 5 to 10 mpy for the first year of exposure but increased to about 30 to 50 mpy in the second year. In the heat-affected zone the corrosion rates remained essentially constant at about 5 to 10 mpy during the two-year exposure period. The increase in corrosion rate of the base metal is inconsistent with the corrosion behavior of plain-plate specimens. The cause of this anomaly has not been established, but this behavior is believed to be

related to the presence of a galvanic cell consisting of the base metal and weld metal as the anodes, and the heat-affected zone as the cathode. It is conceivable that marine fouling on the surface of the specimen prevented dilution of the acid anolyte which, in turn, caused the increase of corrosion rate. As will be shown later, the corrosion rates of HY-130(T) weldments did not increase with time. Furthermore, it was determined in an earlier ARL study<sup>3)</sup> that the various areas of the HY-130(T) steel weldments did not constitute a strong galvanic cell.

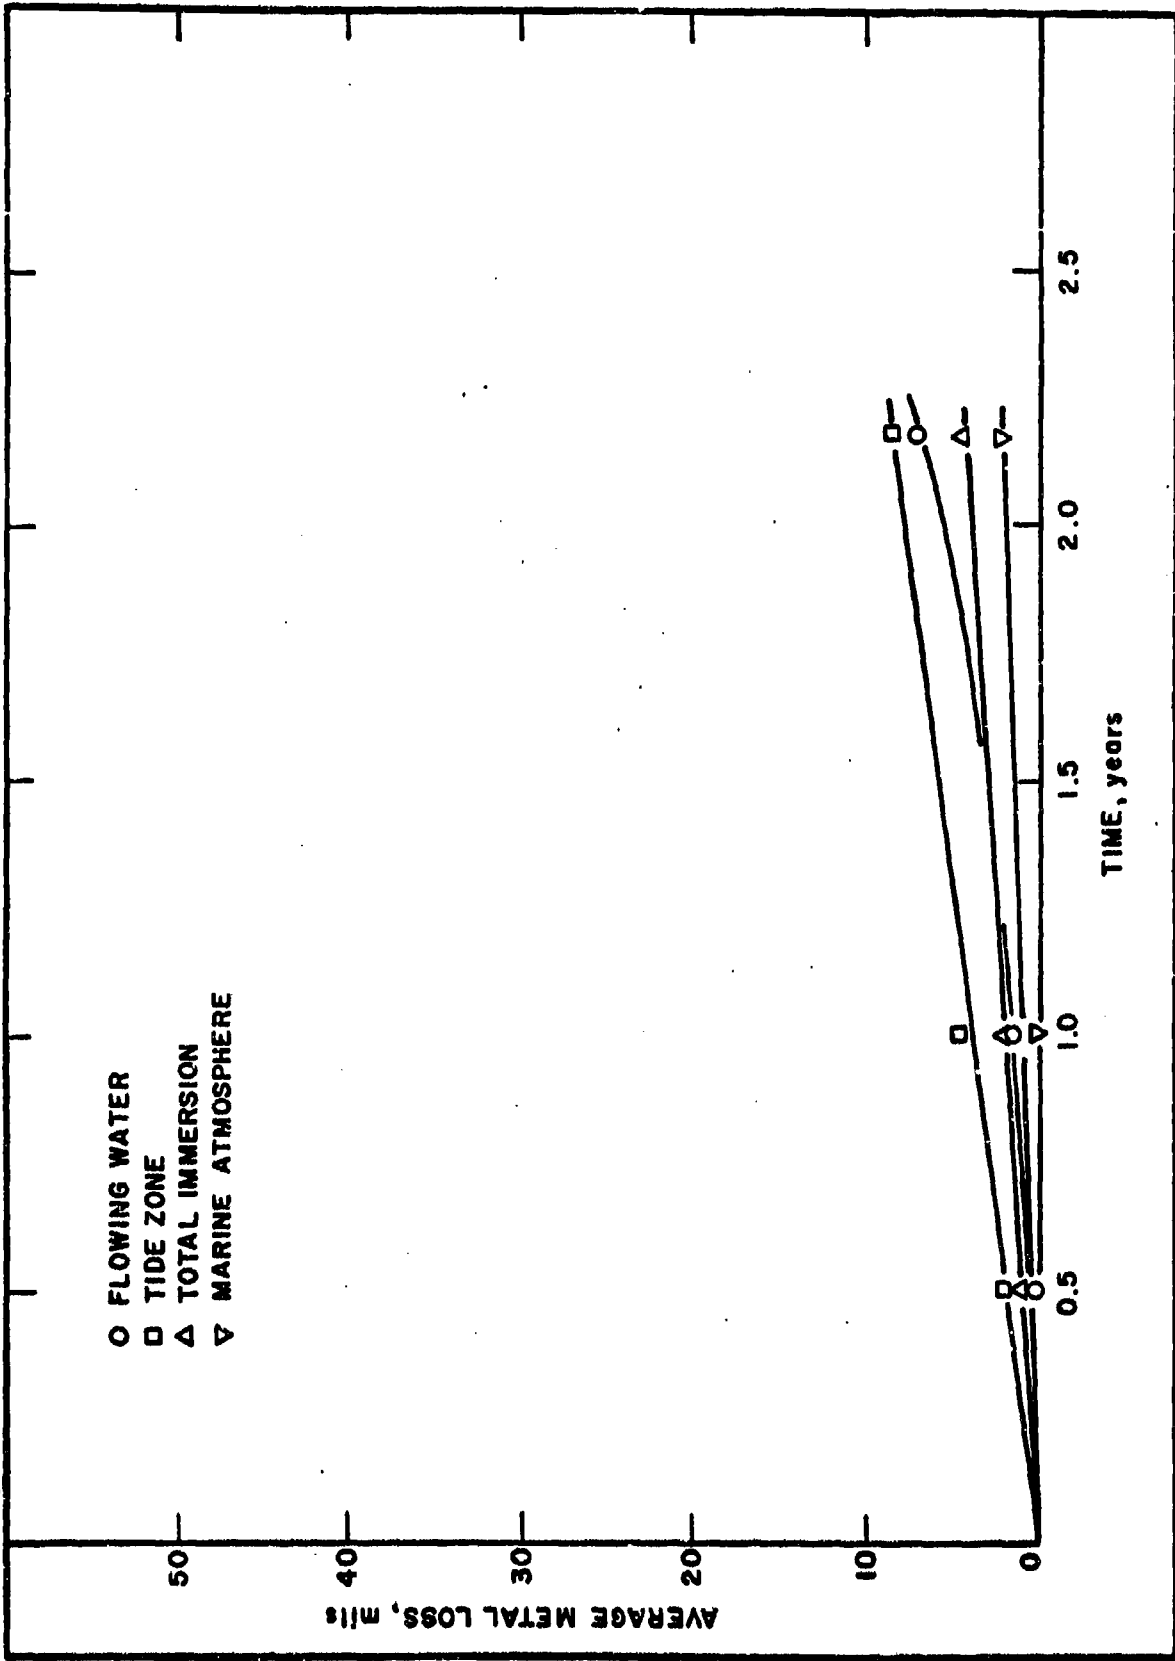
FIGURE  
NO.  
6

# HEAT-AFFECTED-ZONE CORROSION OF HY-80 STEEL WELDMENTS IN MARINE ENVIRONMENTS

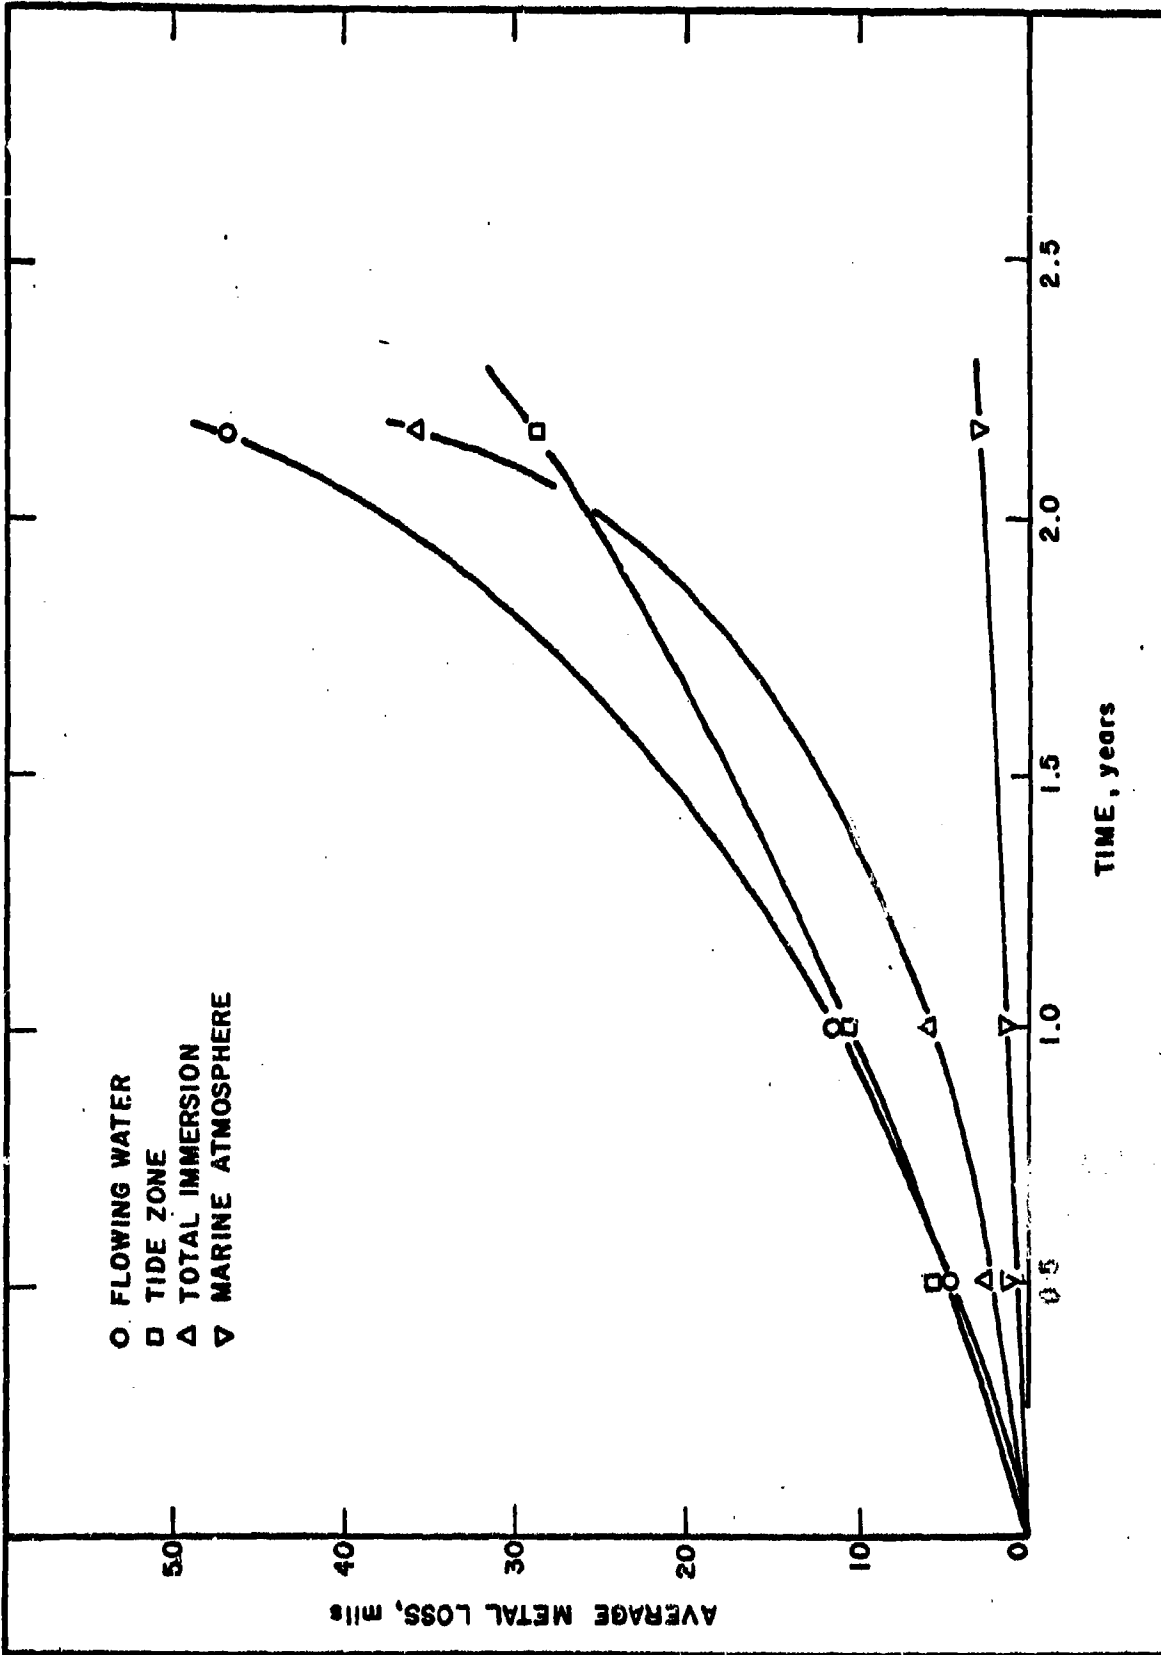
WELD-METAL CORROSION OF HY-80 STEEL WELDMENTS IN MARINE ENVIRONMENTS

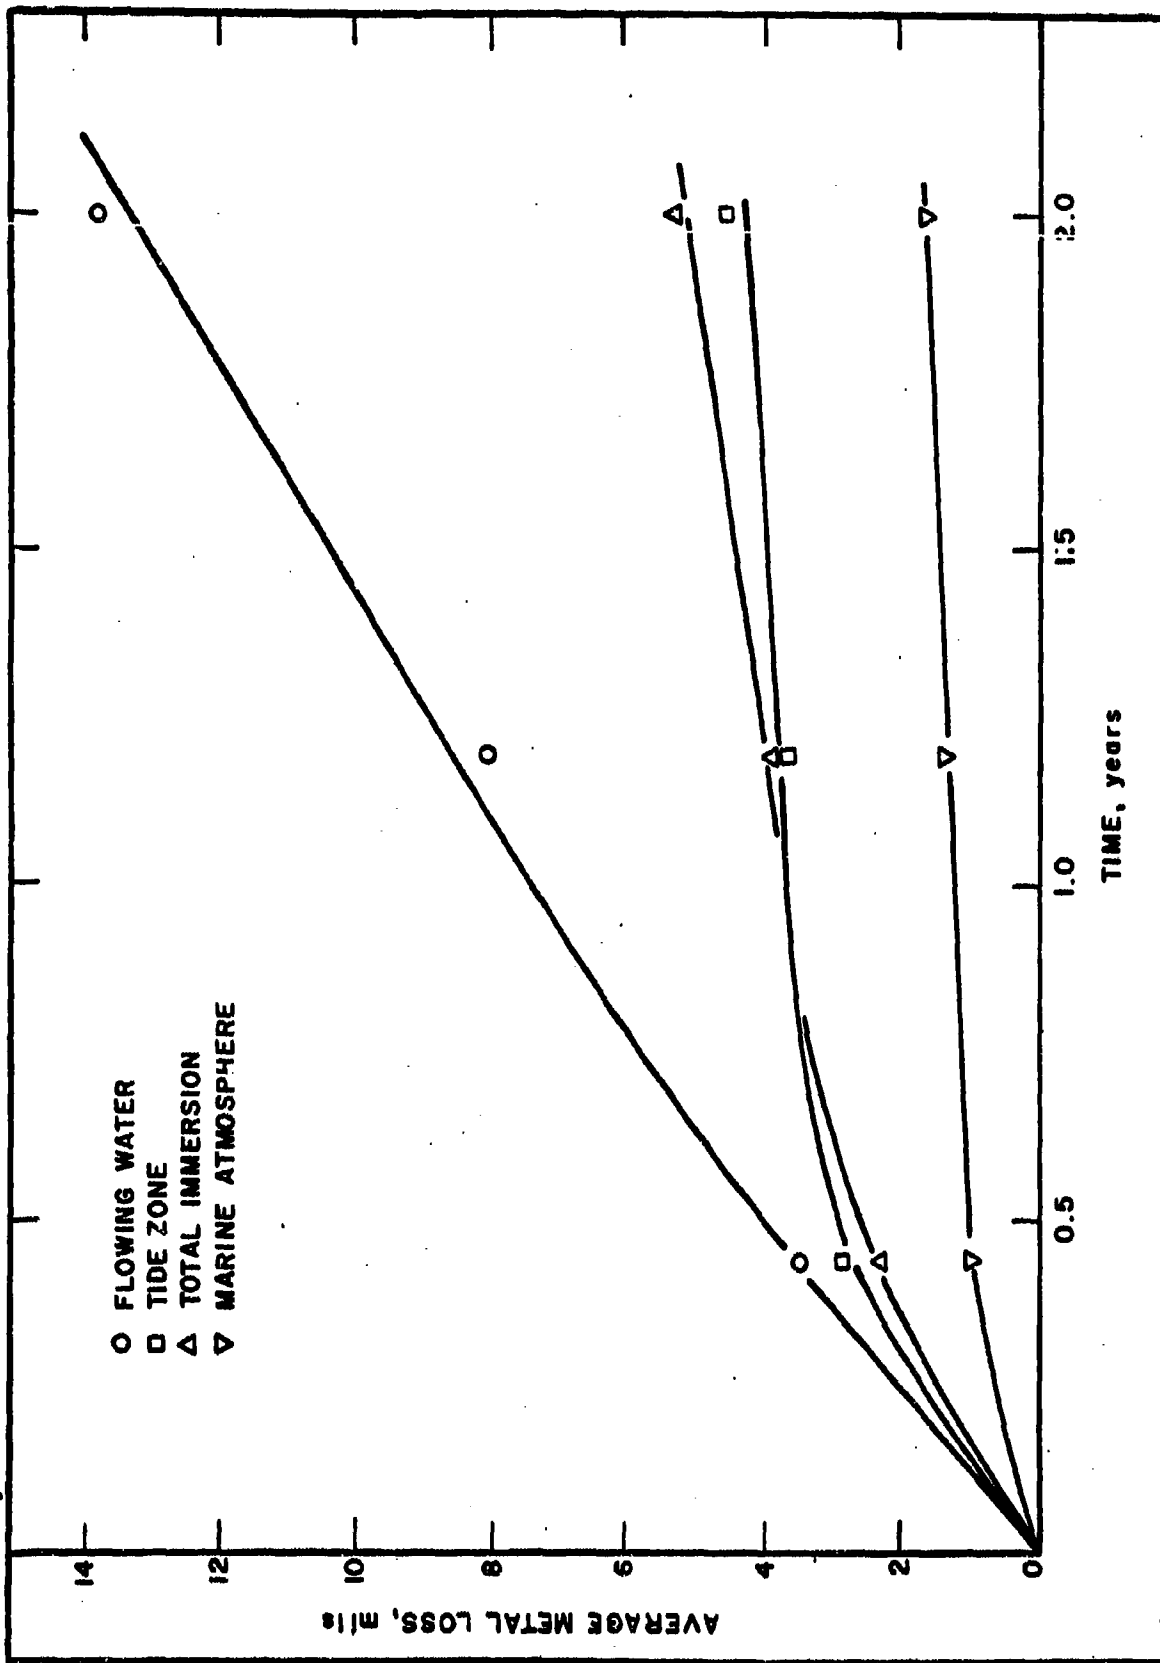
**CORROSION OF HY-130(T) STEEL IN MARINE ENVIRONMENTS**

The results obtained from plain-plate HY-130(T) steel specimens exposed in surface waters are given in Figure 8. The observed corrosion was very uniform on all surfaces of the specimens. The corrosion rates decreased during the two-year exposure, in total immersion, in the tide zone, and in the marine atmosphere. The initial corrosion rates were about 5 mpy in total immersion, 6 mpy in the tide zone, and 2 mpy in the atmosphere. After about one year the corrosion rates decreased, and during the second year of exposure they were about 1.5 mpy in total immersion, 0.7 mpy in the tide zone,

and 0.5 mpy in the atmosphere. In the flowing sea-water the corrosion rate remained essentially constant at about 7 mpy over the 2-year test period. The decreasing corrosion rates, in all exposure conditions except flowing sea-water, indicate that the rust films formed were gradually becoming protective. Considering the corrosion test as a whole, it can be concluded that the general corrosion behavior of plain-plate HY-130(T) steel specimens is substantially equivalent to the corrosion behavior of HY-80 steel.

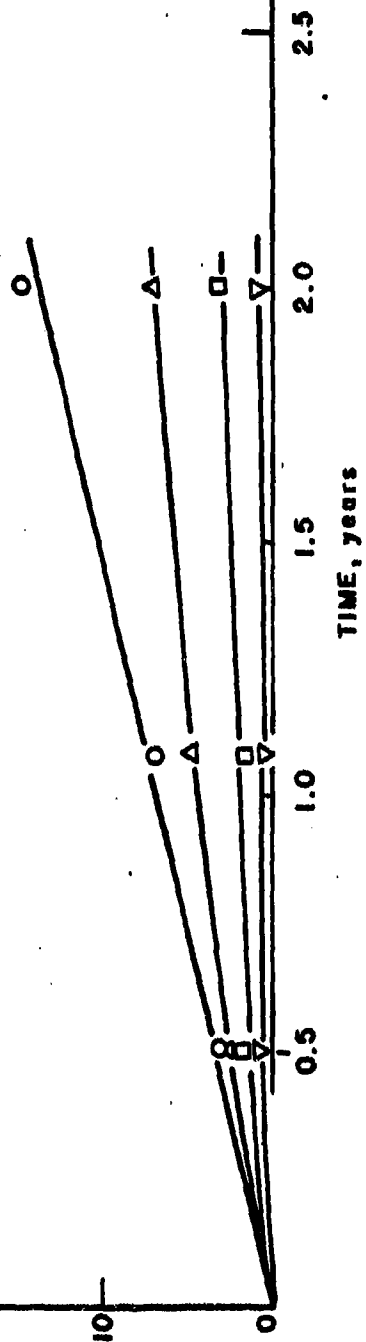
BASE-METAL CORROSION OF HY-130(T) STEEL WELDMENTS IN MARINE ENVIRONMENTS

The corrosion behavior of welded 5Ni-Cr-Mo-V steel specimens is given in Figures 9, 10, and 11 for the base metal, heat-affected zone, and weld metal, respectively. In flowing sea water and in the tide zone the welded HY-130(T) steel specimens corroded in the weld metal (4.0 - 9.0 mpy) somewhat more than in the base metal (1.5 - 6.7 mpy) or heat-affected zone (0.3 - 2.5 mpy). However, the difference in corrosion rates between the various areas of the weldment is not considered significant. This corrosion behavior is consistent with earlier laboratory tests<sup>3)</sup> which showed that the corrosion potentials of the weld metal were only 6 to 7 millivolts anodic to those of the base metal.

The corrosion rates of HY-130(T) steel base metal obtained from welded specimens were essentially identical with those obtained on plain-plate specimens. In general, these tests in various marine environments showed that HY-130(T) weldments were appreciably more corrosion resistant than HY-80 steel weldments.

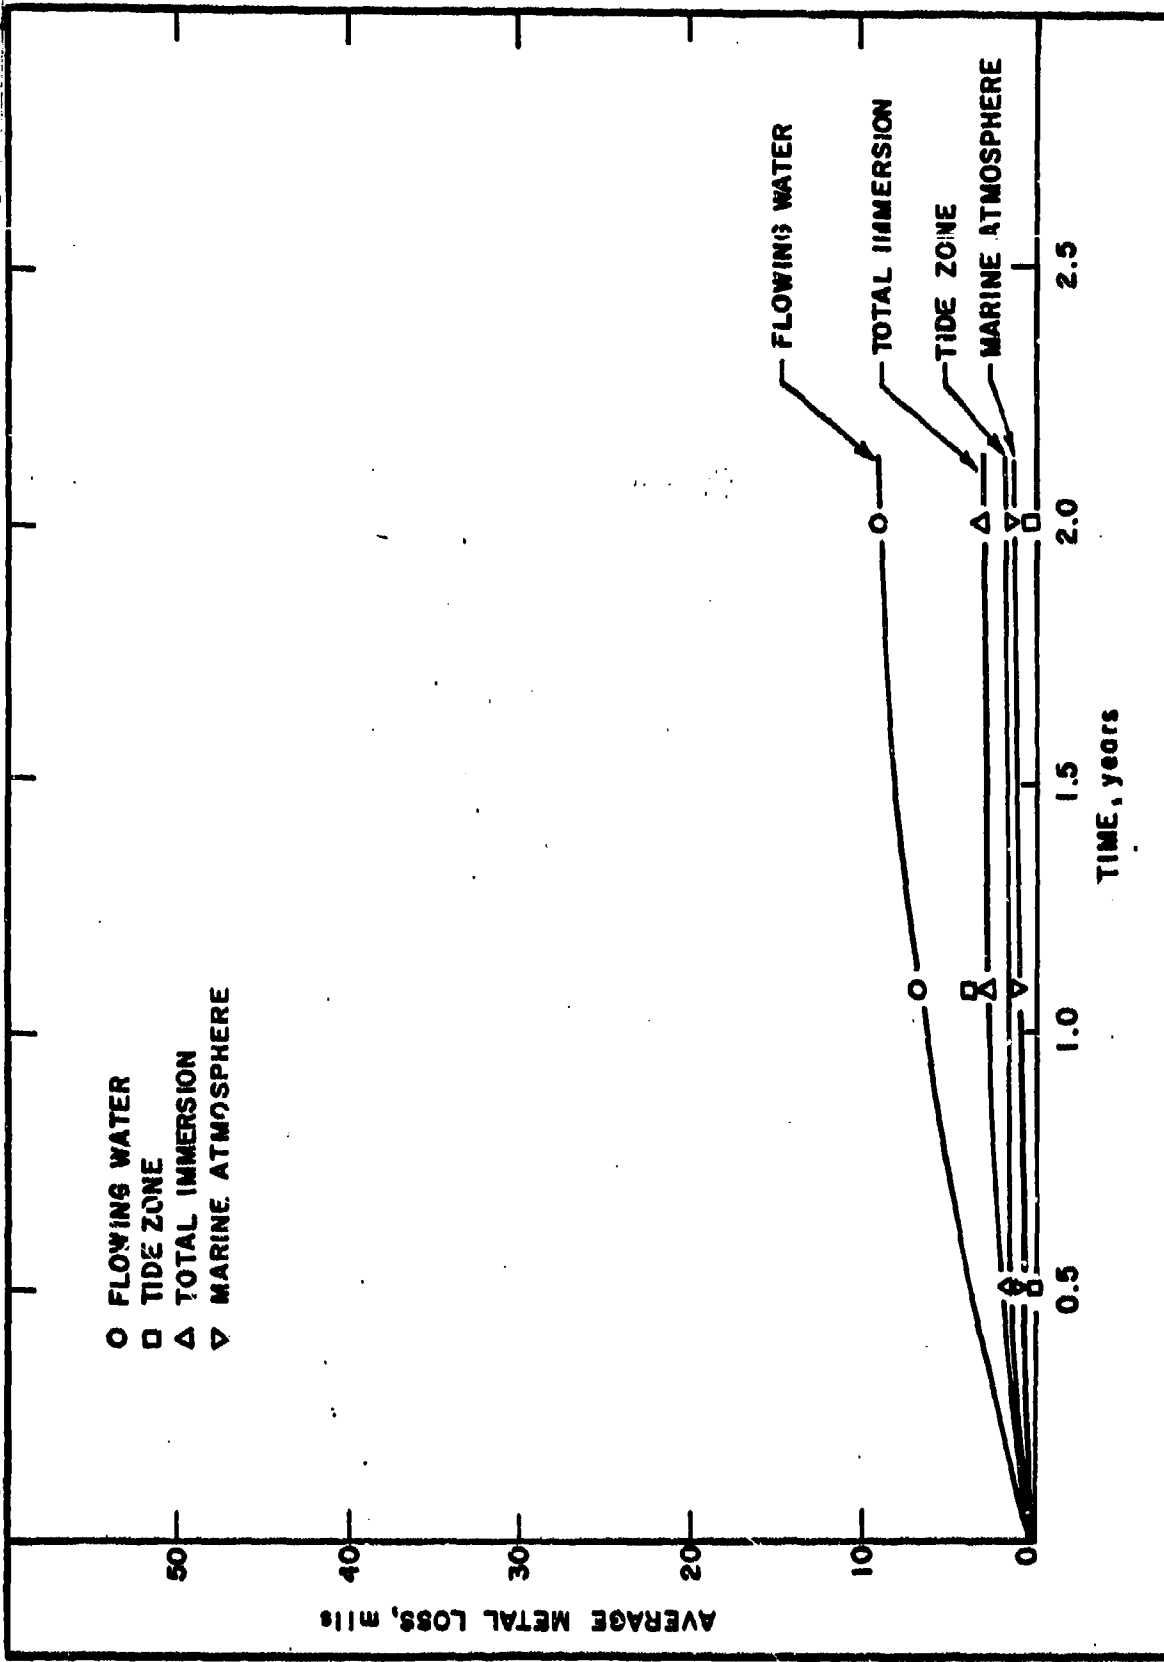
HEAT-EFFECTED-ZONE CORROSION OF HY-130 (T) STEEL WELDMENTS IN MARINE ENVIRONMENTS
