COMPARATIVE DOWNWASH  
AND  
SIMULATED FOREST RESCUE TESTS  
OF THE HH-3E, HH-53B  
AND THE XC-142A AIRCRAFT

December 1967

Aeronautical Systems Division

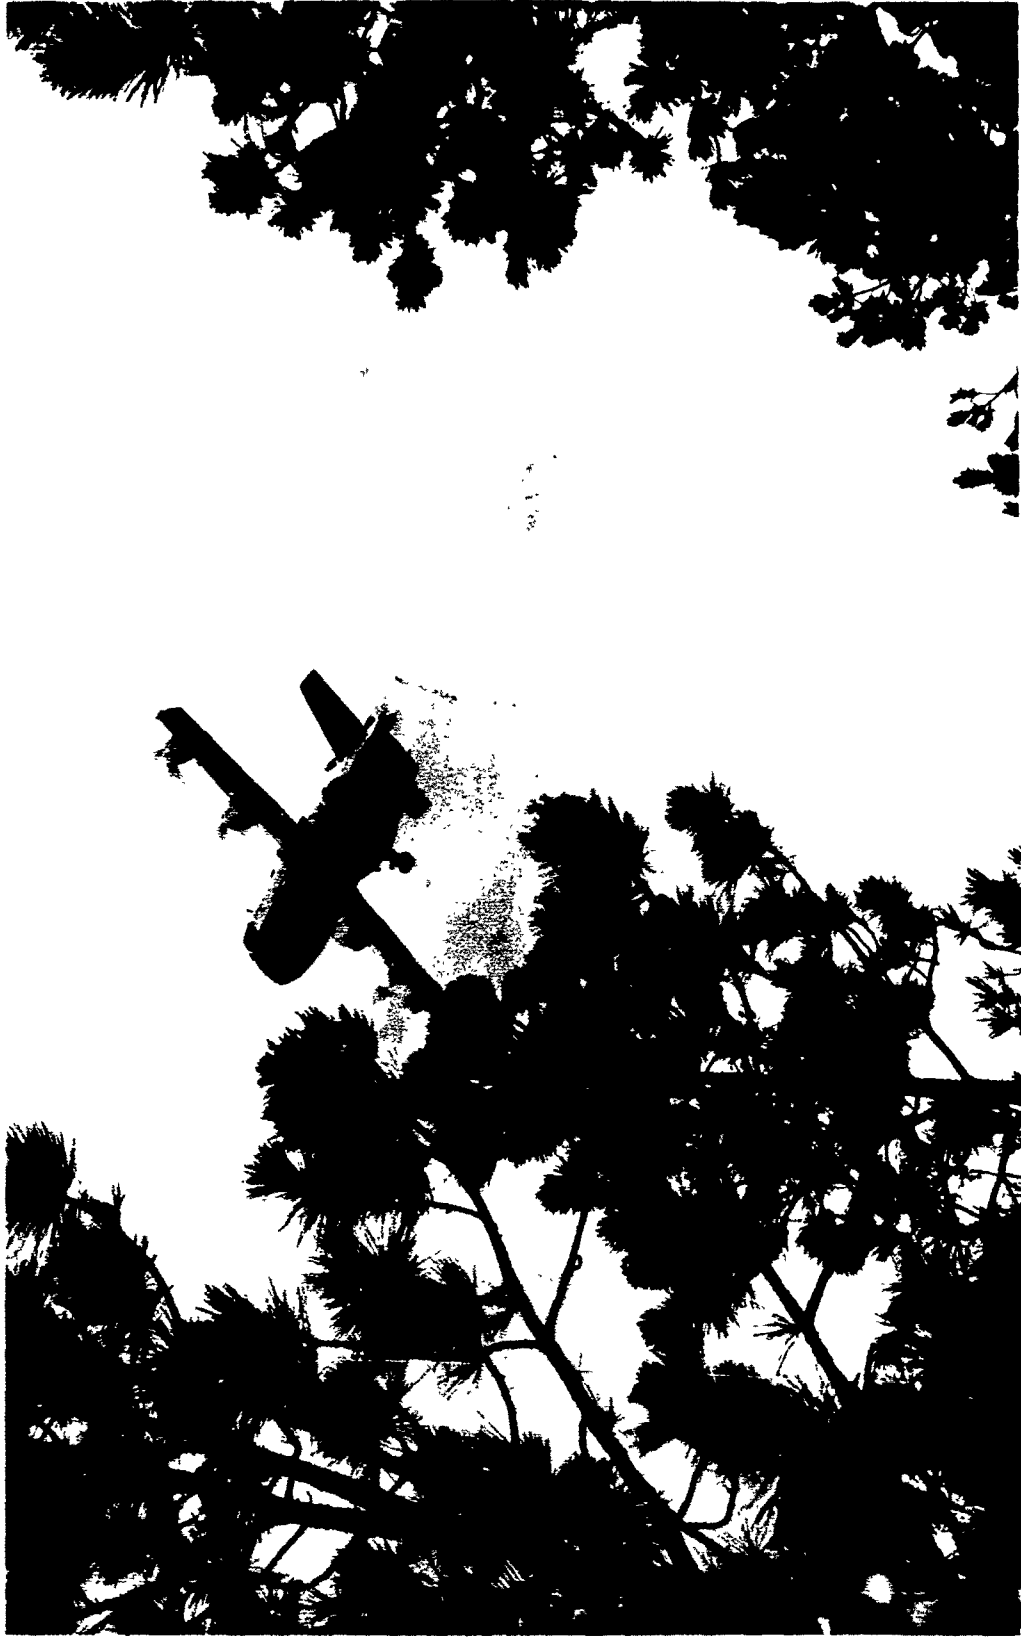
Figure 1. XC-142 DOWNMASH SURVEY TEST, EGLIN AFB, FLORIDA, AUG 21-25-67.  
XC-142 HOVERING OVER FOREST TEST SITE.

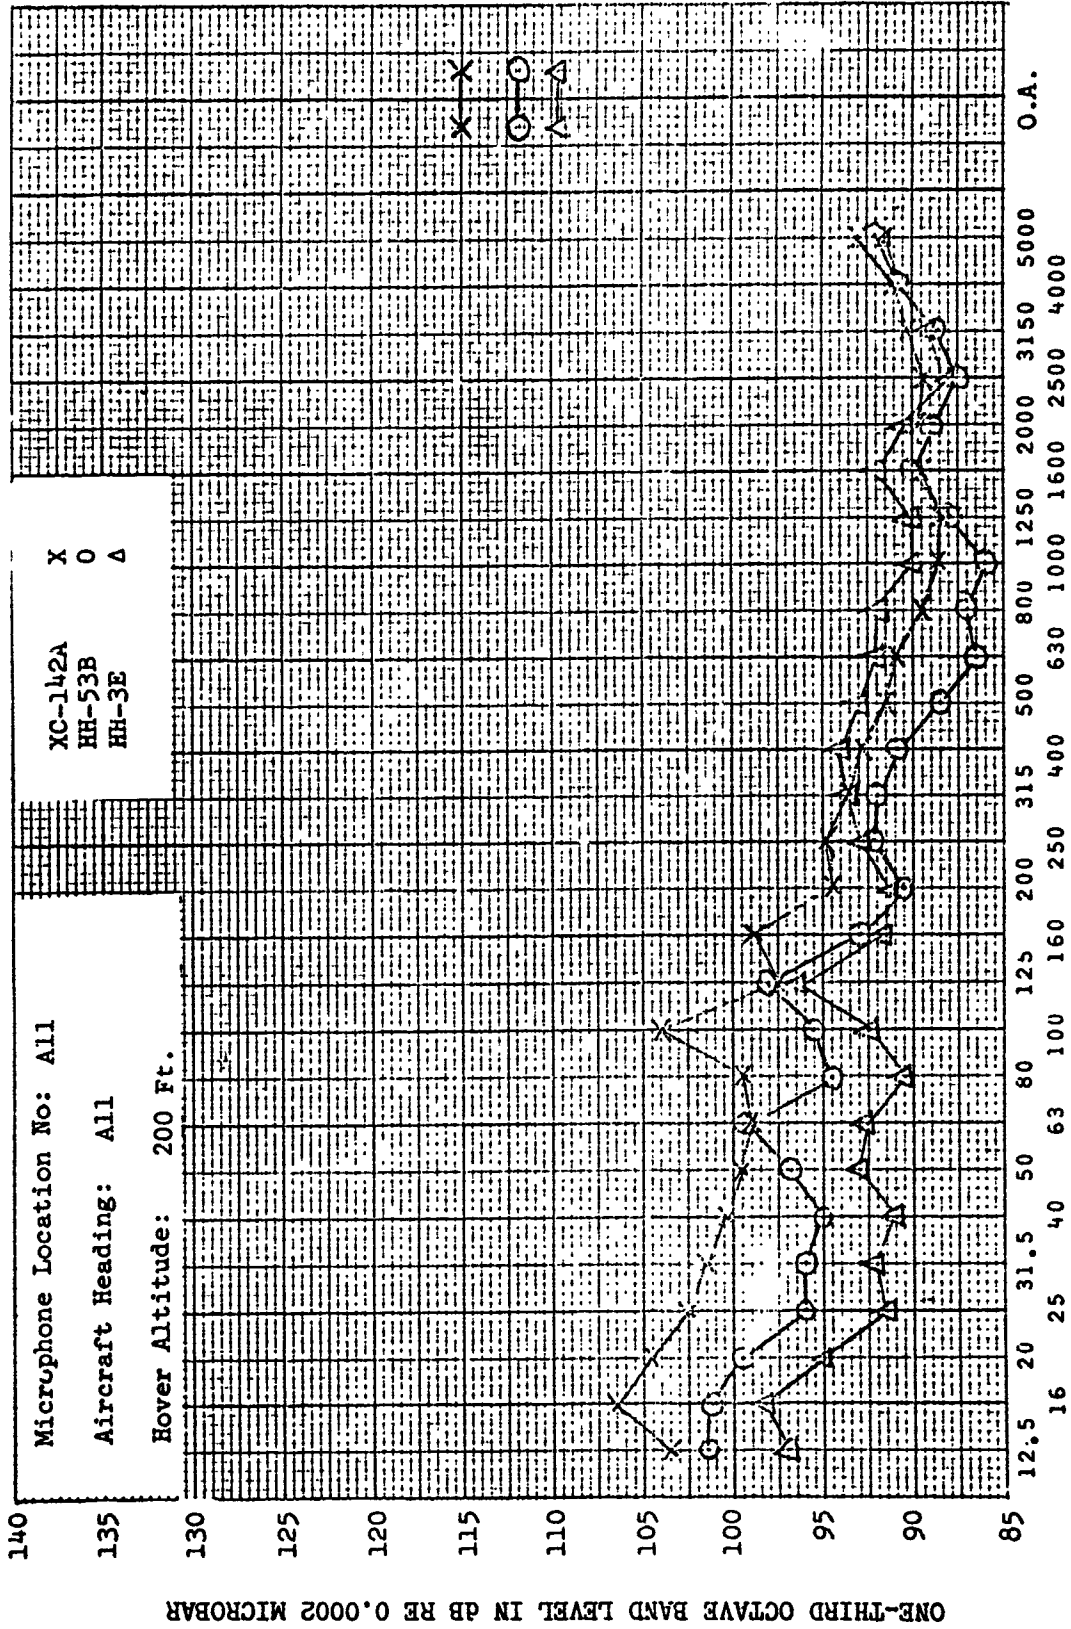
Figure 33 - Average Overall Sound Pressure Level Below XC-142A, HH-53B and HH-3E vs Hover Altitude
