QUALIFICATION TESTING OF THE BDU-12/B PRACTICE BOMB

TECHNICAL REPORT NO. AFSWC-TR-68-19

October 1968

Vibration, shock, and static tests were performed for the purpose of upgrading the BDU-12/B to a supersonic air drop capability. Only one of the four units tested was capable of withstanding the predicted parachute opening forces, and that was with a negligible margin of safety. A potential, though not serious, fatigue characteristic was discovered in the tail mounting hardware. The BDU-12/B cannot be qualified for supersonic release.

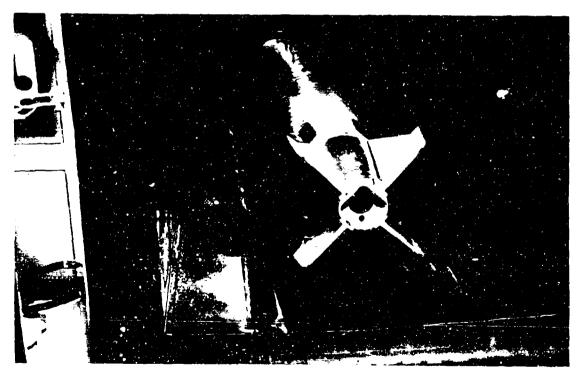
Figure 2. 350 Heat Exposure

Past experience has shown that structural components fabricated of aluminum alloys may have their required strength characteristics degraded to an unacceptable level by exposure to temperatures associated with supersonic flight. Consequently, prior to any testing, the front part of the tail fins of BDU-12/B, SN 5227, were exposed to a temperature of 412°F for 20 minutes. The rest of the unit was placed in a 300°F environment and soaked for 20 minutes. See figures 1 and 2.

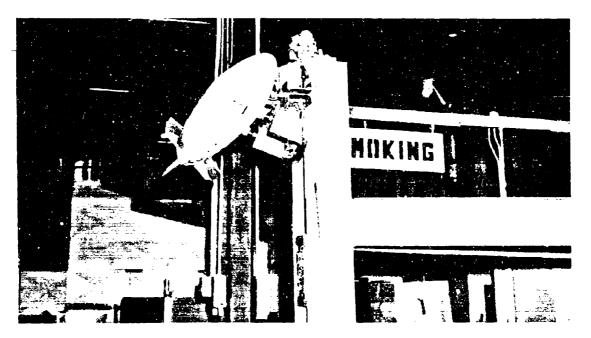
Figure 3. Typical Shock Test Setup

The required shock test is specified in method 516, Procedure 1 of MIL-STD-810A. This requirement is a slope-front sawtooth input of 20-g magnitude and a duration of 10 ms. This input is applied three times, first in one direction and then in the other, along the three mutually perpendicular axes for a total of 18 shocks. The large shock test machine at the Kirtland AFB facility is a home-built steel frame which is dropped onto a lead pig. The test item is mounted to a simulated bomb rack which, in turn, is affixed to the shock tester as shown in figure 3.

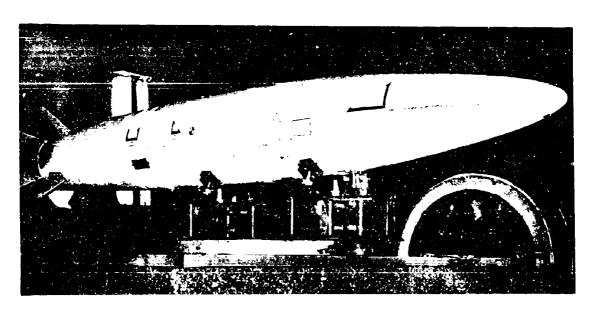
Figure 4. Typical Vibration Setup

Method 514 of MIL-STD-810A, to which this unit was tested in vibration, calls for a resonant search to 2,000 Hz and then dwells at detected resonances. This is conducted along each of the three mutually perpendicular axes. A Ling, Model 249, hydraulic shaker and a large slip table are used at this facility for vibration testing. Figure 4 shows a typical test setup where the shaker is driving the slip plate.

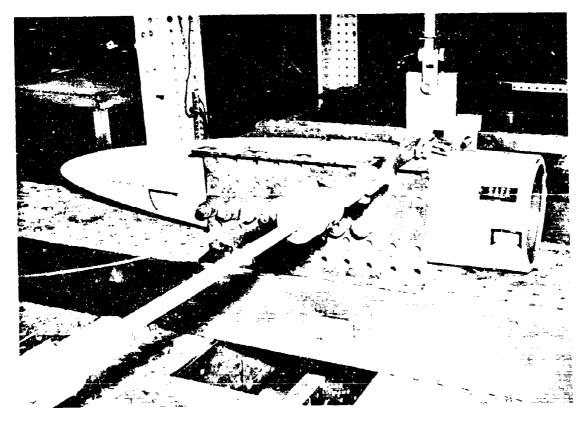
Figure 6. Triaxial Lug Loading

This same forward case was the one used in the lug tests which were passed successfully with no visible permanent deformation to either lugs or case. The tail cone, on the other hand, was so badly bent because of impact that it would no longer match with its tail fins.

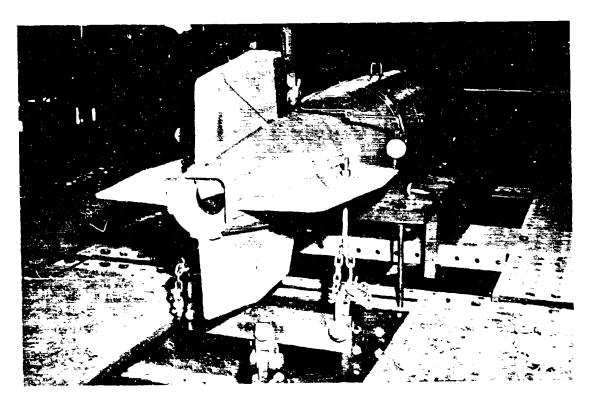
Figure 7. Tail Fin Test Setup

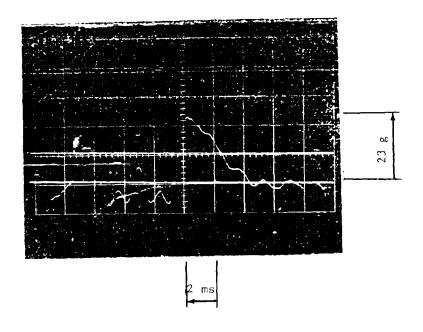
Figure 8. Typical Shock Test Record

As explained in section II, the shock test equipment was quite crude. Each shock input was only one-half the specified 10 ms. Required g levels, however, were easily obtained. After the 18 shock-pulse inputs had been imposed, the unit was visually inspected. No evidence of any failure could be detected. Figure 8 is the record of a typical shock pulse as seen by the unit.

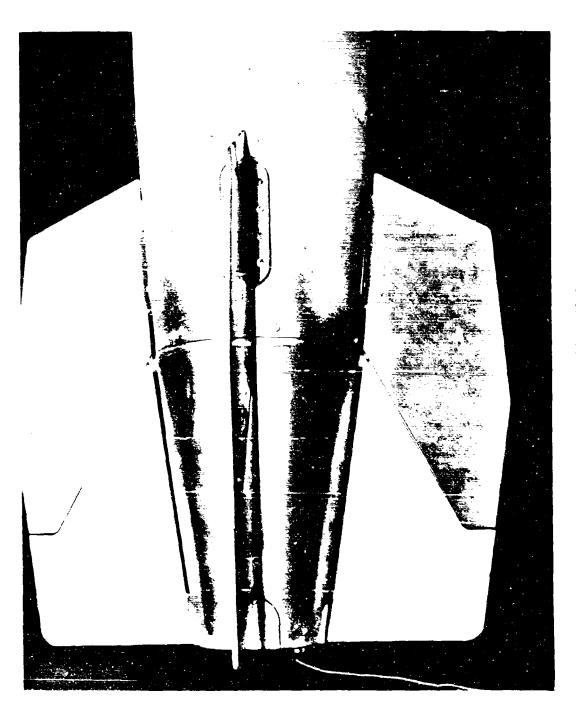
Figure 10. Static Test Failure

The first static pull on the parachute shroud lines of SN 5227 reached only 91,056 of the specified 120,000 pounds before failure. The mode of failure can be seen in figure 10. It can be seen that the forward casing pulled apart just forward of the retaining ring. The broken hardware in the center of the picture does not represent a failure. It is merely the result of impact on the steel pull rod after the case had failed.

This same unit, as yet undamaged, was then used to repeat the parachute shroud line static pull test. It broke in the same manner as SN 5227 but at 77,216 pounds. In an attempt to obtain some sort of statistical validity to these ruptures, two more units were subjected to the parachute pull test. SN 5230 broke at a total pull of 82,499 pounds and SN 1369 broke at 95,098 pounds, both in a manner identical to the first two.

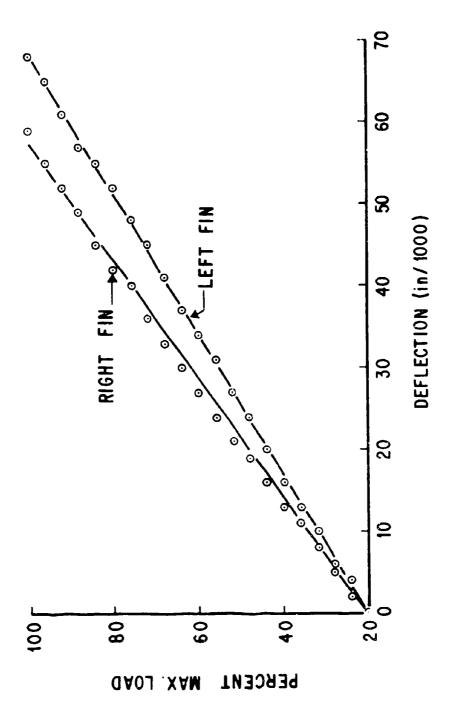
Figure 11. Tail Fin Test

The tail fin static test was conducted on SN 0935. Figure 11 is a plot of the results showing that the fins sustained the applied loads satisfactorily. A preload of 20 percent was applied to eliminate possible extraneous effects of nonlinearity in the test setup. The left fin returned to within 0.006 inch of its initial 20 percent deflection and the right one to within 0.011 inch. Whether these slight residuals were in the tail, test setup, or both is undetermined. For all practical purposes it is considered that the elastic return was linear.
