CLARK RANGER FORKLIFT (CRF)

SUBJECT: Final Report - Clark Ranger Forklift (CRF)

FINAL REPORT

ACTIV Project No. ACL-29/68I

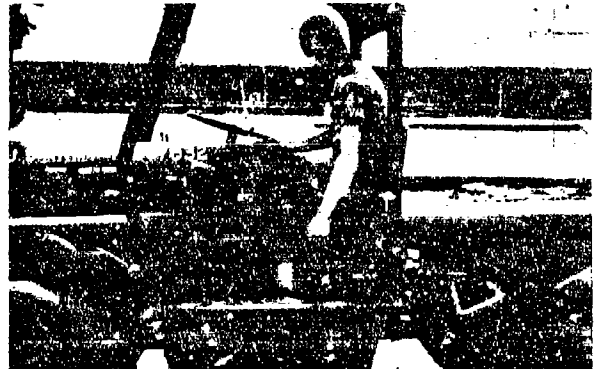
APPENDIX 2 TO ANNEX B

Three separate motions are required to engage the parking brake because of the awkward position and the portion of its travel arc where the resistance is greatest. It would be more practical to locate it below the seat as indicated in the lower right picture.

(3) Relocation of the hand brake to a position just below the operator's seat on the left side was recommended.
