# DEVELOPMENT OF FUSED SLURRY SILICIDE COATINGS FOR THE ELEVATED-TEMPERATURE OXIDATION PROTECTION OF COLUMBIUM AND TANTALUM ALLOYS

S. Priceman  
L. Sama  
Sylvania Electric Products Inc.  
Hicksville, New York

Technical Report AFML-TR-68-210  
December 1968

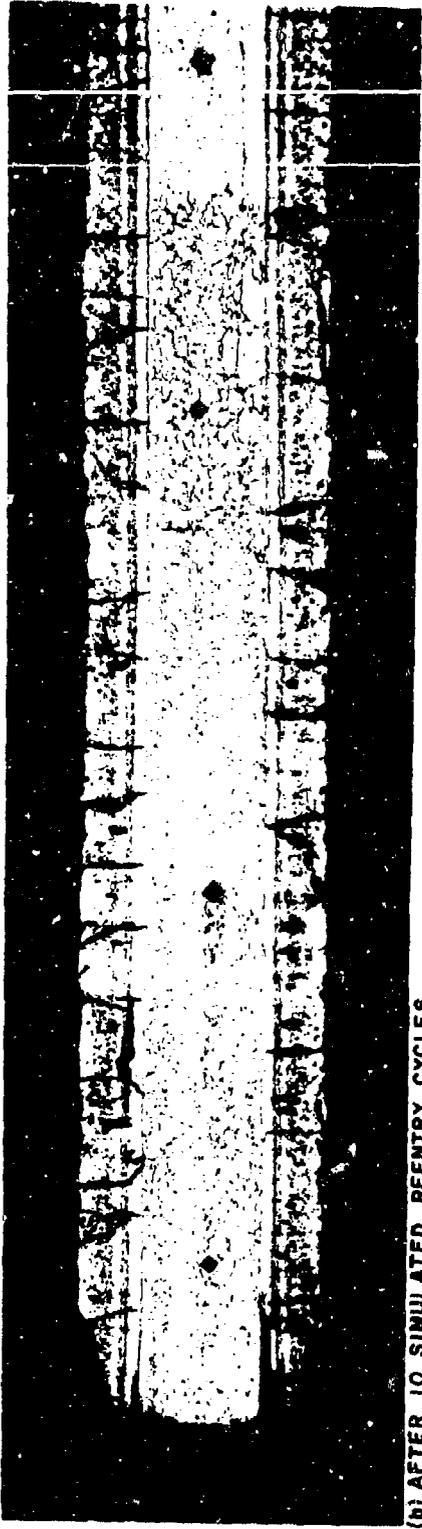
(a) AS DEFECTED (edge of 0.032 hole is at left)

Figure 53 Sections Through Reentry Simulation Exposed Defected Coated Specimens (100X).  
(Reduced 10 Percent in Reproduction)

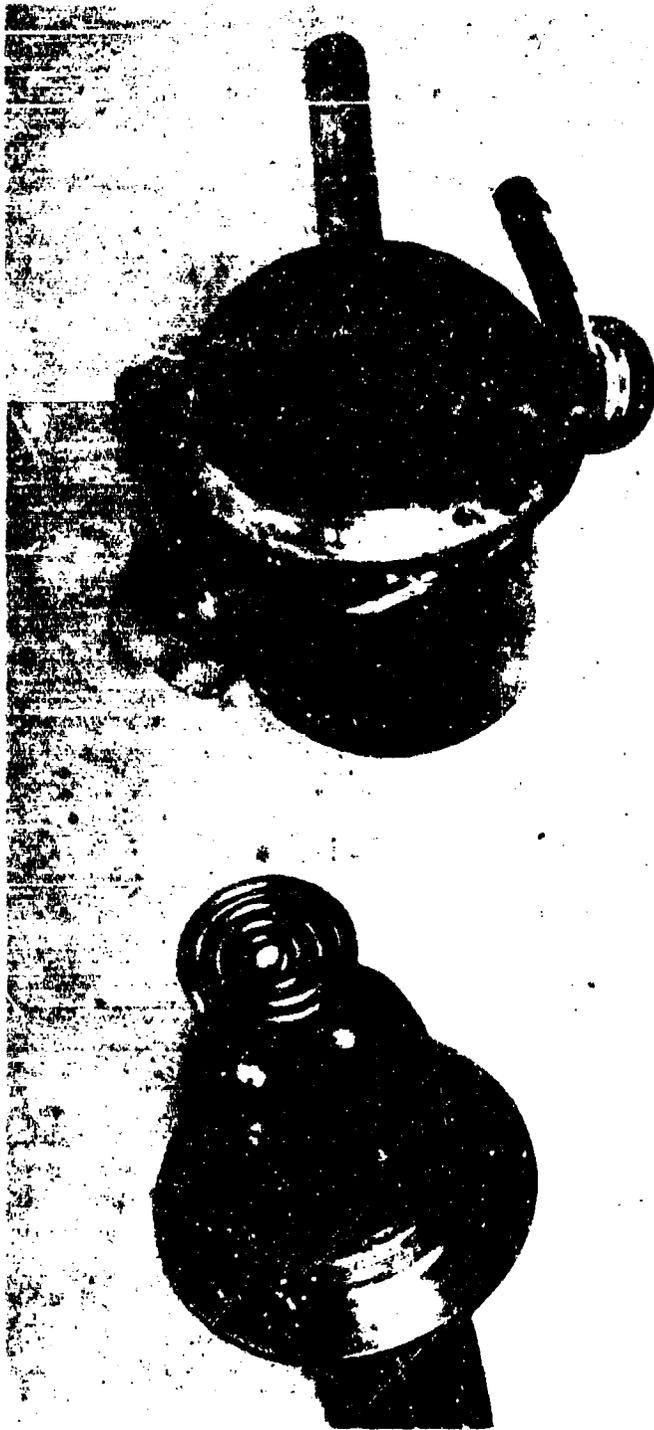
Figure 94 Disassembled View of Coating Repair Unit

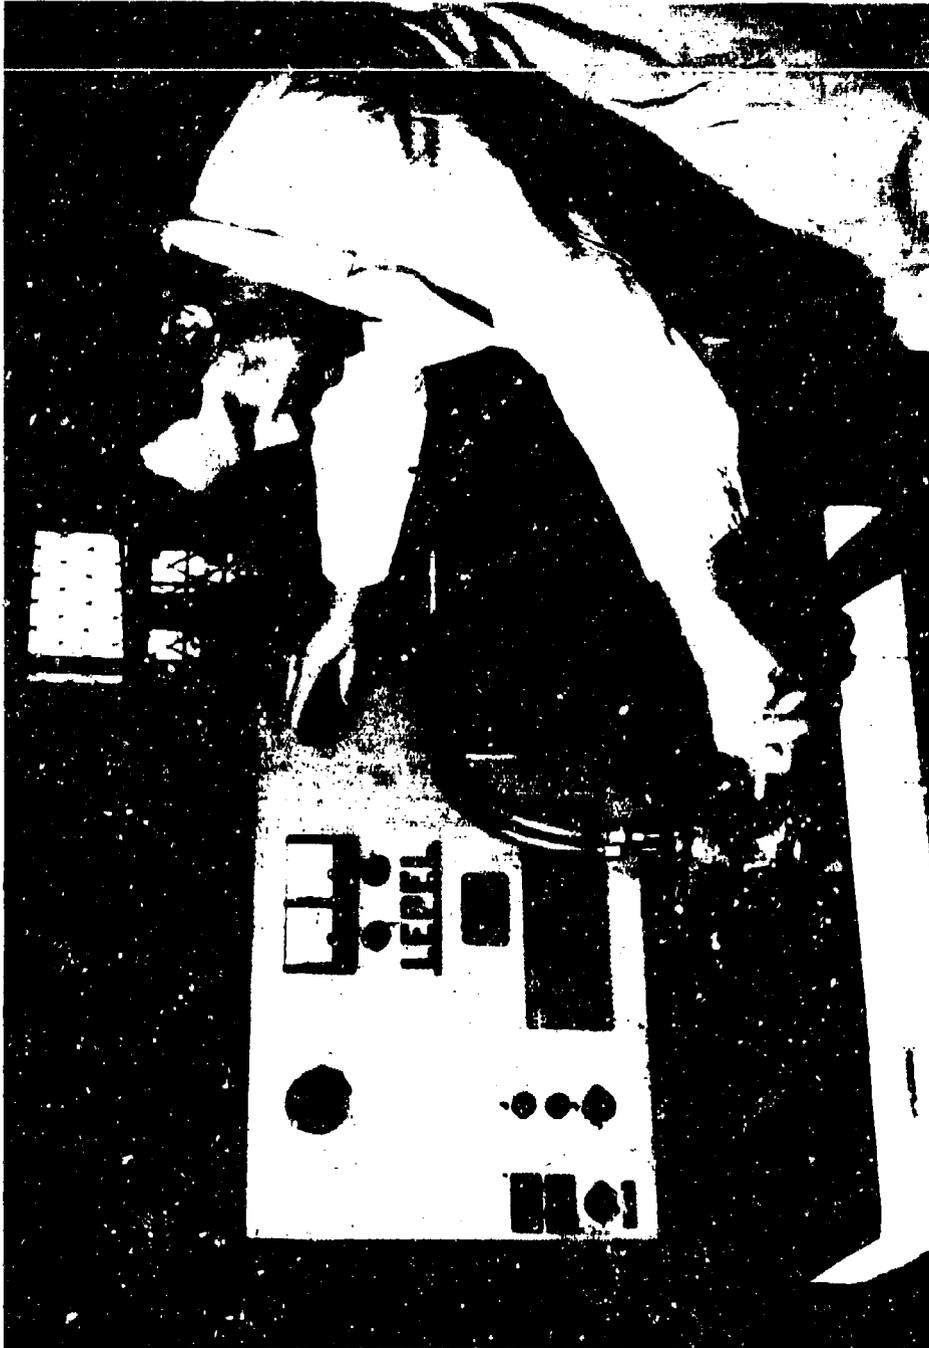
Figure 95 Portable Coating Repair Unit
