TEST FIRING OF A CASTABLE CARBON ROCKET NOZZLE

TECHNICAL REPORT AFRPL-TR-69-39

AIR FORCE ROCKET PROPULSION LABORATORY
DIRECTORATE OF LABORATORIES
AIR FORCE SYSTEMS COMMAND
UNITED STATES AIR FORCE
EDWARDS, CALIFORNIA

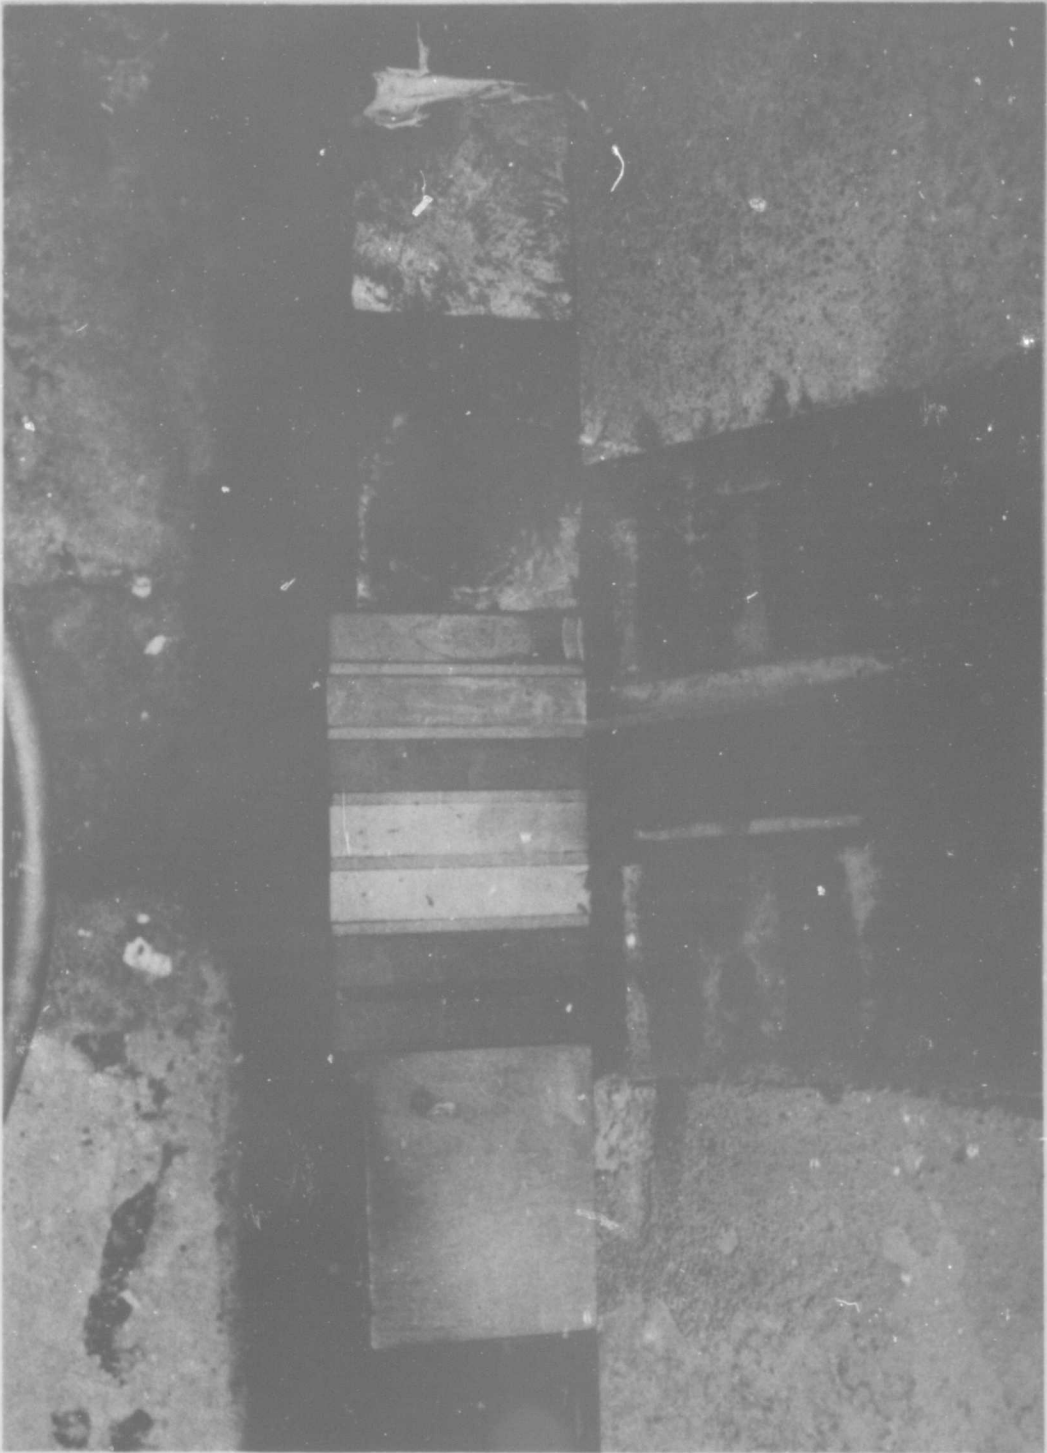
Figure 6. Blast Pad Materials

Blast Pad Materials and Testing Fixture Materials tested are shown in Figure 6, and engineering sketches are shown in Figures 7, 8, and 9. A photograph of the assembly installed for the test is shown in Figure 10. The materials were not inserted into the exhaust plume as shown in

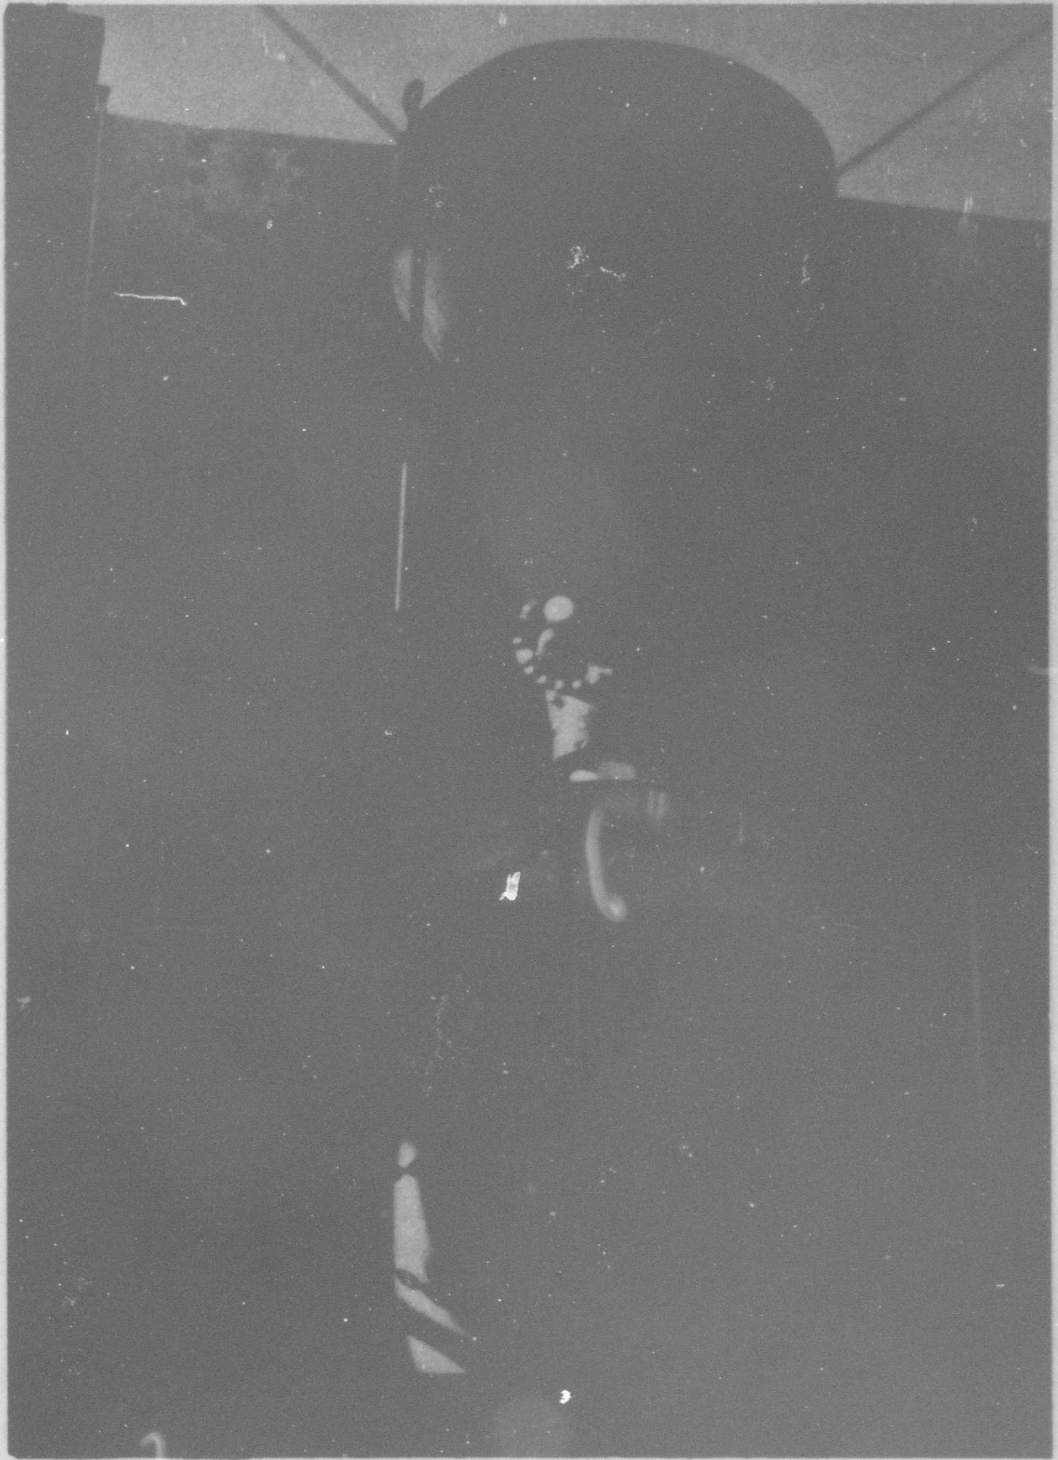
Figure 11. Vacuum Casting Fixture

The nozzle was received from Thiokol Chemical Corporation, and installed in the 36-inch char motor aft closure. Forty-eight hours prior to the scheduled motor loading, the chamber insulation was coated with PBAN polymer. Immediately before loading, the polymer was reapplied to insure an even coating. Vacuum casting fixtures were attached (Figures 11 and 12), and the propellant was loaded through a slit-plate deaerator. The aft closure was installed and the high-strength closure bolts torqued with a pneumatic wrench. The materials testing fixture was installed concurrent with the aft closure installation. Some difficulty was experienced during torquing of the bolts at the fixture attachment locations. This difficulty proved to be significant factor. A BKNO_3 bag igniter (see Figure 13) was installed 6 inches above the propellant surface and the motor was fired.

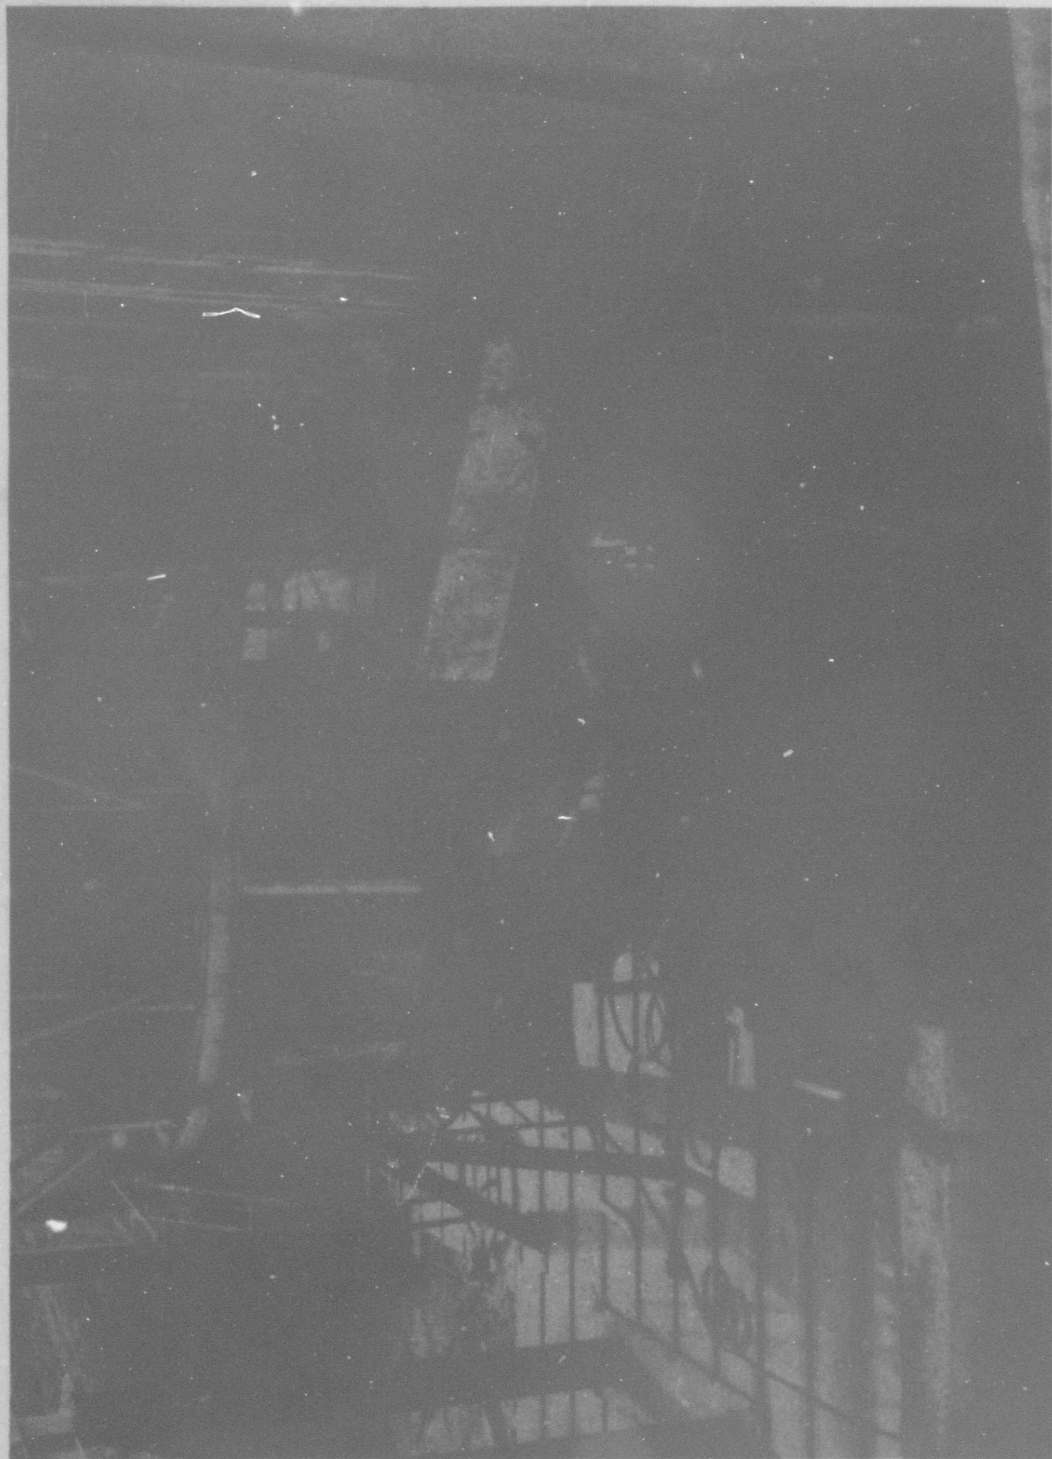
Figure 20. Overall View of Facility Damage

The thrust stand was severely damaged, and it was determined that all load cells and flexures would have to be replaced. Major structural components of the stand will be repaired and reused.

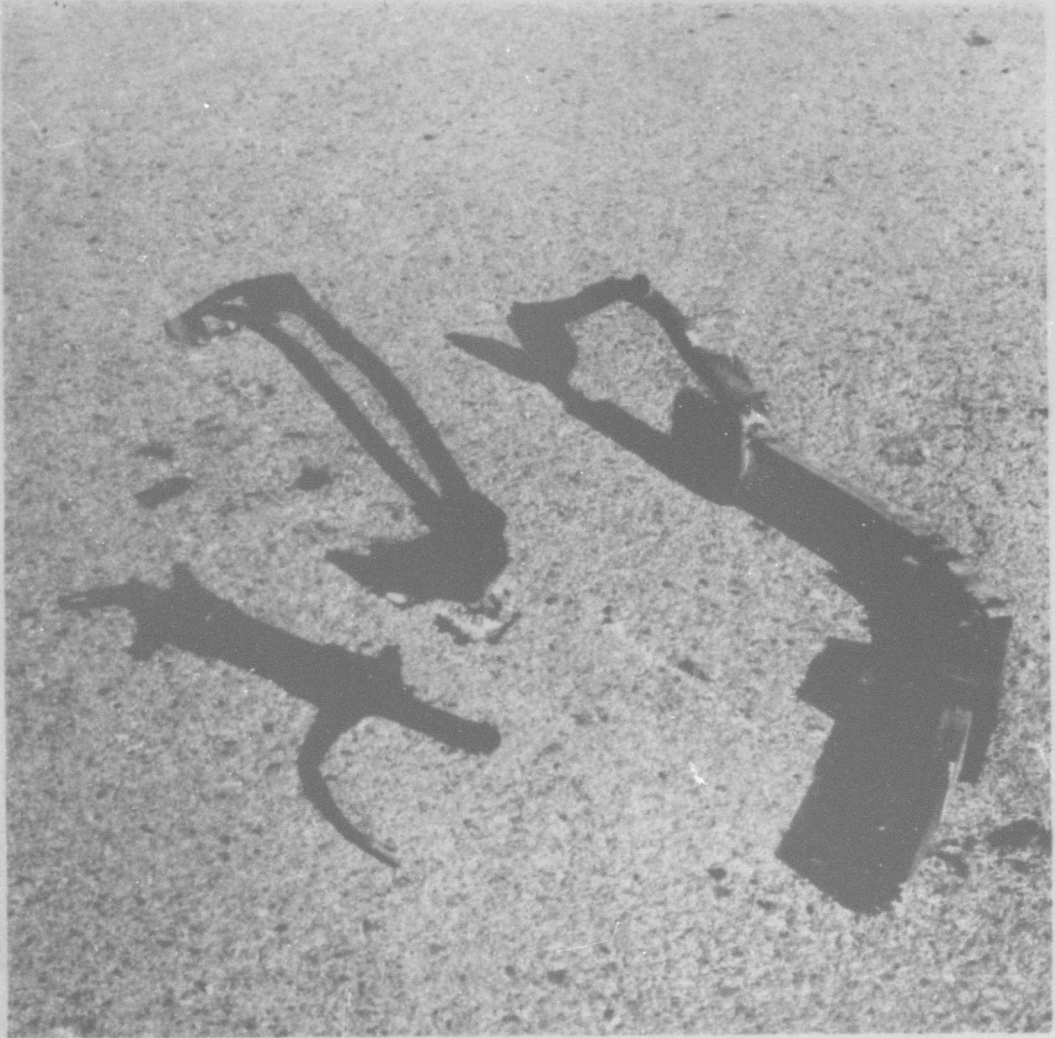
Figure 22. Remains of Materials Test Fixture

Postfire photographs showing melted regions of the motor closure and case are shown in Figures 18 and 19. An overall view of facility is shown in Figure 20 and the aft closure is shown where it landed (arrows) approximately 200 yards from the test pad in Figure 21. The materials sample arm recovered approximately 250 yards from the test pad and 70 yards from the closure, is shown in Figure 22. No useful data was obtained from the materials test.
