FINAL REPORT
DEVELOPMENT OF CASTABLE CARBONACEOUS
MATERIALS FOR SOLID ROCKET NOZZLES

THIOKOL CHEMICAL CORPORATION
WASATCH DIVISION

Technical Report AFRPL-TR-69-129

March 1969

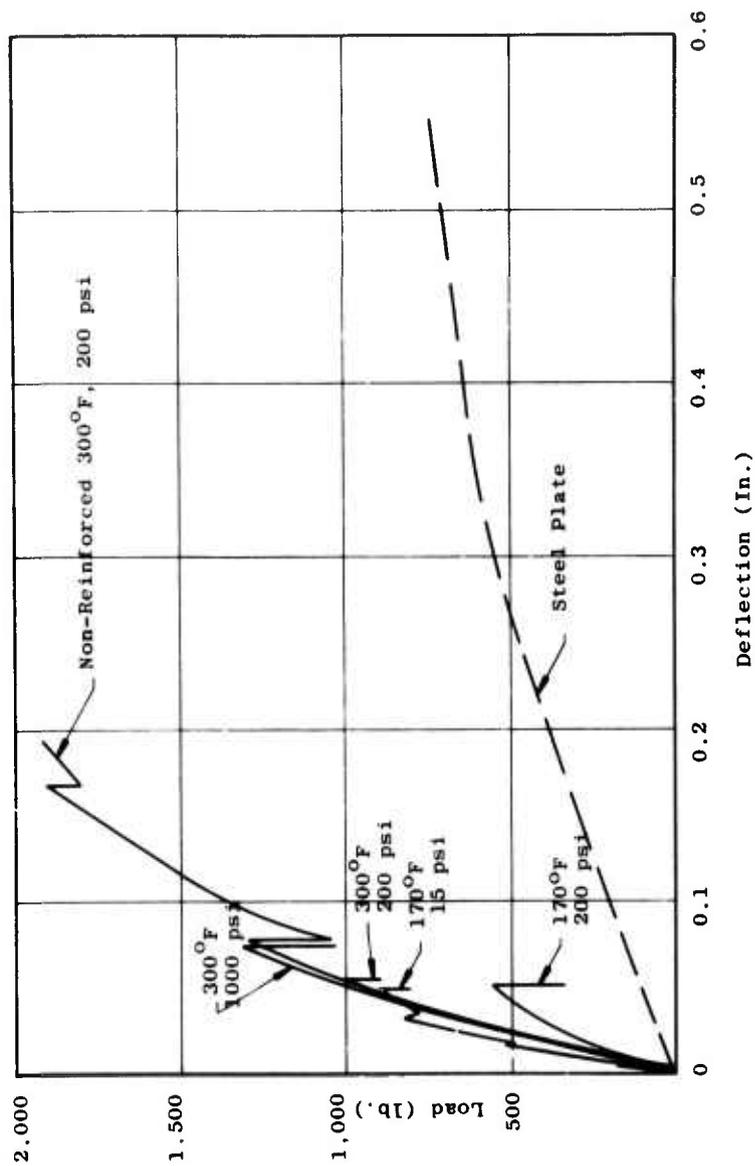
Figure 5. Composite Beam Tests, T-2610

The results of the T-2610 composite beam tests (Figure 5) are similar to those for the T-4113. The one sample cured at 170° F was prepared only for a comparison value. The T-2610 formulation was not designed for cure at this temperature. The material did not fail, but moved with the steel similar to the T-4113. The remaining T-2610 specimens failed by complete cracking of the material. The T-2610 material would not adhere properly to the glass cloth and no slabs of this type were made.

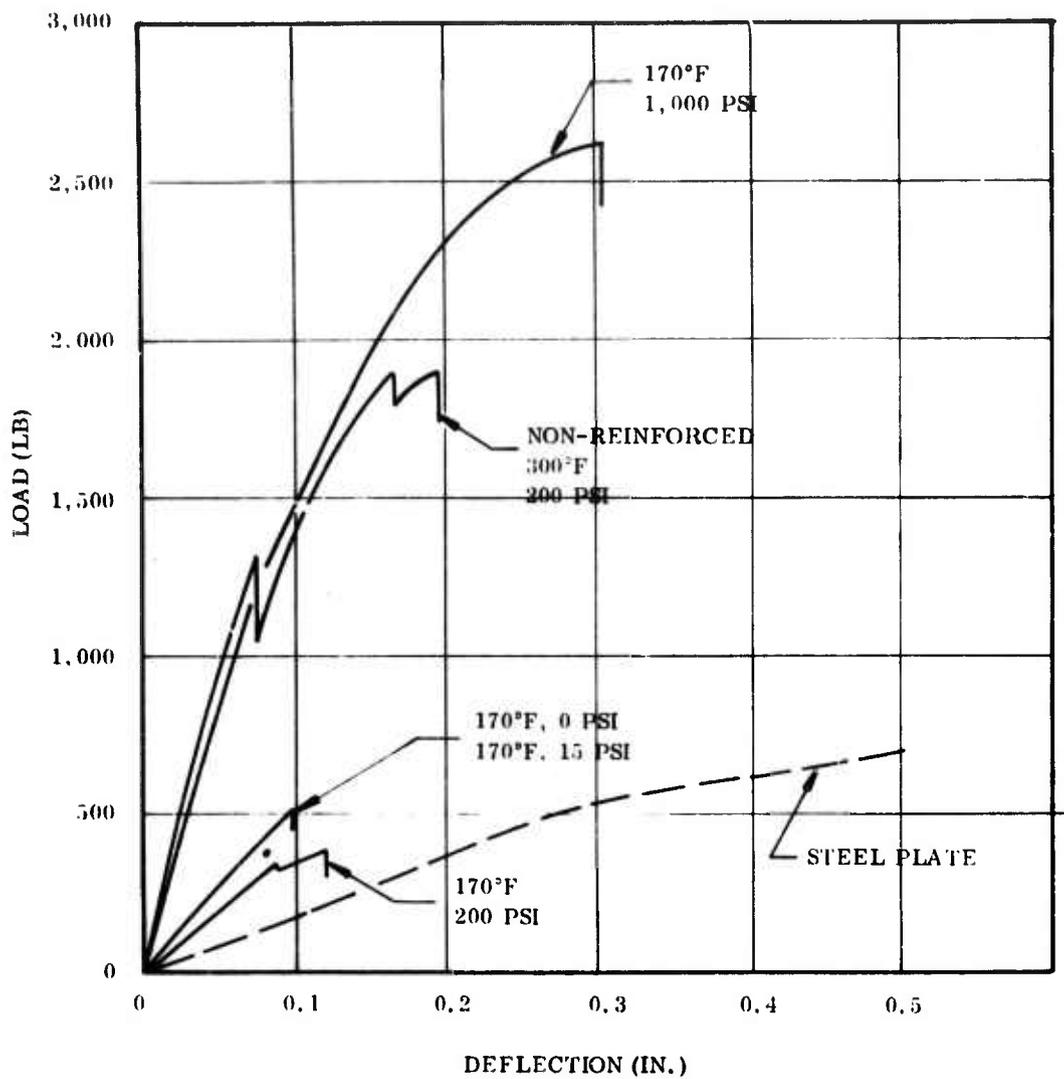
NOTE: ALL SPECIMENS WERE GLASS CLOTH REINFORCED EXCEPT AS NOTED.

Figure 6. Composite Beam Tests, T-4120

Figures 6 thru 8 show the load deflection curves for the T-4120 material. The nonreinforced material failed in stages with the initial failure occurring at a load of 1,300 psi and final failure at 1,900 psi. With one minor exception, the glass cloth or honeycomb reinforcement did not improve the properties of the beam. All glass cloth specimens had initial failures in the 600 to 1,300 lb load range. The honeycomb specimens showed a definite relationship of increasing strength with cure pressure, but only one specimen (300° F, 1,000 psi) had an improvement in properties.

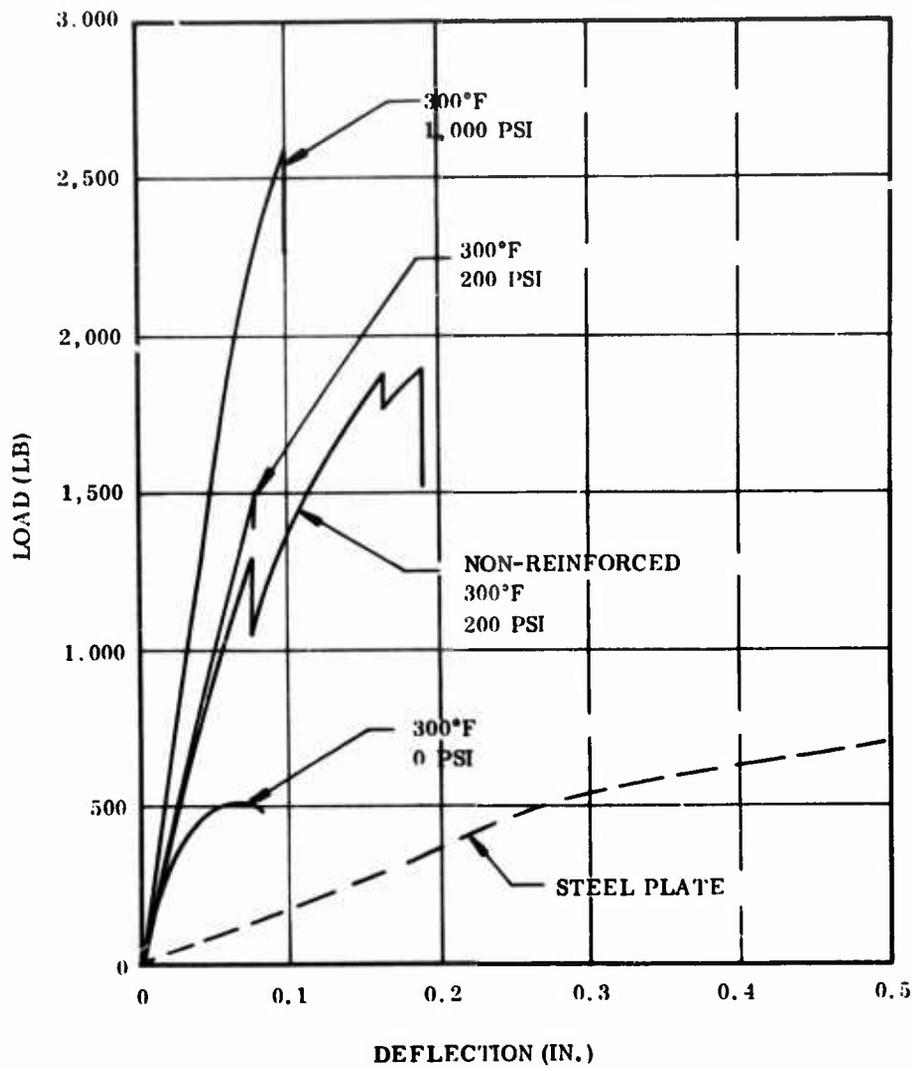
NOTE: ALL SPECIMENS WERE HONEYCOMB REINFORCED EXCEPT AS NOTED.

Figure 7. Composite Beam Tests, T-4129

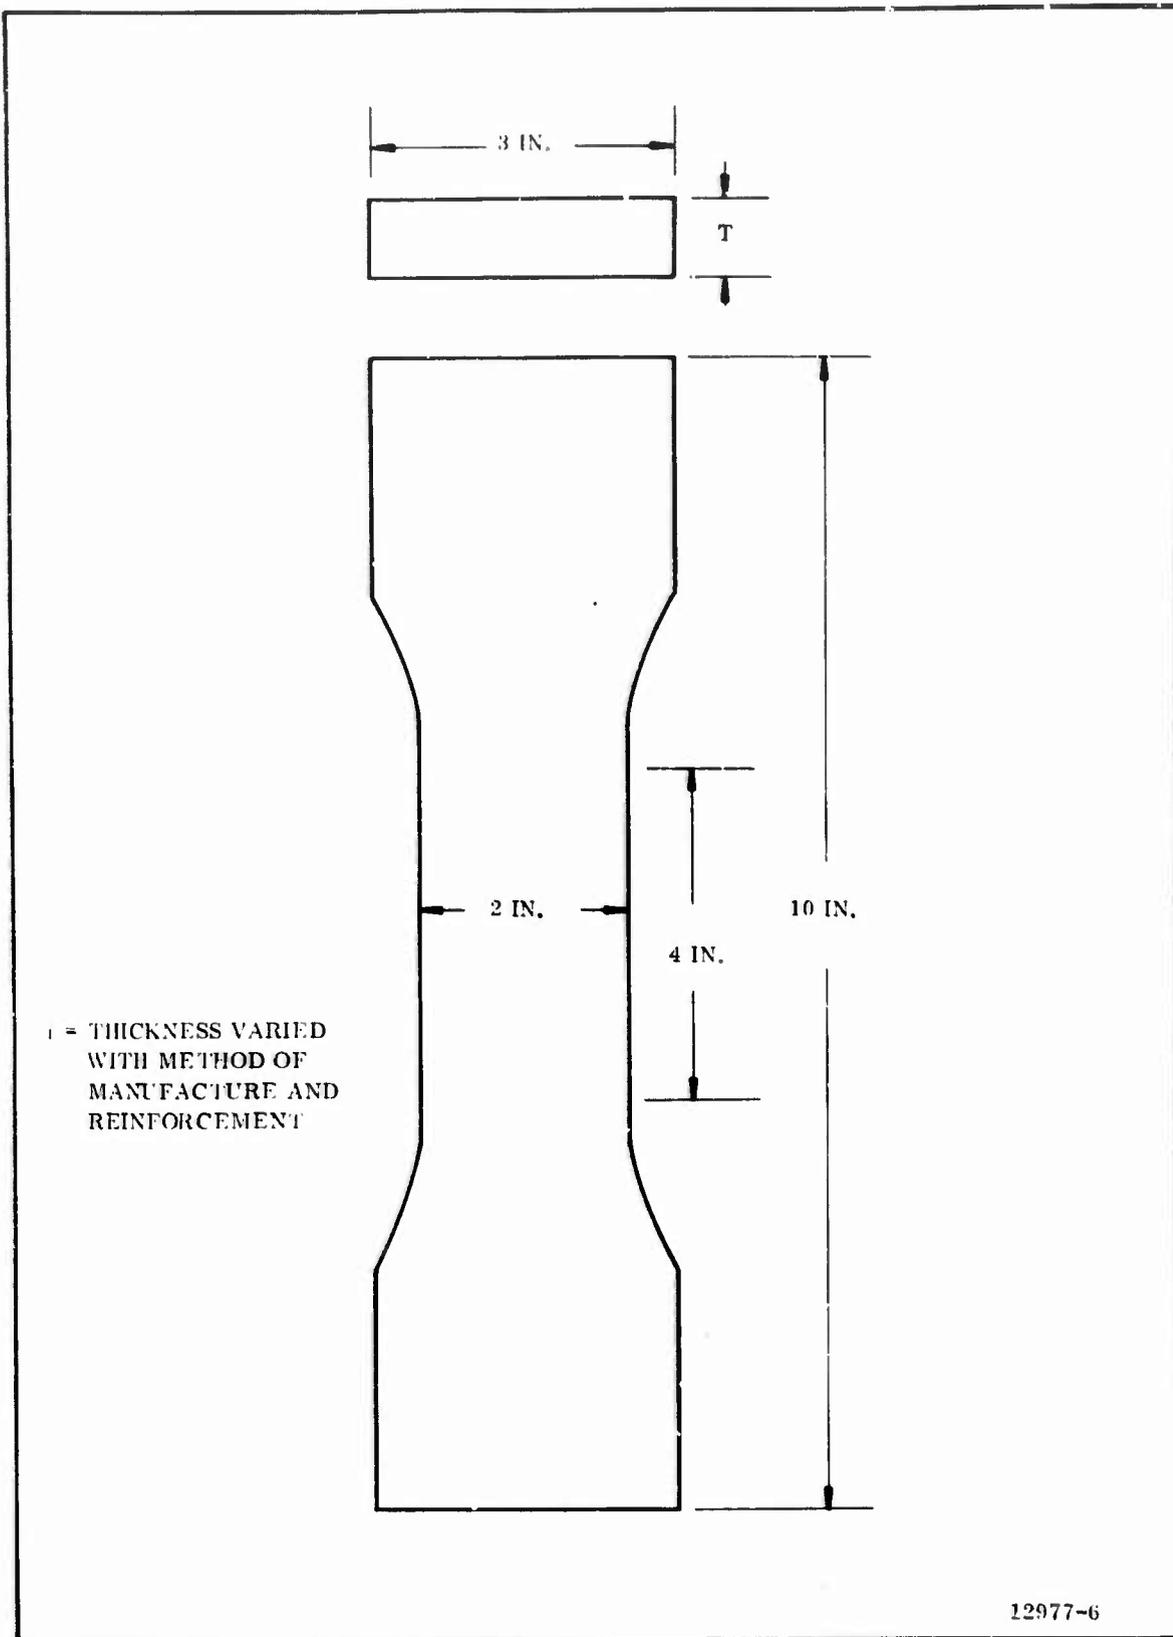
Figure 14. Fabrication Process Development Tensile Specimen

The remaining 3 in. wide portion of each slab was machined into a tensile specimen in accordance with Figure 14. This size specimen was selected to be similar to a standard plastic tensile specimen and yet include, in the gage width, an assurance of multiple honeycomb cells. For comparison purposes, all materials were machined to the same size.

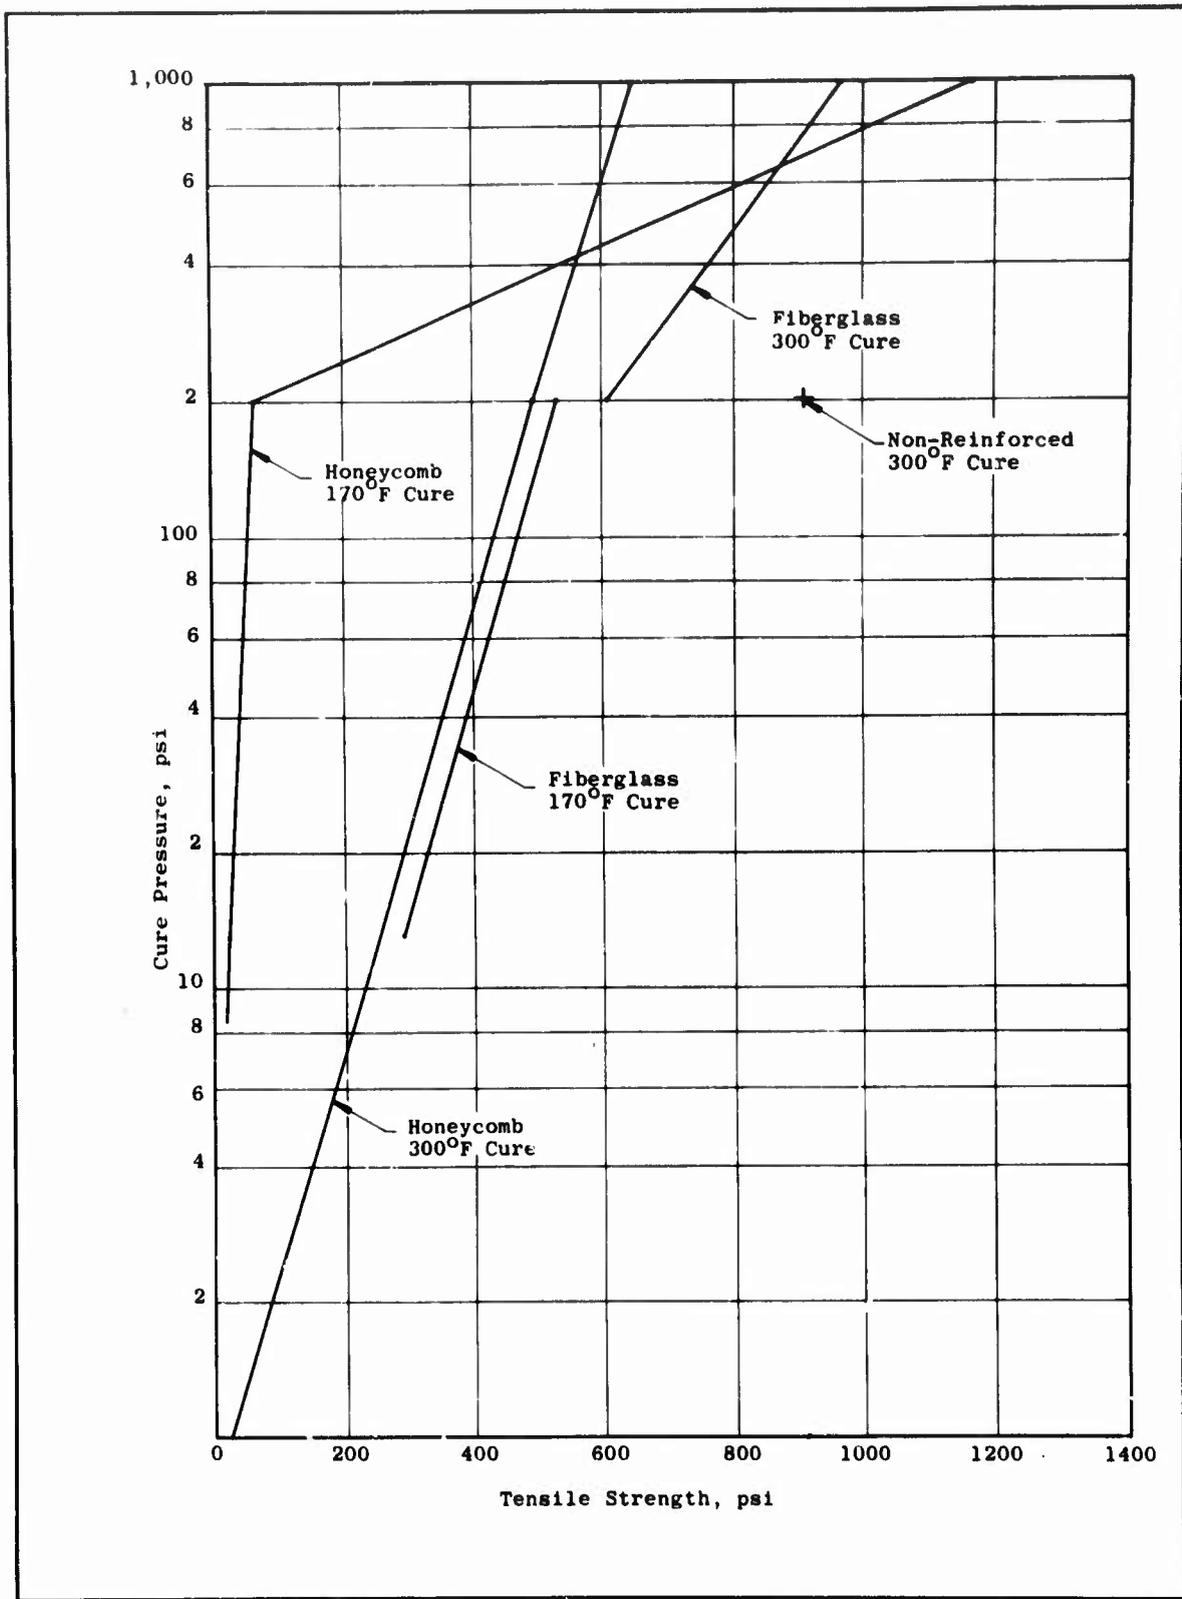
Figure 15. Tensile Strength, T-4120 Reinforced

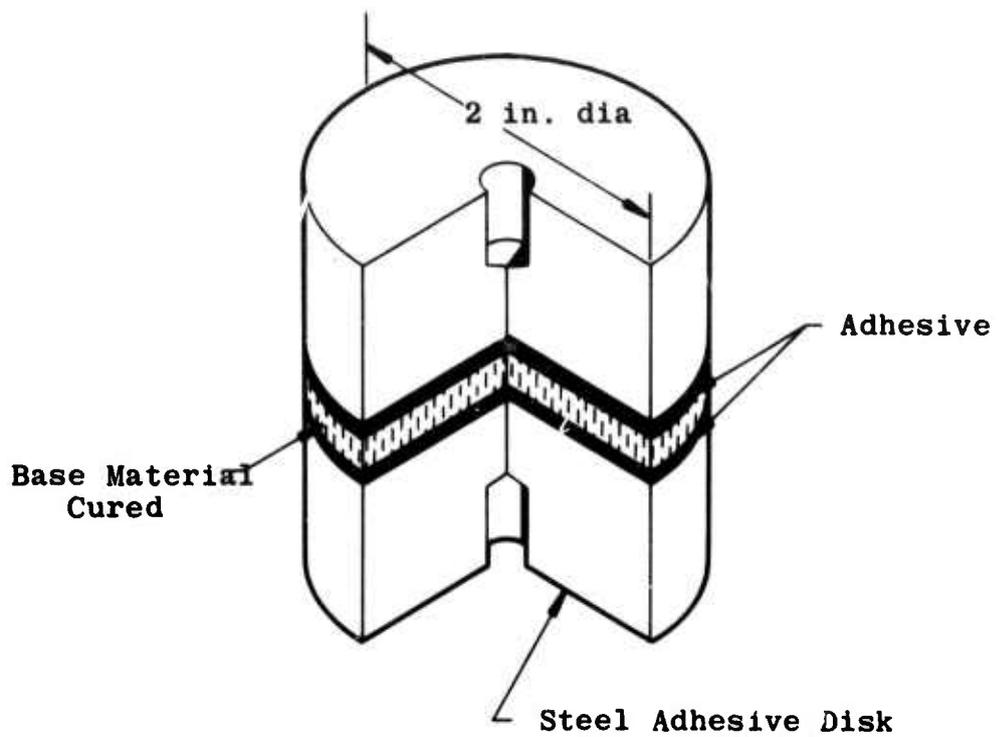
PROCEDURE: Mold base material
Cut into disks
Mill surfaces flat
Bond into assembly

Figure 16. Repair Material Adhesion Specimen, Phase I

This work was divided into two phases. The purpose of Phase I was to obtain an adhesive system that would provide a bond strength between the base material and the steel adhesion discs greater than the cohesive structural strength of the base material and proposed repair materials. Phase II was to develop bond data and erosion data of the repair materials to the base materials.

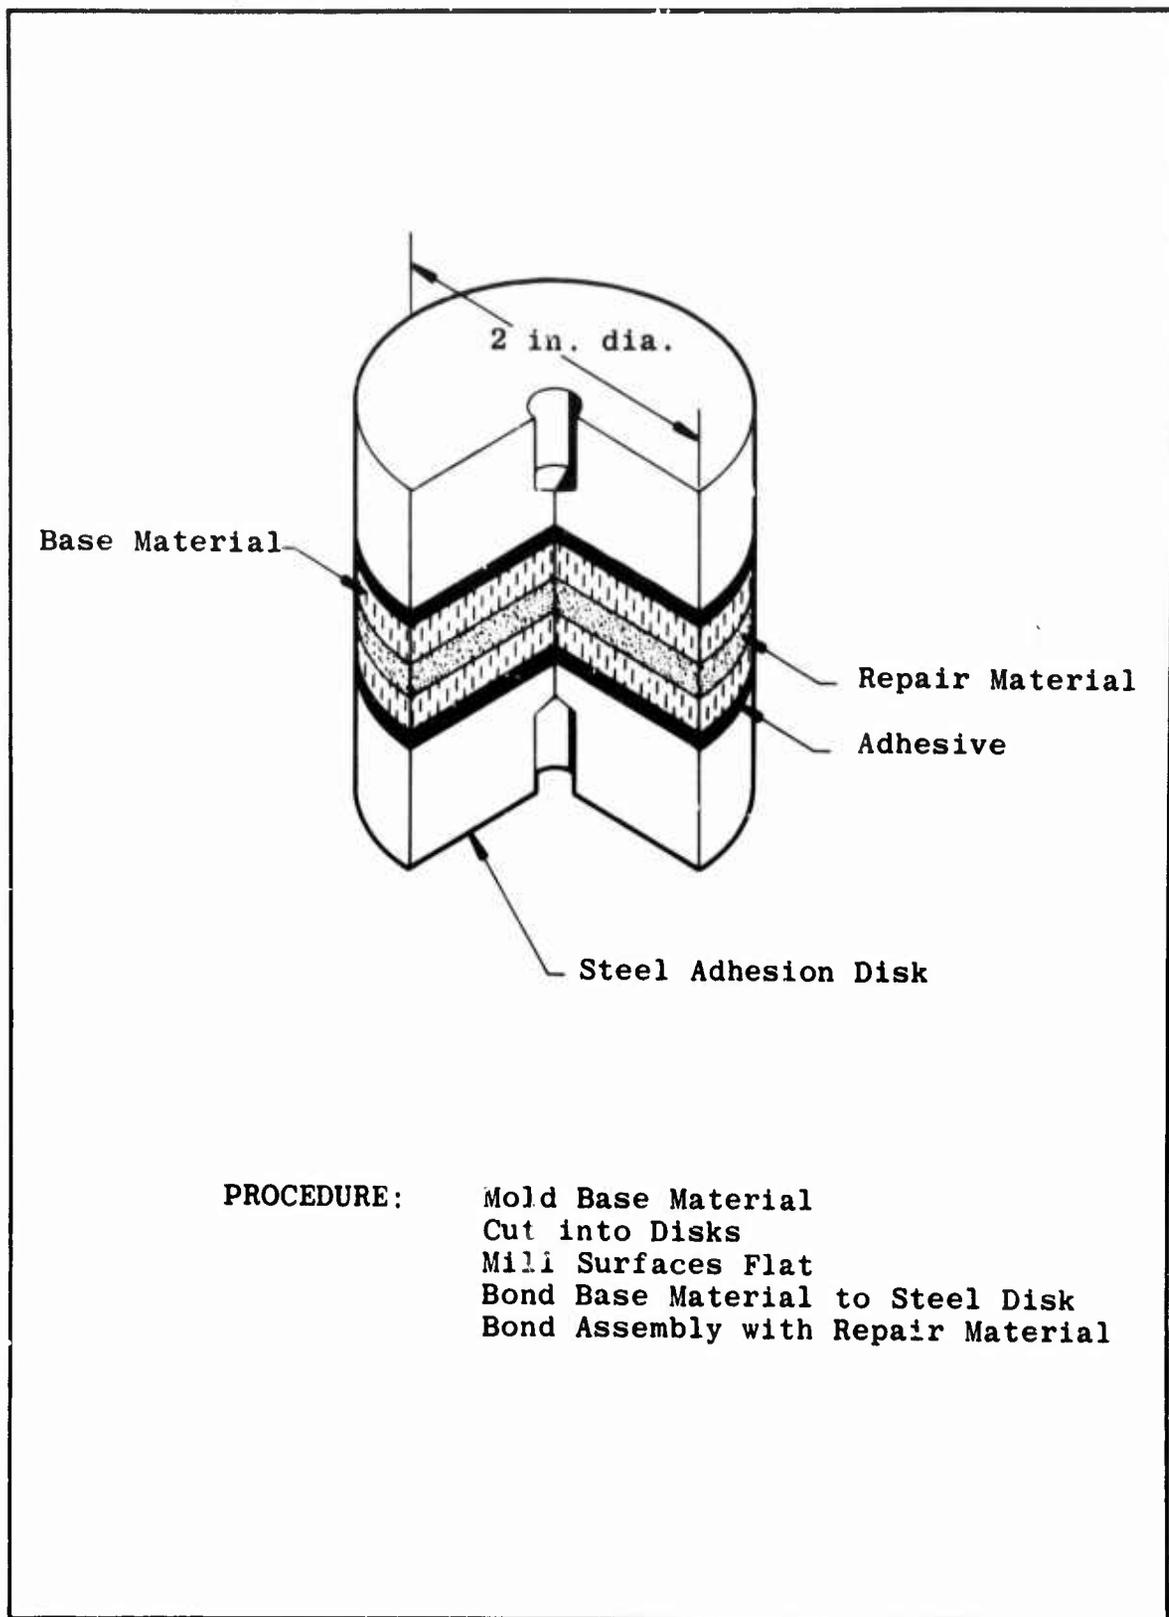
Figure 17. Repair Material Adhesion Specimen, Phase II

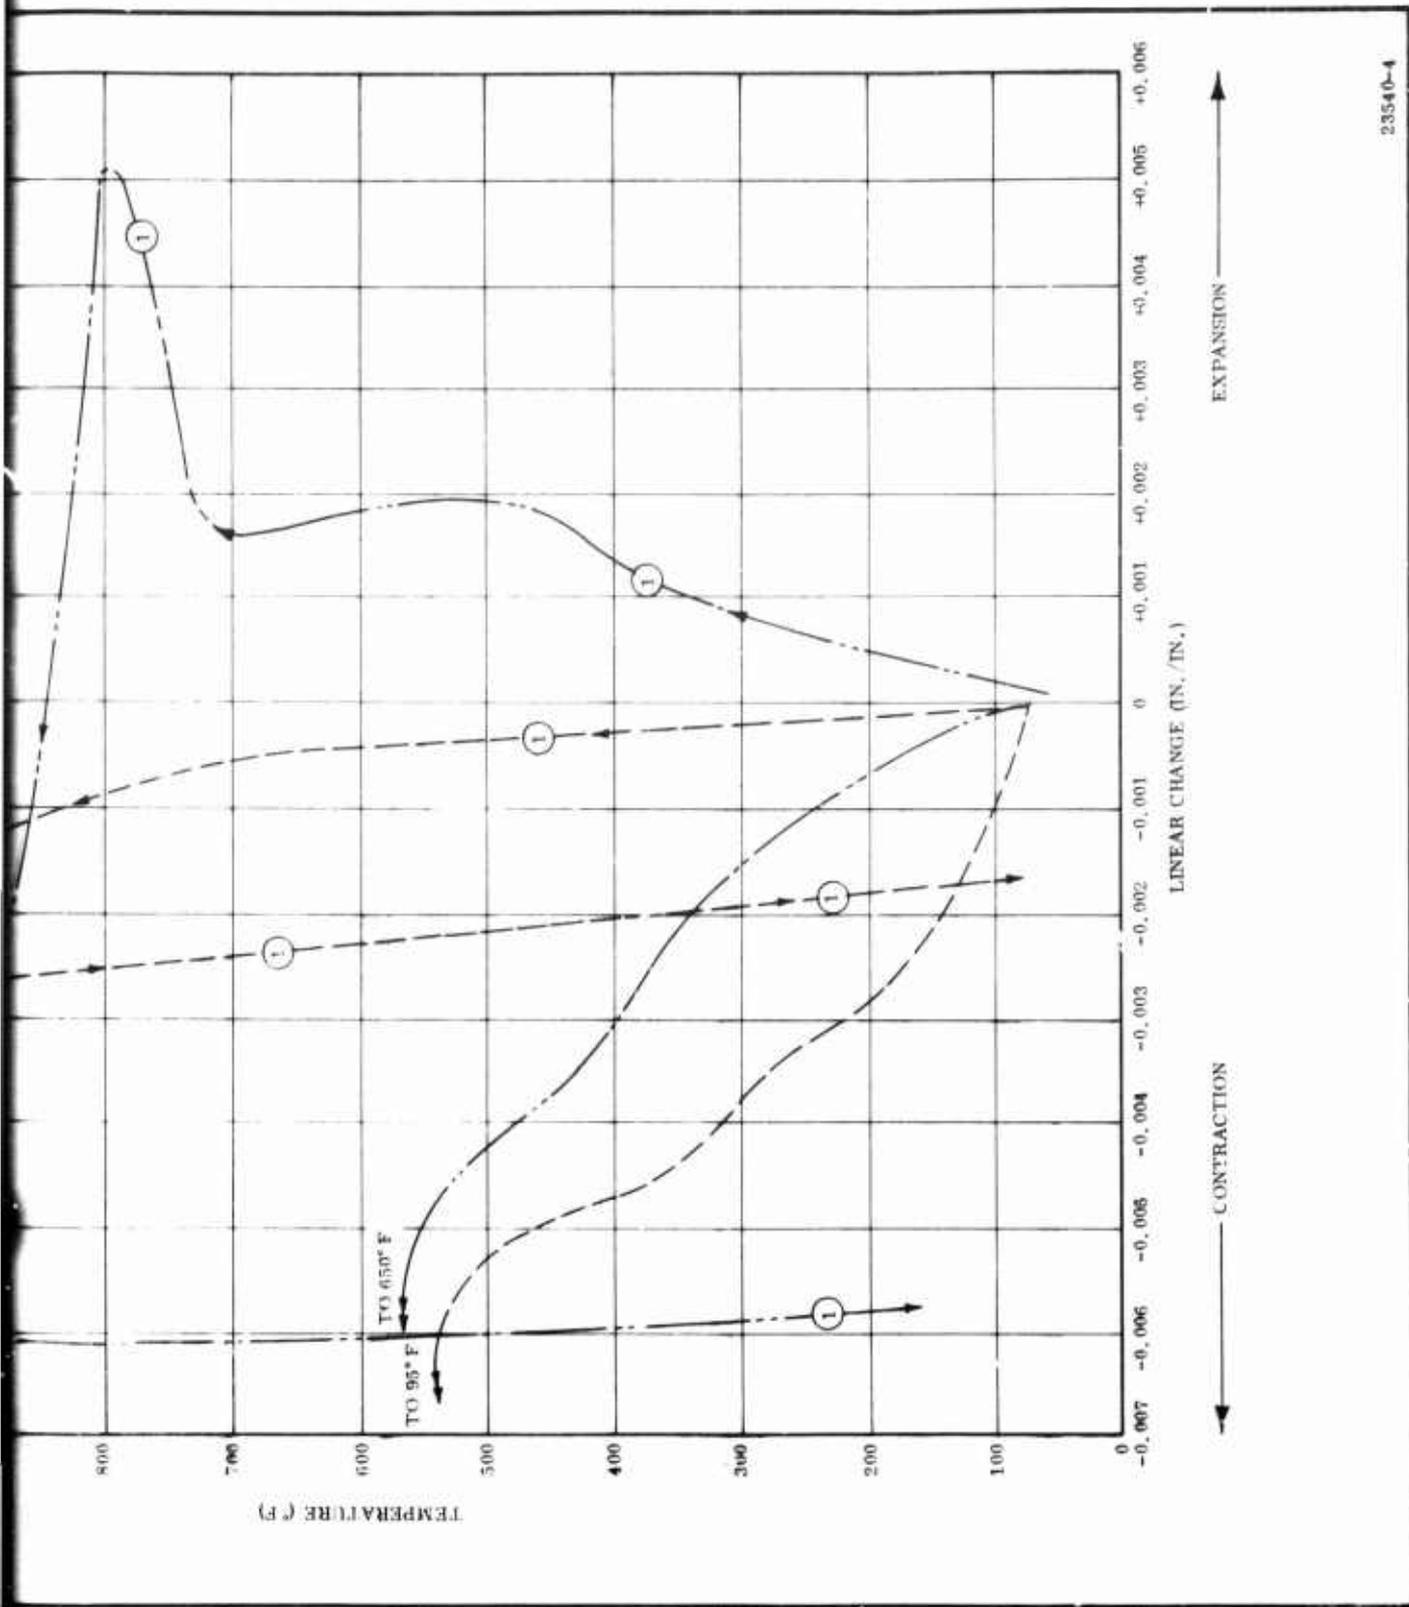
Figure 20. Linear Thermal Expansion, T-4113

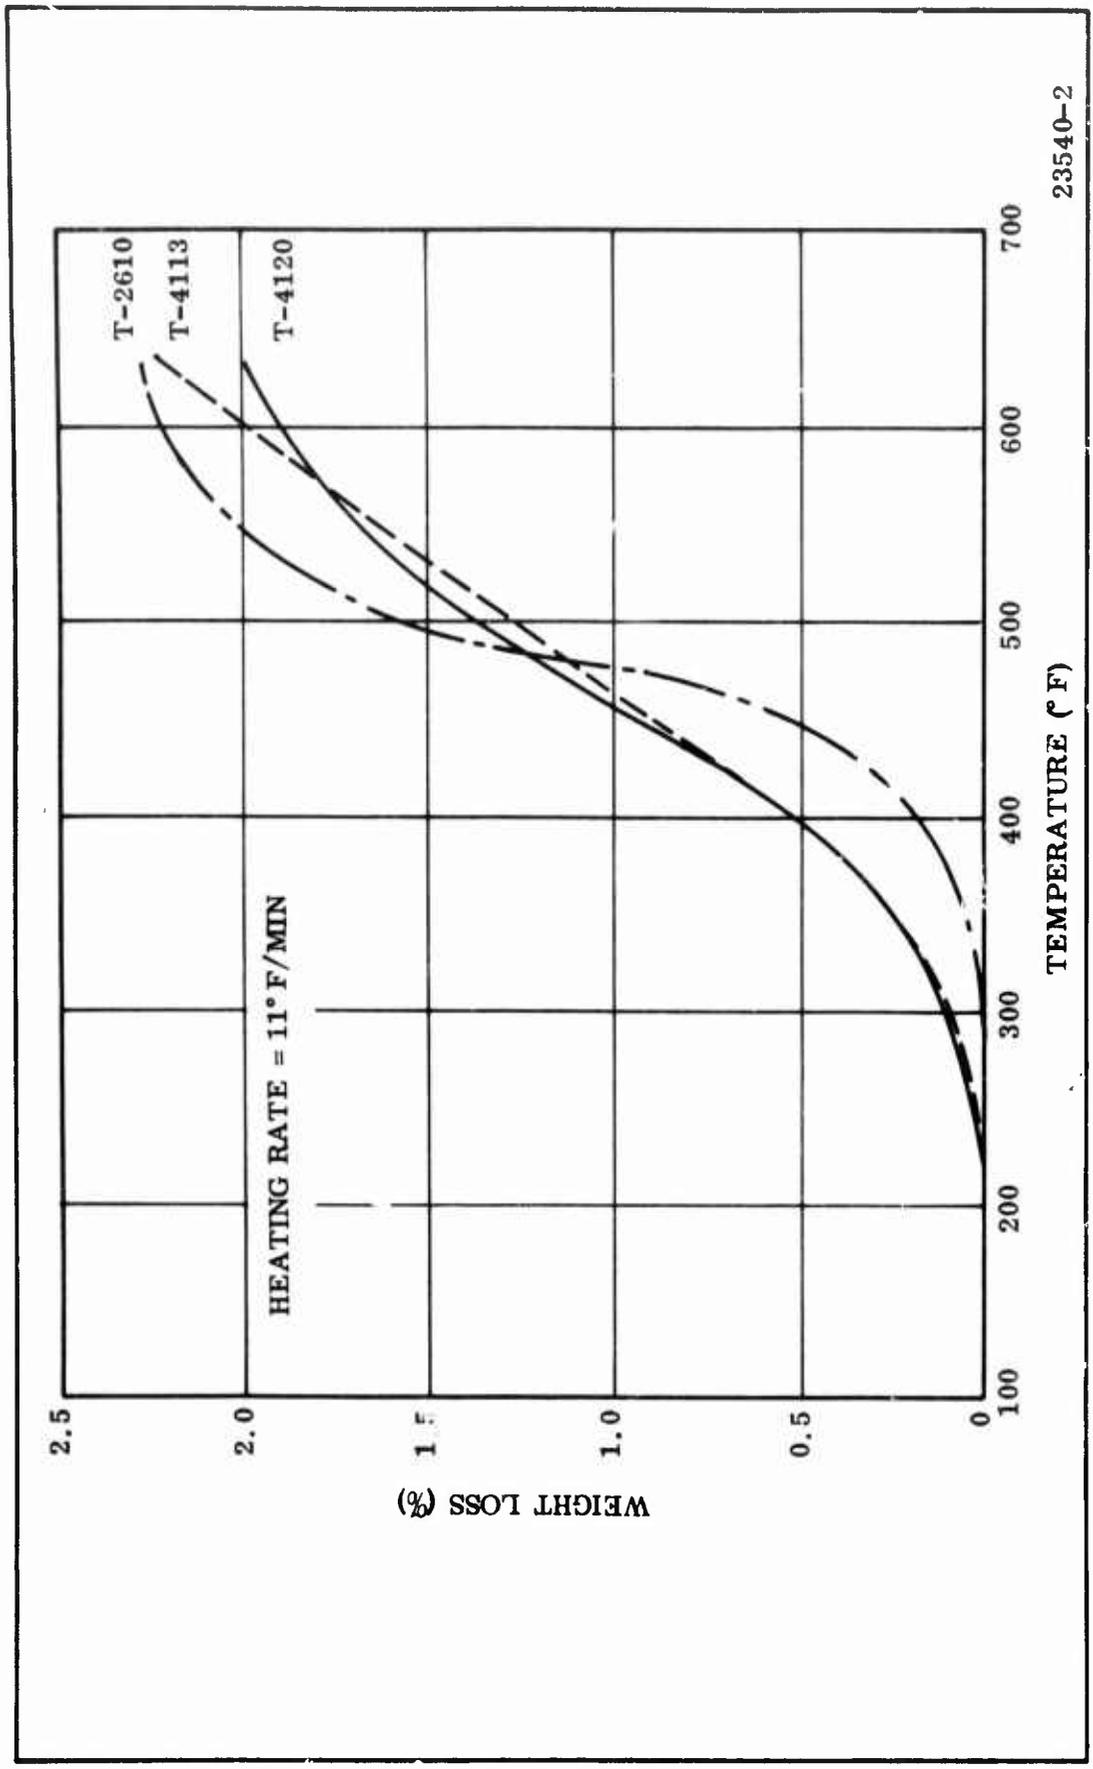
Figure 21. LCCM Weight Loss

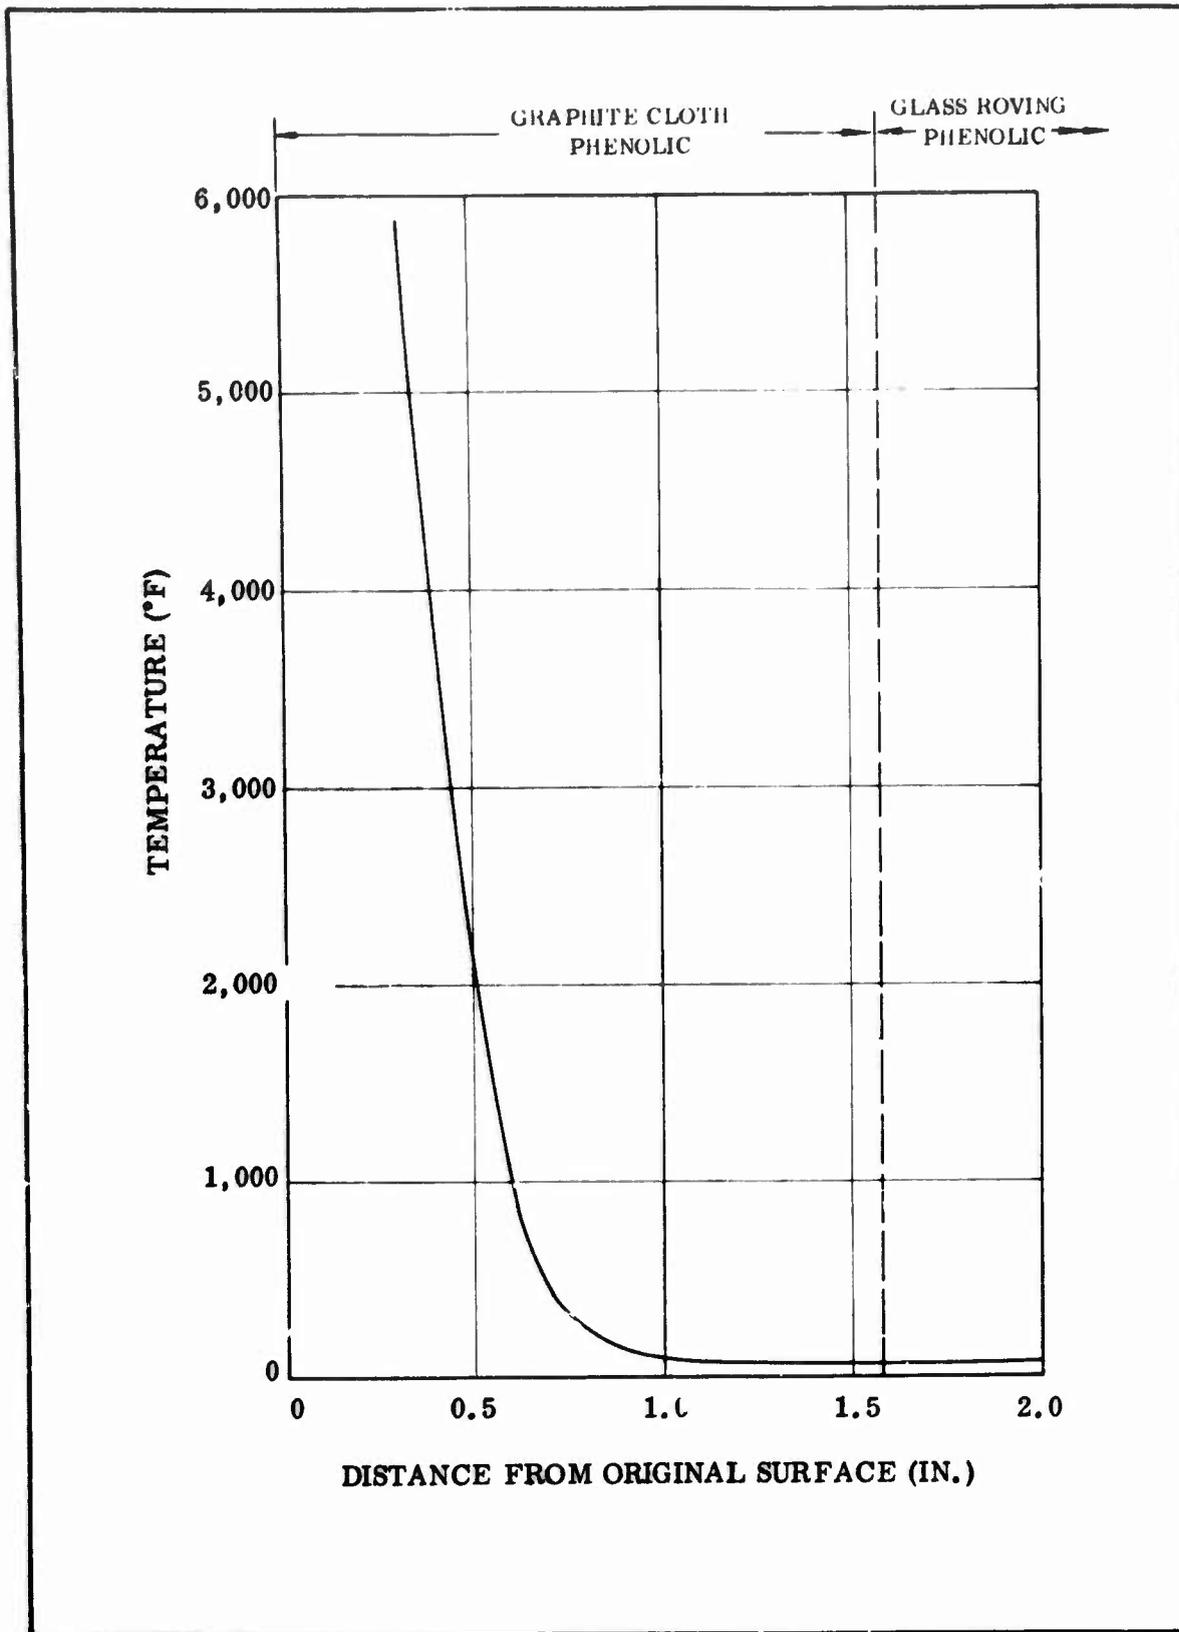
Figure 24. Predicted Thermal Profile, Nozzle No. 1, Station B, 30 Sec

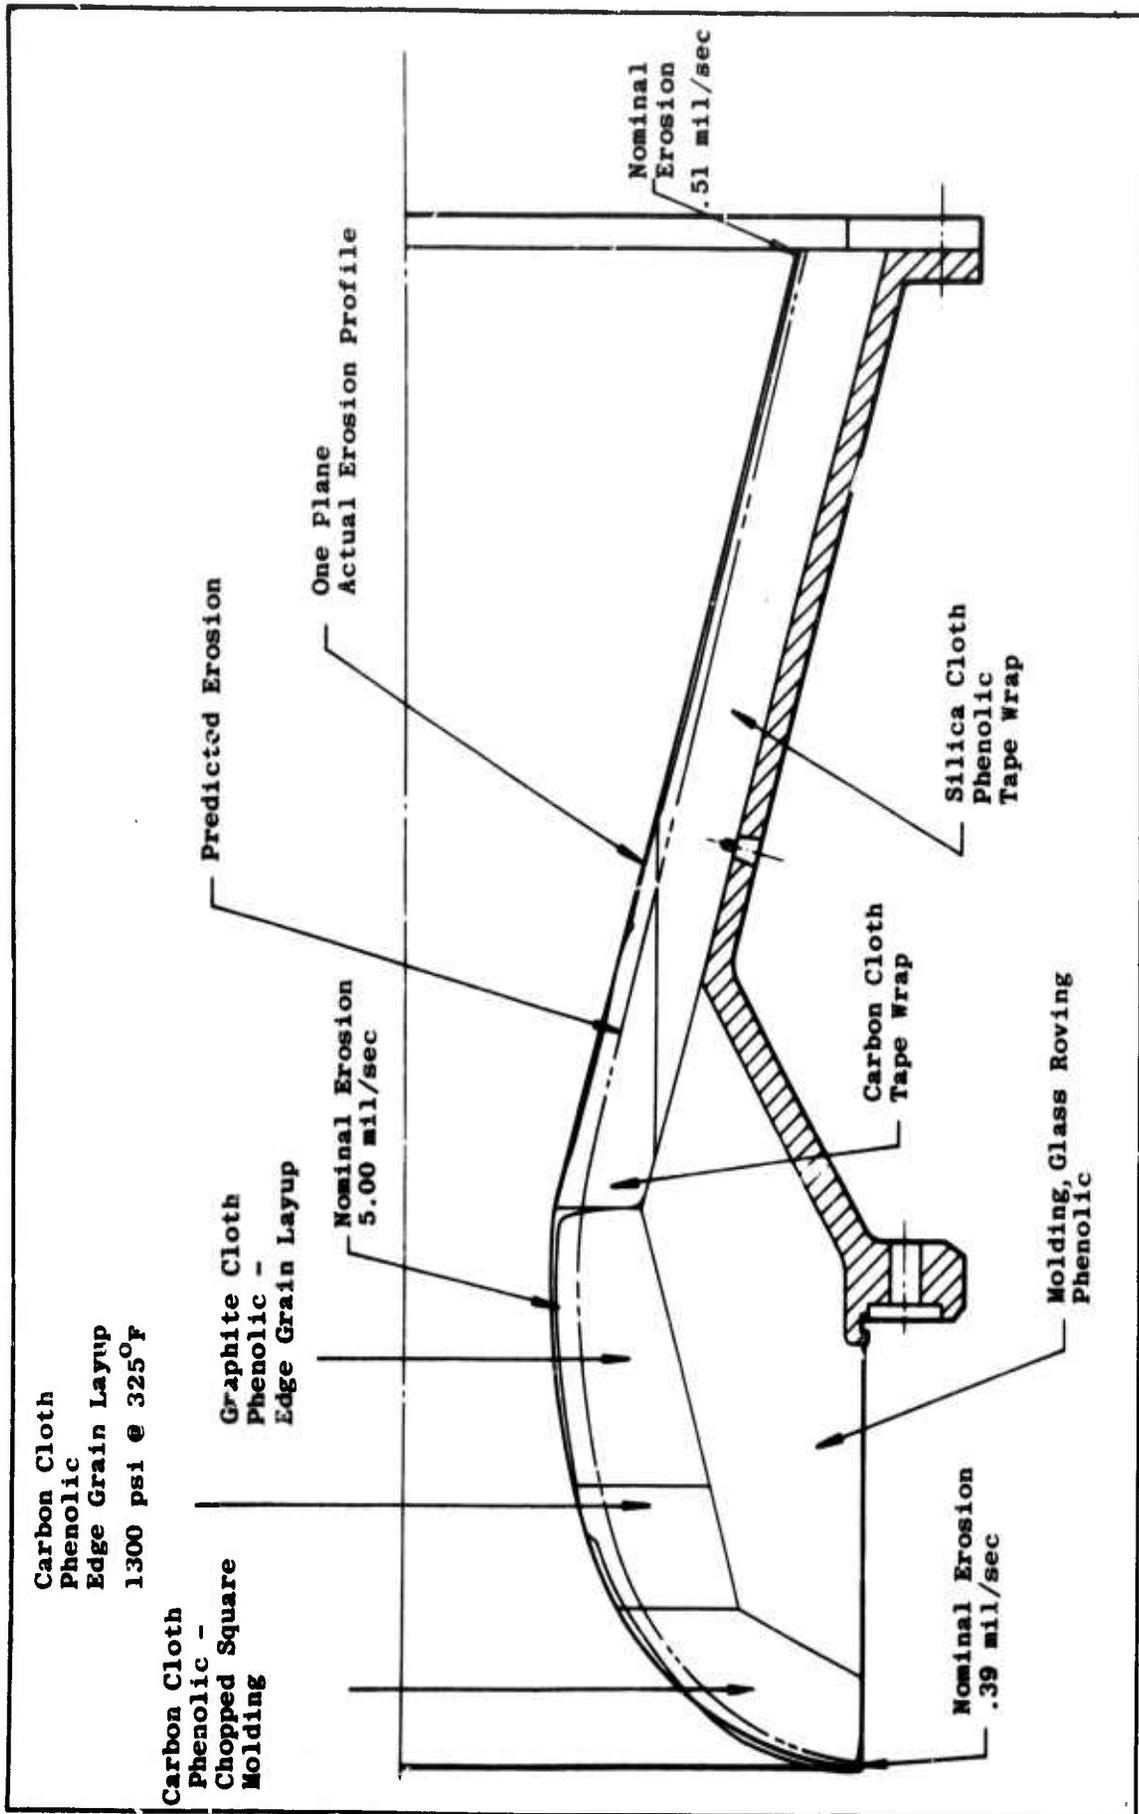
Figure 64. Nozzle No. 1 Erosion Profile

The erosion was determined by sectioning the static tested nozzle component at several locations and measuring the thickness of the residual material. The erosion is the difference between the original thickness (nominal and the measured residual material). The erosion profiles for Nozzles No. 1, 2 and 3 are shown in Figures 64, 65 and 66. The calculated erosion rate at various stations is summarized in Table XXIV using the web time for each motor. The nozzle erosion rate versus area ratio presented graphically in Figure 67 shows the LCCM to be equal or superior to the plastics in the throat and exit cone but not in the inlet. For Nozzles No. 2 and 3,

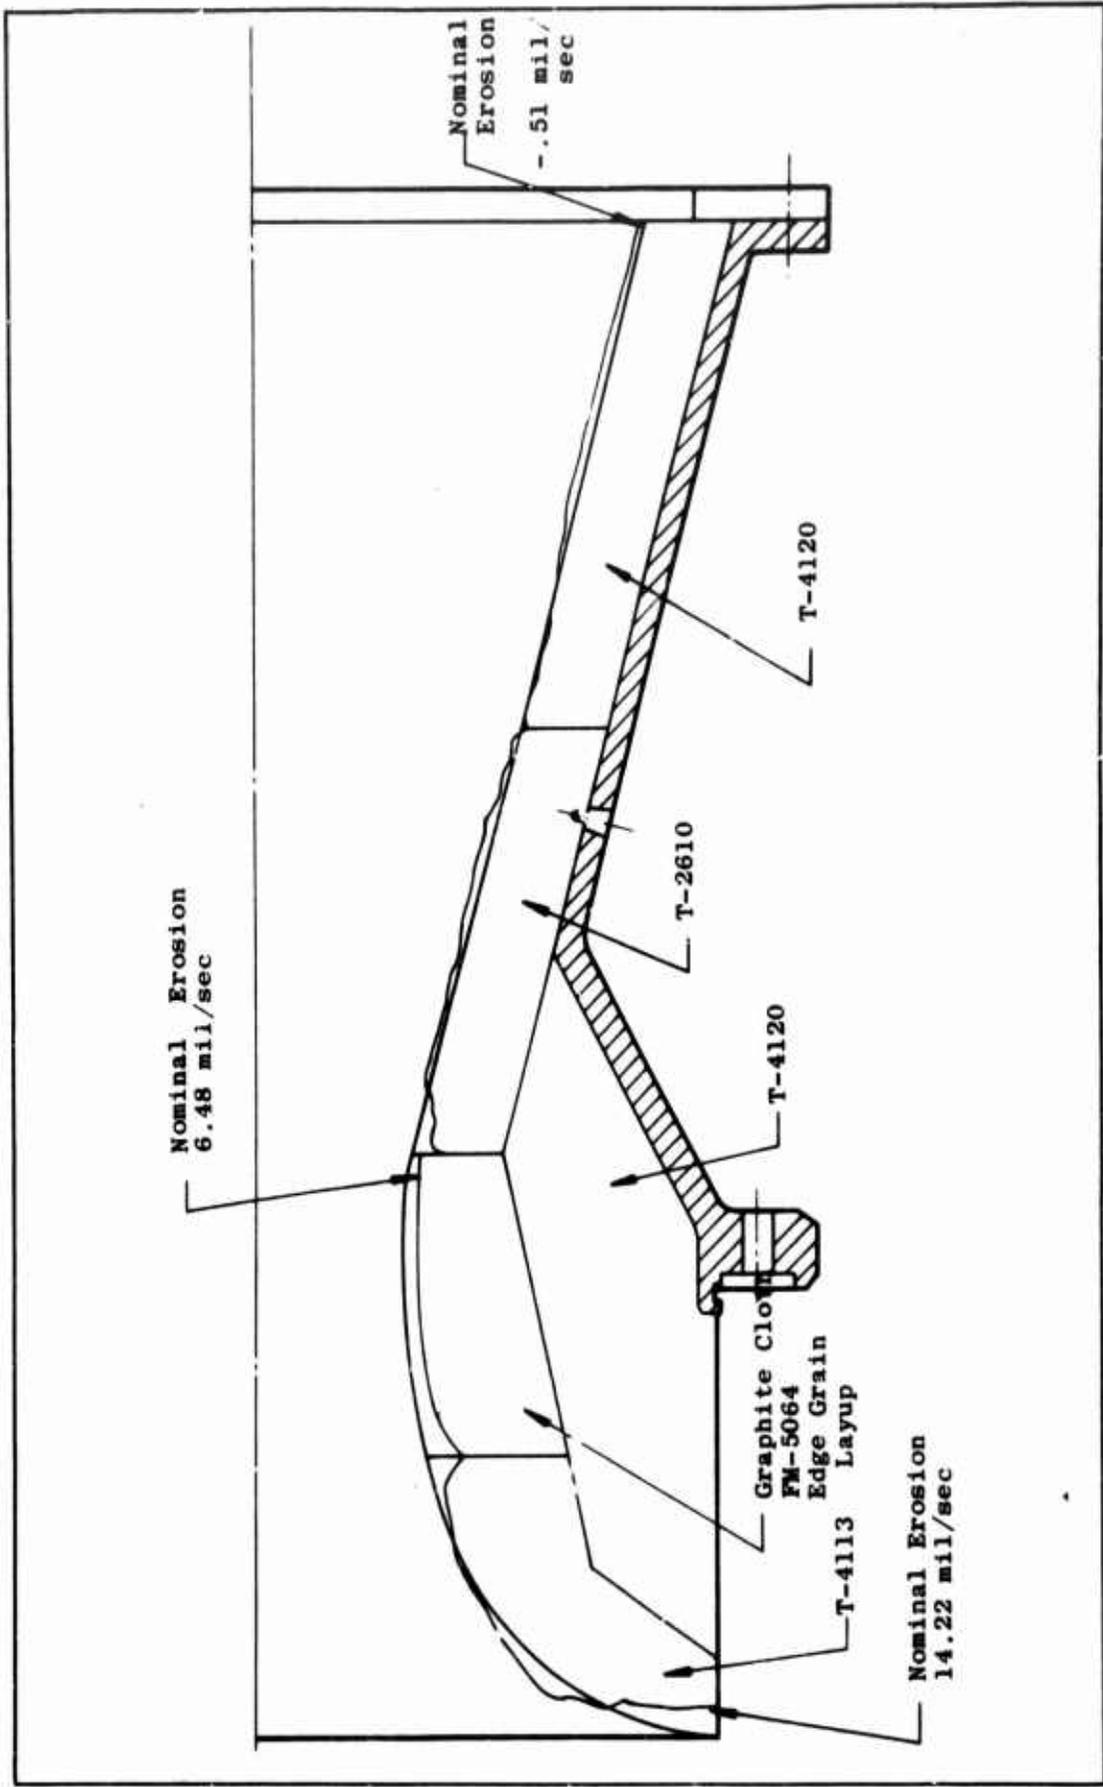
Figure 65. Nozzle No. 2 Eroisor. Profile

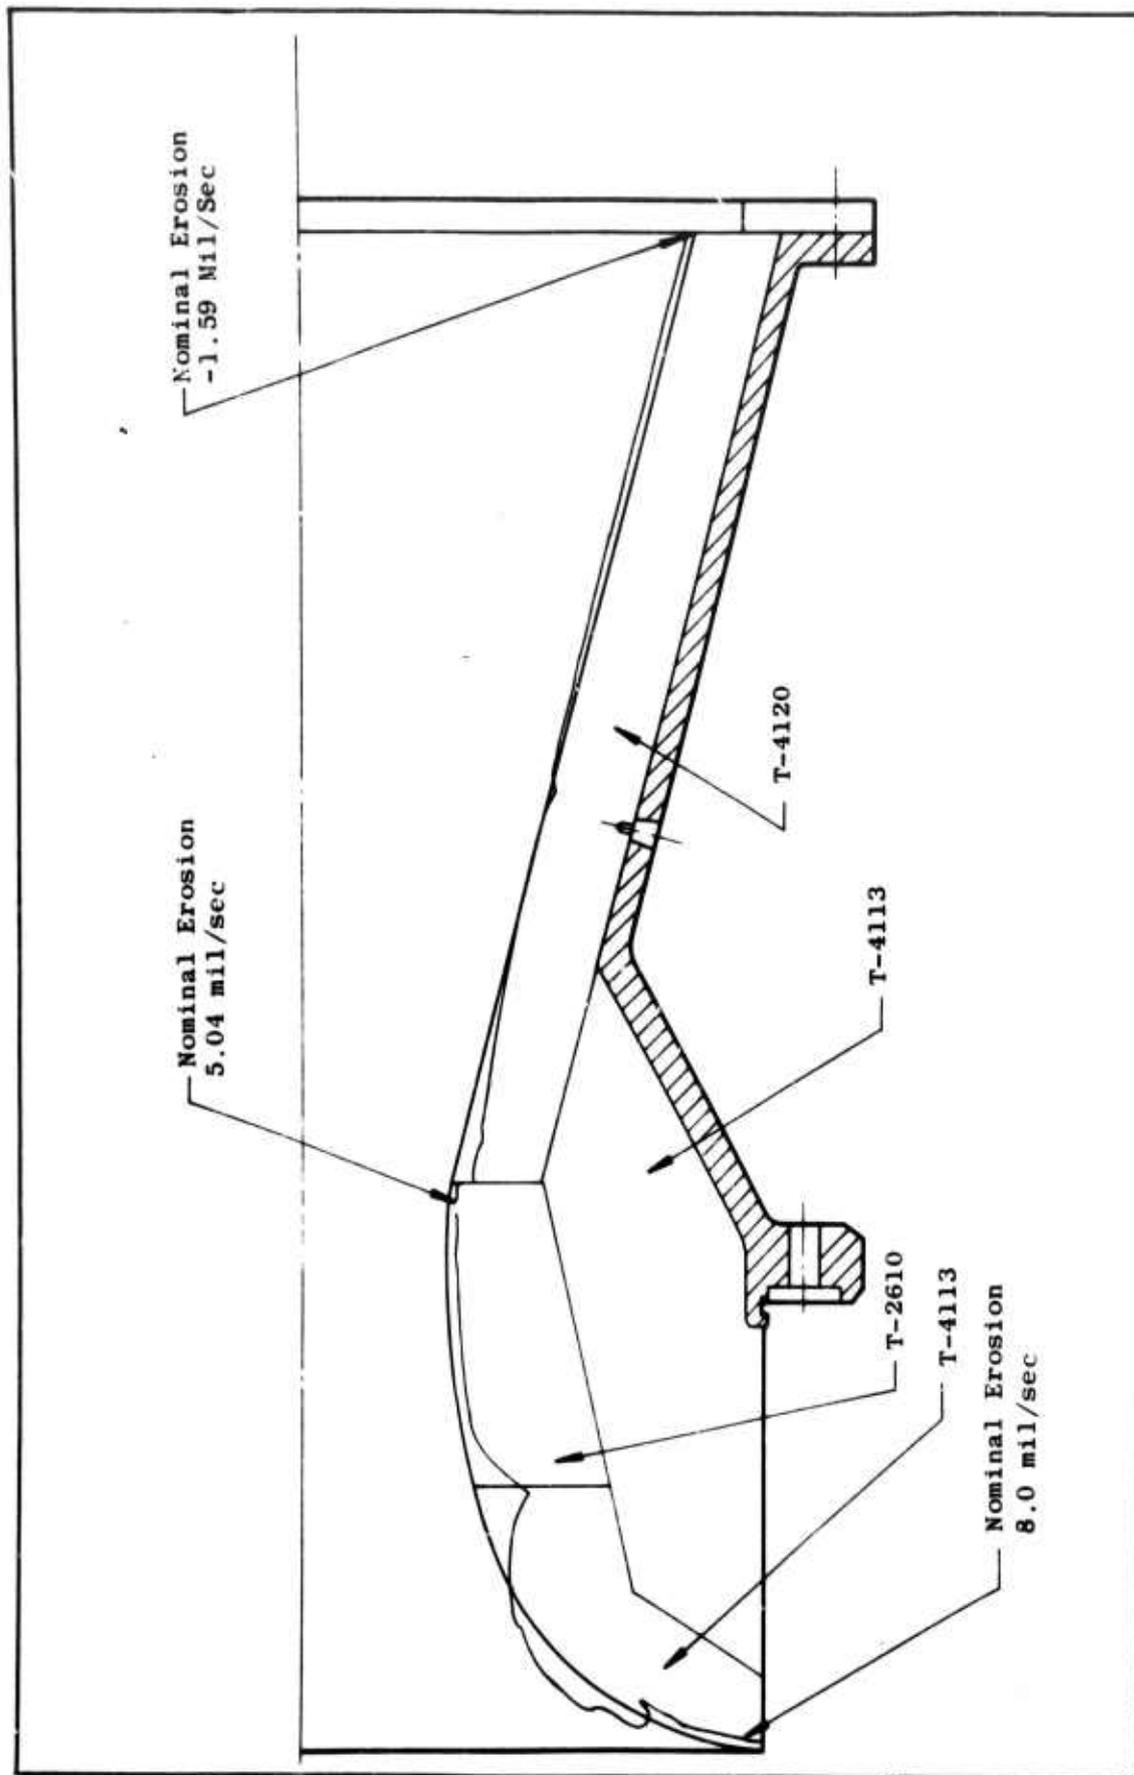
Figure 66. Nozzle No. 3 Erosion Profile
