FINAL REPORT
DEVELOPMENT OF CASTABLE CARBONACEOUS
MATERIALS FOR SOLID ROCKET NOZZLES

THIOKOL CHEMICAL CORPORATION
WASATCH DIVISION

Technical Report AFRPL-TR-69-129

March 1969

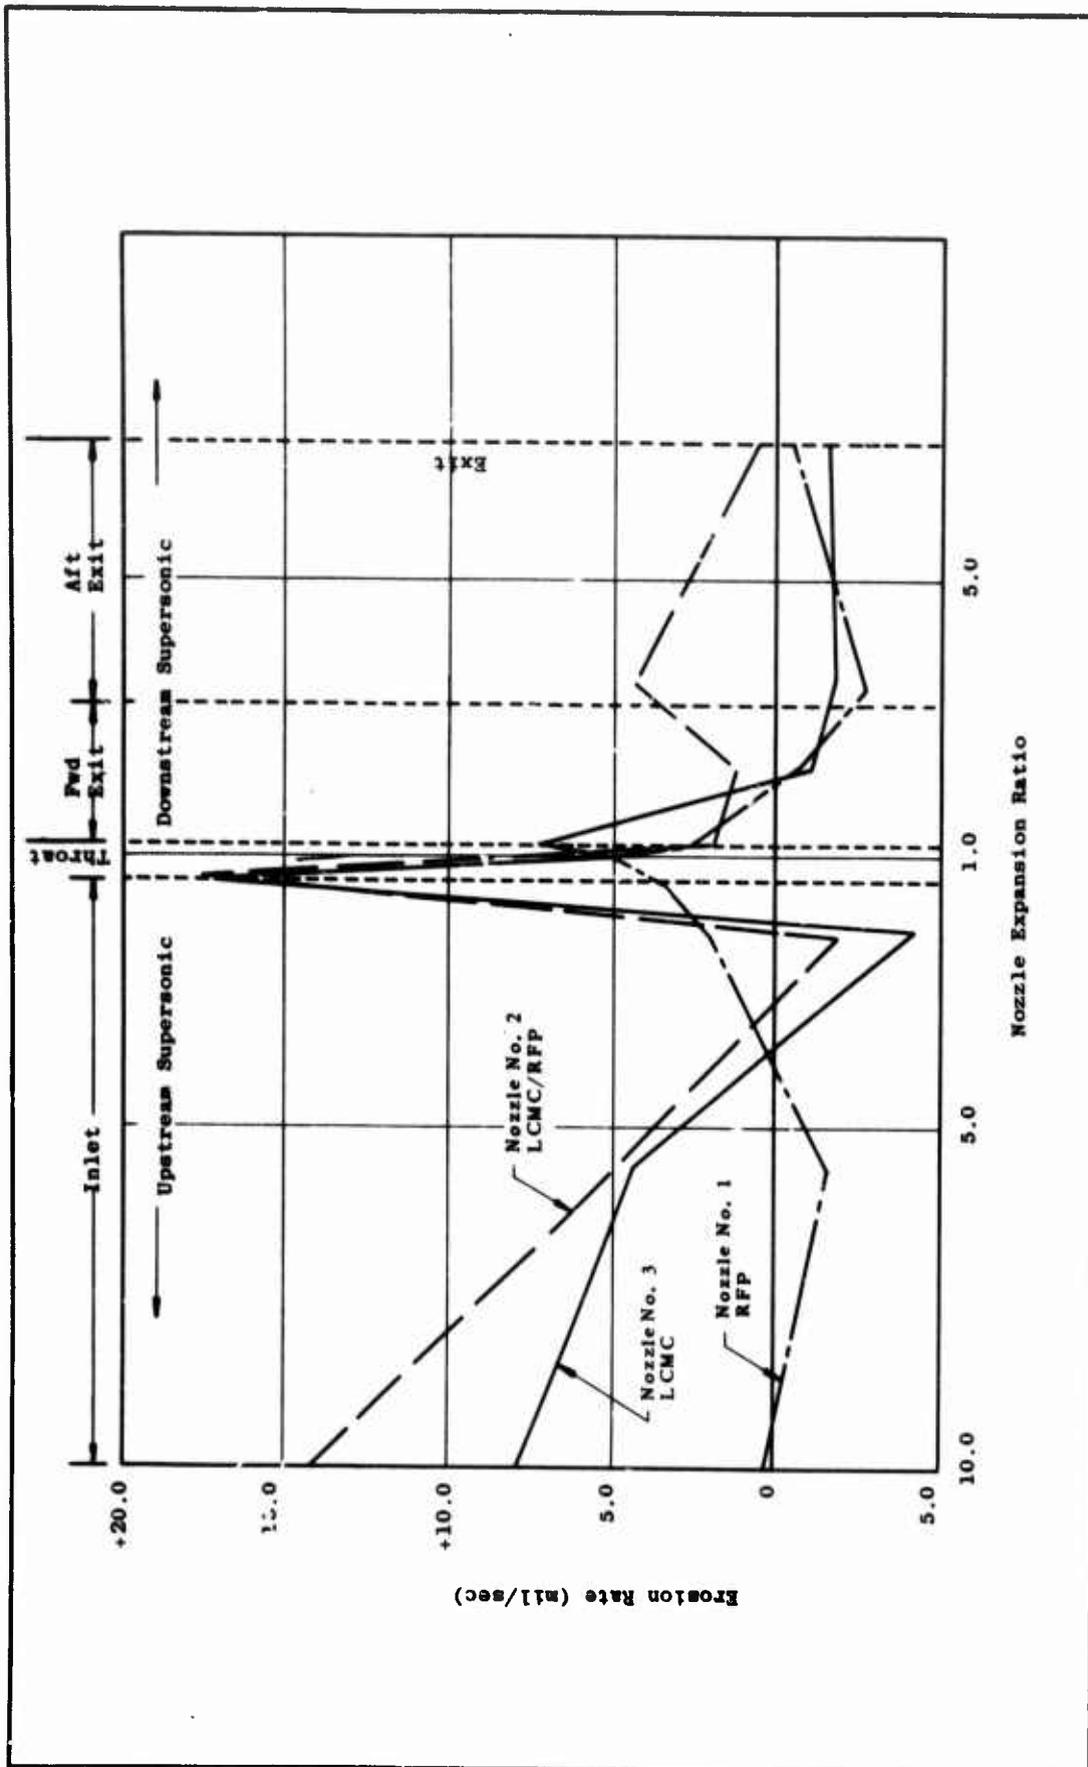
Figure 67. Material Erosion Rate

the high erosion rate at the inlet-nozzle interface was not plotted because the erosion consisted of localized gouging.

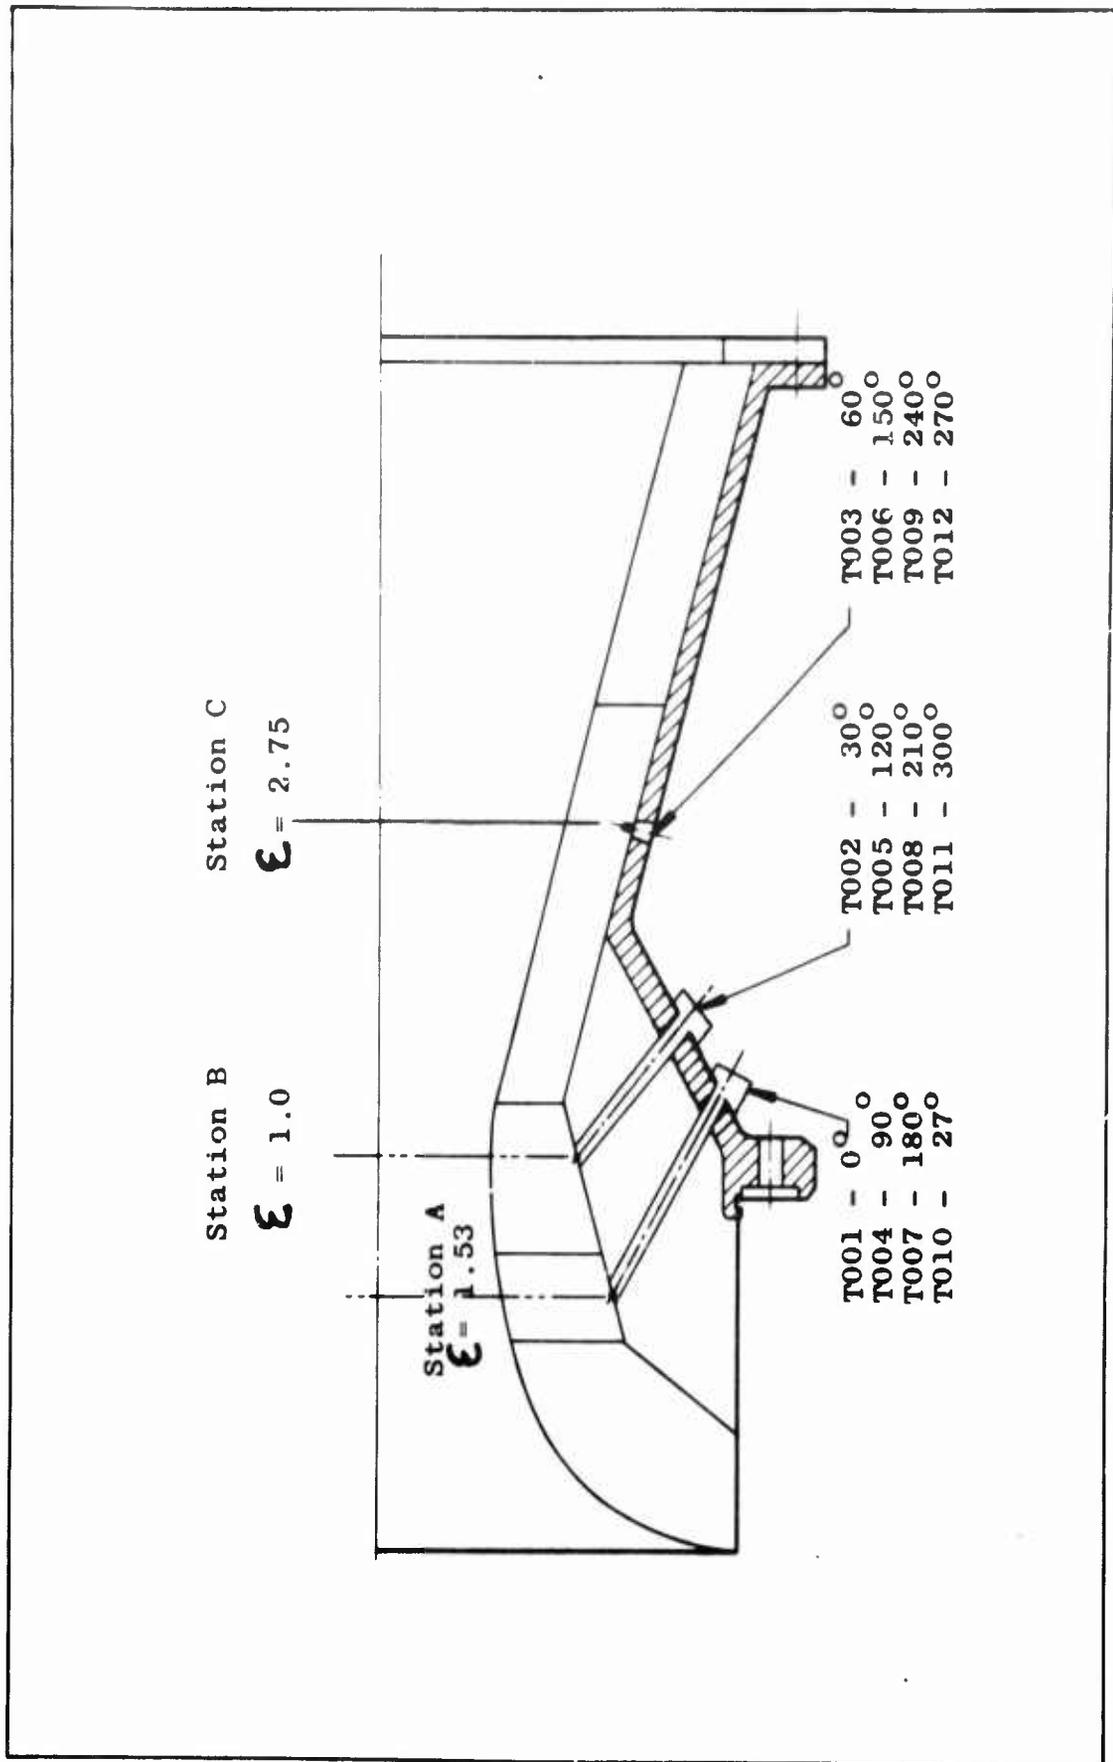
▲ Thermocouple Probes
 4 ea. located at 90 deg

Location Index	Material	Postfire Density gm/cc
1. Throat	T-2610	1.562
2. Throat	T-2610	1.572
3. Throat Backup	T-4113	1.503
4. Throat Backup	T-4113	1.546
5. Inlet	T-4113	1.462
6. Inlet	T-4113	1.410
7. Exit - Aft	T-4120	1.375
8. Exit - Aft	T-4120	1.471
9. Exit - Fwd	T-4120	1.306
10. Exit - Fwd	T-4120	1.520

Figure 68. Nozzle Instrumentation Location

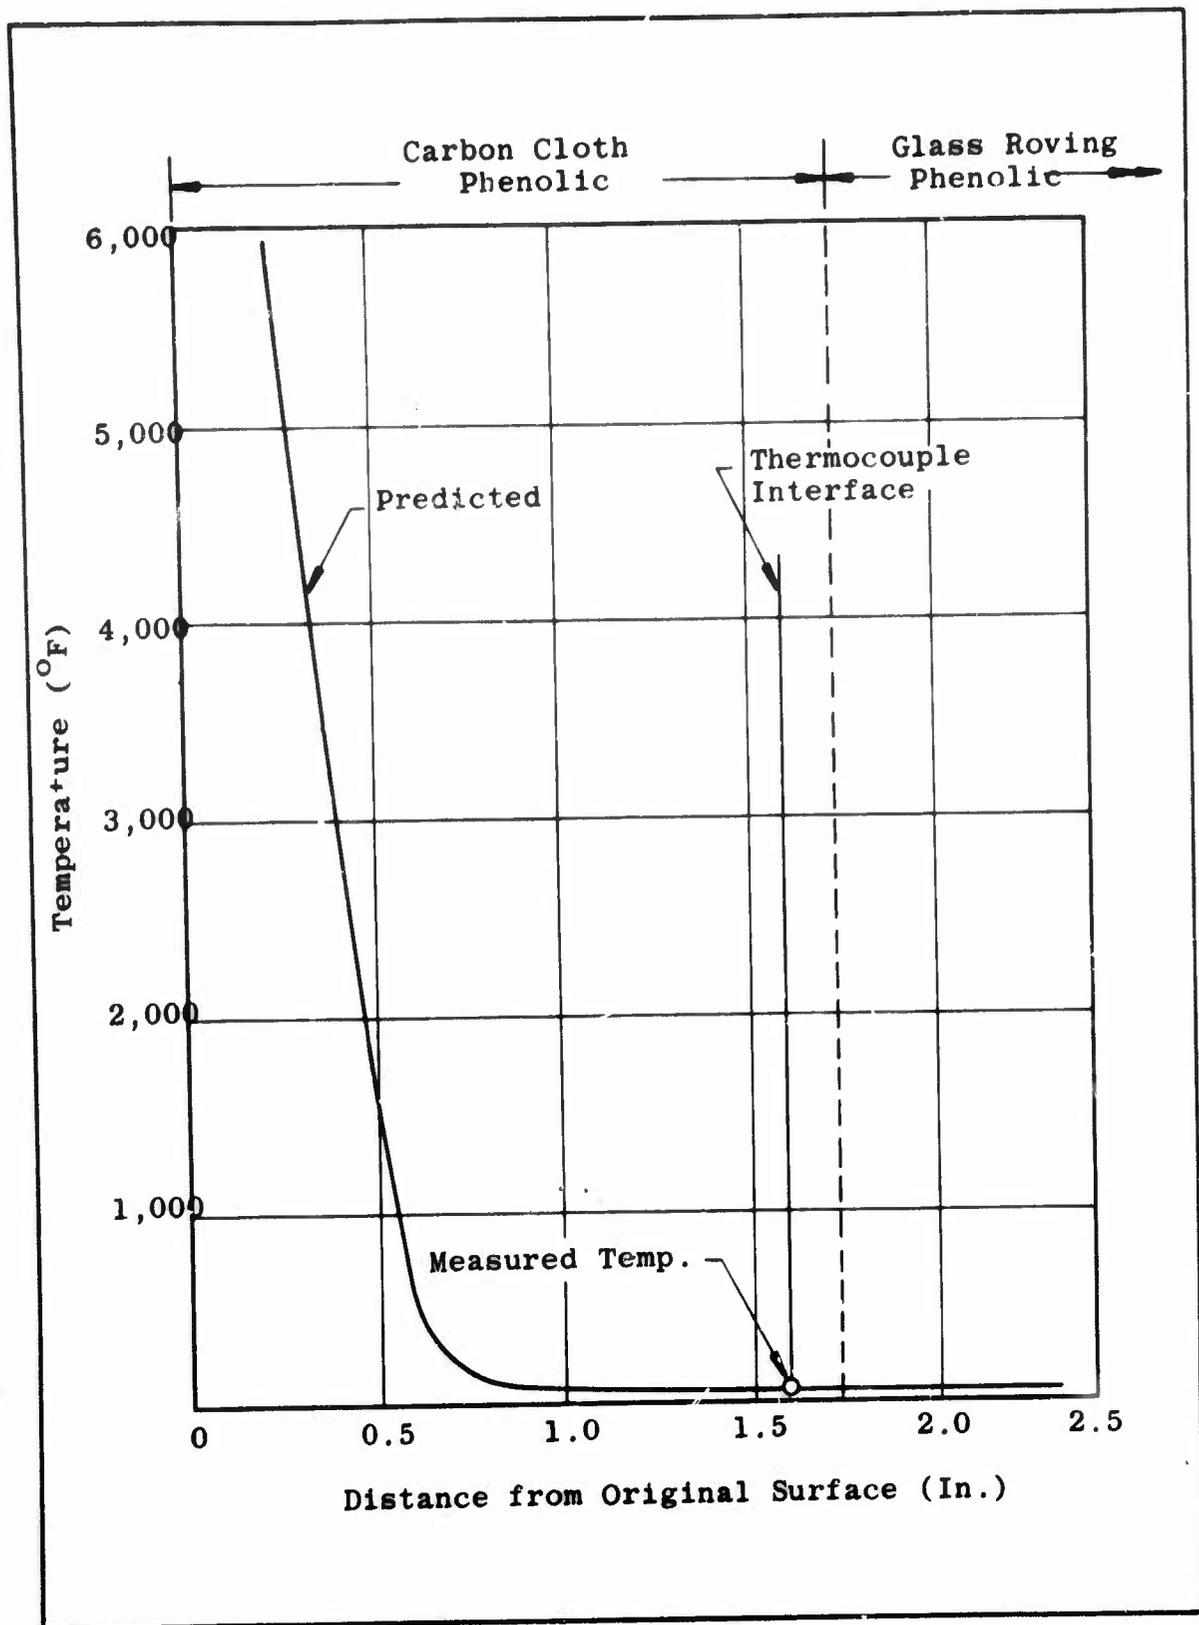
Figure 72. Thermal Profile, Nozzle No. 1, Station A, 30 Sec

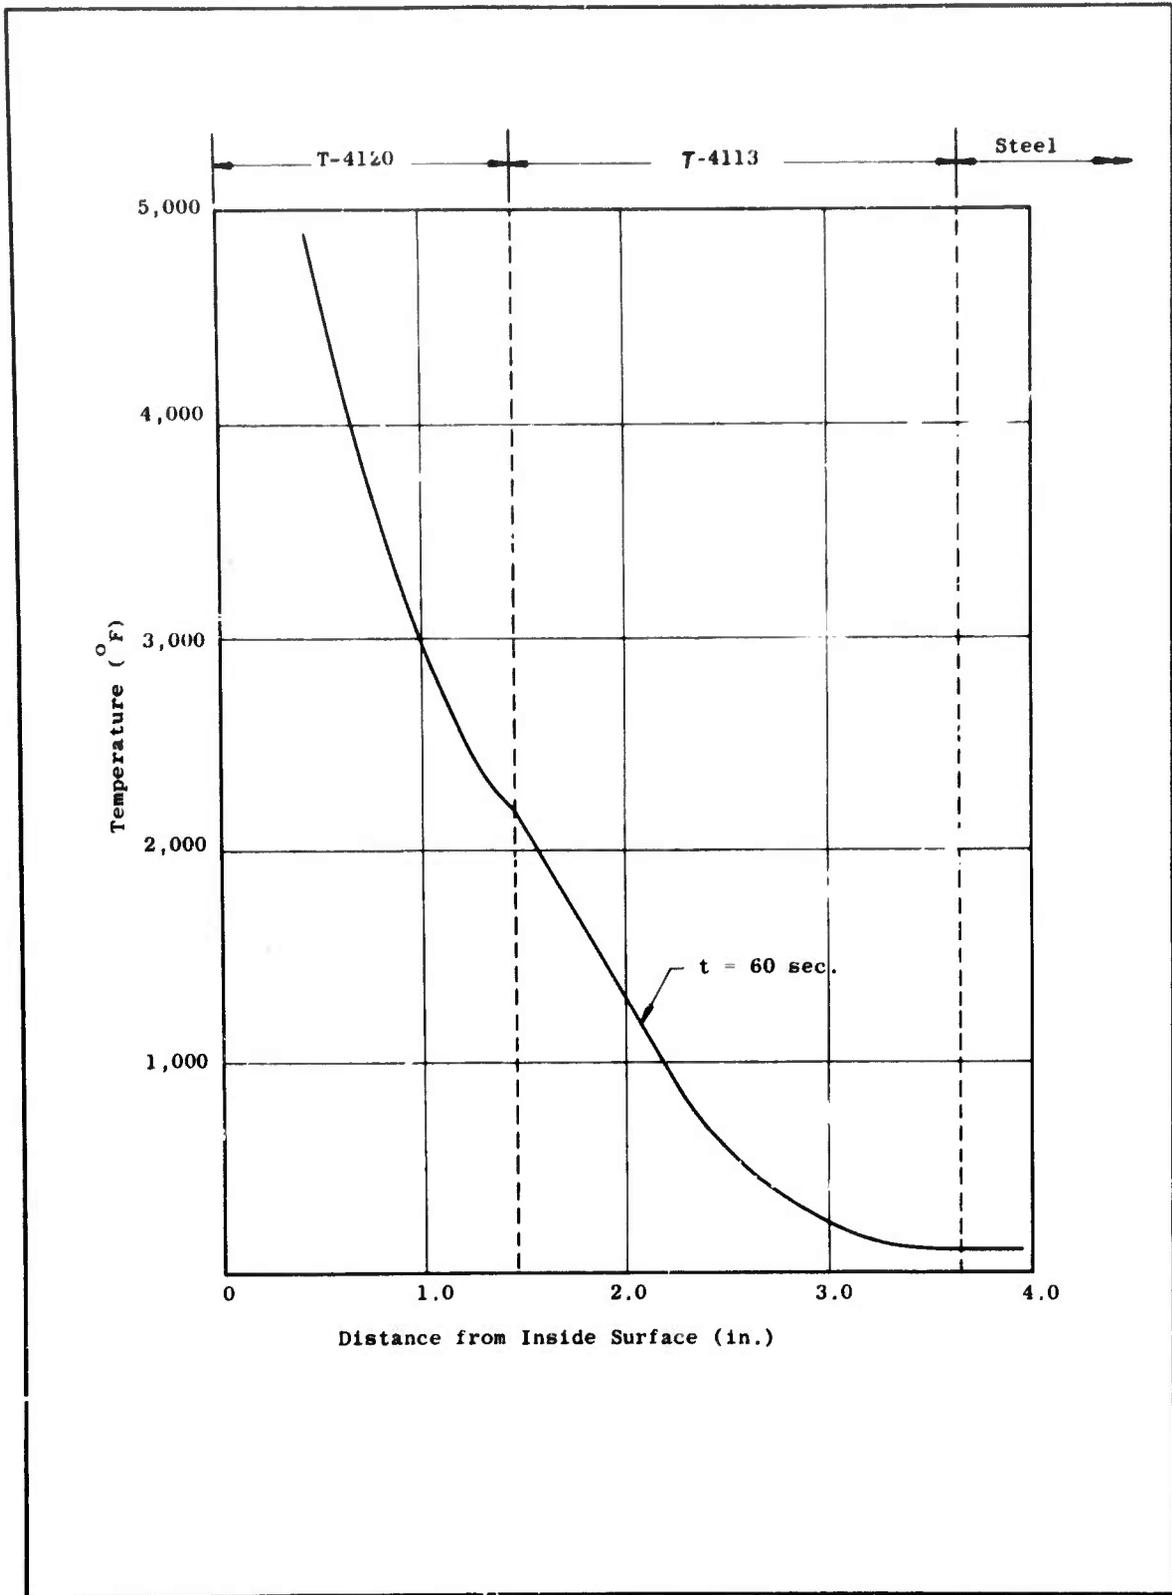
Figure 77. Predicted Temperature Profiles, Nozzle No. 4, Station B

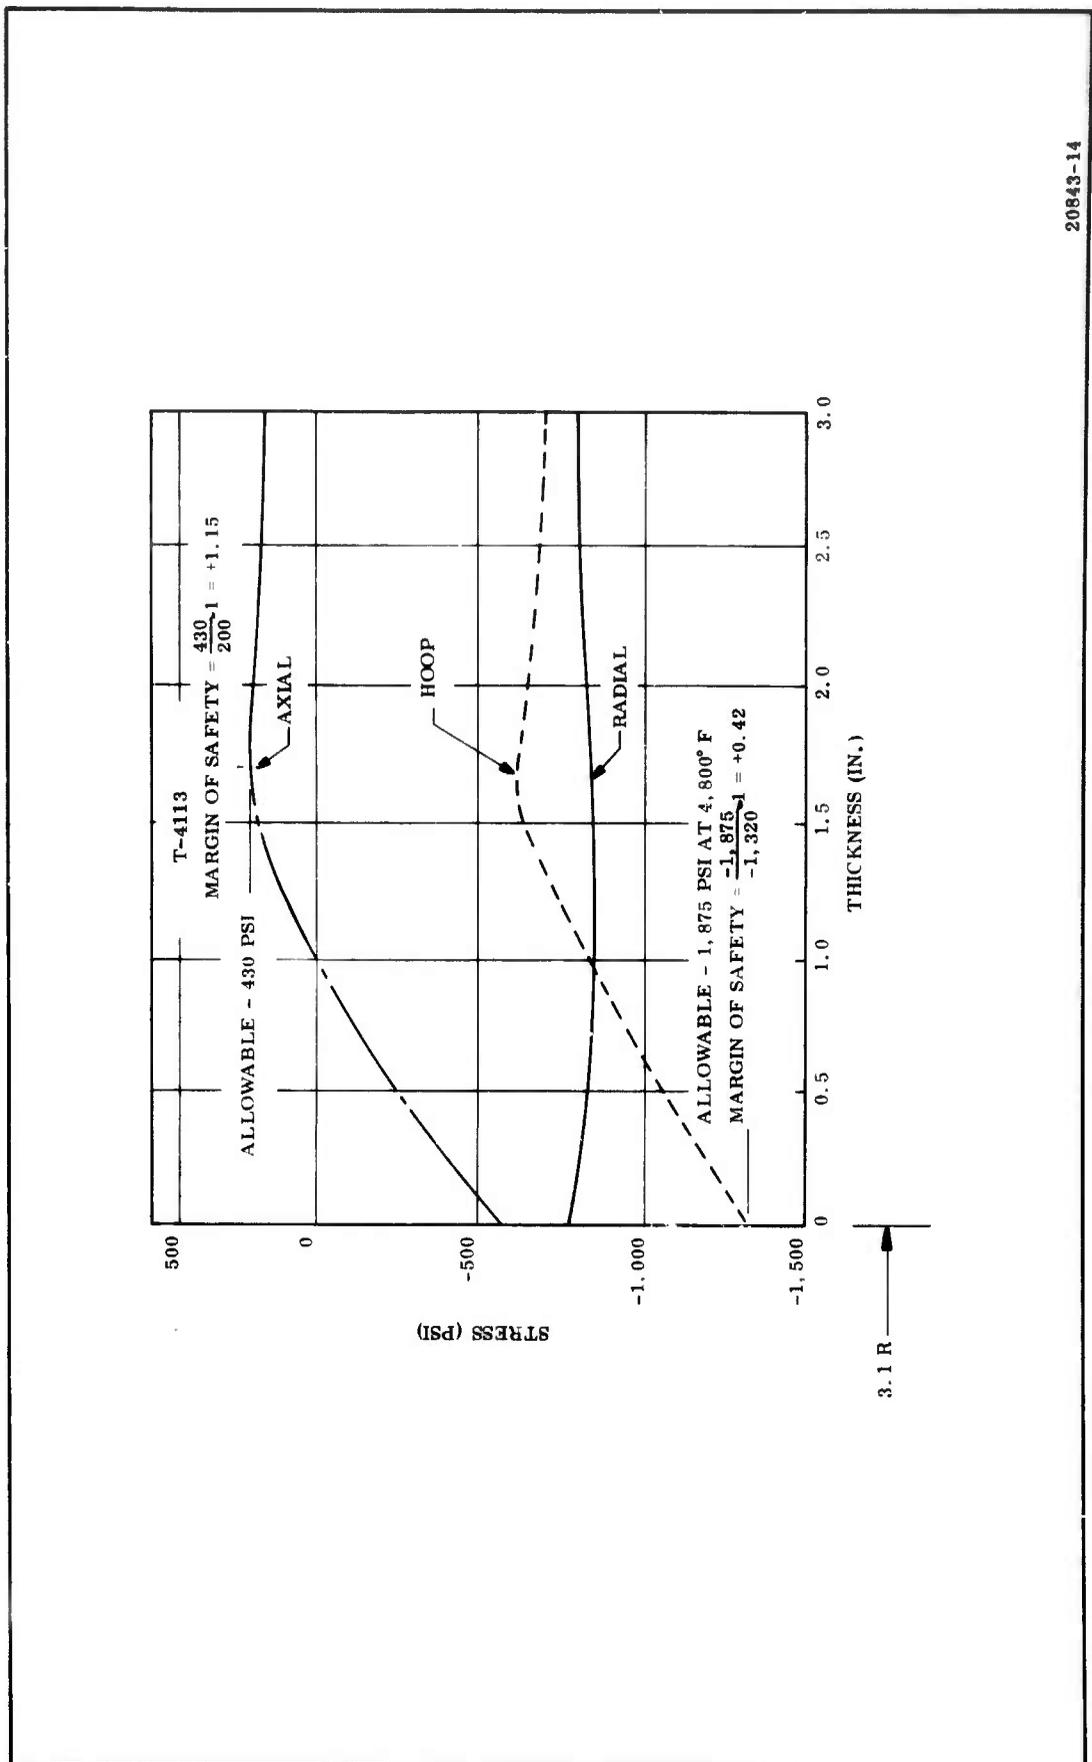
20843-14

Figure 90. Thermal Mechanical Stresses, Station A

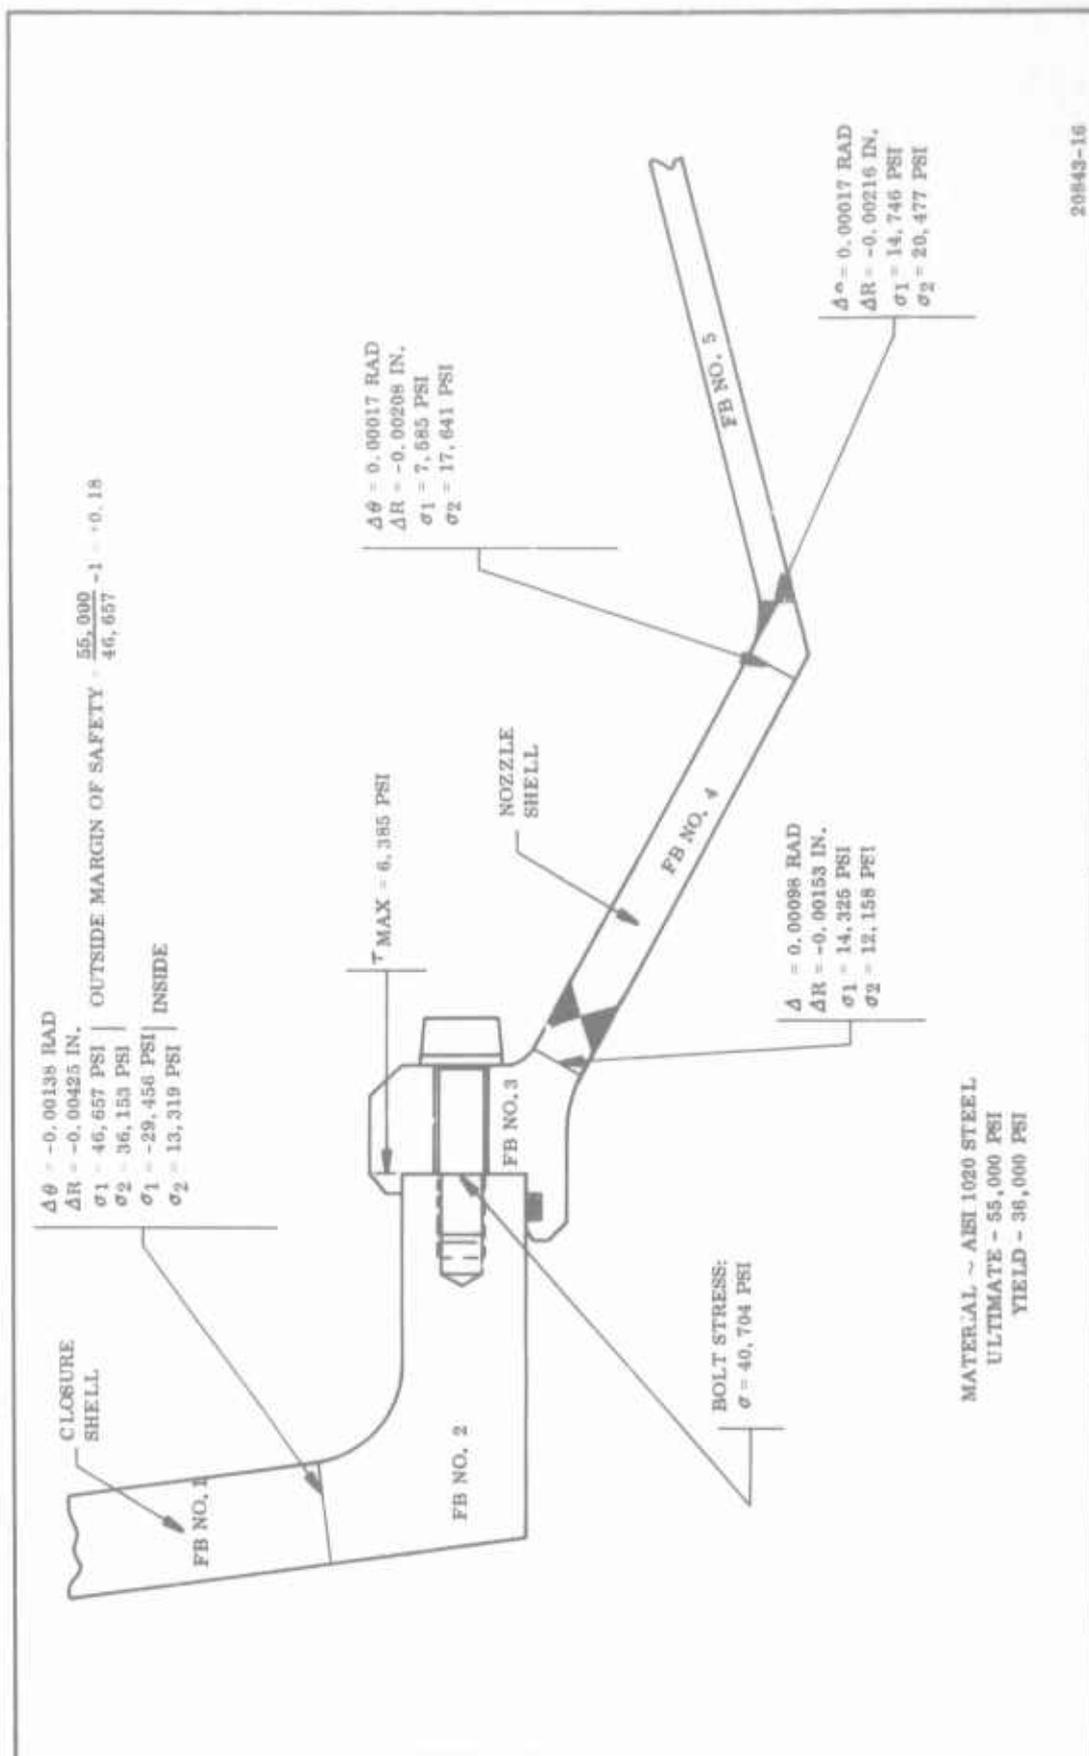
Figure 92. Housing Summary Analysis

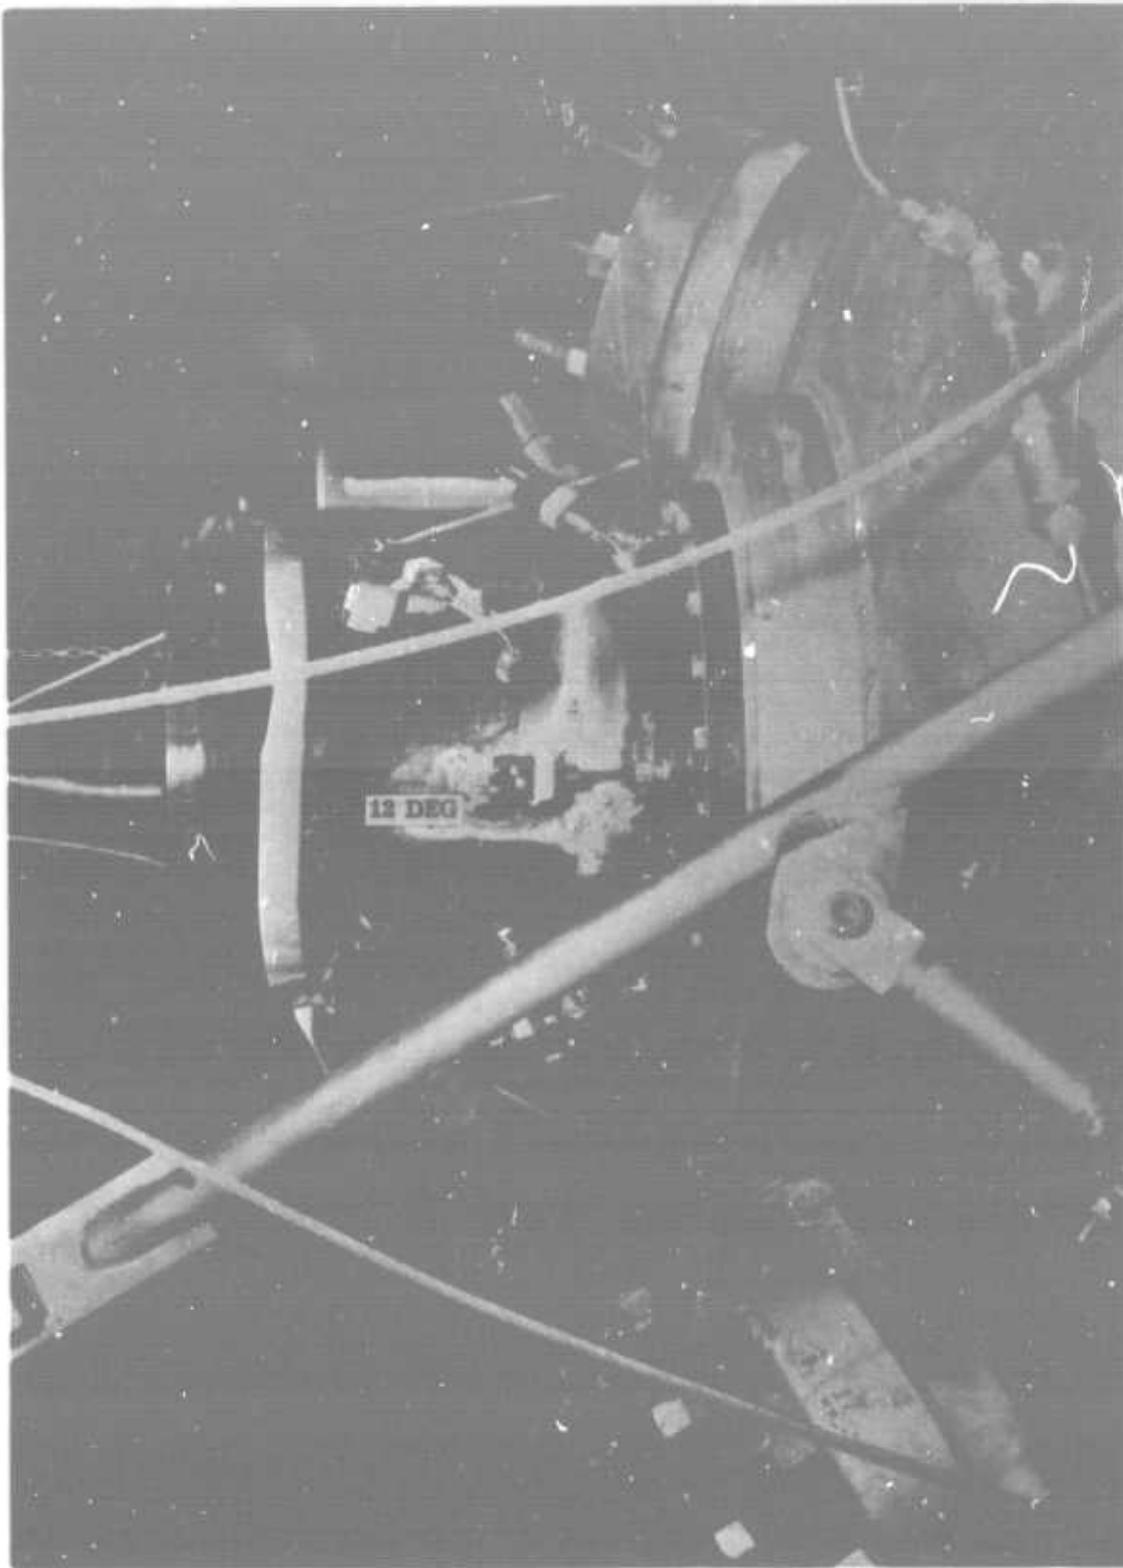
Figure 98. Nozzle No. 5, Small Exit Cone Burnthrough

Figures 97 and 98 show two nozzle burnthrough areas at 12 and 255 deg, the two burst disc assemblies, and the special AF material test panel that was tested in the nozzle exhaust plume.

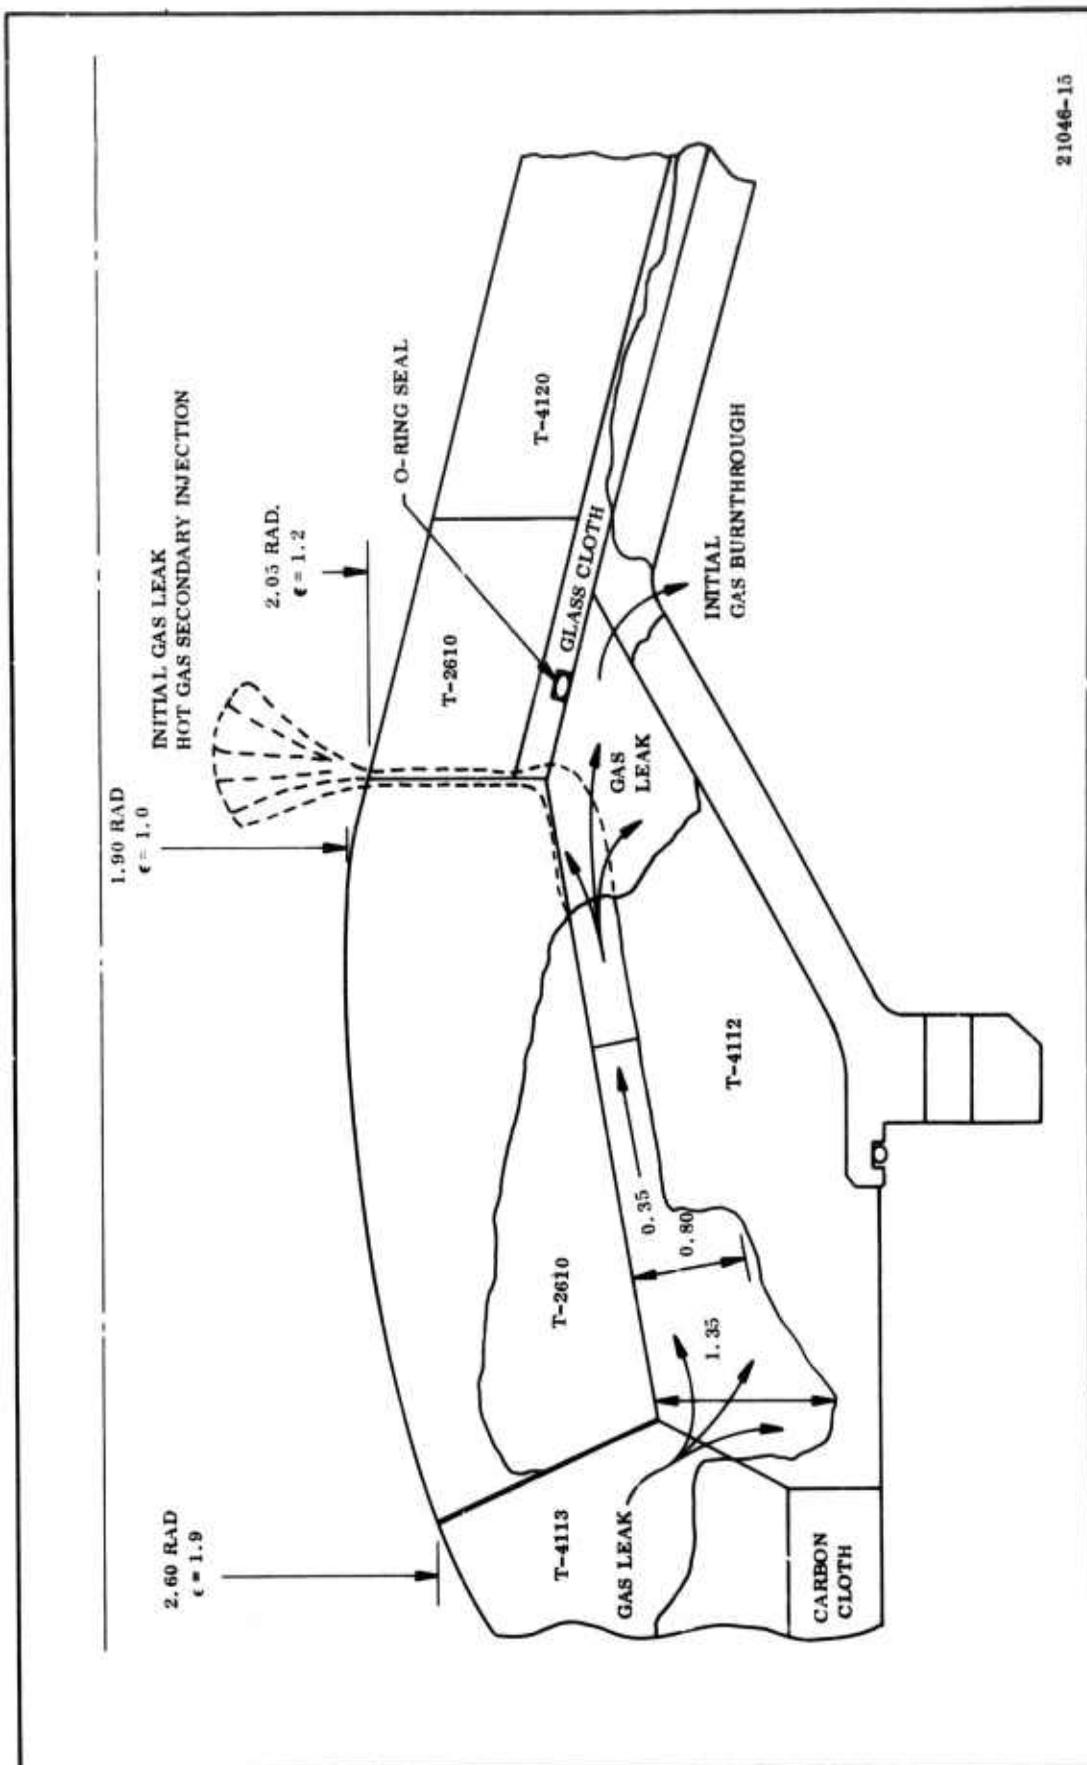
21046-15

Figure 105. Nozzle No. 5, 277 Deg Plane Showing Gas Leak and Exit Cone Burnthrough

The eroded passage under the throat at 277 deg, as shown in Figures 103 and 104, allowed high pressure exhaust gas to leak through the throat to exit cone joint and create hot gas injection 0.70 in. downstream of the throat and at an area ratio of $\epsilon = 1.2$ (Figure 105).

The large and small burnthroughs in the steel exit shell occurred on opposite sides of the gas leak passage at 12 and 277 deg, as indicated below and within the 180 deg arc of gouged exit cone

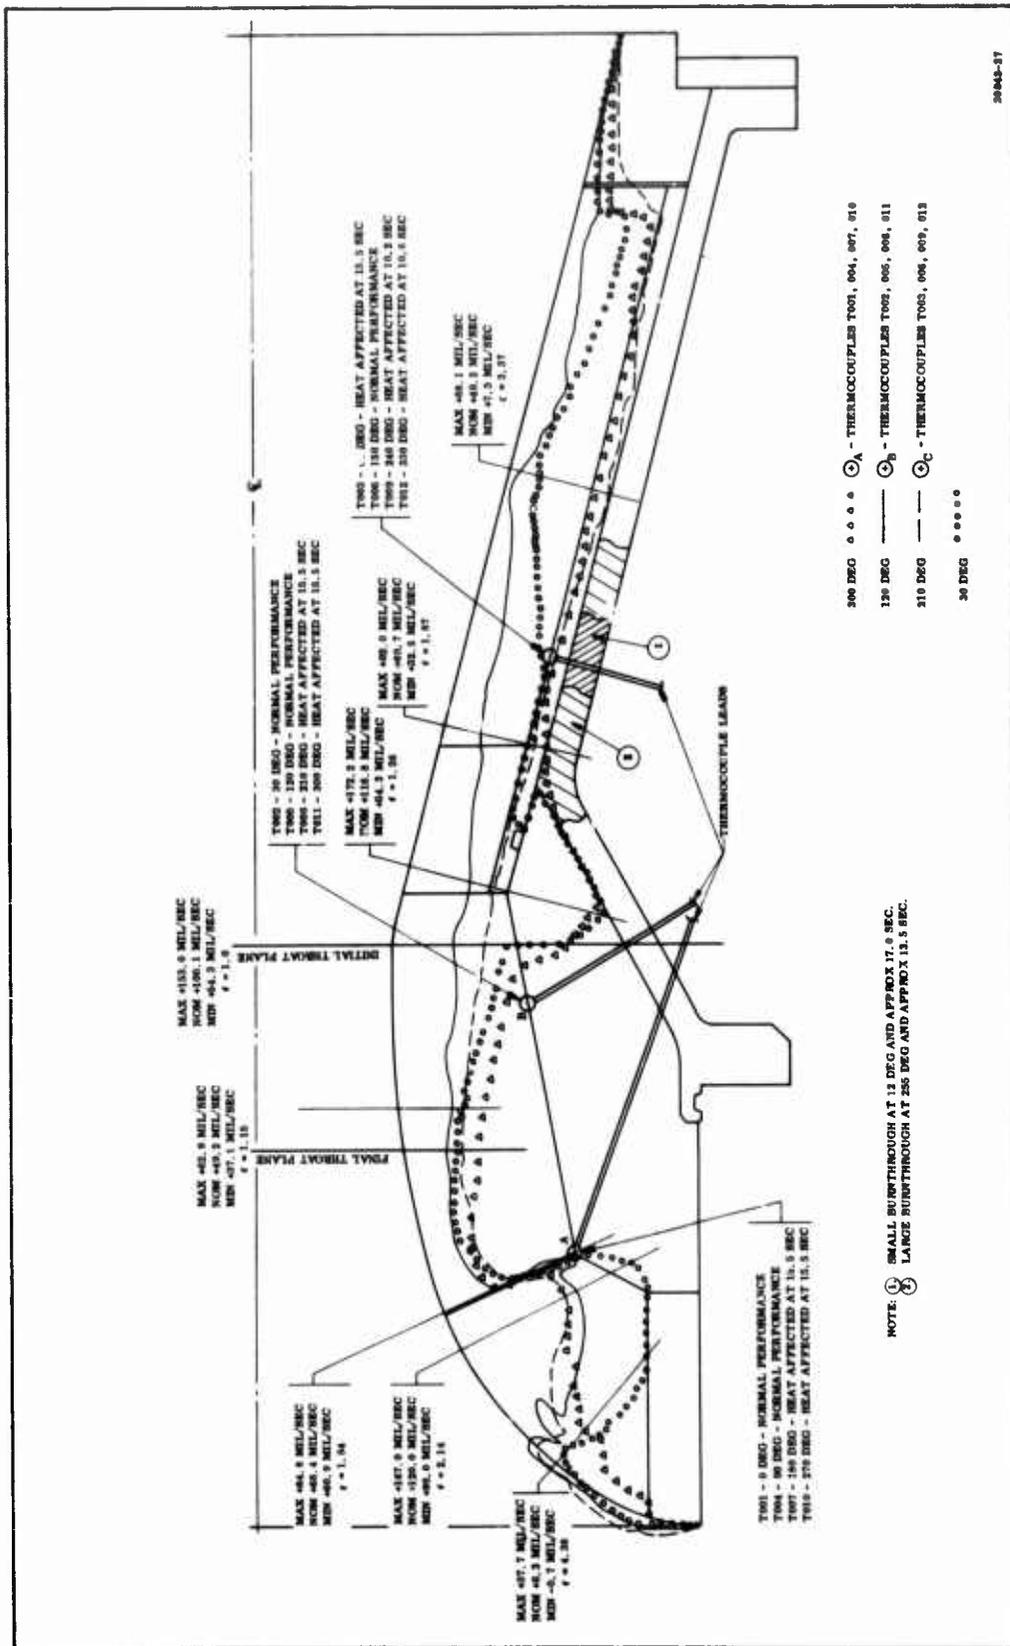
Figure 106. Nozzle No. 5 Material Erosion

The best plane of Nozzle No. 5, least affected by the gas leakage, was at 120 deg. The erosion at the selected area ratios is plotted in Figure 107. The erosion versus area ratio of Nozzle No. 3 of this program, using the same liner materials, also is shown in Figure 107 for comparison.

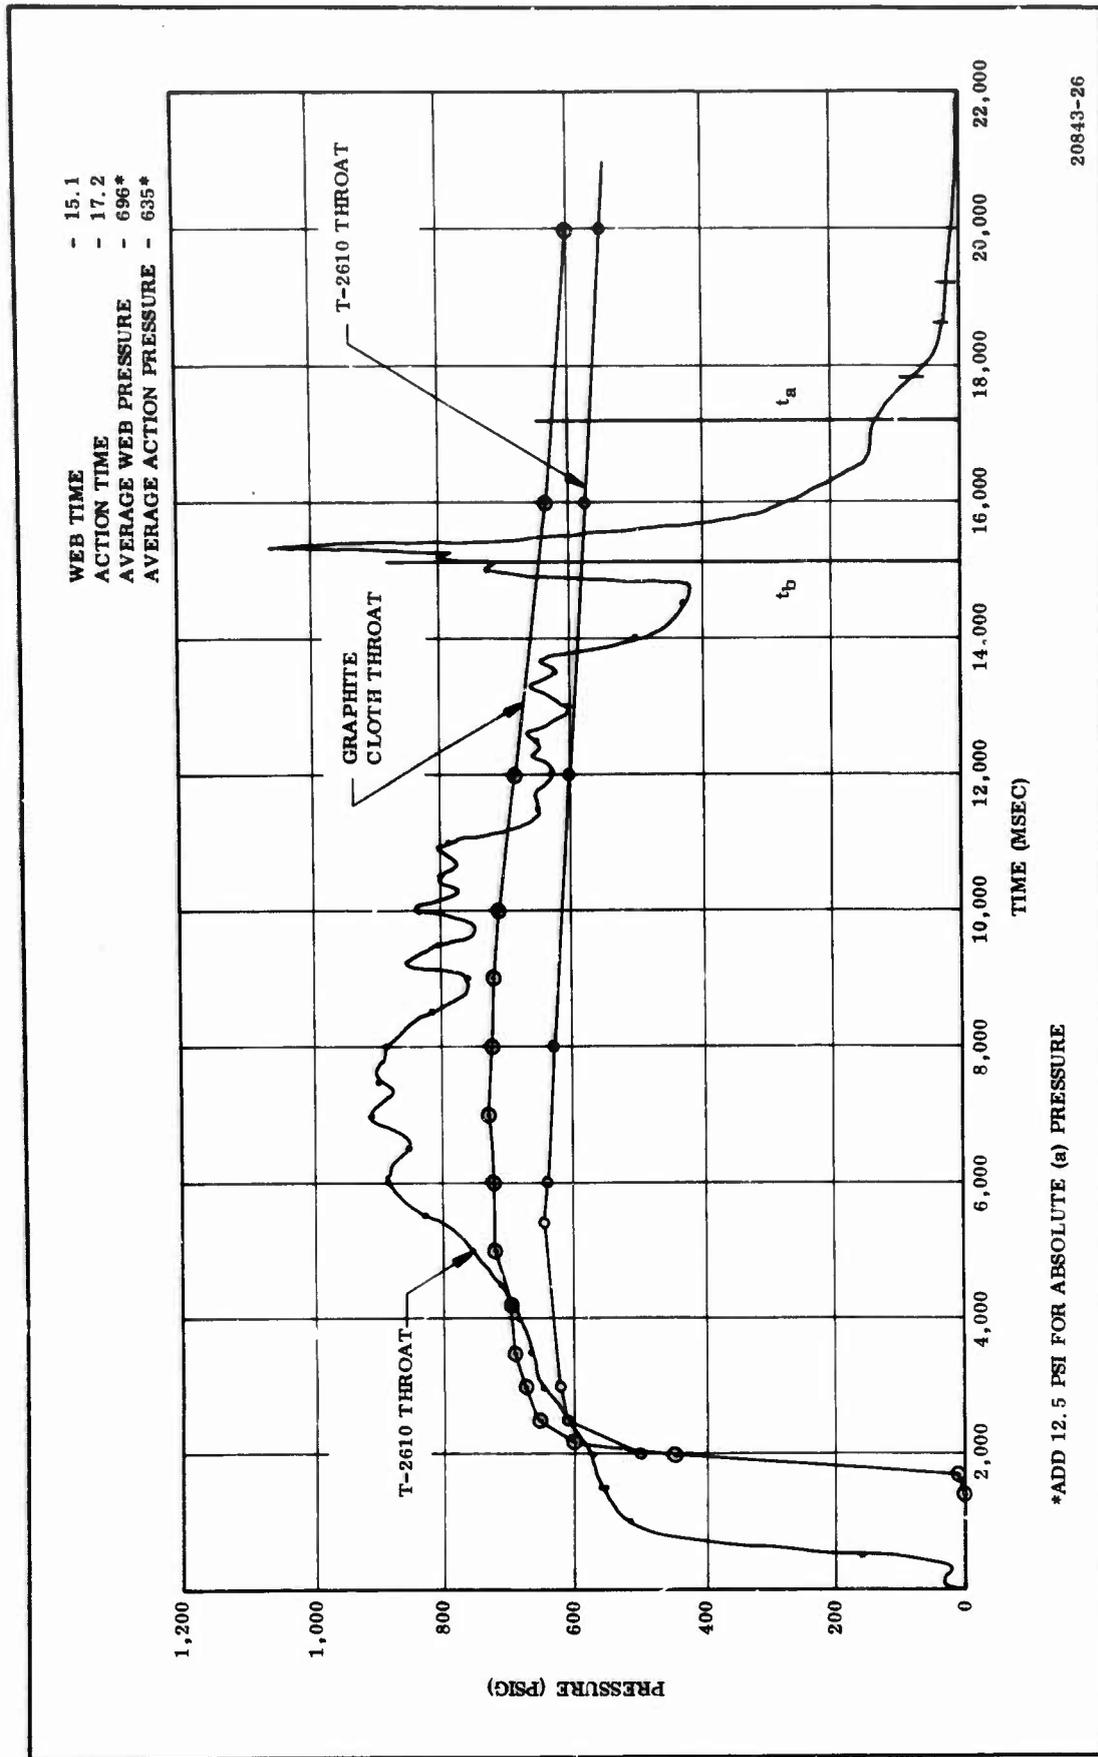
Figure 108. Motor Performance, Nozzle No. 5

Photographic camera coverage at the Edwards AFB test bay included three cameras with shutter speeds of 64, 200 and 1,000 frames per sec. After time sequencing the three cameras (Table XXXIII), the 200 fps camera appeared to obtain the most reliable data. Film coverage taken by this camera indicated that the exit cone was burned through at 12.8 sec, the burst discs were blown at 15.2 sec, and the test ended at 27.7 sec after ignition. The 1,000 fps camera was labeled incorrectly (probably 400 fps), but did indicate that some LCCM material was lost before the exit cone burnthrough, probably exit cone T-4120 material.

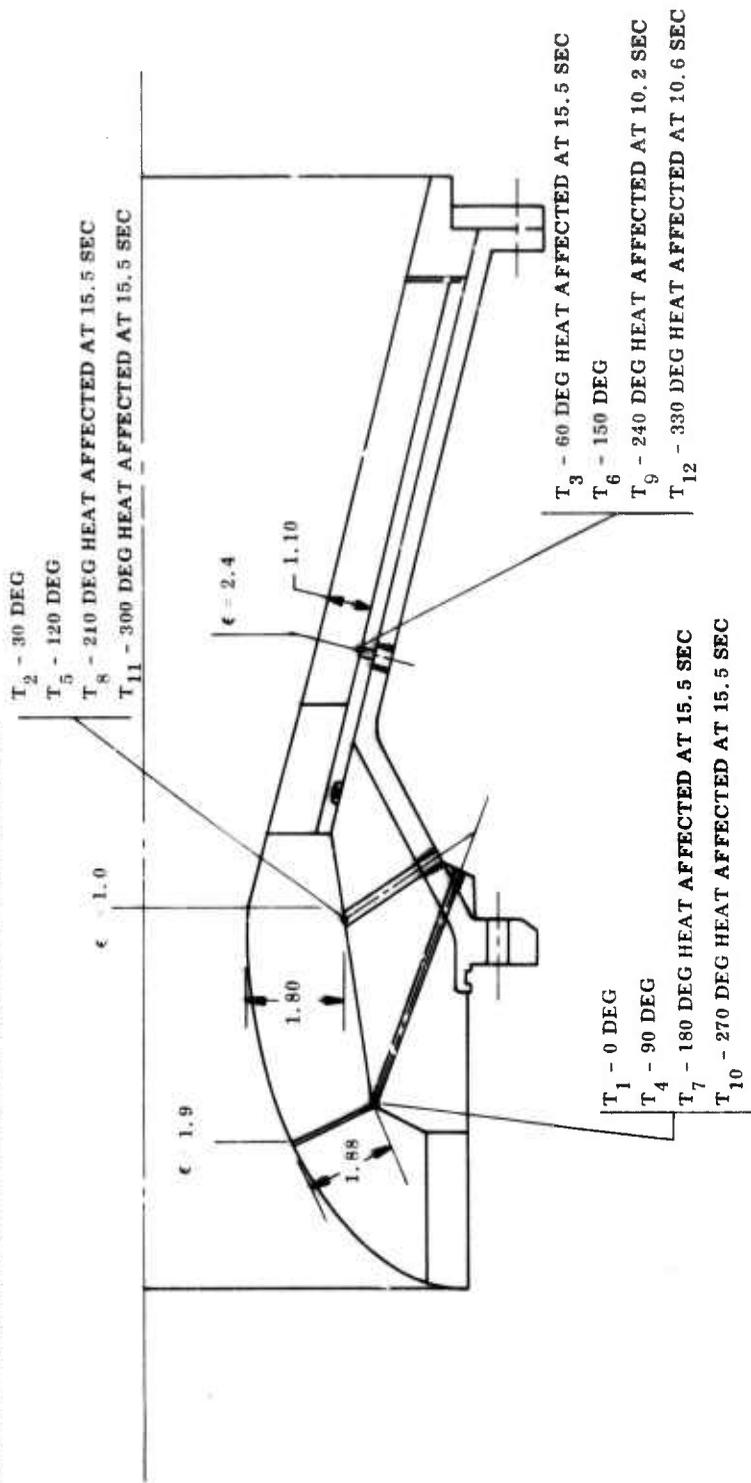
20843-13

1. LARGE EXIT CONE BURNTHROUGH OCCURRED AT 12.8 SEC IN THE 225 DEG PLANE.
2. BURST DISCS BLOW AT 15.3 SEC IN THE 75 DEG AND 225 DEG PLANE ON THE CLOSURE.
3. SMALL EXIT CONE BURNTHROUGH OCCURRED AT 16.2 SEC IN THE 12 DEG PLANE.
4. THROAT-THROAT SUPPORT INTERFACE LEAKED AT 277 DEG PLANE.

Figure 109. Instrumentation Location, Nozzle No. 5

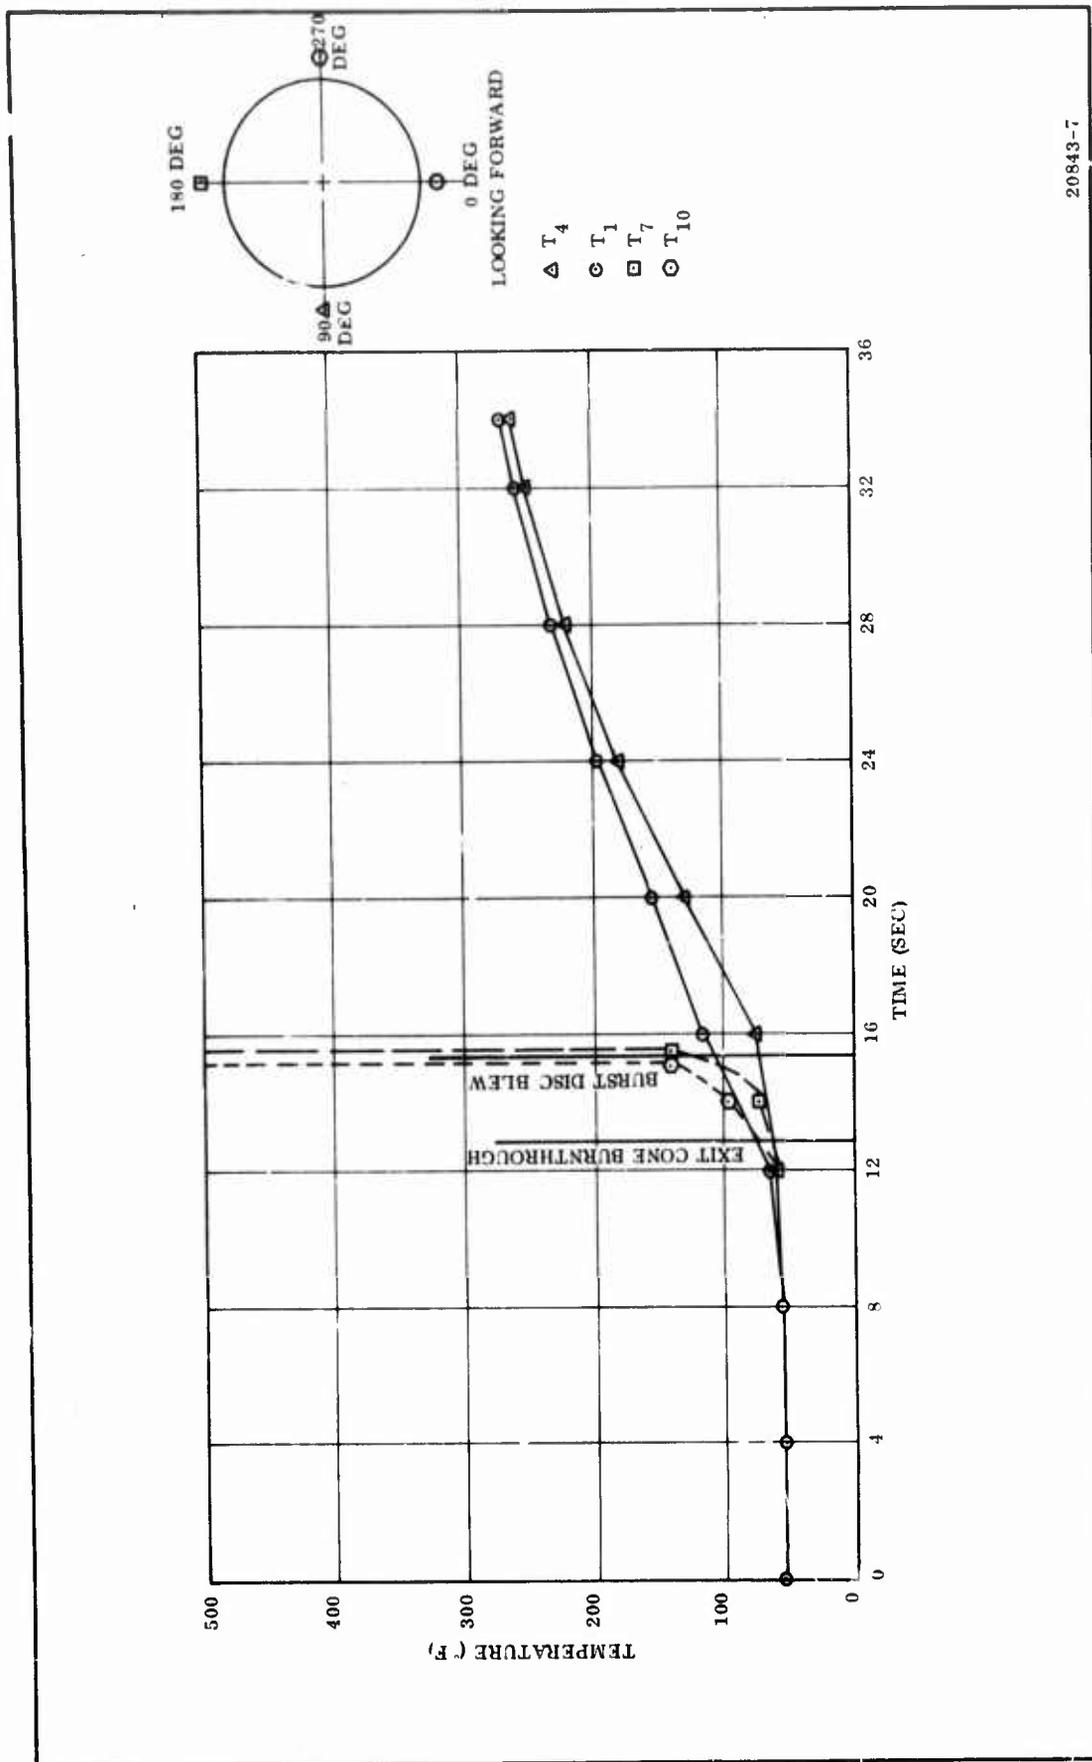
20843-7

Figure 110. Thermocouple Data, Inlet, Nozzle No. 5
