FINAL REPORT
DEVELOPMENT OF CASTABLE CARBONACEOUS
MATERIALS FOR SOLID ROCKET NOZZLES

THIOKOL CHEMICAL CORPORATION
WASATCH DIVISION

Technical Report AFRPL-TR-69-129

March 1969

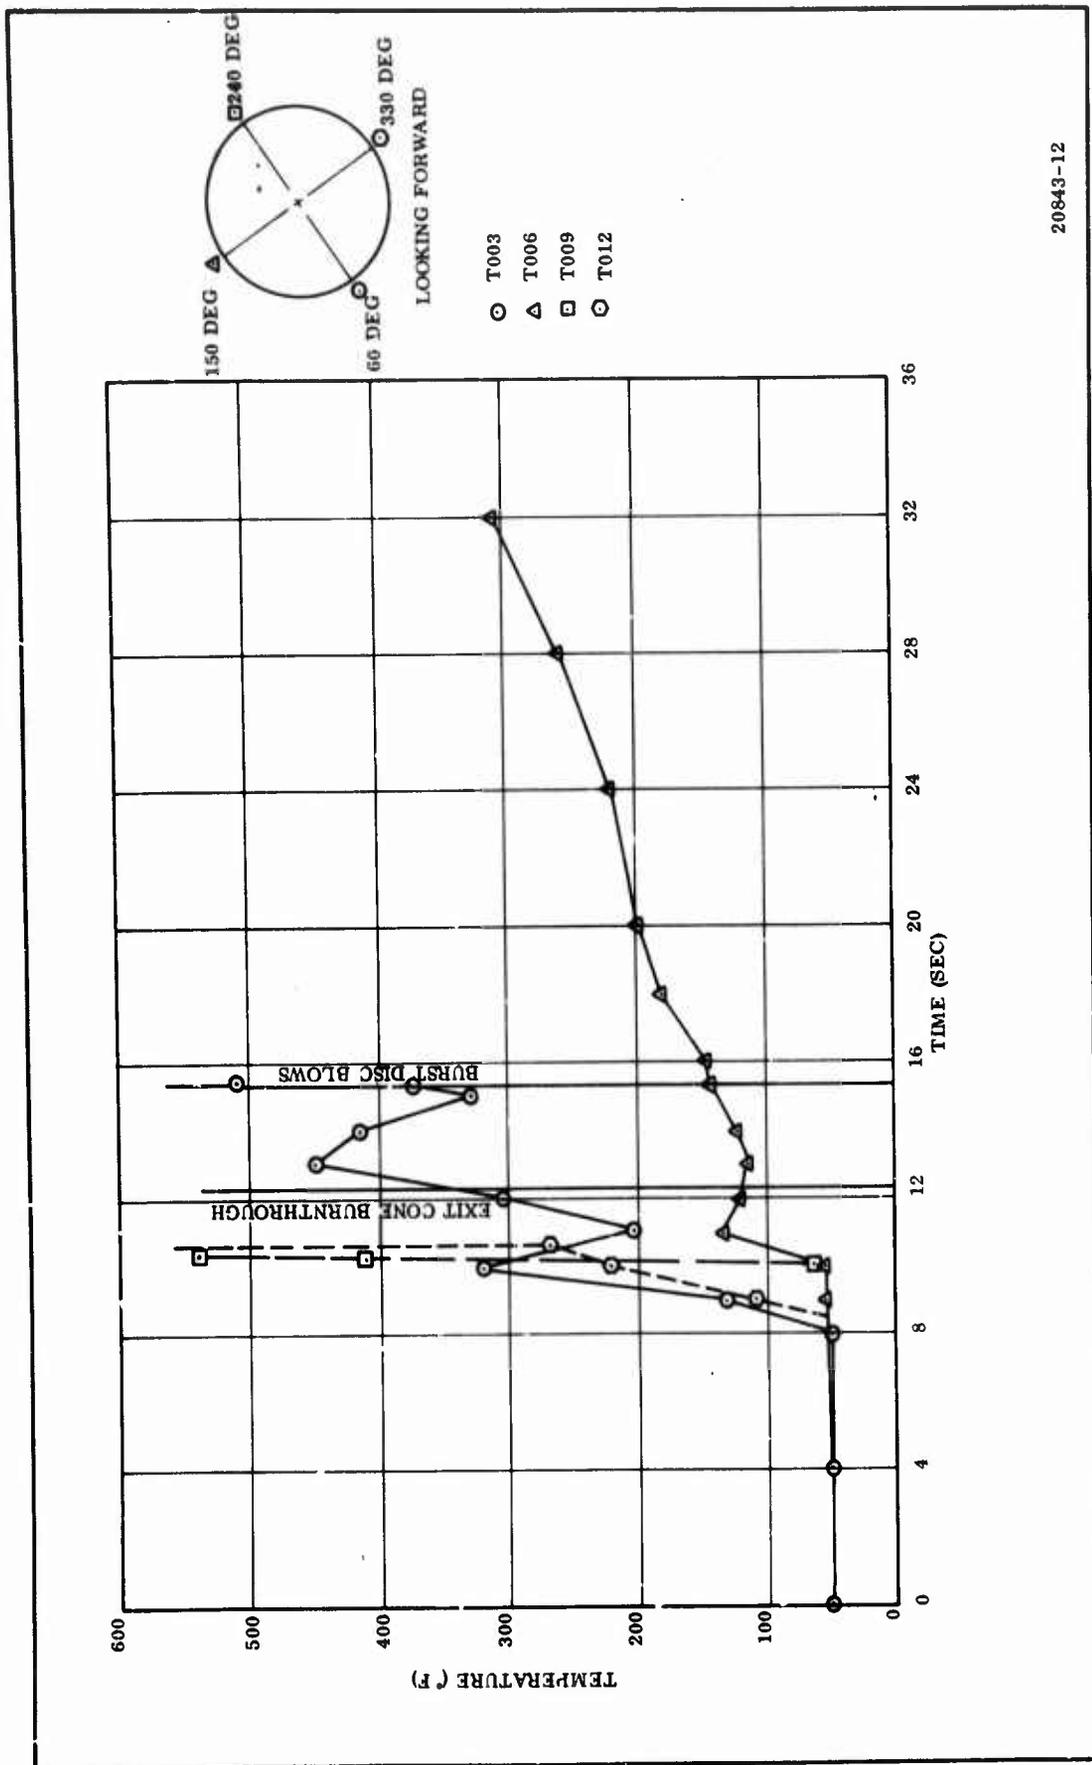
20843-12

Figure 112. Thermocouple Data, Exit Cone, Nozzle No. 5

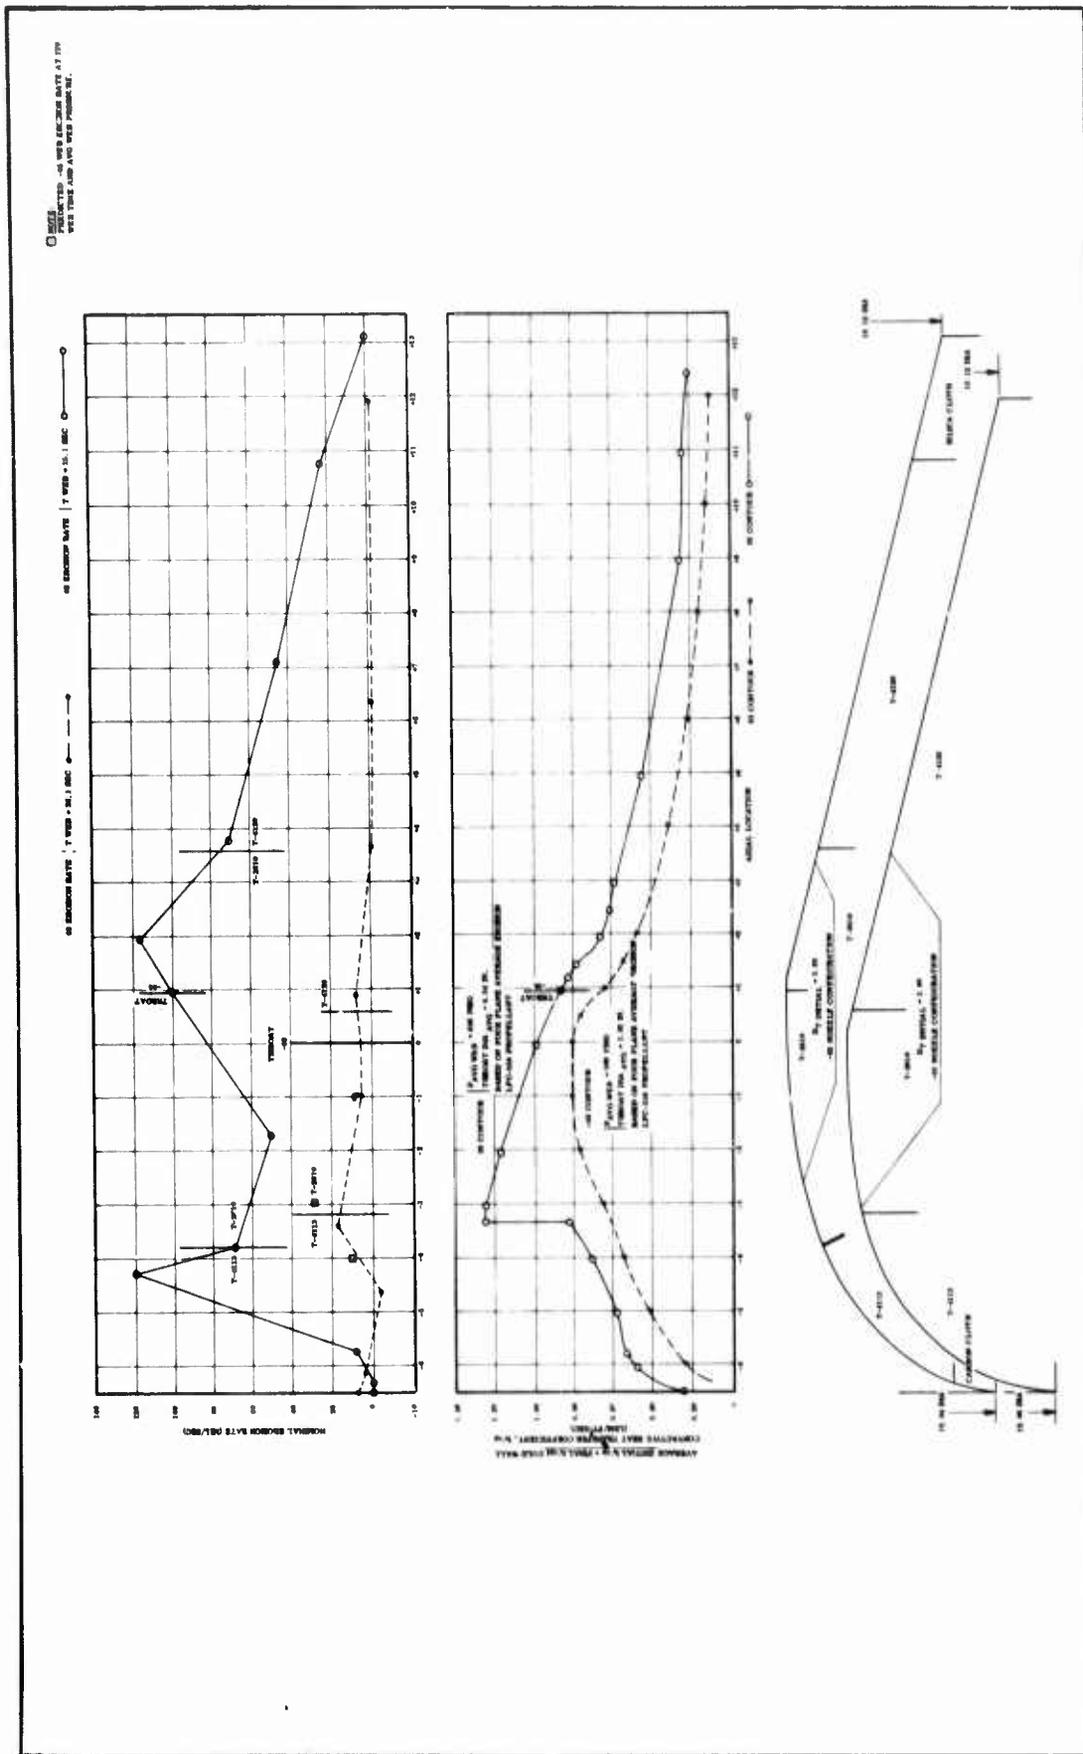
Figure 115. Performance Comparison Between Nozzles No. 3 and 5

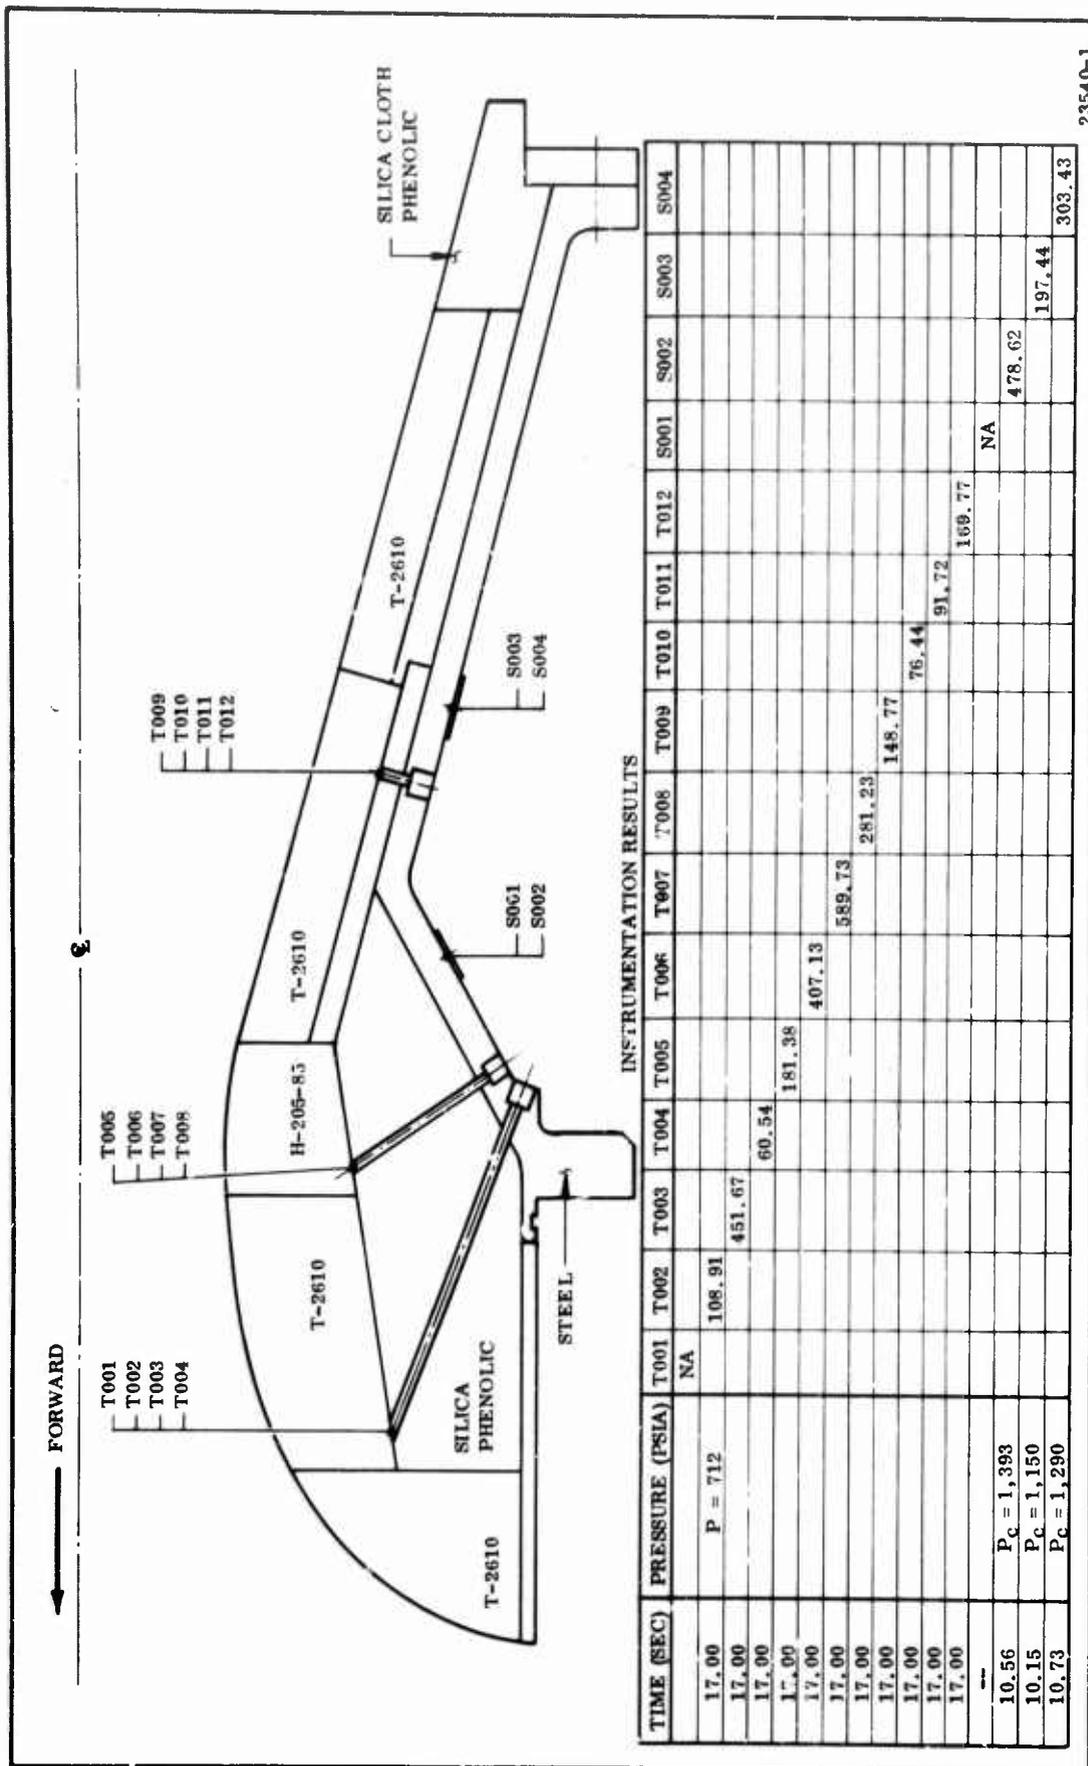
Figure 130. Maximum Instrumentation Readings, Nozzle No. 6

<u>Max Avg Temperature (°F)</u>
Aft inlet (T-2610)	207
Aft throat (H-205-85)	365
Forward exit (T-2610)	122

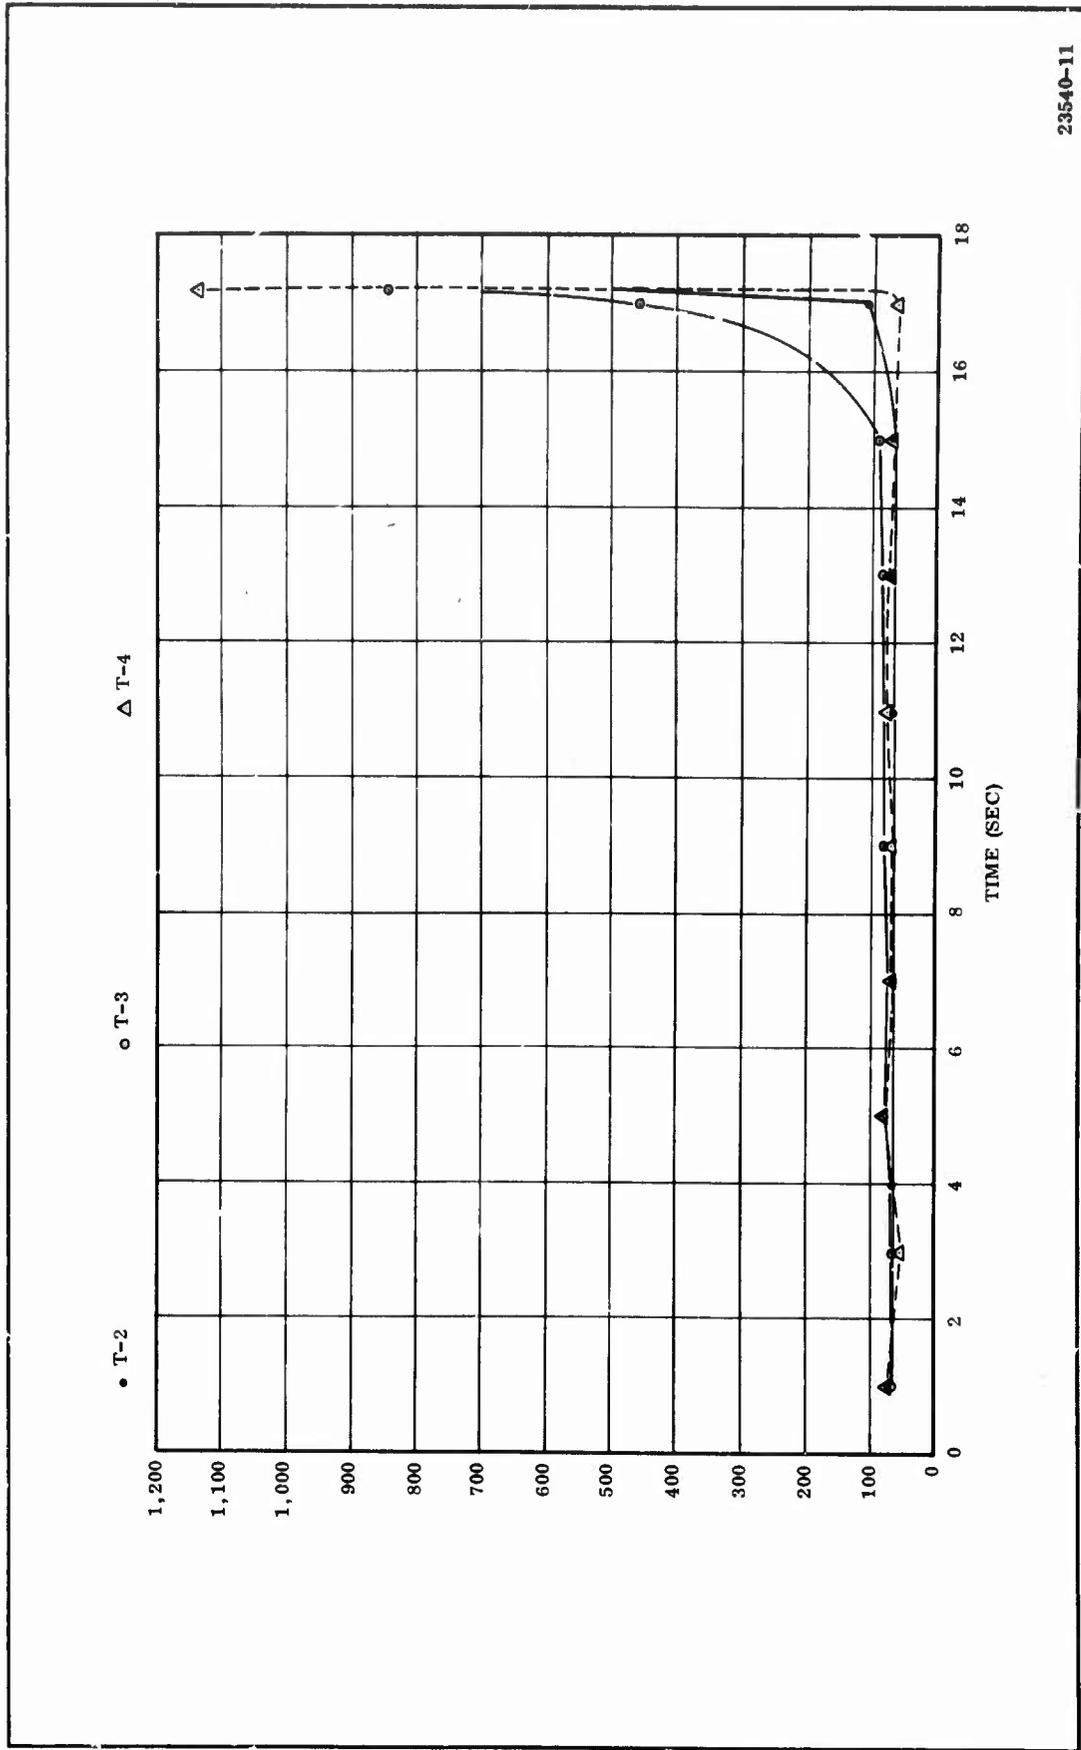
23540-11

Figure 131. Nozzle No. 6 Inlet Thermocouple Reading

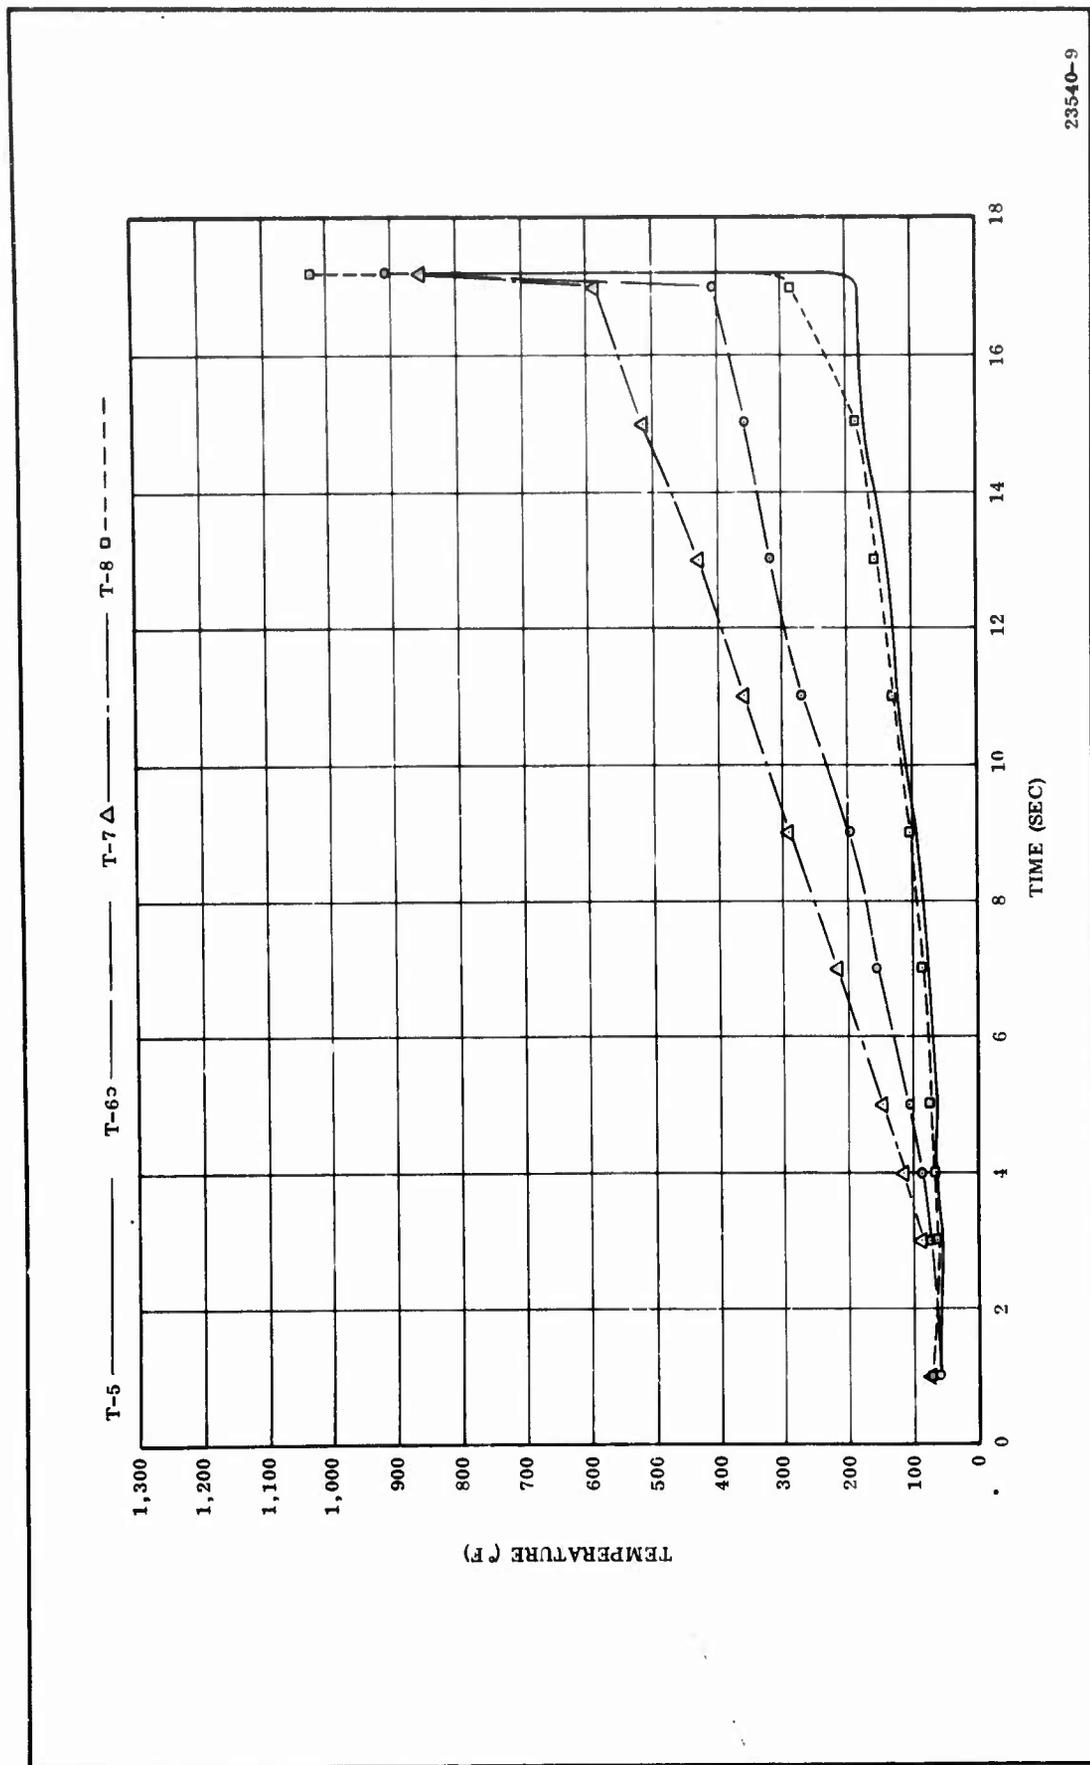
23540-9

Figure 132. Nozzle No. 6 Throat Thermocouple Reading

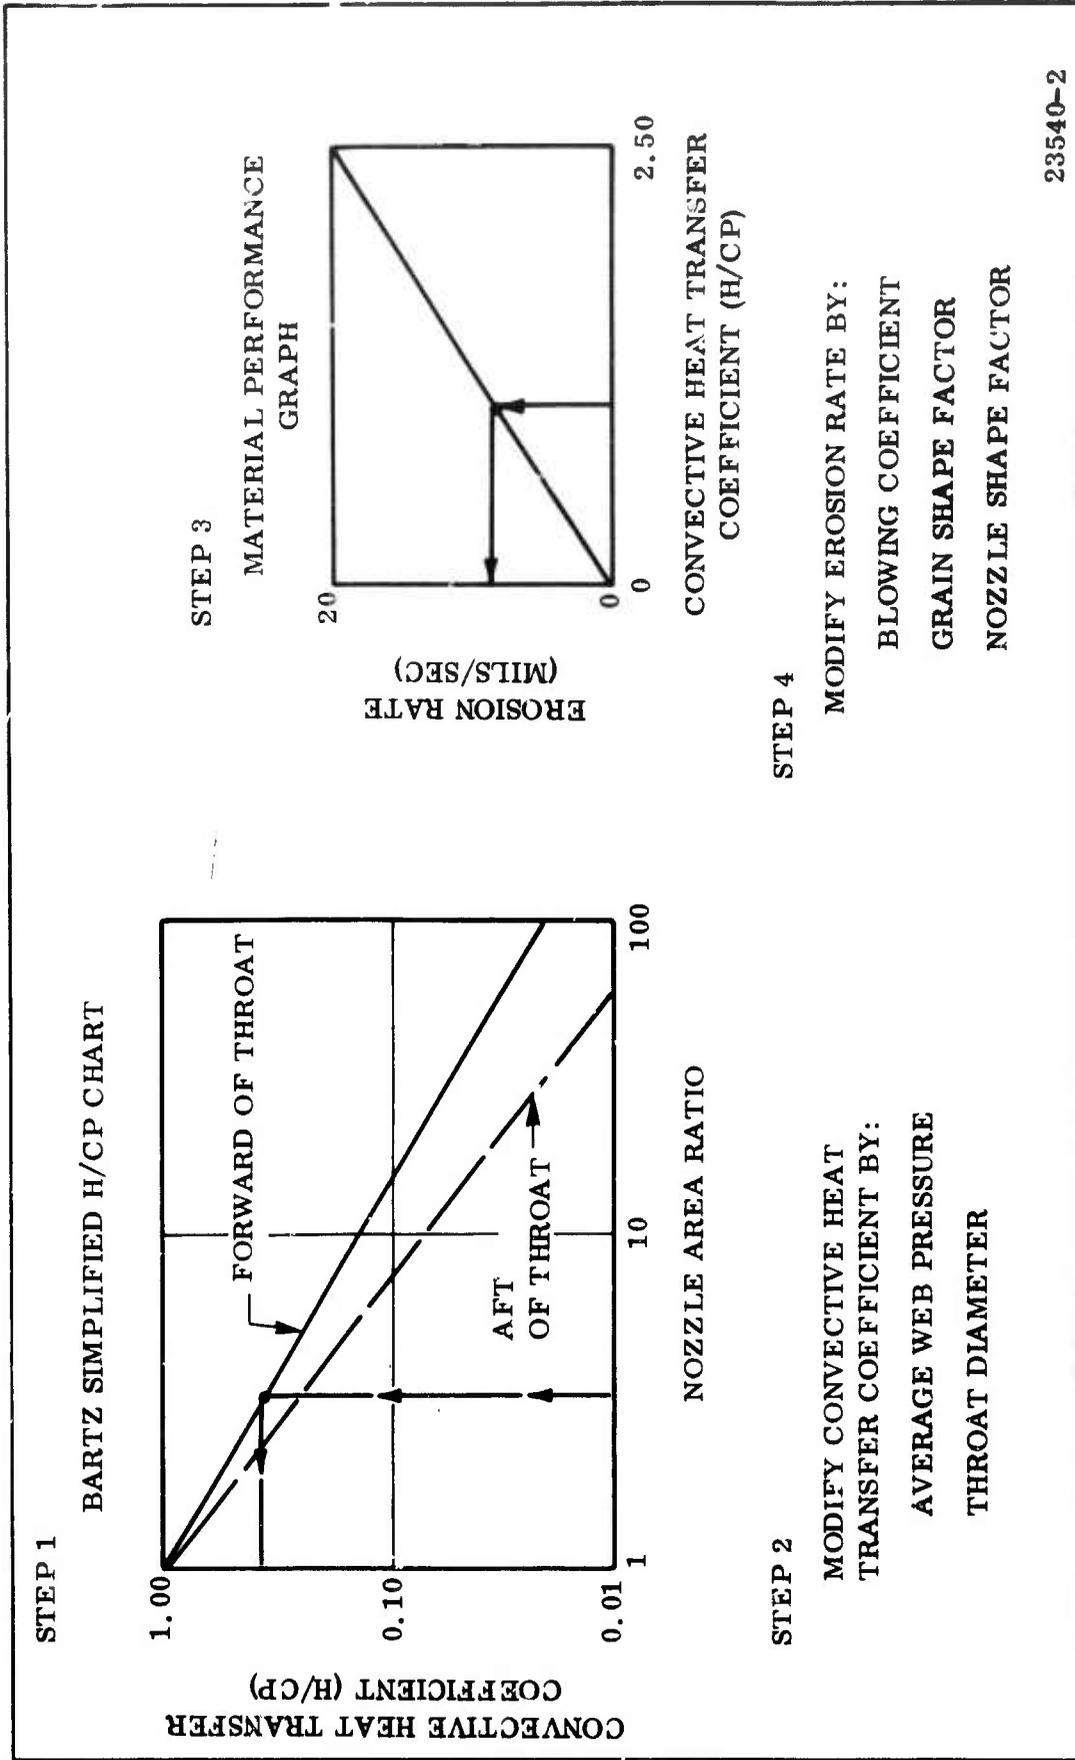
Figure A-2. Wall Erosion Rate Prediction Calculation Steps

3. Enter a material performance graph of the same material as the liner wall with the modified convective heat transfer coefficient and read out the predicted wall erosion rate.
4. Modify the predicted erosion rate by the grain shape factor (GSF), end burner; Star or CP; the propellant blowing coefficient (PBC); and the nozzle shape factor (NSF), external or submerged and type of TVC control.
