IR NO. 69-15

INFORMAL REPORT

UNDERSEA STUDIES
WITH THE DEEP RESEARCH VEHICLE
DEEPSTAR-4000

MARCH 1969

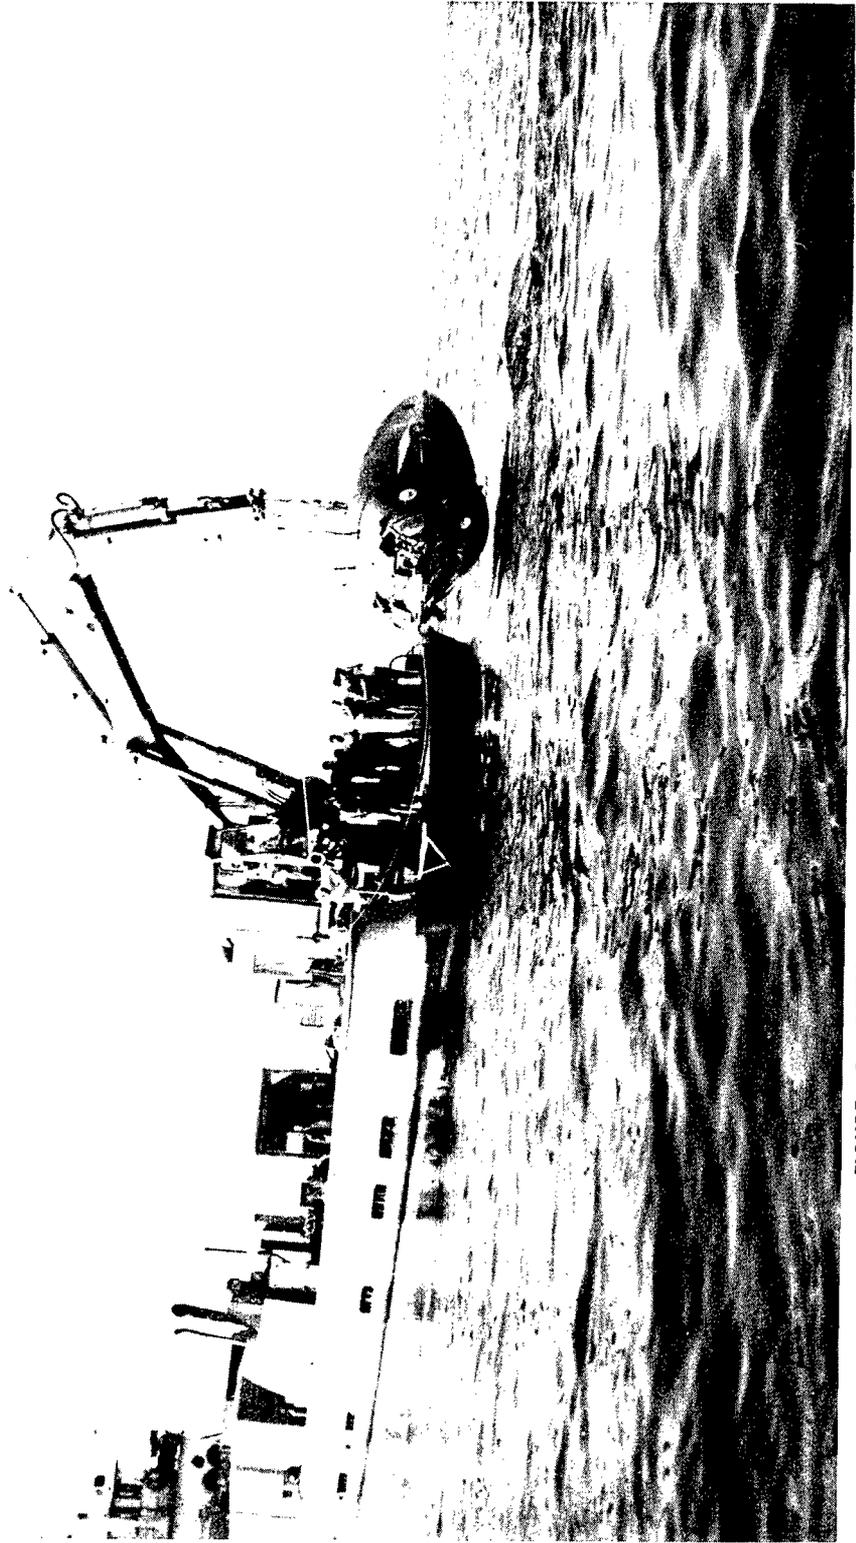
FIGURE 1. DEEPSTAR-4000 DURING LAUNCH FROM M/V SEARCH TIDE

The U.S Naval Oceanographic Office conducted a series of dives using the Westinghouse manned submersible DEEPSTAR-4000 (Figure 1) during October and November of 1967. The purpose of the dives was to conduct geological and biological observations, and to measure various physical properties of the water column along the dive tracks. During the 32-day lease, commencing at New London, Connecticut and terminating at the Panama Canal, it had been planned to make 28 deep dives along the east coast of the United States and in the Caribbean area. However, due to adverse weather conditions and unexpected maintenance time, only 10 deep dives and 3 shallow dives were conducted.

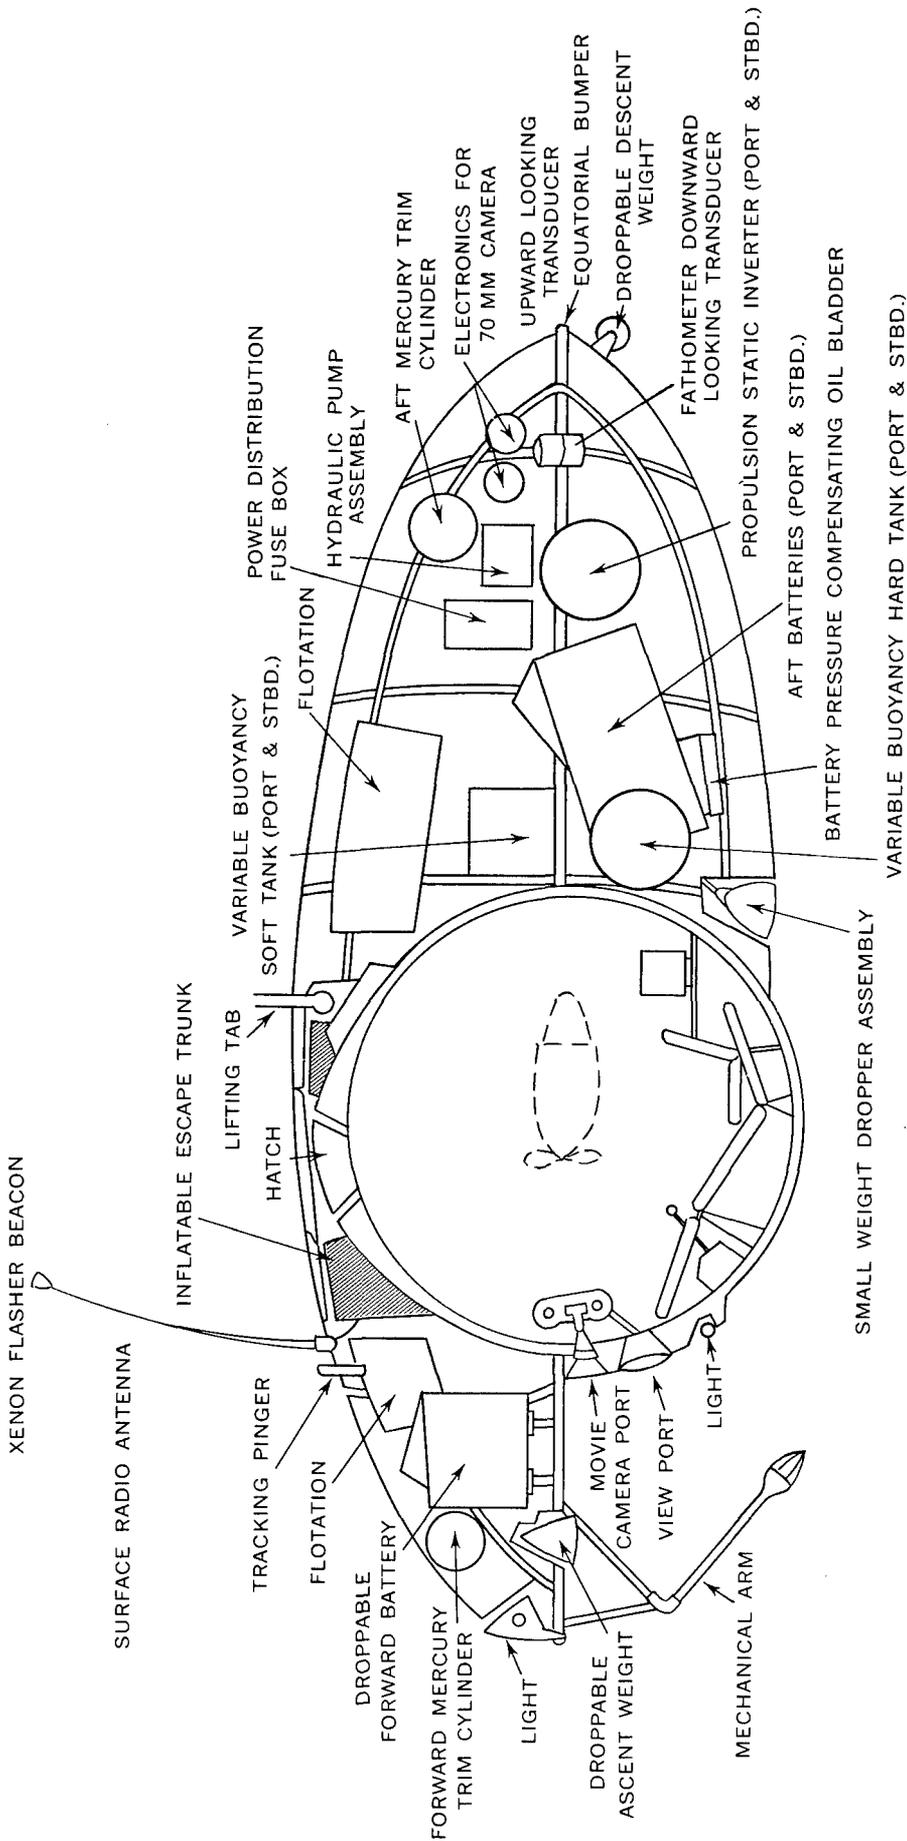
FIGURE 2. SCHEMATIC PROFILE OF DEEPSTAR-4000

<u>VEHICLE:</u>	
LENGTH.....	18 feet
BEAM.....	10 feet
HEIGHT.....	7 feet
CREW.....	One Operator - Two Observers
MAXIMUM OPERATING DEPTH.....	4,000 feet
SPEED.....	Normal 1 knot Full 3 knots
WEIGHT IN AIR.....	19,000 pounds
ENDURANCE.....	12 hours at normal battery discharge rate
LIFE SUPPORT.....	48 man hours endurance
PAYLOAD.....	450 pounds
<u>SYSTEMS:</u>	
PROPULSION AND STEERING.....	Two 4.5 hp reversible AC motors
POWER SOURCE.....	Three Lead-acid 400 amp-hr batteries
DEPTH CONTROL & BUOYANCY.....	Droppable weights and auxiliary tanks
TRIM CONTROL.....	Mercury trim system
NAVIGATION.....	Gyrocompass, fathometers, speed, depth indicators, and forward-looking sonar
COMMUNICATIONS.....	Underwater telephone and CB radio

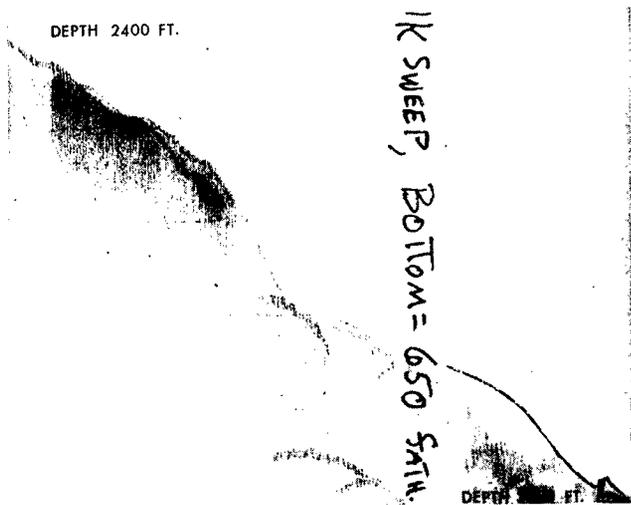
FIGURE 8. ECHO-SOUNDER RECORD ALONG THE DIVE TRACK

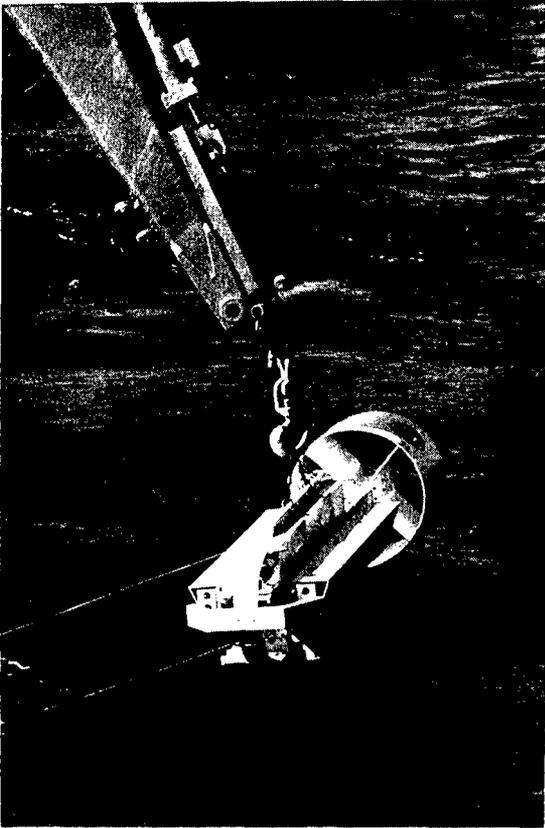
FIGURE 15. OCEAN BOTTOM SCANNING SONAR (OBSS)

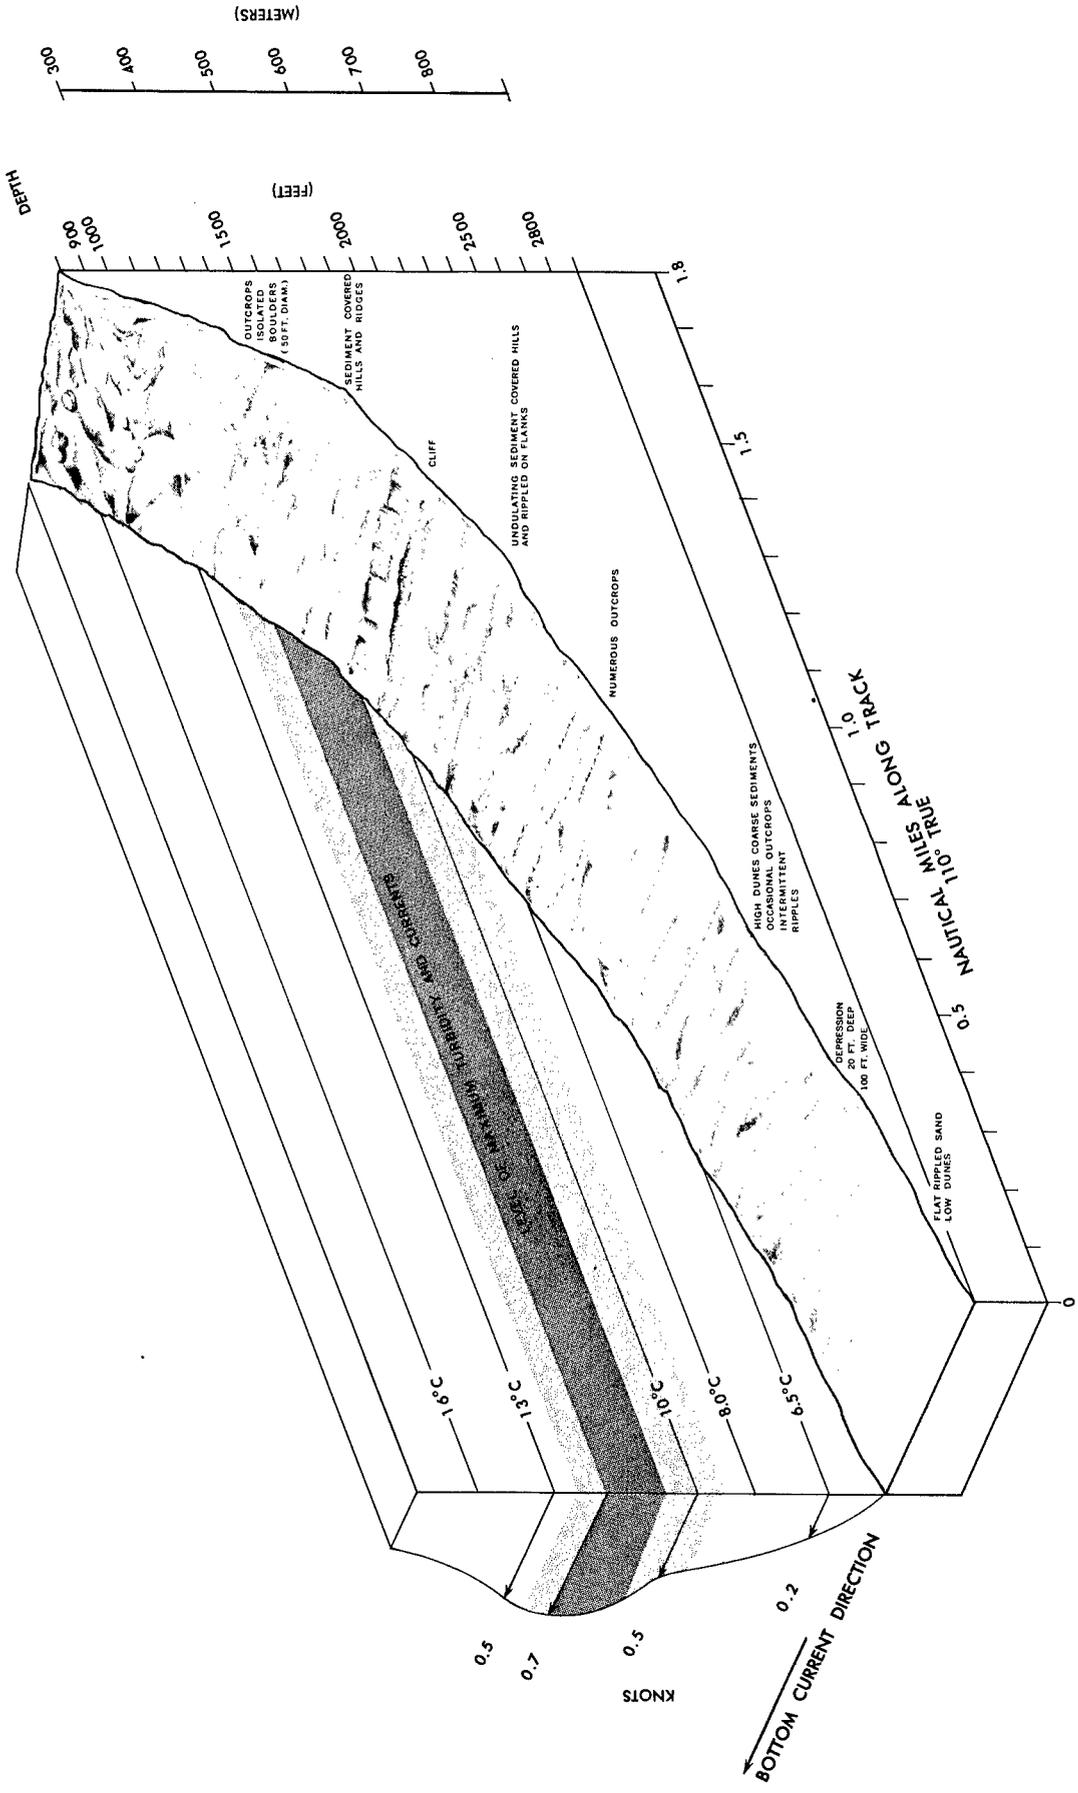
BOTTOM TOPOGRAPHY AND BOTTOM CURRENT PROFILE CAY SAL BANK, DEEPSTAR 4000 SURVEY NOV. 1967

FIGURE 32. SKETCH OF BOTTOM FEATURES NEAR CAY SAL

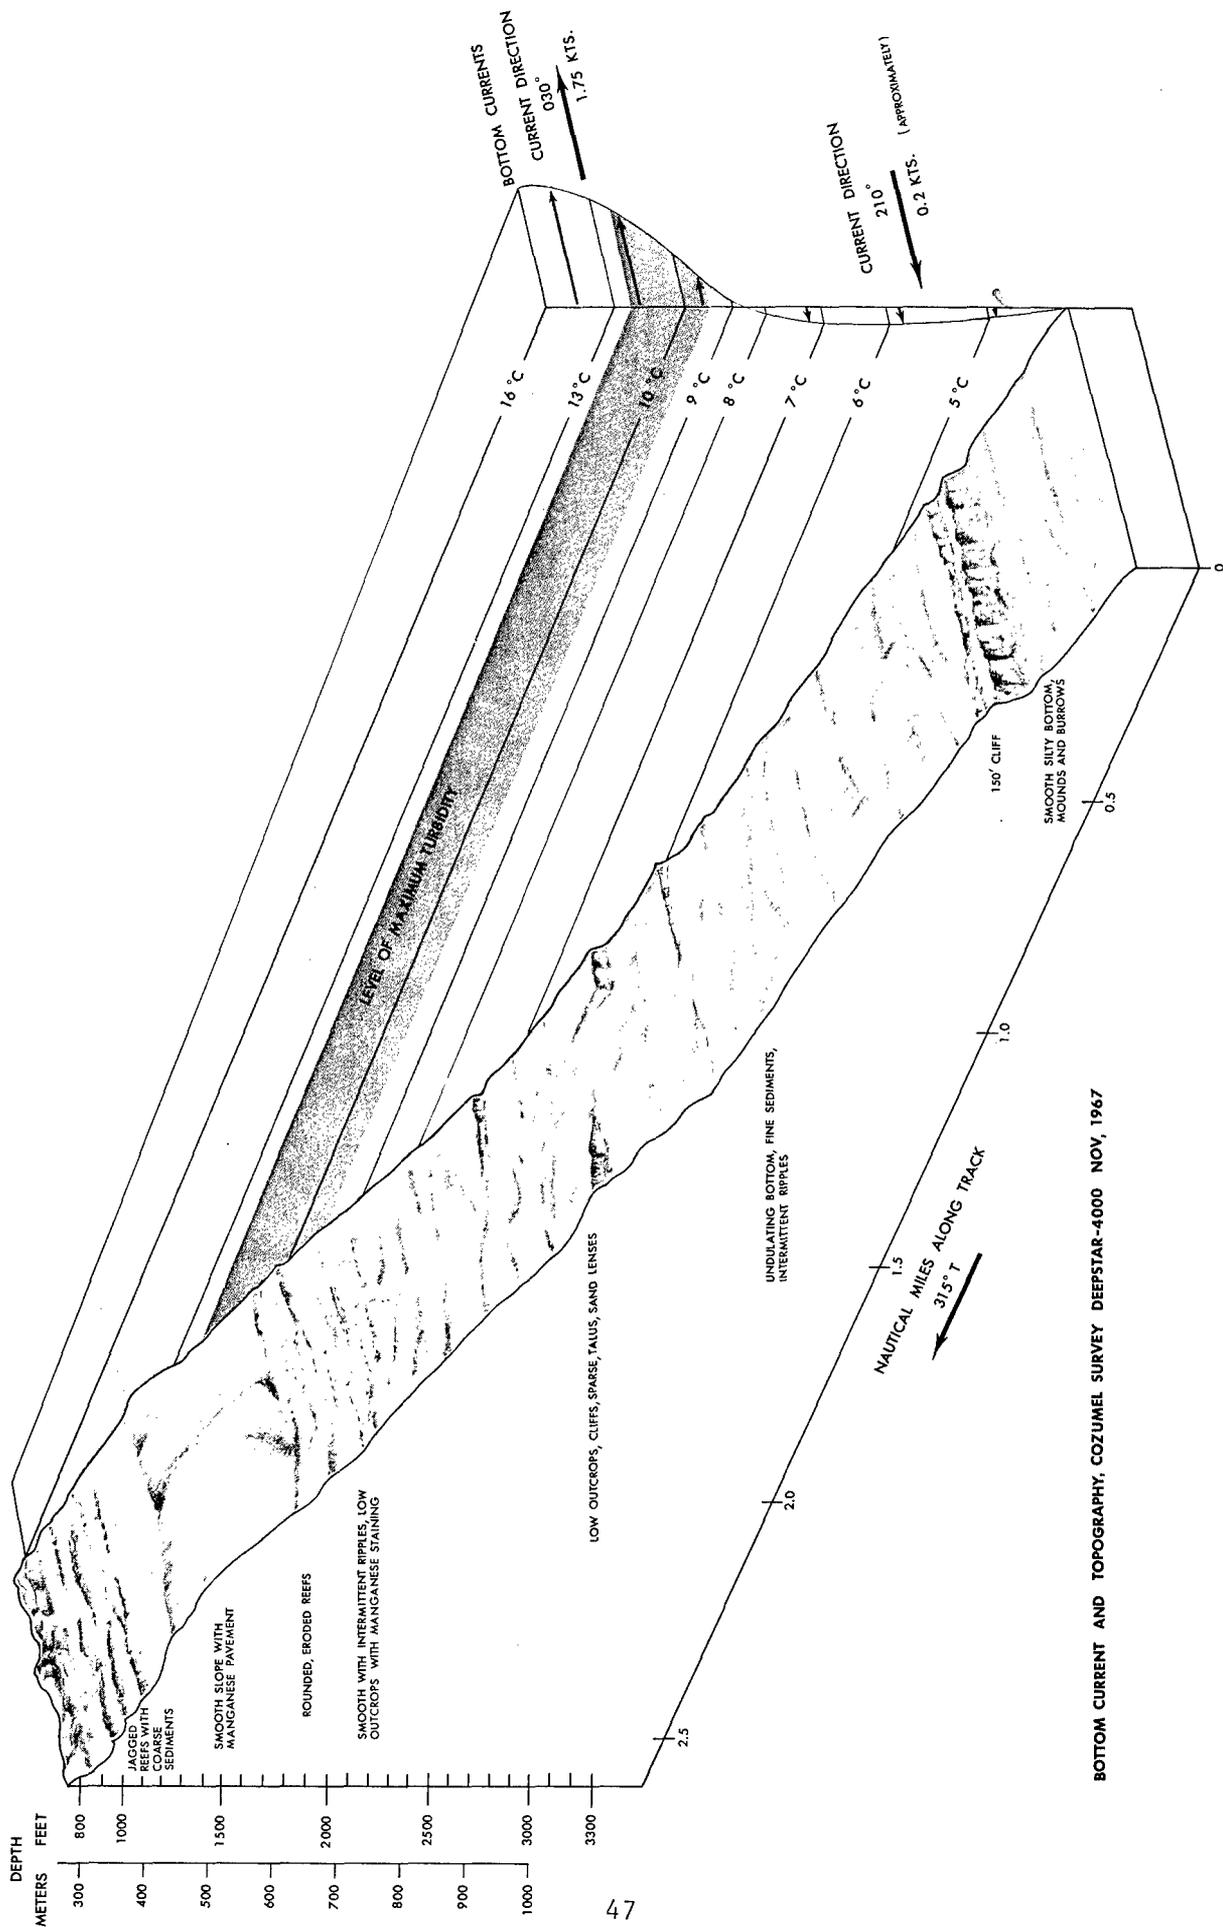
BOTTOM CURRENT AND TOPOGRAPHY, COZUMEL SURVEY DEEPSTAR-4000 NOV, 1967

FIGURE 42. SKETCH OF MAJOR BOTTOM FEATURES NEAR ISLA DE COZUMEL

Figure 42 is a sketch of the area transited by DEEPSTAR; Figure 43 is a bathymetric profile from SEARCH TIDE's echo-sounder, and Figure 44 is the OBSS record along the same track. Two rock samples from this dive are shown in Figure 45.

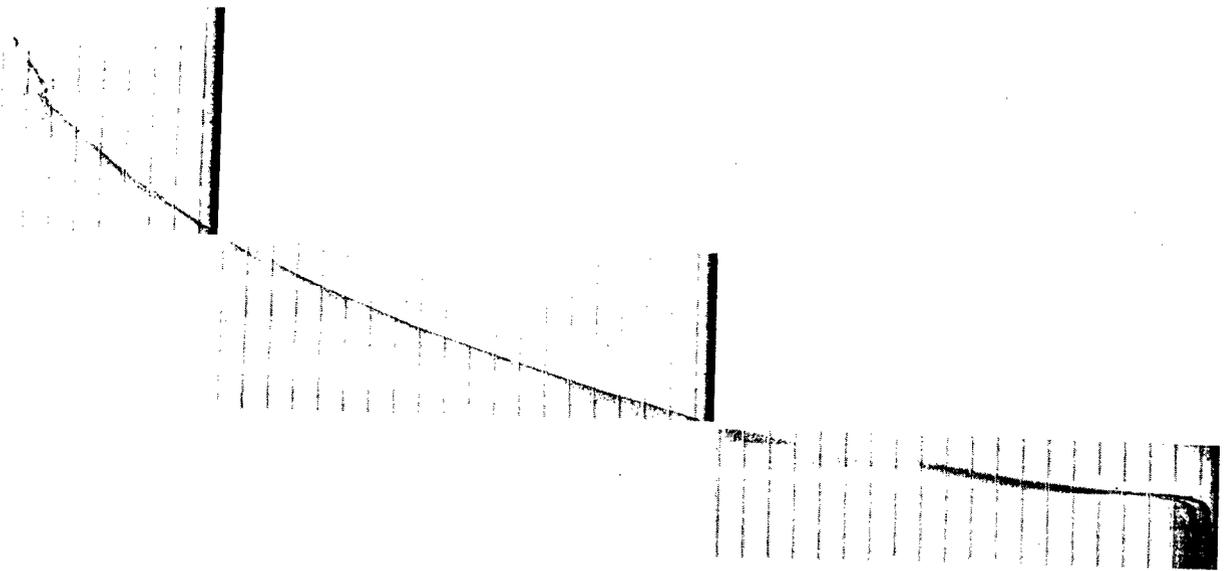
FIGURE 50. ECHO-SOUNDER RECORD FROM MISTERIOSA BANK

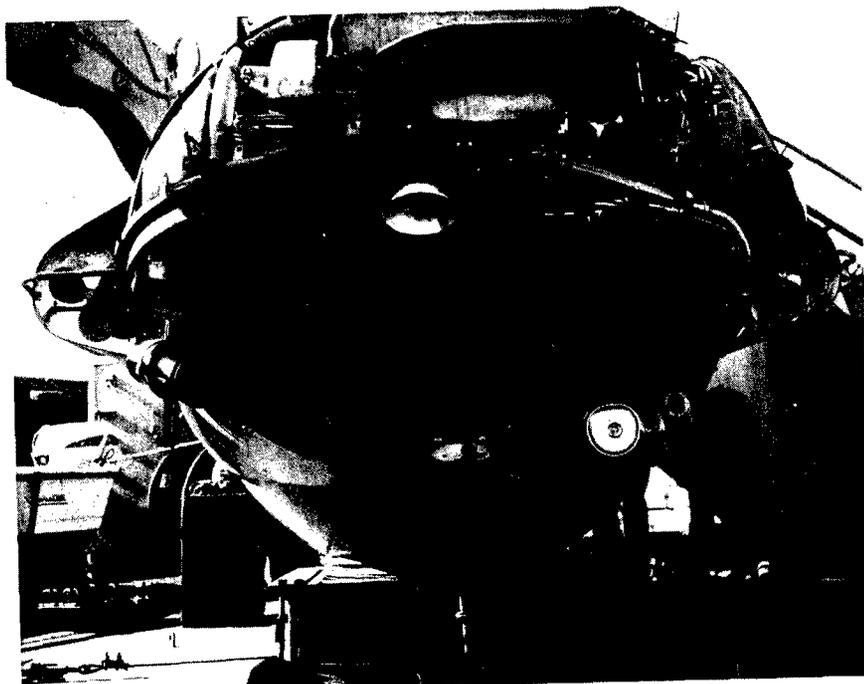
FIGURE 58. VIEWPORT AND CAMERA PORT ARRANGEMENT

DEEPSTAR-4000 (Figure 58) has 2 viewing ports aimed 21° below the

horizontal; one is aimed 16° to port and the other is 16° to starboard of the centerline. Since the field of view of each port is 74° in water, the total field is 106° and the overlapping field is 42° . Hence, the pilot is able to use one port for operating the vehicle while the observer can use the other to view a part of the same area simultaneously. Both of these ports have an interior diameter of 4.33 inches, an exterior diameter of 11.1 inches, and are 3.9 inches thick. This dual-viewing capability is a significant asset since the pilot and observer can easily work together as an effective team in accomplishing the mission.

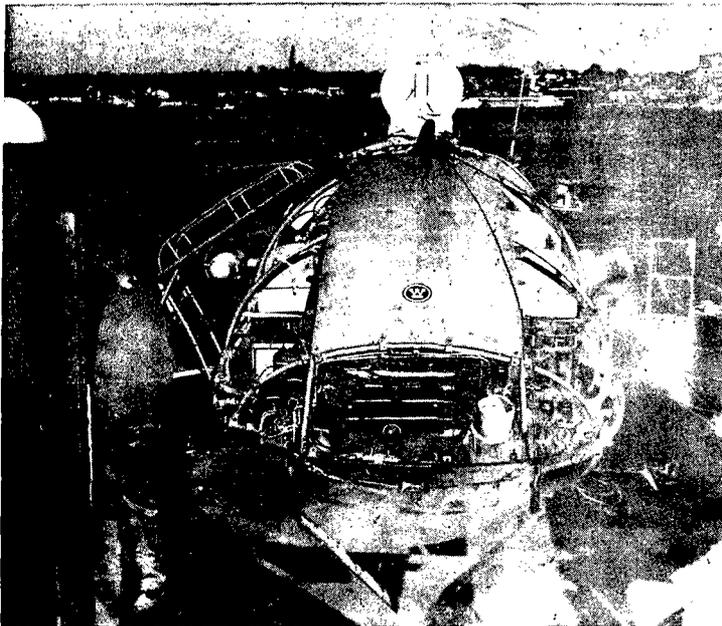
FIGURE 60. FAIRING REMOVED FROM DEEPSTAR FOR EASE OF MAINTENANCE

DEEPSTAR, compared to other vehicles used to date, appears to be better designed for ease of maintenance and servicing. The fiberglass fairing surrounding the pressure hull is easily removed providing access to control equipment and batteries. (Figure 60 shows DEEPSTAR with the fairings removed). During the one-month operation, no dives were cancelled due to unscheduled maintenance. One day of transit time was lost, however, when a crack in an exterior aluminum frame required special welding. The major operational problem encountered with the vehicle was a failure in the main power inverters which supply the two motors. Although this malfunction occurred twice during vehicle check-out on deck, a spare inverter was available and was installed in about 4 hours during the normal battery charging period. A third inverter failure occurred during the last dive before entering the Canal Zone and, due to the time schedule, the dive could not be repeated after repair.

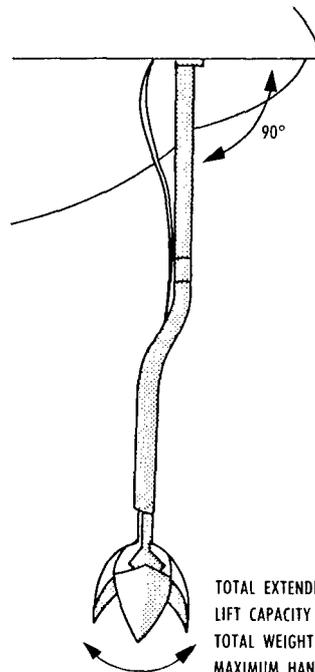
FIGURE 61. RELEASABLE MANIPULATOR ON DEEPSTAR-4000

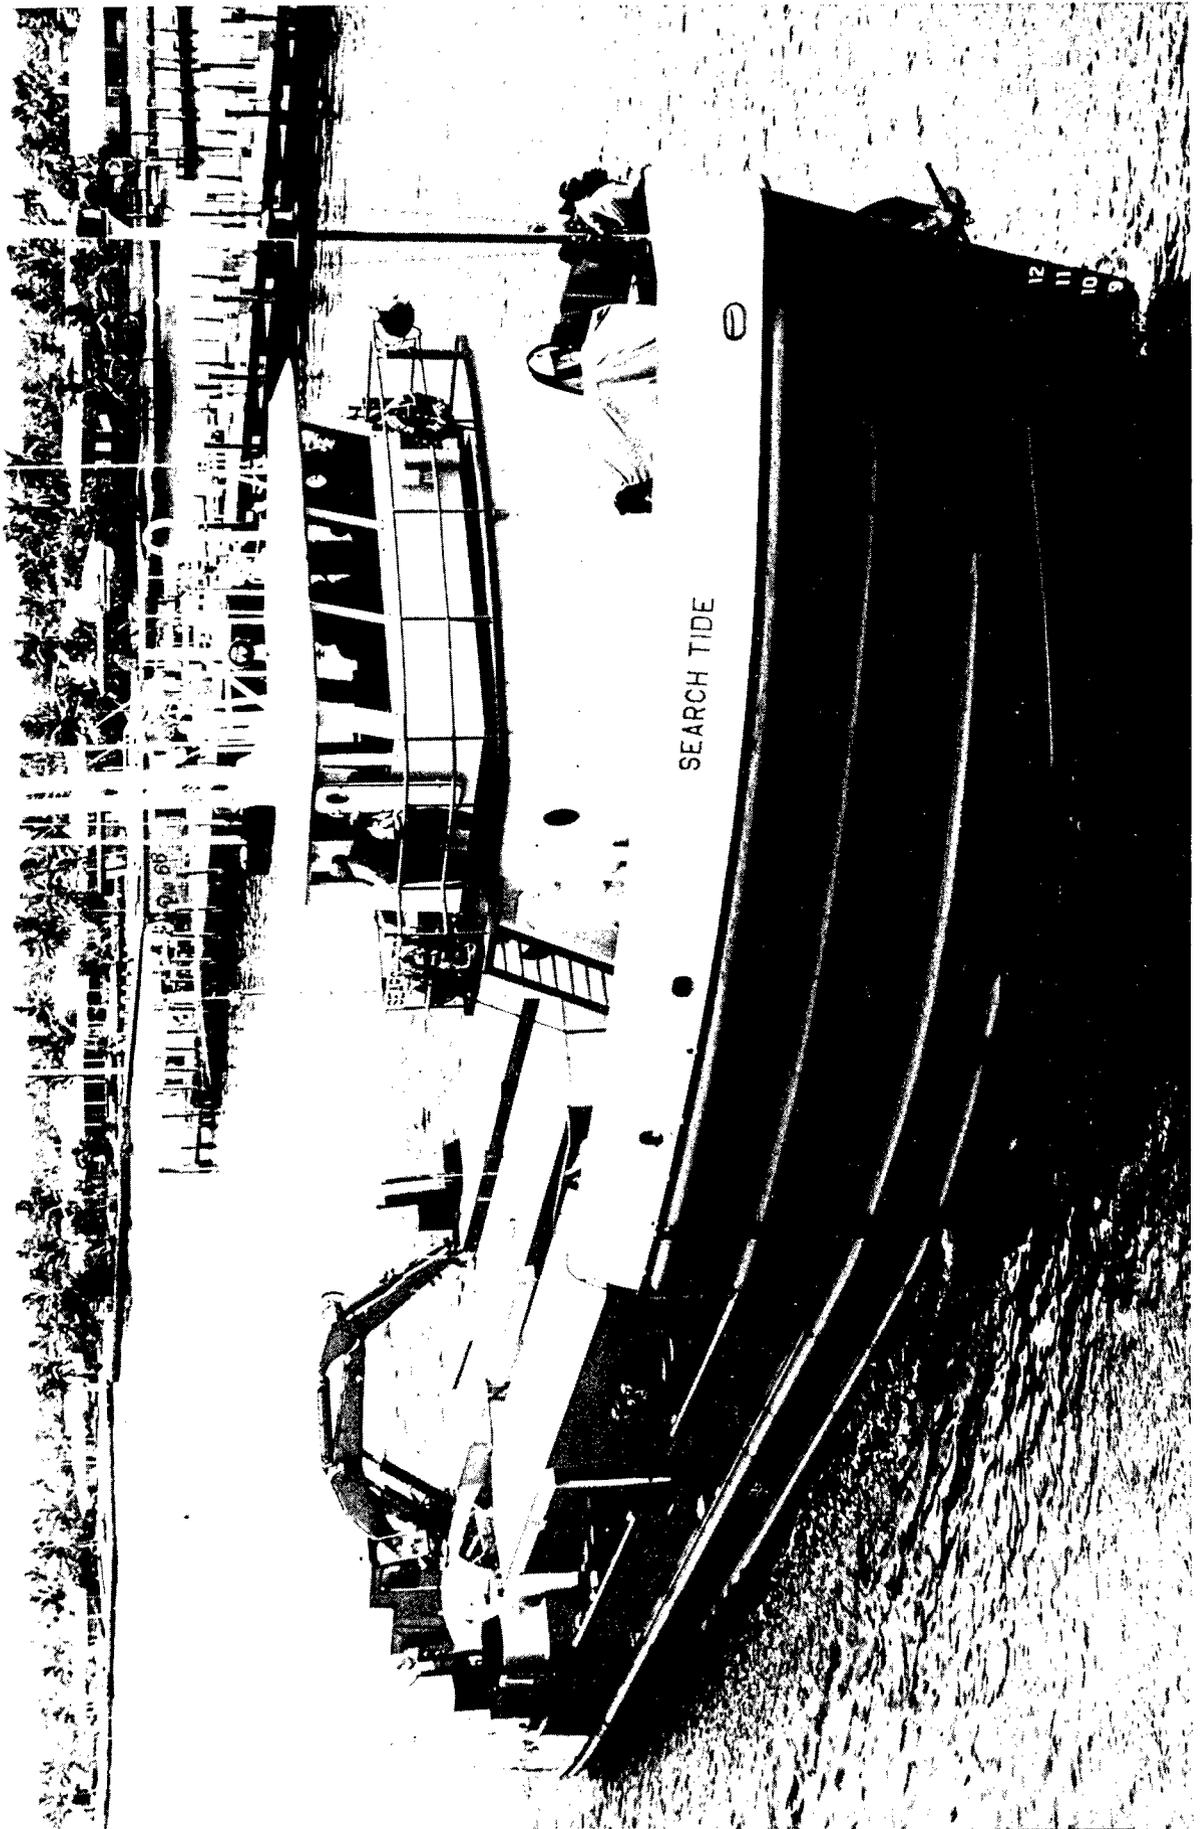
FIGURE 62. M/V SEARCH TIDE

During this operation DEEPSTAR-4000 was supported by the M/V SEARCH TIDE (Figure 62). Major characteristics of this vessel include: length, 155 feet; beam, 36 feet; displacement, 199 tons; maximum draft, 11 feet. This vessel, powered by two Caterpillar 1000 horsepower (max)

diesel engines, has a transiting speed of 12 knots and a range of 5000 miles. This speed and range proved to be most acceptable for the NAVOCEANO operation. The vessel's bridge is located on the 02 level, crew's quarters on the 01 level, and a galley and office are located on the main deck. Four vans located on the fantail provided living space for the submersible crew and NAVOCEANO personnel. Vans housing a dark-room, machine shop, and a maintenance shop for DEEPSTAR's electronics also were located on the ship's fantail. An instrument van for the contract personnel was provided; however, no area for office space was available for the scientists.
