**USAAVLABS TECHNICAL REPORT 70-3**

**1100-HP ROLLER GEAR DRIVE**

**U. S. ARMY AVIATION MATERIEL LABORATORIES  
FORT EUSTIS, VIRGINIA**

**CONTRACT DA 44-177-AMC-30(T)  
TRW MECHANICAL PRODUCTS DIVISION  
CLEVELAND, OHIO**

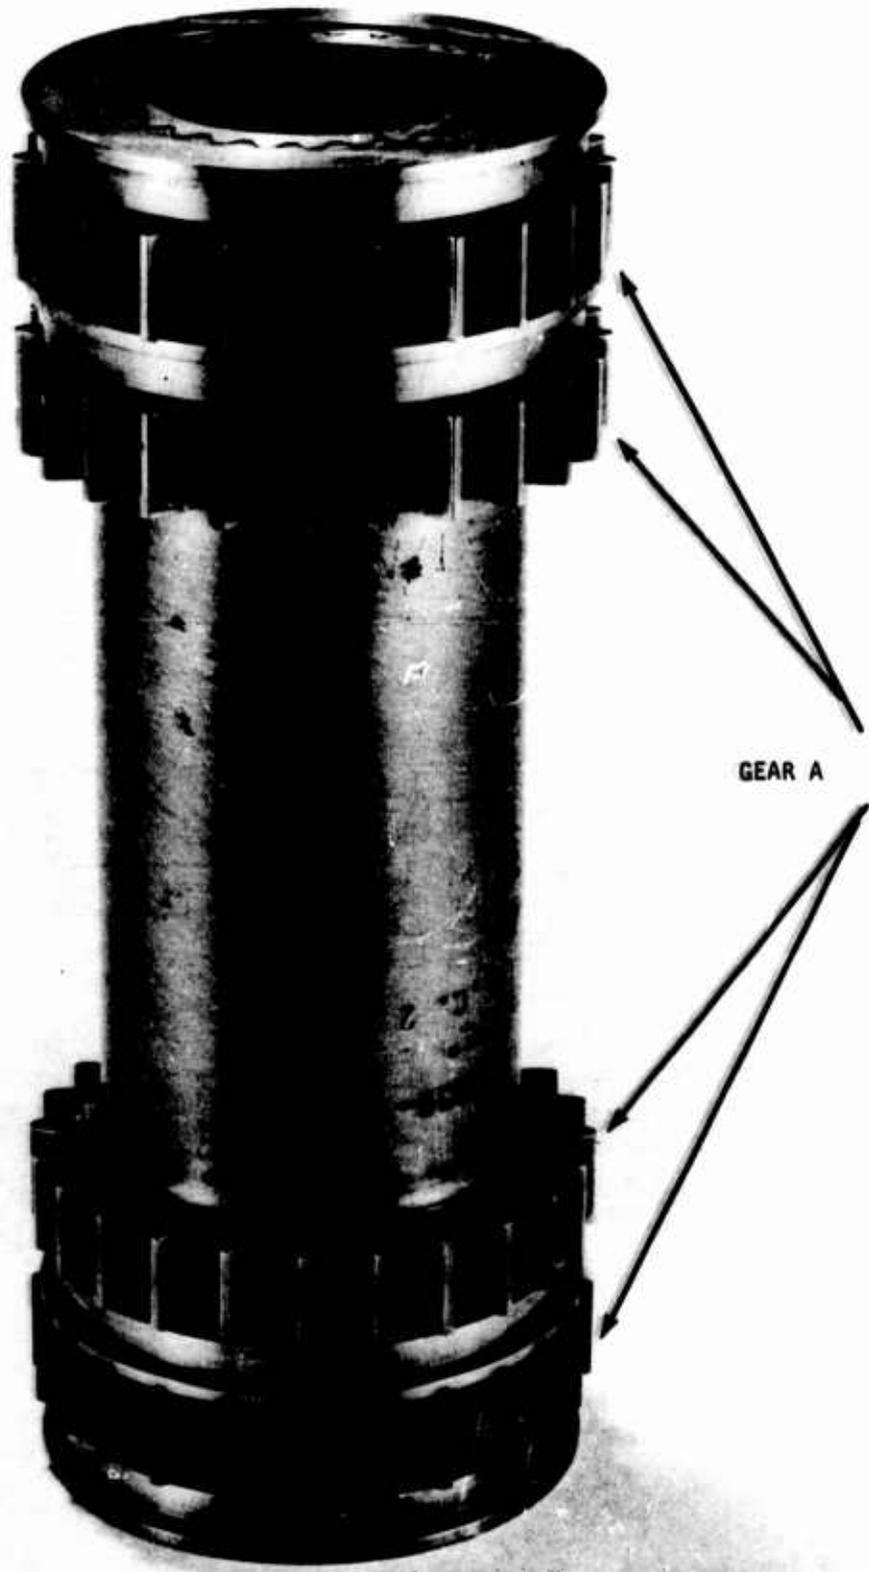
**Figure 3. Sun Roller Gear.**

The sun roller gear shown in Figure 3 is a hollow, cylindrical, multiple-piece element with an internal, centrally located input spline to minimize effects of torsional windup across the face of the gear teeth. The inner gears, which meshed with the three narrow first-row planets, are an integral part of the sun gear shaft. The outer gears, which meshed with the three wide first-row planets, were splined to each shaft end. The teeth of the four gears, A, were integrally cut and finish-ground on both ends of the cylinder.

The outer gears were then removed from the splined shaft ends, and the roller elements were press-fitted to the shoulders on either side of the two outer gears. The gear/roller assemblies were then reinstalled on the shaft splined ends, and the rolling surfaces were finish-ground and lapped

to conform with and be concentric with the pitch diameter of the sun gears. Flanges were provided on the four rollers to provide axial retention of the sun roller gear element.

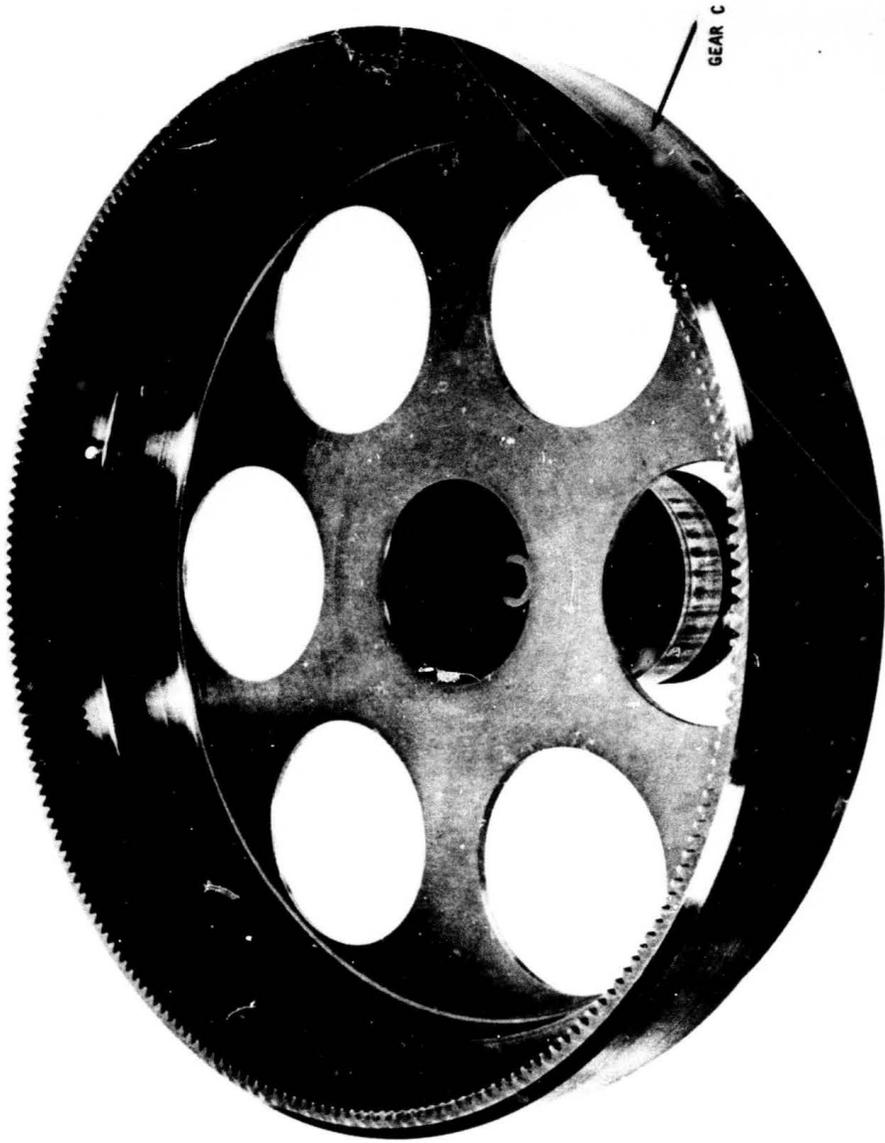
Figure 10. Ring Gear.

The second-row outer planet roller gears,  $X_2$ , transmit torque to the ring gear  $C$ , at six equally spaced contacts. The ring gear is open at the drive input end, and the output end has a piloted mounting flange which is doweled

and bolted to the output drive shaft flange (Figures 10 and 11). The output shaft/ring gear assembly was mounted on two angular contact ball bearings (mounted back to back and spaced 4.5 in. between ball centers) at the output shaft end. The output shaft has an internal spline to accept the output torque coupling adapter.

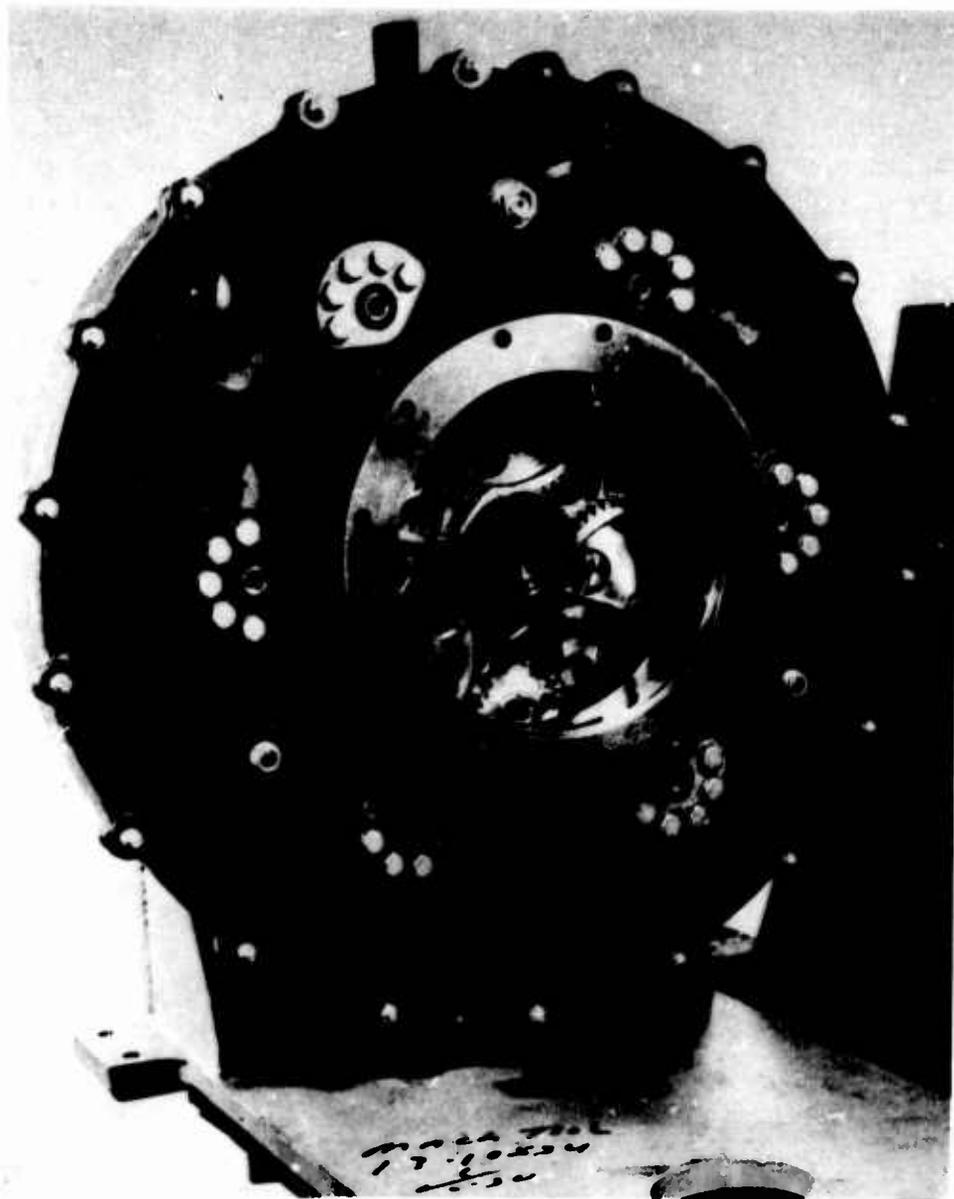
**Figure 12. Roller Gear Support Housing.**

The roller gear support housing was machined from a magnesium casting. Six equally spaced bosses were provided for support of the second-row roller gear shafts. Stainless steel liners were pressed into 1.177/1.197-in.-diameter through-holes in each of the bosses. When assembled with the cover, these liners were bored and reamed to 1.0000/1.0007-in.-diameter to slip-fit with the roller gear shafts. At this time, five .457/.472-in.-diameter through-holes were drilled around each of the six liners for attachment bolts for installing the roller gear shafts (Figure 13). Six equally spaced 2.000-in.-diameter inspection holes were provided for inspection of the second-row roller gears,  $X_2$ , and ring gear, C. These were sealed at assembly by installing flat disk plates with annular O-ring seals. The disks were secured in the holes by installing snap rings on either side of the disk plates.

This support housing contains the mounting flange with twelve bolt holes for attaching the bevel gear duplex bearing support and the bevel gear housing. Three through-holes and two threaded bosses were provided for installing the roller gear lube system manifold. The housing pilot (24.870/24.866-in.-diameter) contains an annular O-ring seal when assembled with the cover.

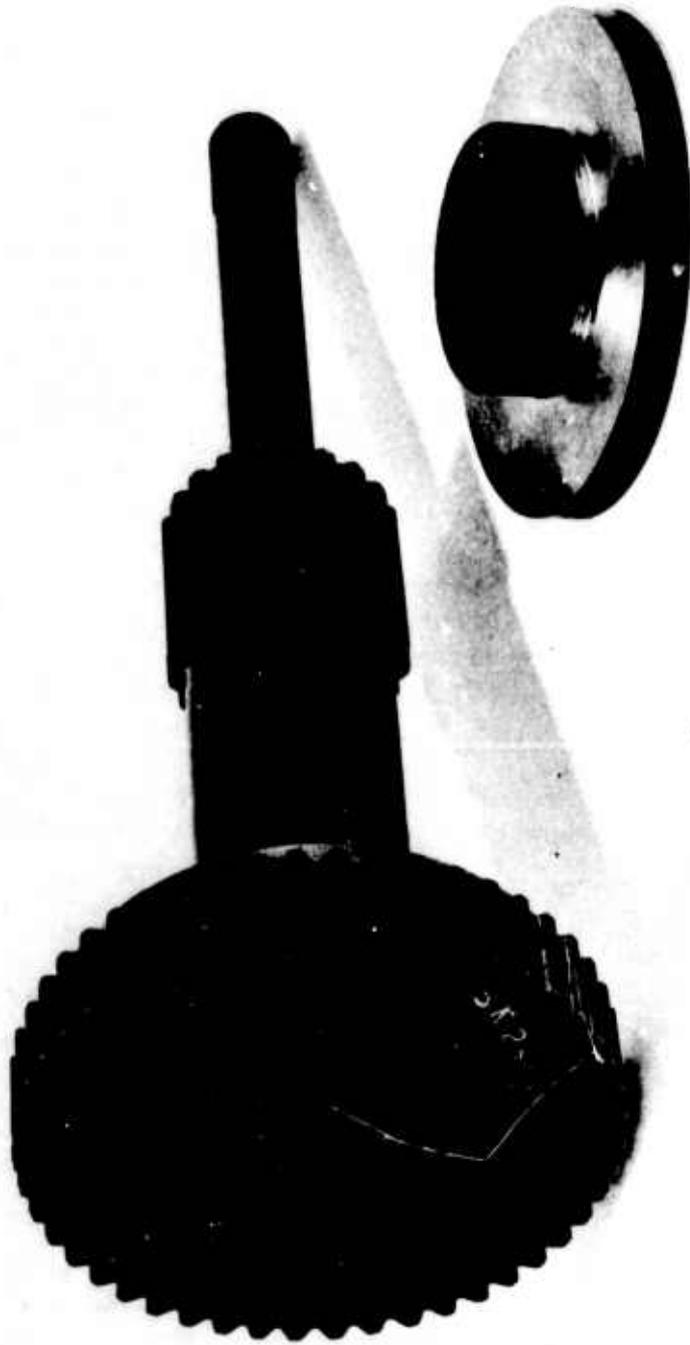
Figure 14. Drive Shaft.

The drive shaft, which transmits torque from the driven bevel gear to the roller gear drive sun gear, A, through a coupling and coupling adapter, engages at the sun gear internal spline. The drive shaft, which is reduced to 1/2-in. diameter beyond the internal spline engagement, extends through the sun gear ID and is threaded on the end. A washer with pilot shoulder which slip-fits into the sun gear ID was placed on the end of the drive shaft threaded end, and a 1/2-in. lock nut was installed on the shaft. This draws the sun gear stackup together and places the sun gear end thrust collars in bearing on the drive shaft shoulder at the input end and on the washer flange at the opposite end. The drive shaft input or large spline is identical to the coupling adapter spline, which was internally splined and locked to the bevel gear output shaft with a flat washer and lock nut (Figure 14). The two splines were engaged with an internally splined drive coupling. The coupling is axially retained by two internal snap rings, which limit axial movement at either spline end.

The drive shaft, coupling, and coupling adapter were made from 4340 steel, heat-treated to  $R_c$  33-38 hardness. All spline teeth were shaped with a surface roughness of  $63\mu$  in.

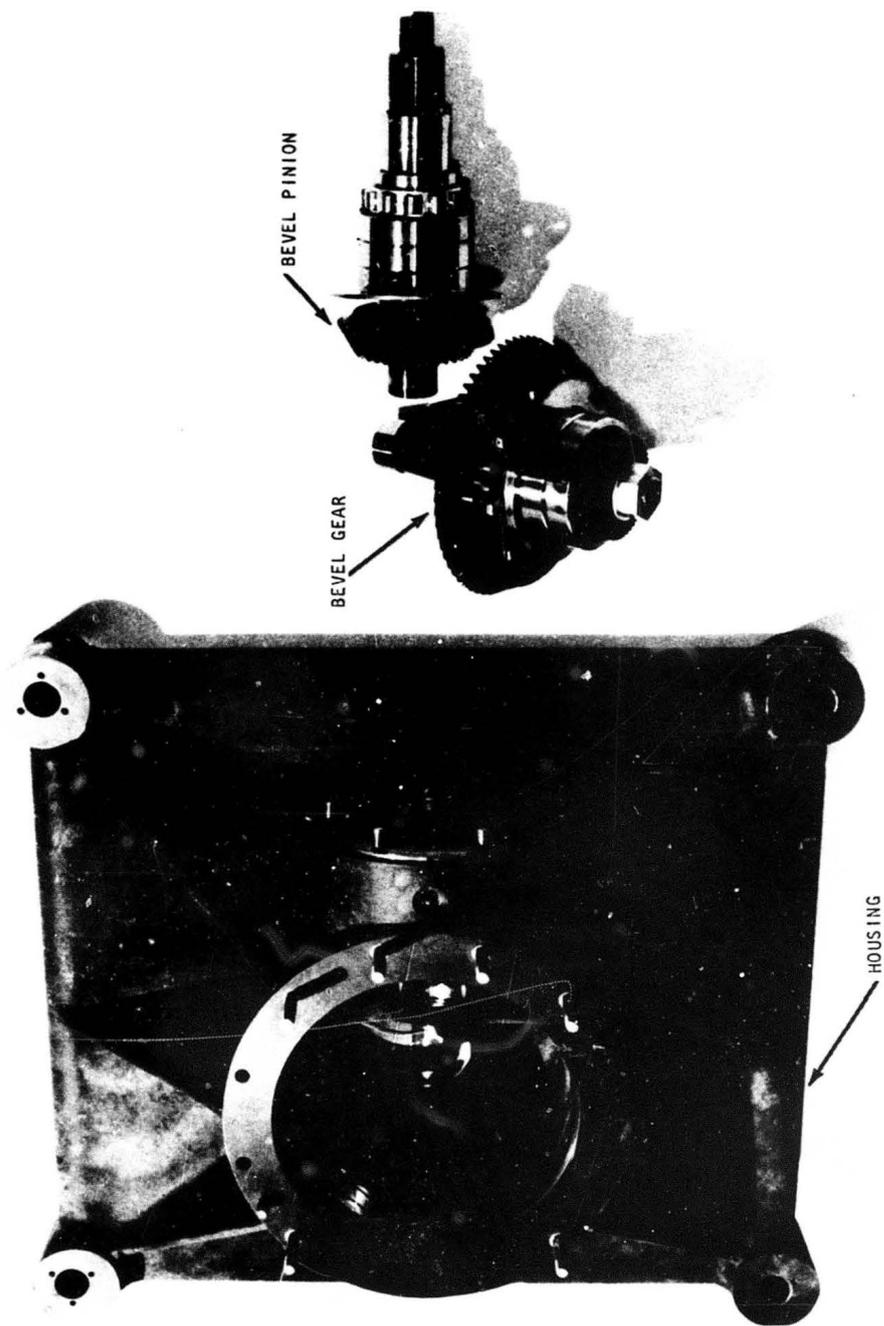
Figure 17. Bevel Drive Components.

The spiral bevel pinion is straddle-mounted. The input end of the gear shaft was mounted on a stack of three angular contact bearings and a roller bearing. Two of the angular contact bearings nearest the gear were mounted in tandem to carry gear thrust loads. The third bearing was mounted back to back with the second to carry reversing thrust loads. The outer roller bearing carried shaft radial loads. The opposite end or gear shaft stub end was mounted on a single roller bearing which carried the highest gear radial loads (Figure 17).

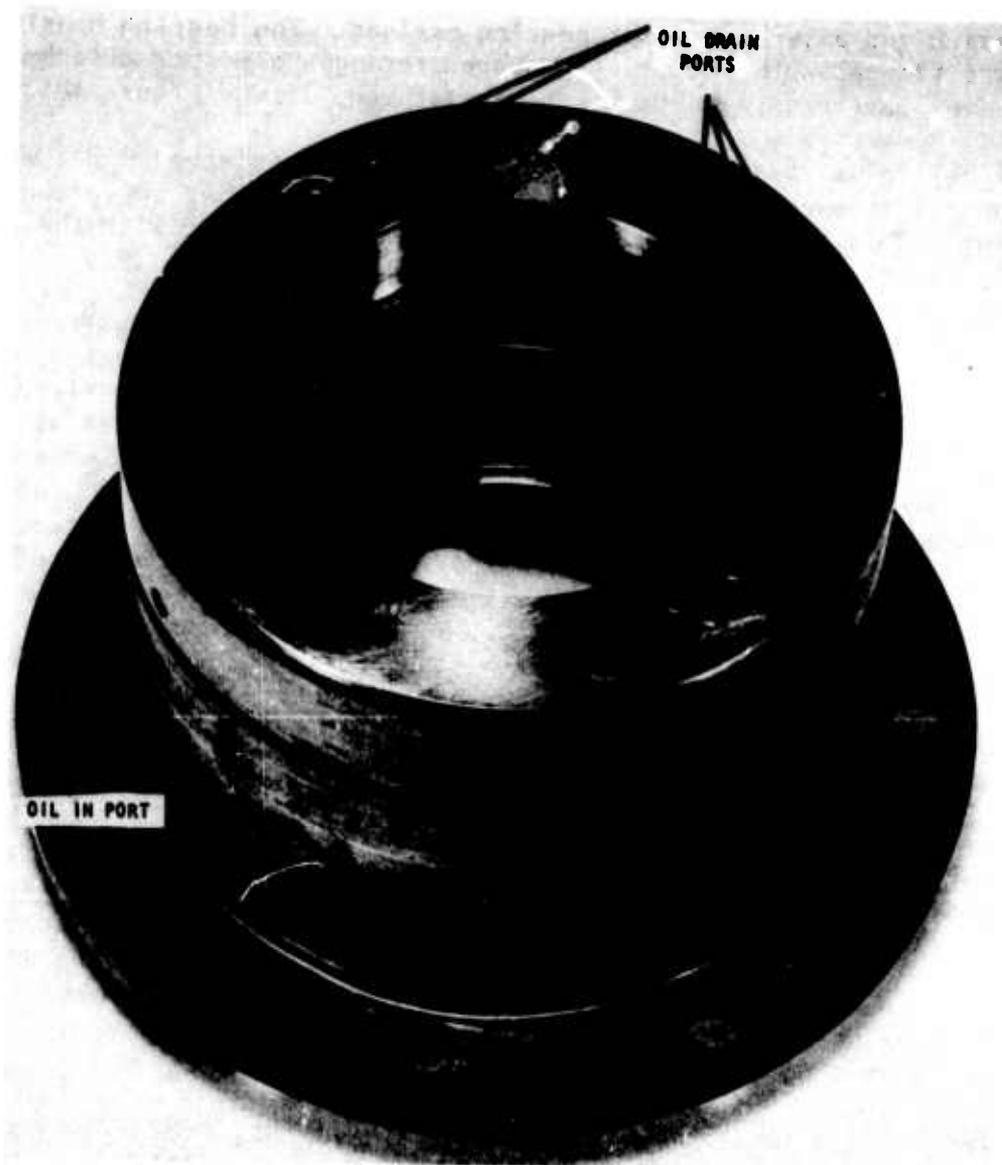
**Figure 18. Bevel Pinion Bearing Housing.**

into a magnesium bearing housing. A steel bearing retainer plate, through-bolted four places to the end of the bearing housing, retained the bearing stack and assured correct bearing preload. The bearing housing outer end was flanged with six equally spaced through-holes for attachment to the bevel gear housing with its six attachment studs (Figure 18).

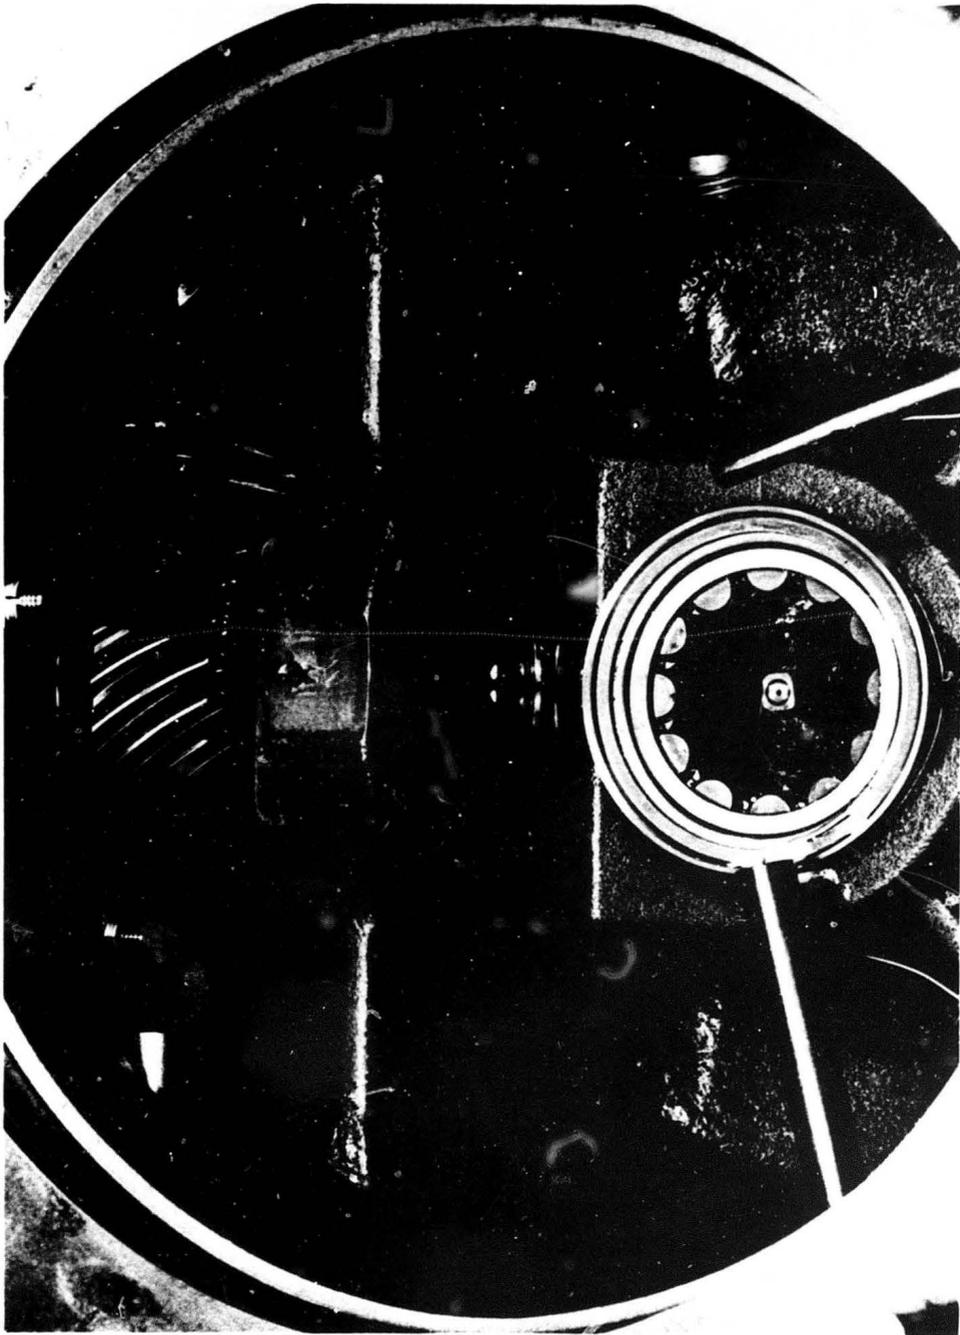
Figure 19. Bevel Gear and Pinion Inner Roller Bearings.

The inner roller bearing is retained by a stainless steel liner which has an inner flange on one end and a snap ring on the other to retain the bearing. This liner was pressed into a bore concentric with the other bearing cartridge bore in the bevel gear housing (Figure 19).

The inner roller bearing is retained by a stainless steel liner which has an inner flange on one end and a snap ring on the other to retain the bearing. This liner was pressed into a bore concentric with the bearing retainer pilot diameter in the bevel gear housing (Figure 19).

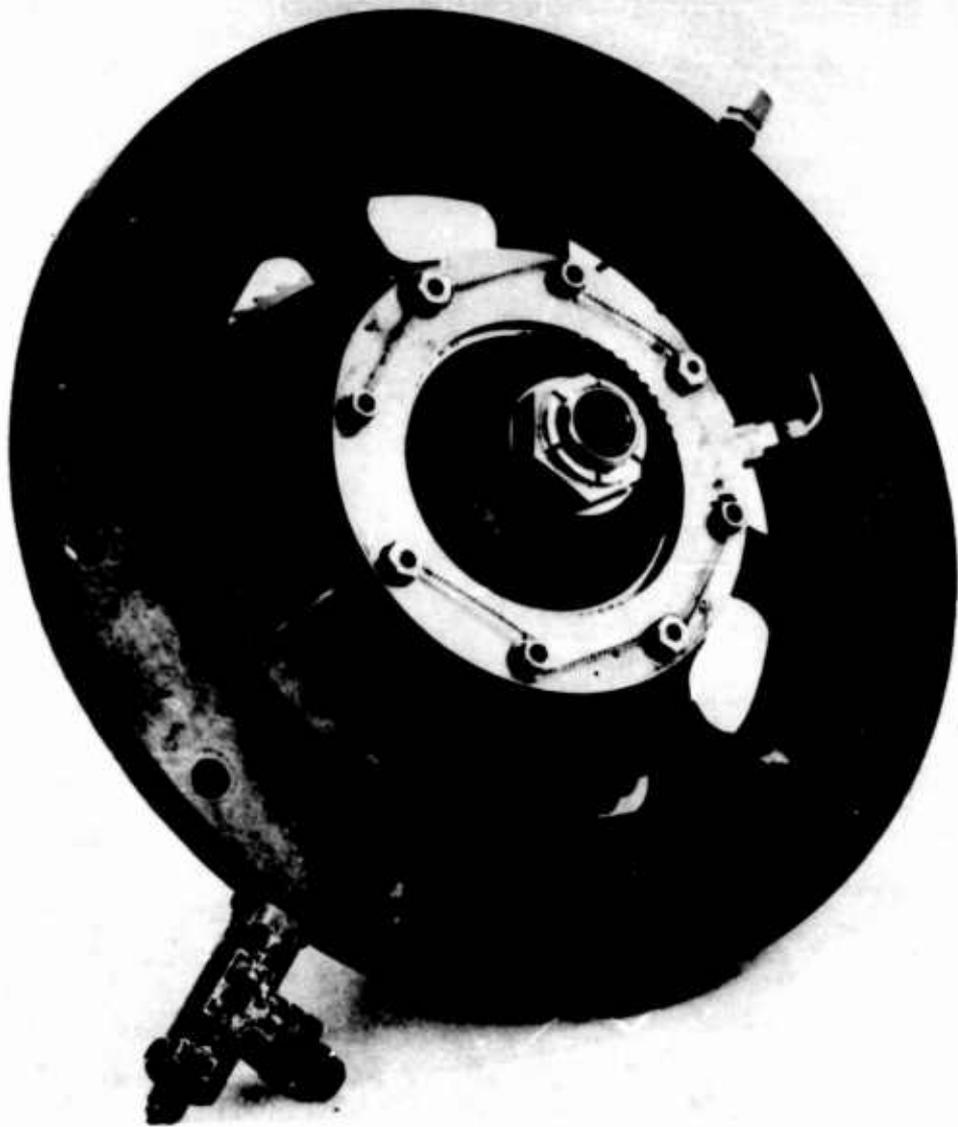
**Figure 20. Bevel Gear/Shaft and Bearing Support Assembly.**

The two angular contact bearings were slip-fit into a stainless steel liner, which in turn, was pressed into the magnesium bearing support. The bearings were retained axially by retainer plates at either end which were bolted to the bearing support (Figure 20).

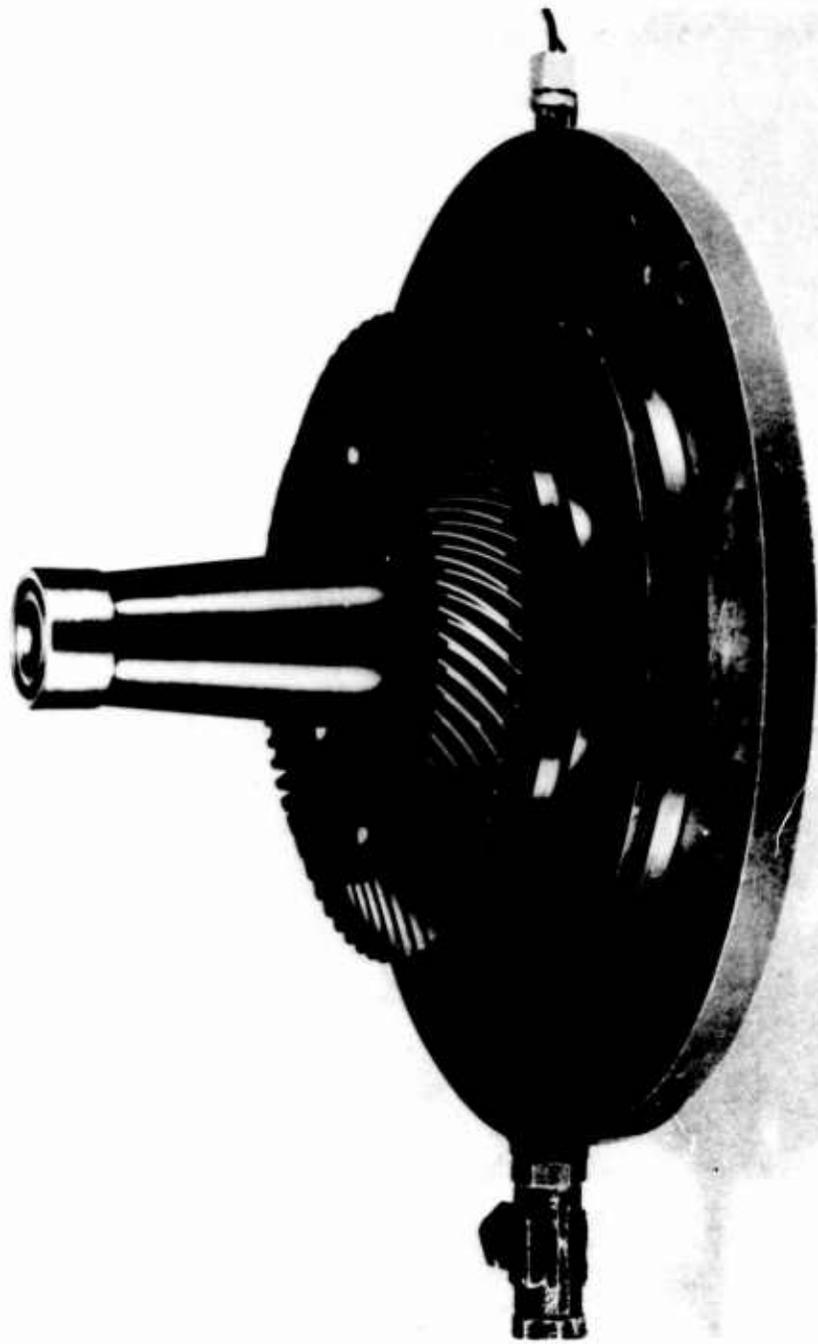
**Figure 21. Bevel Gear/Shaft and Bearing Support Assembly.**

The driven gear was positioned axially for the correct mounting distance by a shim plate that was inserted between the bearing retainer and housing at the mounting flange interface (Figure 21).

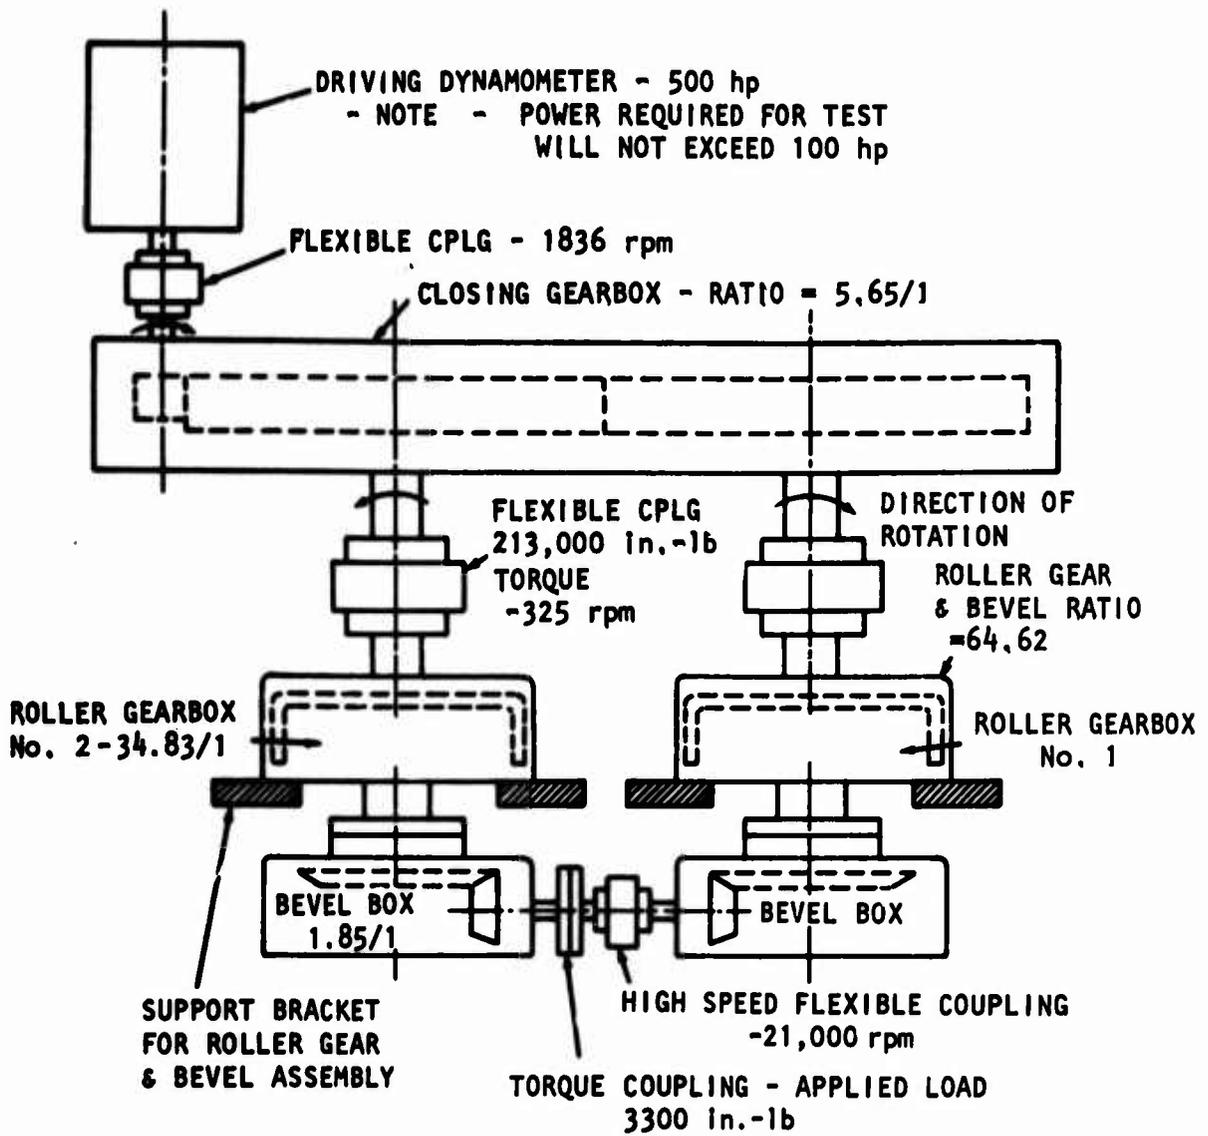
Figure 22. Test Rig Schematic.

The testing system employed the principle of back-to-back (four-square loop) coupling of two test units in a closed-power path. An instrumentation system was provided to measure loads, speed, oil flows, pressures, temperatures, and vibration levels. In addition, frequent analysis of the lubrication oil was made to determine the iron content in parts per million to provide a warning of incipient failure.

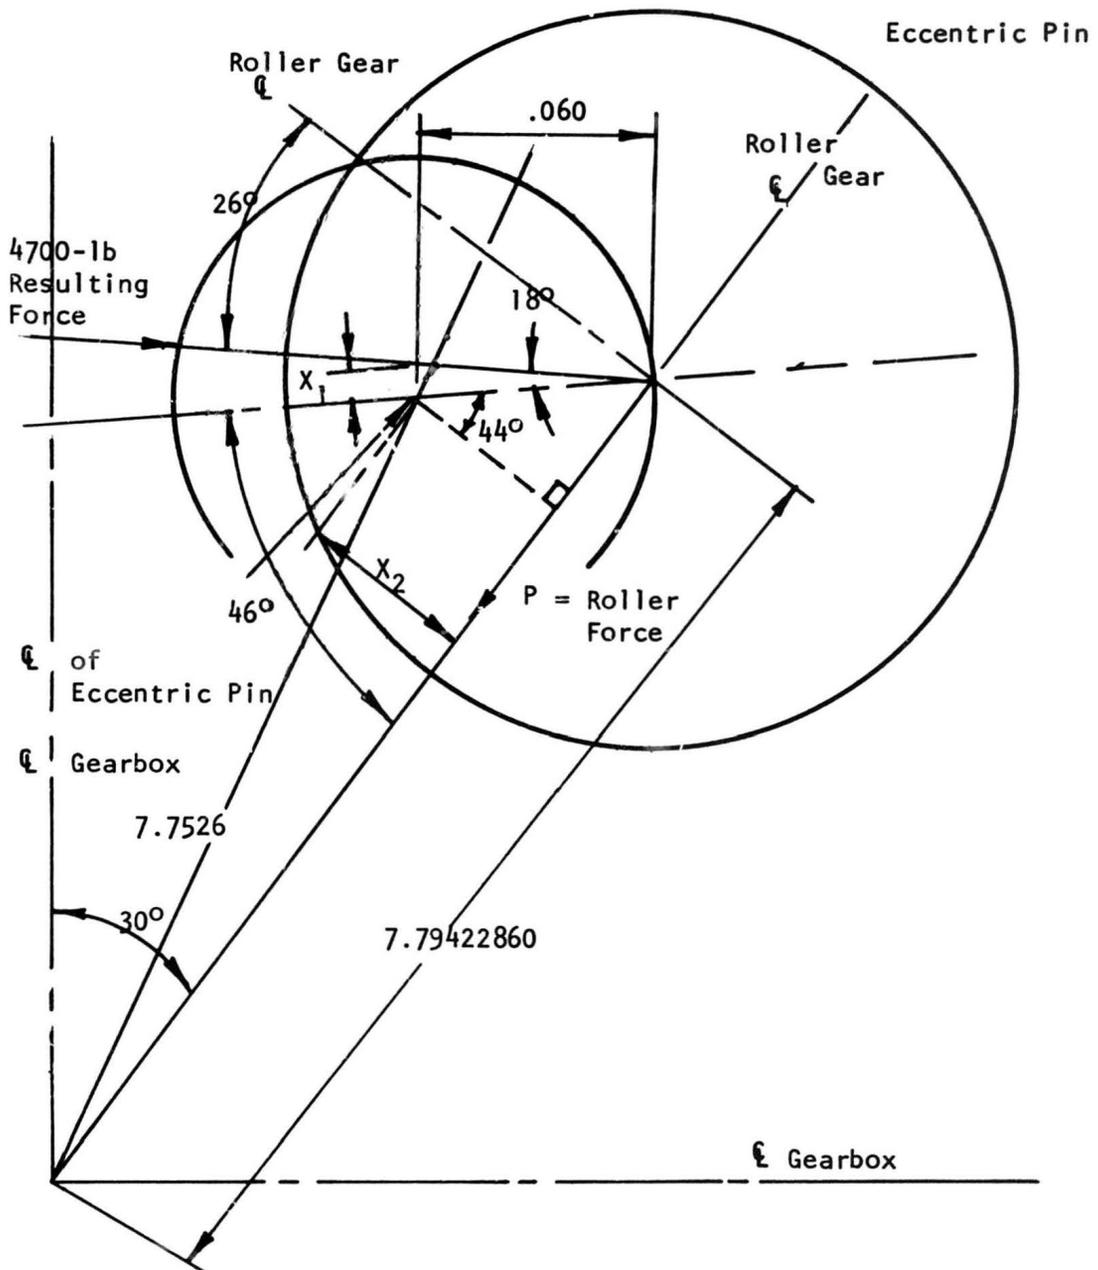
This represents the eccentric when assembled with no preload but with roller gears on center locations ready for automatic preload.

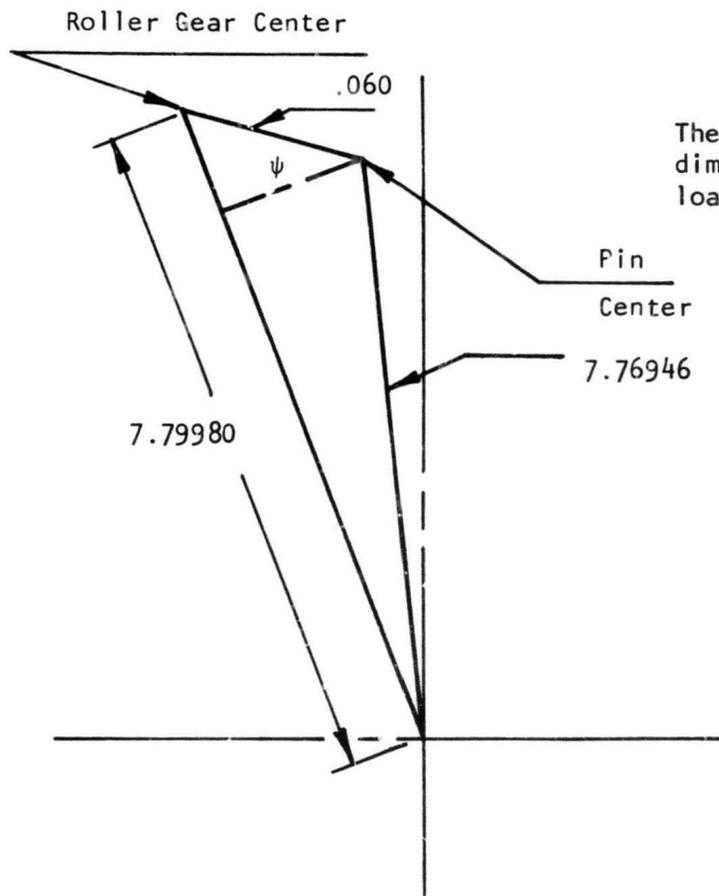
These are the dimensions under load and temperature.
