**DESIGN, DEVELOPMENT,  
AND FABRICATION OF  
FMU-35/B BOMB FUZE**

**HONEYWELL INC.  
ORDNANCE DIVISION**

**TECHNICAL REPORT AFATL-TR-67-80**

**JULY 1967**

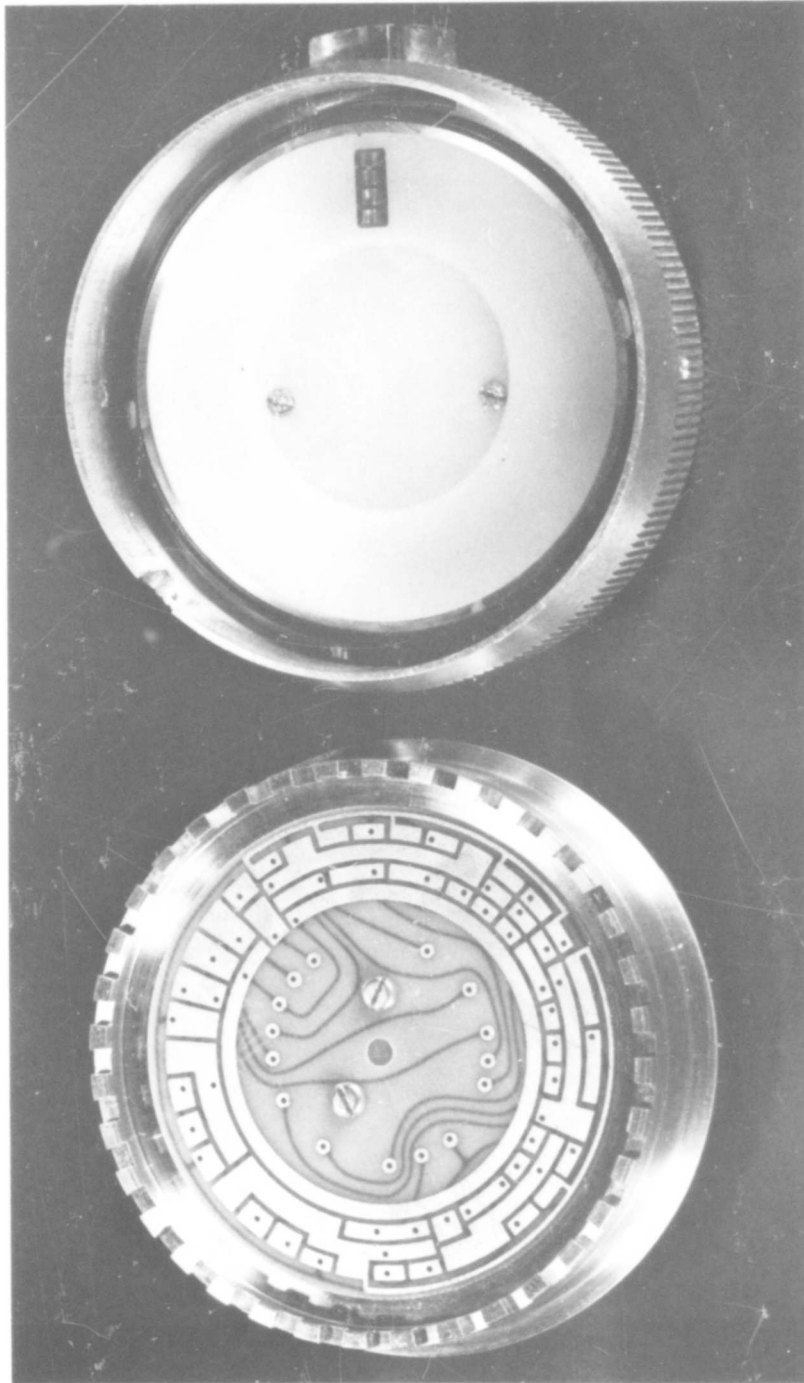
Figure 2. Selector Switch Housing (A) and Cover Assembly (B)

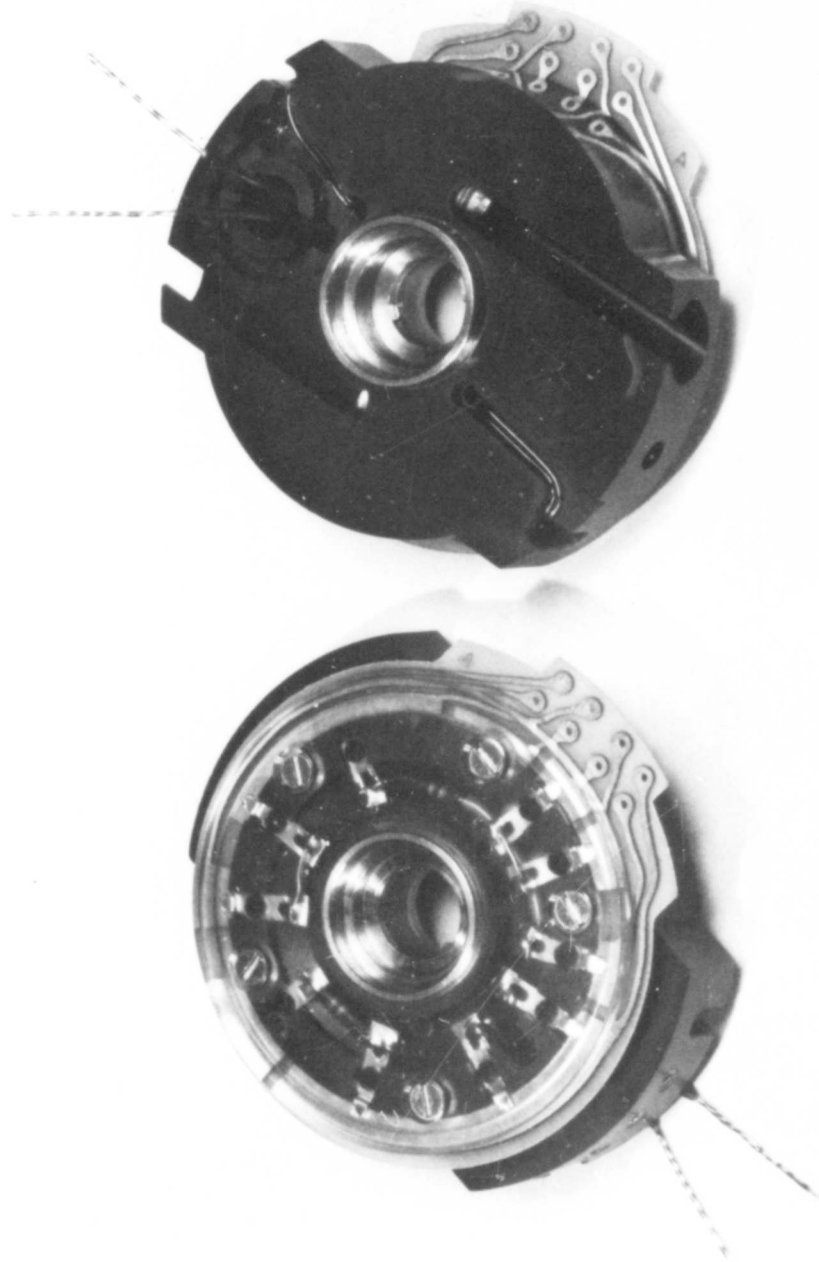
Figure 36. Rotor and Contact-Plate Assembly (Final Design)

##### a. Explosive Train Assembly (Figures 35 and 36).
