SURFACE INTEGRITY OF MACHINED STRUCTURAL COMPONENTS

Metcut Research Associates Inc.
Cincinnati, Ohio

Technical Report AFML-TR-70-11
March 1970

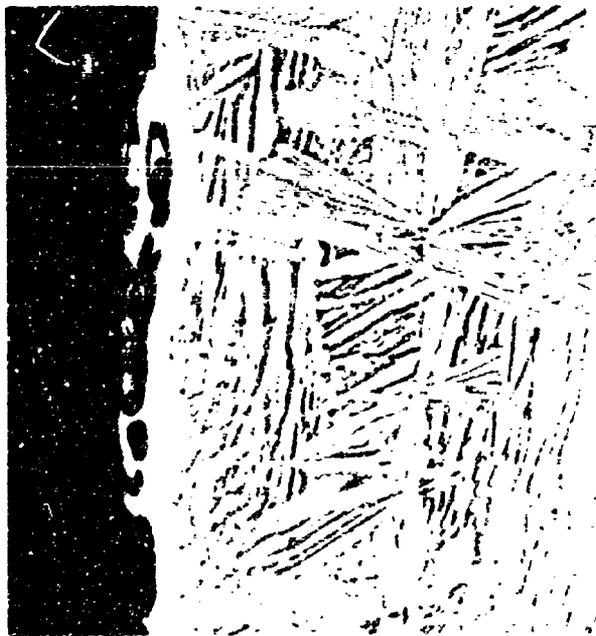
(a) Finishing Conditions - A slight recast layer is evident but without measurable hardness change.
Surface Finish: 90 AA
1000X

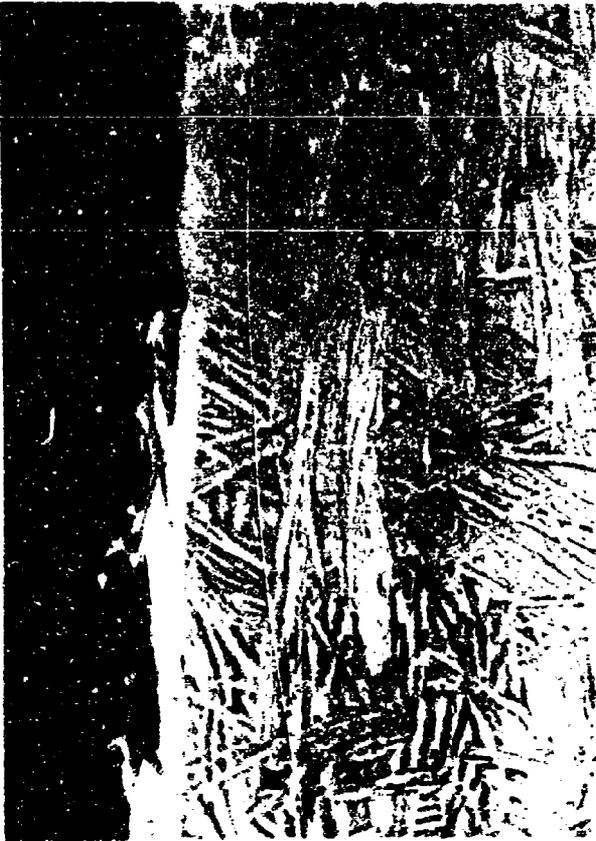
(b) Roughing Conditions - Slight recast layer plus hardness increase approximately .002" deep due to localized surface heating.
Surface Finish: 180 AA
1000X

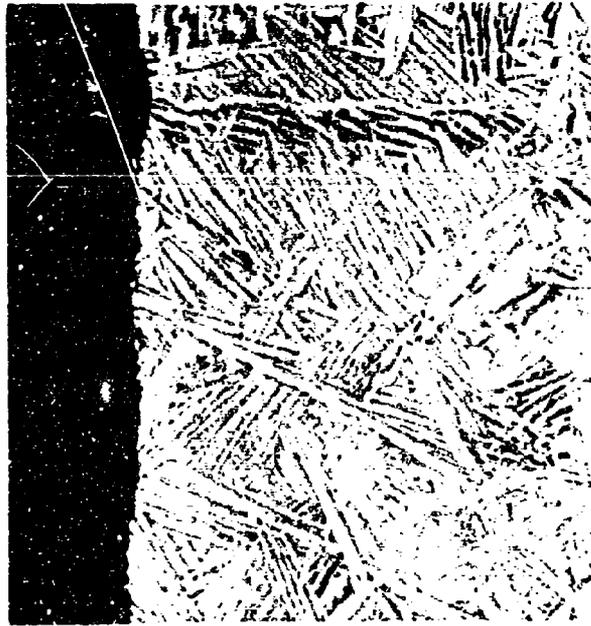
(a) Gentle Conditions - No visible surface distortion but with hardness loss approximating 5 points R_c .
Surface Finish: 20 AA 1000X

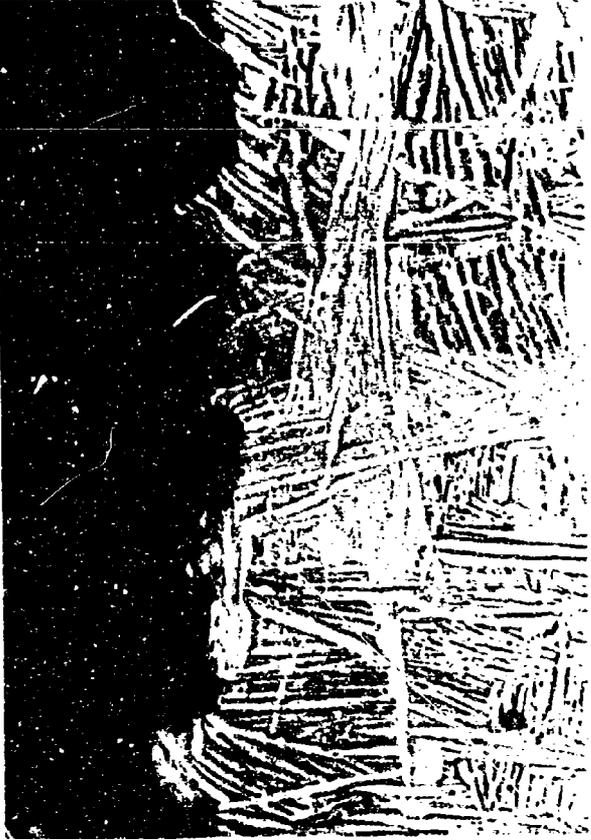
(b) Abusive Conditions - Significant surface roughening also exhibiting hardness loss of 5 points R_c .
Surface Finish: 165 AA 1000X

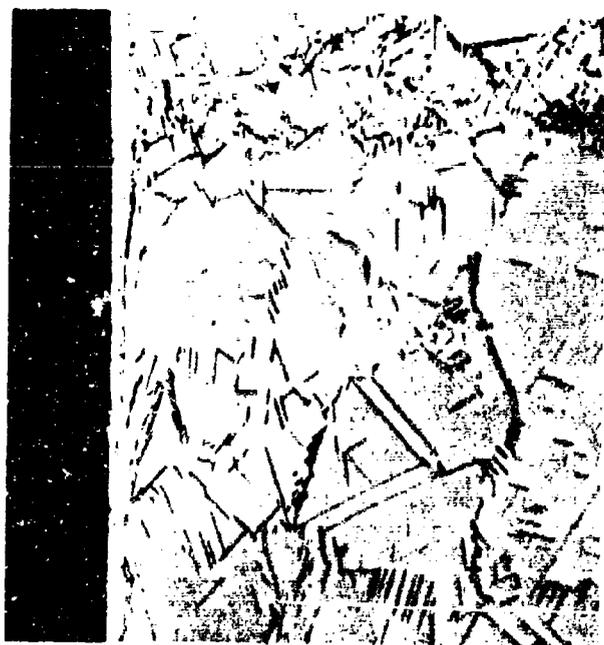
SURFACE CHARACTERISTICS OF
INCONEL 718 (Solution Treated and Aged, 44 Rc)
PRODUCED BY END MILLING - PERIPHERAL CUTTING

(a) Gentle Conditions - Thin layer of surface distortion is evident, but of insufficient depth to detect hardness change.

Photomicrographs of Inconel 718 produced by end milling are shown in Figures 54 and 55. The end milling-end cutting (Figure 54) shows no evidence of measurable hardness change, although a small degree of plastic deformation can be seen on the sample cut under abusive conditions. Peripheral cutting (Figure 55) produced a higher degree

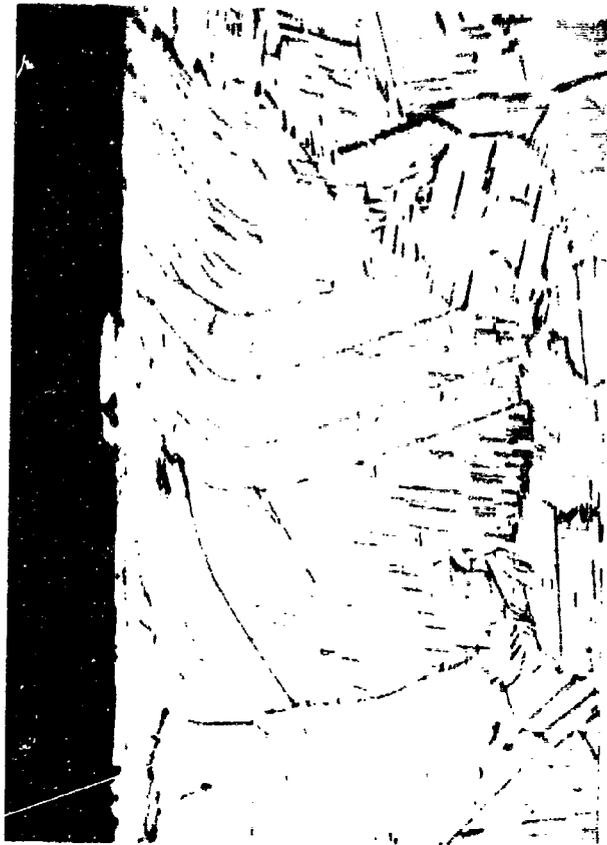
(b) Abusive Conditions - Surface distortion readily apparent. Microhardness increase indicates strain hardening approximately .002" deep.

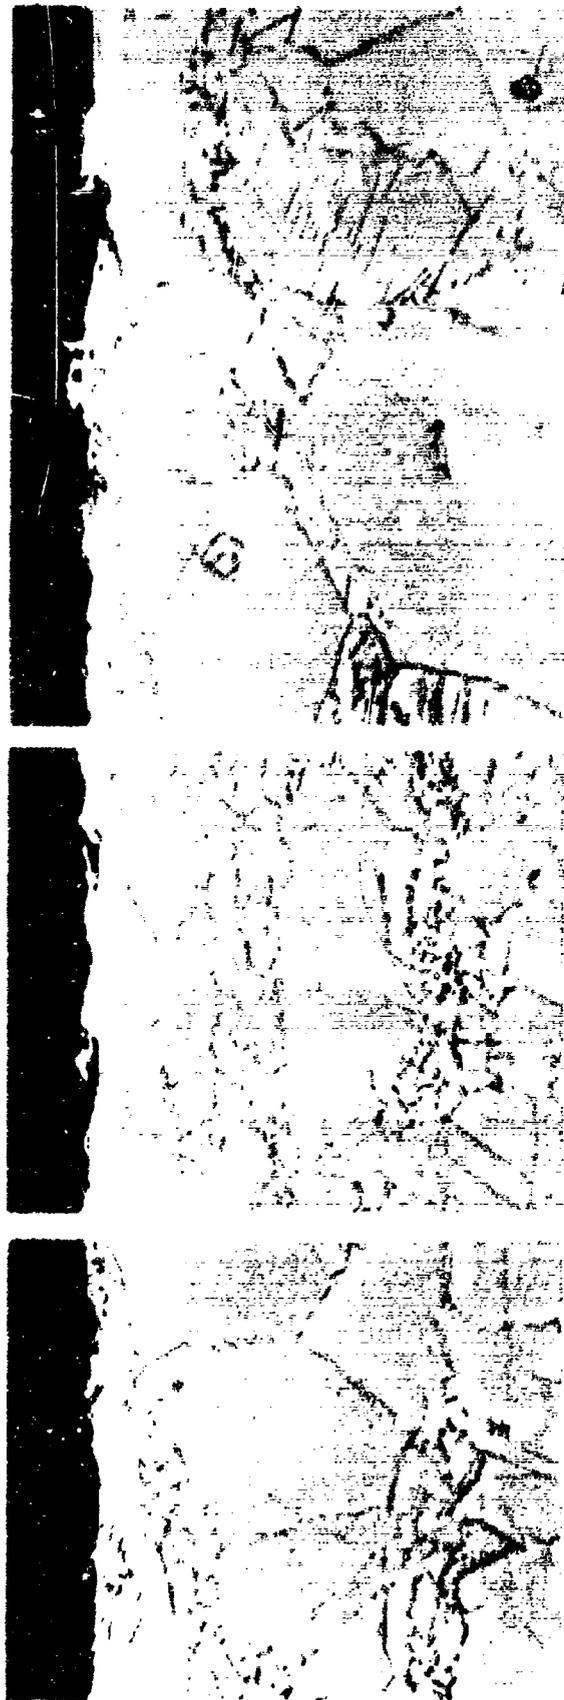
**SURFACE CHARACTERISTICS OF
INCONEL 718 (Solution Treated, 98 R_B)
PRODUCED BY GRINDING**

(a) Gentle Conditions (b) Conventional Conditions (c) Abusive Conditions

None of the various grinding procedures produced visible surface alterations as a result of the particular grinding variables employed. The absence of surface changes is judged both from microstructure and from microhardness measurement.

Photomicrographs of Inconel 718 produced by gentle, conventional, and abusive grinding are shown in Figure 51 for the as-solutioned material and in Figure 52 for the fully aged material. Notice the increasing surface roughness associated with an increase in grinding severity. Notice also the microhardness increase associated with conventional and abusive grinding on the solution treated material. This hardness increase is believed due to localized aging of the alloy during grinding because of localized surface heating. Notice that the depth of hardness increase is much greater in the case of abusive grinding than in the case of conventional grinding (.015 in. versus .005 in.). The gentle grinding did not produce sufficient heating to cause any measurable surface hardness increase. Microhardness variation in the fully aged material was not observed. This is shown in Figure 52. In both of these materials, microstructure changes are at a minimum, except for differences in surface roughness as noted above.

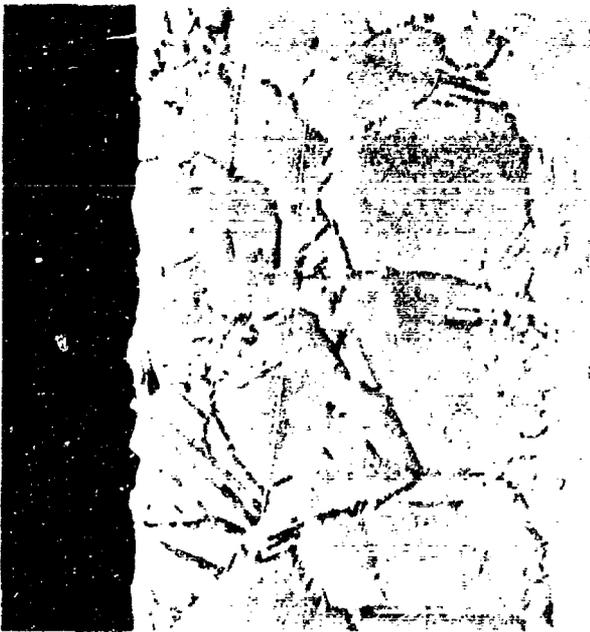
(a) Gentle Conditions - No visible surface alterations were produced although some surface softening was noted.

Surface Finish: 19 AA
1000X

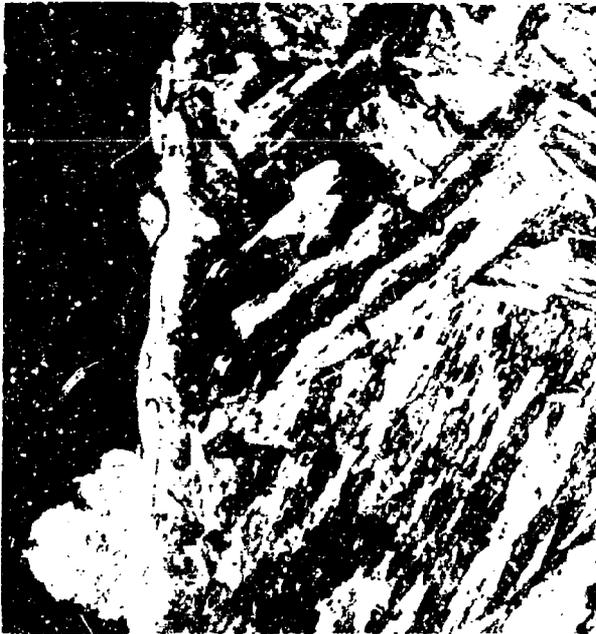
(a) Finishing Conditions - A spotty layer of recast metal averaging .0001" deep was formed on the surface.

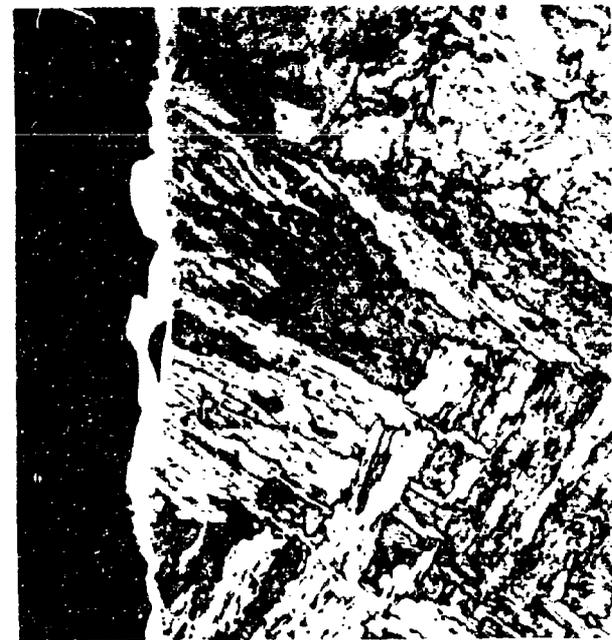
(a) Finishing Conditions - A thin continuous recast layer averaging .0001" deep was formed on the surface. 1000X

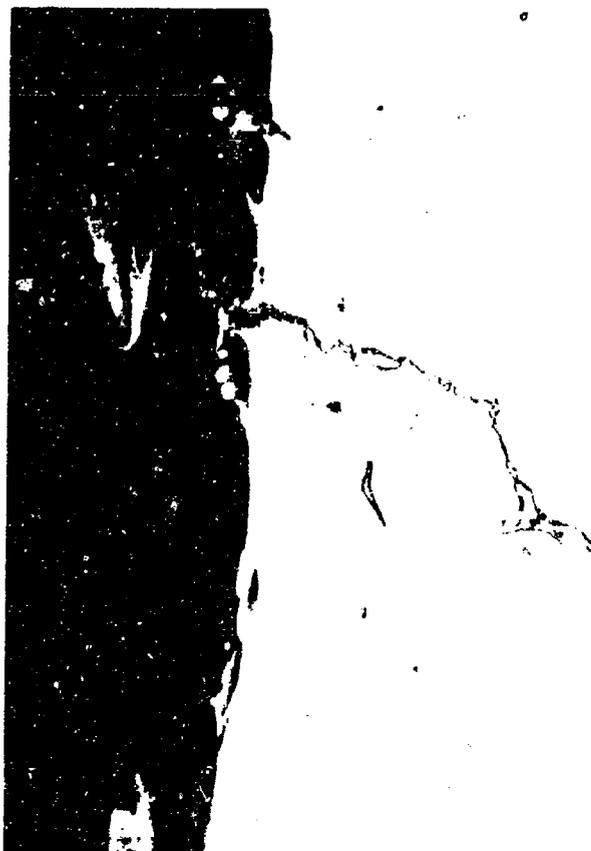
(b) Roughing Conditions - A continuous recast layer averaging .001" deep was produced on the surface. In general, this layer tended to crack at grain boundary intersections with the surface. No micro-hardness changes were observed.

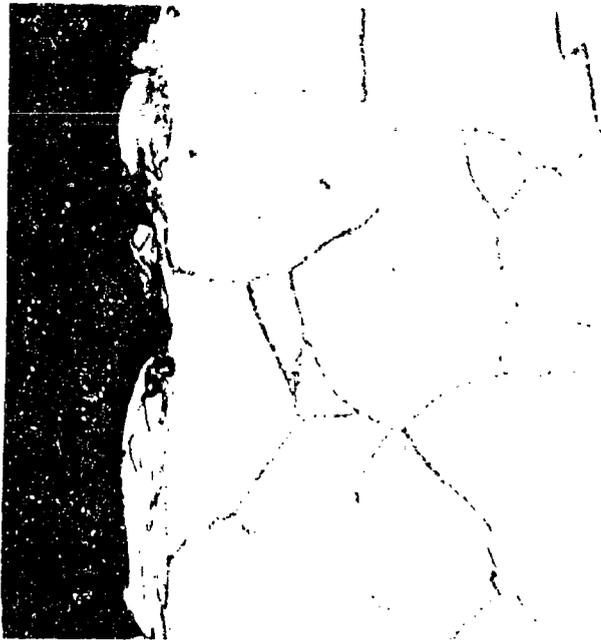
(a) Finishing Conditions - A discontinuous recast layer averaging .0002" deep was produced on this surface.

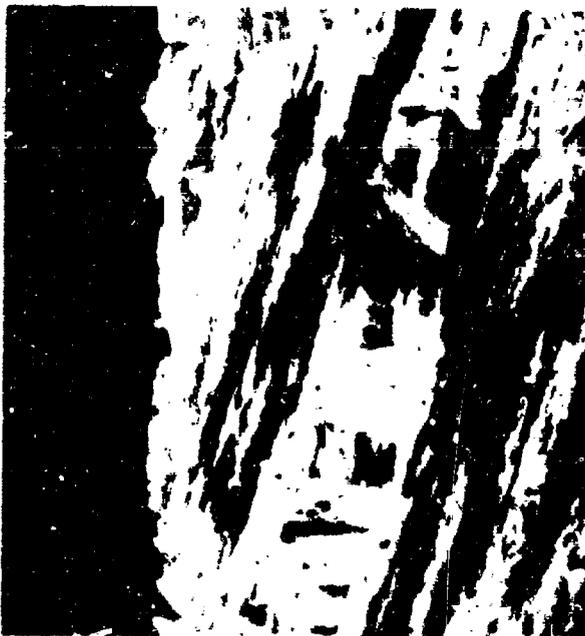
(a) Gentle Conditions - Slight surface pitting and tendency toward intergranular attack.
Surface Finish: 20 AA 1000X

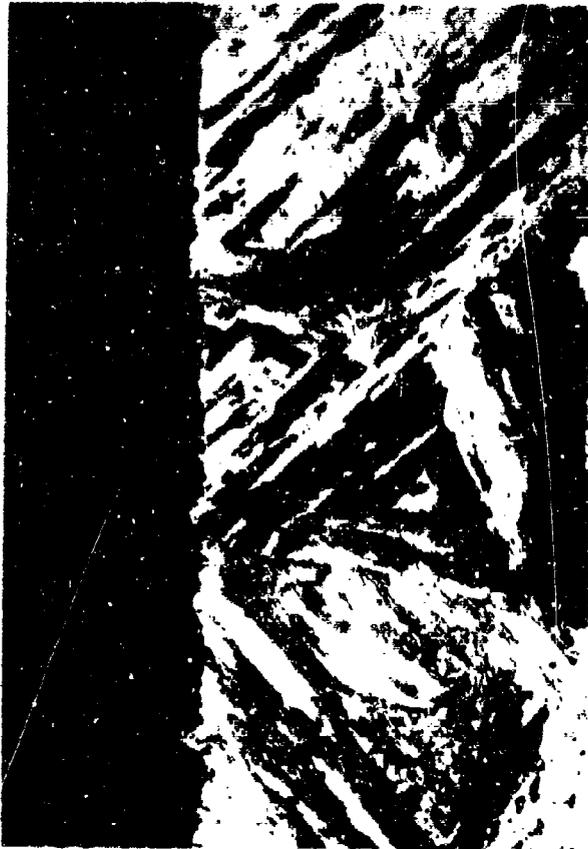
(b) Abusive Conditions - Surface roughening and hardness loss similar to that produced by Gentle conditions.
Surface Finish: 25 AA 1000X

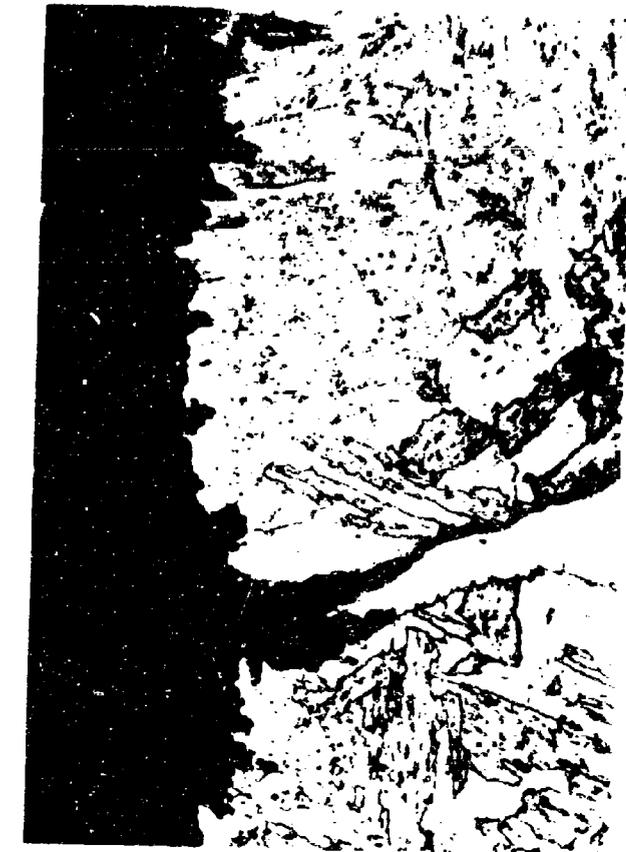
(a) Gentle Conditions - Slight surface roughening with tendency toward intergranular attack.
Surface Finish: 15 AA 1000X

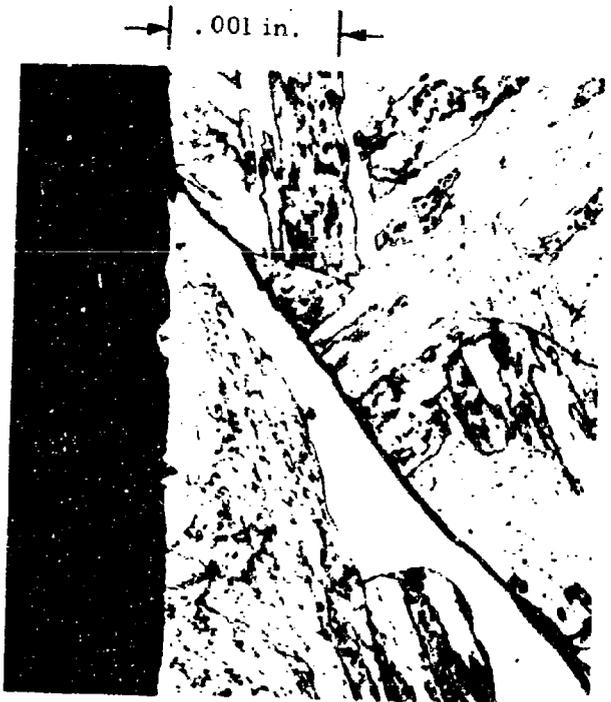
(b) Abusive Conditions - Moderate surface roughening and severe intergranular attack.
Surface Finish: 85 AA 1000X

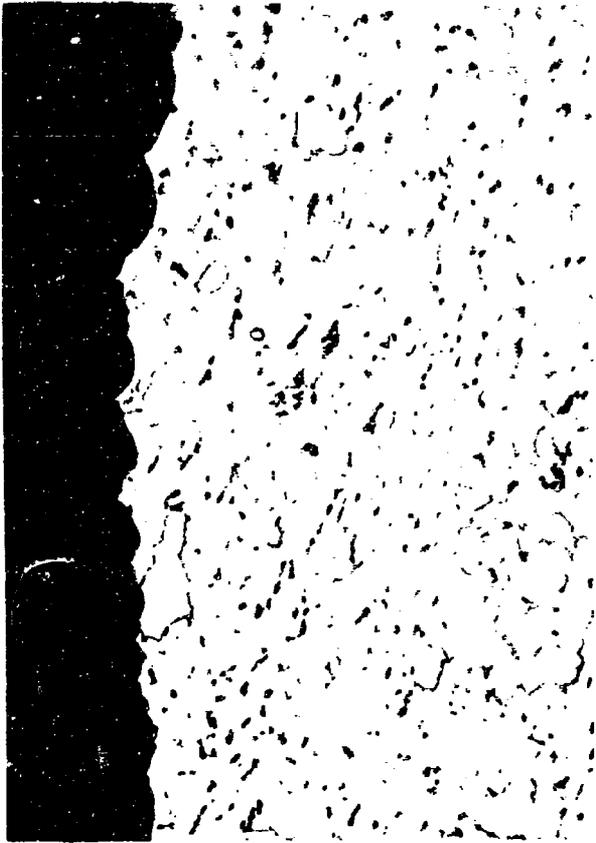
(a) Gentle Conditions - Slight surface irregularity but without evidence of microstructure change. Note hardness loss indicated.
Surface Finish: 15 AA 1000X

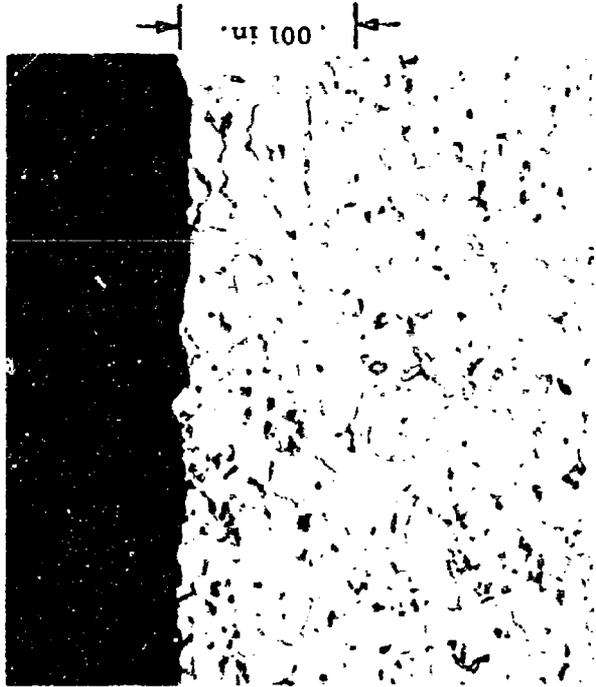
(b) Abusive Conditions - Moderate level of surface roughening plus slight drop in microhardness.
Surface Finish: 90 AA 1000X

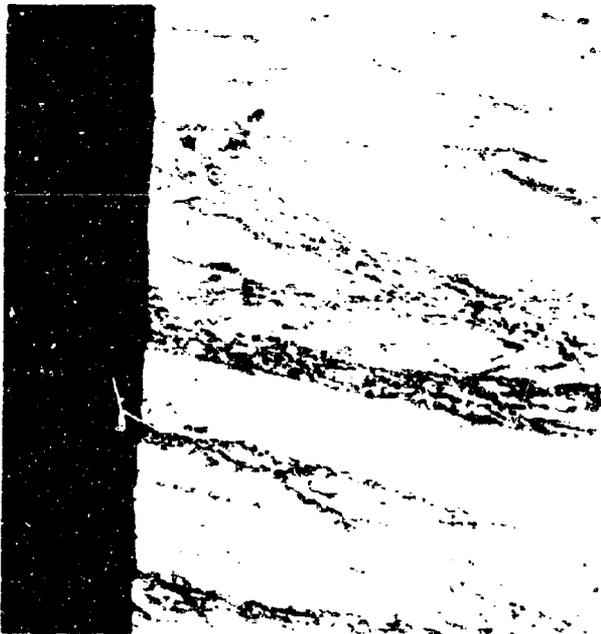
(a) Gentle Conditions - No visible surface effects. Note hardness change below.
Surface Finish: 10 AA 250X

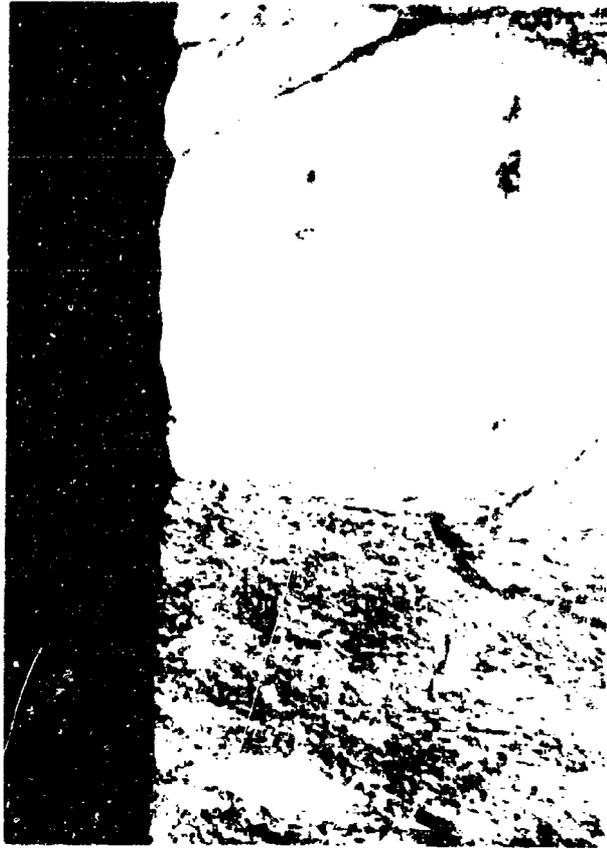
(b) Abrasive Conditions - Very slight surface roughening tending toward intergranular attack plus hardness loss noted.
Surface Finish: 30 AA 250X

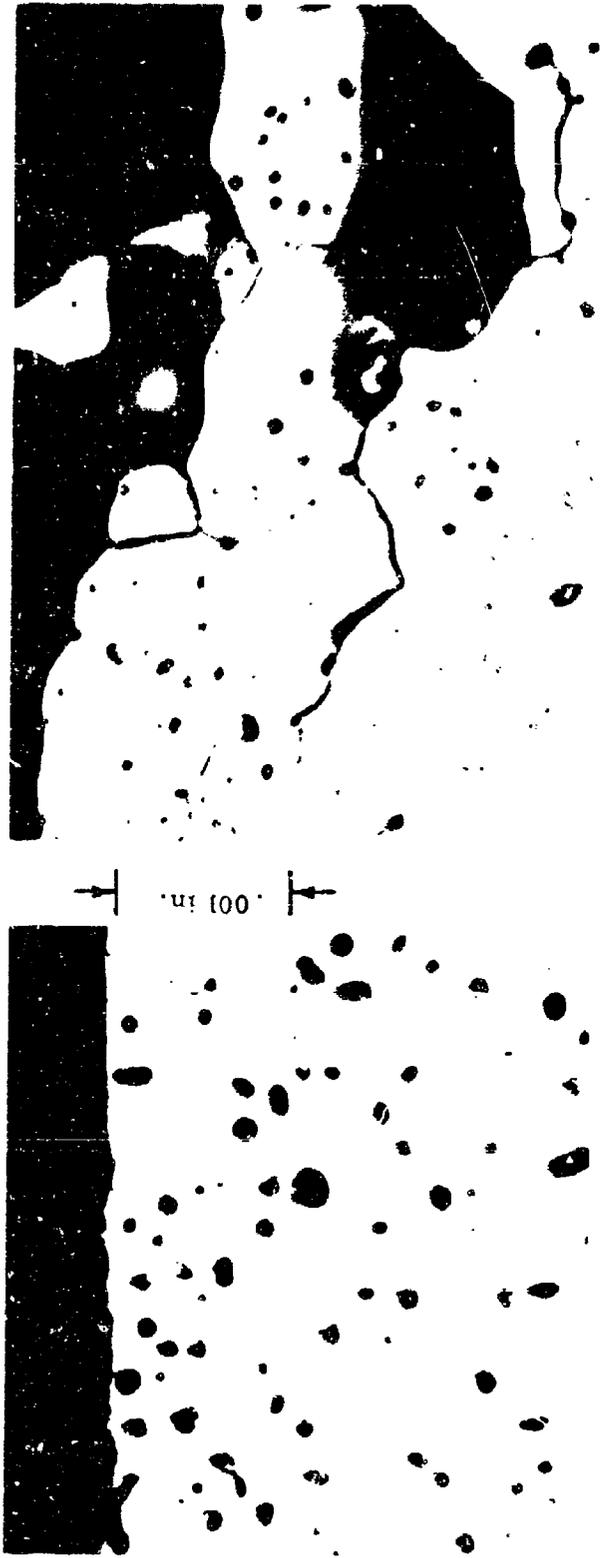
(a) Gentle Conditions - Microscopic surface pitting probably due to attack of pores in the material.
Surface Finish: 70 AA 1000X

(b) Abusive Conditions - Pronounced surface roughening and intergranular attack. Note the slight hardness loss resulting from ECM under both Gentle and Abusive conditions.
Surface Finish: 200 AA 1000X

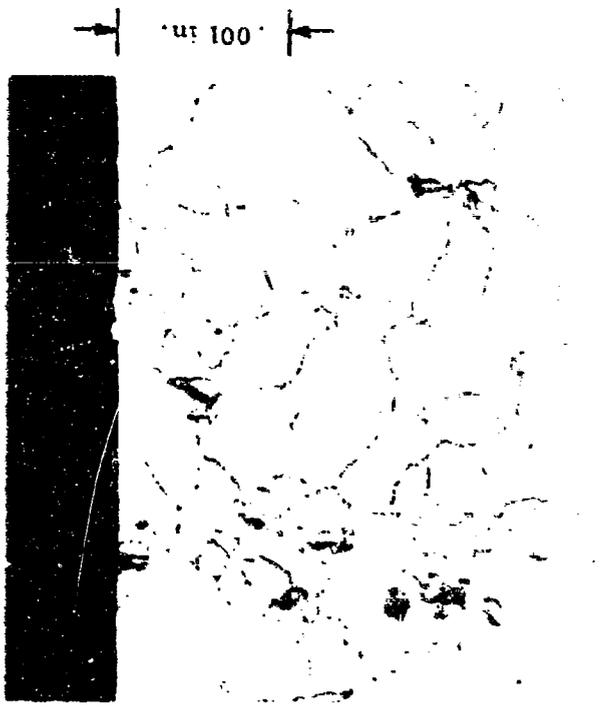
(b) Abusive Conditions - Same general appearance as noted for sample produced by Gentle ECM.
Surface Finish: 50 AA 1000X

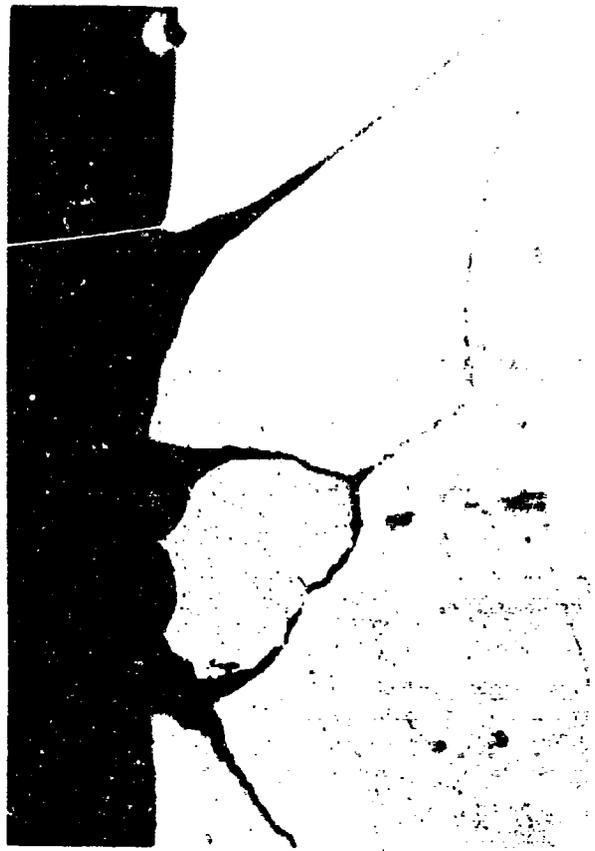
(b) Abusive Conditions - Severe intergranular attack.
Surface Finish: 75 AA 1000X

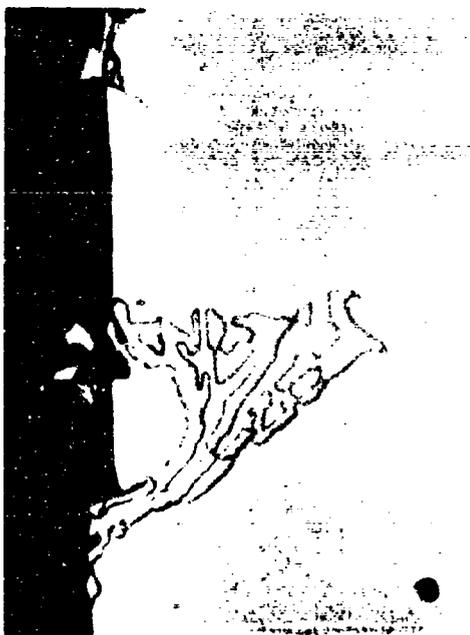
(a) Gentle Conditions - Surface roughening due to nonuniform attack of second phase and also to different grains of the matrix.
Surface Finish: 25 AA 1000X

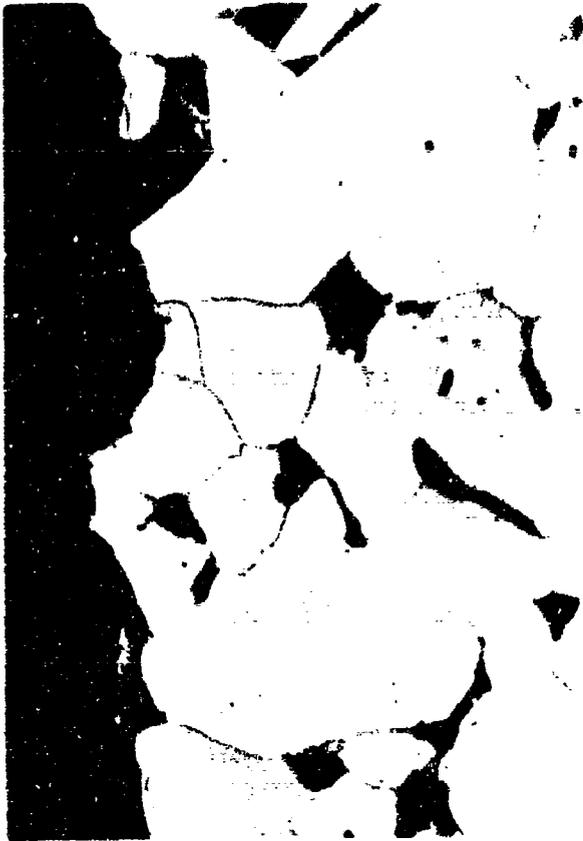
Figure 141

(b) Abusive Conditions - Slight roughening of surface without other evidence of disturbance except micro-hardness loss noted below.
Surface Finish: 140 AA 1000X

The iron base alloys reviewed in this study (Figures 141 through 153) were all processed quite successfully using chemical machining. The stainless grades gave some evidence of surface roughening under abusive conditions, although intergranular attack and subsurface cracking were not evident. Likewise, Ti-6Al-4V (Figures 154 and 155) was processed successfully insofar as surface roughness was concerned.

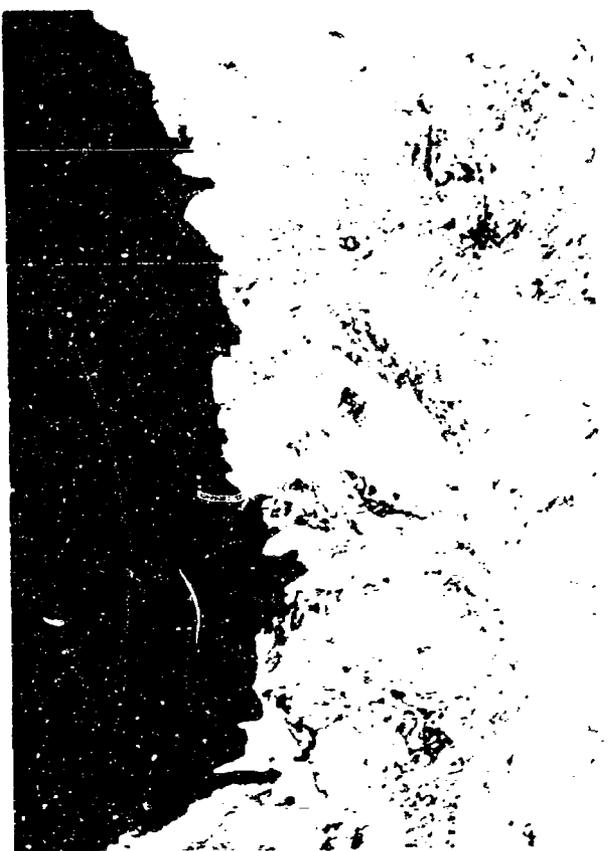
(b) Abusive Conditions - Marked surface roughening on both a micro and macro scale.
Surface Finish: 680 AA 1000X

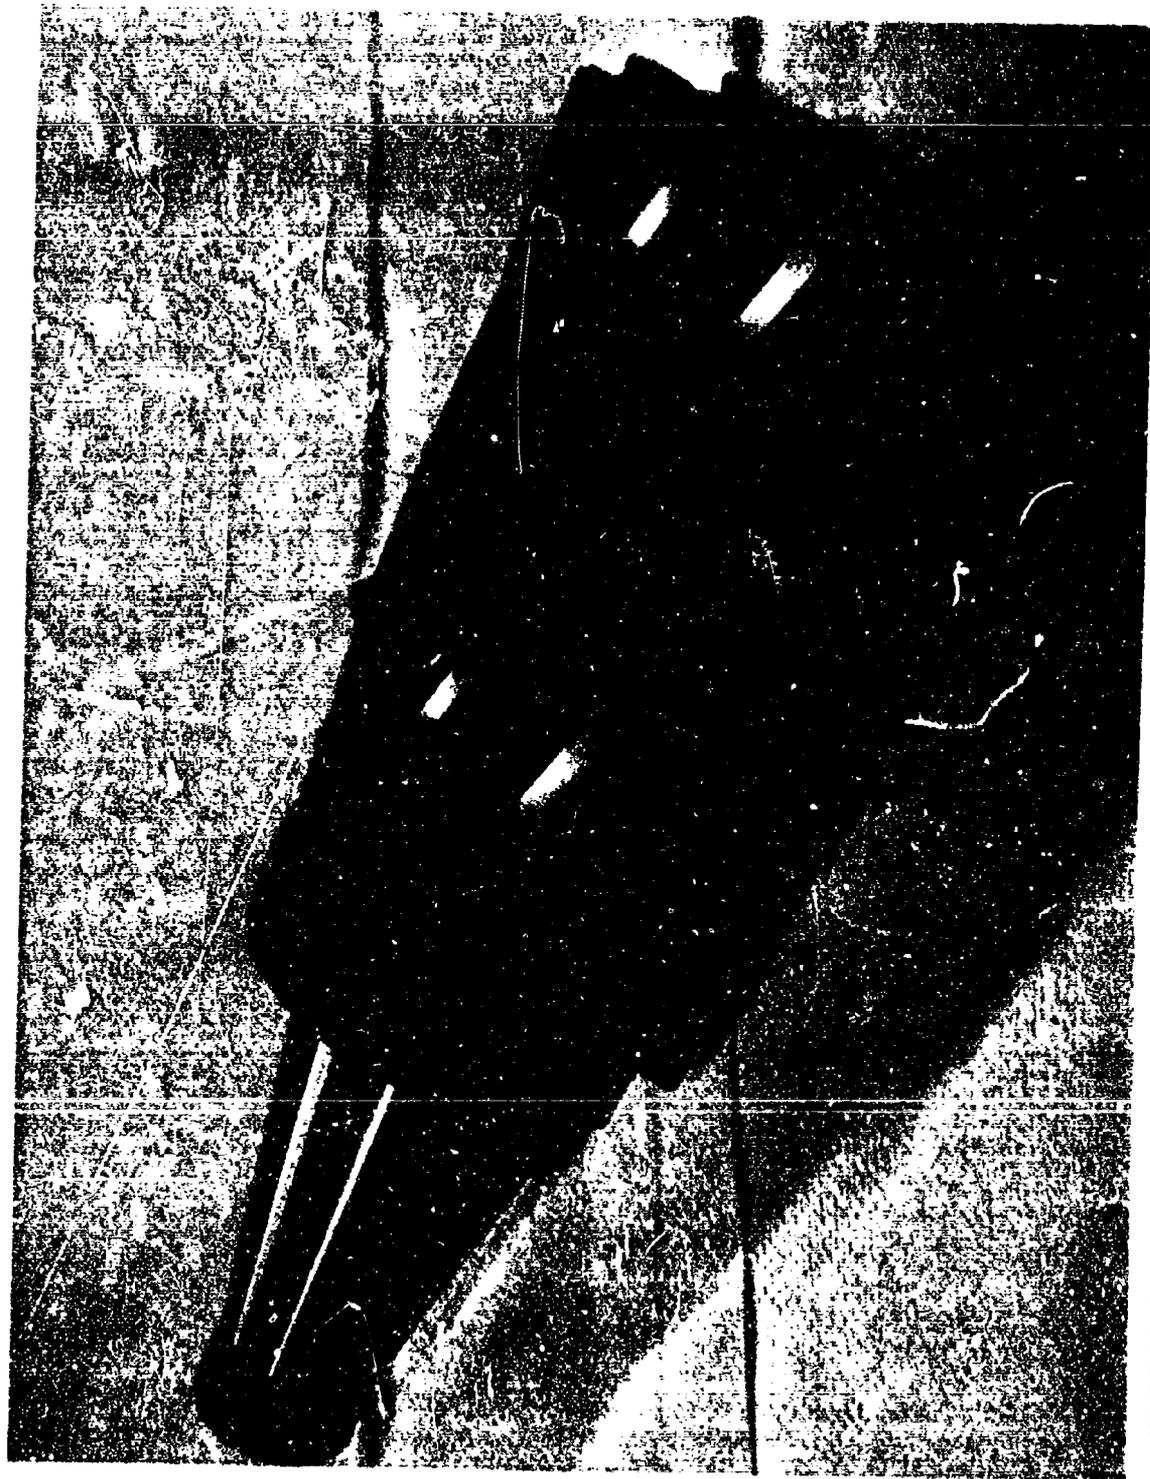
MILLING CUTTER - USED FOR END MILLING, PERIPHERAL CUTTING OF Ti-6Al-4V

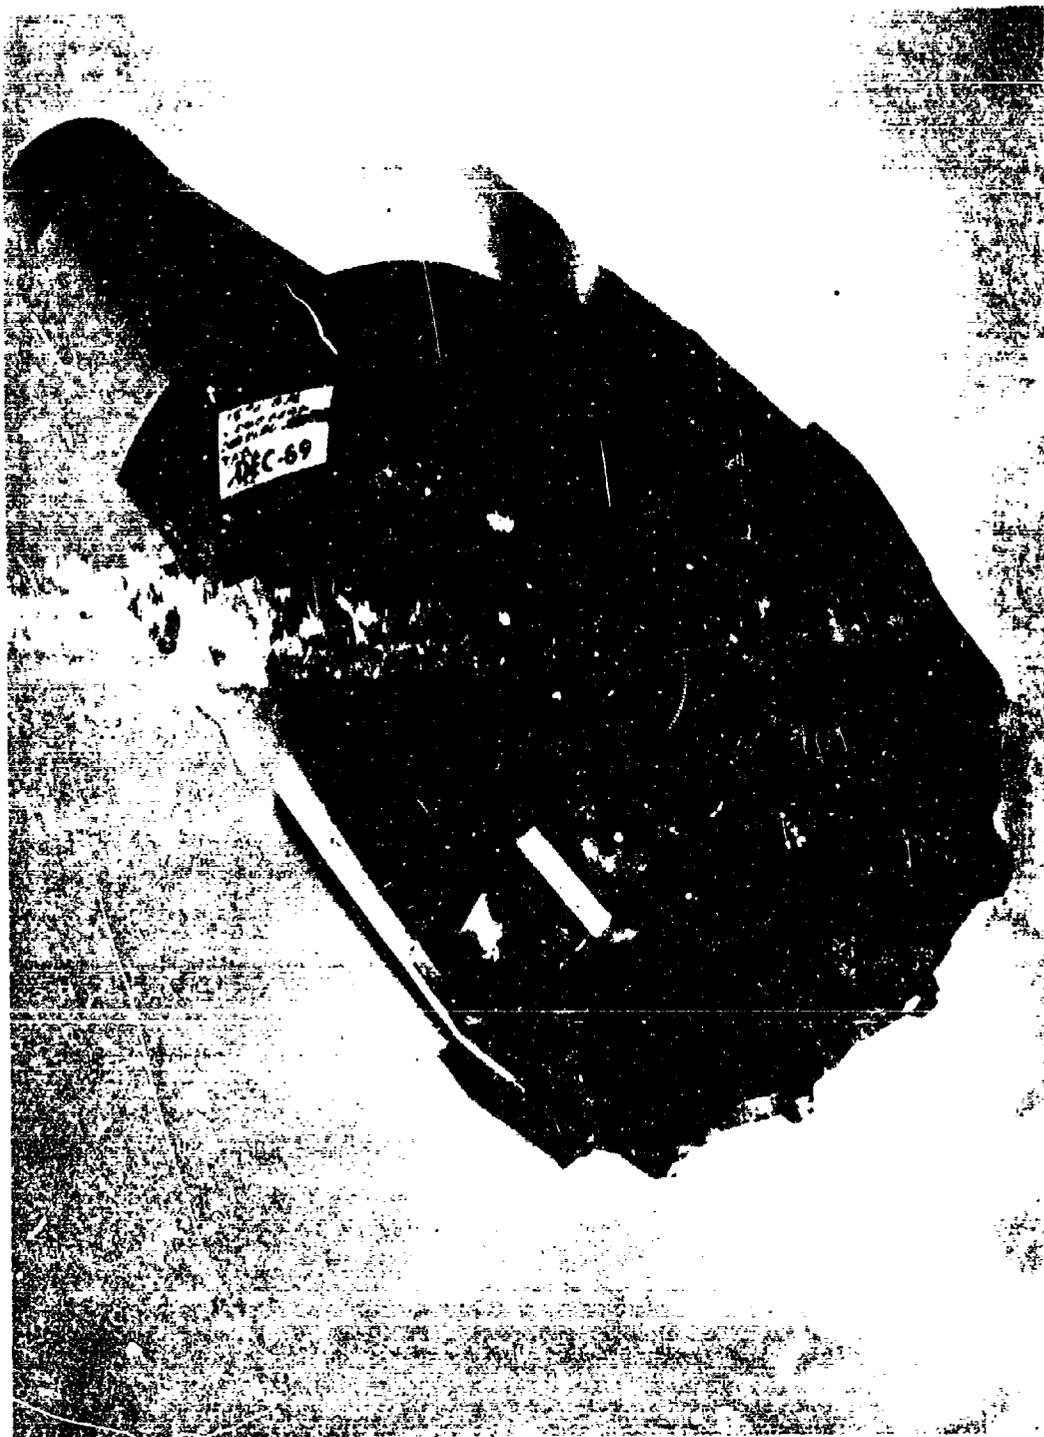
MILLING CUTTER - USED FOR END MILLING, END CUTTING OF Ti-6Al-4V

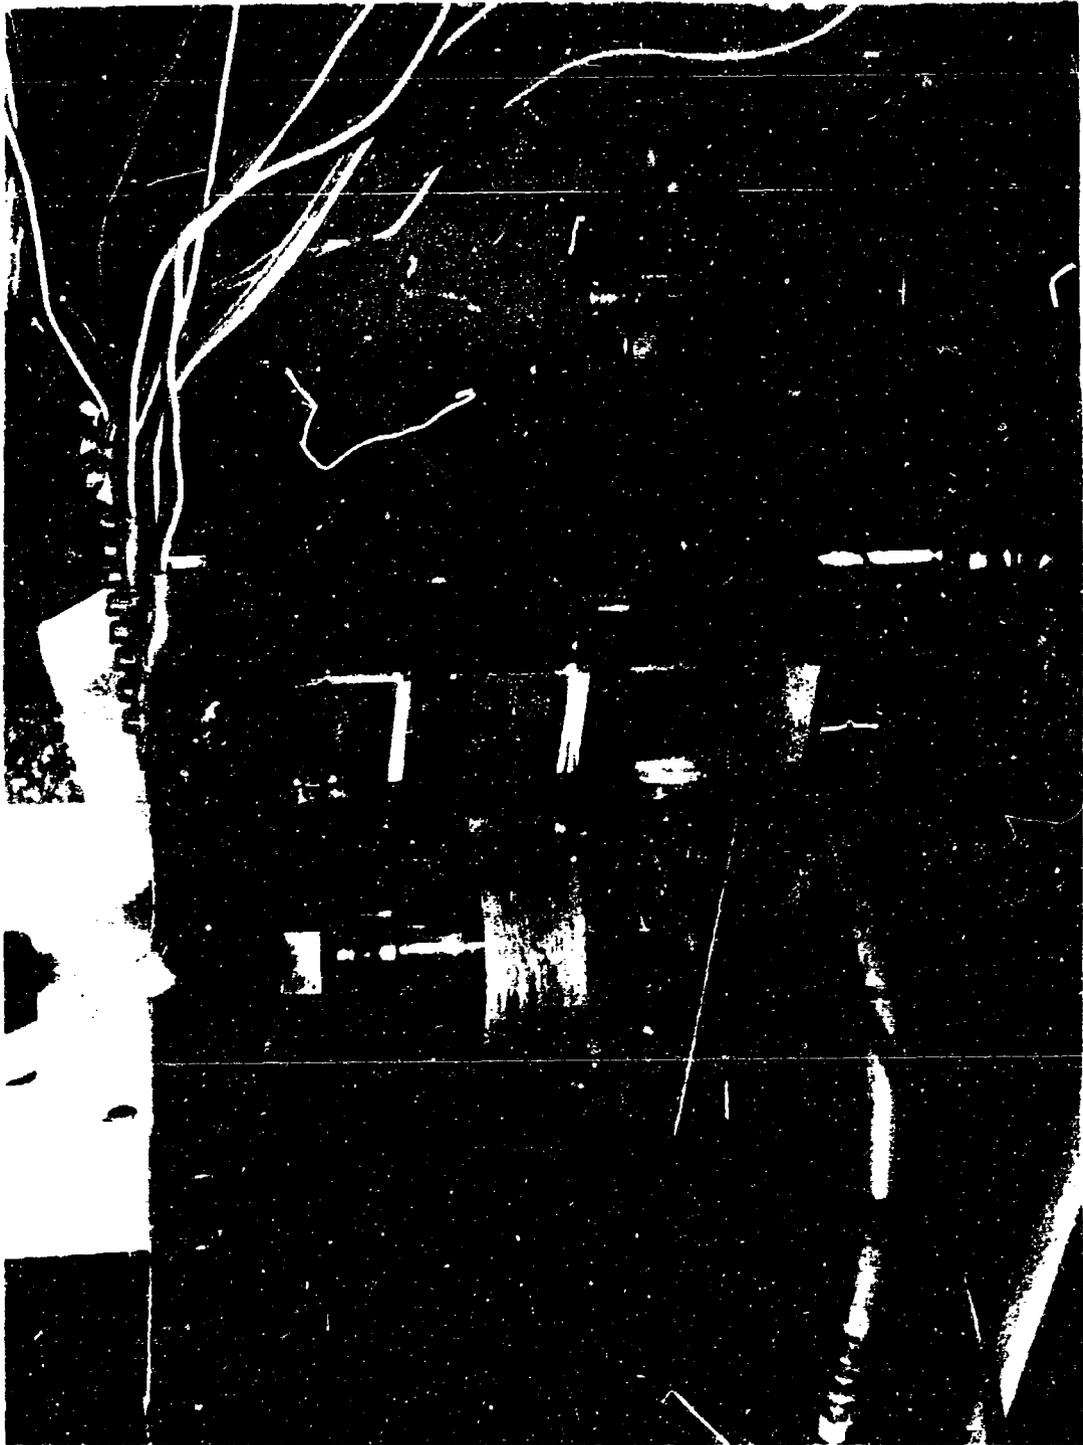
TOOLING SETUP FOR MAKING EDM TEST CUTS ON FATIGUE SPECIMEN COUPONS.

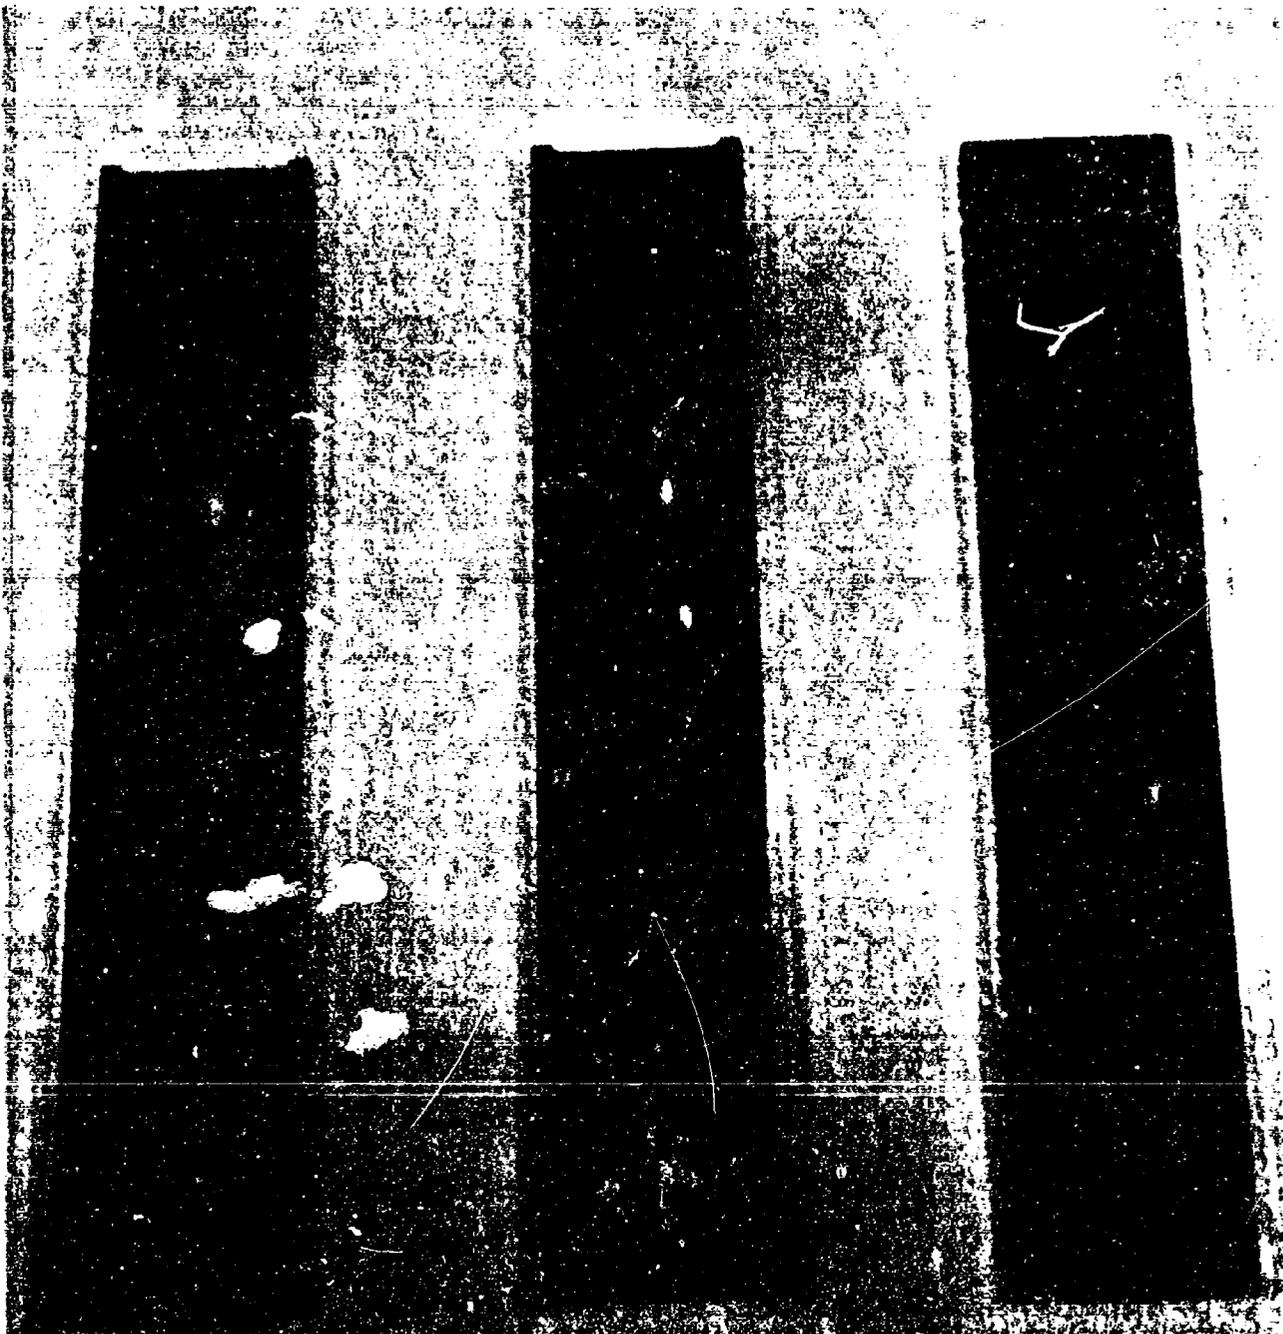
TOOLING SETUP FOR MAKING EDM TEST CUTS ON RESIDUAL STRESS COUPONS.
