USAAVLABS TECHNICAL REPORT 69-97

INVESTIGATION TO DETERMINE THE FEASIBILITY OF DETECTING IMPENDING METAL FATIGUE FAILURE THROUGH USE OF AN INDUCTIVE SENSING DEVICE

By
George G. Moross

February 1970

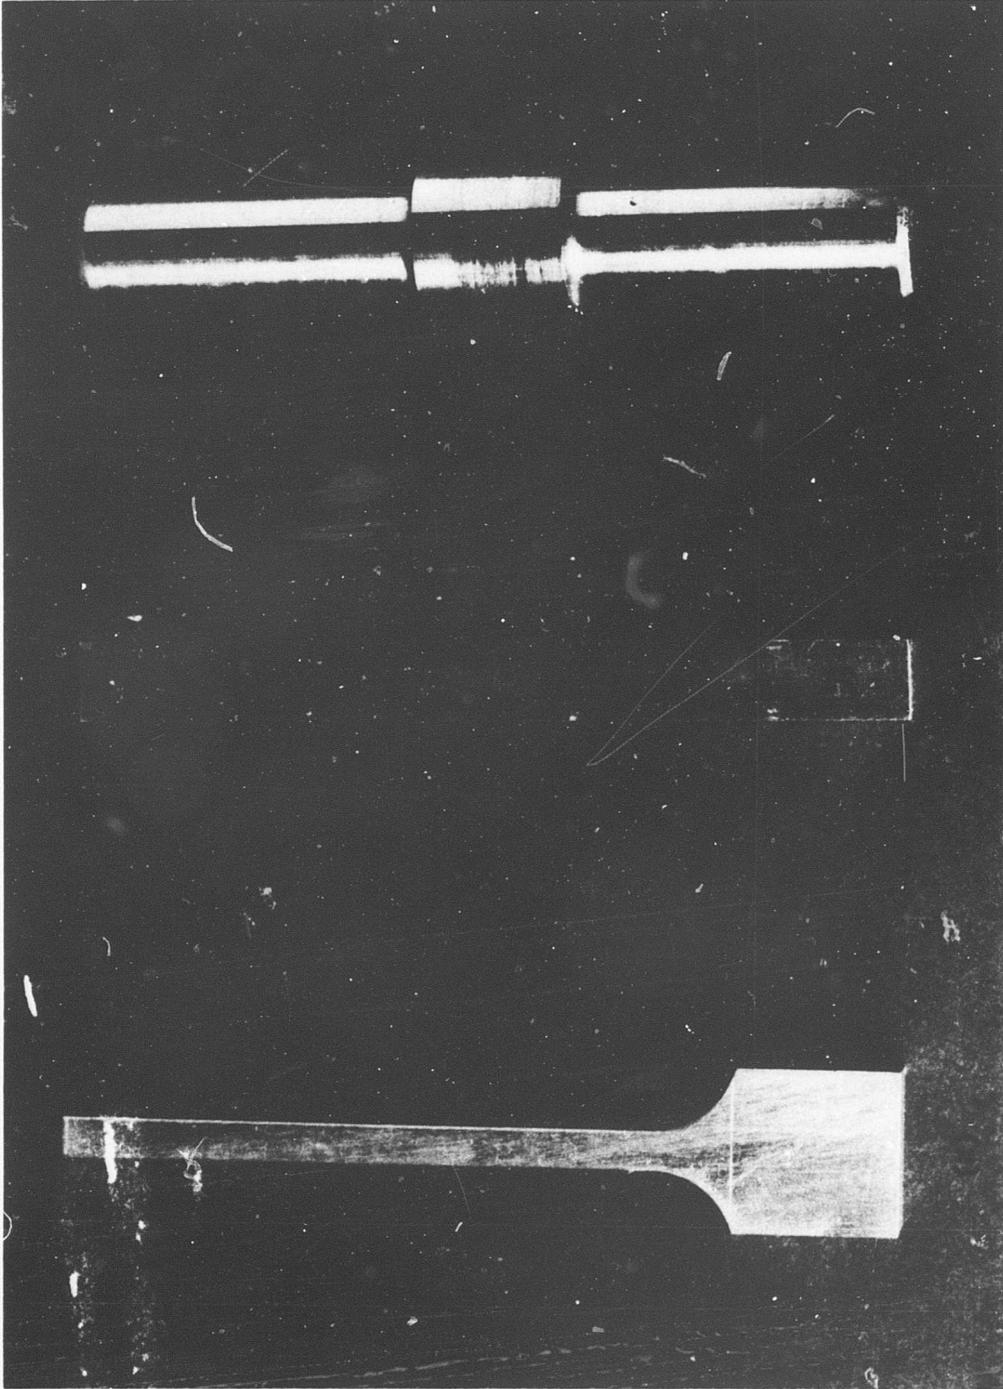
Figure 1. Test Samples.

The samples, as shown in Figures 1a, 1b, and 1c, were fabricated from these materials. Figures 1a and 1b were used for vibratory beam testing, and Figure 1c was used for geared-roller testing. Since the motivation for the fatigue testing was to produce fatigue damage (i.e., cracking) in a controlled fashion, a 1/4-inch by 1/2-inch by 5-inch sample, with stress-raiser, was used. At the beginning of testing, the configuration shown in Figure 1a was run, and the inductive probe was scanned along the radius. The radius, which was intended to force the location of the fatigue crack, was not small enough. For this reason, a number of runs resulted in a fatigue failure initiating outside the scanned area. This suggested a change in sample configuration to the one shown in Figure 1b, wherein a simple notched beam provides a sufficient stress-raiser for reliable results. The samples for Section 1.4 (1) were run, as machined, with no special surface preparation; samples of the same configuration for Section 1.4 (3), Section 1.4 (4), and Section 1.4 (5) were electropolished after fabrication, providing a smooth, polished surface to insure clarity of acetate replicas and scanning electron micrographs of high quality.

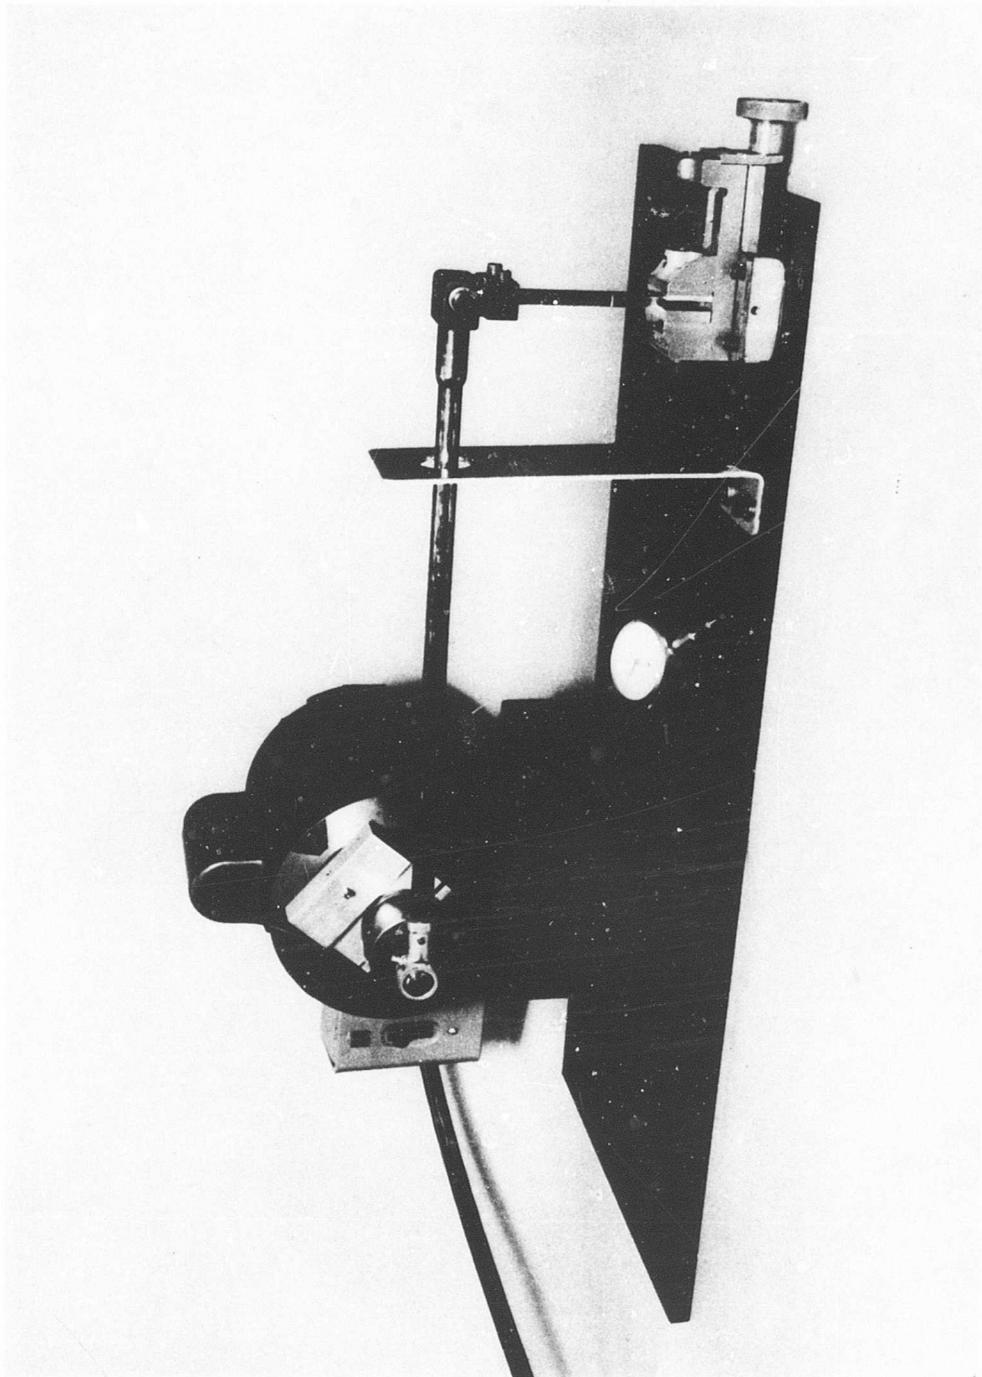
Figure 2. Vibratory Beam Fatigue Machine.

A photograph of the vibratory beam fatigue machine is shown in Figure 2. Two of these machines were used in order to facilitate the running of the tests, since the tests required constant monitoring. The dial gage was used during initial setup to measure deflection and to insure a totally reversing stress. An optical sensor was used to measure the actual motion at speed. The difference between the two measurements, which amounted to .002 inch, was then taken into consideration. Therefore, the deflections quoted in the data are actual deflections under dynamic conditions. The machines, which run at a nominal speed of 3450 cycles per minute, were provided with a speed control which allows a small variation in cycle rate to avoid damaging resonances. The total number of cycles was recorded electronically.

The sample was firmly clamped in the vise, the upper rod was clamped to the sample, and the system was adjusted to provide the desired positive and negative deflection. The sample was scanned (and replicated for task (3) of Section 1.4), and the test was started. During the initial phases of testing, many inductive scans were taken prior to the first acquisition of a signal; however, with experience, the number of readings prior to signal could be reduced without losing any information. After the first appearance of the signal, readings were taken periodically until failure occurred, which we have defined as fracture.

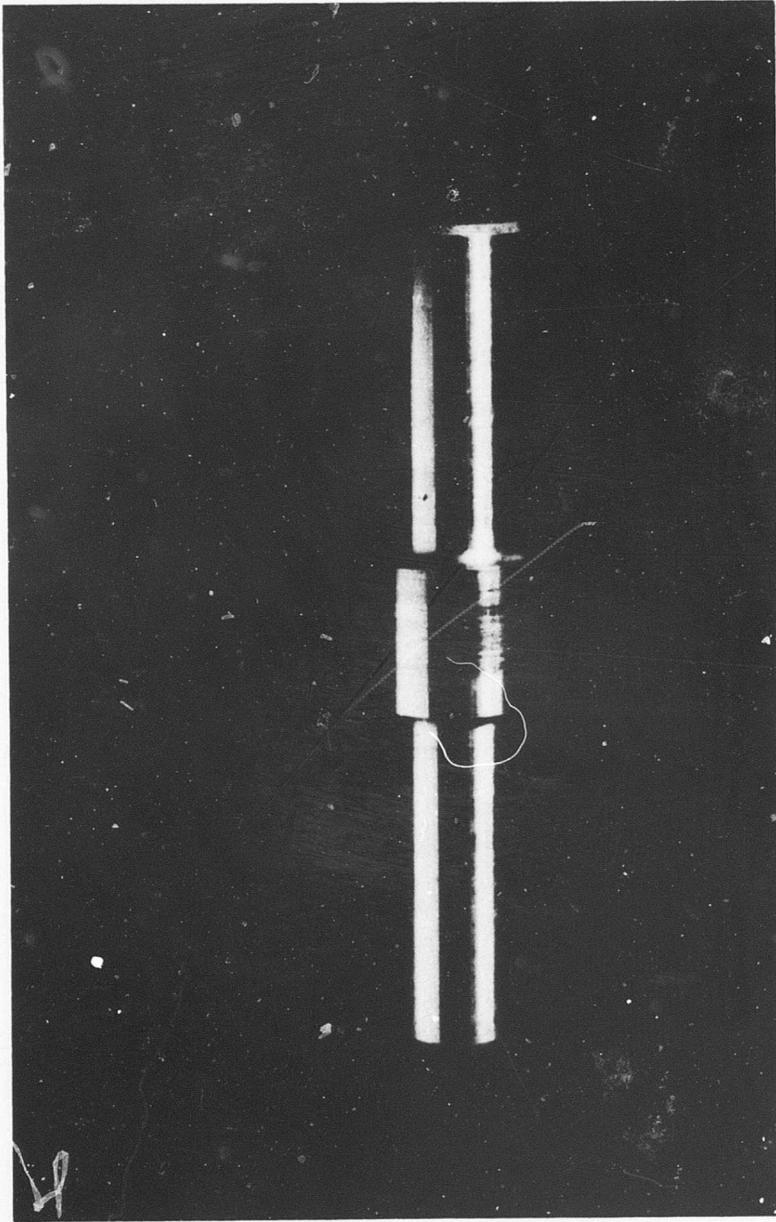
Figure 5. Roll Test Sample.

A photograph of the sample is shown as Figure 5. The area of rolling contact is the 1.00-inch-diameter section in the center of the sample. A 5.00-inch-diameter crowned roller on the upper shaft bears against the sample, producing an extremely high Hertzian stress. Loads were selected to provide varying times to failure.

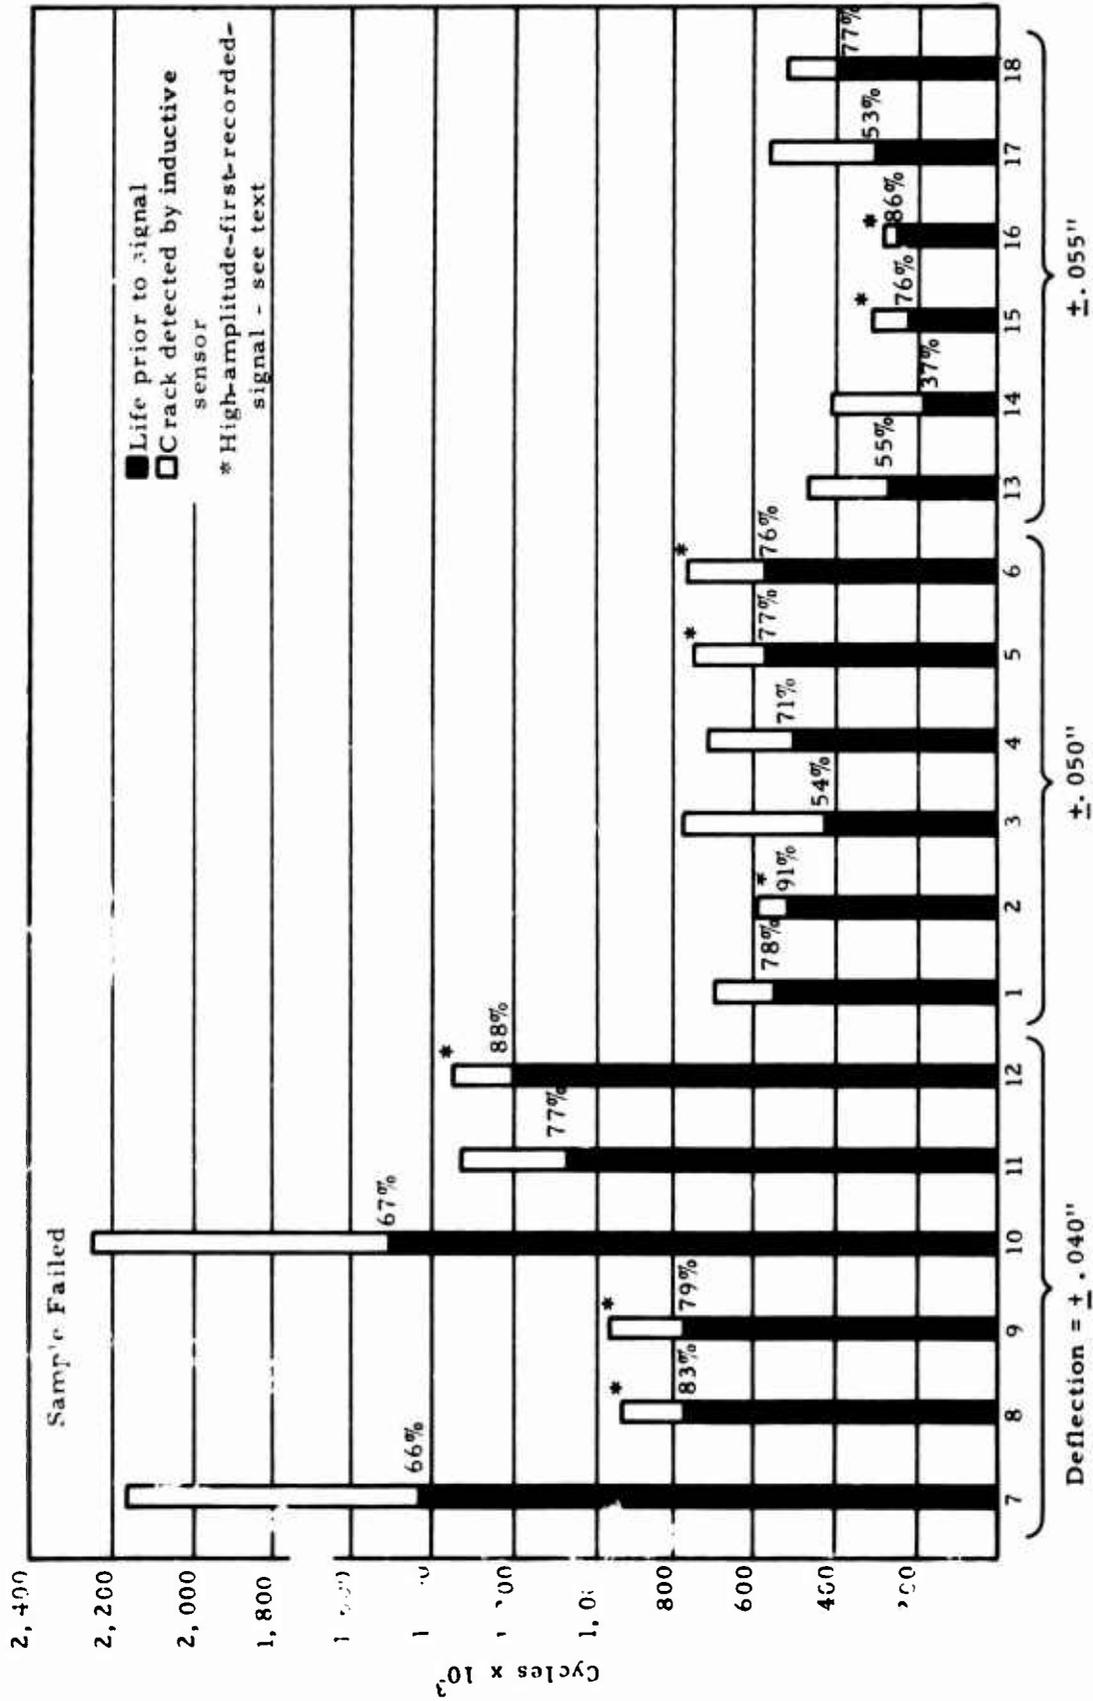
Figure 11. Graphical Presentation of Results, Aluminum.

Eighteen samples were fabricated, prepared (as described previously), and tested using the methods outlined in Section 2.2.1. Deflections for the three stress levels were set at $\pm .040$, $\pm .050$, and $\pm .055$ inch. The cycles to failure averaged 1.4×10^6 , $.7 \times 10^6$, and $.43 \times 10^6$, respectively. The bar graph shown in Figure 11 presents the results of all 18 aluminum samples. The top of the black portion of a bar indicates the number of cycles at which a signal appeared. The top of the clear portion indicates the number of cycles at which failure occurred. The ordinate is calibrated in number of cycles, while the abscissa shows test number. The number at each bar indicates the percentage of life at which the signal appeared.

Because scanning was performed periodically during the test, the crack had developed considerably by the time the first scan was taken. This implies that the signal could have been observed at an earlier period had a reading been taken then and that a lower percentage would have been indicated. A correction has not been applied; thus, the asterisk indicates that the given percentage figure is conservative.

The average percentage for the $\pm .040$ -inch deflection is 76.7% (with three asterisks); for the $\pm .050$ -inch, 74.5% (three asterisks); and for the $\pm .055$ -inch, 64.0% (two asterisks). The average percentage across all 18 samples is 71.7%, which, when taking the conservative treatment of data into account, would indicate a figure of below 70% of time to failure at which the signal appeared. The earliest signal appeared at 37% of life (sample 14), while the latest indication of 91% showed a very large signal amplitude at that point; hence, it is reasonable to assume that acquisition of signal should have been much earlier.

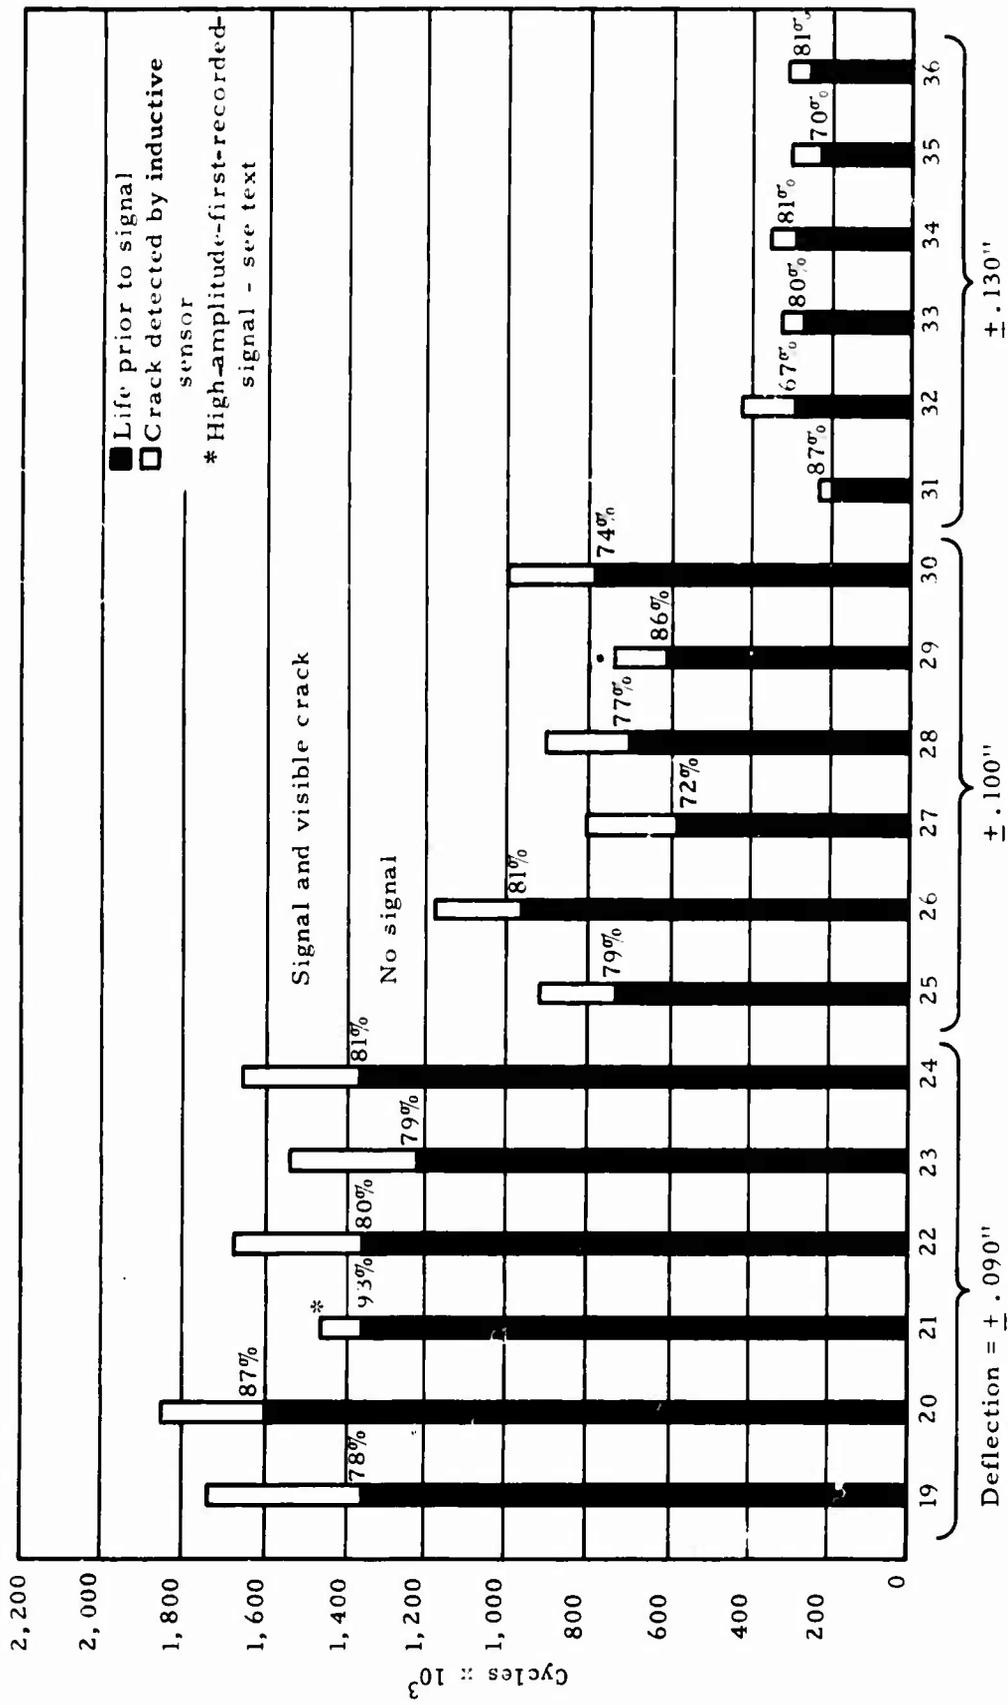
Figure 15. Graphical Presentation of Results, Inconel X.

Eighteen samples were fabricated, prepared, and run as described previously. Deflections for the three levels were set at $\pm .090$ inch, $\pm .100$ inch and $\pm .130$ inch. The cycles to failure averaged 1.4×10^6 , $.94 \times 10^6$, and $.33 \times 10^6$, respectively. The bar graph shown in Figure 15 presents the results of all 18 Inconel samples. The legend for the graph has been presented in Section 3.2.1.

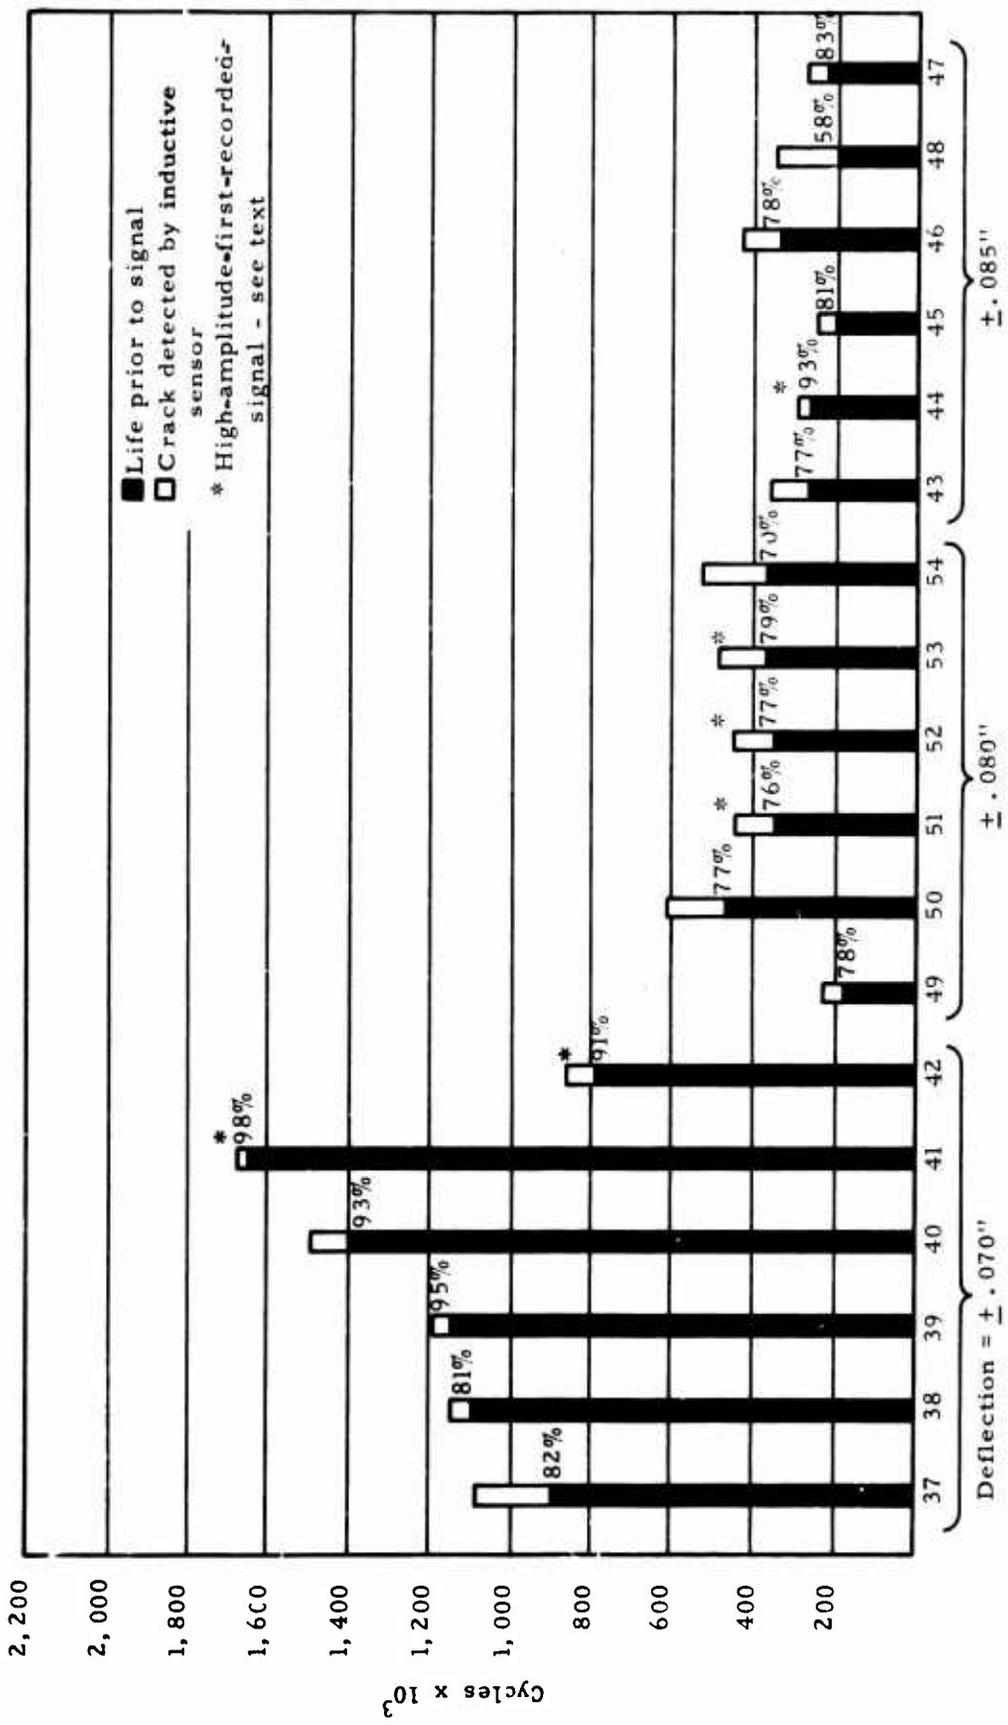
Figure 19. Graphical Presentation of Results, Steel.

Deflections for the three stress levels were set at \pm .070 inch, \pm .080 inch and \pm .085 inch. The cycles to failure averaged 1.24×10^6 , $.46 \times 10^6$, and $.32 \times 10^6$, respectively. The bar graph shown in Figure 19 presents the results of all eighteen, 9310-steel samples. The legend for the graph has been presented in Section 3.2.1.

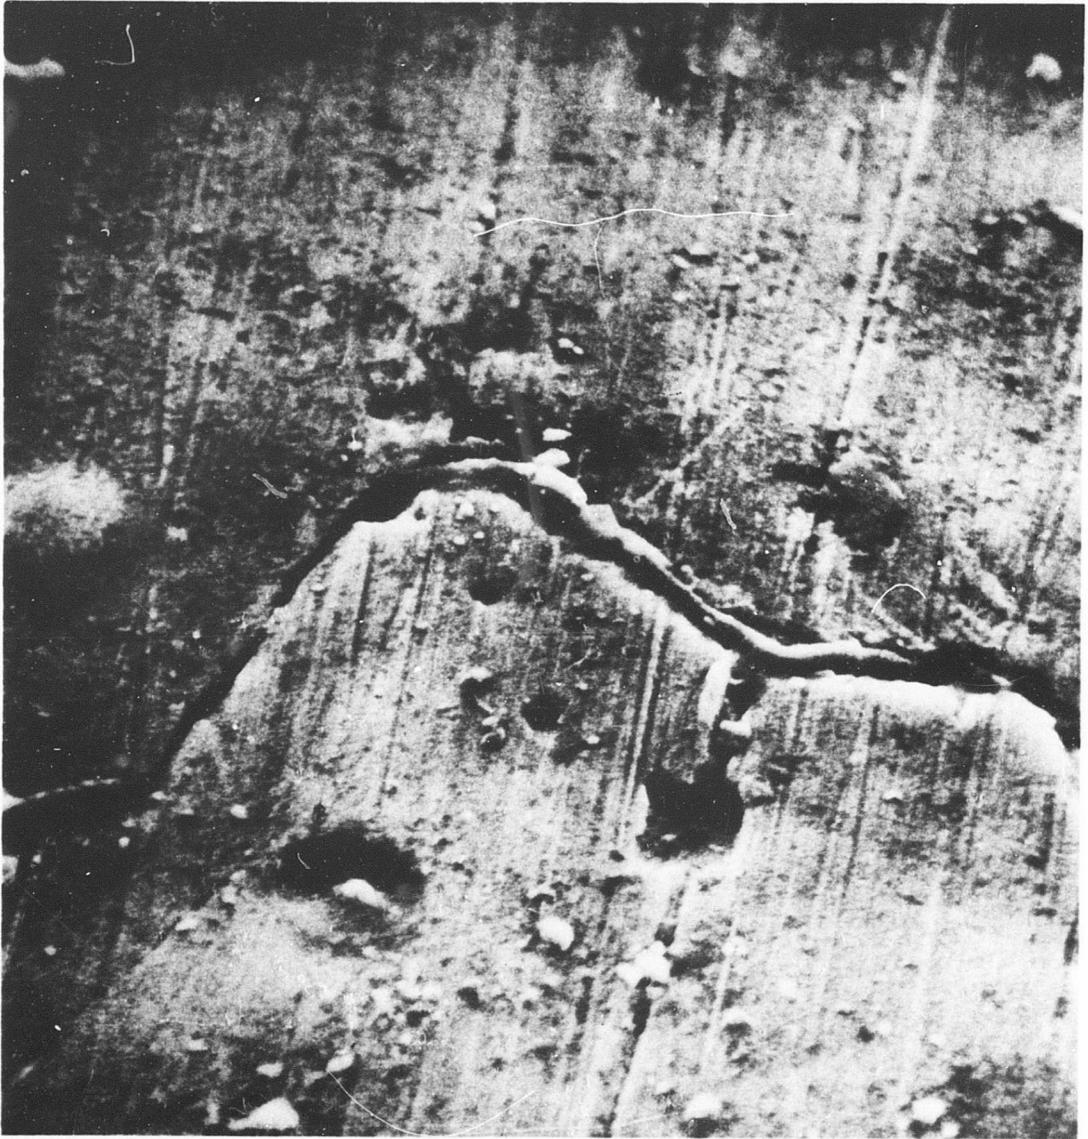
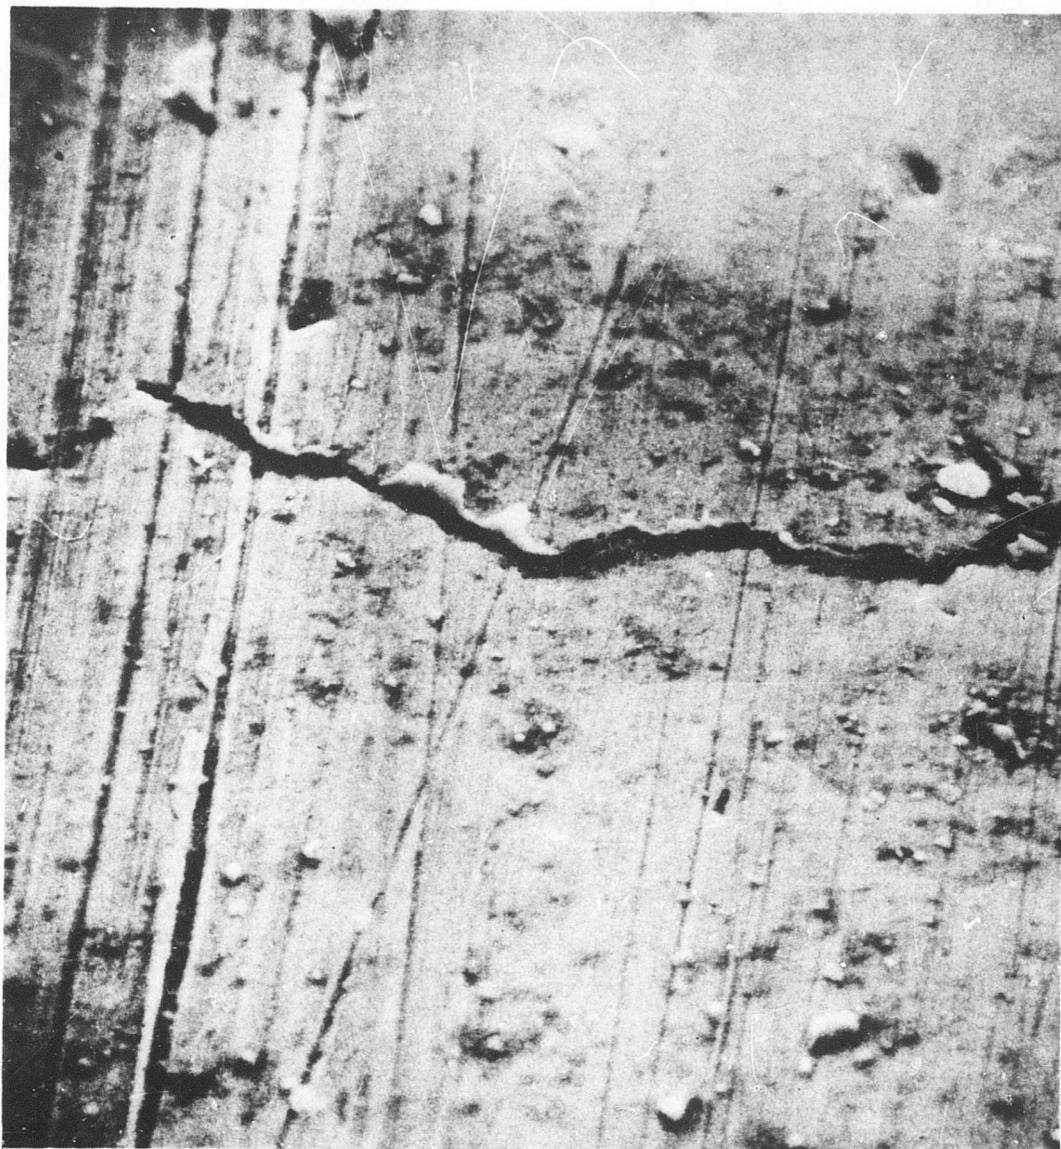
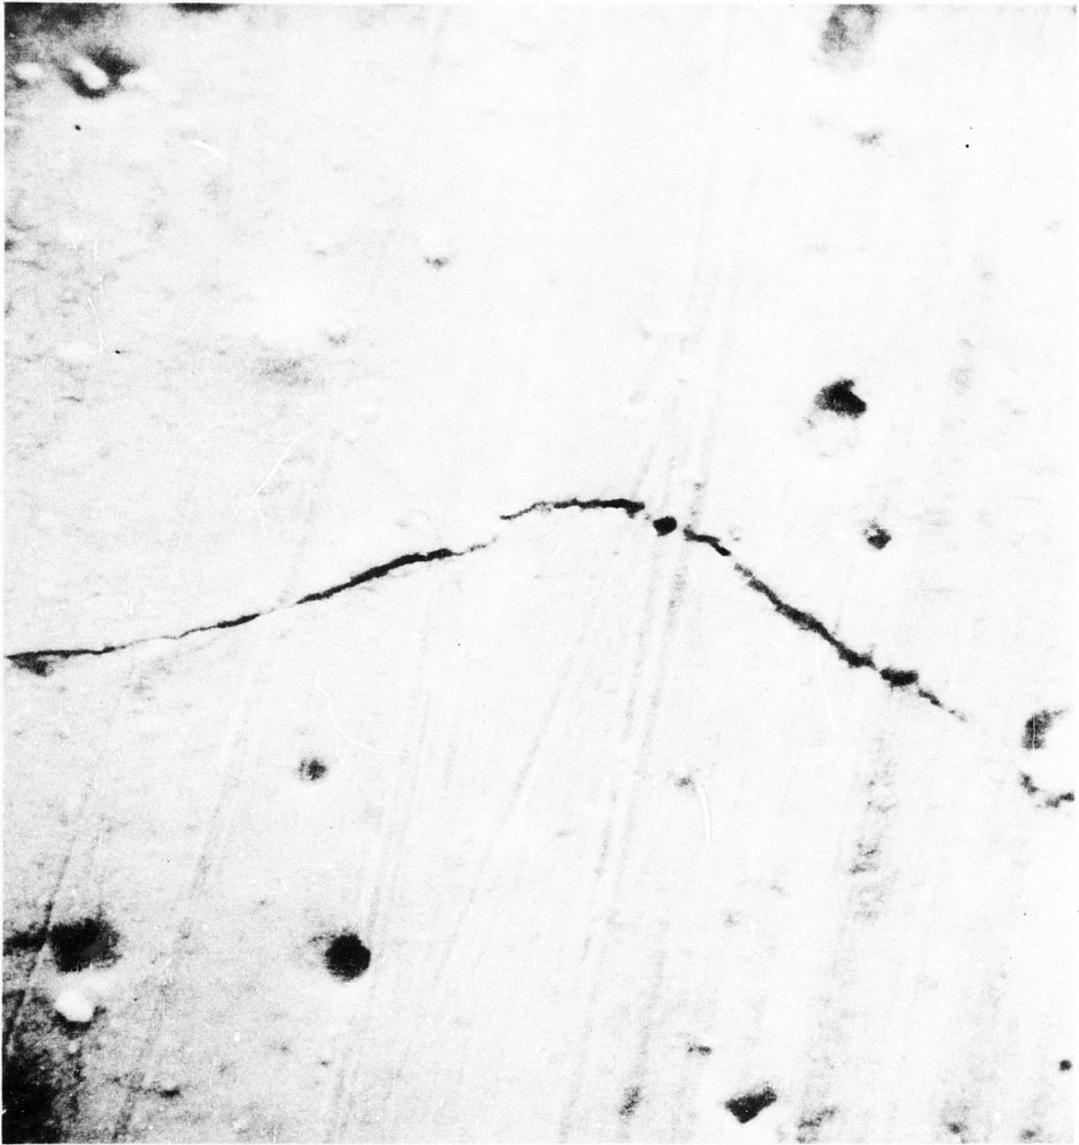
Figure 28. Aluminum Sample A5, X4000, $d = 2.9$ mm.

Figure 29. Aluminum Sample A5, X2200, $d = 3.2$ mm.

Figure 30. Aluminum Sample A5, X4000, d = 4.2 mm.

The inductive sensor scans of aluminum sample 5 are presented as Figure 27. Readings were taken at pretest, at 400,000 cycles, and at 600,000 cycles; a signal appeared at 800,000 cycles on the back surface. The sample was then run further to 915,000 cycles to generate a sizable crack. It should be noted that at 800,000 cycles, the signal shows a depression with a small "pip" in the center. At 900,000 cycles, the signal shows two large depressions, one on each side of the central signal. It is significant that this type of signal has been observed throughout the program as being characteristic of an incipient failure on an aluminum sample. A question has been raised as to the phenomenon responsible for this characteristic signal on aluminum. This can be answered by a study of Figures 28, 29, and 30. Figure 28 clearly shows a crack that turns into an indentation on each side of an extrusion. Figure 29, taken closer to the center of the sample, shows an apparent tearing of material along the crack. The surface scratching, which is apparent but not serious in these scanning microscope pictures, is serious enough to obliterate detail in the electron microscope pictures. Figure 30 shows the leading end of the crack, 4.2 mm from the root of the notch. The photographs are labeled with a letter and one dimension. The letter indicates the distance from the root toward the center of the sample. Since the notch separation is 9.4 mm, Figure 30 is taken .5 mm from the center line of the specimen. From previous experiments, it has been determined that the area of sensitivity of the probe encompasses a width of approximately 4 mm (2. mm each side of center). Therefore, cracks shown in the photographs will be responsible for a signal indication if the dimension shown is greater than 2.7 mm. Figures 32, 33, 34, 35, and 36 are photomicrographs of sample 11 aluminum. The scan signals are shown as Figure 31. The last reading, 625,000 cycles (back), shows an extremely small "pip", which, experience has shown us, is the first indication of a valid flow signal. Figure 34 shows well-defined crack propagation; however, the position dimension shows that this was taken only 1.4 mm from the notch. Figure 35, taken .5 mm toward the center, shows much less damage, and the surface damage is seen to end at 2.1 mm in Figure 36. It is apparent that there is little damage beyond 2.1 mm, and the extremely small signal (most likely due to flux fringing at the edge of the probe, increasing the sensitive area) bears this out.

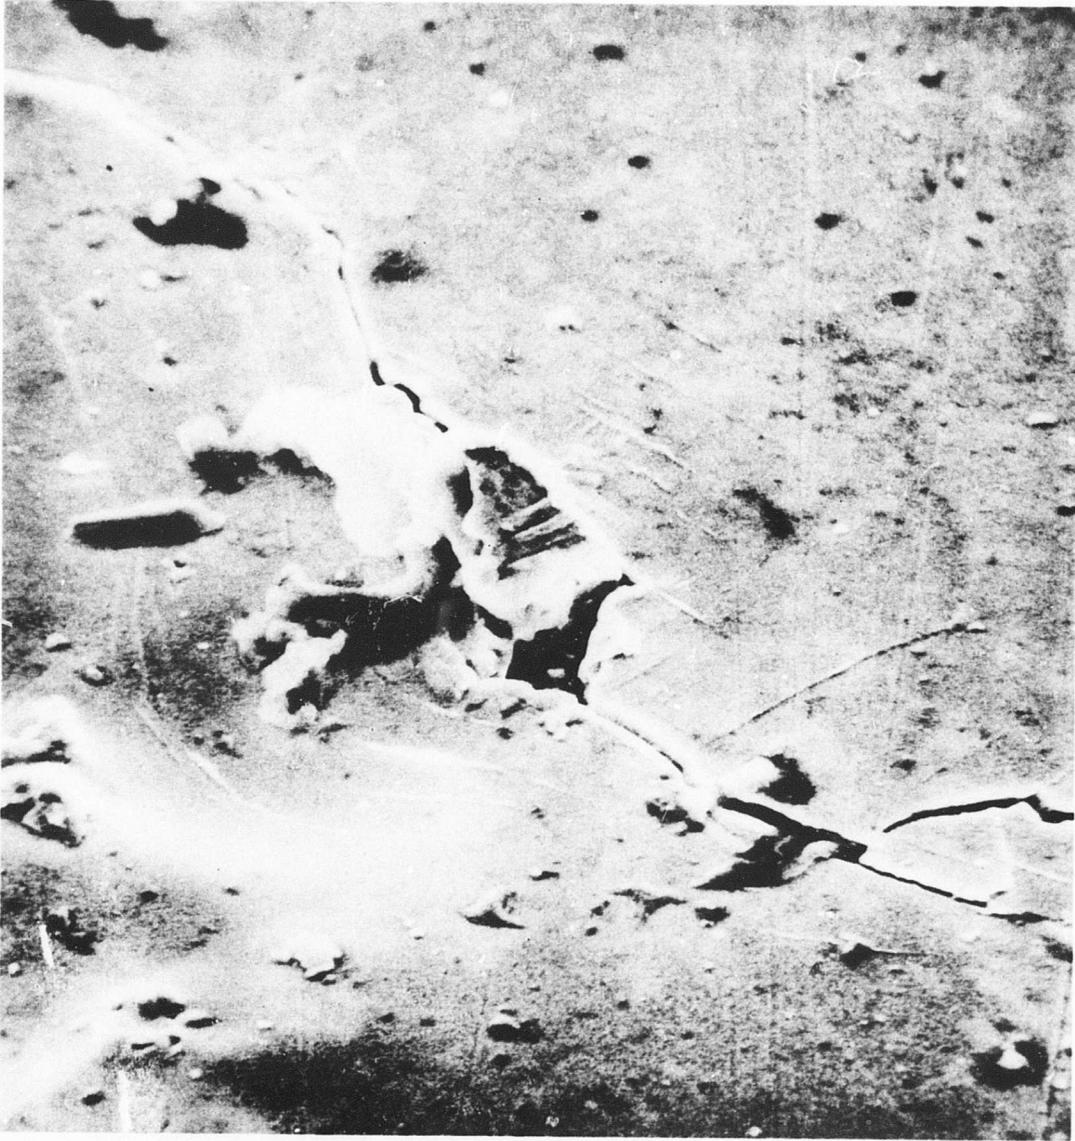
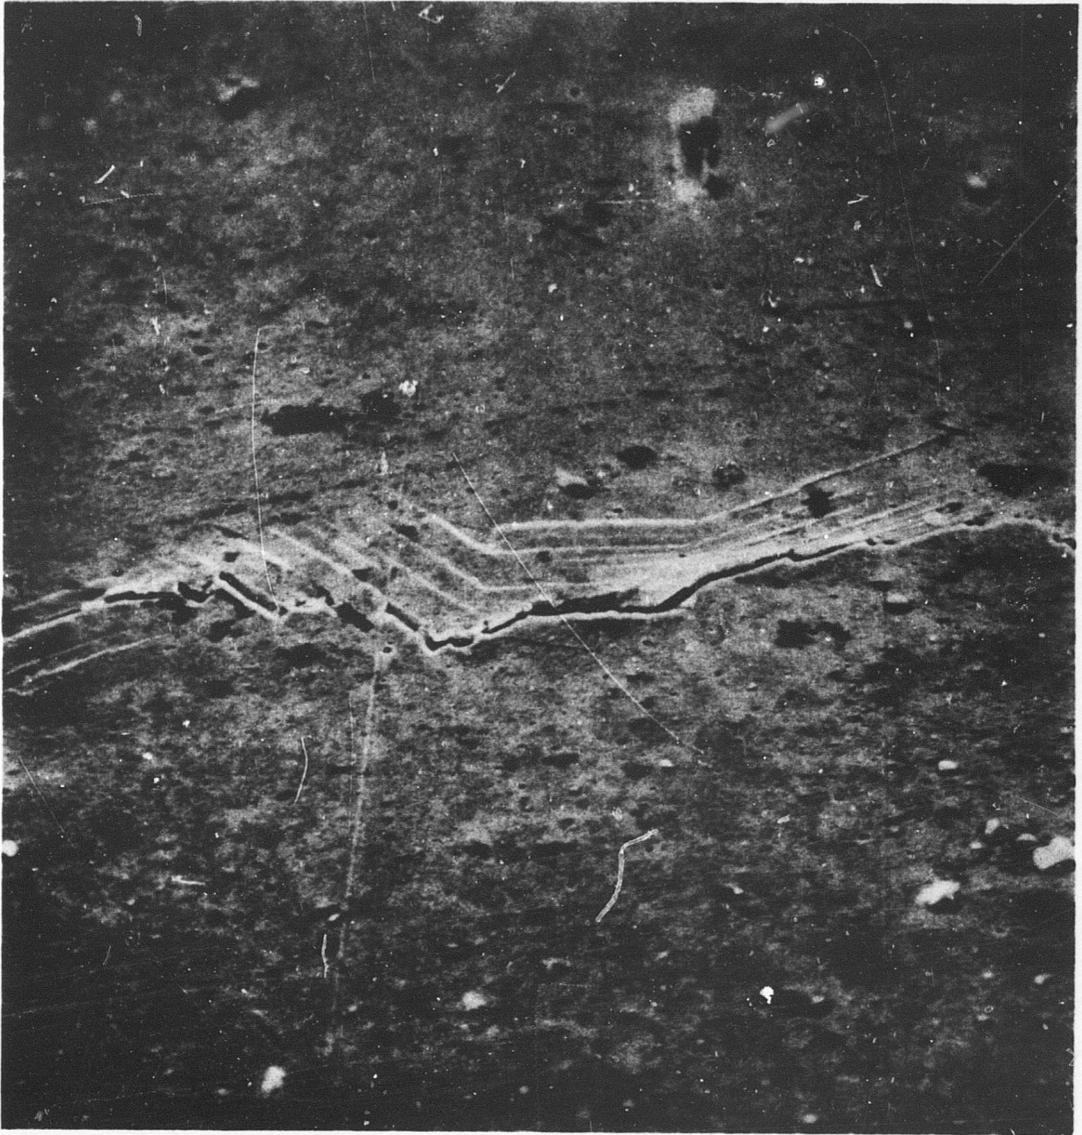
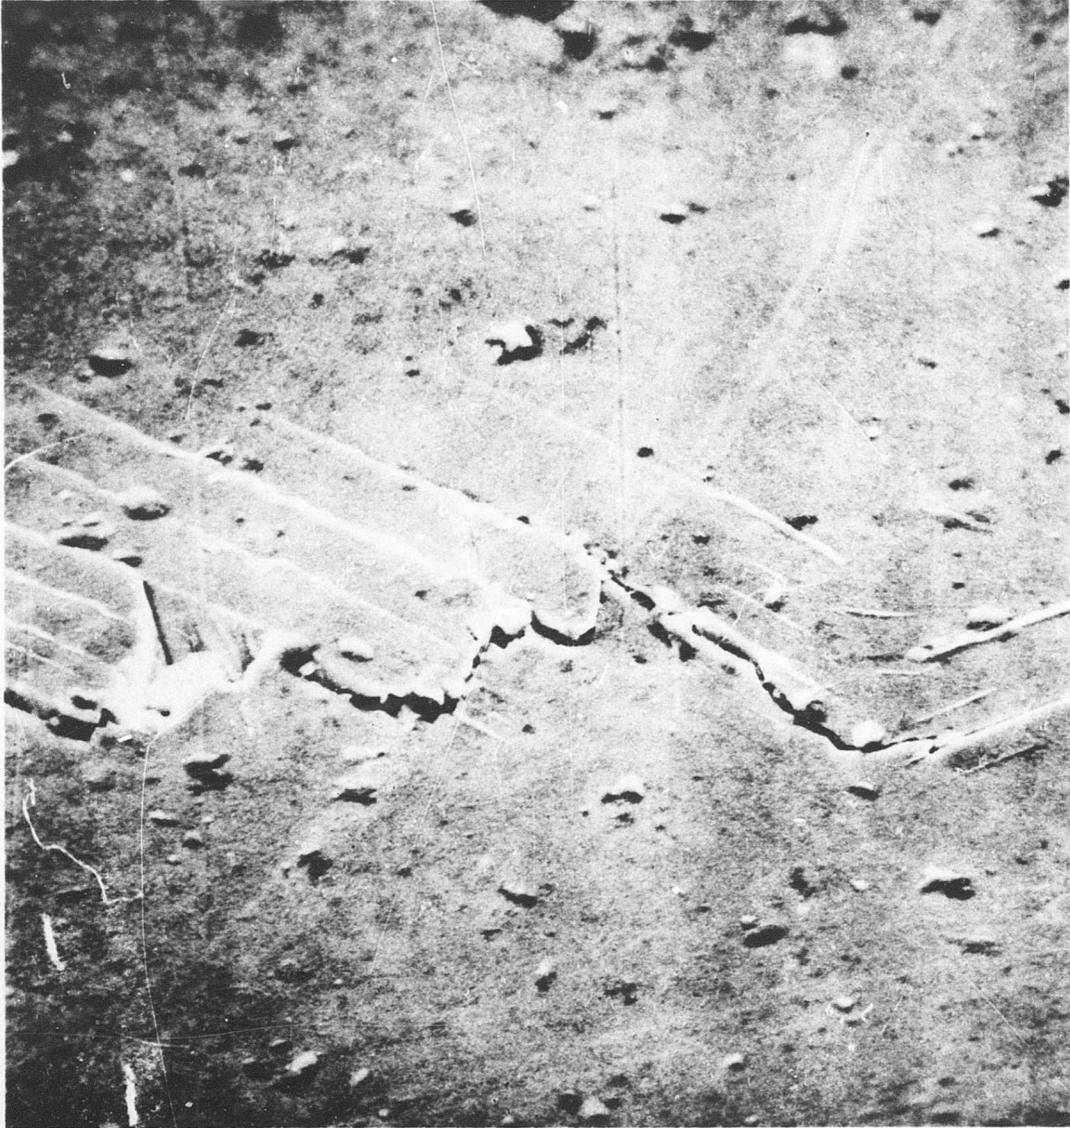
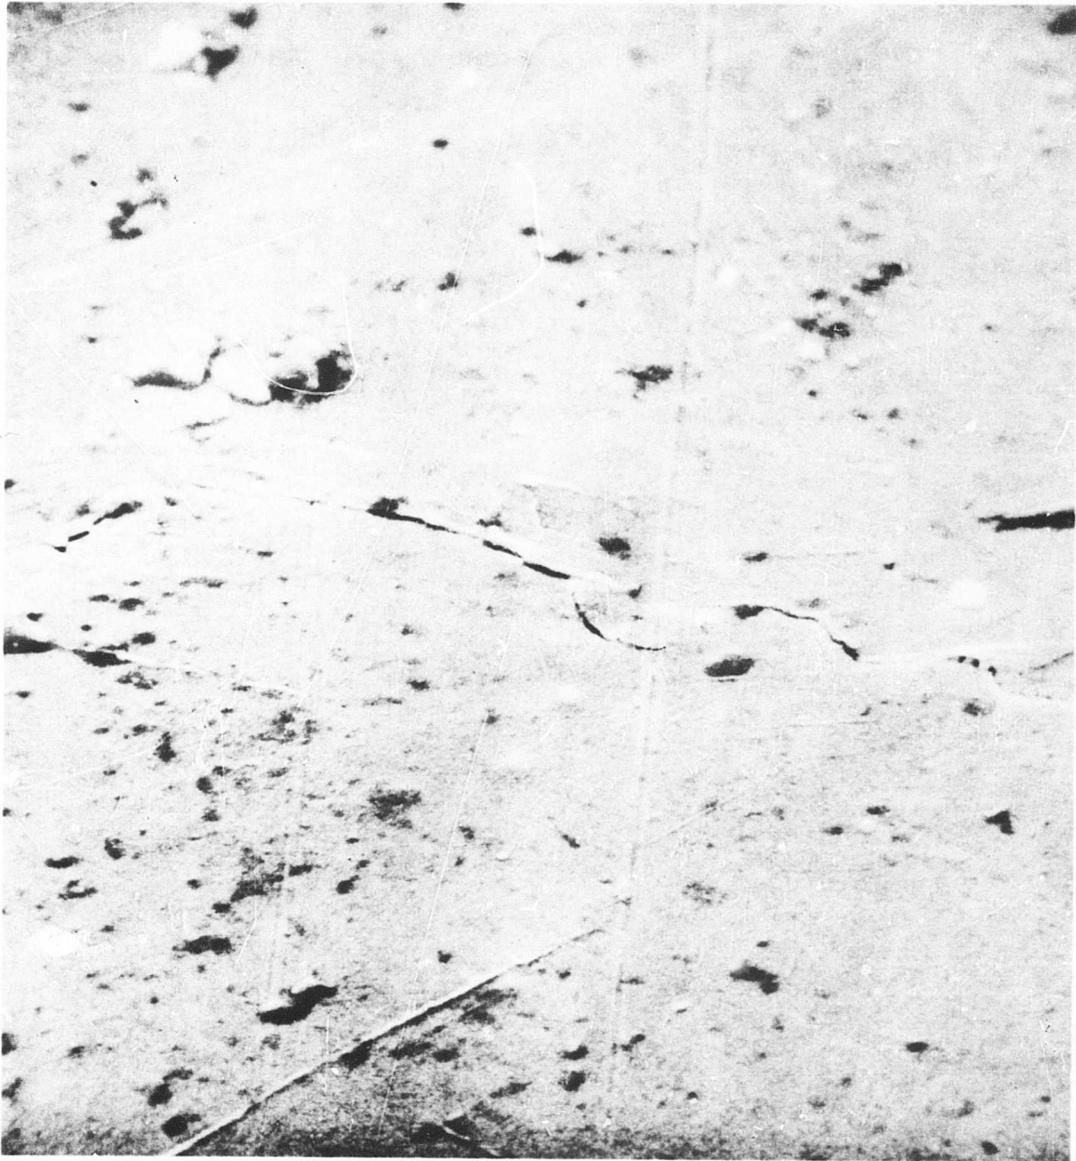
Figure 38. Inconel Sample I7, X4000, $d = .73$.

Figure 39. Inconel Sample I7, X2000, d = 1.50.

Figure 40. Inconel Sample I7, X4000, $d = 2.28$.

Figure 41. Inconel Sample I7, X4000, $d = 2.41$.

The inductive sensor scans of Inconel sample 117 are shown in Figure 37. As before, an extremely small signal at 1,100,000 cycles motivated termination of the test and preparation of the sample for scanning electron microscopy. Figure 38, 39, 40, and 41 show the damage at this point. Figure 38 shows gross damage at .73 mm from the root of the notch. Figures 39 and 40 show the crack at 1.5 and 2.28 mm from the

notch and, in addition, very clearly show the presence of slip parallel to the crack. Figure 41 shows the furthest easily observable propagation of the crack. Again, the presence of slip is evident parallel to the crack. Figure 42 shows the inductive scans of Inconel sample I10. A sizable signal at 800,000 cycles motivated termination of the test and preparation for scanning electron microscopy. Figures 43, 44, 45, and 46 are photomicrographs of the sample taken at 1.74 mm, 2.05 mm, 2.46 mm, and 3.03 mm, respectively, from the root of the notch. As before, these figures show a decrease in crack size with distance from the notch. The pock marks visible in these figures are most likely caused by the electropolishing procedure used in the initial preparation of the sample.
