USAAVLABS TECHNICAL REPORT 69-97

INVESTIGATION TO DETERMINE THE FEASIBILITY OF DETECTING IMPENDING METAL FATIGUE FAILURE THROUGH USE OF AN INDUCTIVE SENSING DEVICE

By
George G. Moross

February 1970

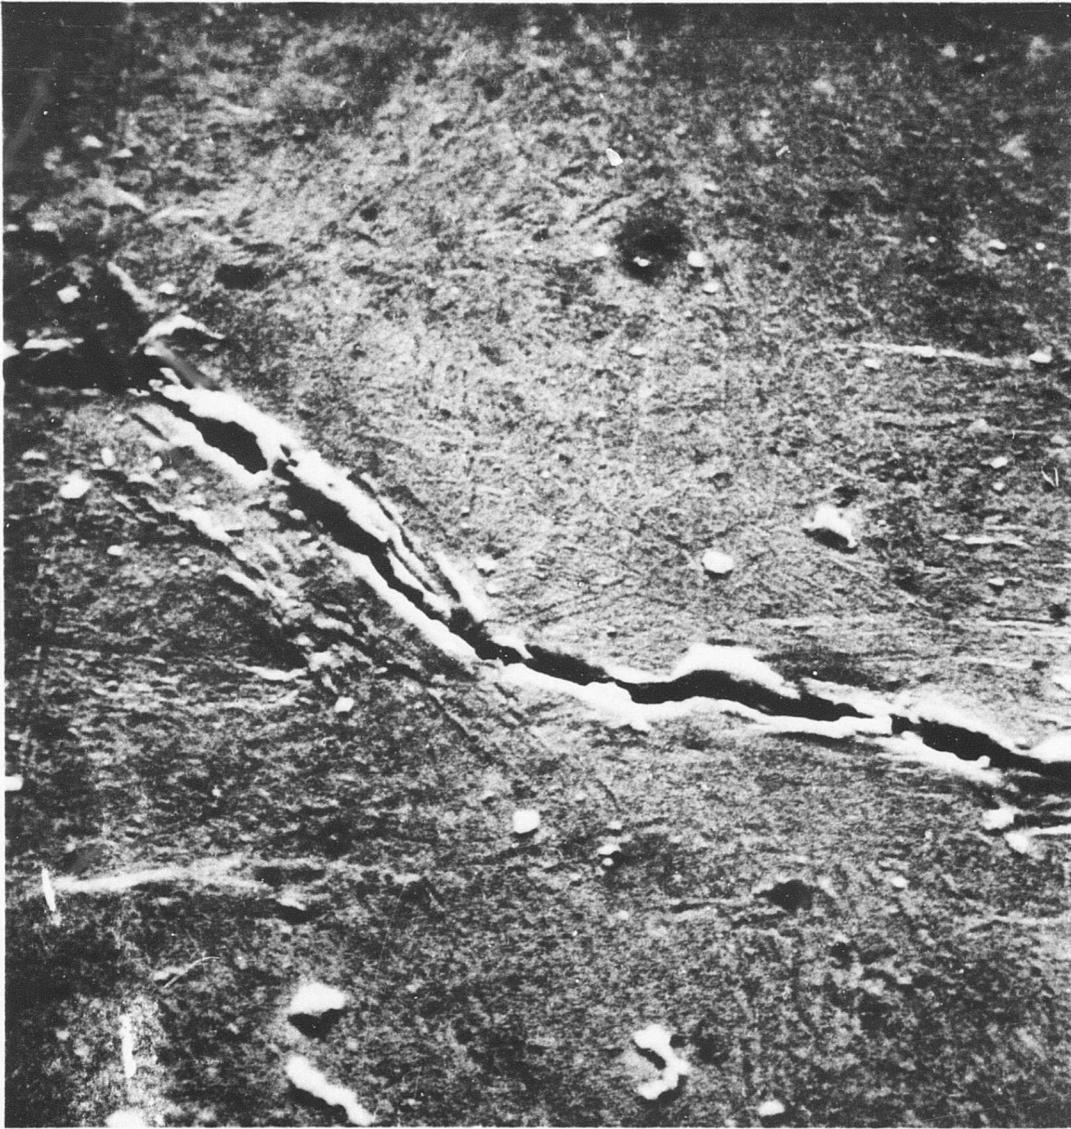
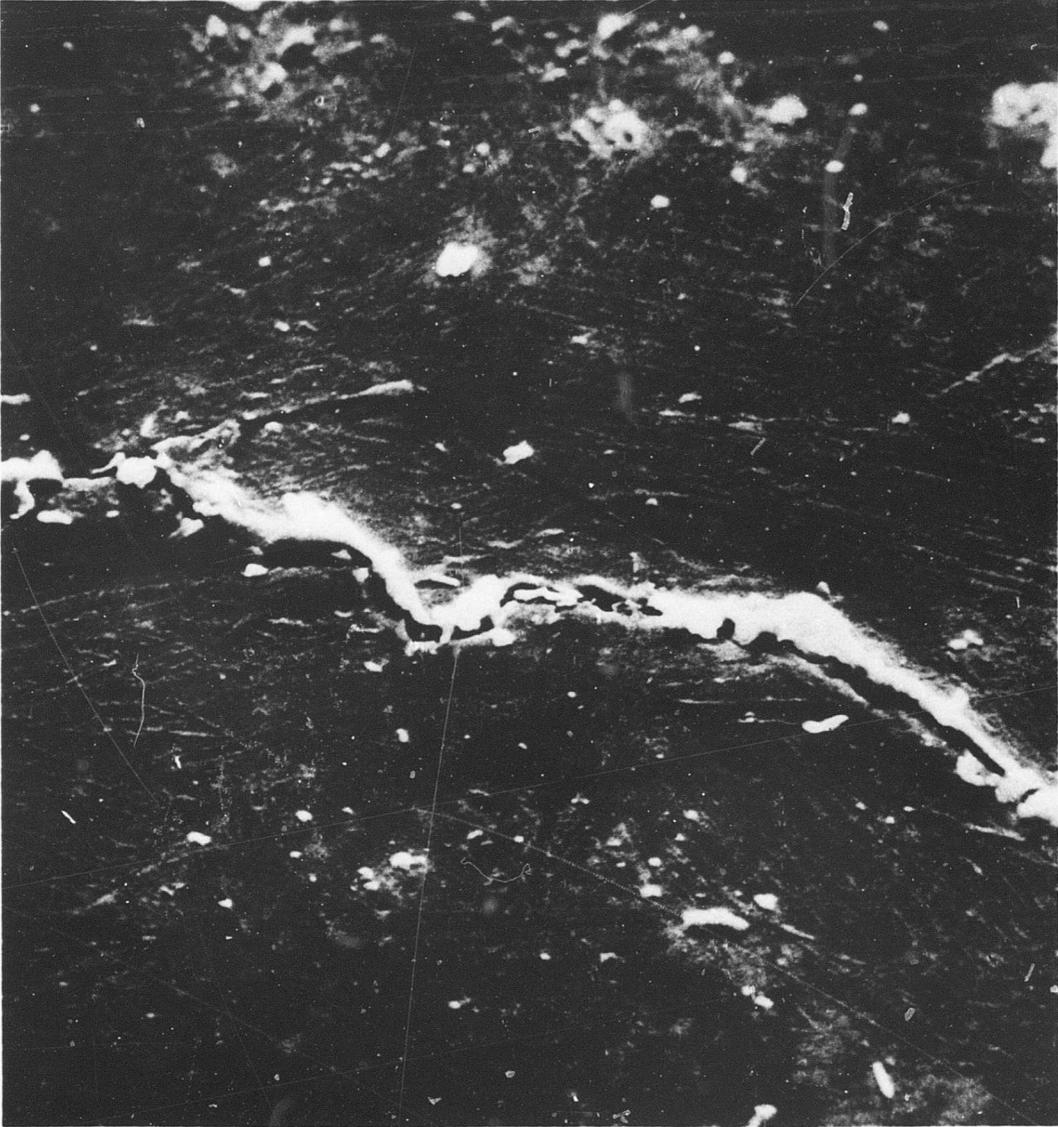
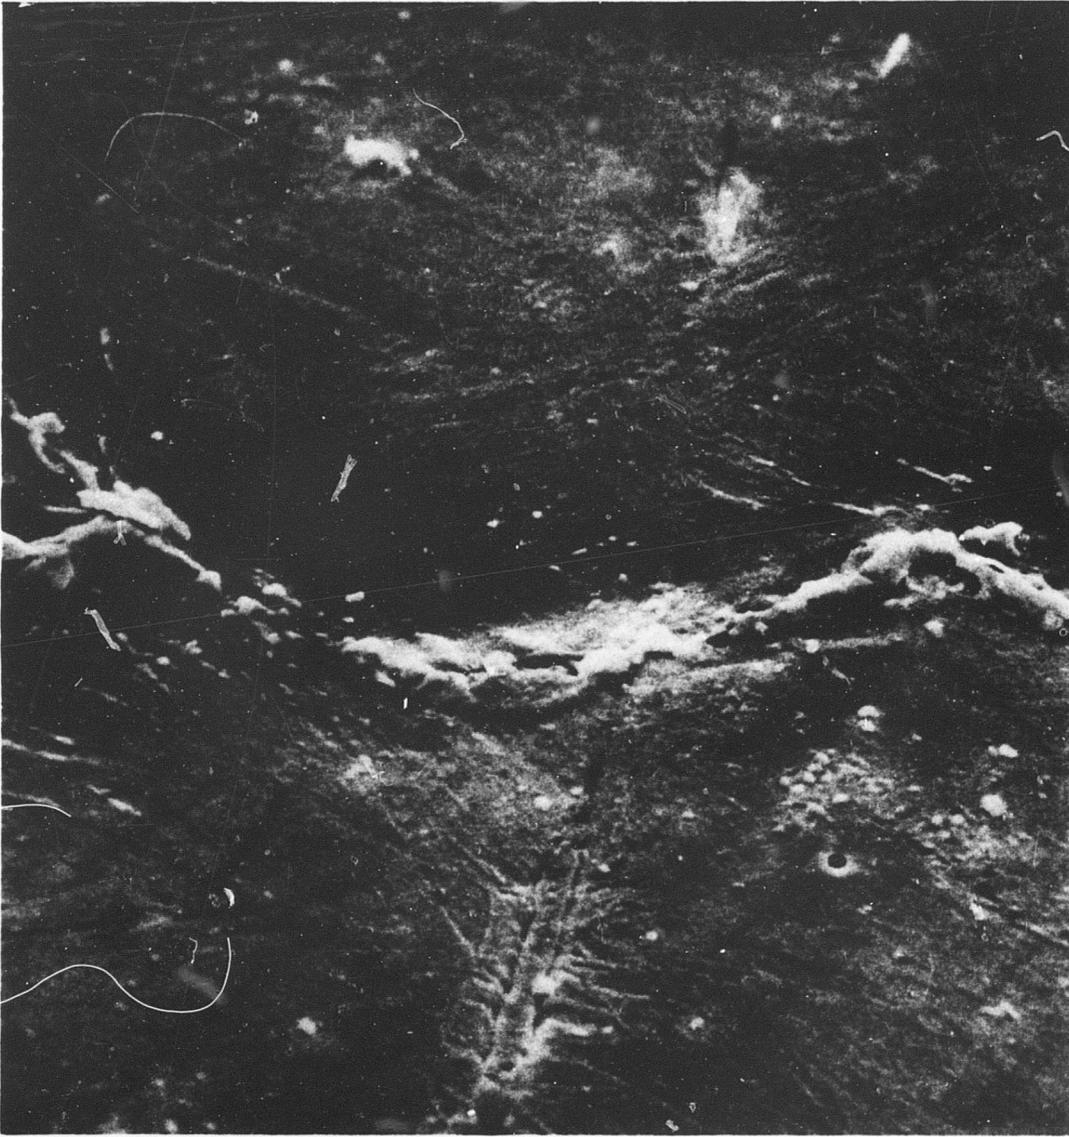
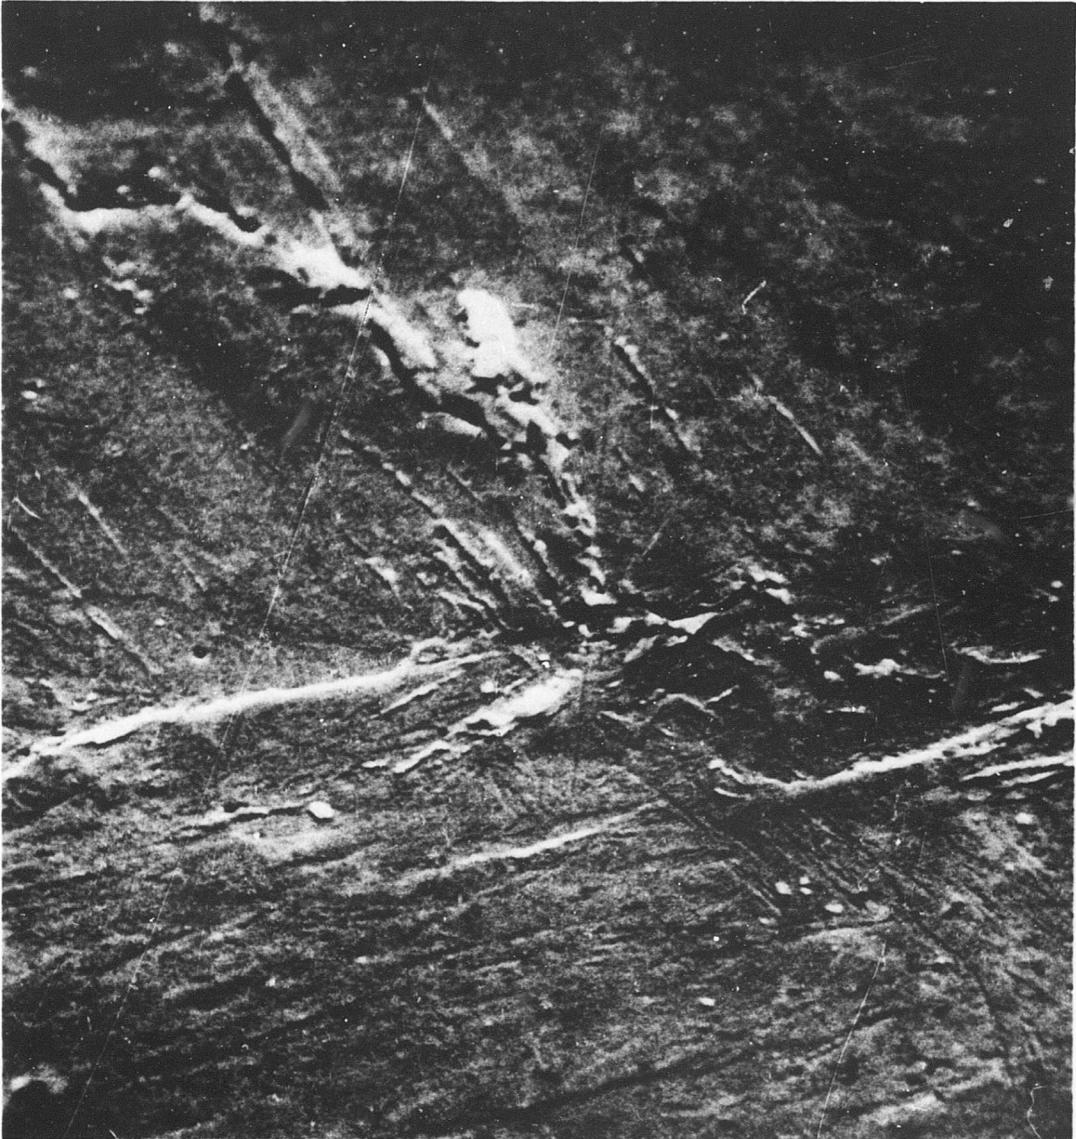
Figure 48. Steel Sample S11, X4000, $d = 1.98$.

Figure 49. Steel Sample S11, X4000, $d = 2.91$.

Figure 50. Steel Sample S11, X4000, $d = 4.16$.

Figure 51. Steel Sample S11, X4000, $d = 4.95$.

Figure 47 shows the inductive scans on steel sample S11. A sizable signal is apparent at 350,000 cycles. At this point the sample was prepared, and the photomicrographs shown in Figures 48, 49, 50, and 51 were taken. In general, the slip seen in the Inconel micrograph is not evident, and the crack appears to be partially obscured by a white-appearing substance. This substance has been shown by electron microprobe analysis to be an oxide. As with the aluminum and Inconel samples, the photographs show a crack that decreases in size with distance from the root of the notch. It is significant to note that the crack has progressed further in the steel than in the other materials, which corroborates the later appearance of the signal in general for steel samples.

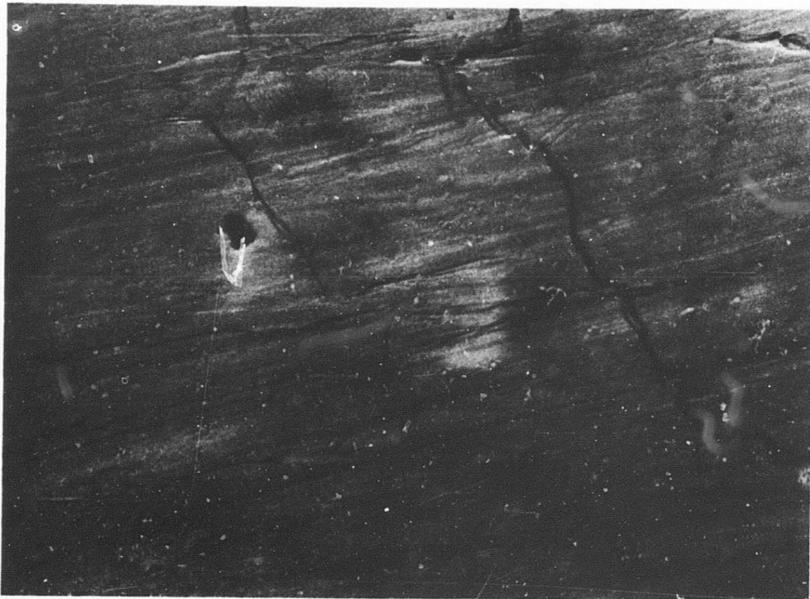
Figure 53. Surface of Sample A12, Slip in Vicinity of Crack, X9000.

presence of slip is seen. A better photograph of slip near a crack is shown in Figure 53, taken of aluminum sample A12 at 9,000-power magnification, where the slip is clearly normal to the scratches. Figure 54 shows the opposite surface of aluminum sample A12, also at 9,000-power magnification. No distinct cracks are seen (the white lines are most probably separations of the replica); however, the pits from the electro-polishing are very clearly presented.

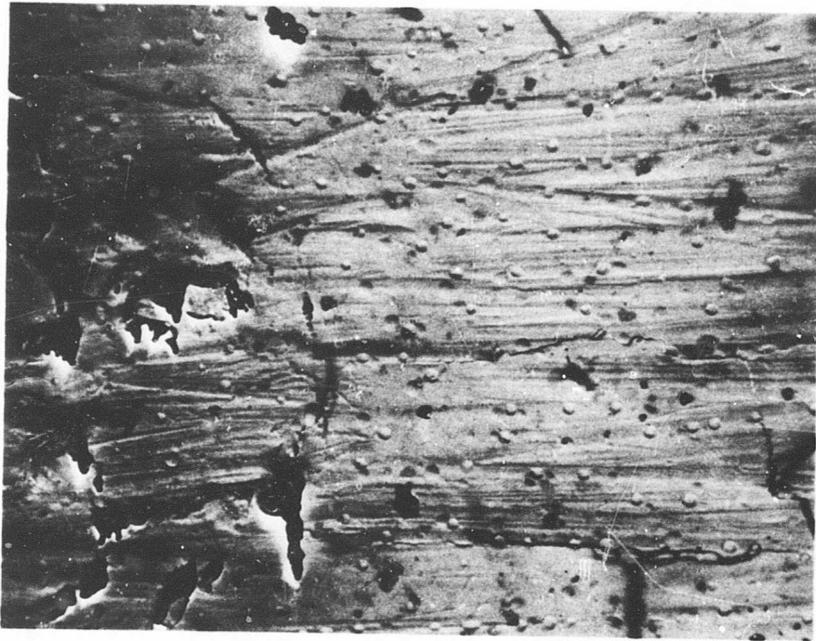
Figure 54. Opposite Surface of Al2, No Clear Evidence of Slip, X9000.

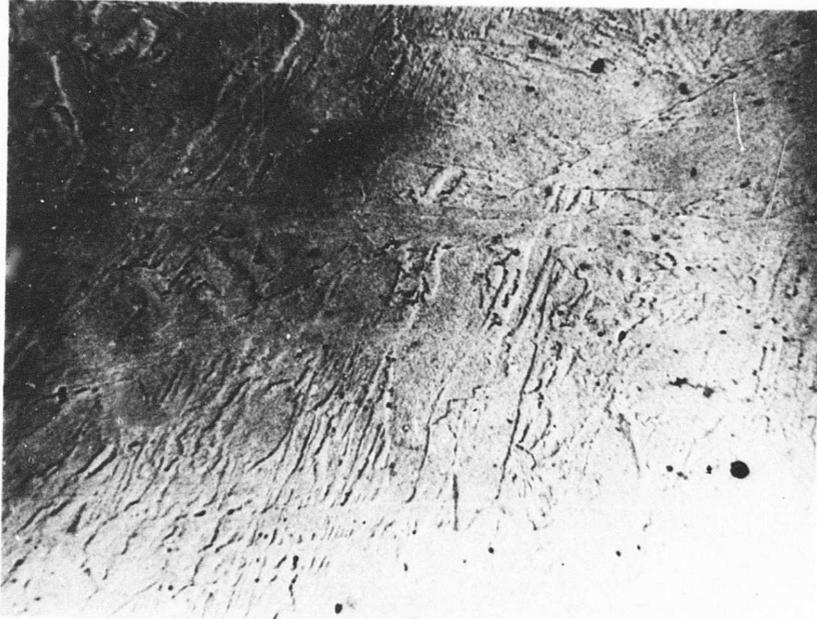
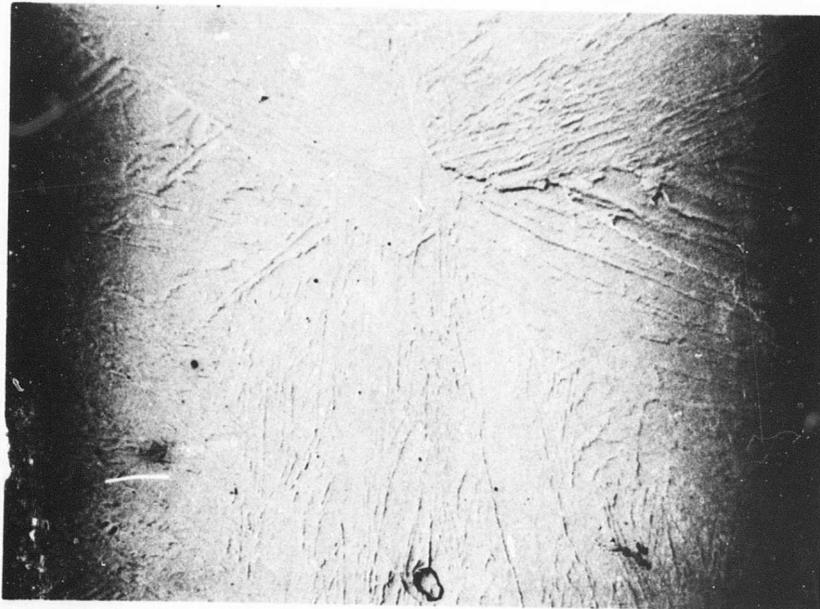
Figure 60. Surface of Steel Sample 1, Immediate Vicinity of Crack, Martensite-Like Structure, No Slip Evident, X3000.

Figure 61. Surface of Steel Sample 2, Immediate Vicinity of Crack, Martensite-Like Structure, No Slip Evident, X3000.

Figures 60 and 61 clearly show the martensite-like structure on the surface of the steel samples. Figure 60 shows steel sample S1 at 3,000-power magnification, and Figure 61 shows steel sample S2 at 3,000-power magnification. Figure 62 shows a crack edge of steel sample S1 at 9,000-power magnification. The martensite-like structure is clearly visible; however, little or no slip is seen near the crack (as it was for Inconel and aluminum) because of the fineness of the micro-structure.

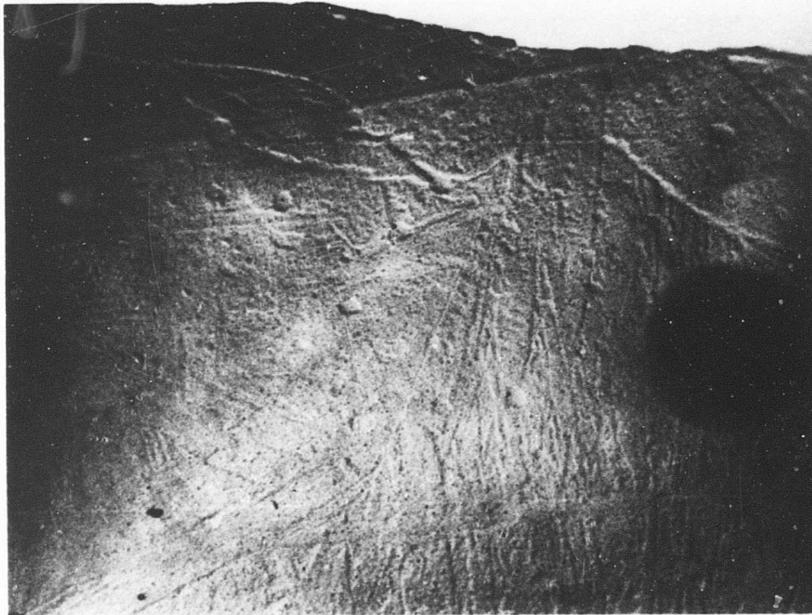
Figure 62. Sample S1, Edge of Crack at Top, No Slip Evident (Characteristic Observation for Steel Samples), X9000.

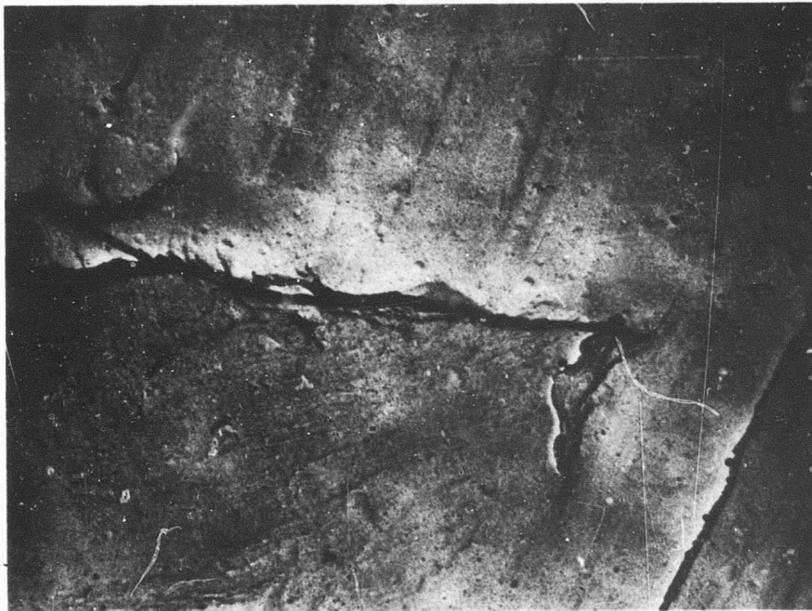
Figure 63. Sample S1, Tip of Primary Crack, No Evidence of Other Material Damage, X9000.

Figure 63 shows the tip of the main crack on steel sample S1, 750,000 cycles at 9,000-power magnification. Some structure is seen; however, features other than the crack, which could give rise to a signal, are not evident.

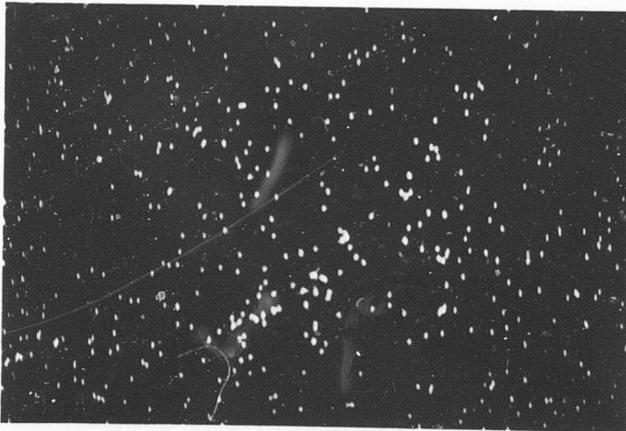
Figure 66. Microprobe Images of Steel Samples.

(a) Specimen Current
Image of Crack
in Steel, Site A.

(b) Crack in Steel,
Site A, OK_{α} Image,
15K Counts.

(c) Crack in Steel,
Site A, Spectrometer
Set on Background
Near OK_{α} Line, 15K
Counts.

- (a) One O- K_{α} picture shows the presence of O along the crack.
- (b) Other X-ray images (Ni- K_{α} , Cr- K_{α} , CK $_{\alpha}$ images) give negative results.
- (c) Step scan studies show an increase in O at the crack in agreement with observation (a). The amount of additional O is apparently less near the end of the crack than some distance back from the end. This may be a real effect or an artifact due to more of the O radiation being absorbed where the crack is narrower.
- (d) Specimen current and X-ray images all show a lack of homogeneity in samples and the formation of ridges of disturbed alloy along both edges of the crack.

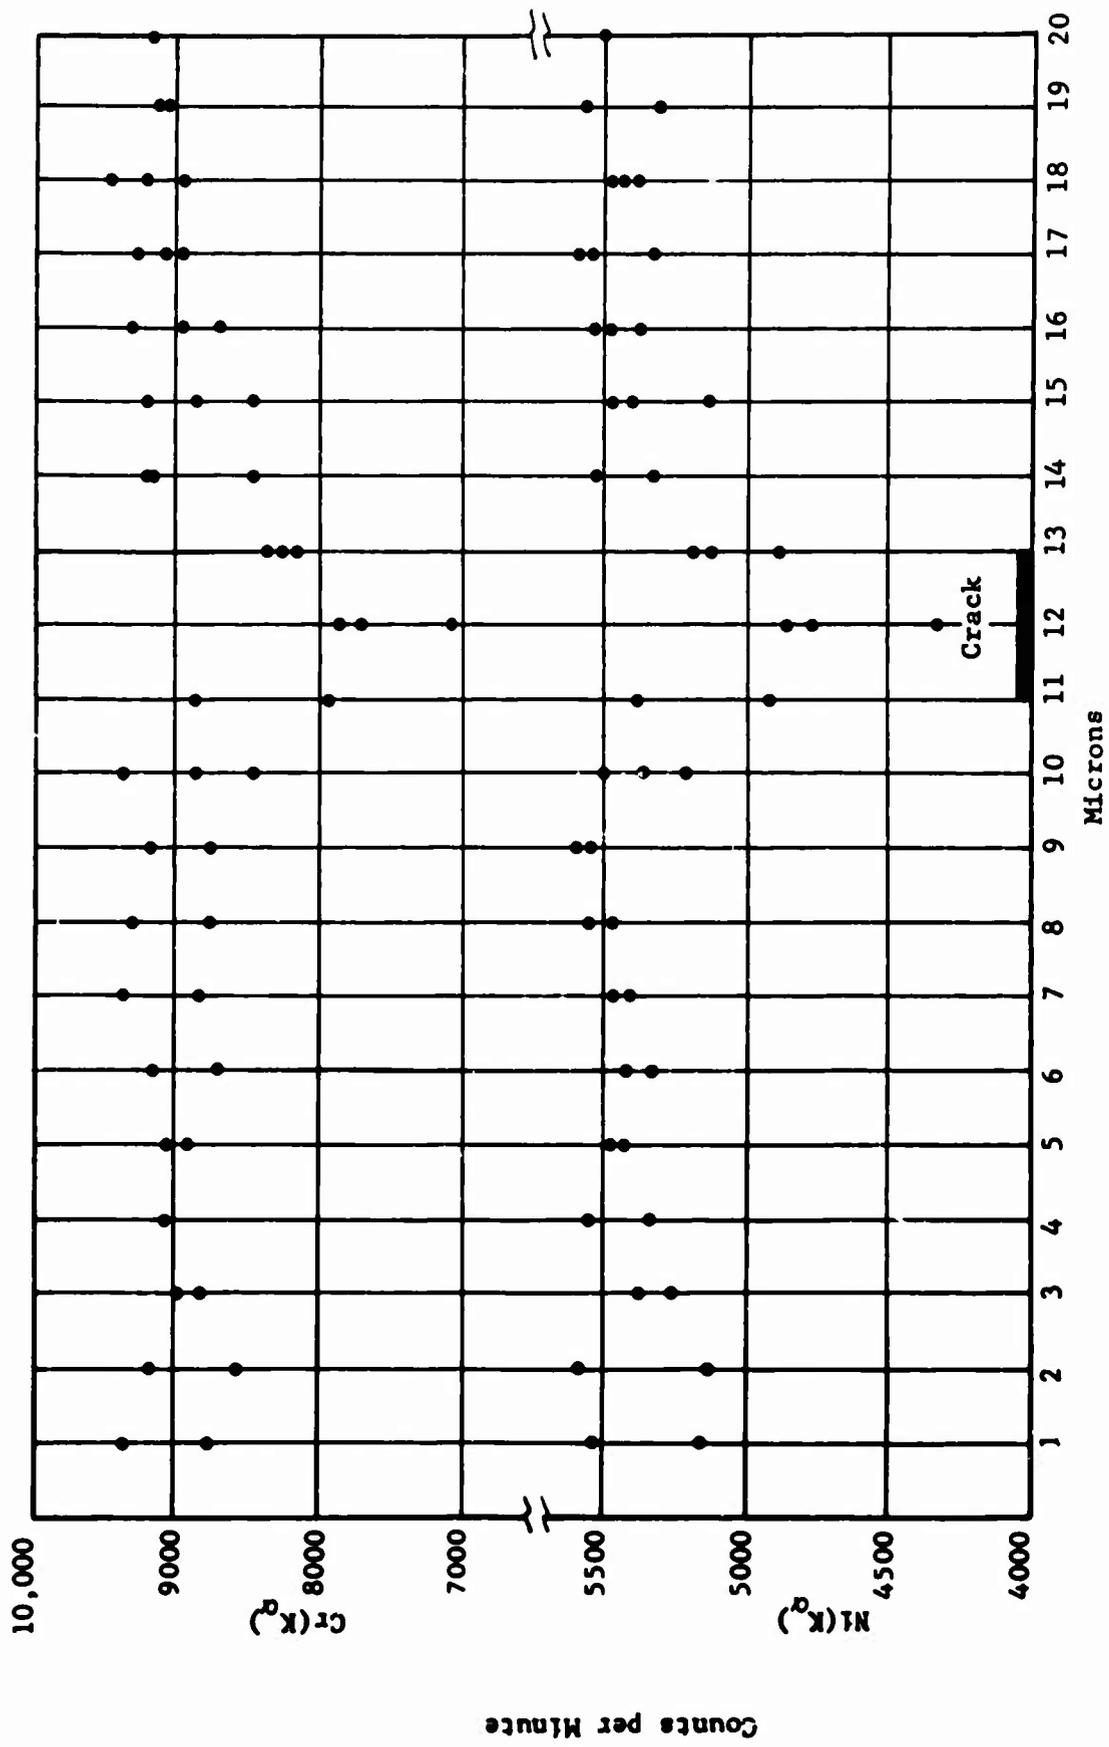
Figure 67. Step Scan of Crack on Inconel Sample Chromium and Nickel Dip at Crack.

- (3) **Step scan study.** In this method, the microprobe beam is moved in 1μ steps along a straight line (at right angles to a crack) on the sample. One X-ray spectrometer is focussed for a characteristic line of one element suspected or known to be present in the sample. A second X-ray spectrometer is focussed for a characteristic line of another element suspected or known to be present. X-ray photons received by each spectrometer detector during a 50-second counting period at each step are recorded automatically on a paper tape. In general, the location of the crack across the line of scan can be determined from the position of a minimum or maximum in the number of counts due to one of the elements (e.g., in the case of the steel sample, the position of the crack coincided with a minimum in the number of counts due to Fe- K_{α} radiation and a maximum due to O- K_{α} radiation).

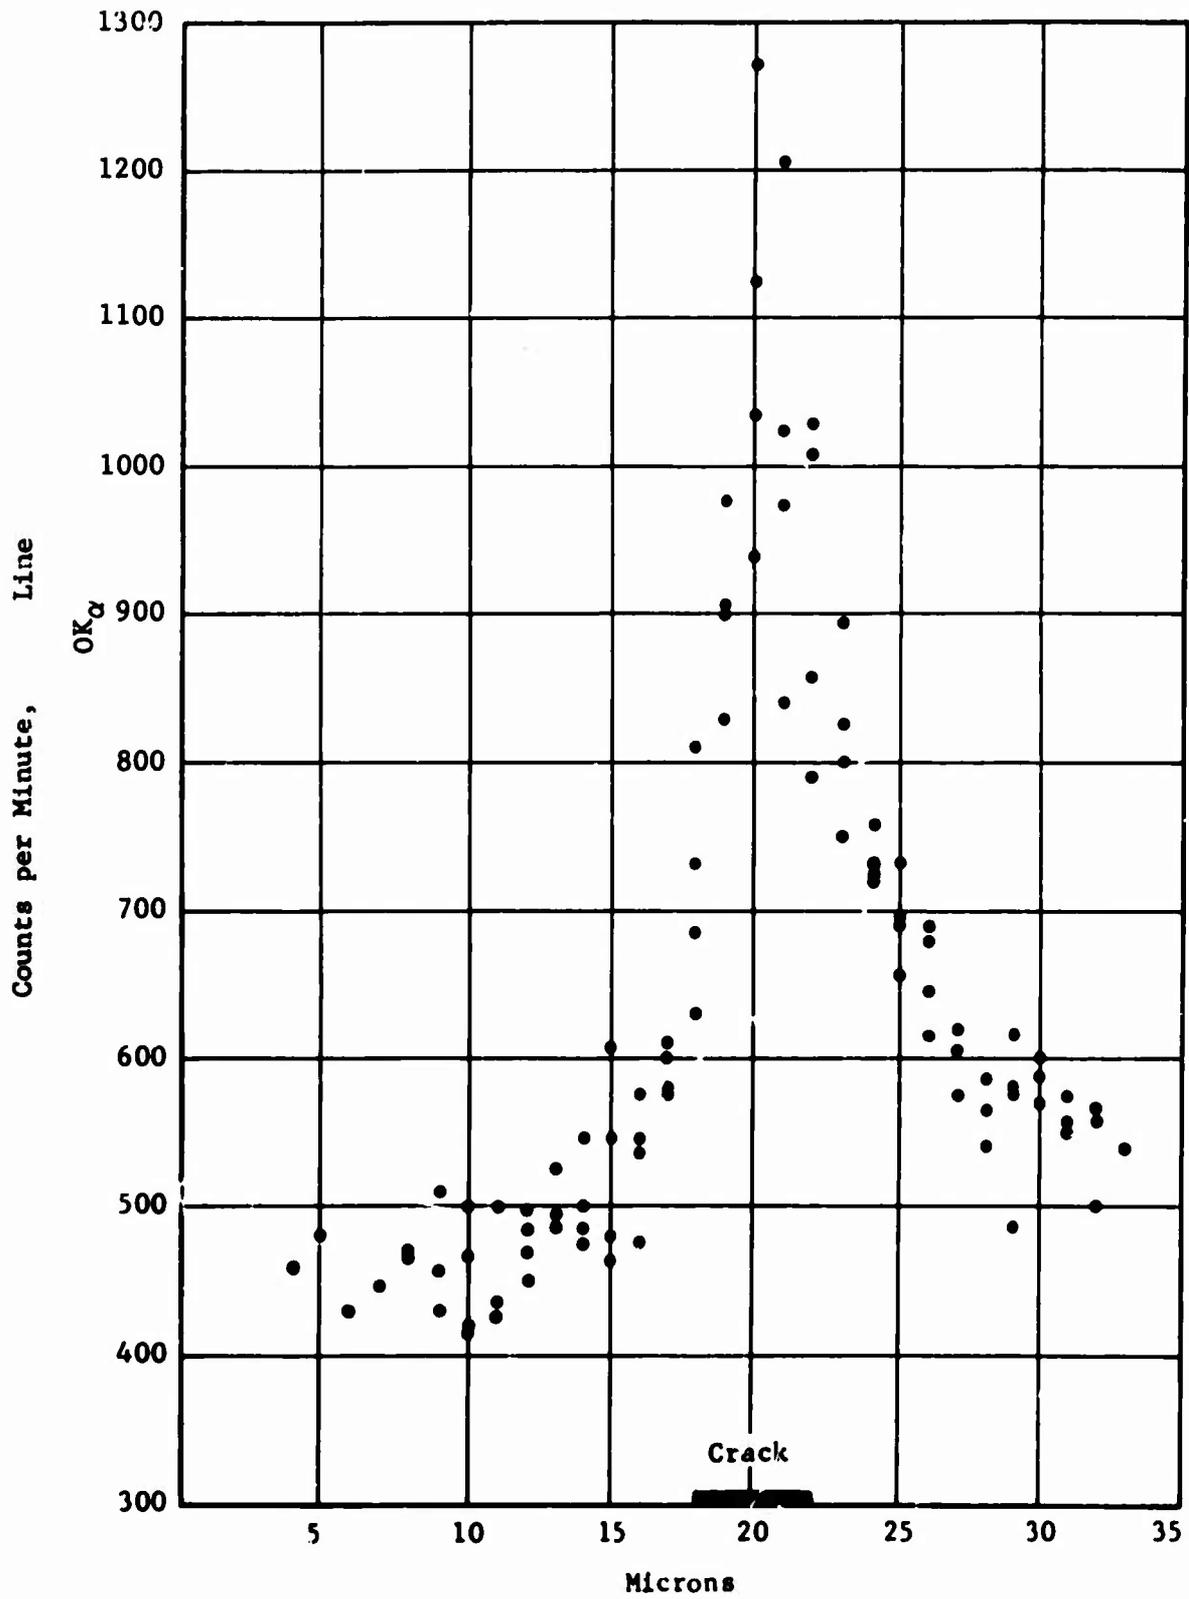
Figure 68. Step Scan of Crack on Steel Sample, Oxygen Peak at Crack.
