AEDC-TR-70-228

# RESULTS OF TESTING ULTRAHIGH PRESSURE ELECTRIC ARC HEATERS

Results of testing three electric arc heaters designed by Electro-Optical Systems (EOS) are presented. Two of the heaters had power input ratings of 1 MW; one was designed for nitrogen and one for air operation. The third was rated at 5 MW for air operation. All three heaters were of segmented constrictor design for d-c operation. Operating experience and design information were gained from the 1-MW heaters. In their present form, neither is useful for ablation or aerodynamic tests because of unreliable operation and unsteady pressure and power outputs. The 5-MW heater was designed for 200 atm pressure and 3830 Btu/lb enthalpy. This goal was not achieved because of repeated failures and heater damage caused by electrical arc-overs. The best demonstrated performance by the 5-MW EOS heater was 6135 Btu/lb at 23 atm pressure. Some comparisons are made of the thermodynamic performance, component durability, and maintainability of the 5-MW EOS heater and a Linde heater of equal power rating. All testing was done at Arnold Engineering Development Center.

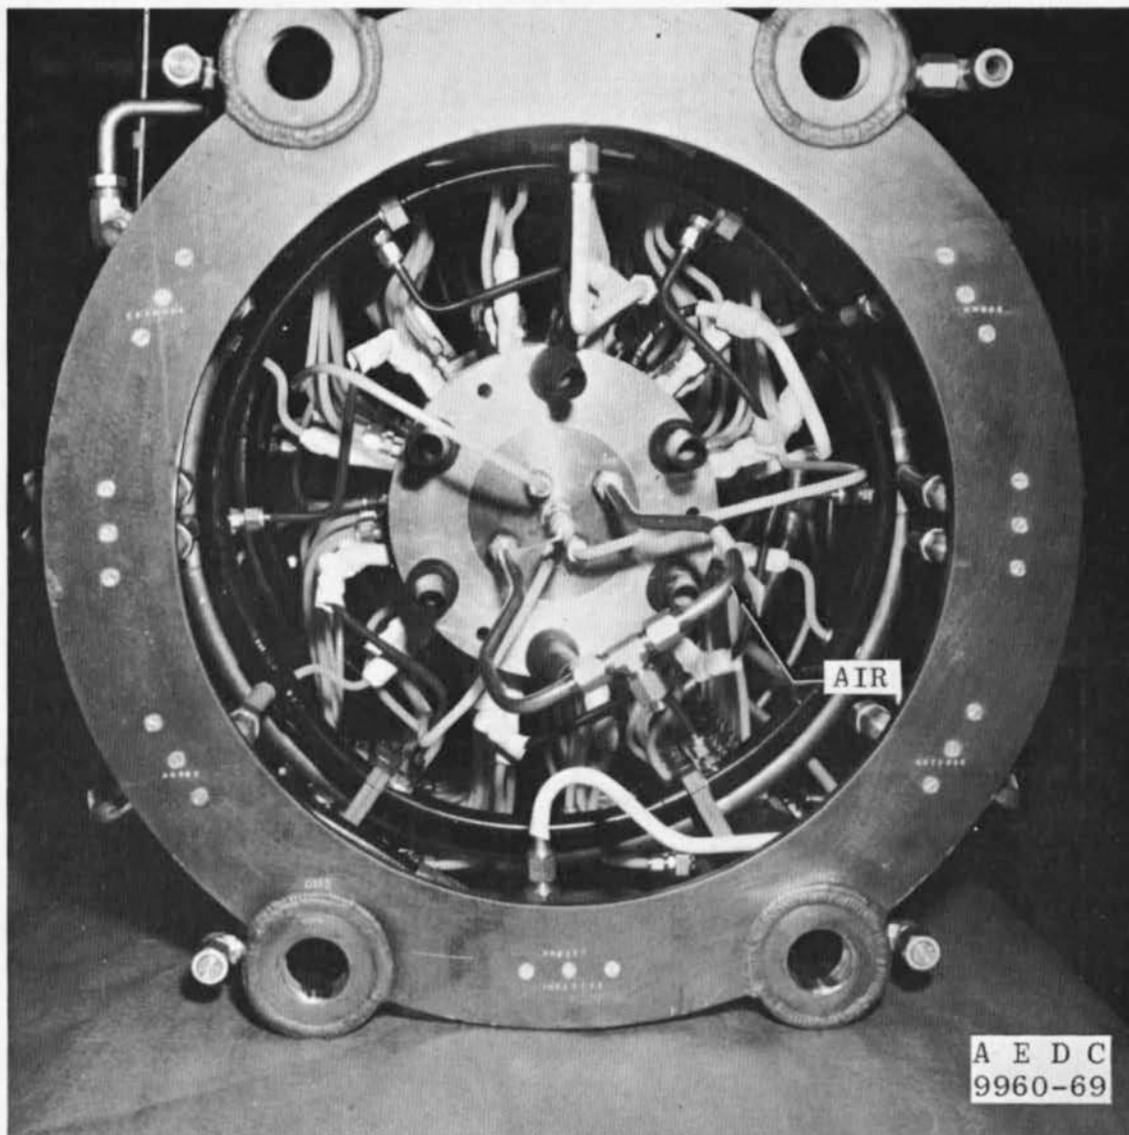
e. Rear View  
Fig. 6 Continued

A section drawing of the 5-MW arc heater is shown in Fig. 6a. This heater is similar to the 1-MW air heater, except that there are 65 insulated channel segments versus 20 for the 1-MW heater. The constrictor column diameter was 0.934 in., the axial distance between electrodes was 17.561 in., and the throat diameter of the exit nozzle was 0.215 in. The electrodes are similar, with the upstream electrode being the anode and the downstream electrode the cathode. Spin coils are coaxial with each electrode so as to rotate the electrode arc column terminations, augmenting air swirl. Cooling water for the nozzle, electrodes, channel segments, and the back plate is supplied from two manifolds (see Fig. 6c). Figure 6b is a view of the disassembled heater, illustrating the complexity of construction. Front, side, and rear views of the assembled heater are shown in Figs. 6c, d, and e. The assembled heater mounted on the test stand with power leads connected is shown in Figs. 6f and g.

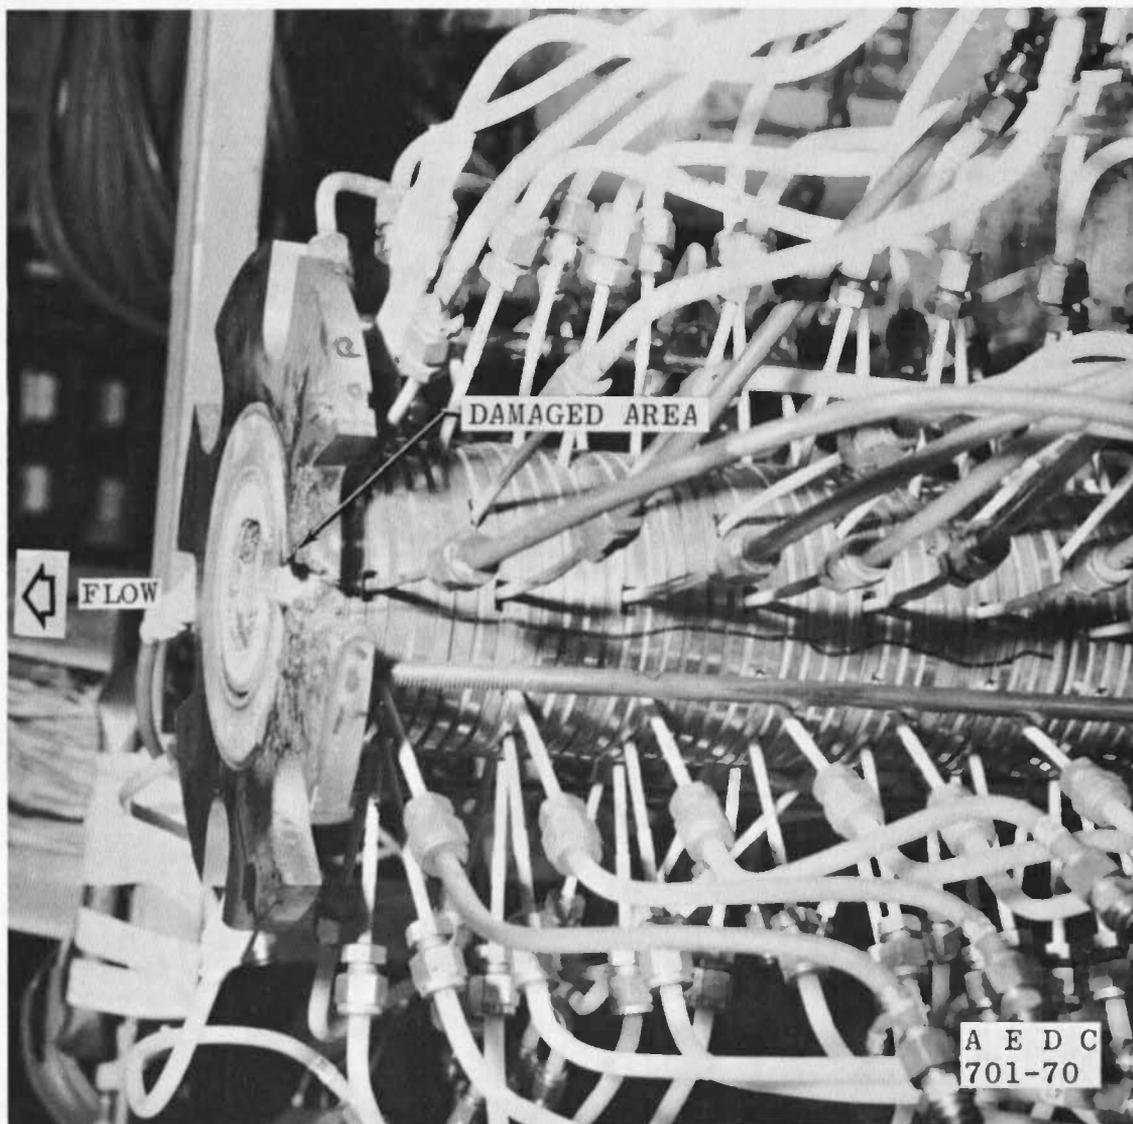
During Run E15, before the anode and air injection configurations were changed, a hot spot developed at the downstream base segment, and the hot gas burned through

the base segment (Figs. 12a and 13a). The cathode spin coil also sustained slight damage (Fig. 12b). This is the only case of major damage not caused by an electrical arc-over. As a result of the base segment burnthrough, both base segments were redesigned (see Figs. 13a and b). Both segments were provided with more coolant flow and better thermal protection. In addition, the upstream base segment was provided with air injection ports (Fig. 13b); this was done to prevent the arc from attaching to the anode downstream corner (Fig. 10a). Also, the shape and diameter of the anode were changed (Fig. 10b) to aid in moving the location of the arc attachment point.

a. Downstream Base Segment  
Fig. 12 Photographs of Damage to 5-MW Heater, Run E15

b. Cathode Spin Coil  
Fig. 12 Concluded
