THE EFFECTS OF HIGH INTENSITY ELECTRICAL CURRENTS ON ADVANCED COMPOSITE MATERIALS

PHILCO-FORD CORPORATION
Aeronautic Division
Newport Beach, California

REPORT NO. U-4866

Prepared Under Contract
N00019-70-C-0073

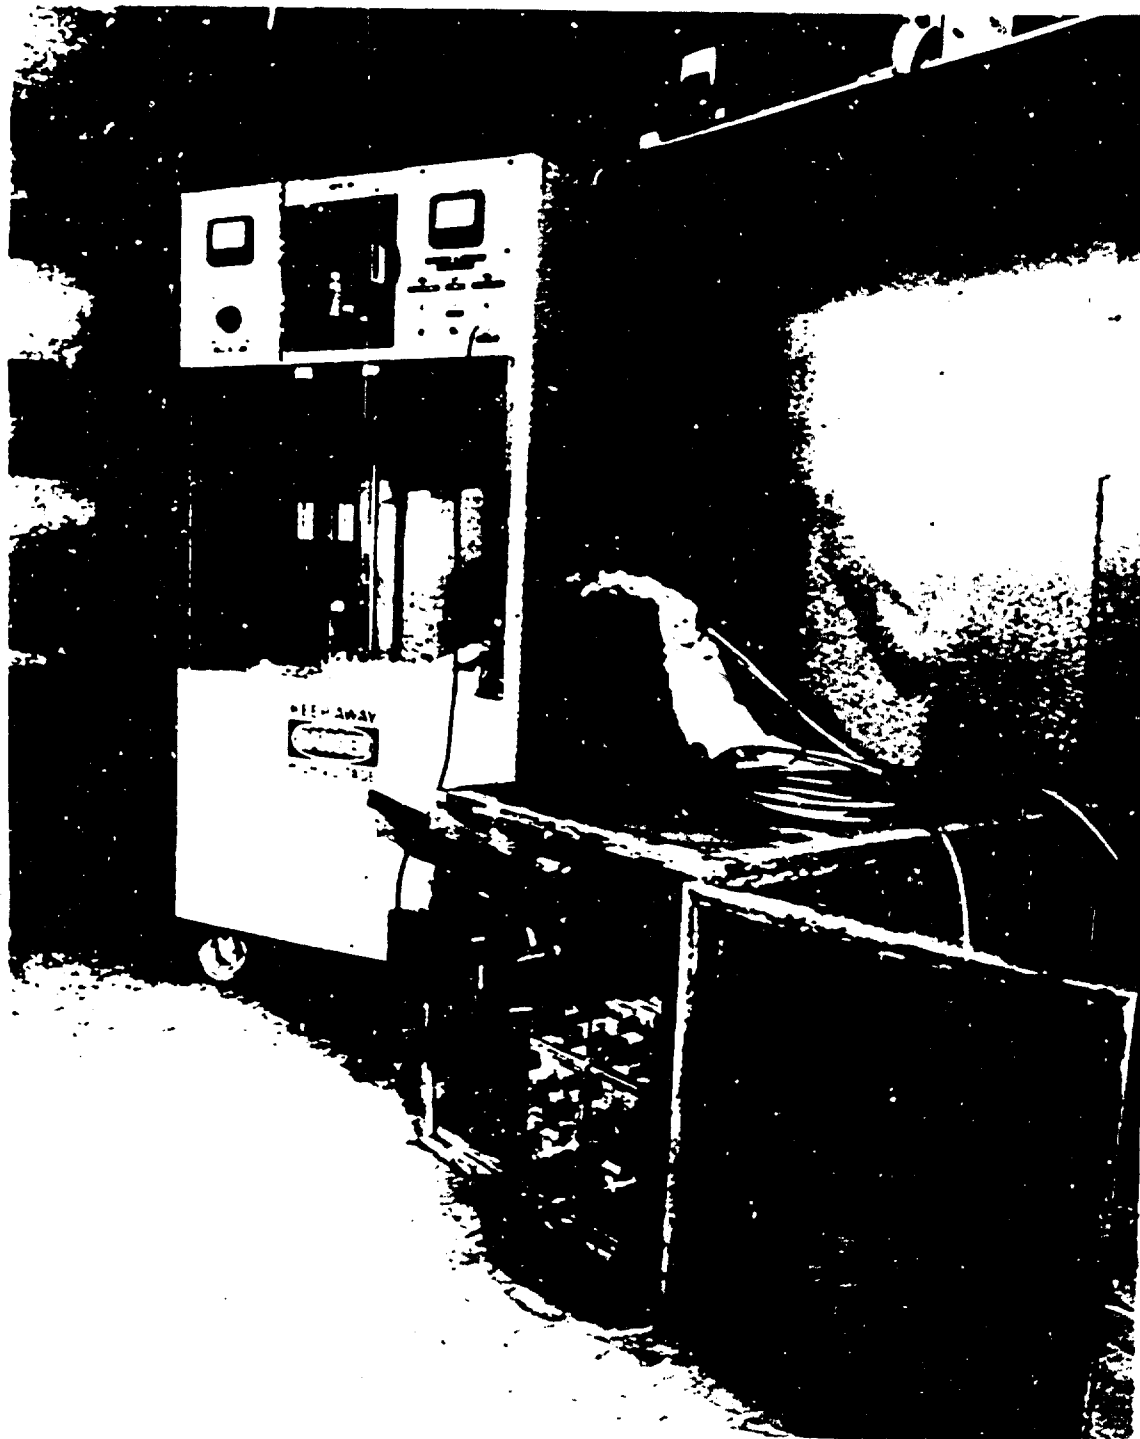
FIGURE 2-2. IMPULSE GENERATOR AND PERIPHERAL MEASURING EQUIPMENT.

The primary difference to be noted in the set-up pictured in Figure 2-2 and 2-7 is the technique used for measuring the injected current. Previously these measurements were made by using a current pulse transformer. During testing these transformers were found to fall off slightly at low frequencies which required a small correction factor to be introduced when reading values out on the tail of the wave (a necessity when determining the dynamic impedance of the specimen). The technique employed in measuring the current is to measure the voltage across a linear (non-inductive) resistance shunt in series with the test specimen. By using a shunt resistance value which is much smaller than the test specimen resistance, there is an insignificant amount of error in the voltage signal

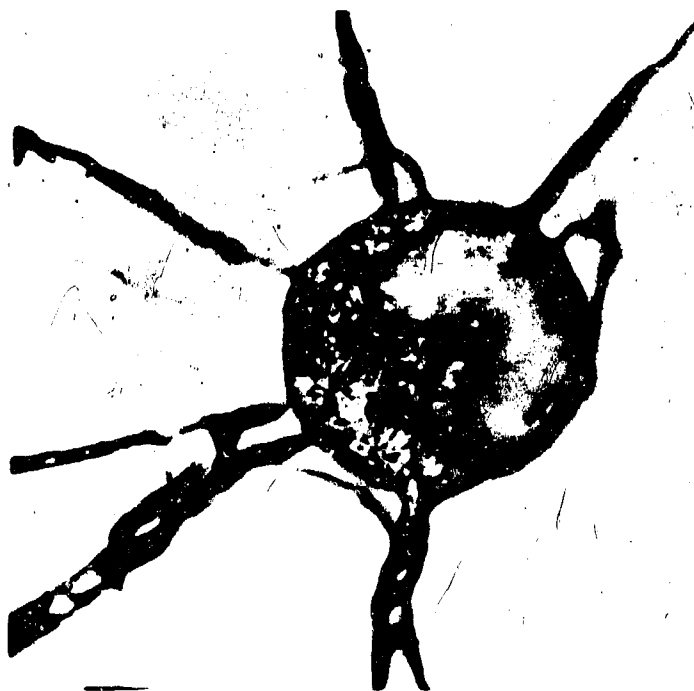
FIGURE 2-57 (2000X) VIEW OF BORON FILAMENT IN BU #17 COMPOSITE WHERE THE CORE HAS MELTED AND RESOLIDIFIED.

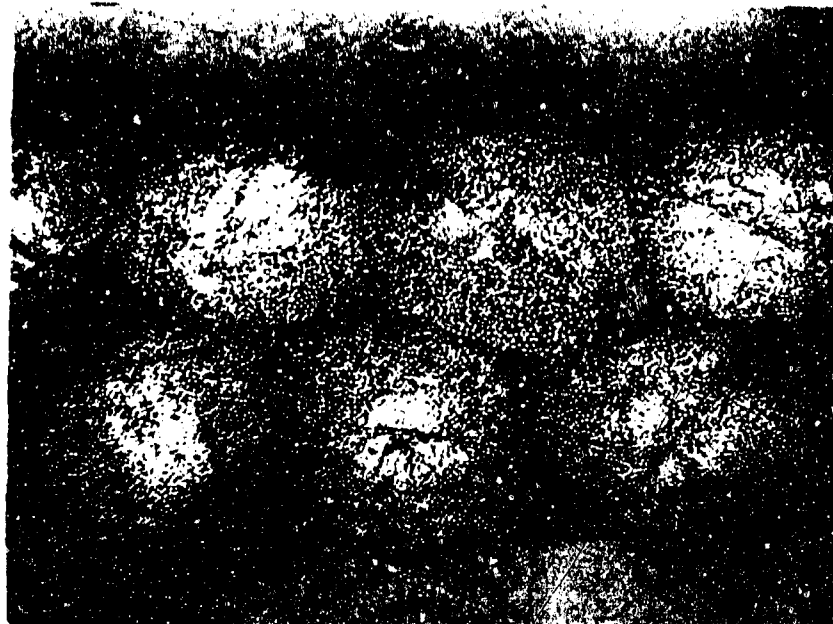
FIGURE 2-76. (100X) HMG-50/EPOXY SPECIMEN AFTER
 13.04×10^4 AMPERES PER CM^2 OF FILAMENT CREST
 CURRENT INJECTION--NO DAMAGE.

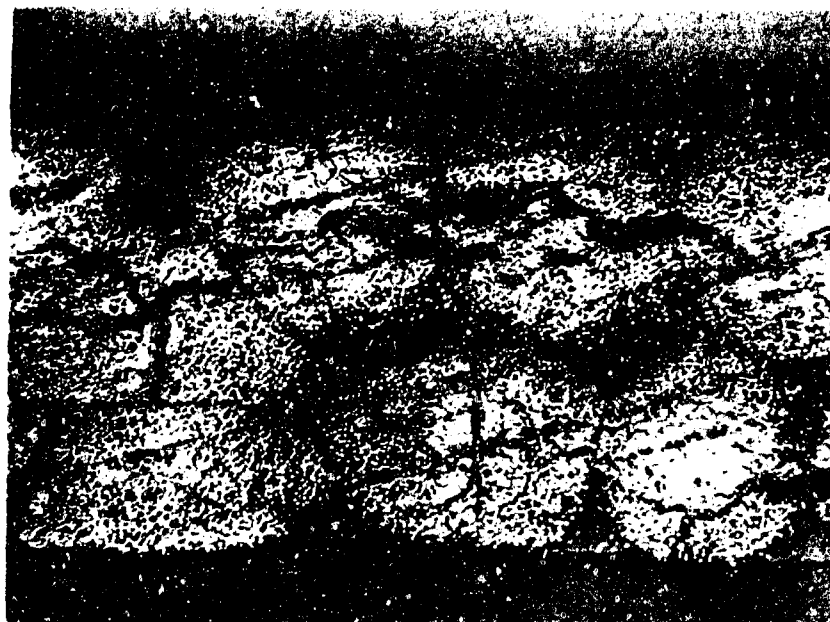
FIGURE 2-77. (100X) HMG-50/EPOXY SPECIMEN AFTER
 20.4×10^4 AMPERES PER CM^2 OF FILAMENT CREST
 CURRENT INJECTION--BURNED AND DELAMINATED.
