AIR FORCE PRELIMINARY EVALUATION OF THE UH-1H HELICOPTER

TECHNICAL REPORT No. 70-22

AUGUST 1970

AIR FORCE FLIGHT TEST CENTER
EDWARDS AIR FORCE BASE, CALIFORNIA
AIR FORCE SYSTEMS COMMAND
UNITED STATES AIR FORCE

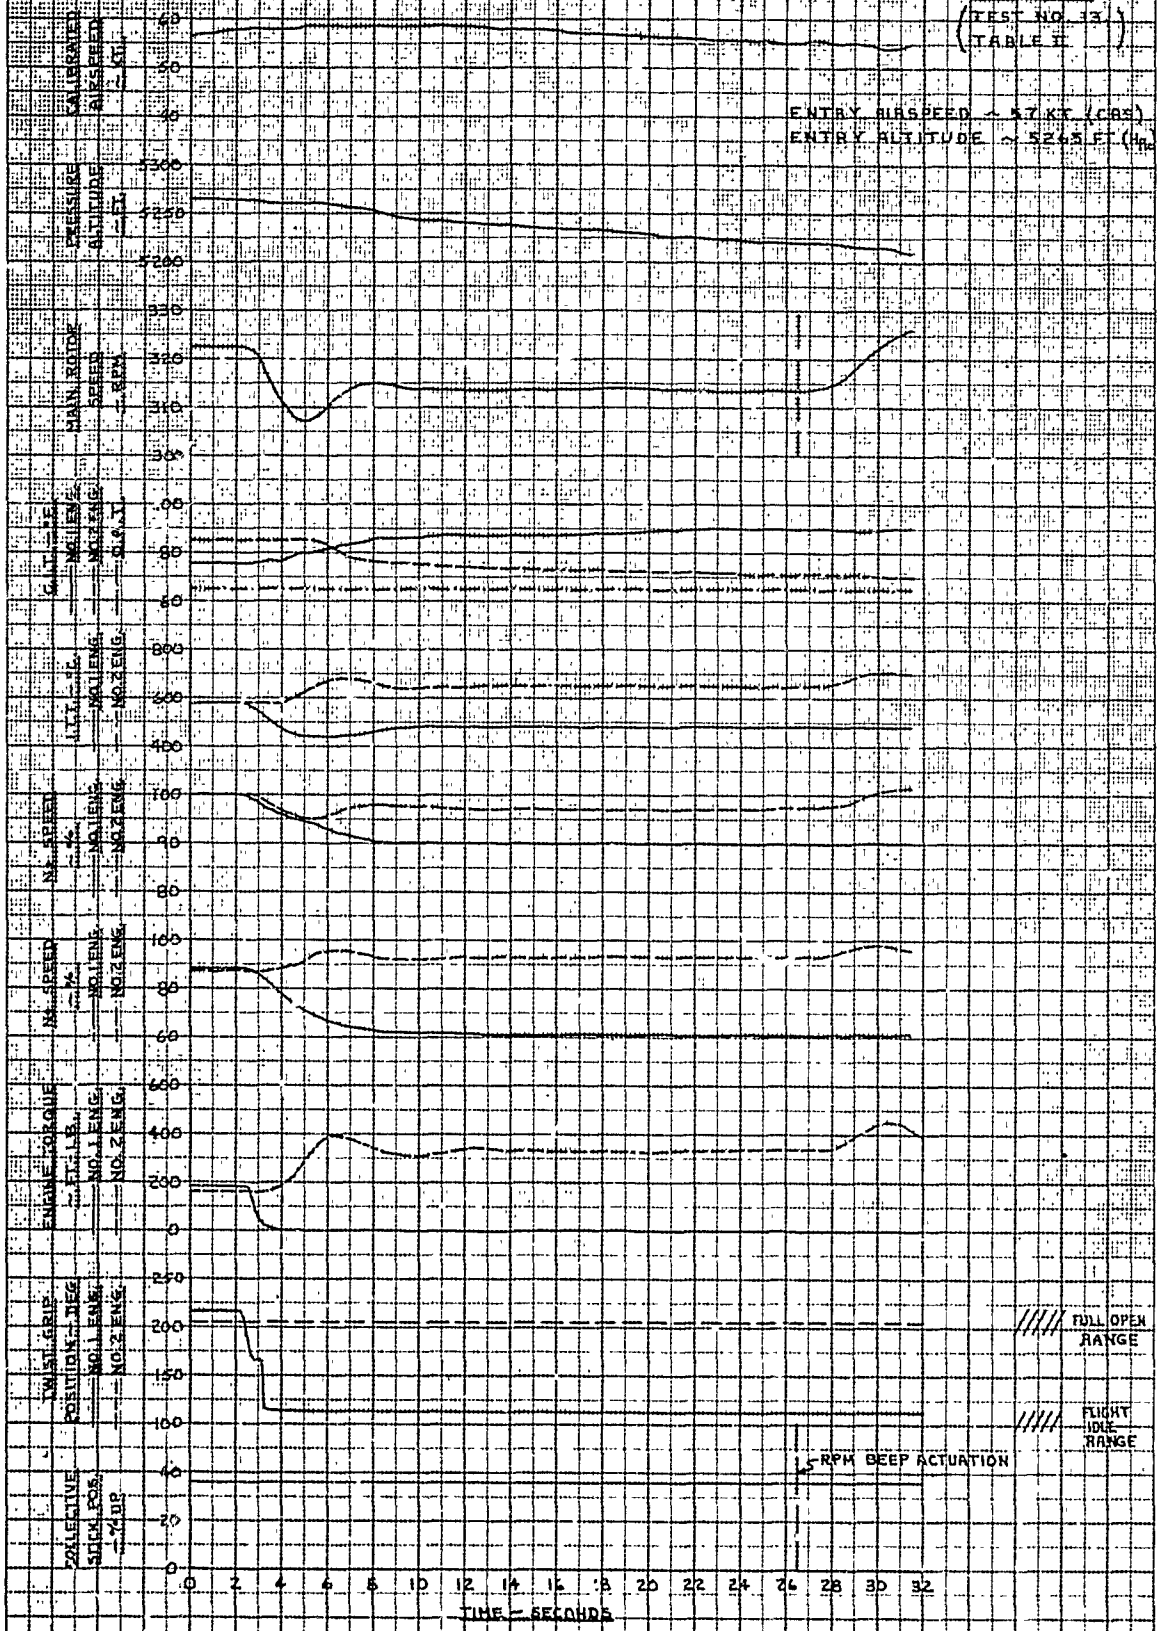
Fig. 24 TIME HISTORY OF POWER TRANSIENT - SINGLE ENGINE THROTTLE CHOP
