# Evaluation Of The Fused Slurry Silicide Coating Considering Component Design And Reuse

*MCDONNELL DOUGLAS AERONAUTICS COMPANY - EAST*

TECHNICAL REPORT AFML-TR-70-154

December 1970

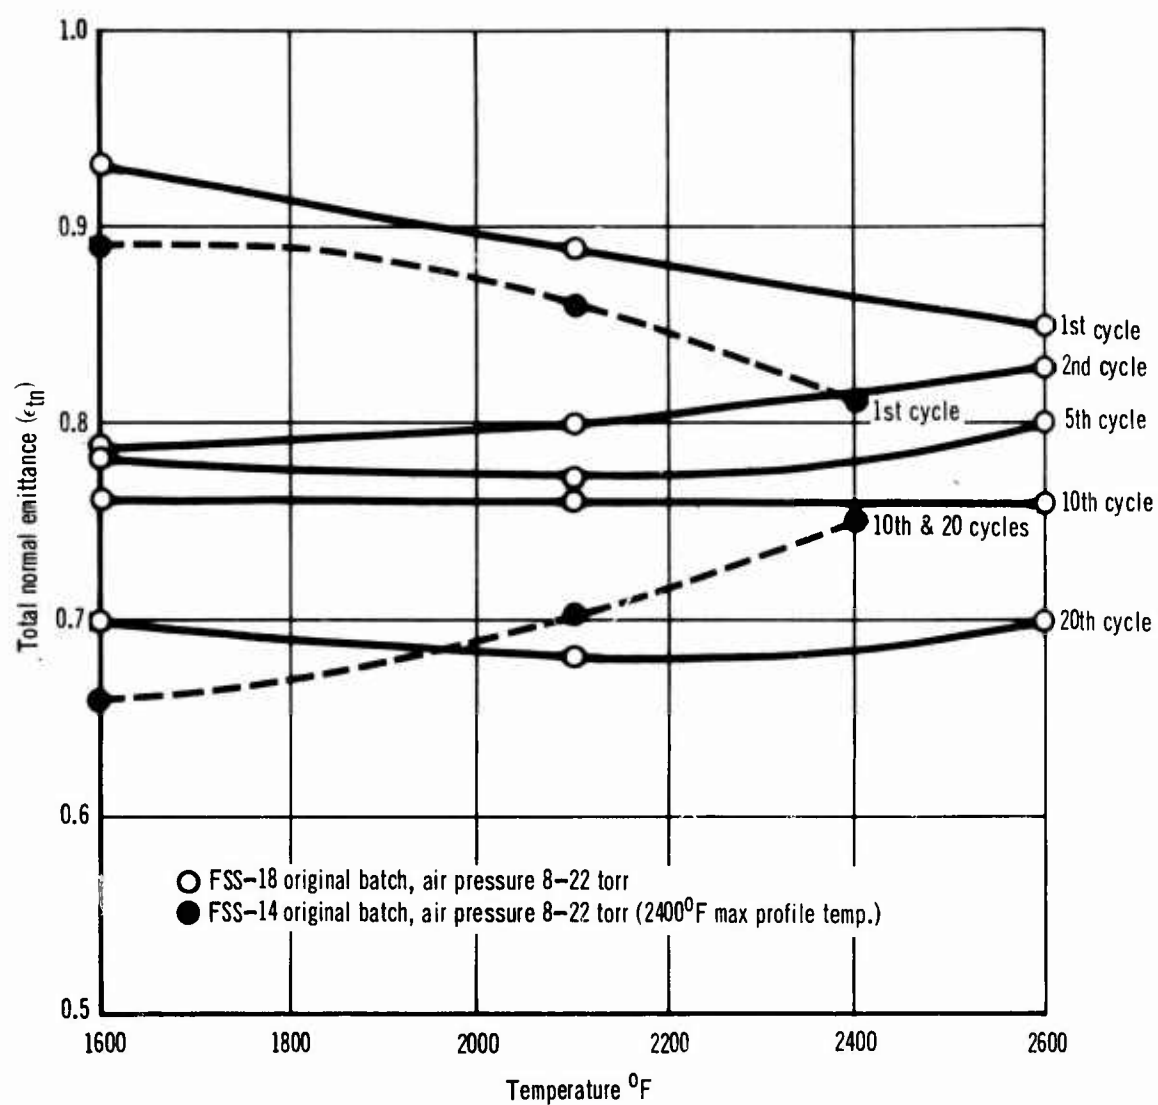
Figure 107 Emittance of R-512E Coated Columbium (Original Batch)  
Versus Temperature (2600 $^{\circ}\text{F}$  Max)

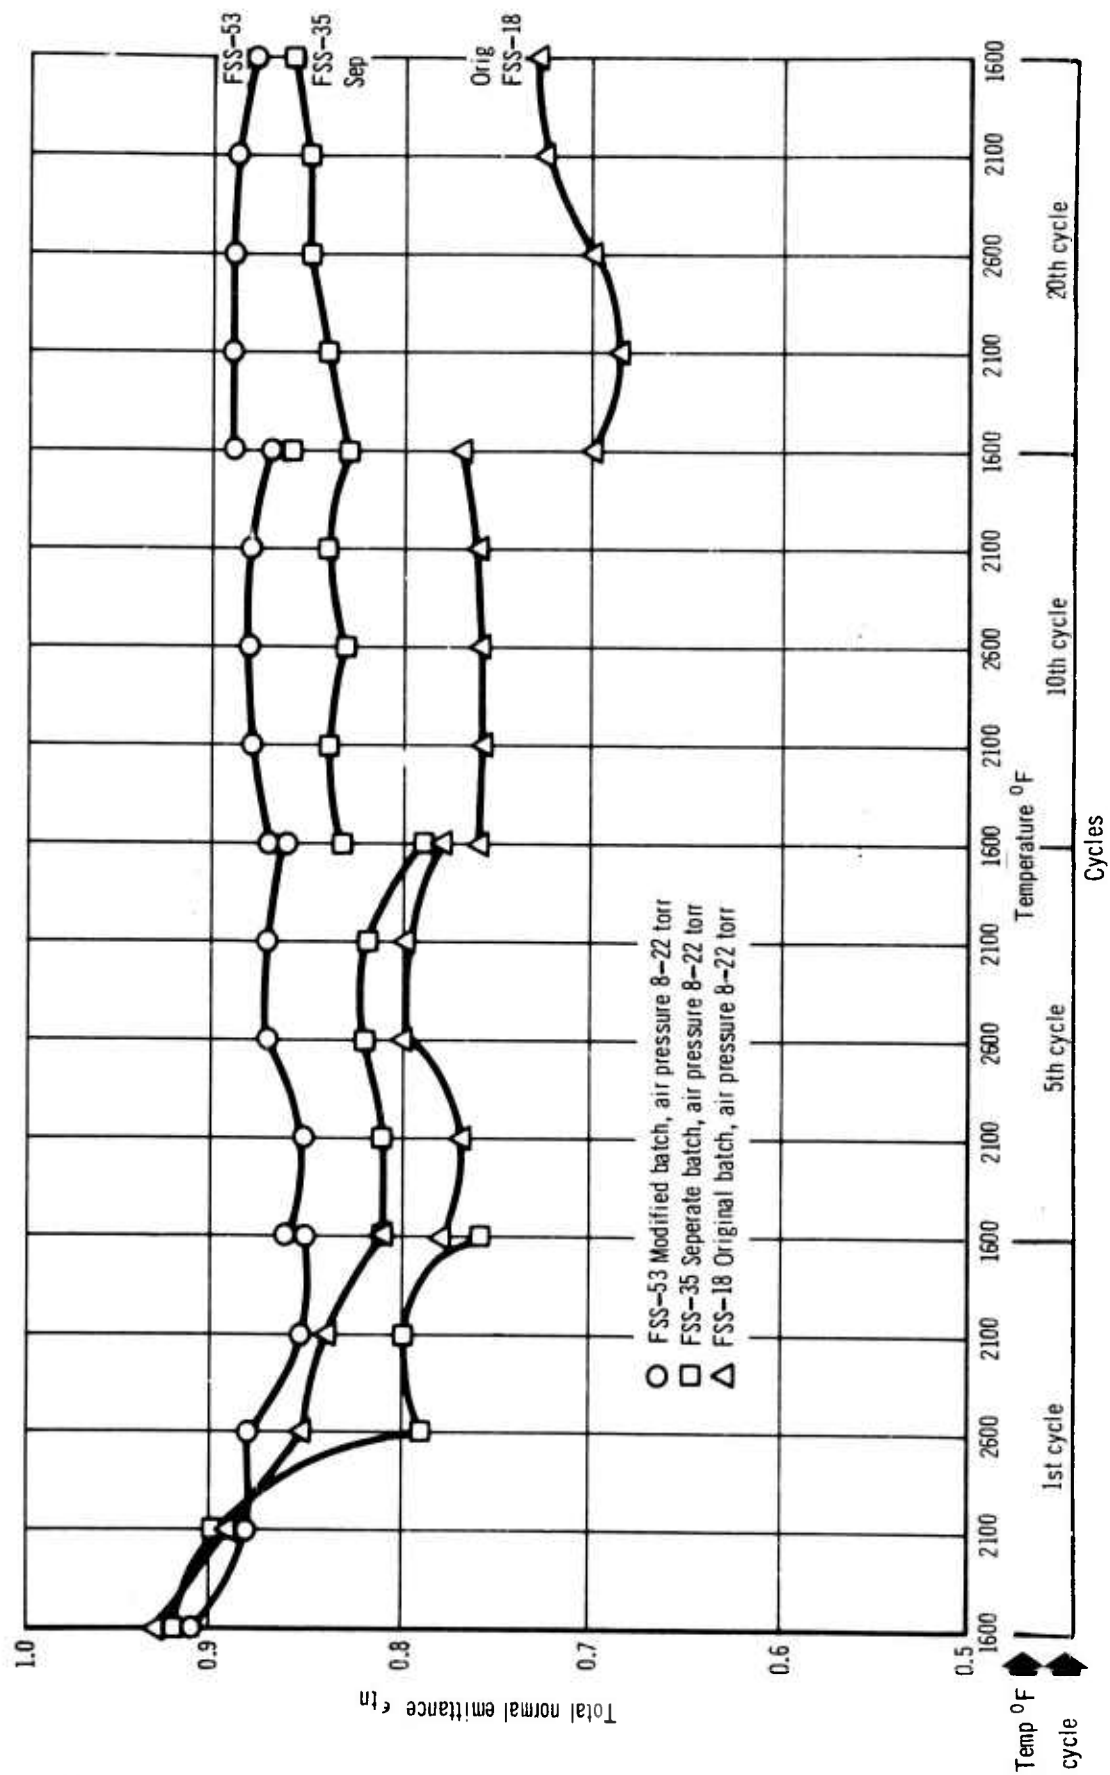
Figure 111 Emissance Of R-512E Coated Columium (Three Different Batches) Versus Temperature (2600 $^{\circ}\text{F}$  Max.) And Cycles

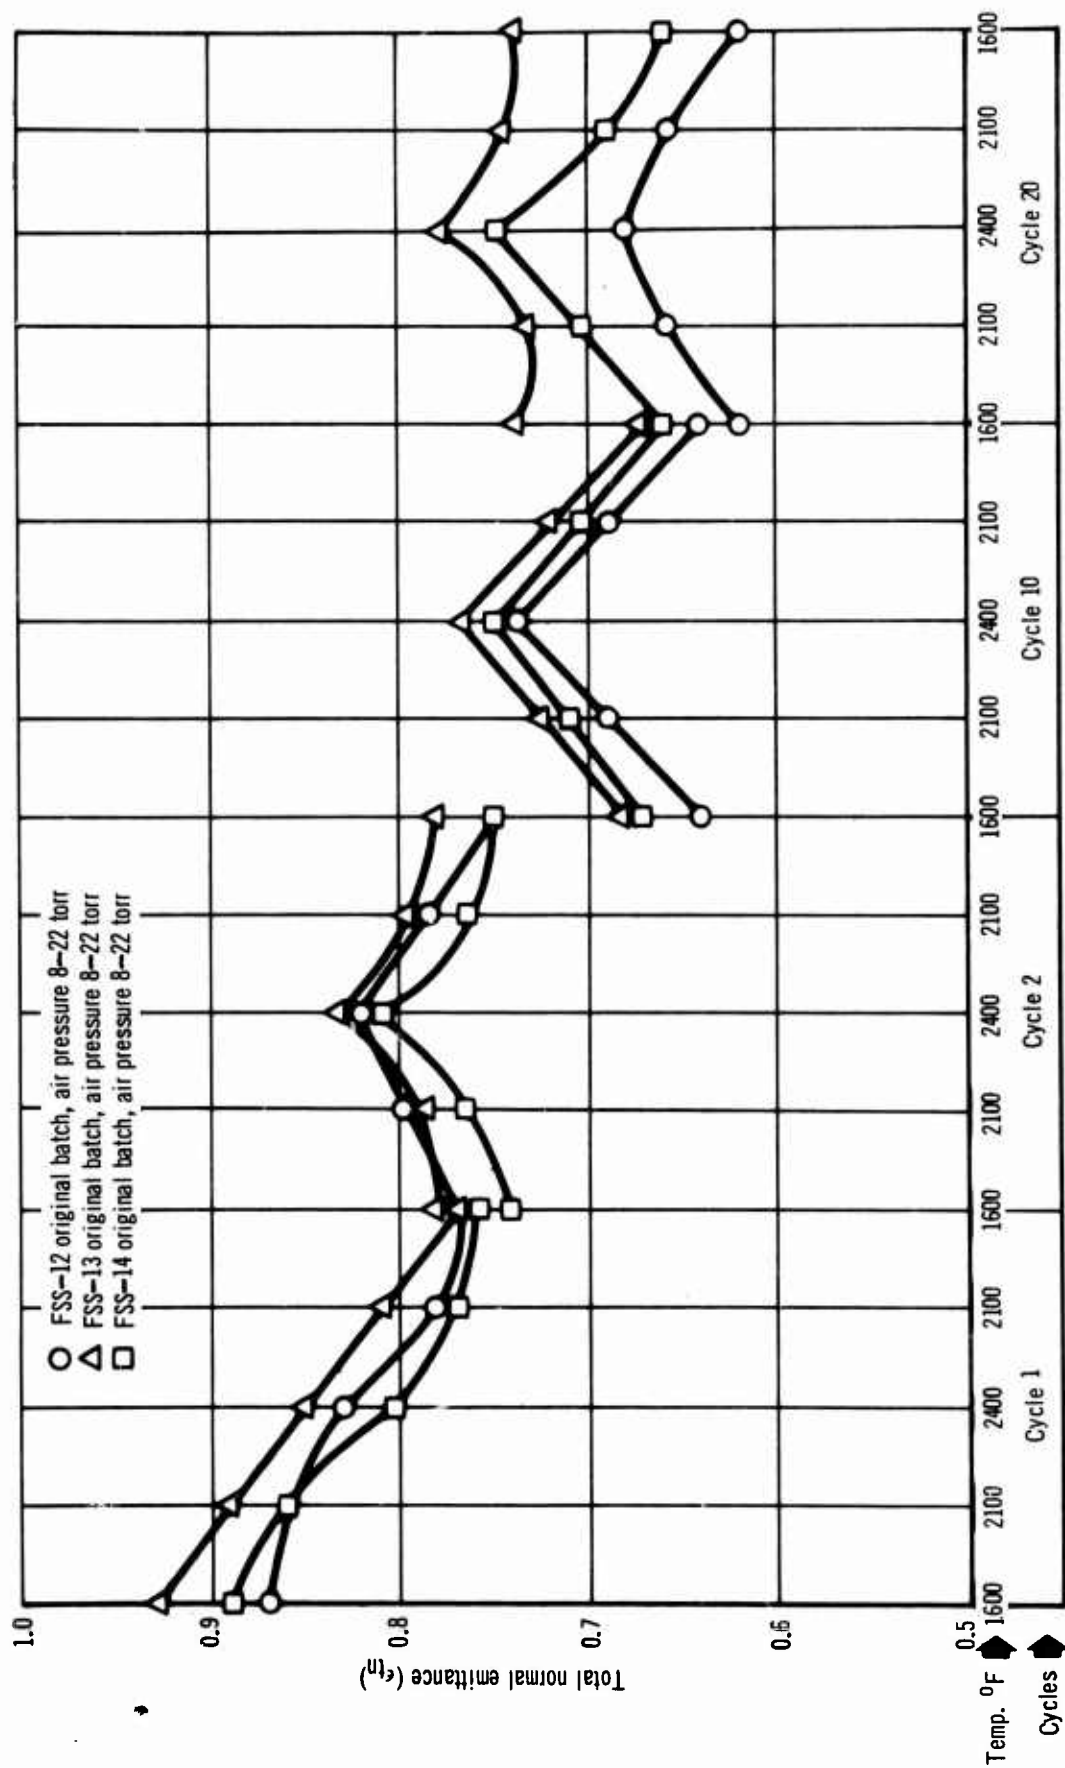
Figure 118 Emittance Of R-512E Coated Columium (Original Batch) Versus Temperature (2400°F Max) & Cycles
