TECHNICAL REPORT M-70-II

MOBILITY EXERCISE A (MEXA) FIELD TEST PROGRAM

PERFORMANCE OF MEXA AND THREE MILITARY VEHICLES IN SOFT SOIL

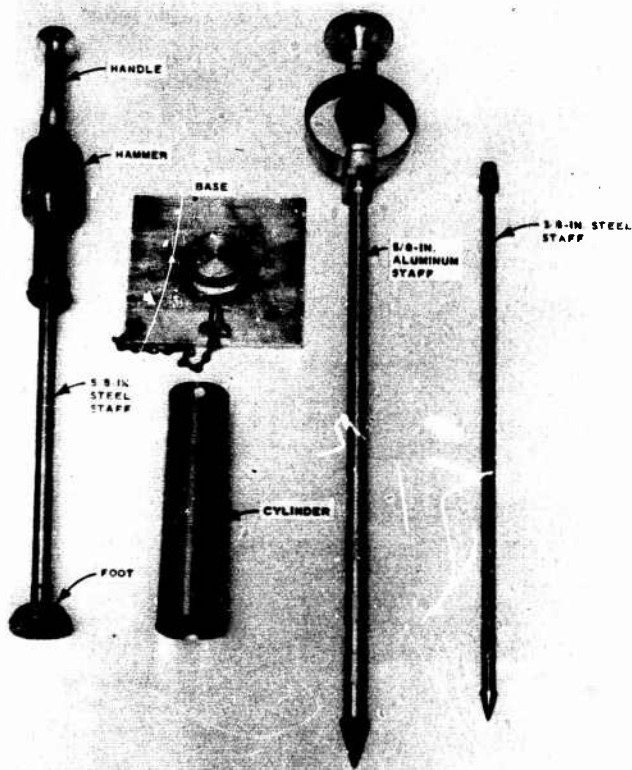
Fig. 2. Remolding equipment

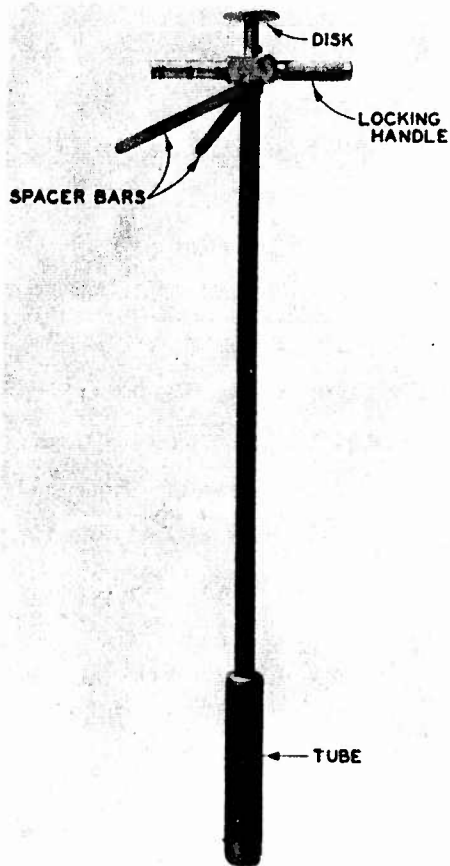
Fig. 3. Trafficability sampler

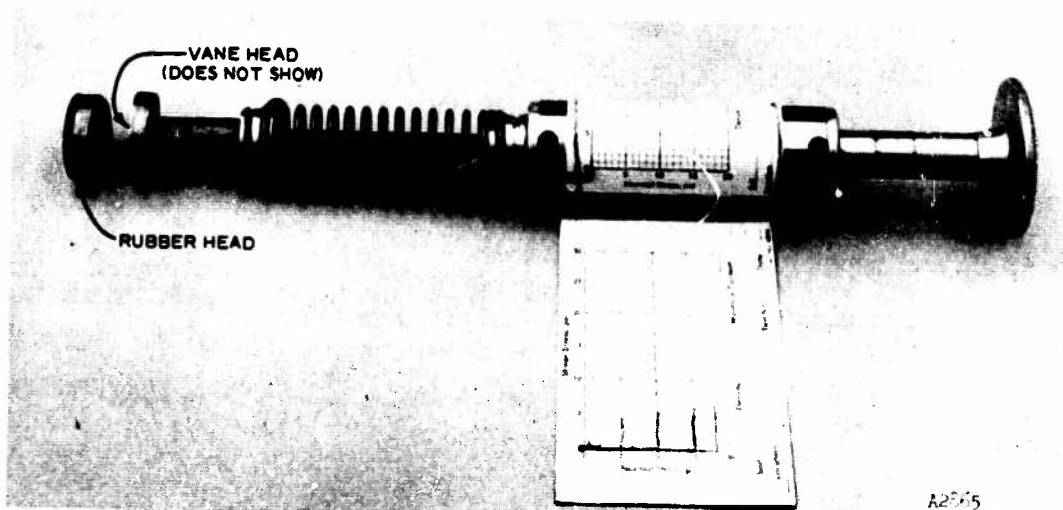
Fig. 4. Cohron sheargraph

Shear stress. The greatest shear stress recorded when torque is applied to the sheargraph head during initial soil failure for a particular normal stress maintained on the sheargraph handle. (The sheargraph, shown in fig. 4, is a hand-operated instrument utilizing a coiled spring for measuring torque and load.)

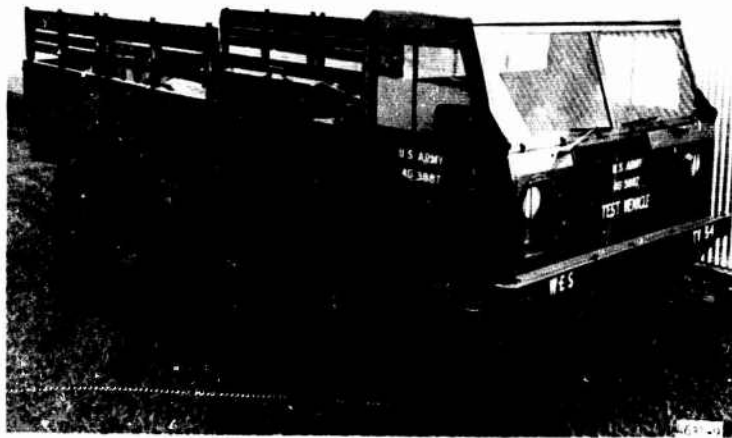
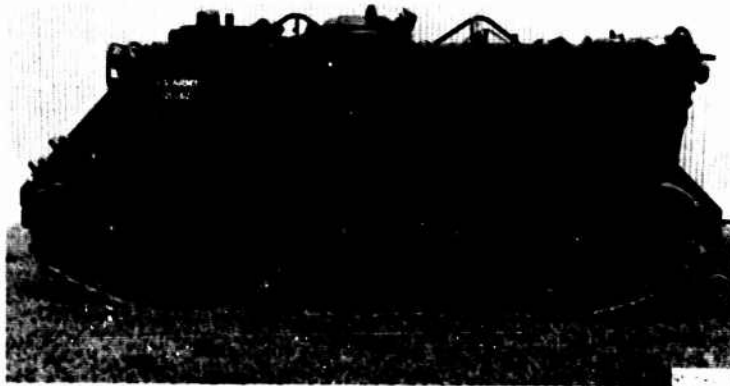
a. XM410E1

b. M35A2 (mod)

c. M113

Fig. 5. Military vehicles used in test program

7. The wheeled military vehicles tested were the XM410E1 and the M35A2 (mod) and the tracked vehicle was the M113 (see fig. 5). The MEXA

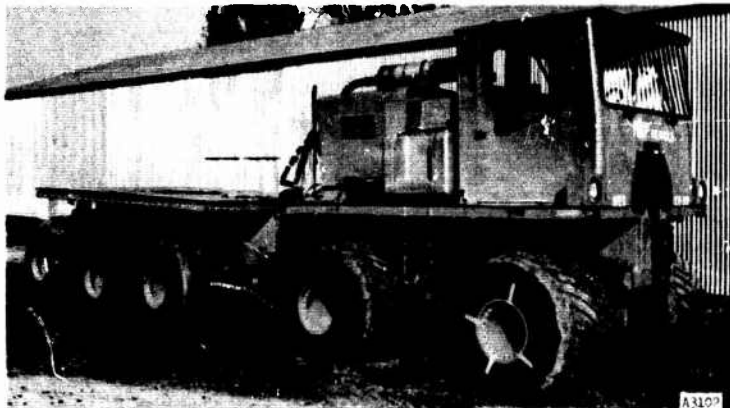
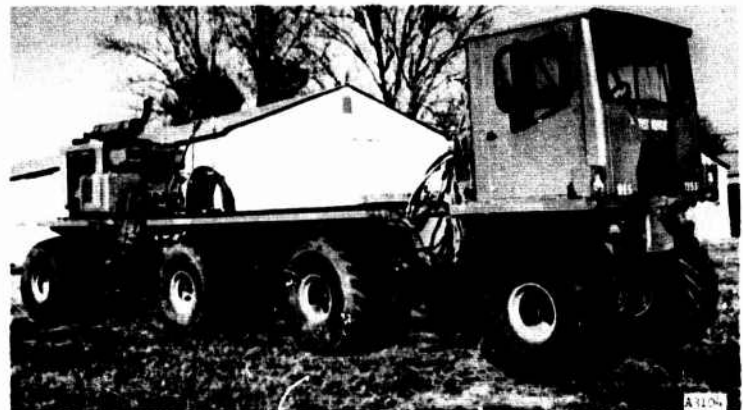
a. MEXA 10x10

b. MEXA 8x8

c. MEXA track

Fig. 6. MEXA vehicles used in test program

vehicles tested were the MEXA 10x10 and MEXA 8x8 (both wheeled) and the MEXA track (see fig. 6). The modifications to the M35A2 consisted of changing the tires to 11:00x20 NDCC and changing from dual rear wheels to single rear wheels. Pertinent data for the six vehicles are given in

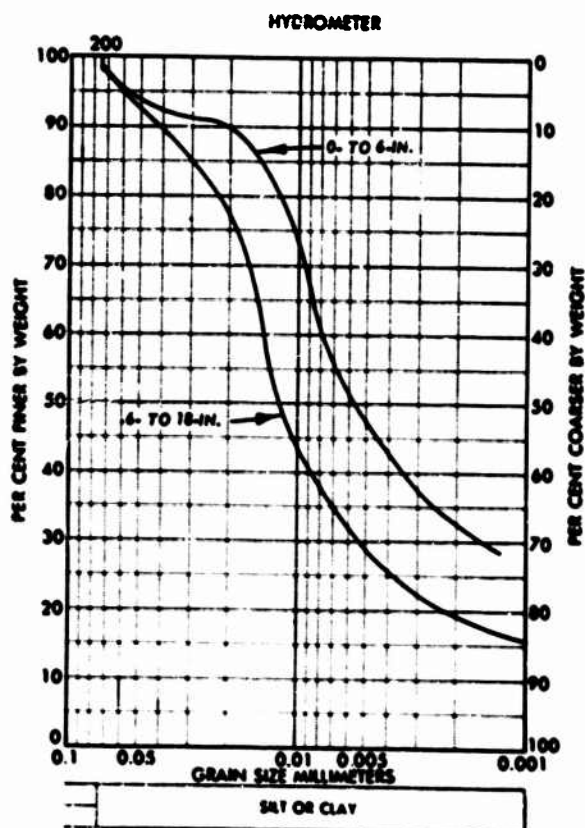
Fig. 9. Soil gradation curves and classification data, WES Reservation test site

SEV OR DEPTH	CLASSIFICATION	U	R	P
6- TO 6-IN.	CH	66	26	40
6- TO 18-IN.	CL	49	23	26

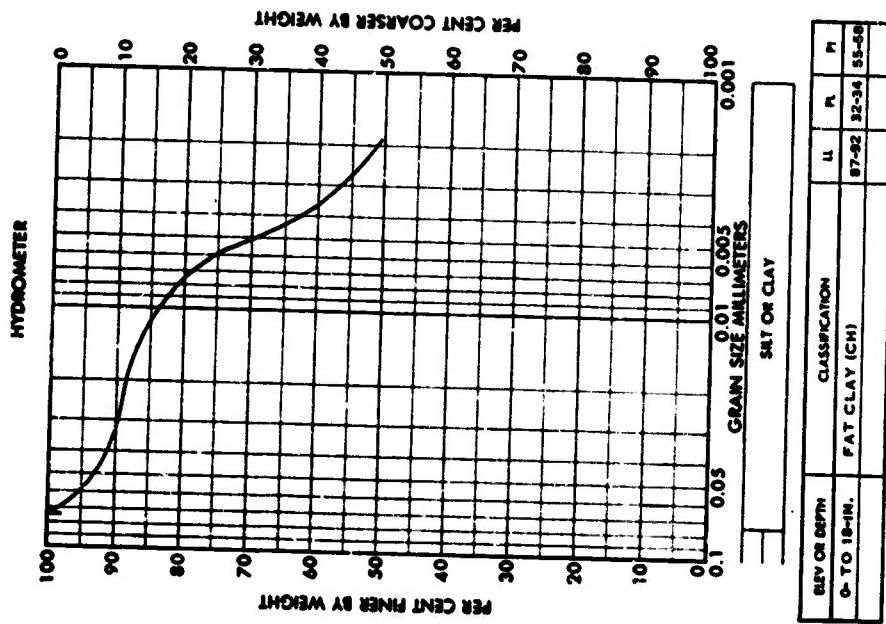
Fig. 12. Soil gradation curve and classification data, Chotard Lake test site

(fig. 10). The water level of the lake rises and falls with that of the Mississippi River, which feeds the lake. At the time of testing the river was low, and a flat expanse of lakeshore was exposed and accessible. The shoreline for a distance of about 400 ft from the lake was practically devoid of vegetation. Inland from this open area was an area that extended for about 300 yd on which willow trees with trunk diameters ranging from 6 to 10 in. were growing. Views of the site are shown in fig. 11. Tests were conducted in both the open and wooded areas. The soil to a depth of 18 in. was classified as fat clay (CH), according to the USCS (fig. 12).

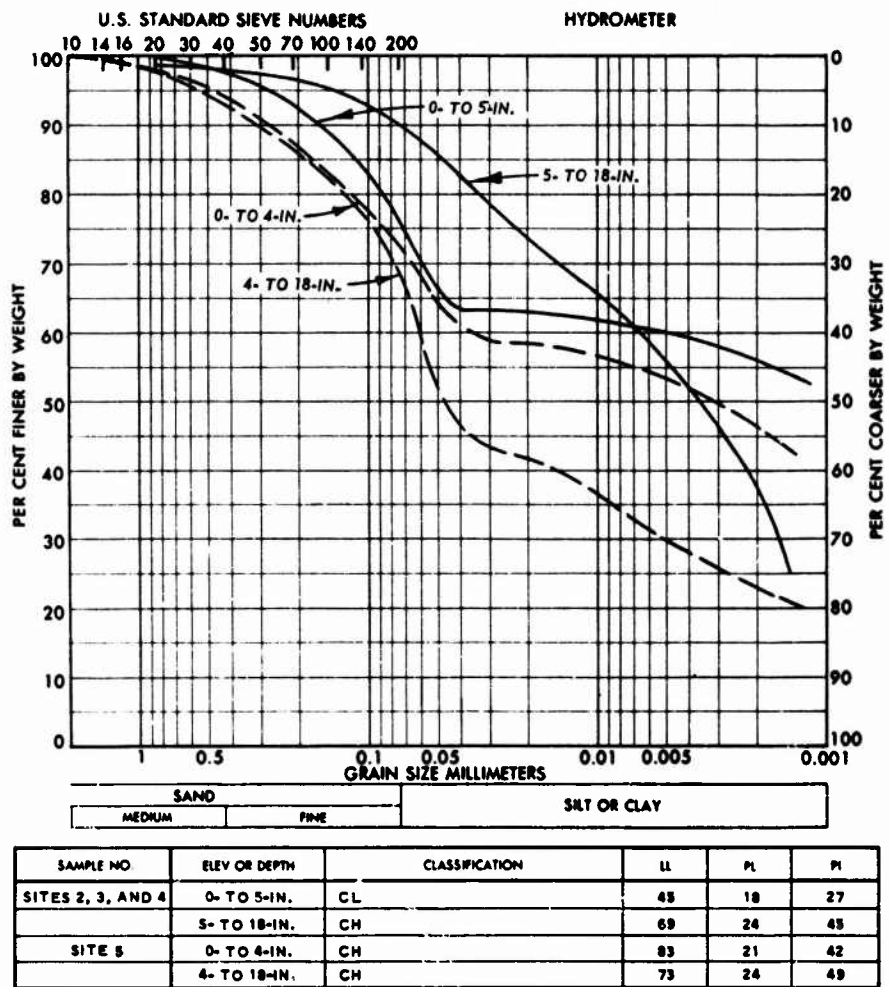
Fig. 15. Soil gradation curves and classification data, Carson Sink test sites

covering about 400 square miles. It is located about 20 miles northeast of Fallon (see fig. 13). Carson Sink serves from time to time as a sump for water diverted from the Carson River to relieve flooding of adjacent farmlands and of nearby Fallon National Wildlife Refuge. At the time of testing, most of the ground at Carson Sink was firm and free of surface water. After a thorough investigation of the playa, four sites (see fig. 14), each having a different soil strength, were established and tested. The soil of sites 2, 3, and 4 classified as lean clay (CL) in the 0- to 5-in. layer and as fat clay (CH) in the 5- to 18-in. layer. The soil of site 5 classified as a fat clay (CH) in the 0- to 18-in. layer. (Classifications were in accordance with the USCS.) Soil gradation curves representative of the test sites at Carson Sink are shown in fig. 15.

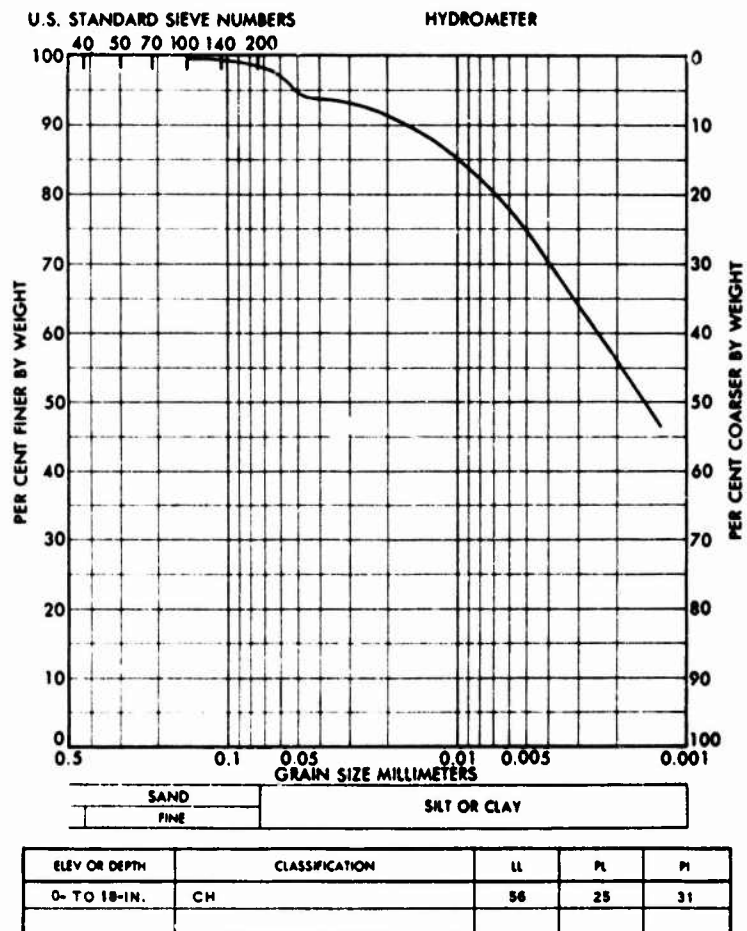
Fig. 18. Soil gradation curve and classification data, Four Mile Flat site 6

and 8), each of different soil strength, were established in the eastern half of the playa. At the time of testing, the sites were generally flat, soft, and free of surface water. The soil classified as a fat clay (CH) in the 0- to 18-in. layer. There was a hardpan composed of sand and salt at a depth of 26 to 30 in. that was too firm to penetrate with a hand probe. Views of the sites are shown in fig. 17. A soil gradation curve that is representative of the sites is shown in fig. 18.

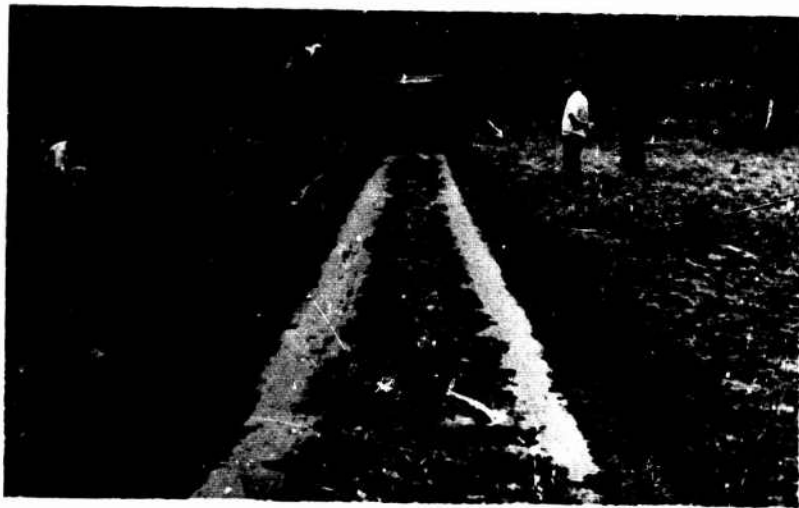
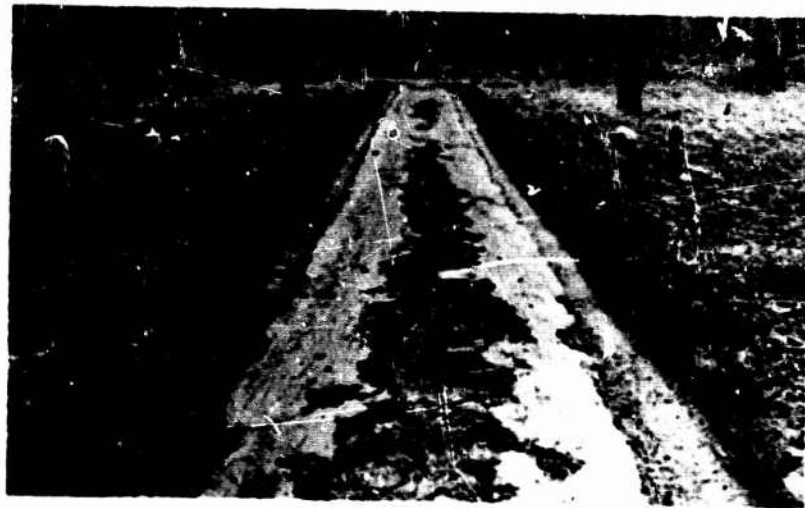
a. After 1 pass

b. After 35 passes

c. After 50 passes

Fig. 19. VCI test in progress at Chotard Lake, XM410E] (item 4)

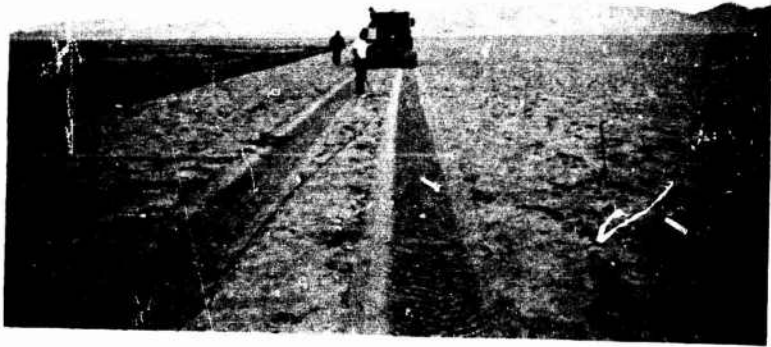
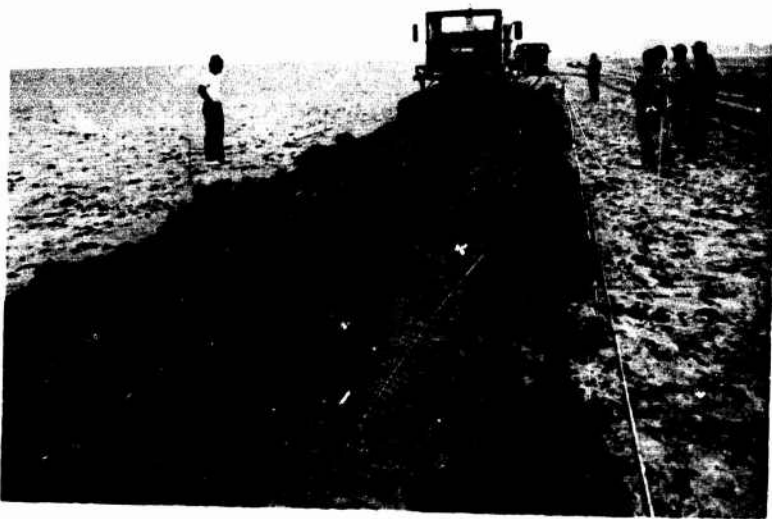
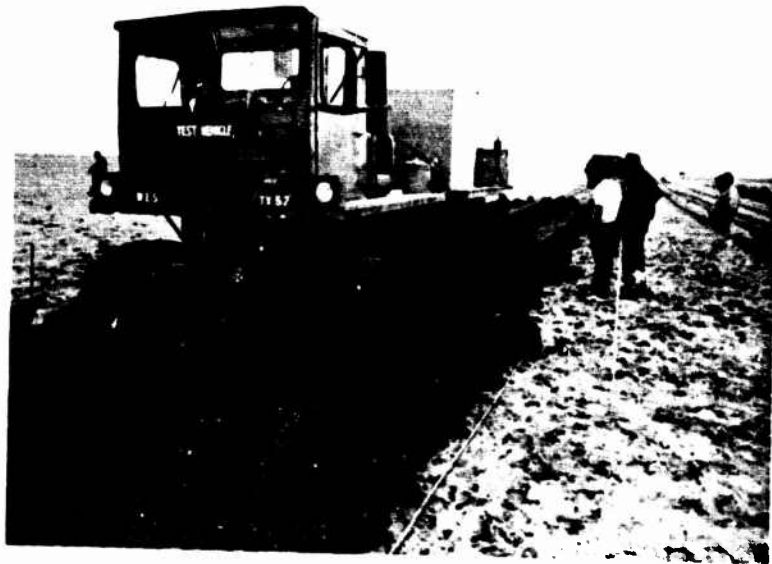
a. After 1 pass

b. After 44th pass

c. After 54th pass

Fig. 20. VCI test in progress at Carson Sink site 3, MEXA 10x10 (item 54)

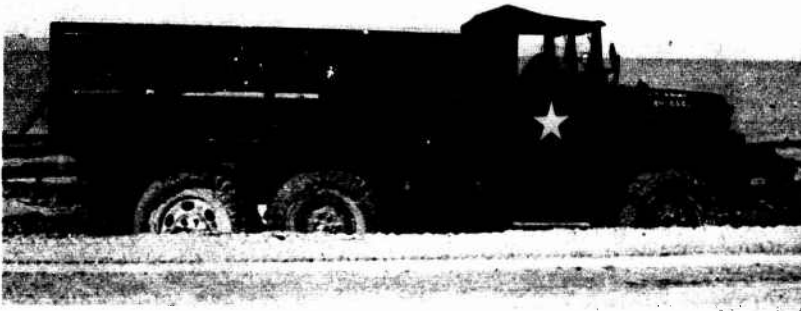
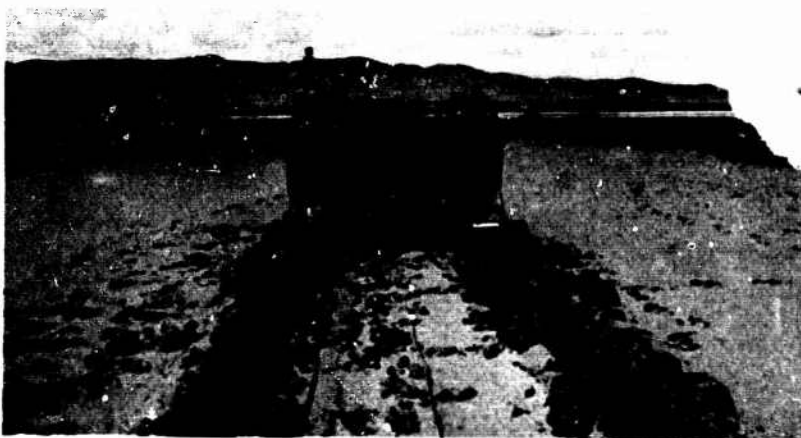
a. XM41OE1 was immobilized on 7th pass at Chotard Lake (item 5)

b. M35A2 (mod) was immobilized on 2d pass at Carson Sink site 2 (item 19)

c. M113 was immobilized on 1st pass at Four Mile Flat site 6 (item 41)

Fig. 22. Typical VCI test immobilizations, military vehicles

43. For each test, the number of passes completed versus the RCI based on this tentative critical-layer criteria was plotted by vehicle in plate 2. (Hereafter the one-pass VCI based on the tentative critical-layer criteria is designated as VCI_{1t} .) The results are discussed in the following paragraphs. Figs. 22 and 23 show typical VCI test immobilizations.

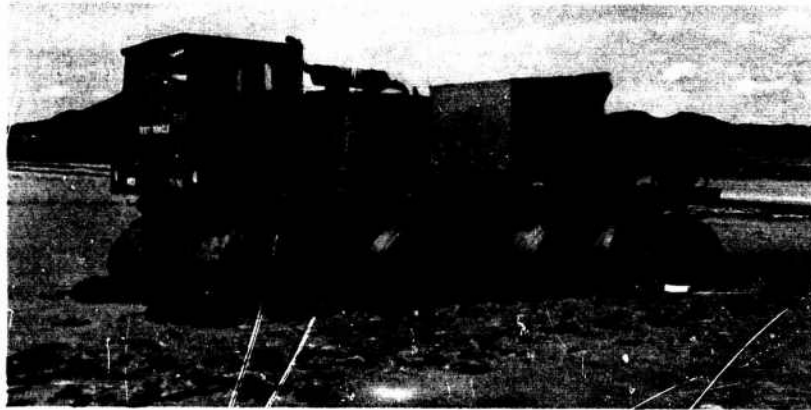
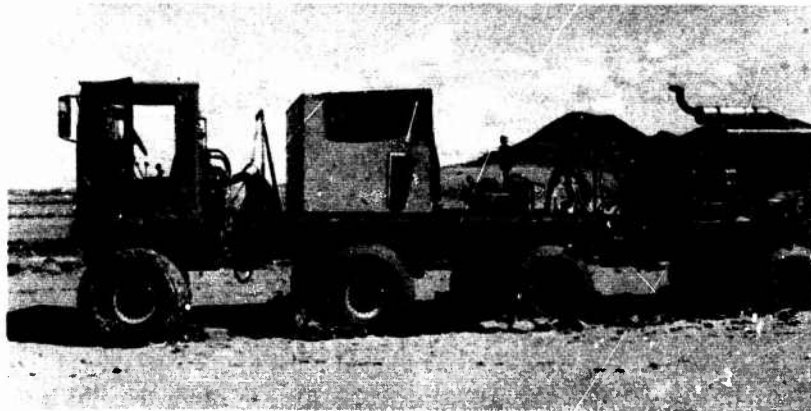
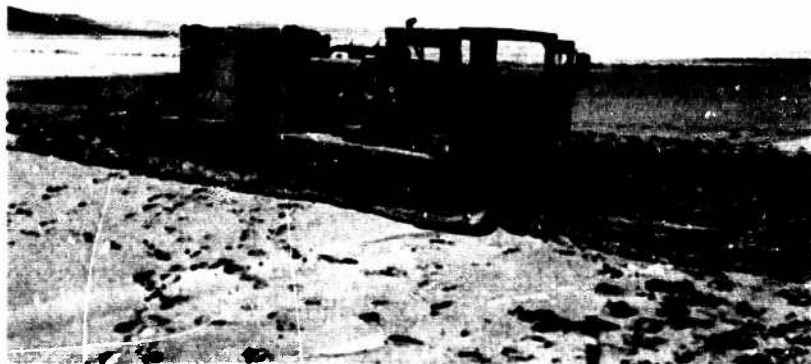
a. MEXA 10x10 was immobilized on 1st pass at Four Mile Flat site 7 (item 55)

b. MEXA 8x8 was immobilized on 1st pass at Four Mile Flat site 6 (item 72)

c. MEXA track was immobilized on 2d pass at Four Mile Flat site 8 (item 85)

Fig. 23. Typical VCI test immobilizations, MEXA vehicles

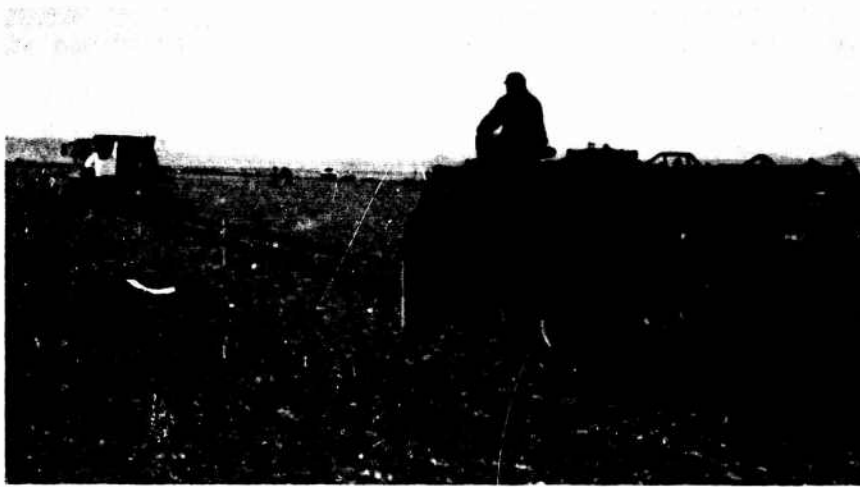
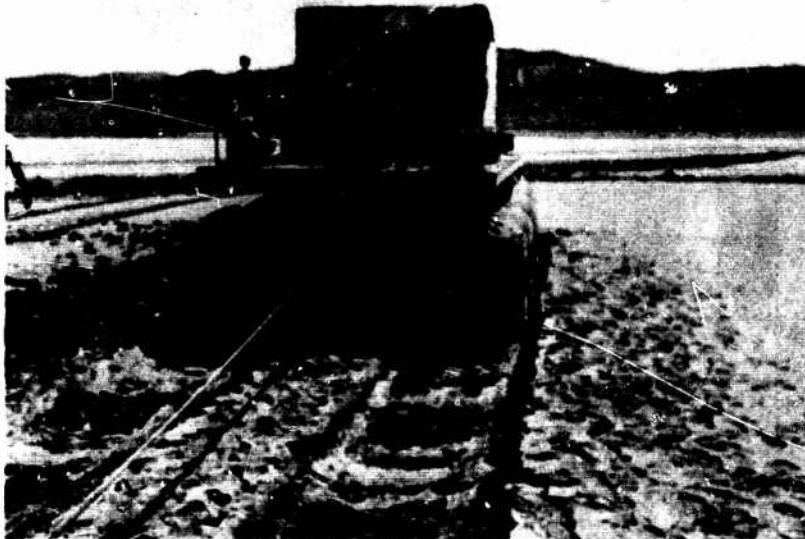
a. Carson Sink site 3, MEXA track (item 137)

b. Four Mile Flat site 6, MEXA 10x10 (item 119)

Fig. 24. MEXA track and 10x10 in position prior to start of drawbar pull tests

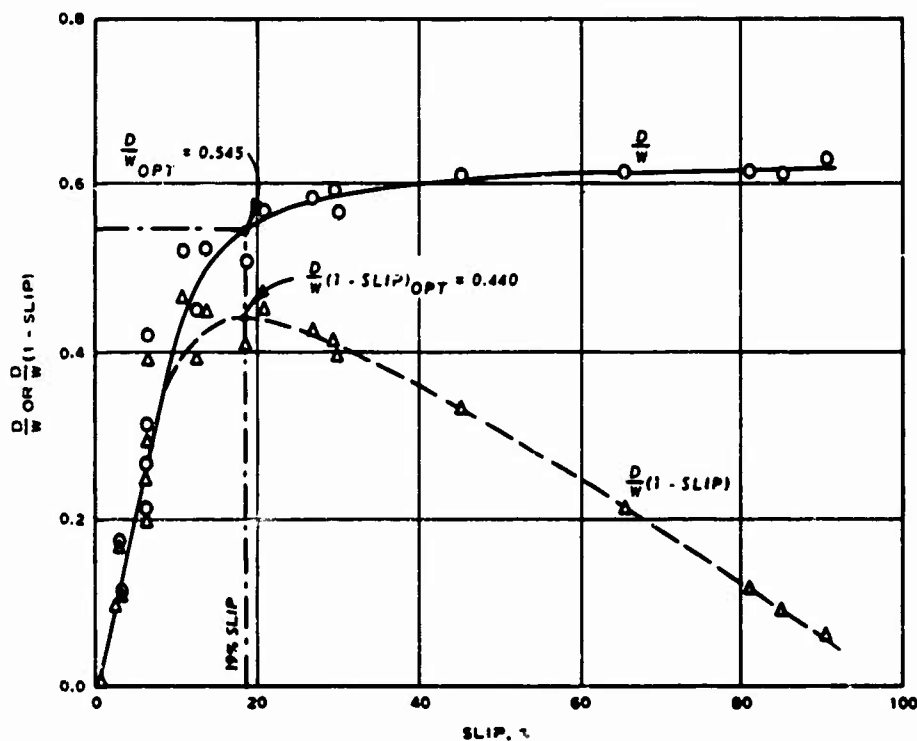
Fig. 25. Drawbar pull versus slip, MEXA 8x8 (item 126)

55. Drawbar pull in terms of drawbar pull coefficient D/W versus wheel or track slip for each test was plotted and curves of best visual fit were drawn through the data points. An example of these plots is shown in fig. 25; D/W is represented by the solid line.

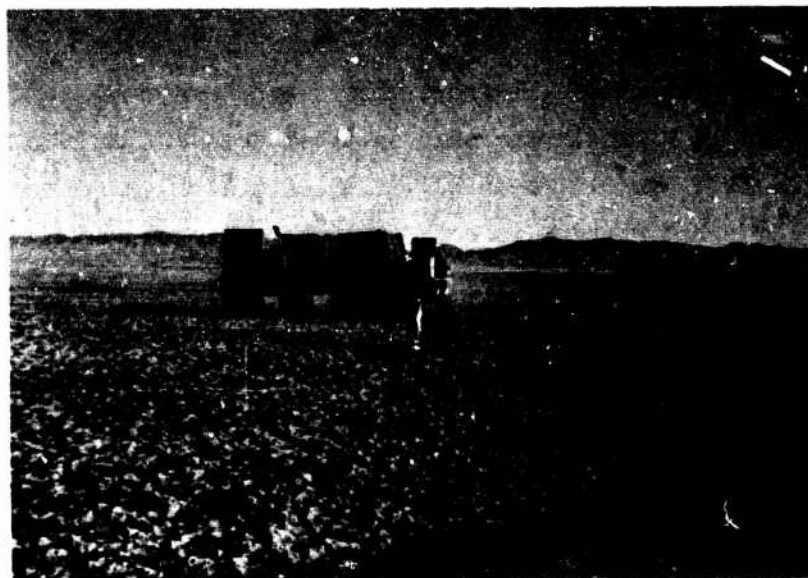
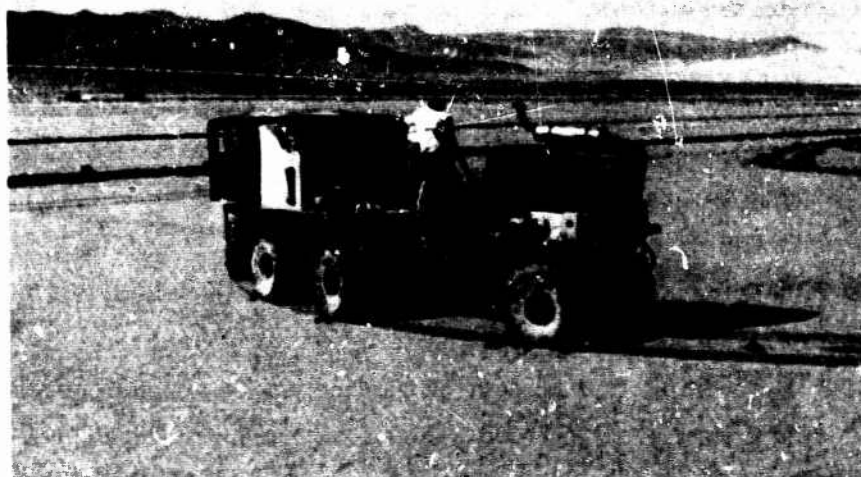
a. MEXA 10x10 after completing a left turn at Carson Sink site 4 (item 240)

b. MEXA 8x8 after completing a right turn at Four Mile Flat site 6 (item 271)

Fig. 26. Typical maneuver tests in progress

the following paragraphs. Typical maneuver tests in progress are shown in fig. 26.

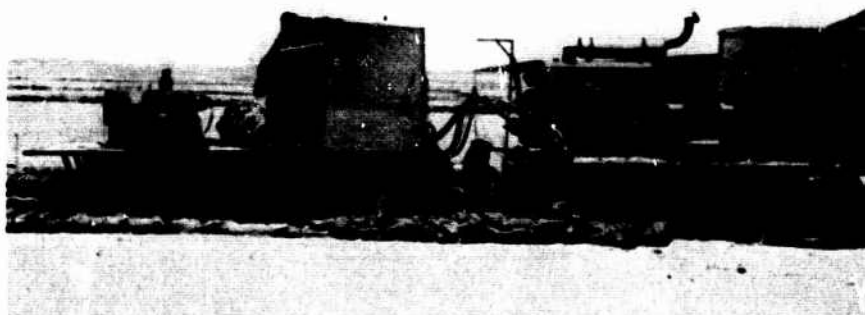
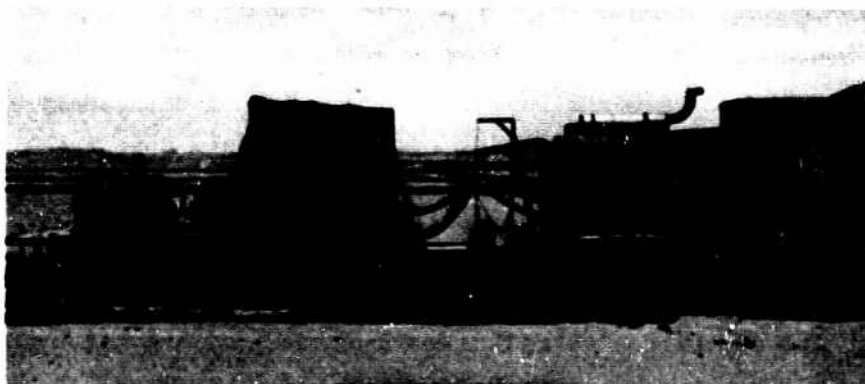
a. Vehicle immobilized, inching cylinder partially extended

b. Vehicle immobilized, inching cylinder fully extended

Fig. 27. MEXA track at Four Mile Flat site 8 (item 85)

100. The inching system (fig. 27) was designed so that, in theory, a vehicle could utilize inching to extricate itself from an immobilization in the following manner. With a vehicle composed of units A and B at the minimum length position (contracted), the operator can brake unit B and apply power to unit A and at the same time activate the inching cylinder located

101. The inching system was used on 14 immobilization tests. Fig. 27 shows the MEXA track during one test. The inching system was helpful in extricating the vehicle in only one test (item 62, with the MEXA 8x8). In 12 tests, either both units moved away from each other, although one unit's brakes were locked, or one unit remained stable whether it was supposed to or not, forcing the other unit to move to and from the first unit. The general observation made by test personnel was that once a MEXA vehicle became immobilized due to a soft soil condition, the more the inching system was used, the more deeply embedded the vehicle became.
