MANUFACTURING METHODS FOR  
SURFACE INTEGRITY OF MACHINED STRUCTURAL COMPONENTS

William P. Koster  
et al  
Metcut Research Associates Inc.

TECHNICAL REPORT AFML-TR-71-258  
April 1972

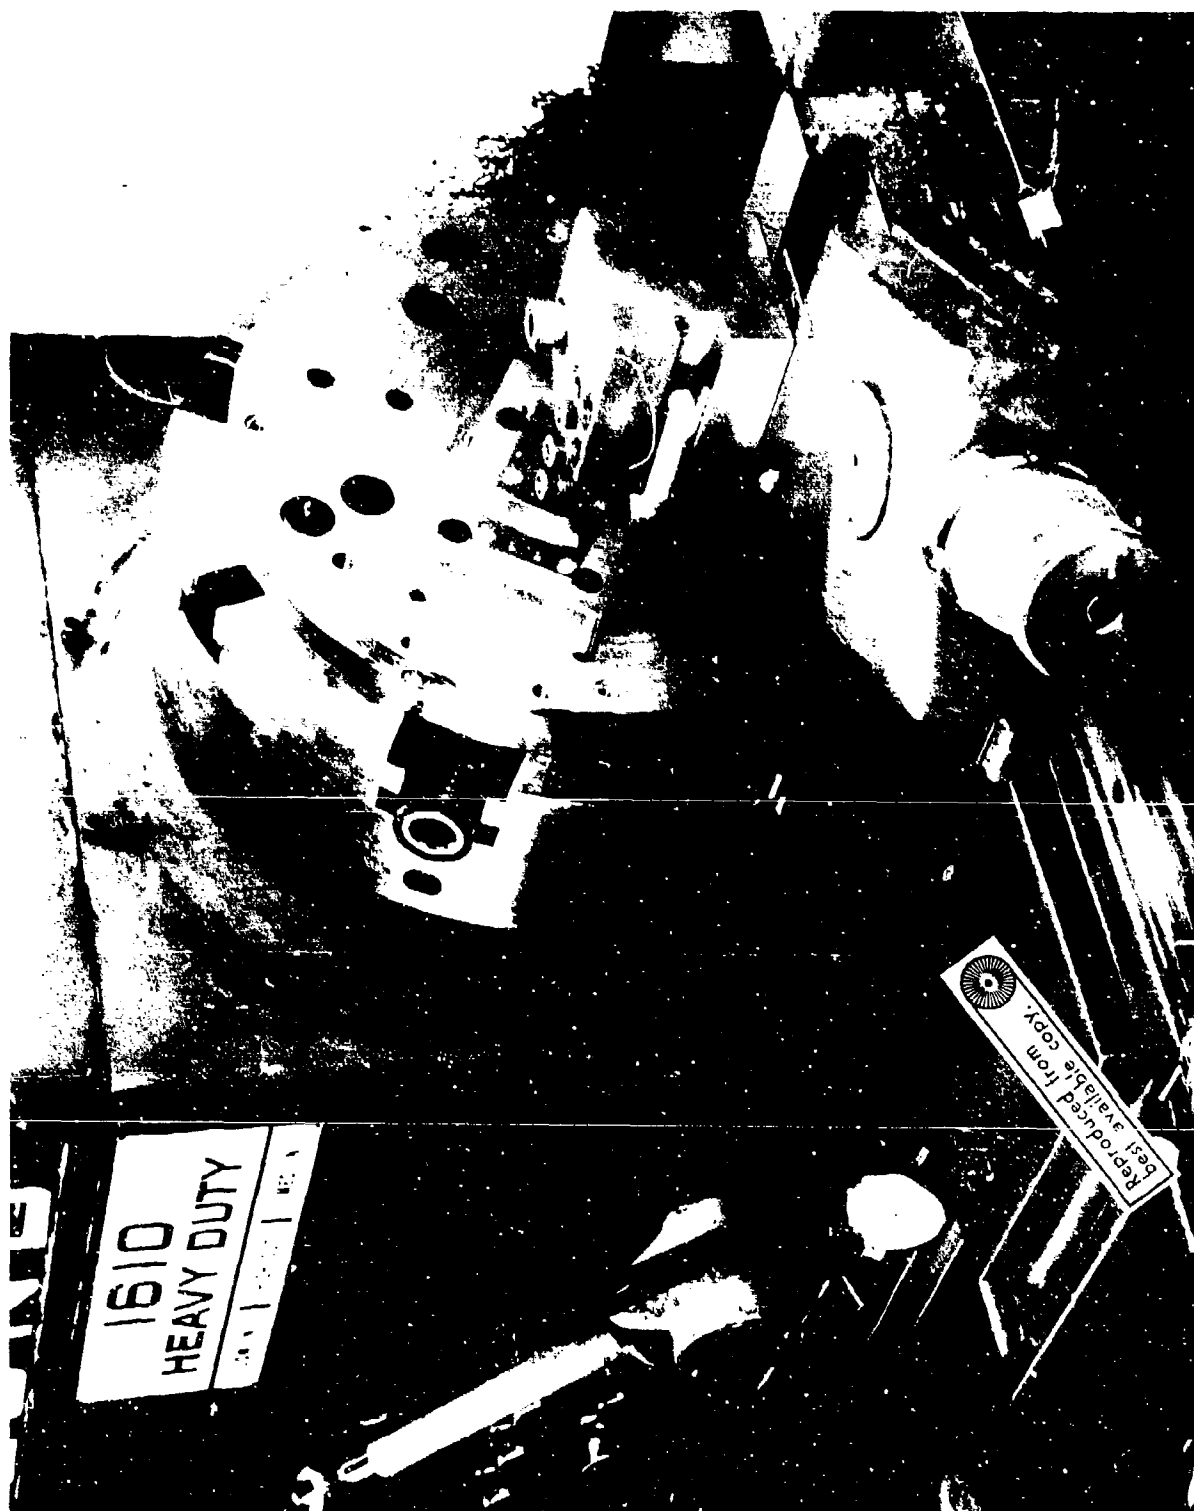
Figure D  
SETUP USED FOR TURNING (FACING) TEST CUTS
