AMMRC CTR 72-19

BRITTLE MATERIALS DESIGN, HIGH TEMPERATURE GAS TURBINE

Arthur F. McLean, Ford Motor Company, Dearborn, Michigan 48121  
Eugene A. Fisher, Ford Motor Company, Dearborn, Michigan 48121  
Raymond J. Bratton, Westinghouse Electric Corporation, Pittsburgh, Pennsylvania 15235

Interim Report, January 1, 1972 to June 30, 1972

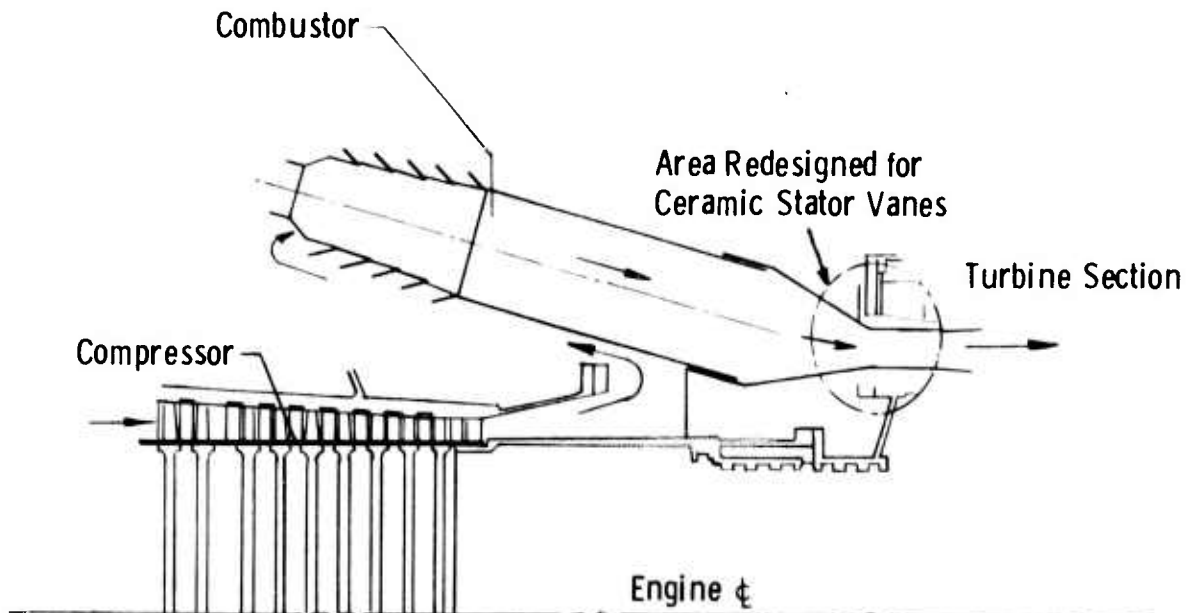
Figure 1.2 — 30 Mw Test Turbine Flow Path

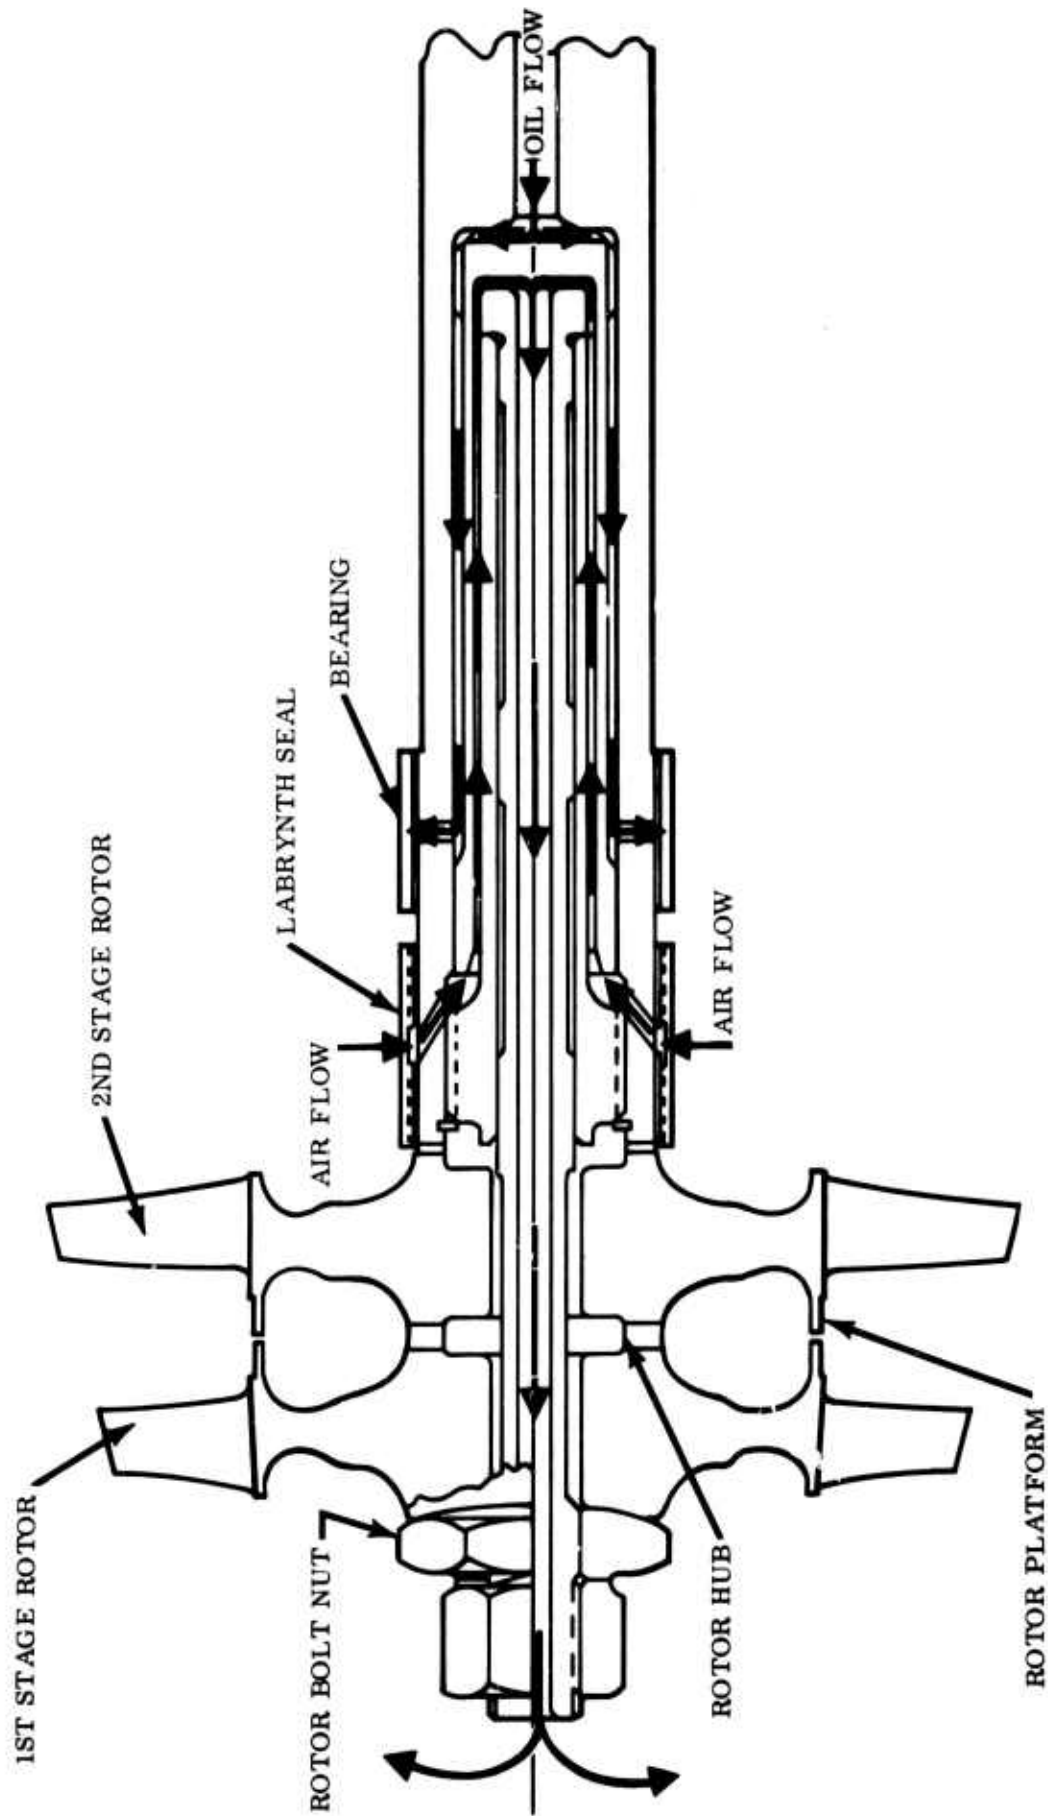
The FDHT program was used to study a rough model of the engine rotors and turbine shaft. The model, Figure 3.2 provided such information as rotor bolt cooling requirements and structure temperatures in the vicinity of the bearings and the turbine shaft. From this data rotor attachment assembly concepts were studied. Three possible concepts were discussed in the previous report(1). The concept chosen to be first analyzed was that of the hollow folded bolt. Based on the first approximation of temperature data available adjacent to the bolt from the FDHT model, bolt requirements were estimated and a bolt design was arrived at for analysis. The rotor bolt assembly to be analyzed is shown in Figure 3.3.

Figure 3.3 — Rotors and Attachment Assembly

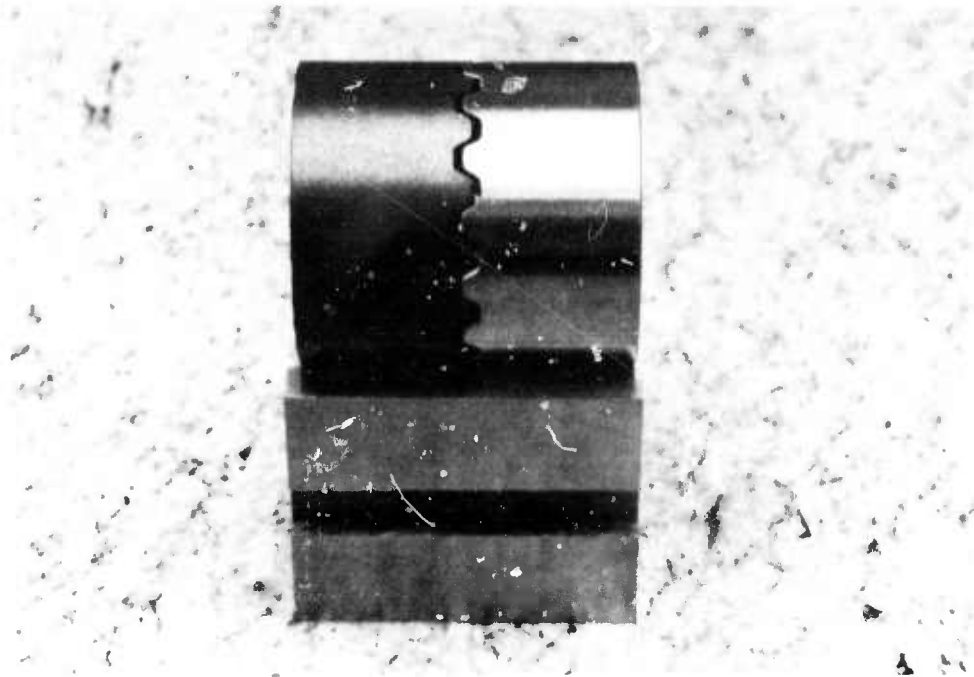
Figure 3.7 — Curvic Coupling Master Set

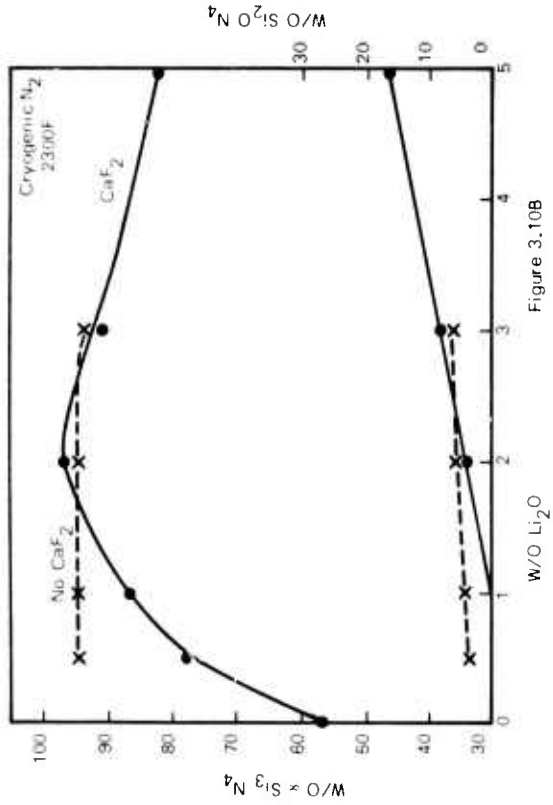
Figure 3.10A

The results as shown in Figures 3.10A, 3.10B and 3.10C are similar. The formation of  $\alpha$   $\text{Si}_3\text{N}_4$  increases with increasing  $\text{Li}_2\text{O}$  concentrations to a point where excess oxygen in the structure results in  $\text{Si}_2\text{ON}_2$  formation at the expense of  $\alpha$   $\text{Si}_3\text{N}_4$ . This is noted by the corresponding decrease in alpha silicon nitride and increase in silicon oxynitride. Lowering the nitriding temperature  $150^{\circ}\text{F}$  for the cryogenic nitrogen conditions (Figures 3.10A and 3.10B) had no significant effect on the formation of alpha silicon nitride or silicon oxynitride. The lithium content after nitriding was approximately 50 percent greater at the lower temperature ( $2300^{\circ}\text{F}$ ). This is desirable since lithium behaves as a sintering aid during hot pressing.

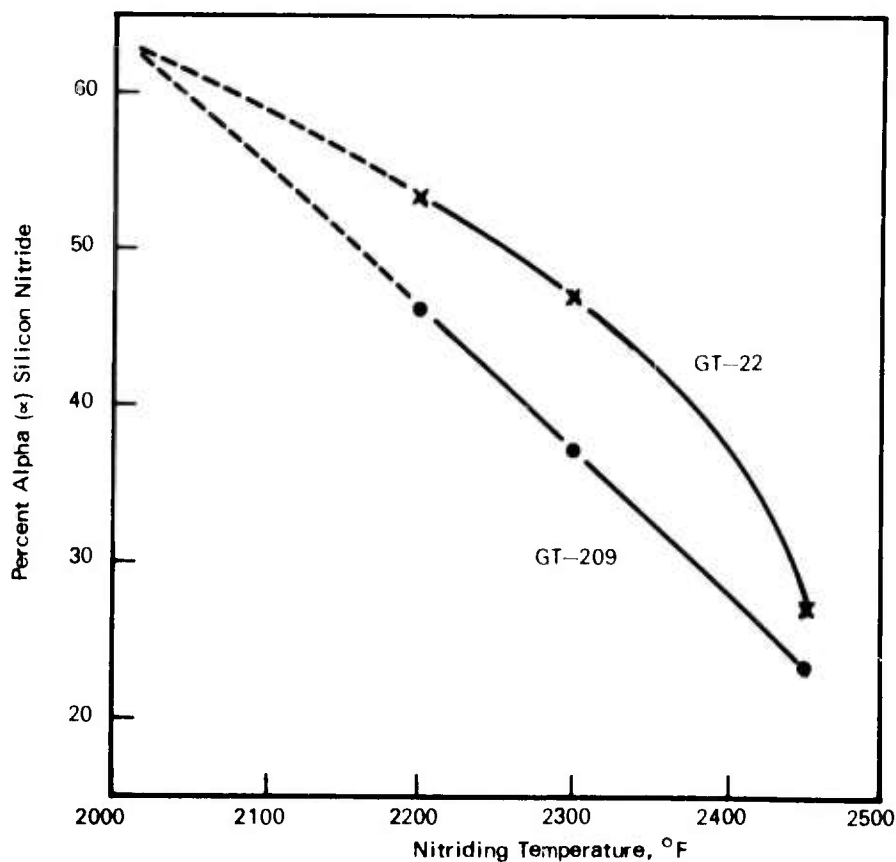
Figure 3.11 — Nitriding Results Using a Static Nitrogen Atmosphere

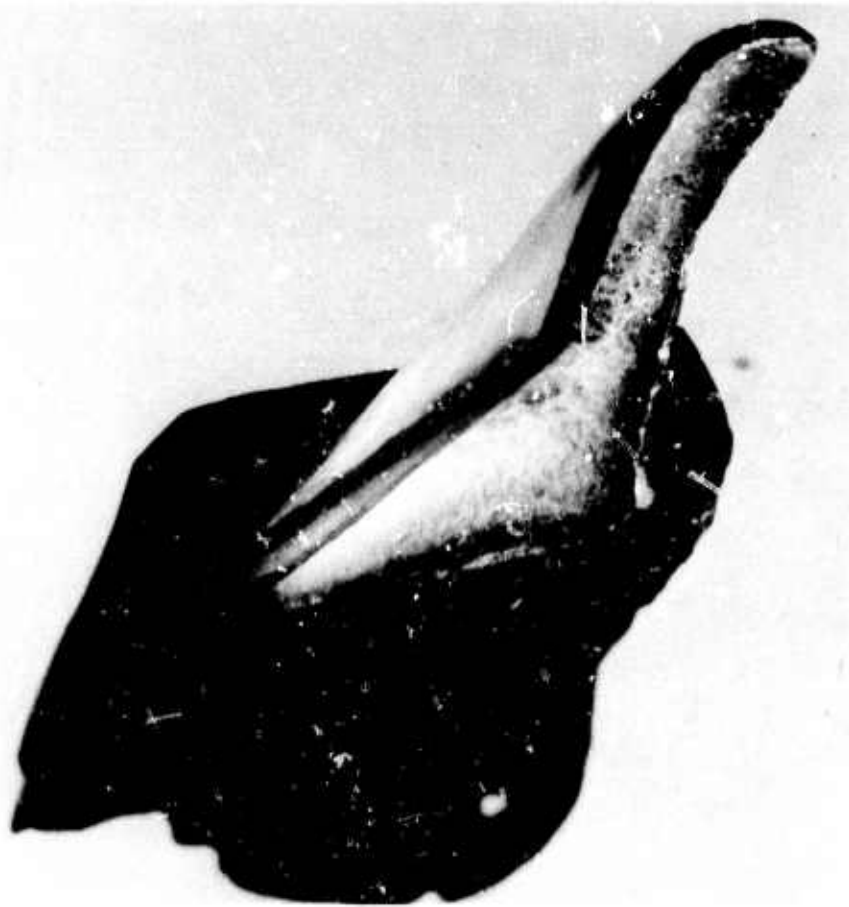
The second part of the two step process consists of forming the rotor hub by hot pressing fresh reactive powder against the assembled blade roots, bonding or "welding" all components into a monolithic rotor. Norton reports that a treatment of the surfaces to be welded is necessary. This treatment, requiring a finite thickness, must be on each side of the root, or tang, of each of the 36 blades.

Figure 3.15 — Hot Pressed Silicon Nitride Turbine Blade

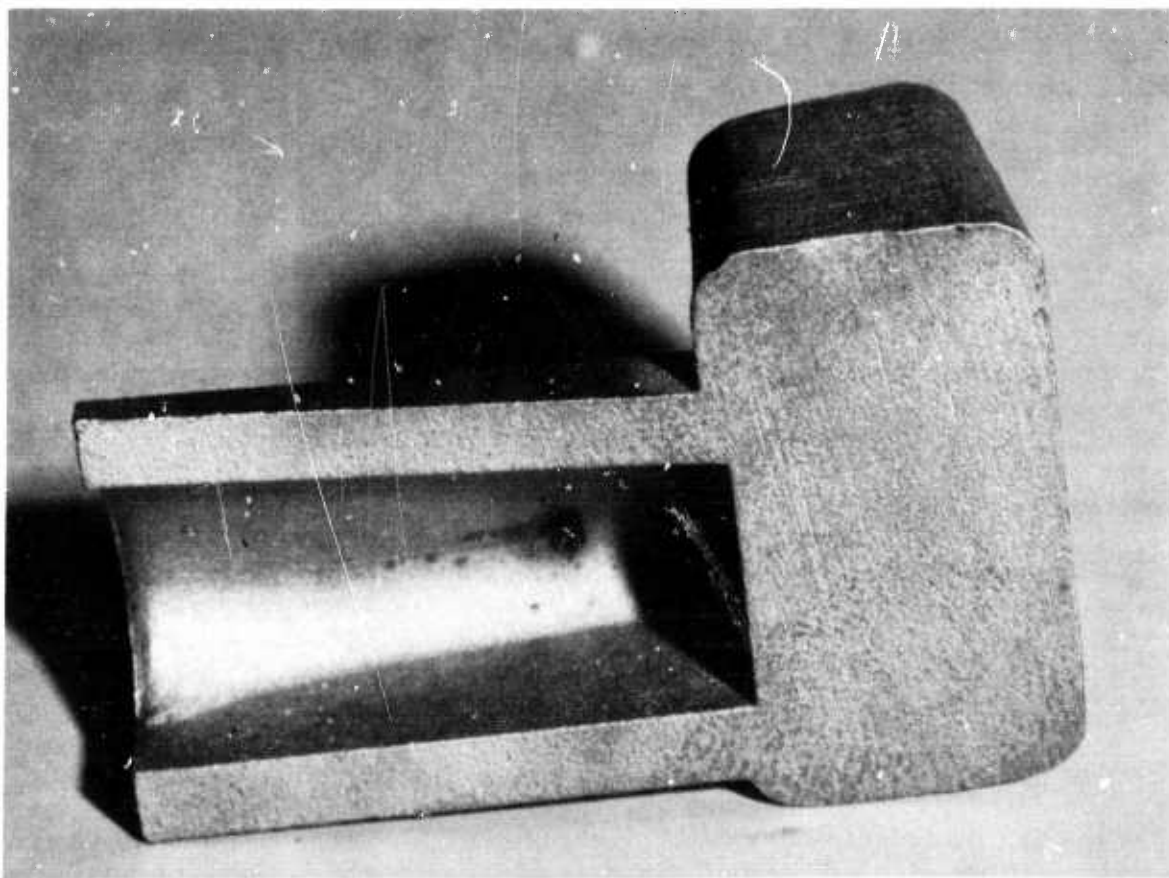
Tool wear is of concern in ultrasonic machining as it is in most machining operations. The tool must be soft and resilient in order to withstand the continual impact of the abrasive particles. For preliminary ultrasonic machining of hot pressed silicon nitride, beryllium copper was selected for the rotor blade contouring. This material showed good resistance to wear and is readily cast in the intricate rotor blade configuration. Such a tool is shown in Figure 3.23. The tools were investment cast using the lost wax technique. The blade contour dies were fabricated by duplicating the airfoil surface of an existing metal turbine rotor using a Kellering machine and hand finishing. One die was fabricated for each side of the rotor blade. Twenty-five of each of the pressure side and suction side tools were cast of beryllium-copper. Low carbon steel was selected for initial work on the disk contouring portion of the program.

Figure 3.23 — Ultrasonic Machining Tool

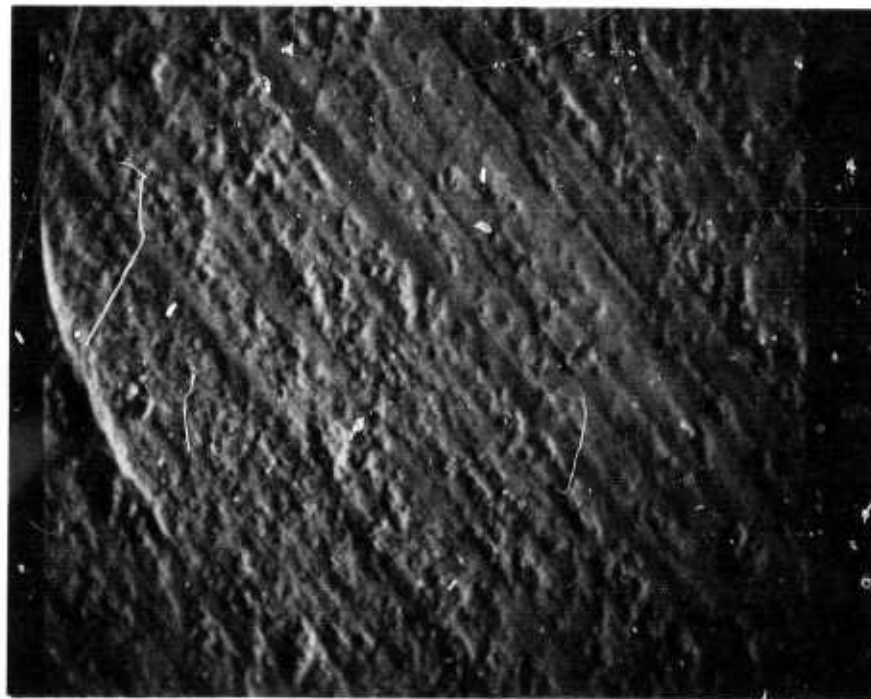
Figure 3.26 — Diamond Ground Surface (540X)

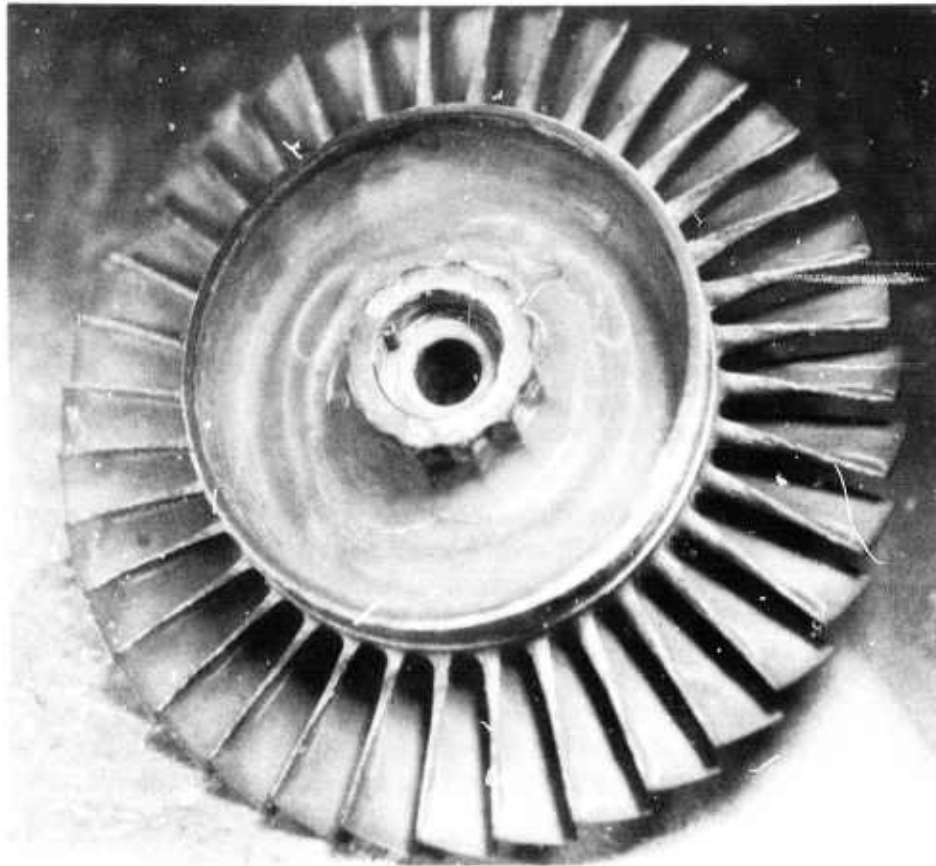
Figure 3.29 — Failed Rotor with Crack in Hub

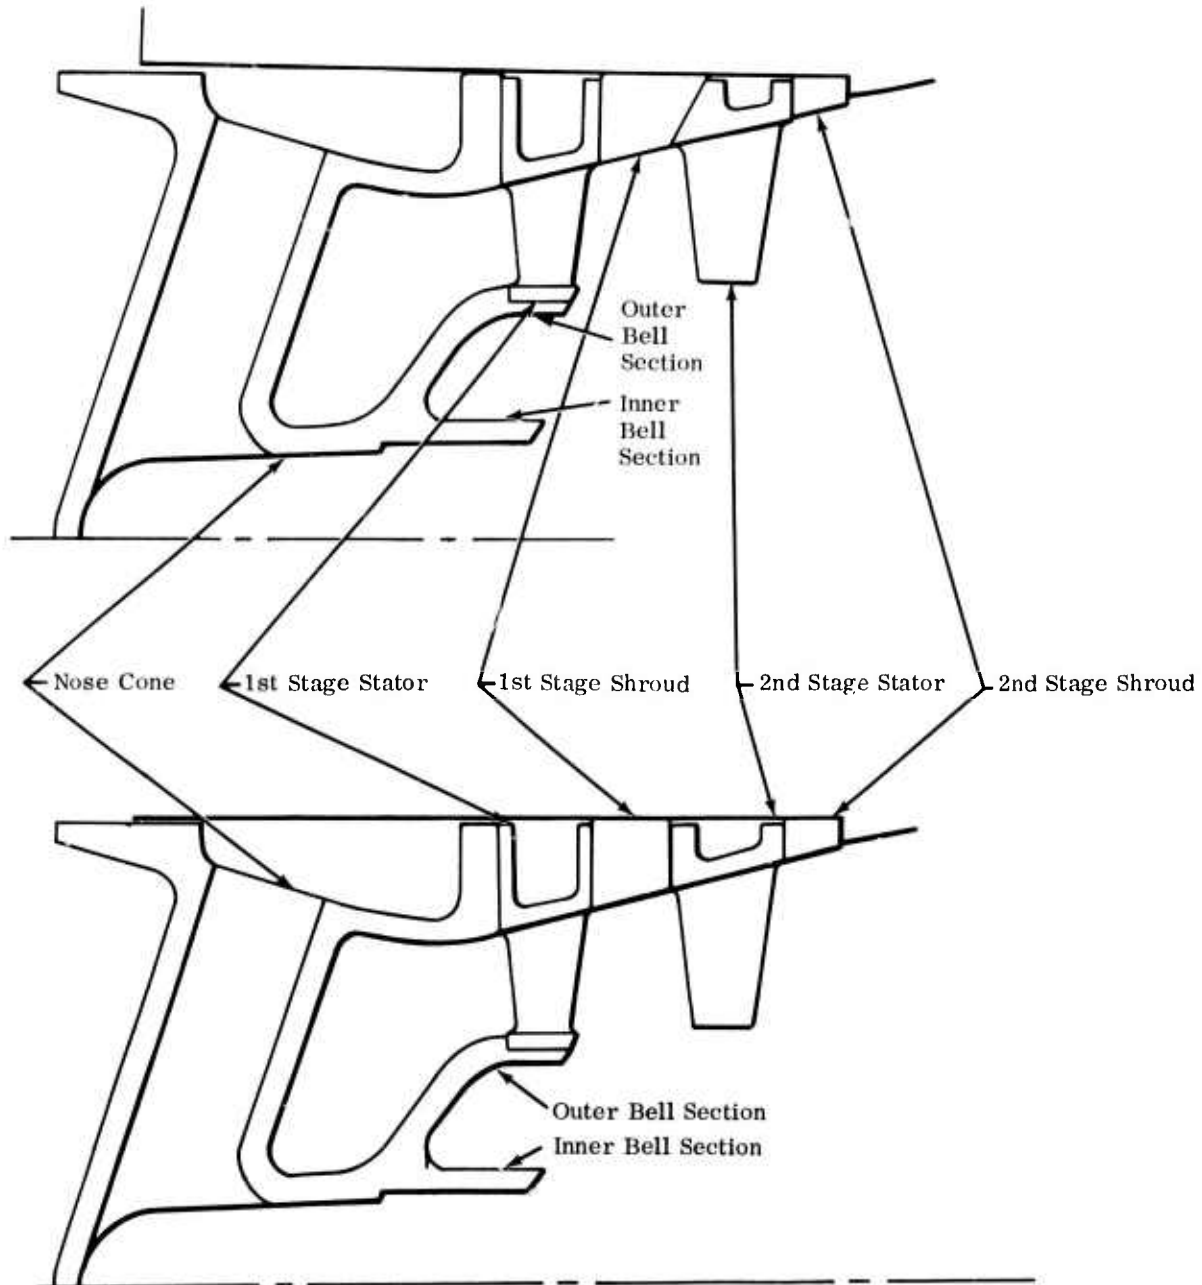
Figure 3.30b — Modified Design B

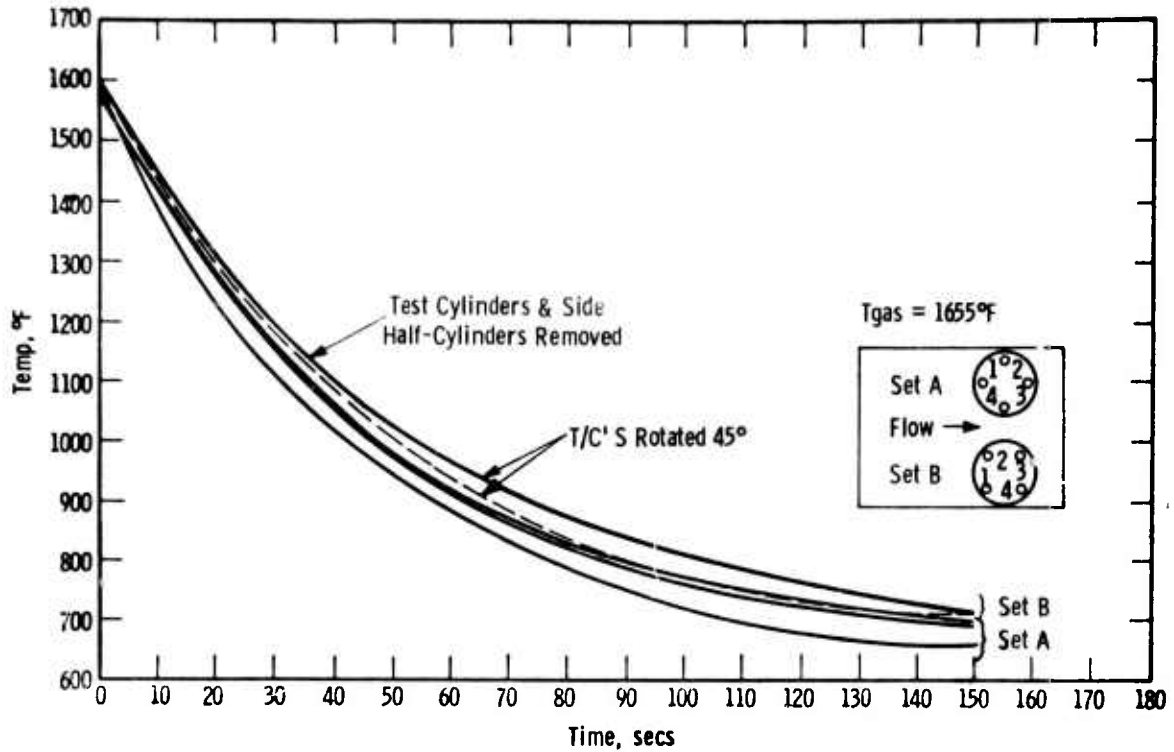
Figure 4.7 — Temperature Decay for a Thermocouple at Position #3 in Thermally Quenched Cylinders of SiC

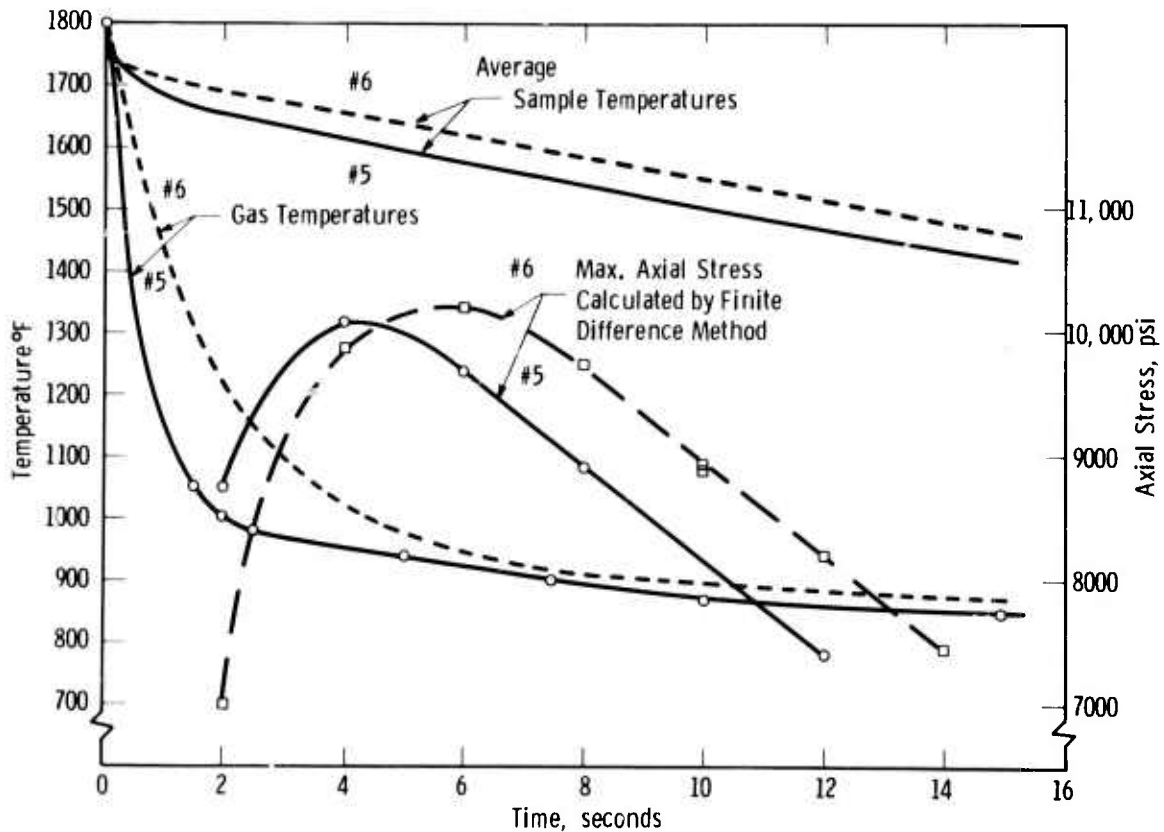
Figure 4.8 — Temperature Decay and Maximum Transient Tensile Stress in the Axial Direction for Silicon Carbide Cylinders Cooled in Test Passage

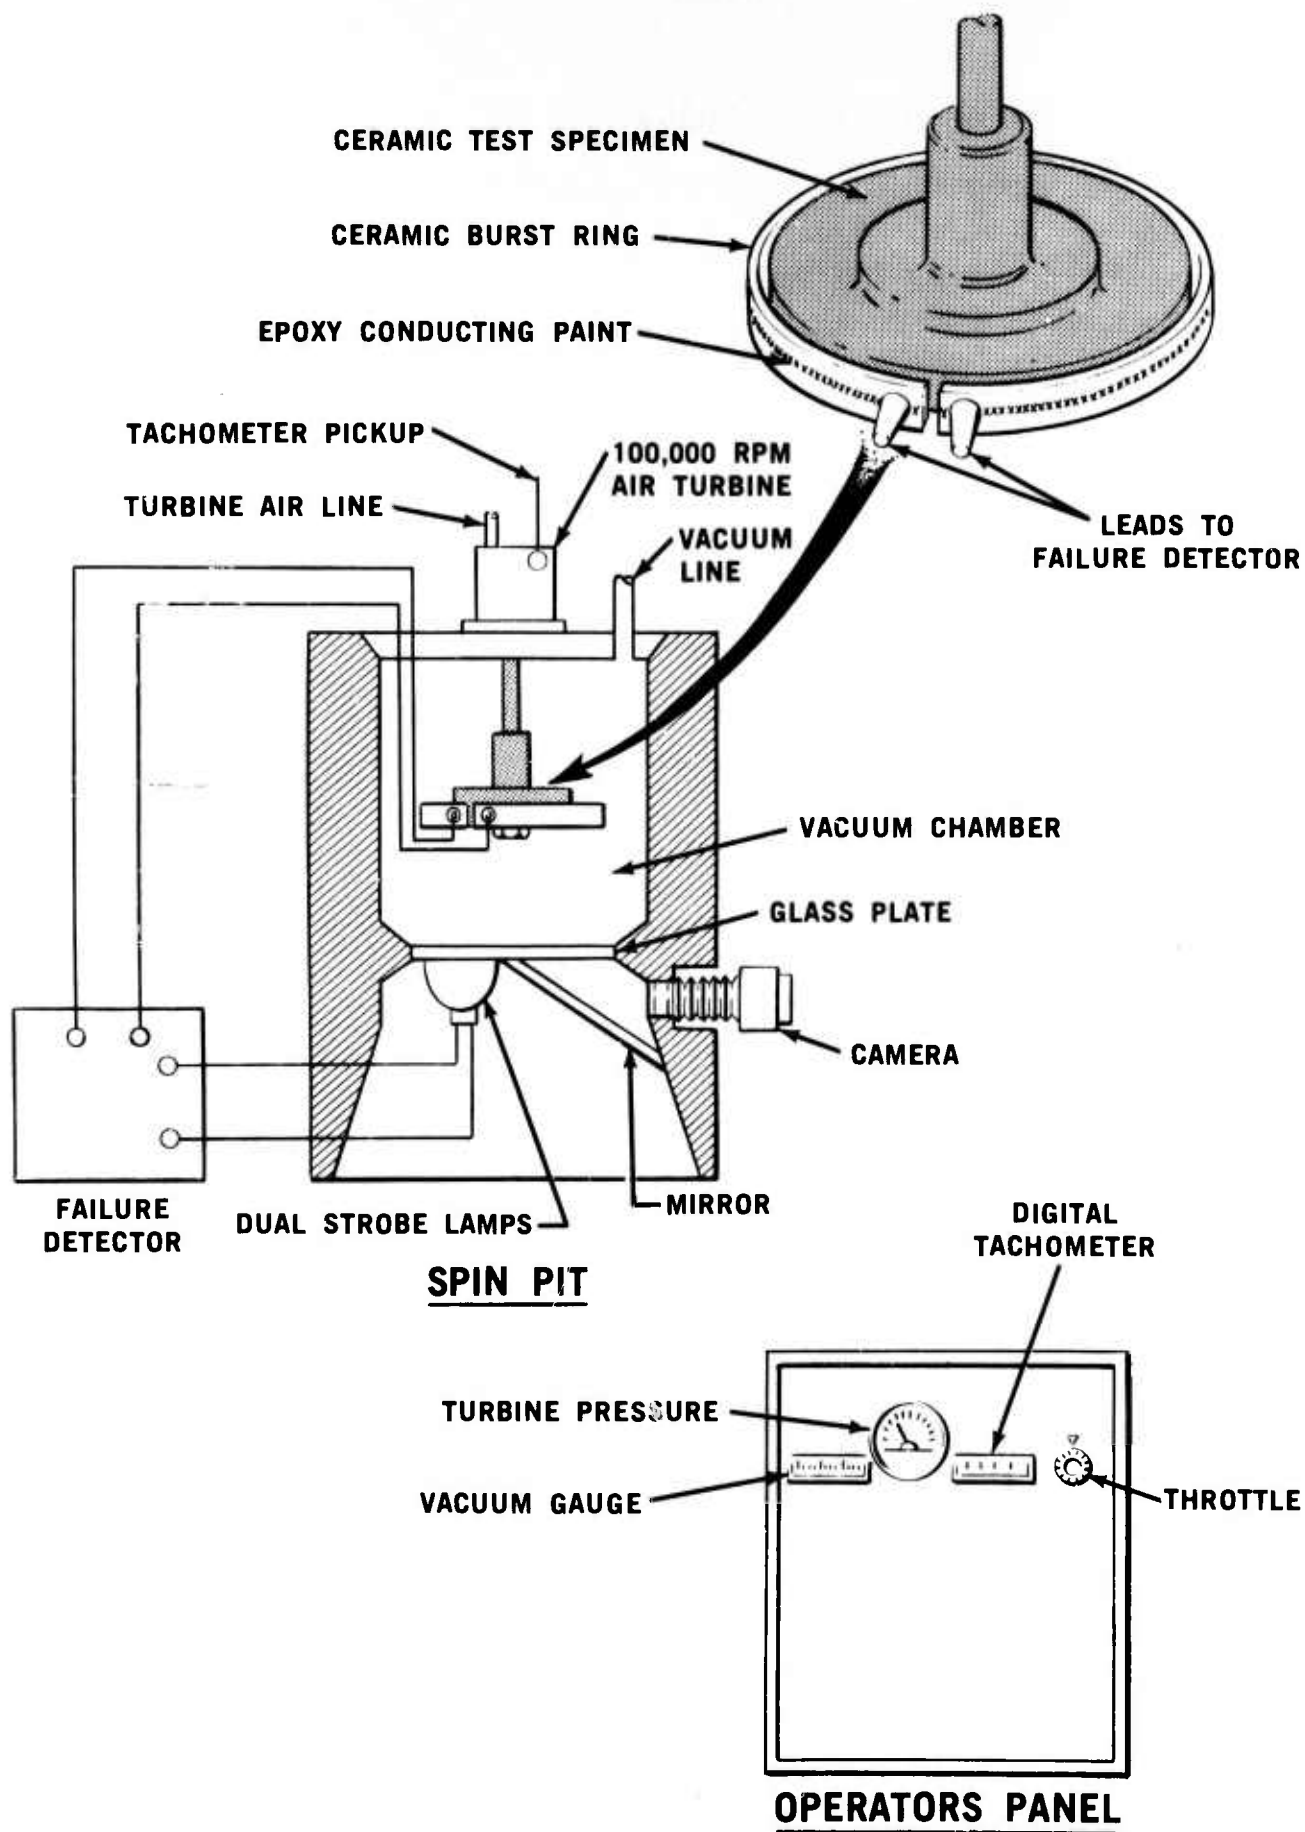
Prior to assembly, the ceramic disks were inspected dimensionally and by ultrasonic c-scan. The disks were mounted on the arbor with a slip fit and retained in position by a hand-tightened nut. The assemblies were balanced to 0.005 oz-inches prior to spinning. The 3/16" spindle was inserted into the arbor assembly and the runout of the spindle checked and straightened, if required, prior to each run. However, even though much care was taken in preparing the assemblies, there was always a low critical frequency encountered in the spin pit tests. Therefore, it was standard procedure in all tests to rapidly accelerate through the low critical into a dynamically stable frequency range. At this point the assembly was slowly accelerated until a burst speed was obtained. The electronic counter was equipped with a delay which allowed the operator to record the maximum RPM obtained.

Figure 5.1 — Schematic of Method for Spin Testing of Ceramic Disks

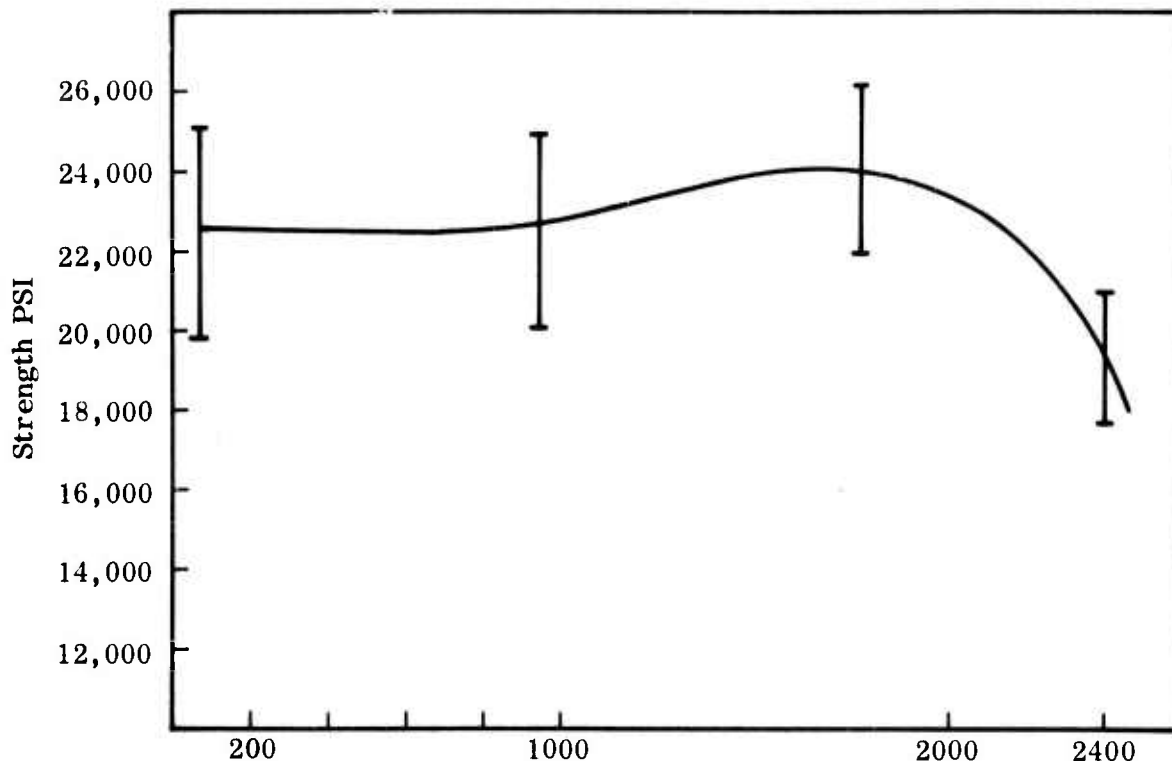
The average strength values at each temperature level are shown in Figure 5.5. At 67°F strength was 22,459 psi with a standard deviation of 2665 psi. At 940°F the mean strength was 22,216 psi with a standard deviation of 2459 psi. For 1760°F the mean strength was 24,000 psi with standard deviation 2130 psi.

Figure 5.5 — Strength vs Temperature for Reaction Sintered  $\text{Si}_3\text{N}_4$

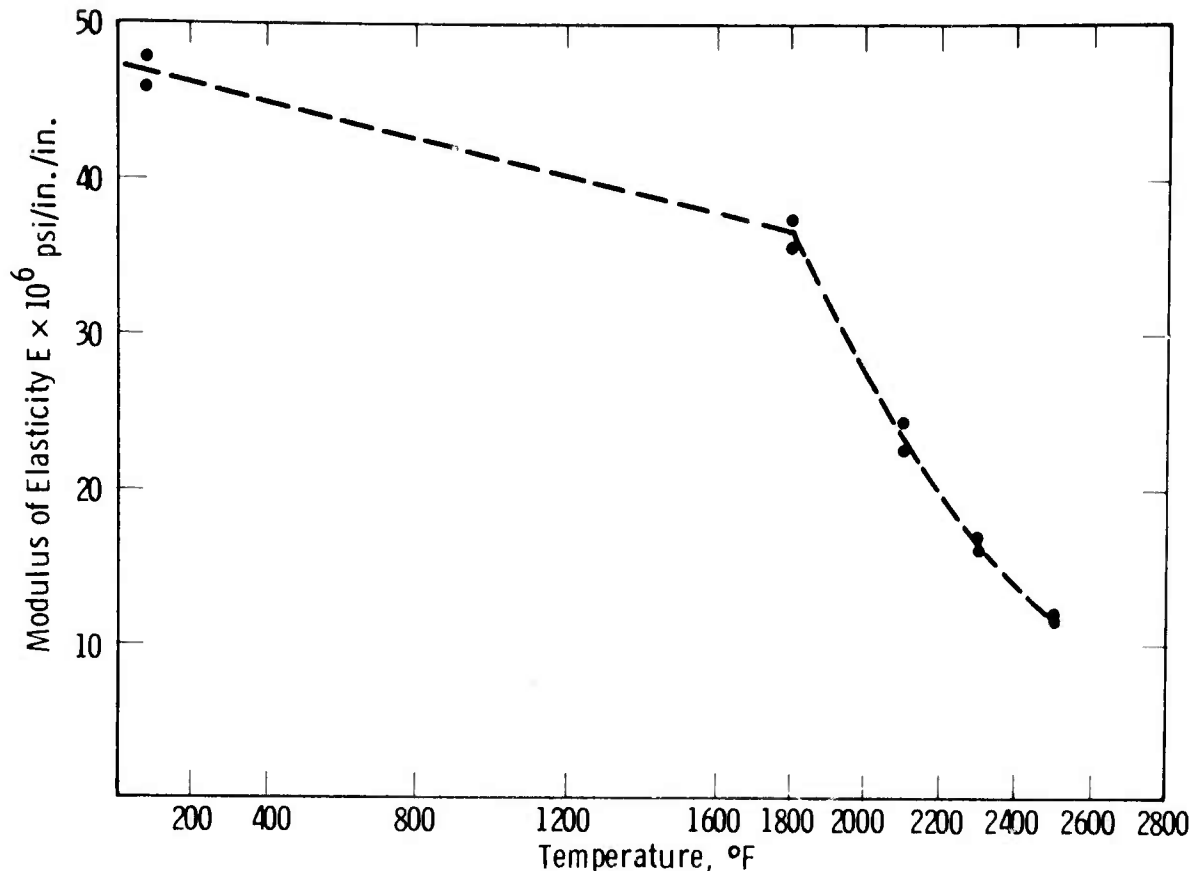
Preliminary modulus of elasticity data were obtained from the tensile tests. Strain was measured optically to 10 micro-inch accuracy using a Physitech Extensometer. The values range from  $44.5 \times 10^6$  psi at room temperature to  $11 \times 10^6$  psi at 2500°F as shown in Fig. 5.11.

Figure 5.11 — Modulus of Elasticity of Hot Pressed Silicon Nitride vs Temperature (Inert Atmosphere)

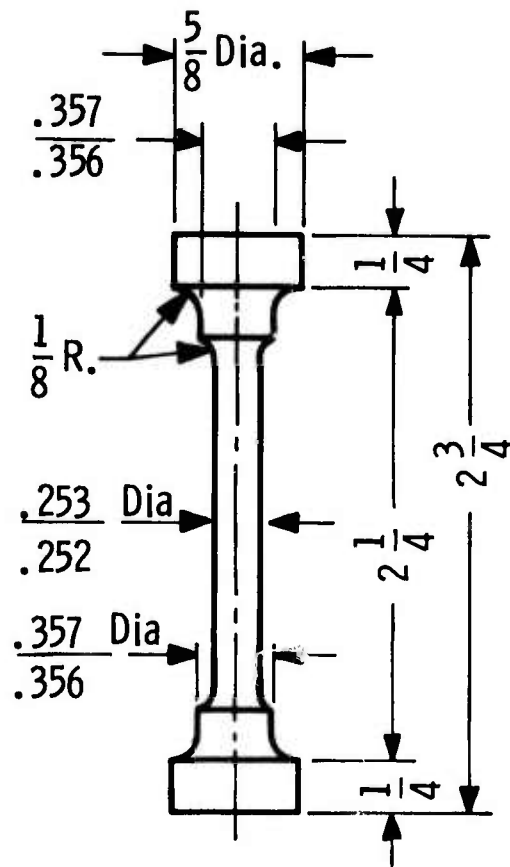
Figure 5.12 — Creep Specimen

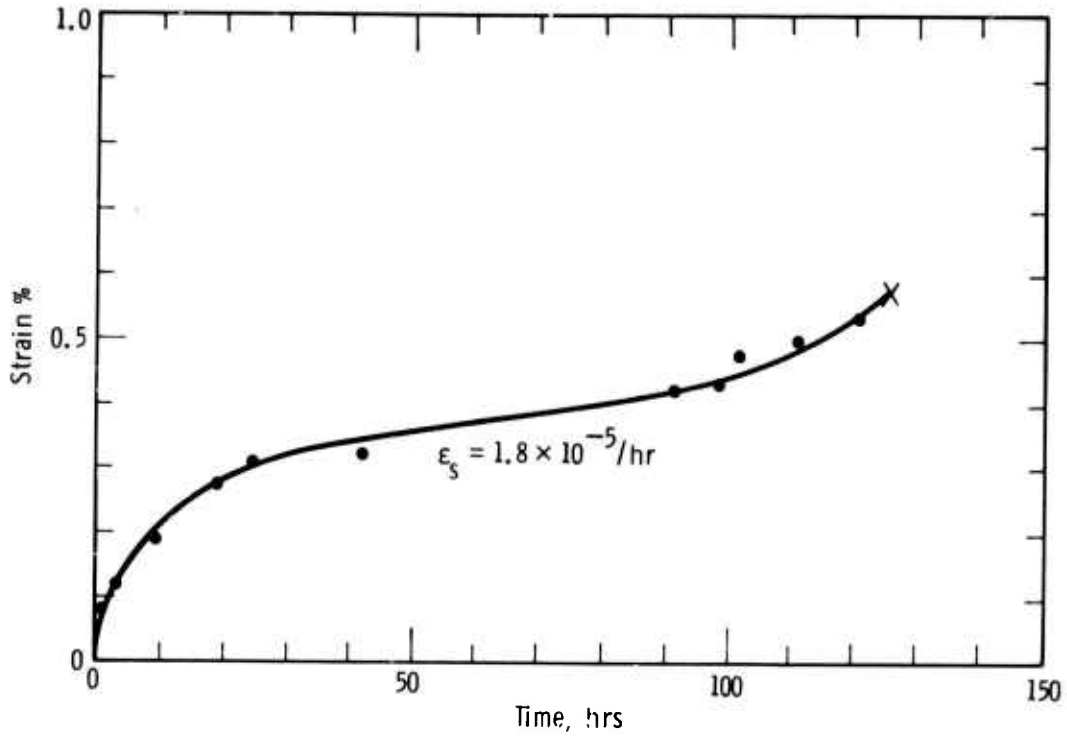
A summary of the creep results on the first batch of specimens is given in Table 5.2. A typical creep curve, selected for the 10,000 psi, 2300°F test condition, is shown in Fig. 5.13. It is interesting to note that the curve displays the classical three stages of creep phenomenon.

Figure 5.13 — Creep Curve, 10,000 psi, 2300°F

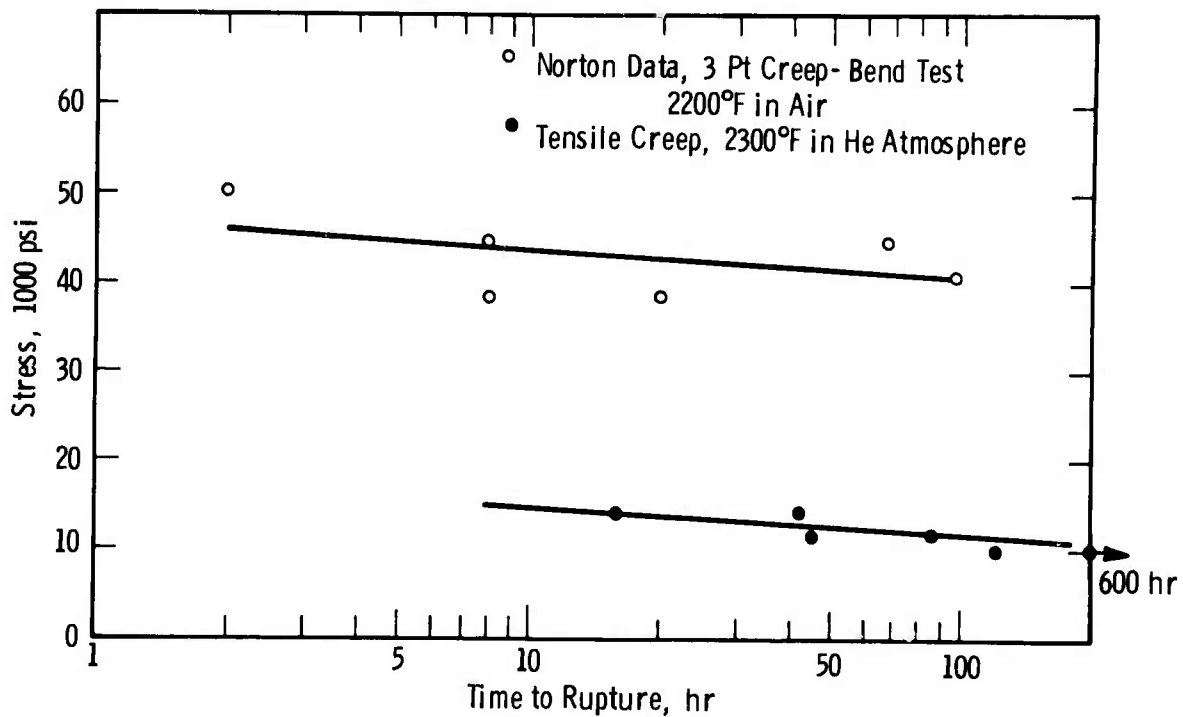
The data are replotted in terms of stress-life time in Fig. 5.14. Also shown in this figure are stress-rupture data obtained from the Norton Company for specimens tested in a three-point bending mode, at 2200°F in air. The effect of the testing mode is quite apparent. It is also noteworthy that the slopes of the two curves are similar.

Figure 5.14 — Stress Rupture Properties of  $Si_3N_4$

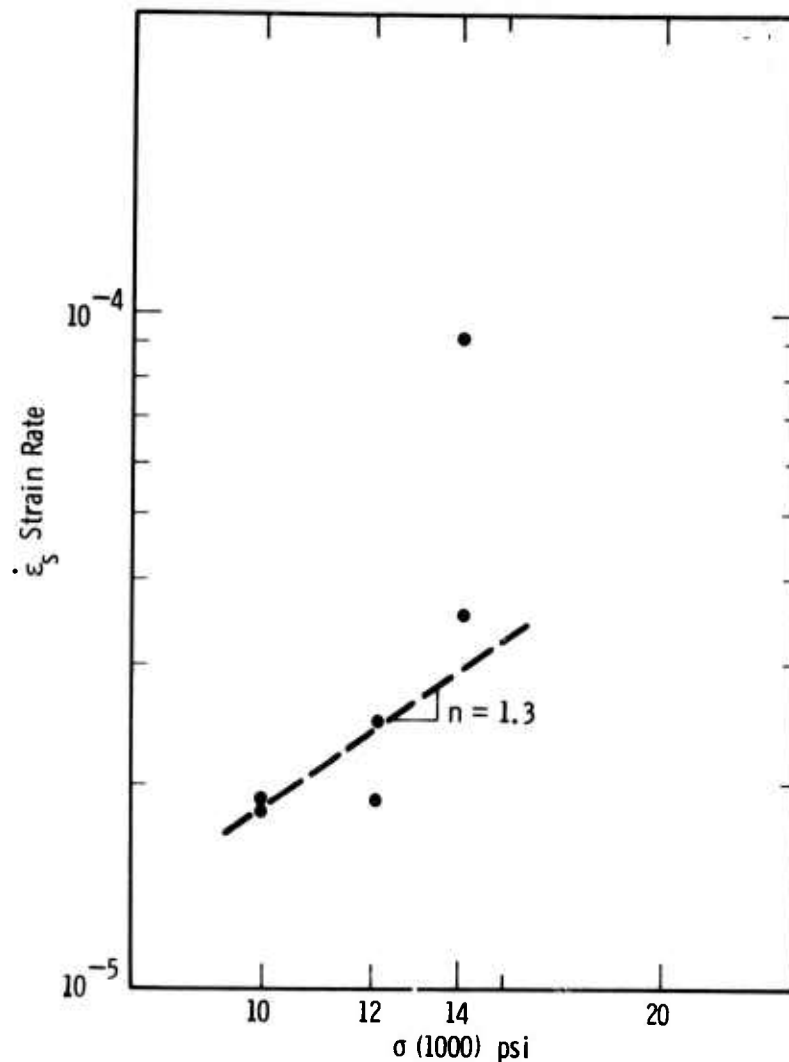
The available data are not sufficient for mechanism analysis. However, when plotted in terms of steady state strain rate vs log stress (Fig. 5.15), the data indicate a low exponent in the relation  $\dot{\epsilon} = \sigma^n$ . An exponent of  $n < 2$  usually indicates a visco-elastic mechanism, i.e., a Nabarro-Herring diffusional creep or a grain boundary sliding. Preliminary transmission electron microscopy data indicate that grain boundary sliding may indeed be the rate controlling mechanism during creep deformation.

Figure 5.15 — Strain Rate vs Stress, 2300°F in Helium Atmosphere

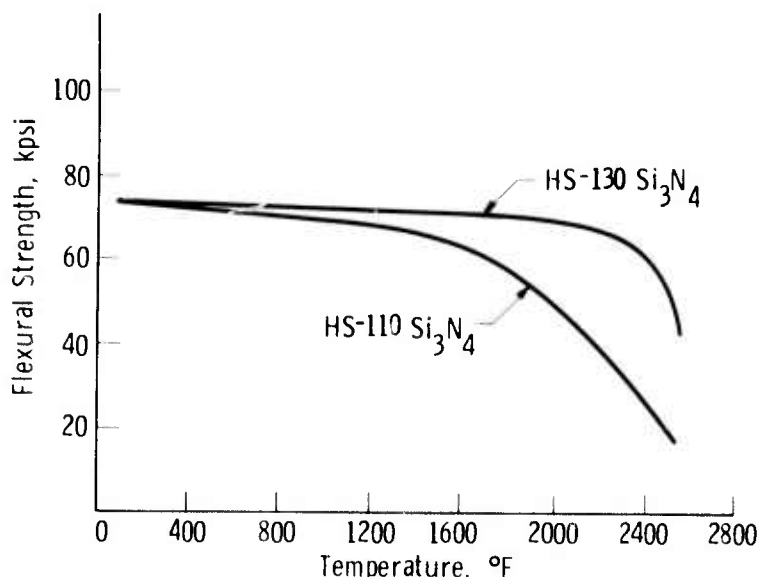
The strength of HS-130 silicon nitride is compared with HS-110 in Fig. 5.16, for the weak direction specimens tested at a cross head speed of 0.02 in/min.\* The strengths of both materials are similar at room temperature. The significant difference is exhibited at elevated temperatures where strength degradation occurs at ~ 1800°F and ~ 2200°F in HS-110 and HS-130, respectively. The change may be attributed to the Ca impurity concentration as discussed in Section 5.2.3.

Figure 5.16 — Strength vs Temperature for Two Forms of Si<sub>3</sub>N<sub>4</sub> (HS-110 and HS-130) Fabricated by Norton Co.

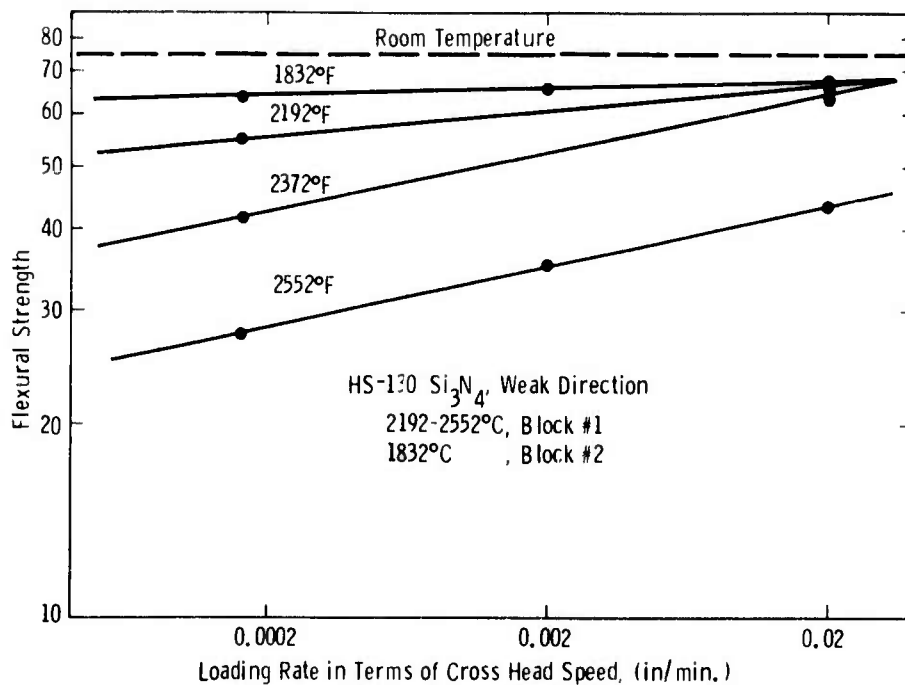
Figure 5.18 — Log Plot of Strength vs Loading Rate at Different Temperatures for HS-130  $\text{Si}_3\text{N}_4$

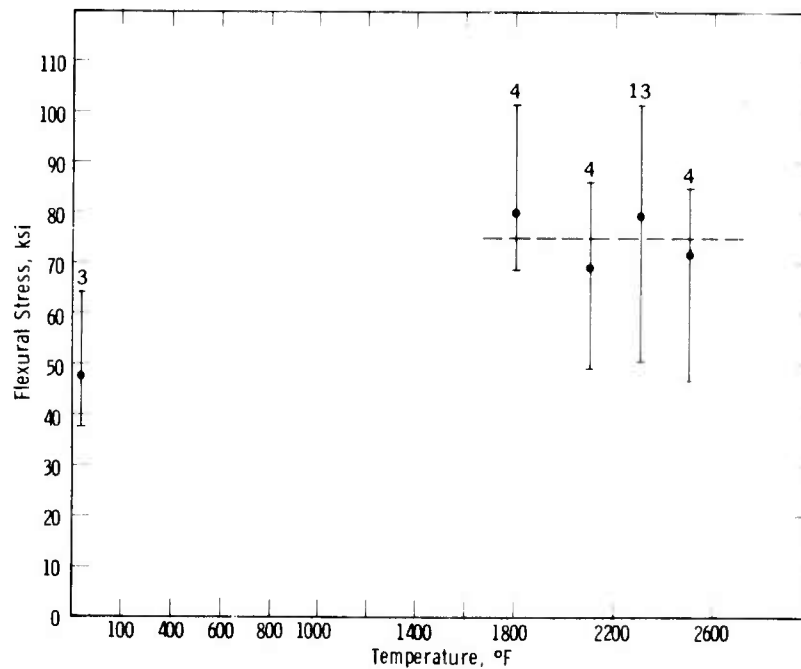
The results of testing a total of 28 specimens of this material are shown in Fig. 5.21. Even though the scatter in these data is very great, the strength of the material appears to increase with temperature to an impressive average value of 75,000 psi at temperatures above 1800°F.

Figure 5.21 — Flexural Failure Stress of Energy Research Chemical Vapor Deposition Silicon Carbide as a Function of Temperature. Numbers indicate the number of samples tested.

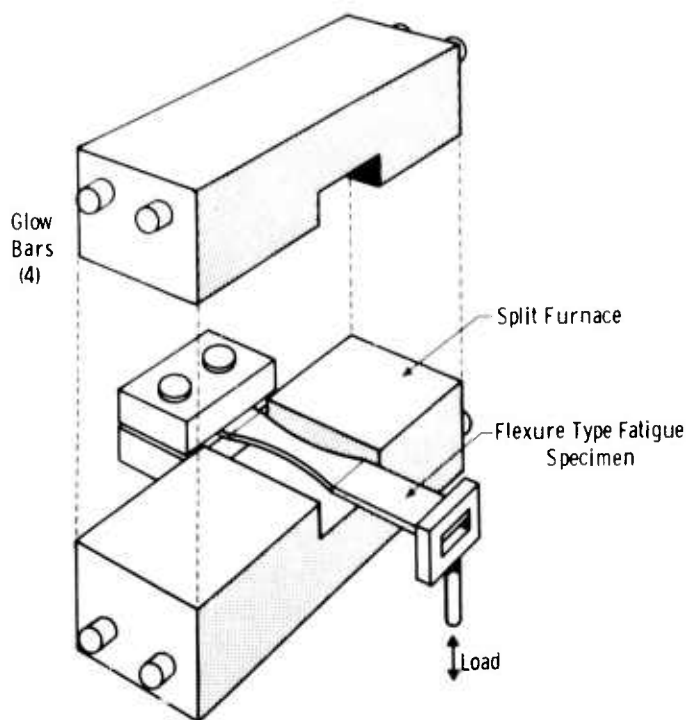
Figure 5.22 — Fatigue Test
