AMMRC CTR 72-19

BRITTLE MATERIALS DESIGN, HIGH TEMPERATURE GAS TURBINE

Arthur F. McLean, Ford Motor Company, Dearborn, Michigan 48121  
Eugene A. Fisher, Ford Motor Company, Dearborn, Michigan 48121  
Raymond J. Bratton, Westinghouse Electric Corporation, Pittsburgh, Pennsylvania 15235

Interim Report, January 1, 1972 to June 30, 1972

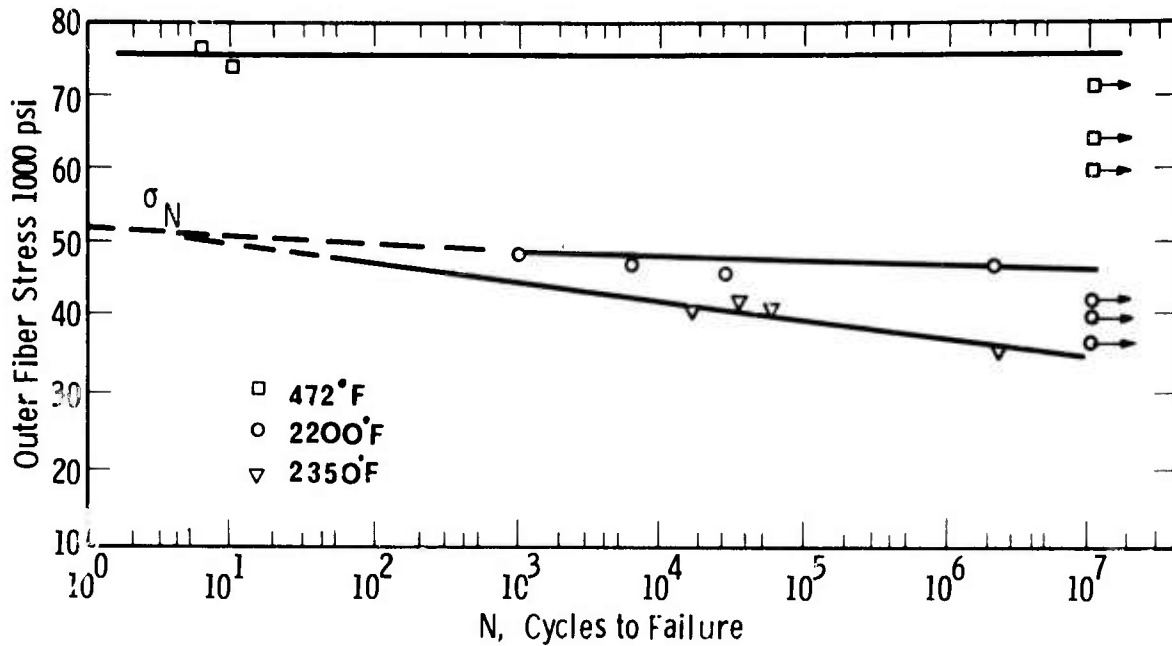
Figure 5.23 — Cyclic Fatigue Behavior of Norton HS-130 Hot Pressed  $\text{Si}_3\text{N}_4$  at 1800 cpm

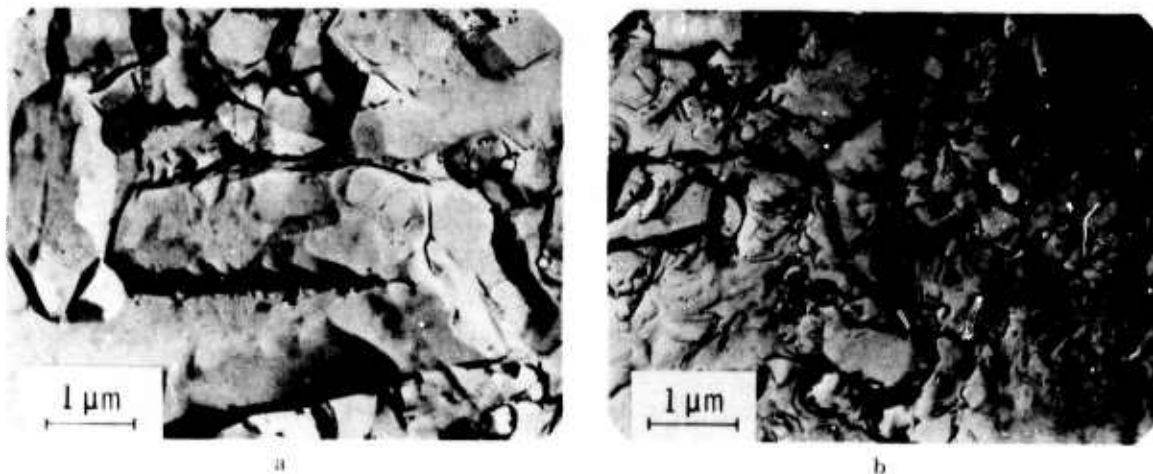
Figure 5.25 — Fracture Surfaces, Fatigue Specimen, HS-110 Material  
 a) 472<sup>o</sup>F b) 2200<sup>o</sup>F

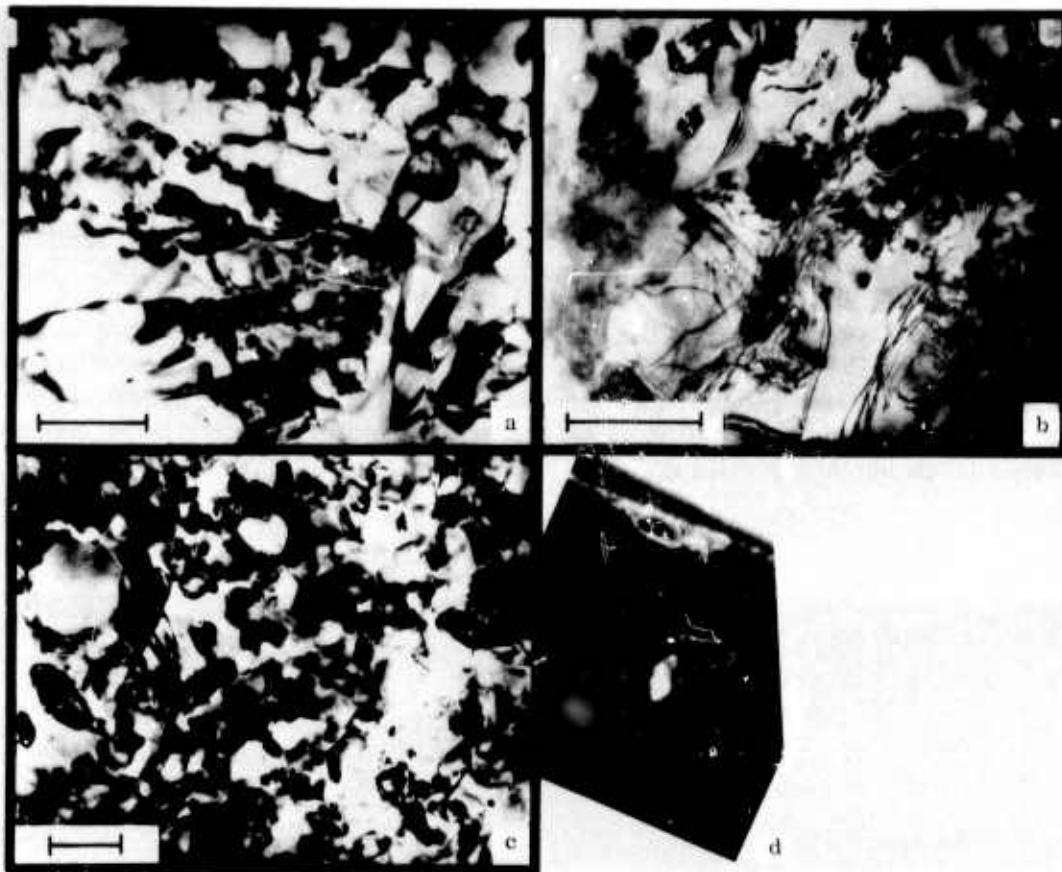
Figure 5.26 — Thin Foil Transmission Micrographs of Fatigue Specimens  $.1\mu\text{m}$  Scale Bars

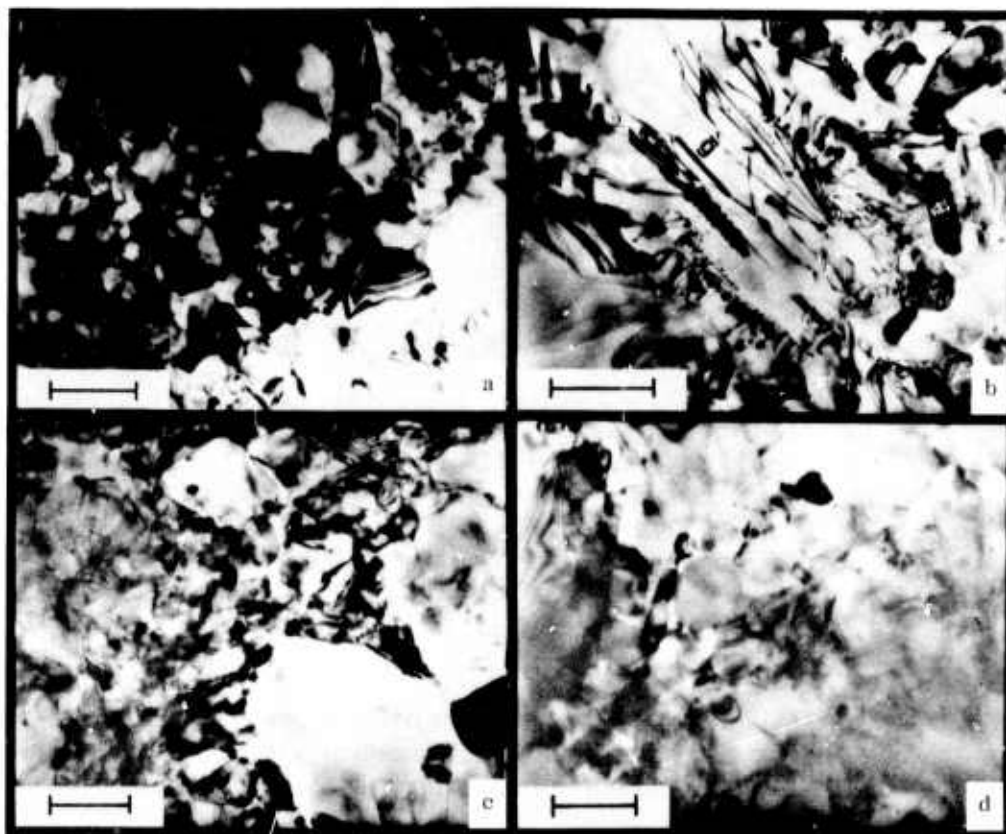
Figure 5.27 — Thin Foil Transmission Micrographs of Creep Specimen, HS-110 Material .1  $\mu$  Scale Bars

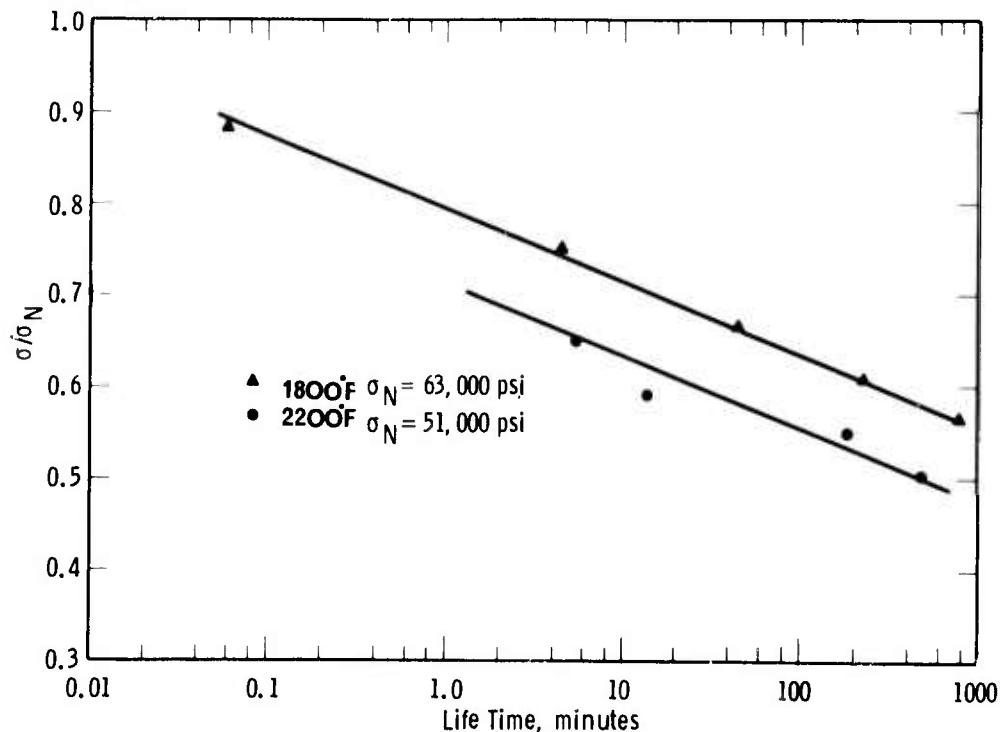
Figure 5.28 — Normalized Stress as a Function of Life Time HS-110 Grade  $Si_3N_4$

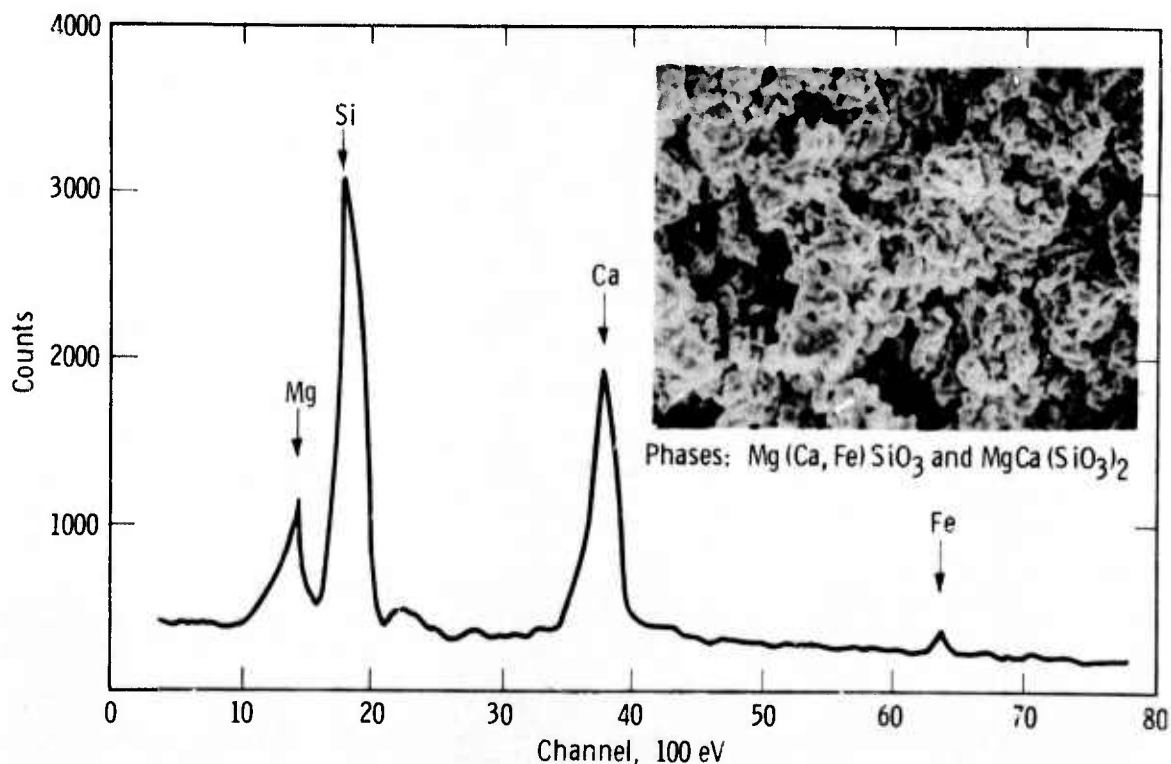
Figure 5.29 — Non-Dispersive X-Ray Analysis of Corrosion Layer, HS-110 Material, 8 Hours at 2200°F in Air

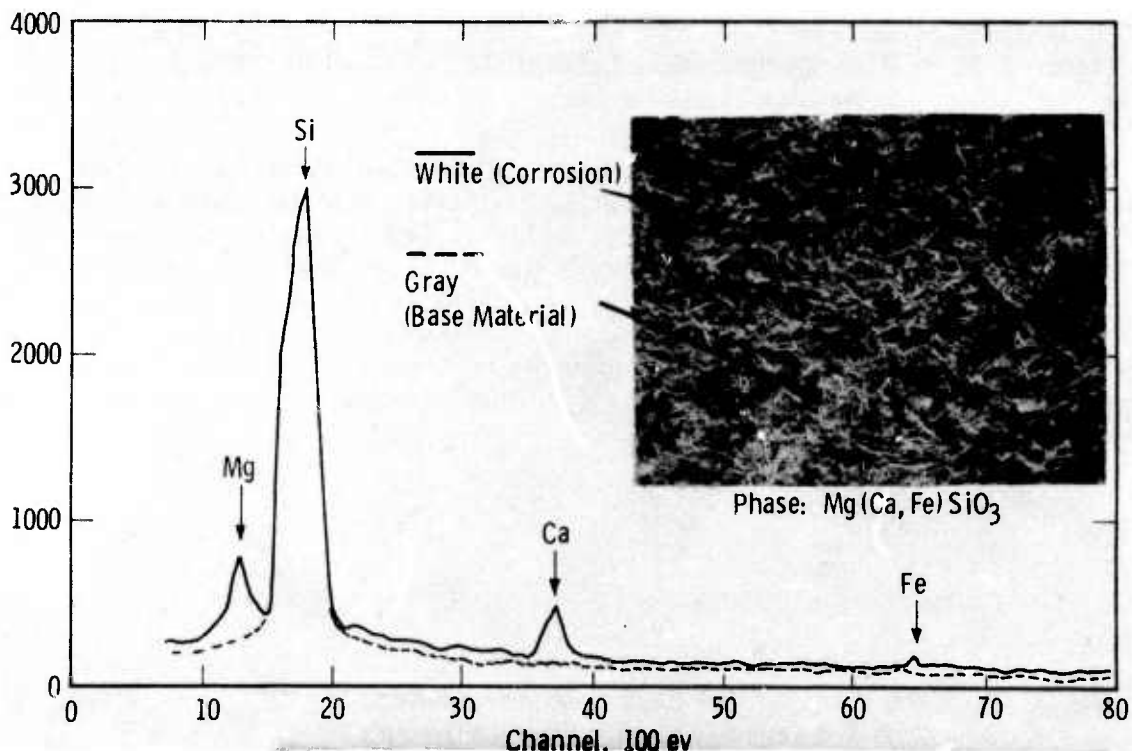
Figure 5.30 — Non-Dispersive X-Ray Analysis of Corrosion Layer, HS-130 Material, 100 Hours at  $2200^\circ\text{F}$  in Air

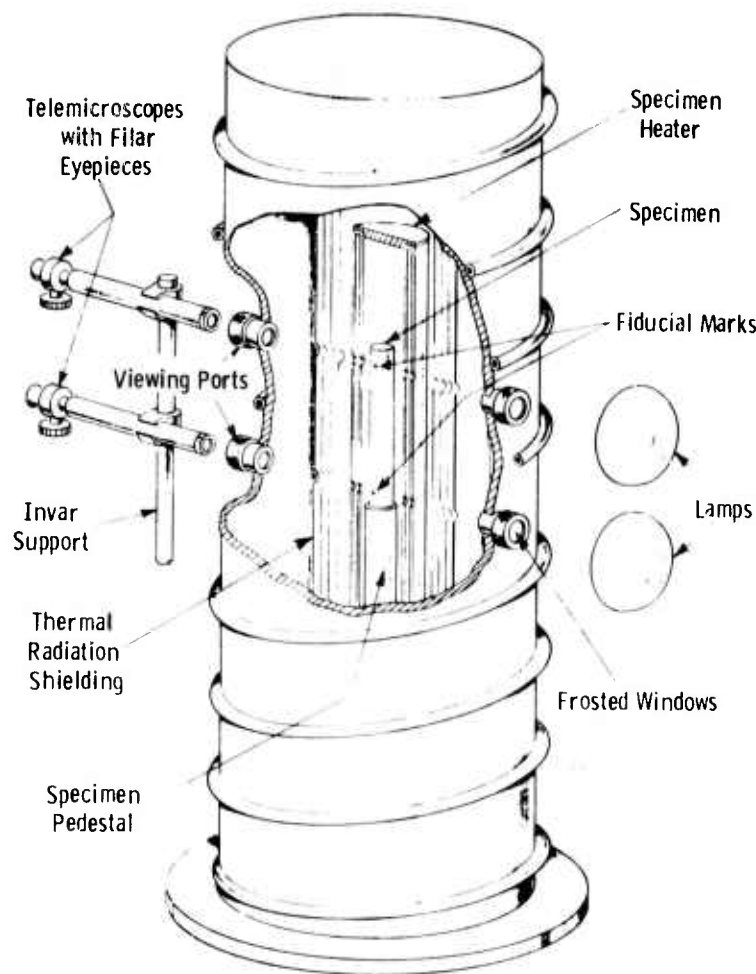
Figure 5.31 — High-Temperature Dilatometer as Used for Direct-View Expansion Measurements

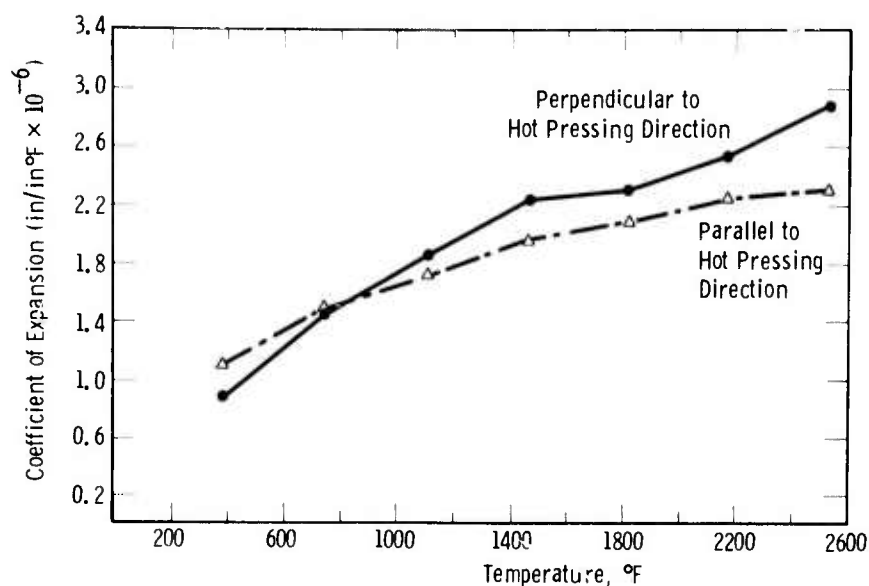
Figure 5.35 — Thermal Expansion of Silicon Nitride as a Function of Temperature and Direction

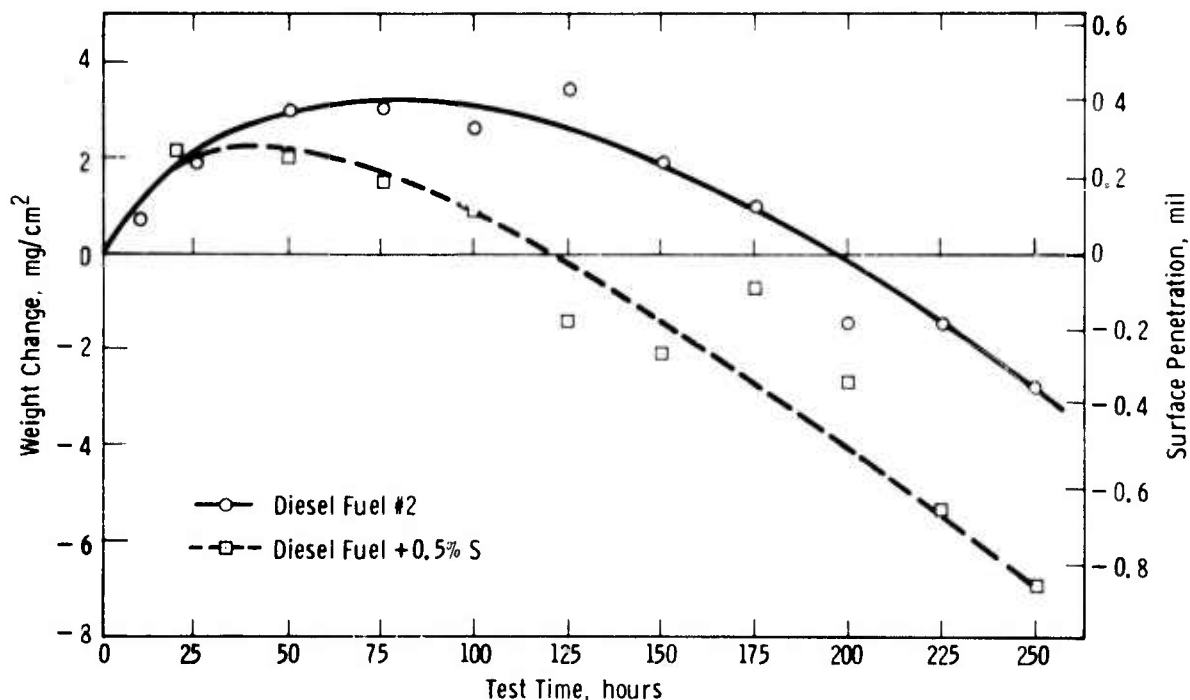
Figure 5.39 — Weight Change Data for Norton HS-130 Si<sub>3</sub>N<sub>4</sub> in Turbine Test Passage at 2000<sup>o</sup>F and 3 Atmospheres Pressure

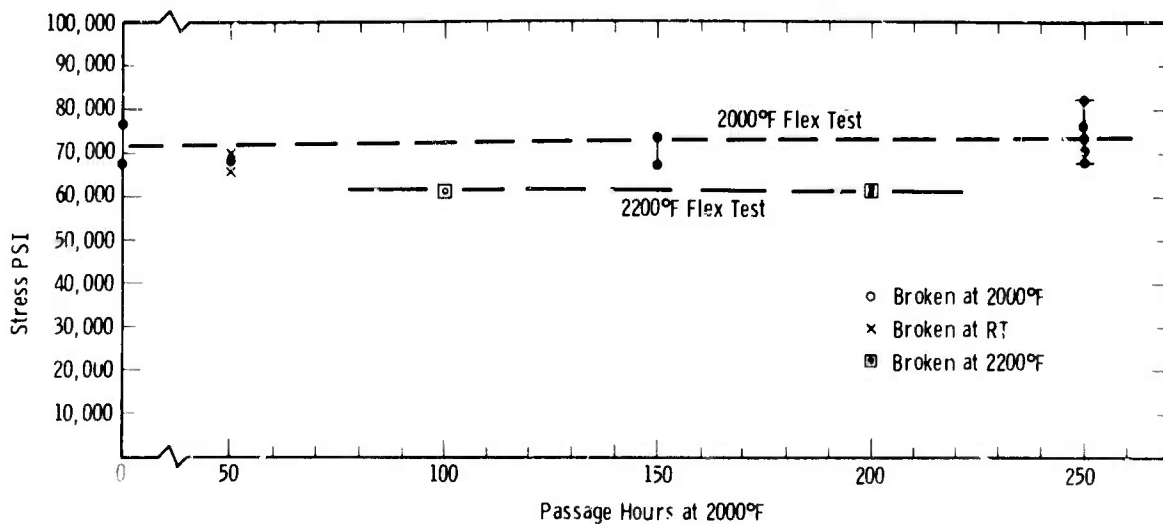
Figure 5.40 — Flexural Failure Stress of  $\text{Si}_3\text{N}_4$  Versus Exposure Time in the Turbine Test Passage at  $2000^\circ\text{F}$ .  $1/4 \times 1/4 \times 2$  Inch Samples in 4 Point Loading (Strong Direction)

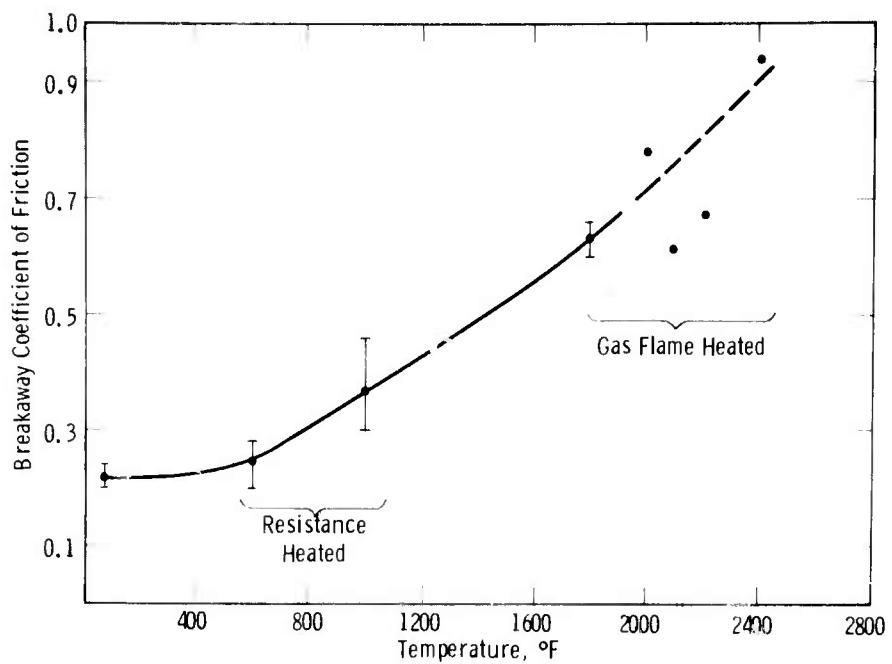
Figure 5.41 — Breakaway Coefficient of Friction of Silicon Nitride vs Silicon Nitride as a Function of Temperature

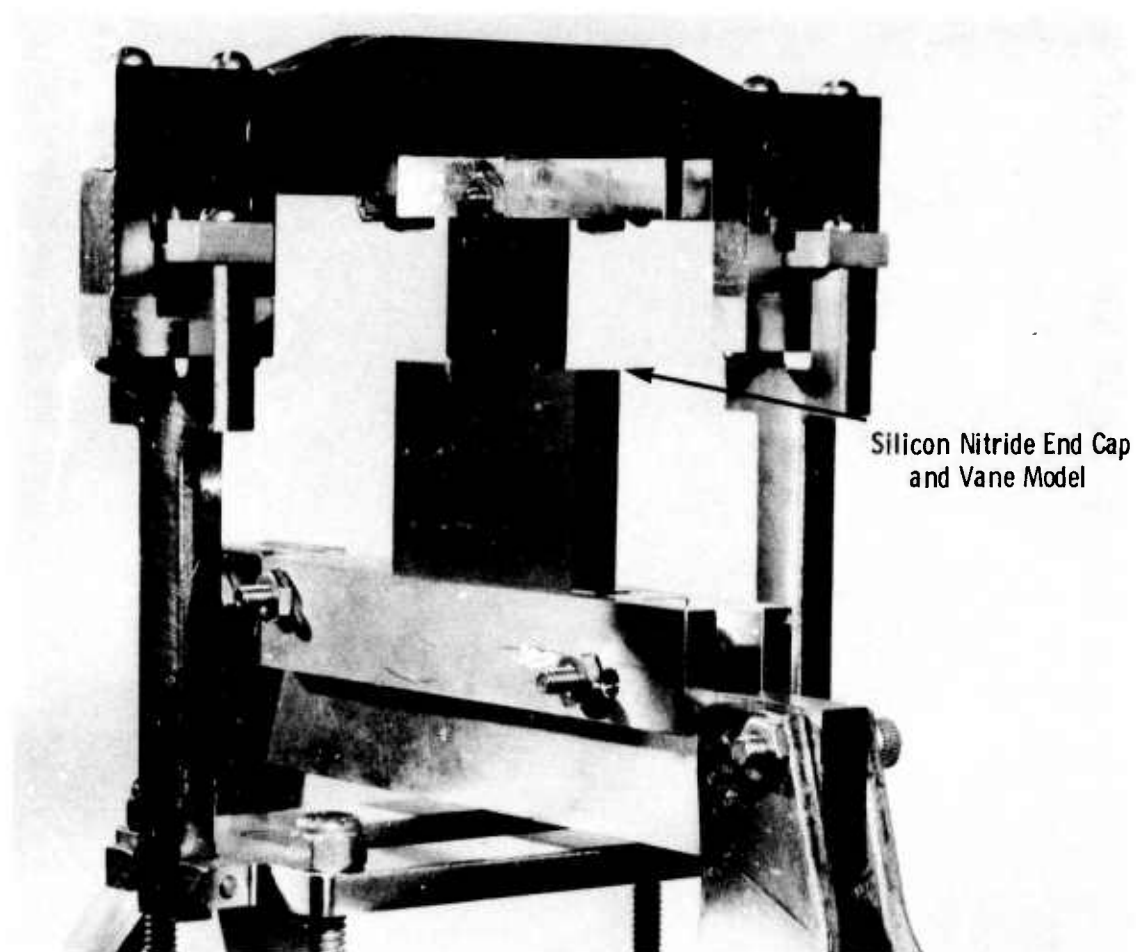
Figure 5.42 — Wear and Fret Test Apparatus

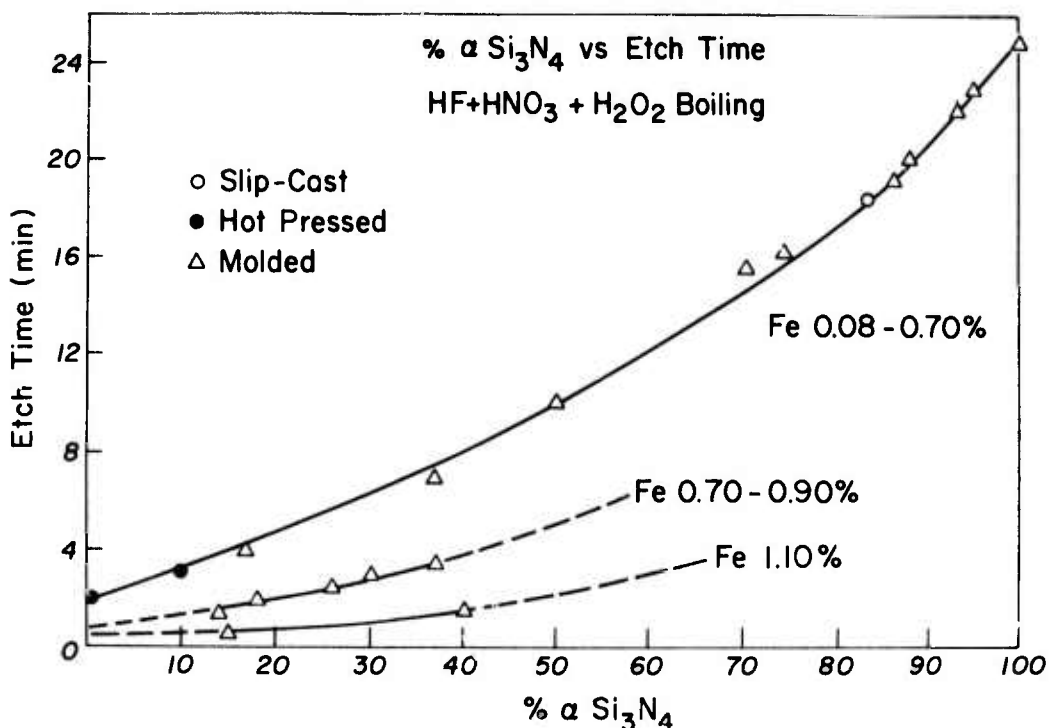
Figure 5.43 - % Alpha  $\text{Si}_3\text{N}_4$  vs Etch Time

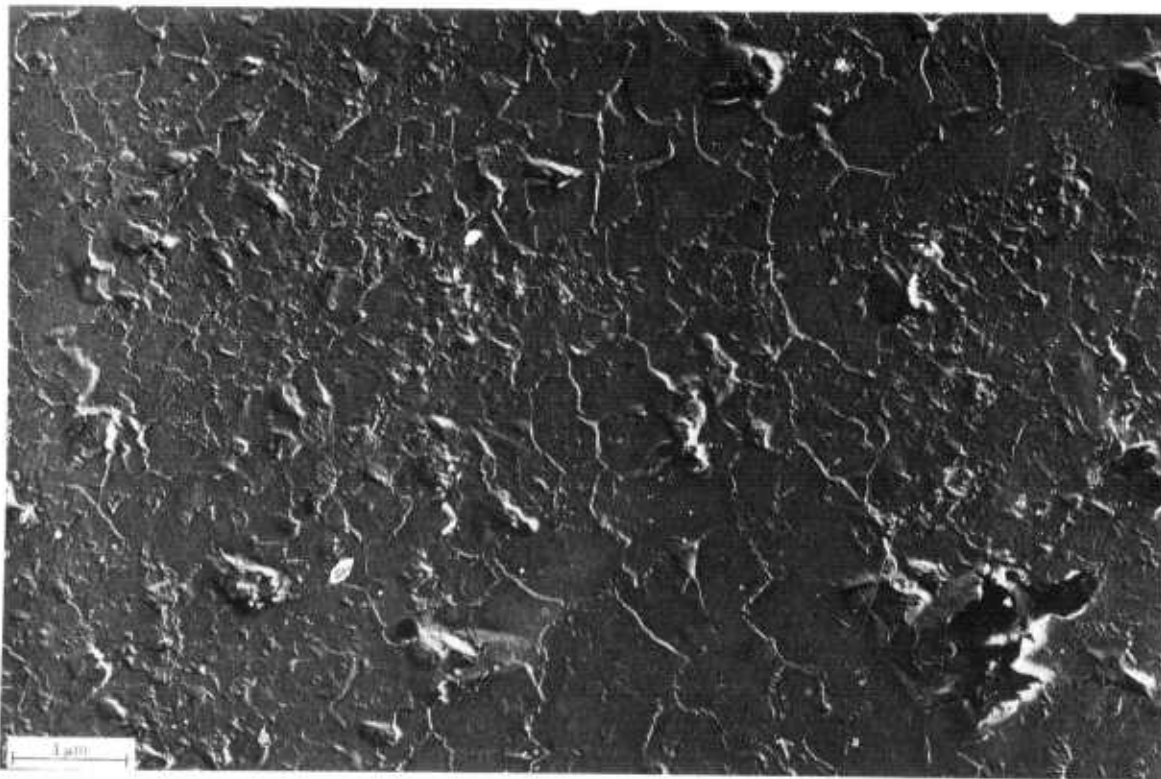
Figure 5.44b — Typical Areas From Sample 228-1 (86%  $\alpha$  , 14%  $\beta$  ) 24,800X

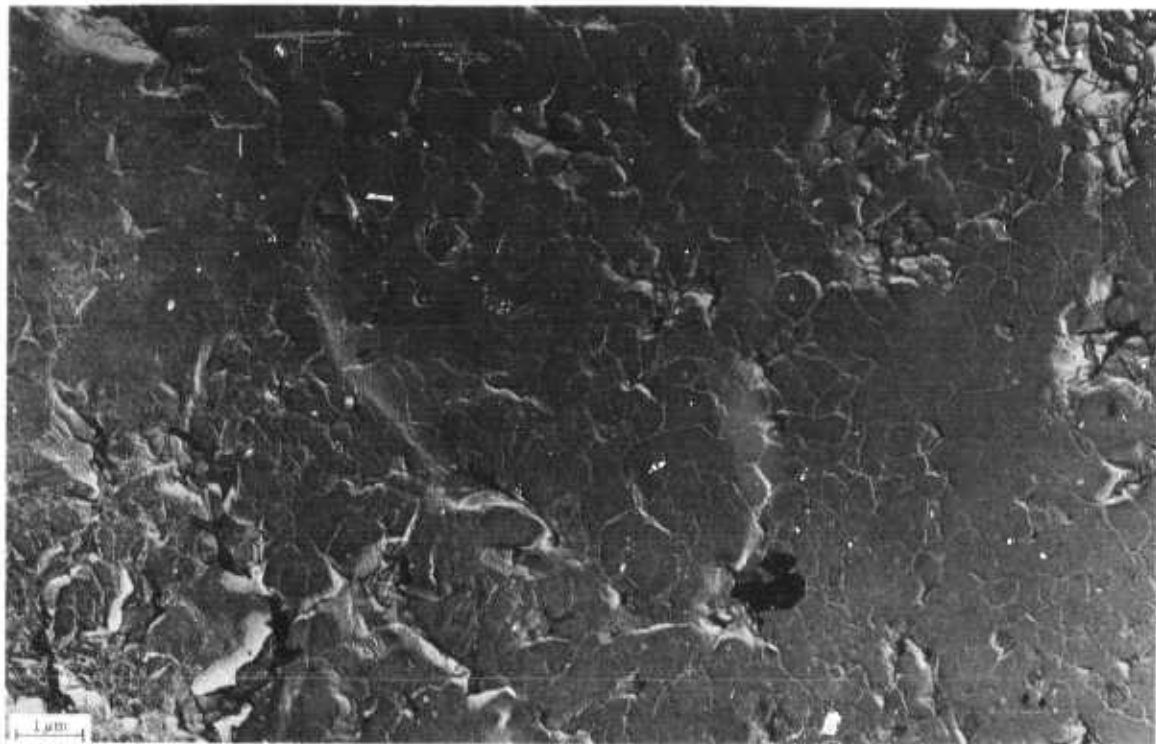
Figure 5.45a — Typical Areas From Sample 228-5 (37%  $\alpha$  , 63%  $\beta$  ) 24,800X

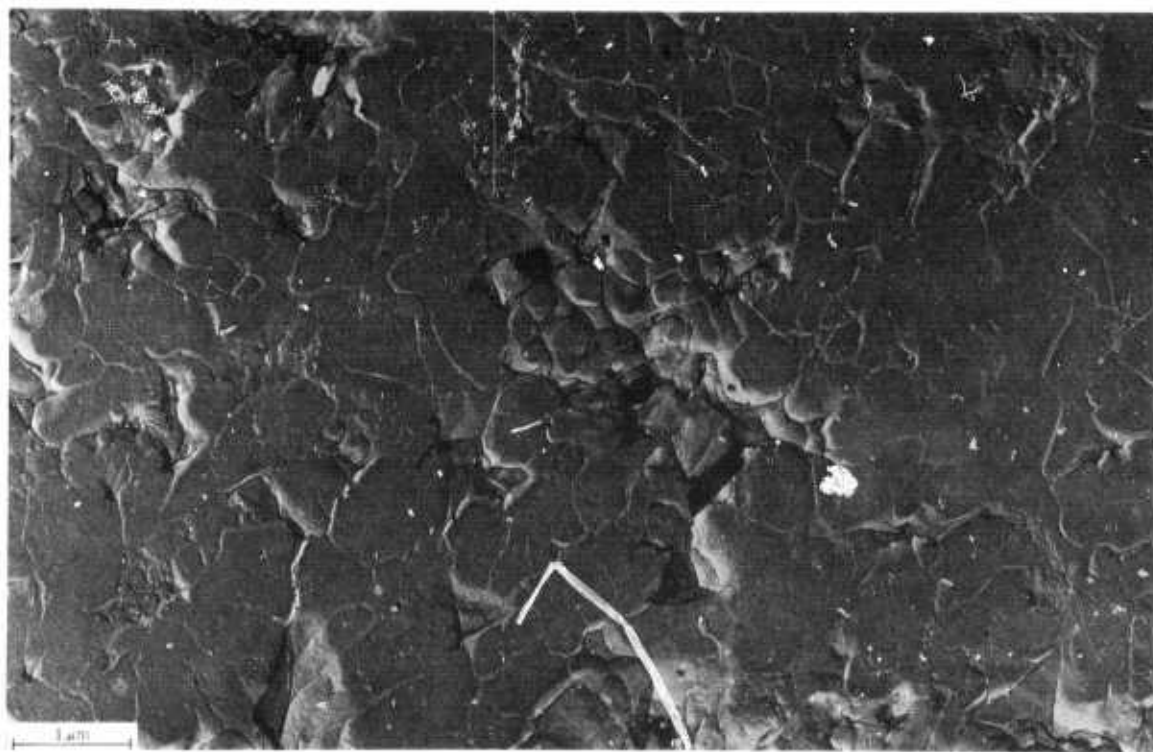
Figure 5.45b — Typical Areas From Sample 228-5 (37%  $\alpha$  , 63%  $\beta$  ) 13,200X

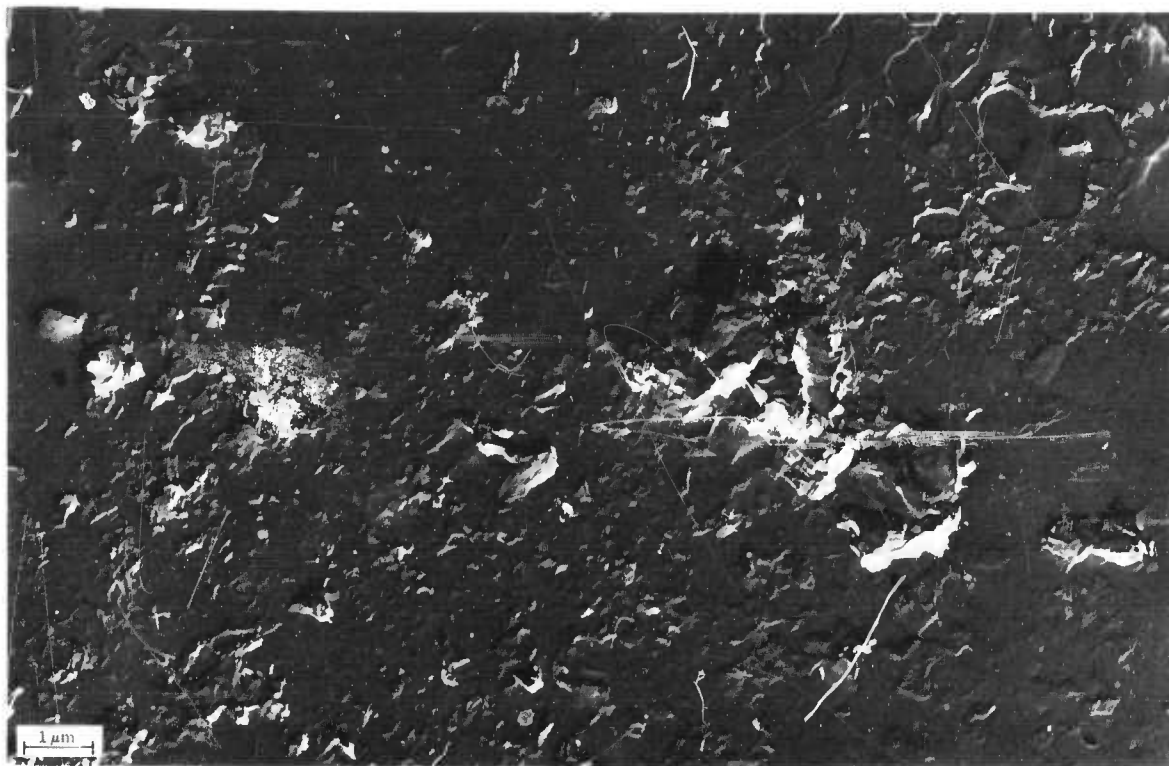
Figure 5.46 — Microstructure of Reaction-Sintered Silicon Nitride  
Typical Areas From Sample 241-5 (18%  $\alpha$  , 82%  $\beta$  ) 13,200X

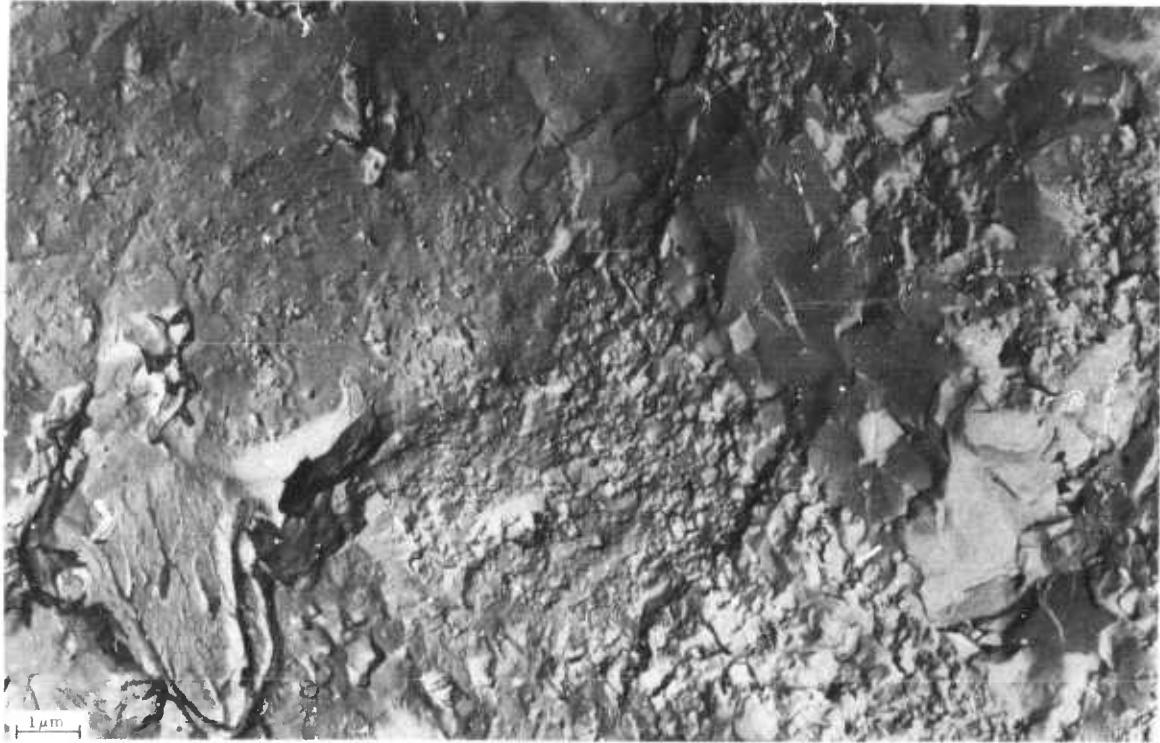
Figure 5.47 — Fracture Surface of Reaction Sintered Si<sub>3</sub>N<sub>4</sub>

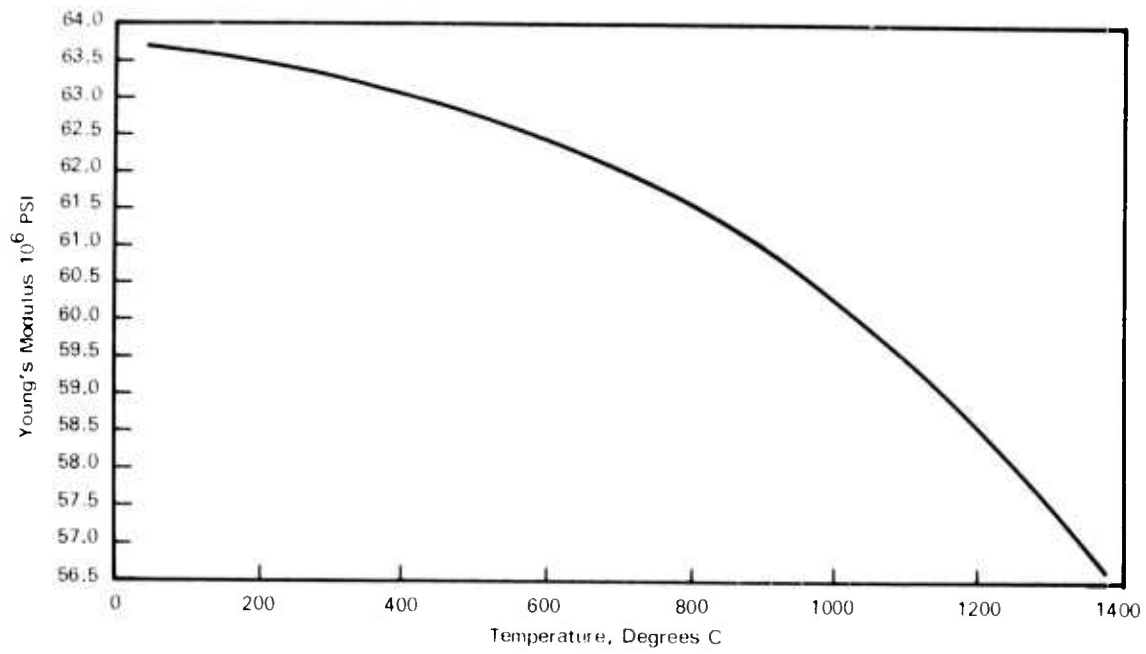
Figure 5.51 — Young's Modulus vs Temperature for Hot-Pressed SiC

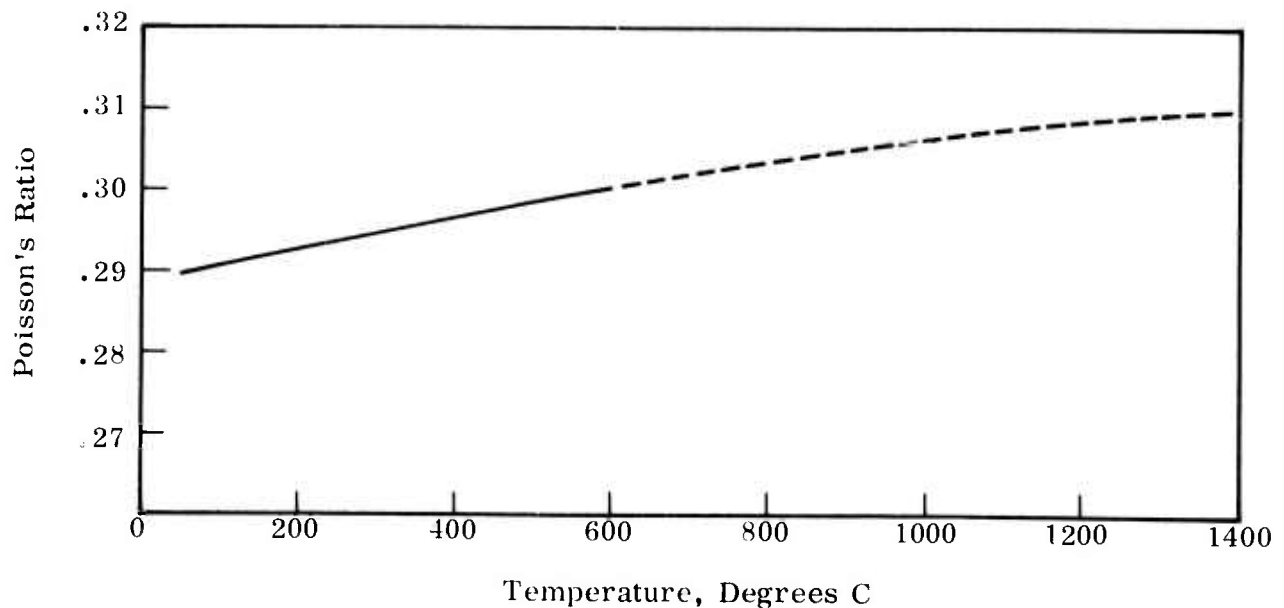
Figure 5.56 — Poisson's Ratio vs Temperature for Hot Pressed Silicon Nitride Assumed from Low Temperature Data and Shape of SiC Curve

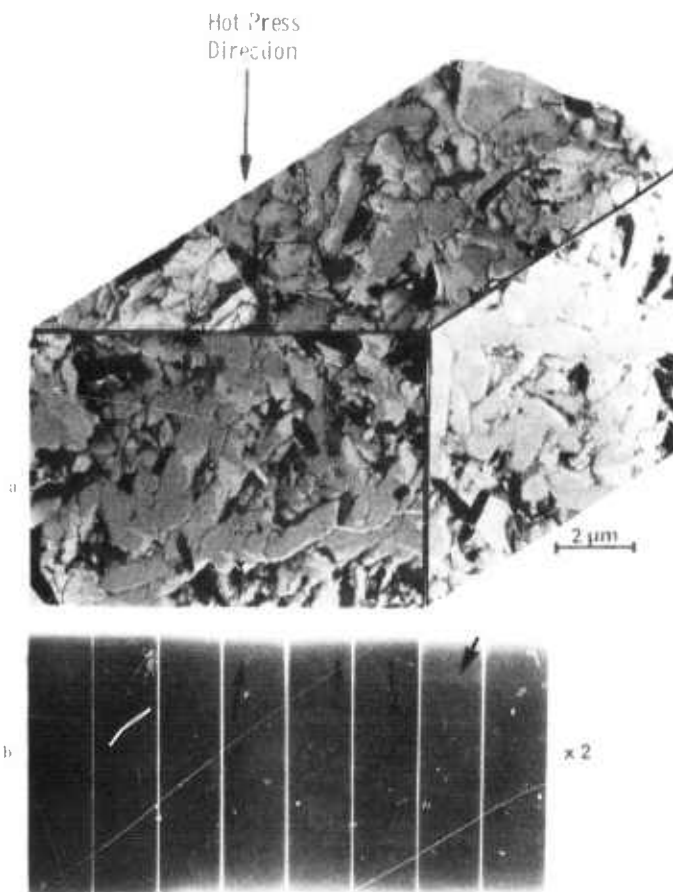
Figure 5.57 — Typical Features of an As-Received  $\text{Si}_3\text{N}_4$  Billet

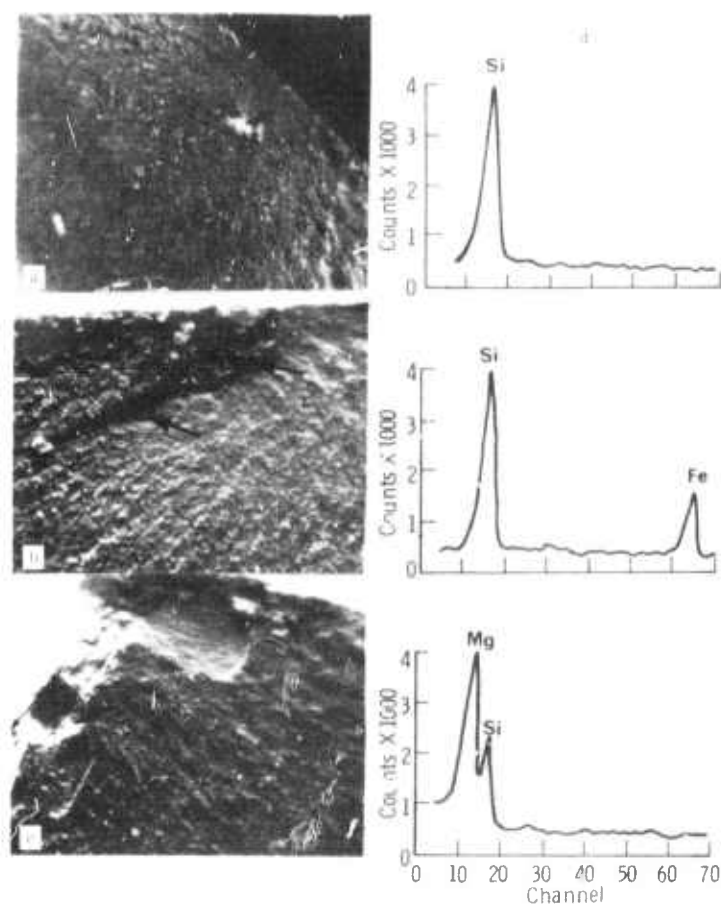
Figure 5.58 — Common Inclusions on Fractured Surfaces Causing Strength Degradation. Four Point Bend Specimens, Tested at  $2350^{\circ}\text{F}$ . Average Strength (20 Specimens) 69,000 psi

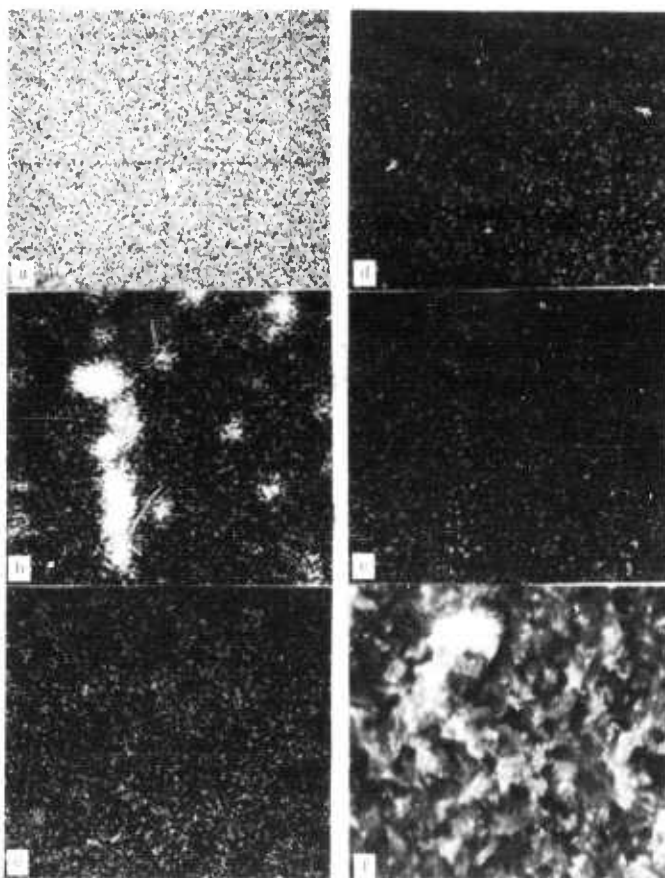
Figure 5.60 — Distribution of Impurity Elements. Microprobe Analysis, HS-110 Material. 1600X

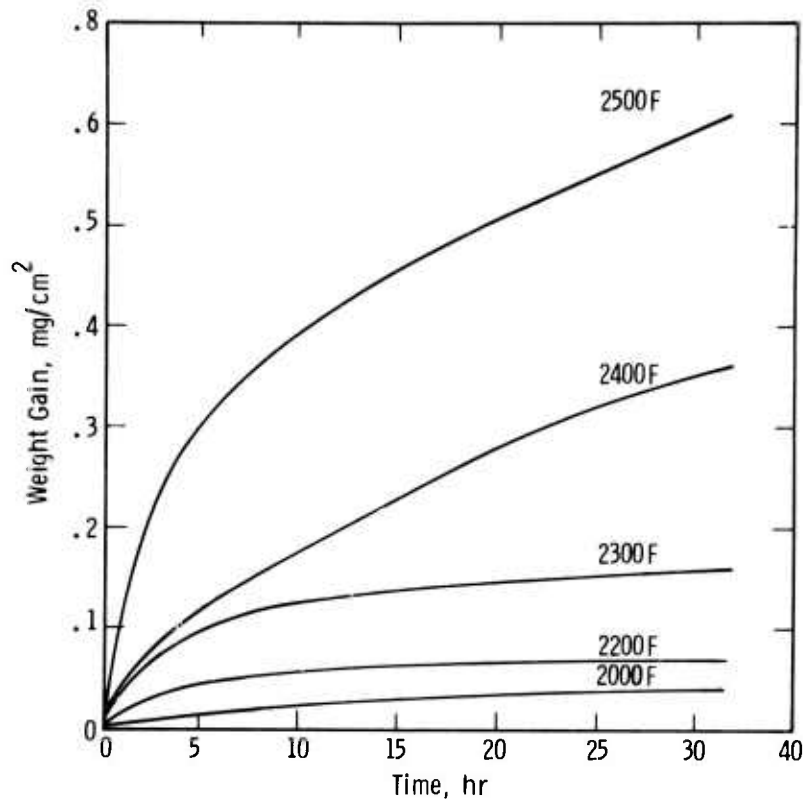
Figure 5.66 — Effect of Temperature on Oxidation of Norton HS-130  $\text{Si}_3\text{N}_4$  in Oxygen at 1 Atmosphere Pressure

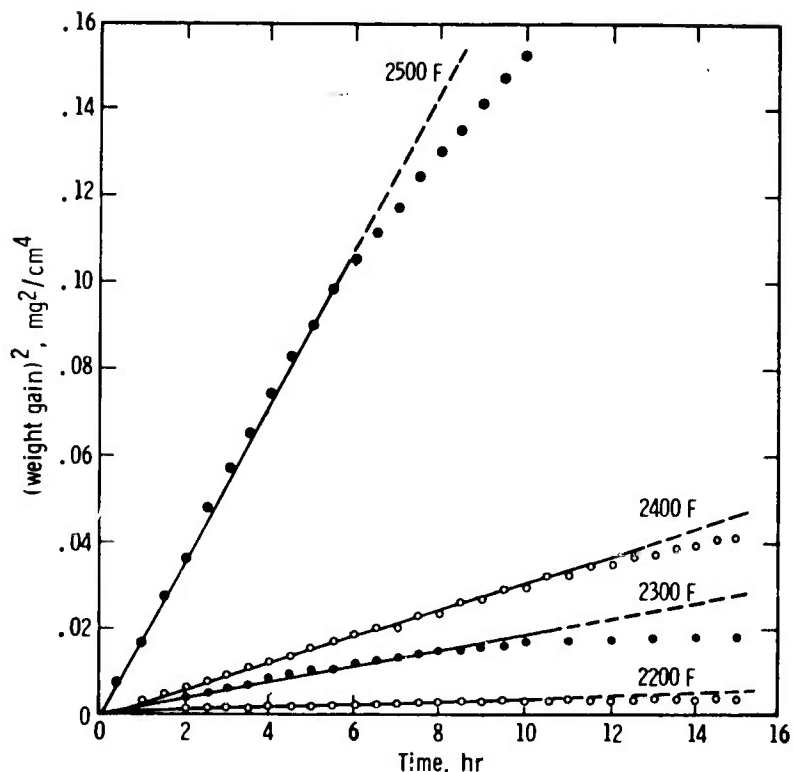
Figure 5.67 — Parabolic Plot of Oxidation of  $\text{Si}_3\text{N}_4$  in Oxygen at 1 Atmosphere Pressure

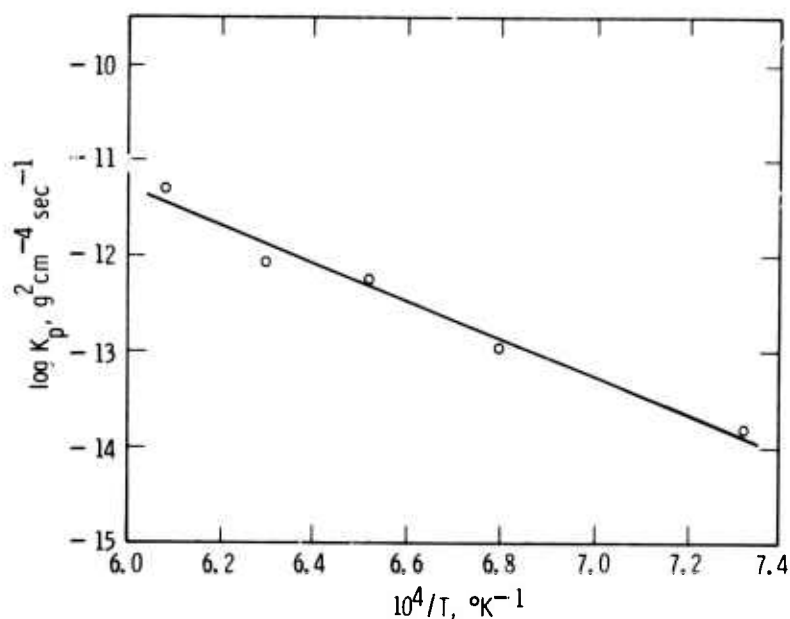
Figure 5.68 — Arrhenius Type Plot Showing Parabolic Rate Constant for Oxidation of Si<sub>3</sub>N<sub>4</sub> in 1 Atmosphere Oxygen as a Function of Temperature

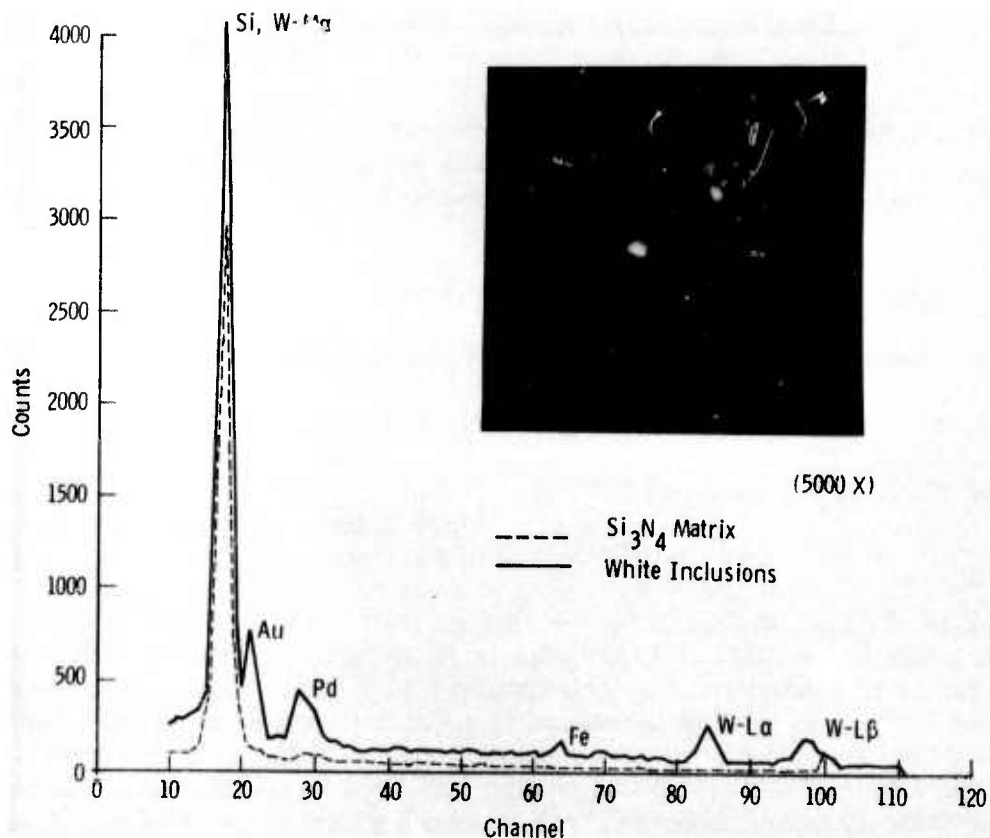
Figure 5.70 — Non-Dispersive X-Ray Analysis of Unoxidized Silicon Nitride Specimen Showing Tungsten Carbide Inclusions

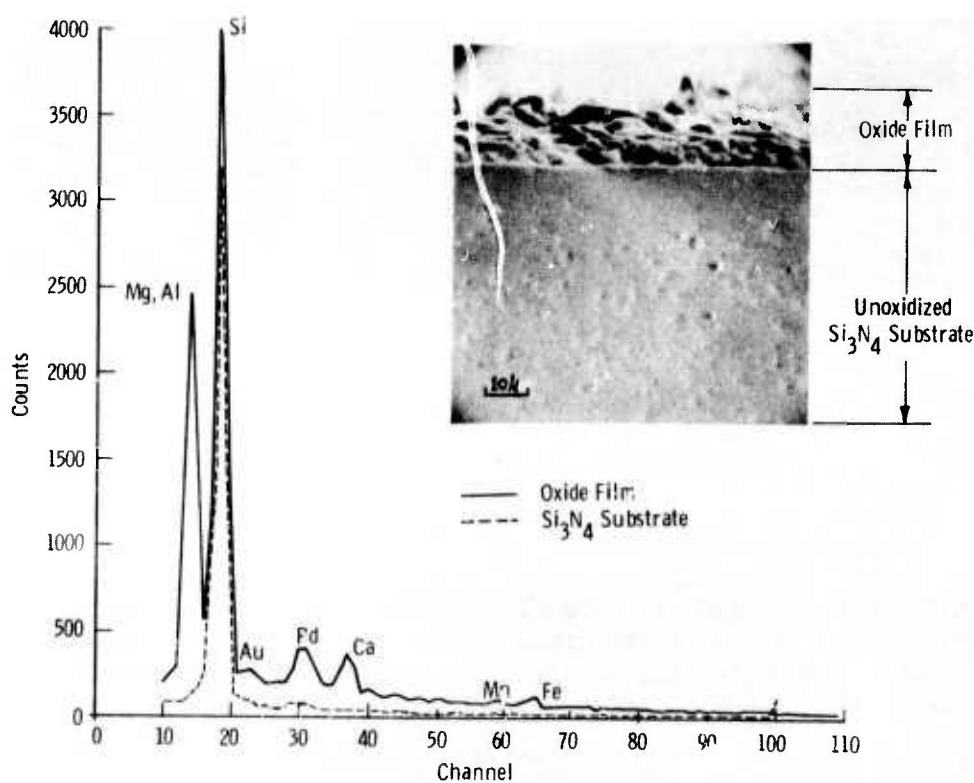
Figure 5.73 — Scanning Electron Micrograph of a Transverse Section of a  $\text{Si}_3\text{N}_4$  Specimen Oxidized at  $2300^\circ\text{F}$  for 30 Hours in 1 Atmosphere Oxygen, With Non-Dispersive X-Ray Analysis in the Oxide Layer and in the  $\text{Si}_3\text{N}_4$  Substrate

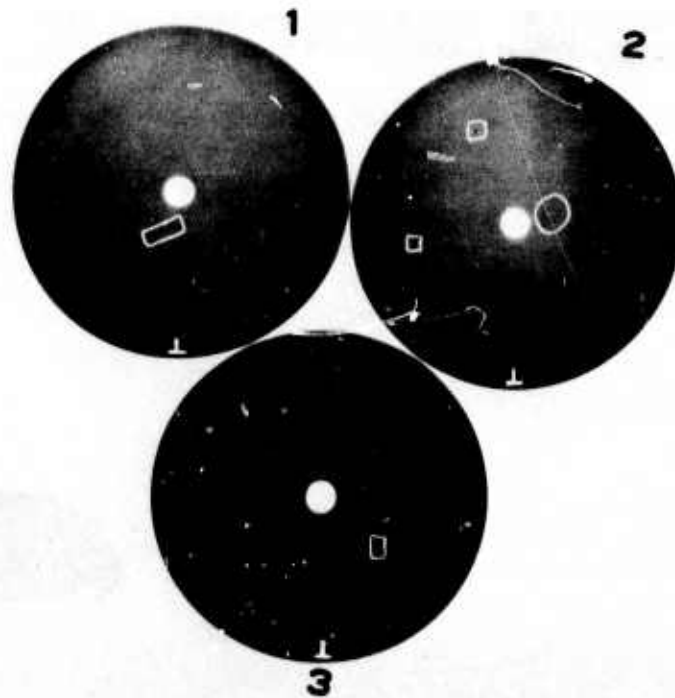
Figure 5.76 — X-Ray Radiographic Reversal Print of Hot Pressed Silicon Nitride Disks
